CAPE LOOKOUT NATIONAL SEASHORE
L. S. S. Boat House

HISTORIC STRUCTURE REPORT

August 2003
Historical Architecture, Cultural Resources Division
Southeast Regional Office
National Park Service

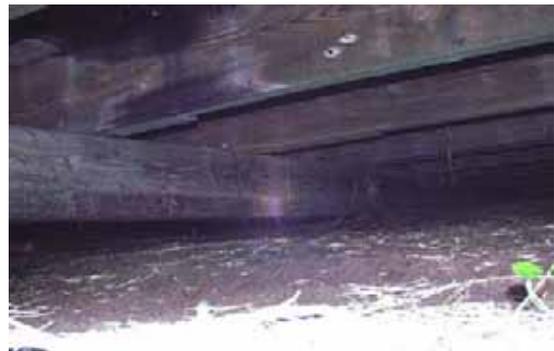
There is evidence that termites have attacked the floor framing, but the damage may not be widespread. Walls are generally plumb, floors

Figure 3 View of floor framing near rear of house. (NPS-SERO-CR, 2003)

- Inspect and repair sills and joists when building is relocated.

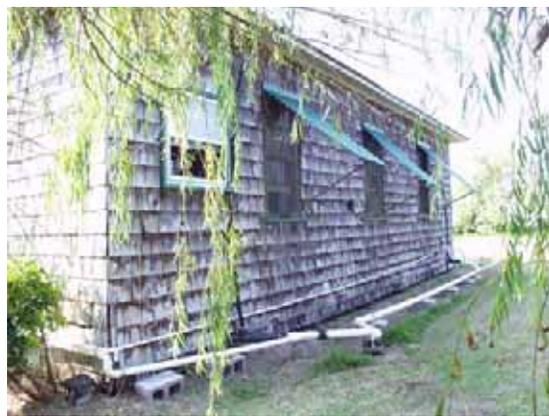
Figure 5 View of rear (northwest) side of house, showing typical exterior finishes. (NPS-SERO-CR, 2002)

- Remove cedar shingles; repair original drop siding.
- Repair existing soffit, window and door casing, and window sills.
- Remove wood- shingle roofing and install standing- seam metal roof.
- Paint soffit, siding, and trim white; paint window sash black.

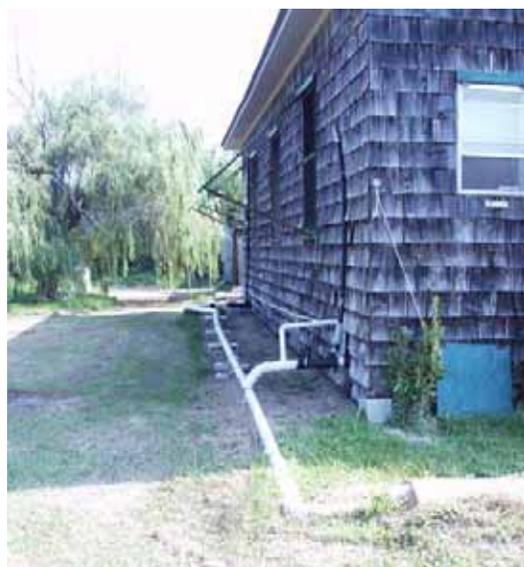
Figure 18 View of waste lines at rear of house. (NPS-SERO-CR, 2003)

The condition of the wiring could not be examined. Water and sewer lines are relatively new but are run in an *ad hoc* fashion across the rear of the house. There is no central heating.

- Install new water supply and waste lines if new rest rooms are installed.
- Design electrical system with simple lighting to serve exhibits.
- Install smoke/fire detector system.
- If necessary, install electrical baseboard heaters.
