CAPE LOOKOUT NATIONAL SEASHORE
Coca-Cola House

HISTORIC STRUCTURE REPORT

August 2003
Historical Architecture, Cultural Resources Division
Southeast Regional Office
National Park Service

2002
Historic Structure Report
Coca-Cola House
CAPE LOOKOUT NATIONAL SEASHORE
Cape Lookout Village
LCS#: 091837

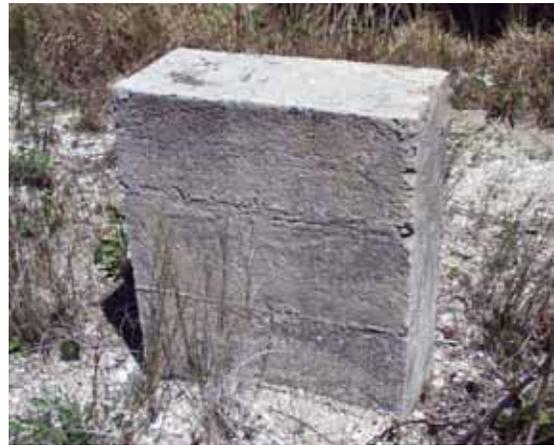
Figure 5 View of typical concrete pier. (NPS-SERO-CR, 2002)

Except for some of the buildings at the old Coast Guard and Lighthouse stations, which were built on brick piers, most of the residences at Cape Lookout were built on wood pilings. The wood frame of the Coca-Cola House, however, was built on poured concrete piers, spaced about six feet apart, and probably set on some sort of spread footing. Piers are about 8" by 15" in plan and 15" high. All of the piers remain in relatively good condition, except where the original porch was removed along the south sides of the house, allowing some of the piers to be overturned or destabilized.

- Eliminate wood-to-ground contact at all locations, repairing damaged beams as necessary.
- Install metal termite shields at all piers.

- Reset concrete piers for missing porches as necessary.

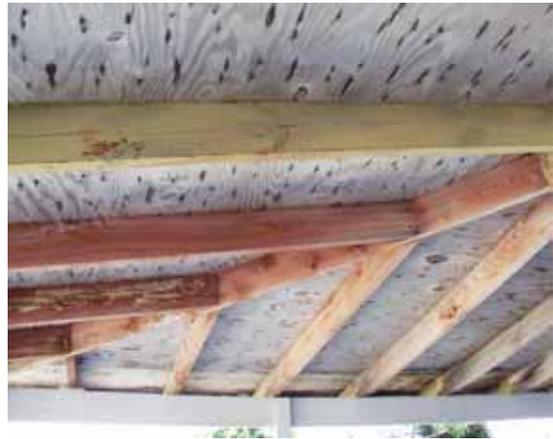
According to tradition, the house was painted red through much of its existence. Traces of this red paint are still visible in the framing of the porch roof around the north corner of the building, and red is also visible on window casing along with white window sash in one of the 1976 photographs. Except for white window sash and an unpainted porch floor, it is

Figure 7 View of original porch roof framing at north corner of house. (NPS-SERO-CR, 2003)

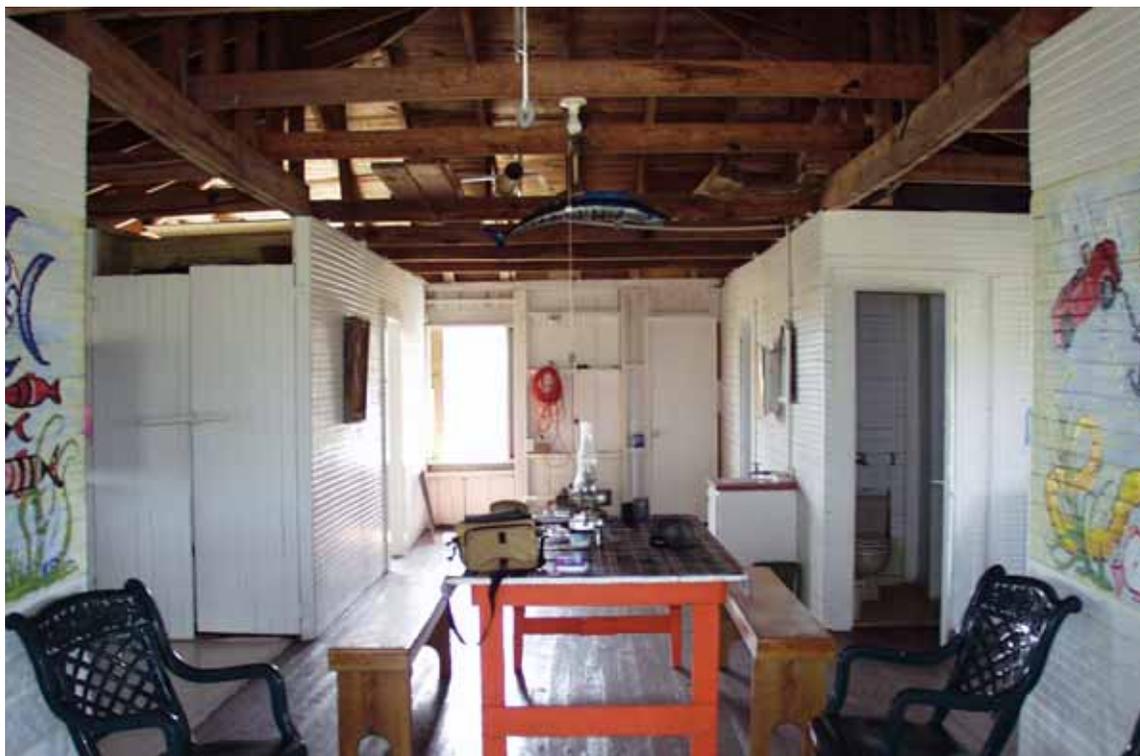
Figure 9 View to southeast showing back door now opening to the garage. (NPS-SERO-CR, 2003)

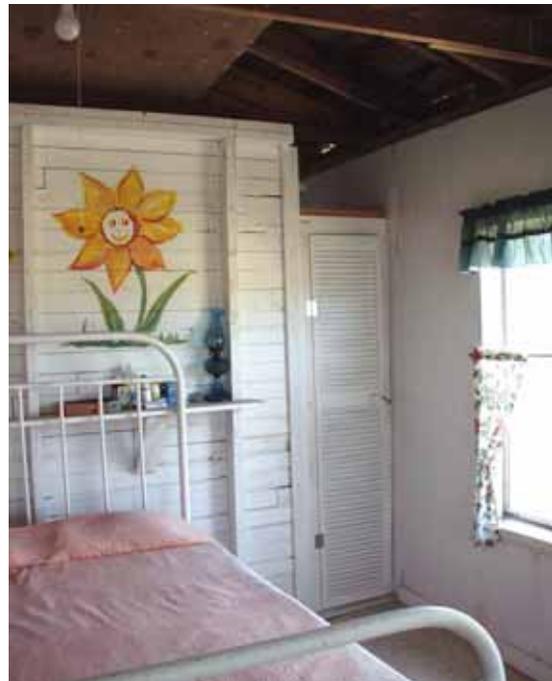
Modern repairs to the roof framing on the southwest side of the house resulted in the removal of small portions of the southeast wall of Room 102 and of the southwest wall of Room 105. In addition, a small closet has been installed in the south corner of Room 102

Figure 16 View south in Room 102, showing altered wall and added closet door. (NPS-SERO-CR, 2003)

- Rework repaired connections between rafters and wall framing to improve appearance from the interior.
- Reconstruct missing wall framing and paneling at southwest ends of walls on either side of southwest wing of hall.
- Repair termite damage as necessary.

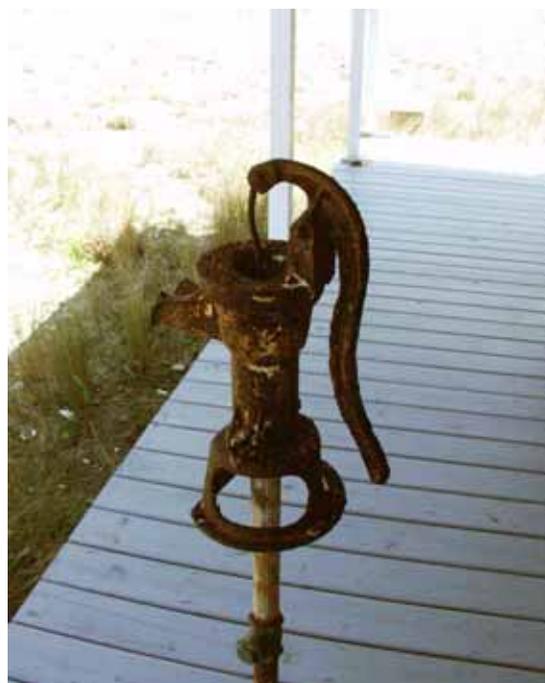
Prior to World War II, the house did not have running water, although water could be drawn from two hand pumps - - one in the kitchen and one on the northeast porch. Lighting would have been provided by kerosene or possibly battery- powered lights. Existing wiring is mostly Romex, without conduit, and, due to the nature of the building, run exposed in most locations. The house has apparently never had any sort of heating system.

Figure 19 Hand-operated water pump on northeast porch. (NPS-SERO-CR, 2003)
