Cape Lookout National Seashore
LEWIS- DAVIS HOUSE

HISTORIC STRUCTURE REPORT

August 2003

2003
Historic Structure Report
Lewis- Davis House
Cape Lookout National Seashore
Cape Lookout Village
LCS#: 091828

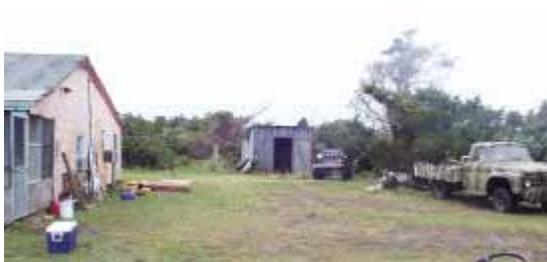
Figure 21 View to northwest, showing metal storage building in rear yard. (NPS-SERO-CR, 2002)

Like the Gaskill- Guthrie House, the house was built on a lot 50' by 220' that combined two of the original lots laid out by the Cape Lookout Development Company in 1915. In the rear yard is a modern metal storage building, 12'-3" by 15'-3". Partially-burned piles of refuse litter the grounds.

- Clear site of rubbish and debris.
- Remove storage building.
- Follow recommendations of Cultural Landscape Report in determining treatment of the surrounding landscape.
- Improve site drainage and eliminate standing water beneath house.

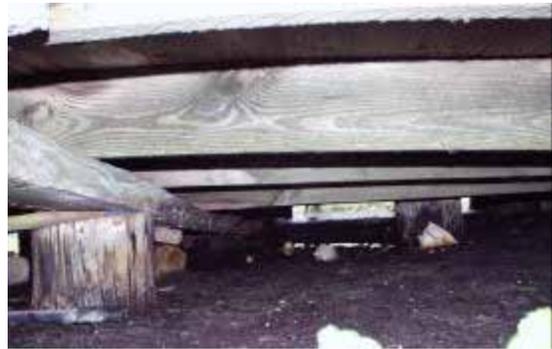
The wood frame of the main body of the house is set on a series of wooden piers, 8" - 12" in diameter, sunk to some indeterminate depth into the ground. Piers are so low that the house's frame is only a few inches above grade. Most are, at best, in fair condition, and concrete block have been inserted at some locations to provide additional support. Water is standing under large areas of the house, contributing to its ongoing deterioration.

Figure 23 View of crawl space and piers. (NPS-SERO-CR, 2002)

- Raise house and replace all wood piles, replicating the existing size and placement of piles.
- Design and install storm- resistant mechanism to tie the house’s wood frame to the foundation piles.

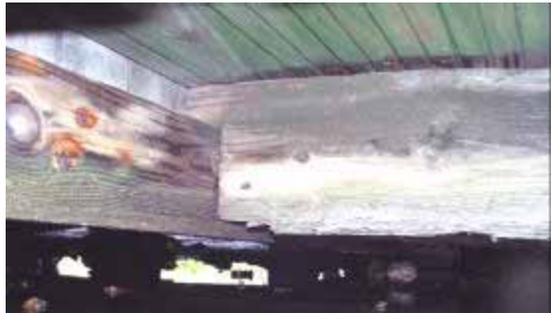
Figure 24 View of typical joist sill connection. (NPS-SERO-CR, 2002)

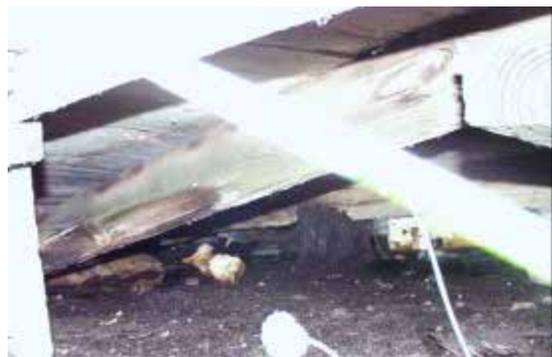
Floor: Floor joists appear to be a mix of 2" by 4" and 2" by 6" (actual dimensions could not be ascertained), set on 30"- 36" centers. Deterioration is widespread. Sills appear to be mostly single 2" by 8". Along the northwest side of Room 104, floor joists and sill have collapsed and there is major structural damage in Room

Figure 25 View of collapsing floor under Room 104. (NPS-SERO-CR, 2002)

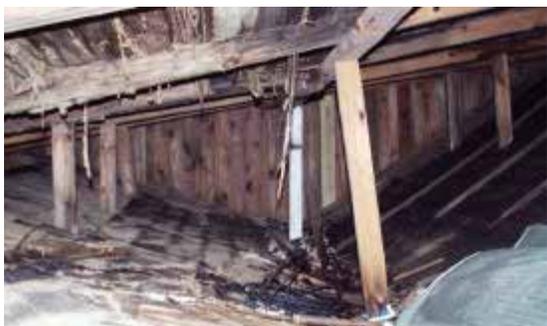
Figure 26 View of junction of roofs of two original structures; note severe termite damage in rafters and decking at left. (NPS-SERO-CR, 2002)

Rafters: There are three main rafter systems in the present structure: one over Rooms 100 and 101, which could not be examined, and another separate system over the rear rooms. When the two halves of the house were joined, a new roof structure was built to cover both of the earlier roofs (see Figure 10). Rafters of this third roof are around 1- 3/4” by 3- 3/4” , on 30” centers, and woefully undersized for their span and pitch. Rafters at the rear of the house have been severely damaged by termites.

- Stabilize structure before repairs proceed.
- Remove 1950s roof structure and restore original roofs.
- Repair floor, wall, and ceiling framing as necessary and make improvements in connections of framing members to reduce the possibility of significant damage from high winds.

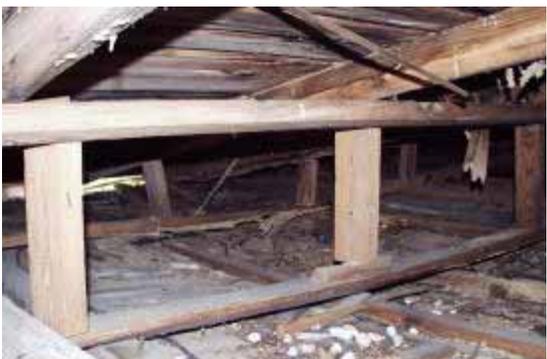
Figure 28 View of heavily-damaged roof and ceiling structure over Room 104. (NPS-SERO-CR, 2002)

Ceilings: Like the walls, the ceilings appear to be very loosely framed, using widely-spaced 2” by 4” joists or, in some cases, 2” by 6” laid flat. The ceiling above Room 104 has been heavily damaged by water penetration and termites.

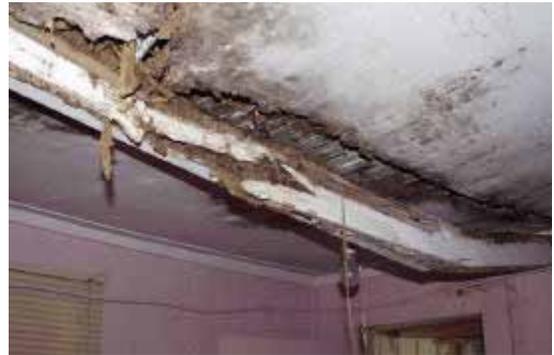
Figure 41 View to east of ceiling in Room 104. (NPS-SERO-CR, 2002)
