# Historic Structure Assessment Report

## **Bishop Barn**

Gettysburg, Pennsylvania

June 2018

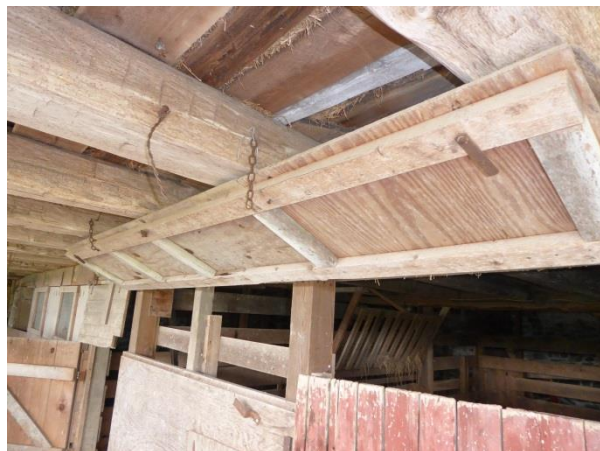
The south elevation lower floor forebay wall has been completely rebuilt with modern materials and in no way reflects what was there originally. Photo: HPTC, 06/22/17.

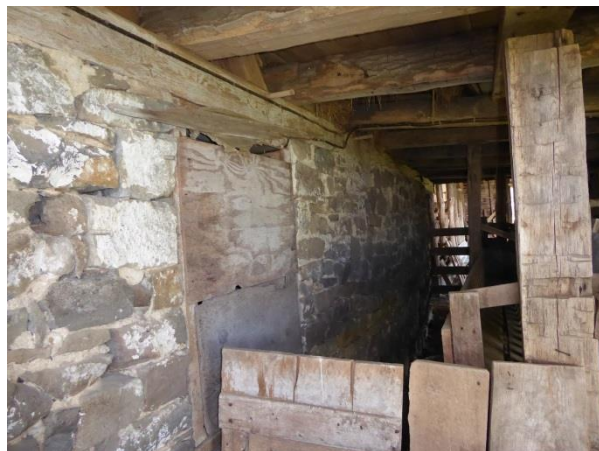
The window opening in the west elevation of the stone foundation is likely original, but has been covered with modern plywood. Photo: HPTC, 06/22/17.

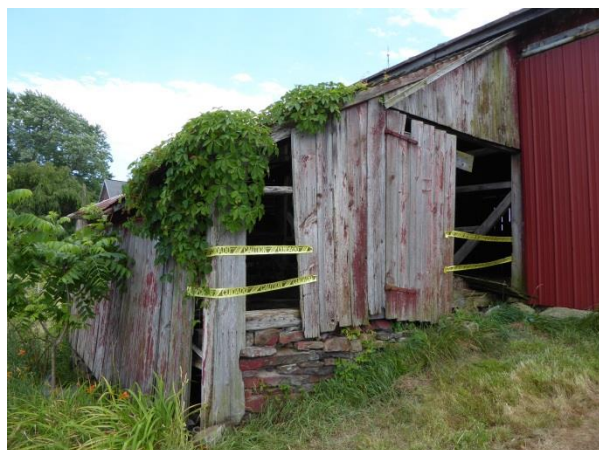
A pair of swining doors (one missing) are located on the west elevation of the outshed granary. Photo: HPTC, 06/22/17.

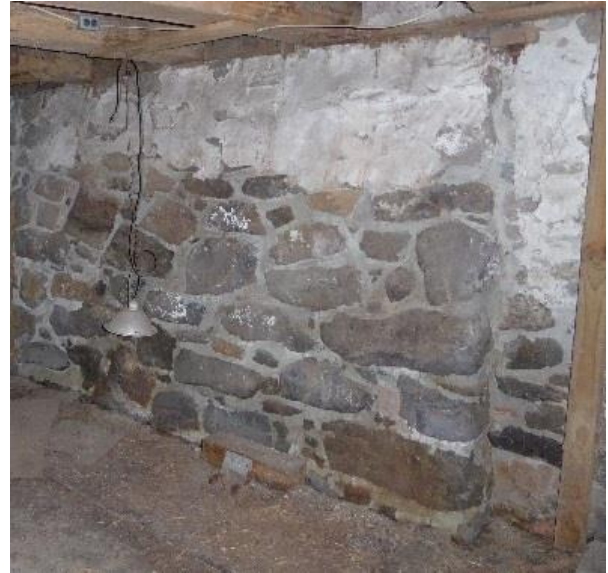
The historic random rubble and ashlar granite and fieldstone foundation walls on the north elevation are covered with modern cement parging. Photo: HPTC, 06/21/17.

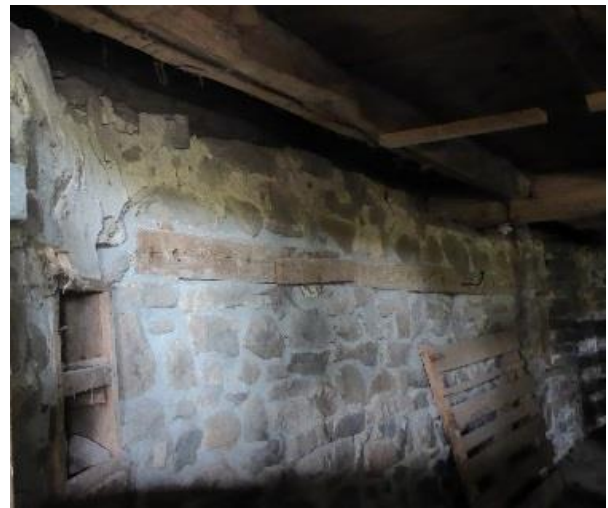
The interior of the west foundation wall has been repointed with Portland cement-based mortar. Photo: HPTC, 06/21/17.

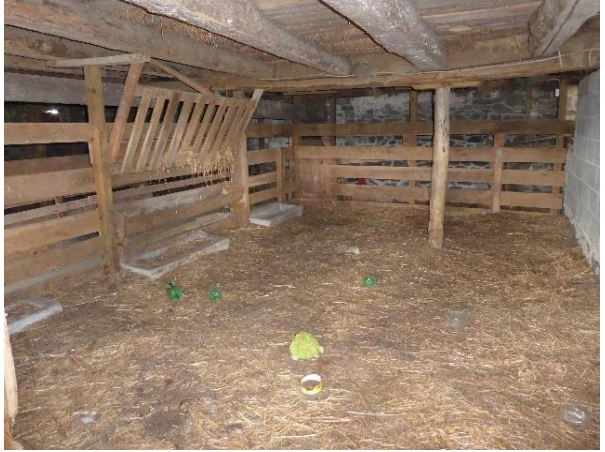
| <b>A1030 Slab On Grade</b> | |
|---|---|
| <p>The entire portion of the lower level enclosed by the stone foundation contains a modern poured concrete slab on grade. A significant portion is covered with straw and other debris limiting assessment by the HPTC staff. It is assumed that the slab is in fair condition with minor cracks across the surface of the floor.</p> | <p>Straw covers a significant portion of the poured concrete slab on grade. Photo: HPTC, 06/21/17.</p> |

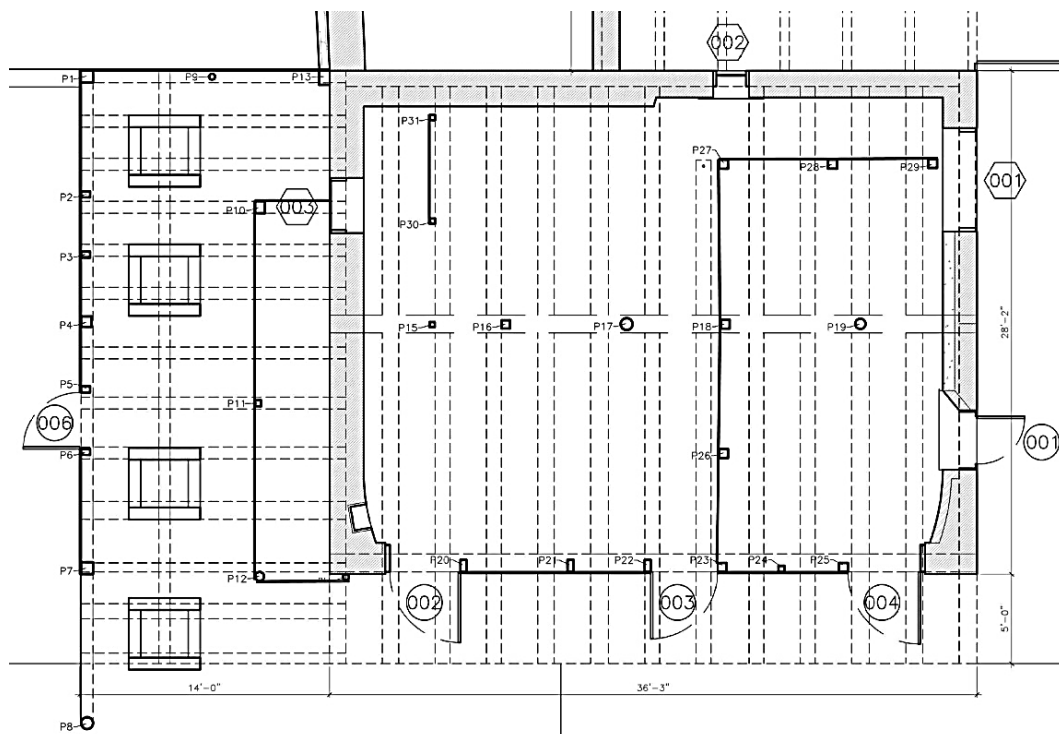
Lower level of the barn; north is right. The posts are numbered. See Appendix A for 11x17 copies of the drawing. Drawing: HPTC, 07/11/18.

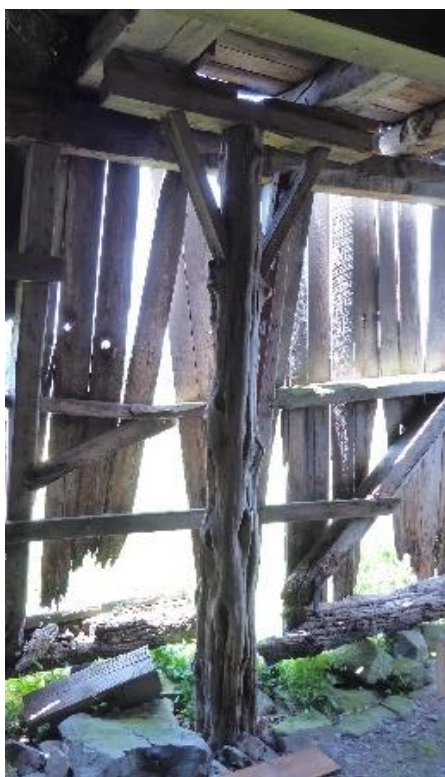
P3 is a replacement post located along the west elevation of the timber-frame foundation wall of the wagon shed. Photo: HPTC, 06/21/17.

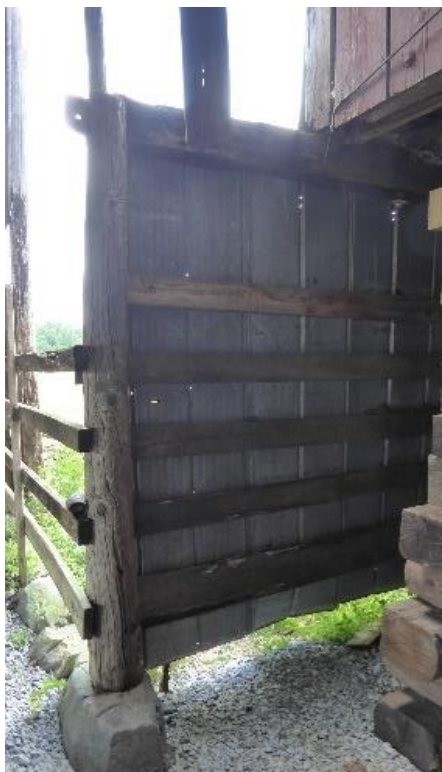
P12 is modern and supplemental to support the floor framing above the wagon shed; the adjacent modern cribbing does the same. Photo: HPTC, 06/21/17.

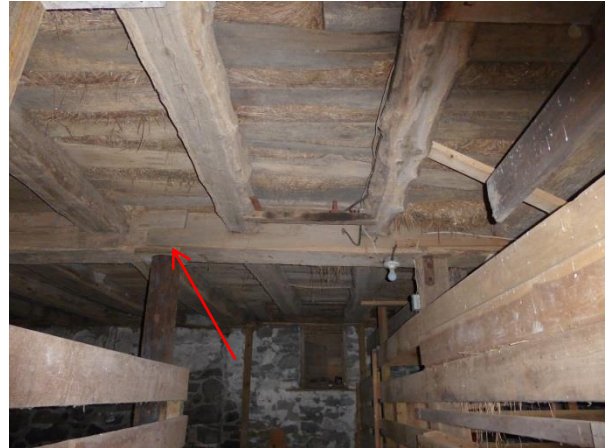
The summer beam is half lapped at the mid-point. The joint is supported by modern replacement P22. Photo: HPTC, 06/21/17.

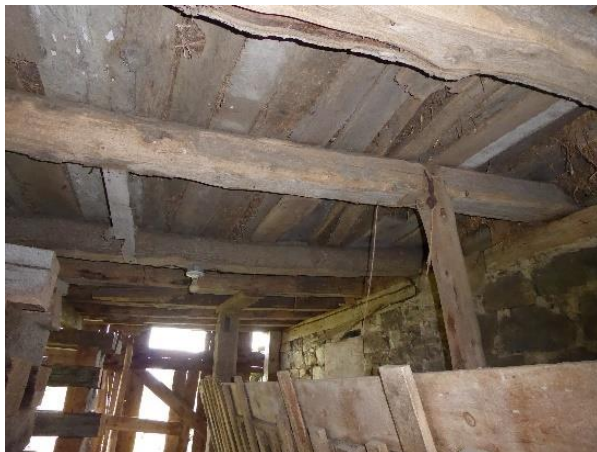
The joists above the wagon shed do not match suggesting they have been replaced over time. Photo: HPTC, 06/21/17.

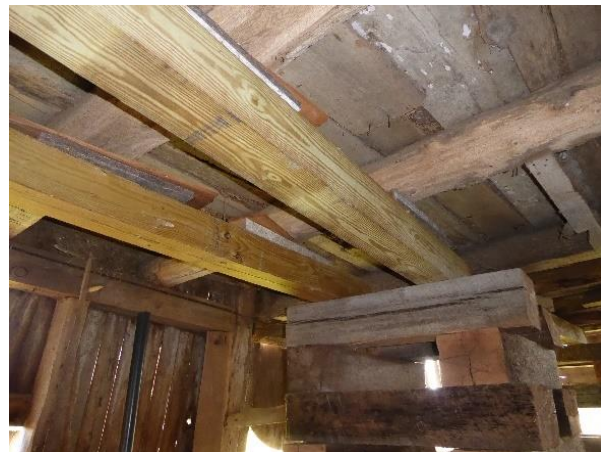
Modern cribbing and supplemental framing support the joists in the wagon shed due to deteriorated foundations. Photo: HPTC, 06/21/17.

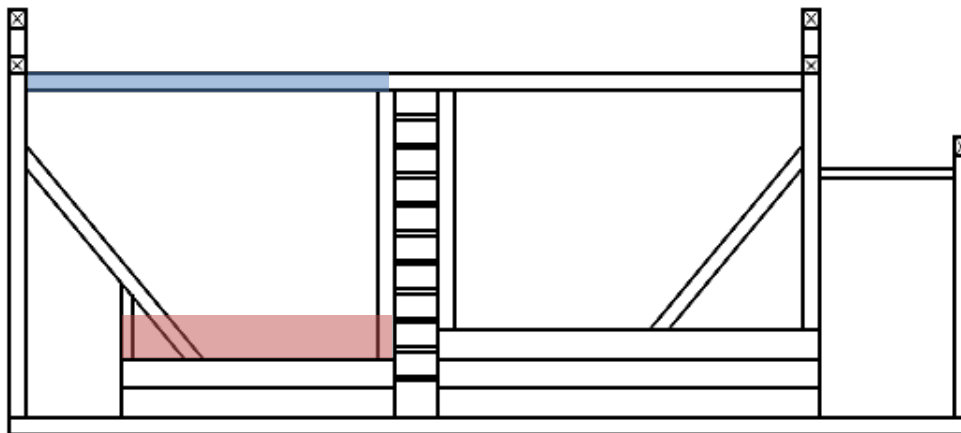
Minor issues identified at the east bent (as seen from the center threshing bay). Red marks the location of a missing board on the flailing wall; blue marks the location of a poorly sistered beam. Drawing: HPTC, 07/11/18.

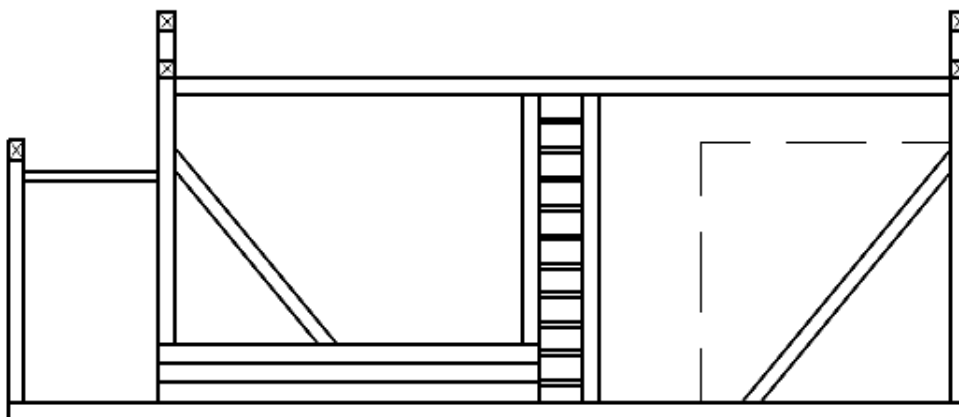
The west bent (as seen from the center threshing bay). No significant issues were noted on this structural system. Drawing: HPTC, 07/11/18.

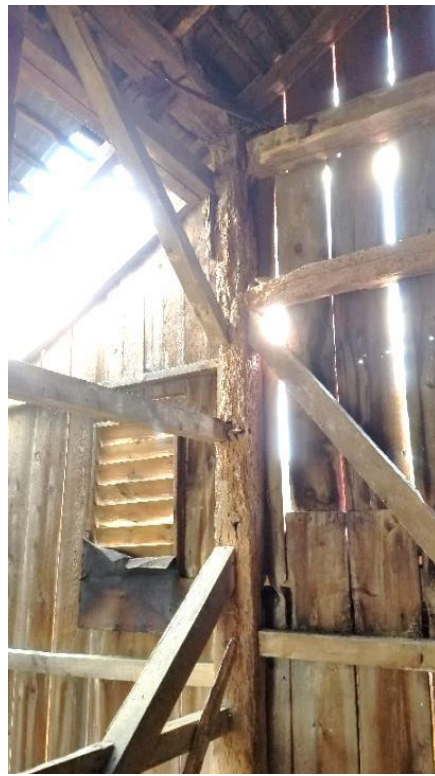
Significant rot and insect damage on the northeast end post. Photo: HPTC, 06/21/17.

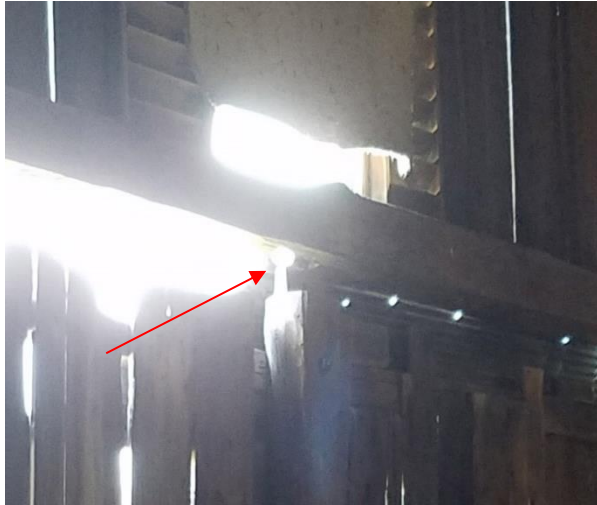
Tenon of the center west wall post is removed from its mortise as the wall is pulled down by failing foundations and framing below. Photo: HPTC, 06/21/17.

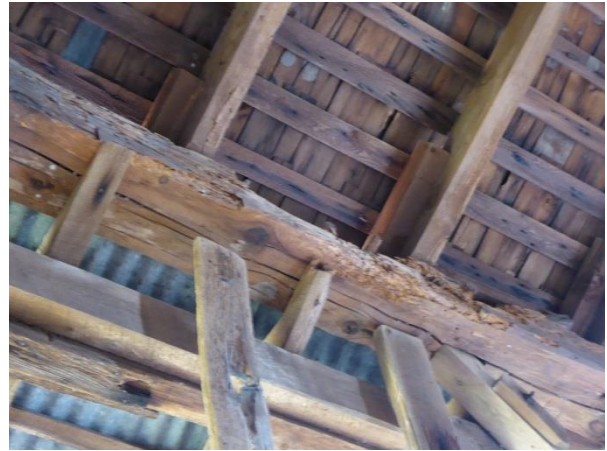
The roof plate of the north elevation has insect damage at its eastern end. Photo: HPTC, 06/21/17.

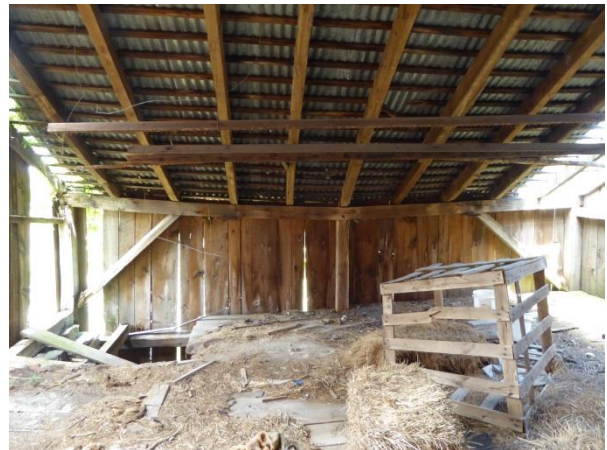
The interior elevation of the outshed granary's north wall. Damage has occurred to the structural members due to damage to the foundation wall below. Photo: HTPC, 06/21/17.

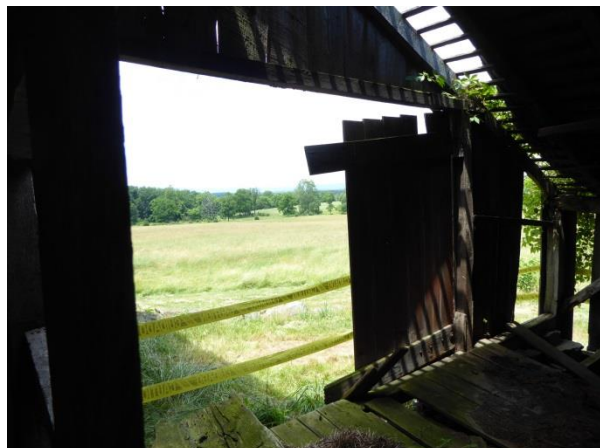
The interior elevation of the outshed granary's west wall. Damage has occurred to the structural members due to the missing roof covering and doors. Photo: HPTC, 06/21/17.

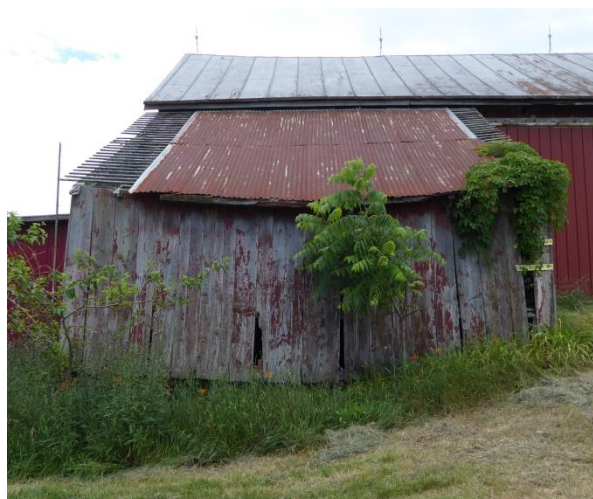
The siding on the north elevation of the outshed granary has not been painted in a long time. Photo: HPTC, 06/21/17.

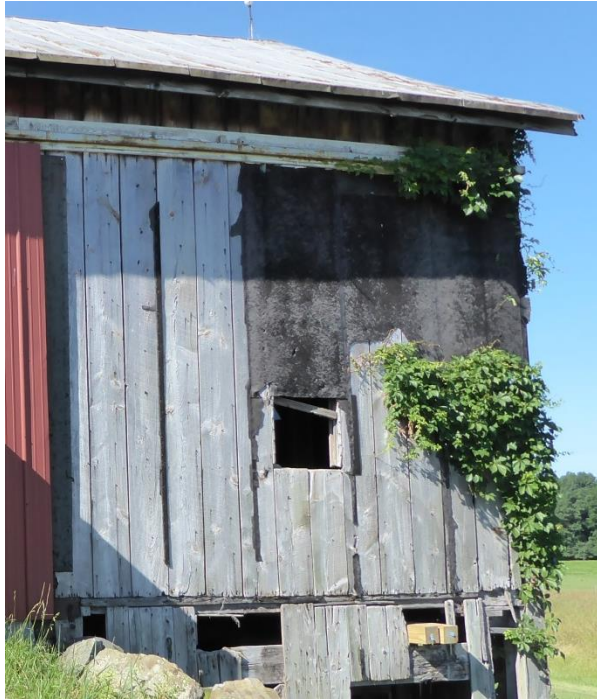
A louvered opening is hidden behind the black roofing material on the north elevation of the barn. The opening has been altered for access into the interior granary. Photo: HPTC, 06/21/17.

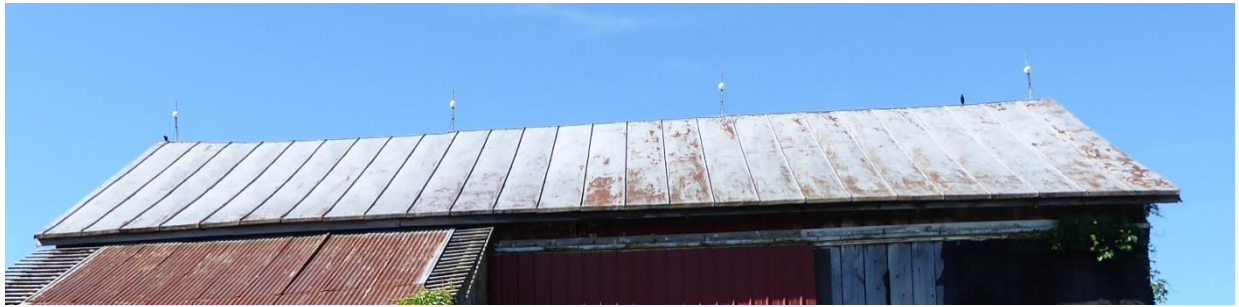
The north slope of the barn gable roof is covered with historic standing-seam metal. Note the deteriorated paint. Photo: HPTC, 06/20/17.

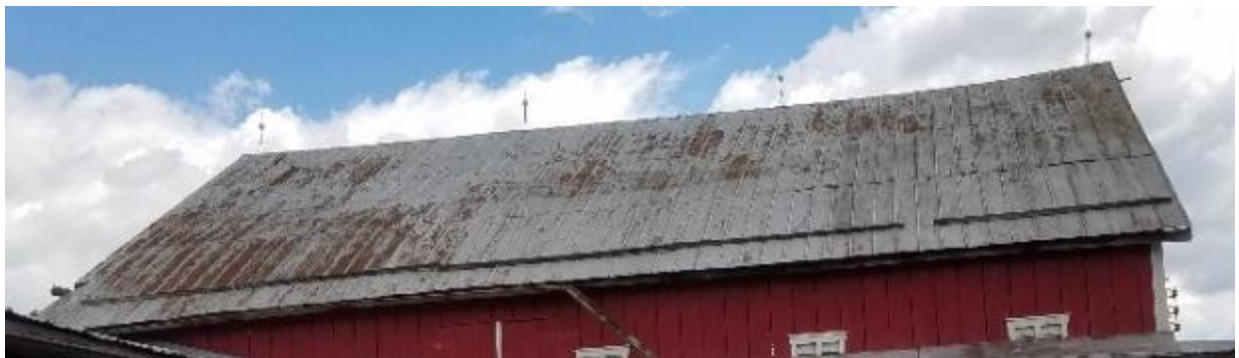
The south slope of the barn gable roof is covered with modern corrugated metal panel. Note the deteriorated paint. Photo: HPTC, 06/21/17.

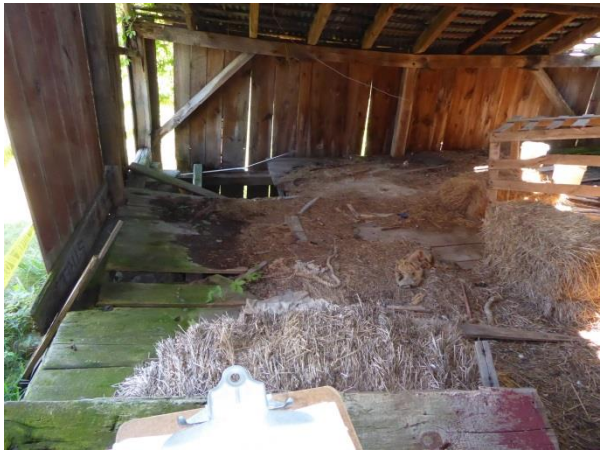
| <b>B301001-2 Outshed Granary Roof Finishes</b> | |
|---|---|
| <p>The corrugated metal roof covering of the outshed granary is missing portions on the east and west sides. Photo: HPTC, 06/21/17.</p> <p><i>Right:</i> Deteriorated interior conditions inside the outshed granary due to missing roof coverings. Photo: HPTC, 06/21/17.</p> | |

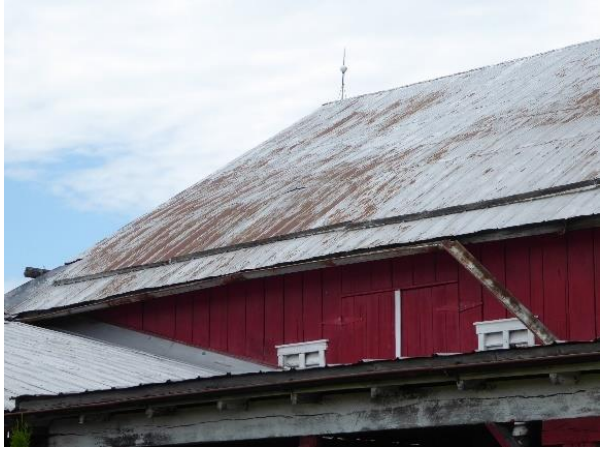
| <b>B301005 Gutters &amp; Downspouts</b> | |
|---|---|
| <p>Remnants of galvanized metal 0'-6"-wide half-round gutters are located at the eave line of the south slope of the barn's gable roof. No downspouts are extant.</p> <p>No roof drainage system components are located on the north slope of the barn's gable roof.</p> | <p>Failed south elevation gutters. Photo: HPTC, 06/21/17.</p> |

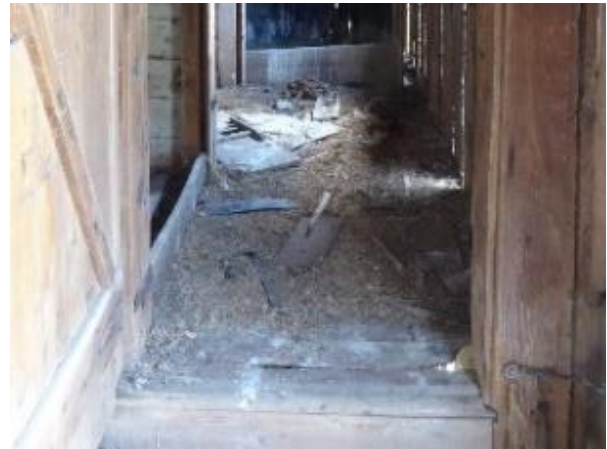
The flooring in the interior granary is deteriorated. Photo: HPTC, 06/21/17.
