## **Bishop House**

Gettysburg, Pennsylvania

# Historic Structure Assessment Report

## **Bishop House 2065 Emmitsburg Road Gettysburg, PA**

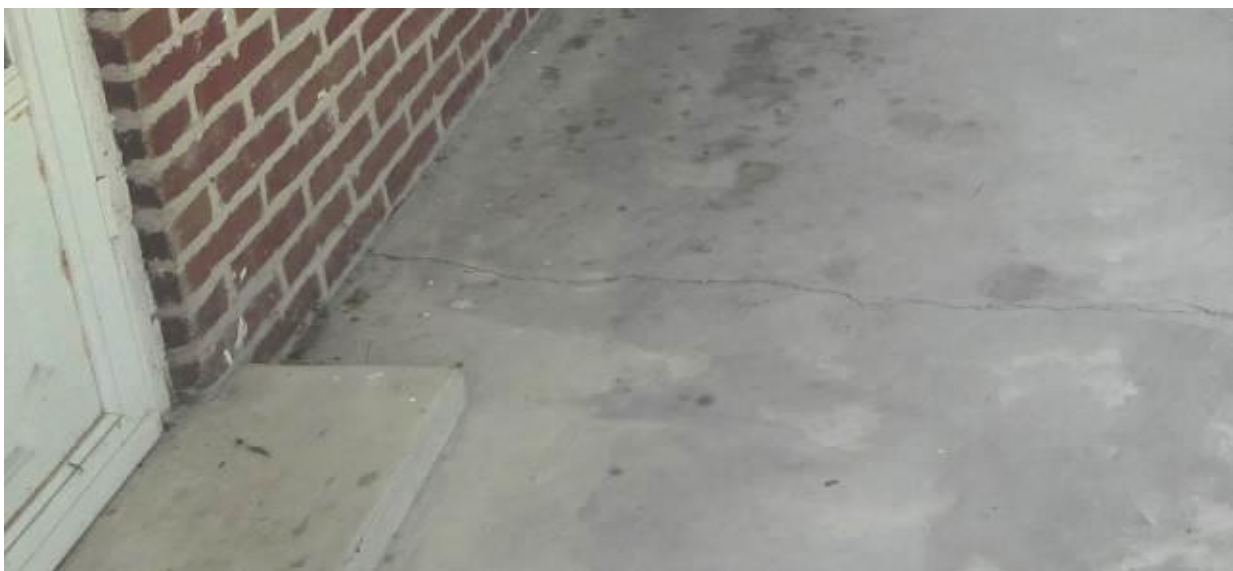
| <p>The sunroom/porch addition foundation is visible cracked on the east entry porch just north of D103, but is in overall good condition. Photo: HPTC, 6/7/17.</p> | | | |

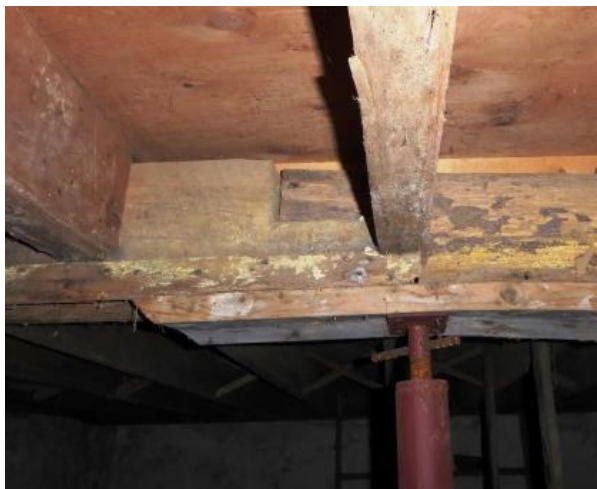
During the condition assessment trip in June 2017, the assessment team observed mold and moisture, principally on the summer beam. Rapid deterioration can occur due to the presence of mold and moisture, and the lack of passive ventilation in the basement which would deter the accumulation of either.

The half lap joint of the two timbers of the summer beam. Both lengths of the beam are extensively deteriorated. Photo: HPTC, 06/08/17.

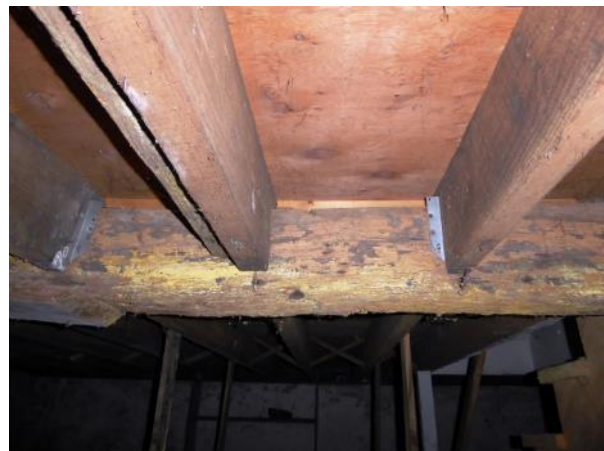
Some galvanized joist hangers have been added between the joists and the summer beam. Note extensive rot and mold, joist sistering, and modern joist hangers. Photo: HPTC, 06/08/17.

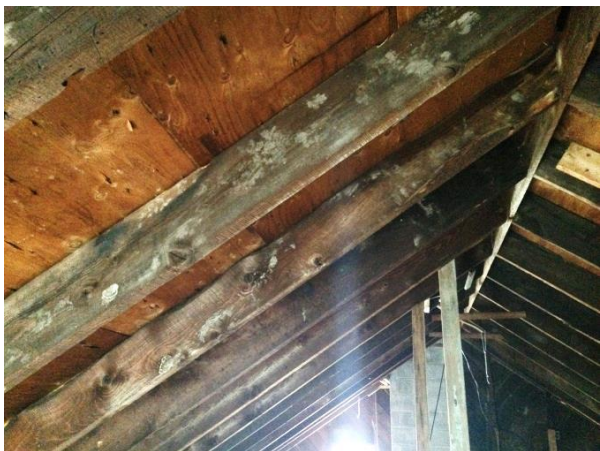
| Main block rafters meet at a ridgeboard. One rafter is sistered (arrow). Photo: HPTC, 06/08/17. | | Mold on rafters. Photo: HPTC, 06/21/17. | |

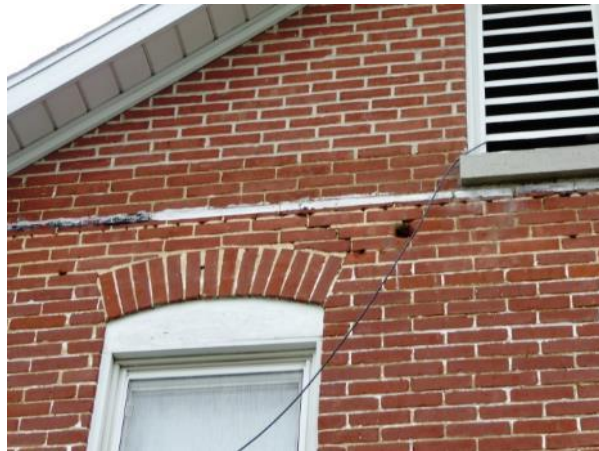
Main block, south wall. Note crack above window opening, missing mortar and brick, and mastic over the face of brick course below vent. This is likely a ghost line from a non-extant porch roof. Photo: HPTC, 06/07/17.

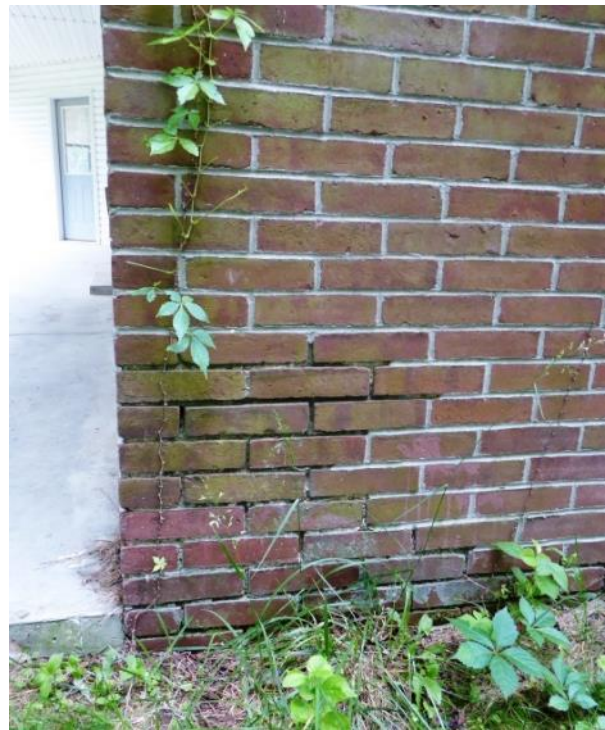
*Right:* Ivy, biological growth, and deteriorated mortar joints on the main block north wall adjacent to the east entry porch. These are all minor issues. Photo: HPTC, 06/07/17.

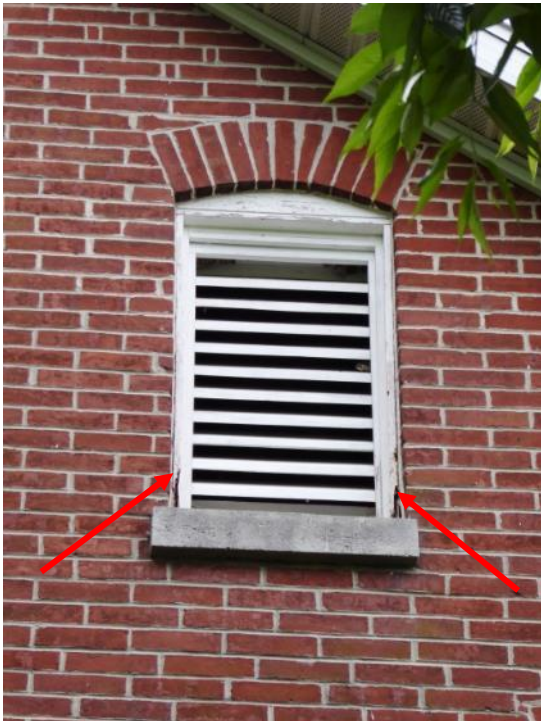
| <p>Wooden louvers are installed in two main block third-floor windows (window openings 302 and 303), one in each gable. These vents are in fair condition and have screens on their interior sides. Wood components of the window openings exhibit paint failure and some rot.</p> | | | | |
| W303 vent, exterior. Note jamb rot and paint failure. Photo: HPTC, 06/07/17. | | W303 vent, interior. Photo: HPTC, 06/08/17. | | |

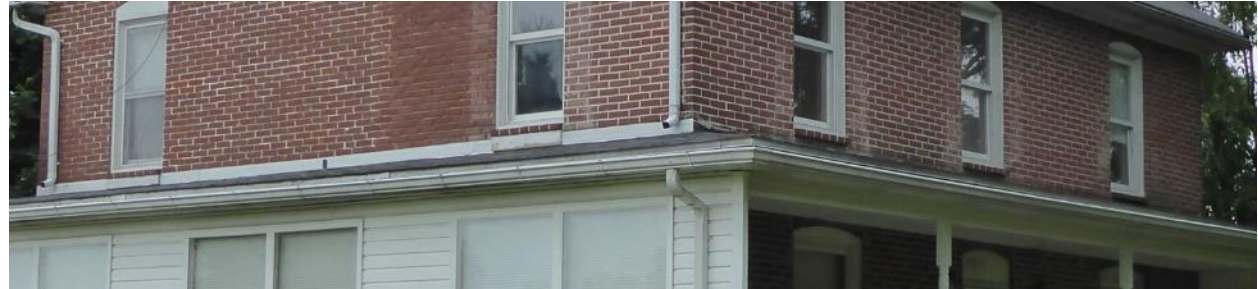
| <p>The juncture between the main block sidewall and sunroom/porch roof is flashed. Trim covering the flashing is extant on the south elevation, but missing from the east elevation. The extant flashing appears to be in fair condition and installed correctly but should be more thoroughly inspected when roof coverings are replaced.</p> <p>The chimney is improperly flashed (slope-flashed rather than step- and counter-flashed), but no leaks were evident within the house due to this detailing.</p> <p>Overall, flashings are in fair condition.</p> | | | | |

Sidewall trim over flashing on the east elevation of the main block is not extant. Photo: HPTC, 06/07/17.

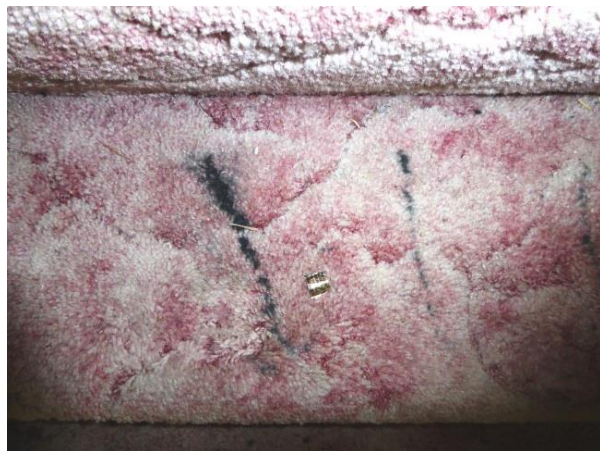
Carpet stains, main stair. Photo: HPTC, 06/08/17.

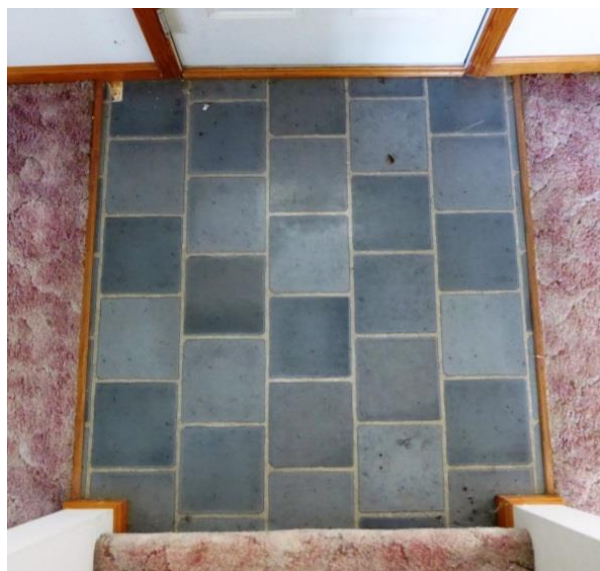
Sheet linoleum between Rooms 104 and 105 mimics natural stone tile. Note area of damage (upper left). Photo: HPTC, 06/08/17.

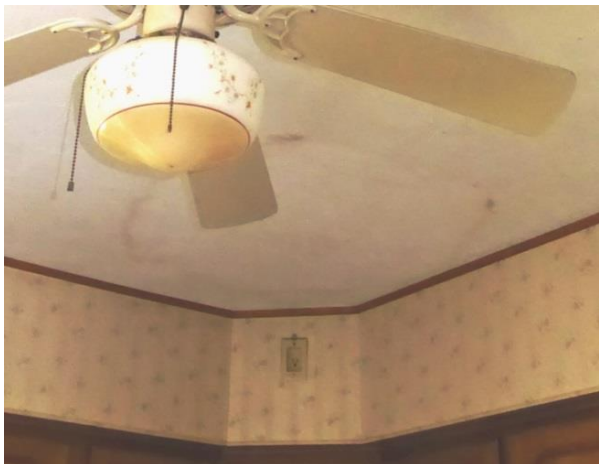
| <p>Typical main block textured ceiling finish, first floor. Photo: HPTC, 06/08/17.</p> | <p>Water staining, northwest corner of Room 102. Photo: HPTC, 06/08/17.</p> |

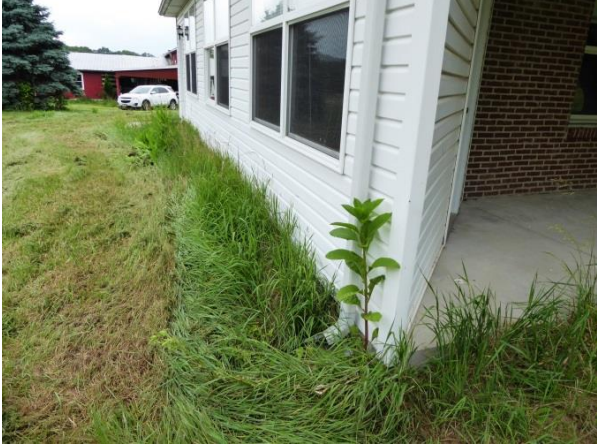
| | | <p><i>Left:</i> Vegetation on the south elevation retains moisture near the building. Photo: HPTC, 06/07/17.</p> | |
