## Carter G. Woodson Home

1538 Ninth Street, NW, Washington, DC

**FINAL SUBMISSION  
JANUARY 15, 2008**

# Historic Structure Report

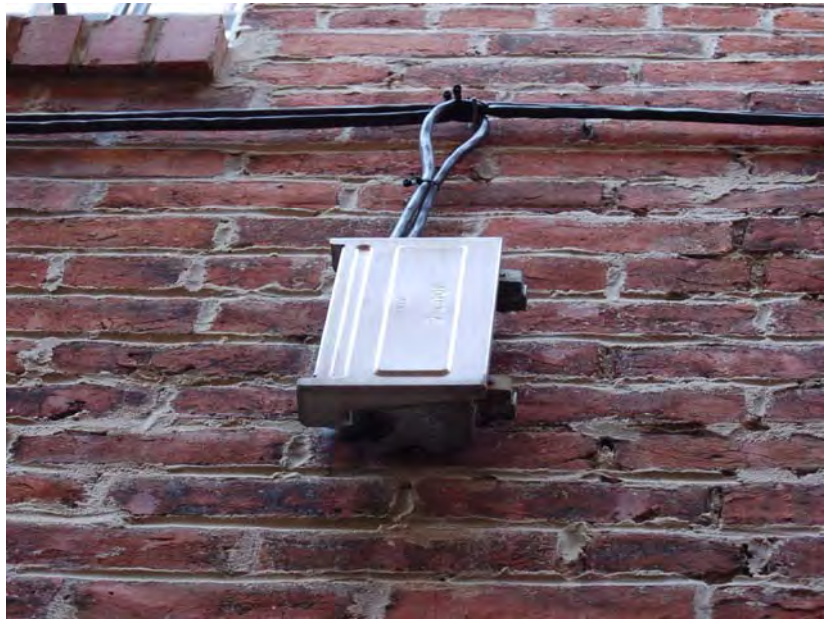
**Figure 3-066:** Surface mounted telephone box and cable. (Photo: BBB, 2007)

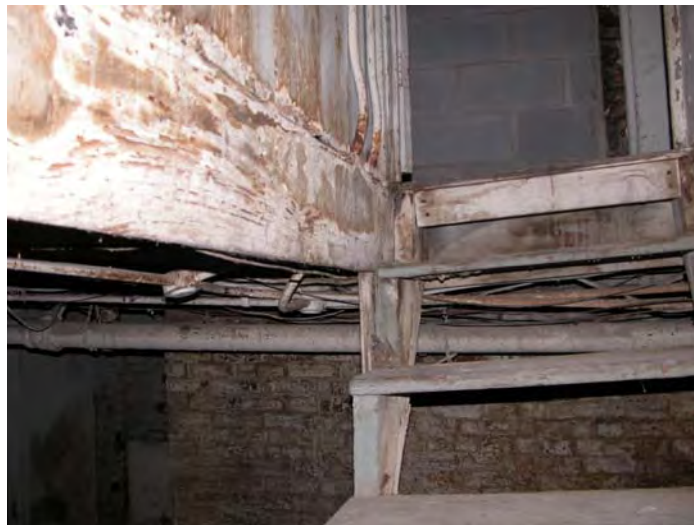
Figure 3-129: Termite damage at stair opening framing. (Photo: BBB, 2007)

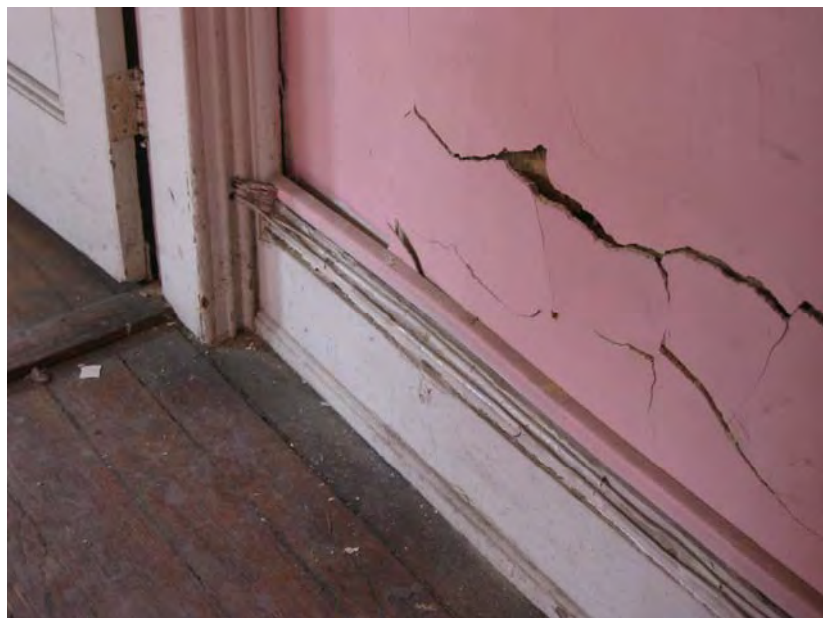
**Figure 3-278:** Plaster separating from substrate at north wall. (Photo: BBB, 2007)

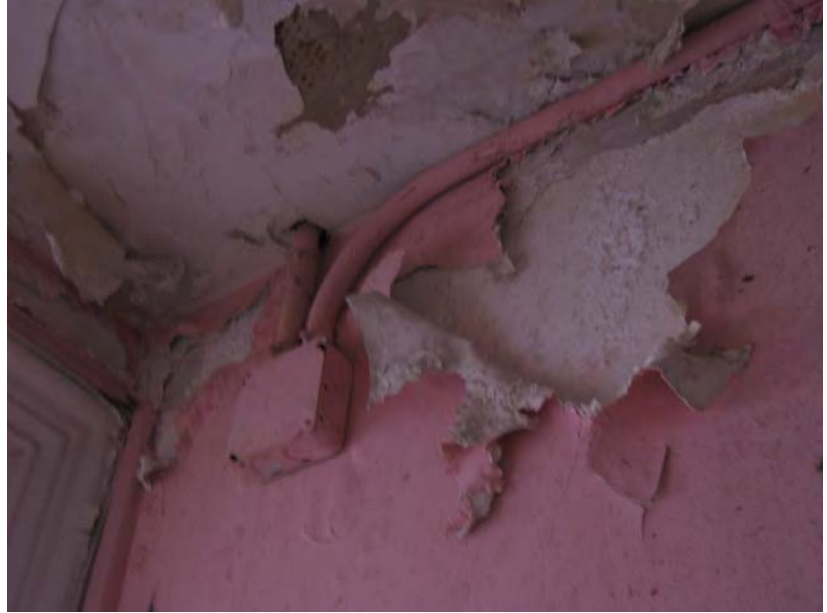
**Figure 3-298:** South wall – east corner water damage and surface mounted conduit.  
(Photo: BBB, 2007)

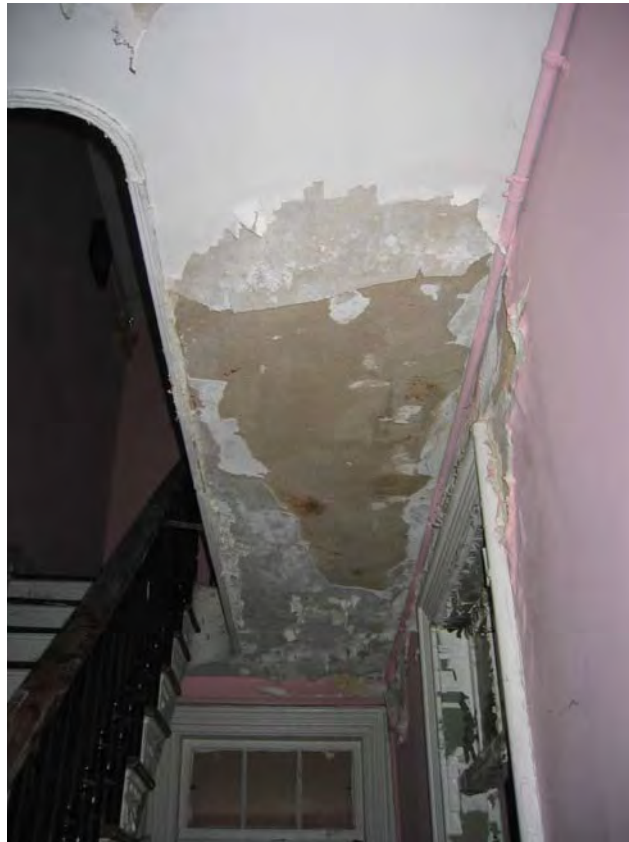
**Figure 3-301:** Plaster ceiling damage. (Photo: BBB, 2007)

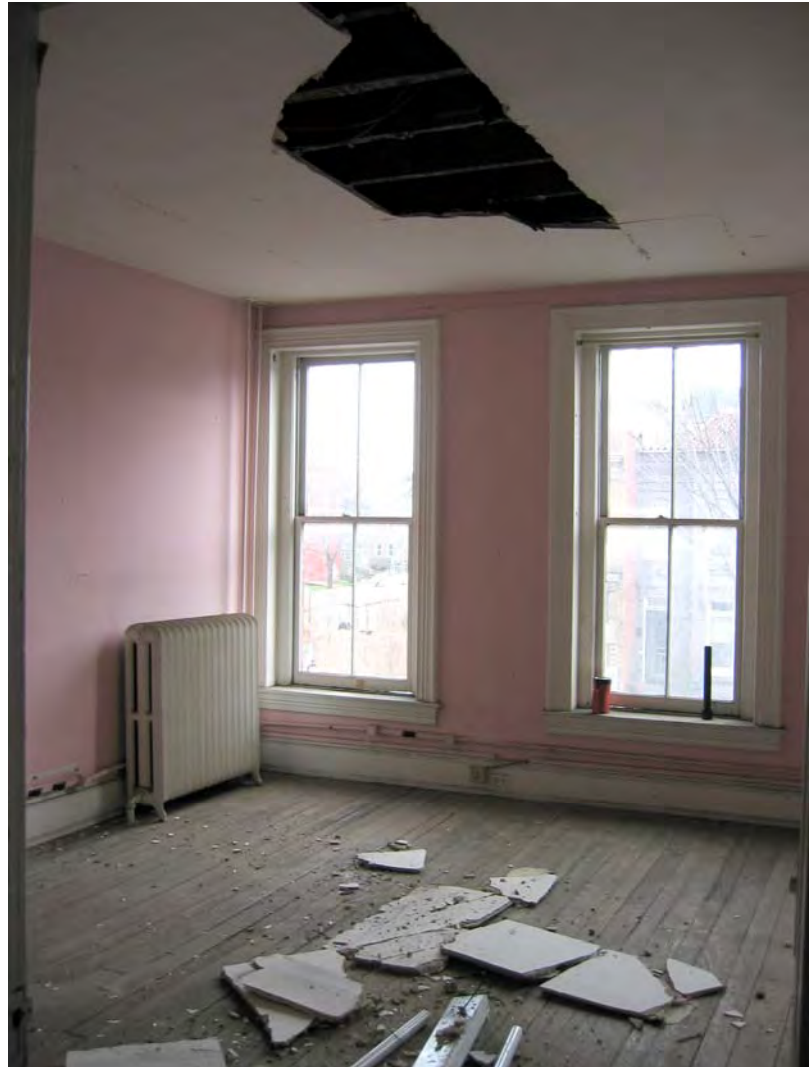
Figure 3-325: Room 203 ceiling failure. (Photo: BBB, 2006)

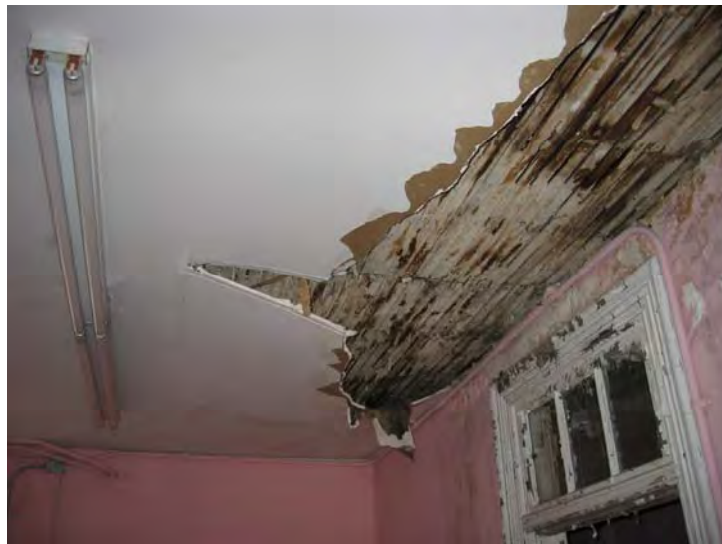
**Figure 3-351:** Ceiling damage at north wall. (Photo: BBB, 2007)

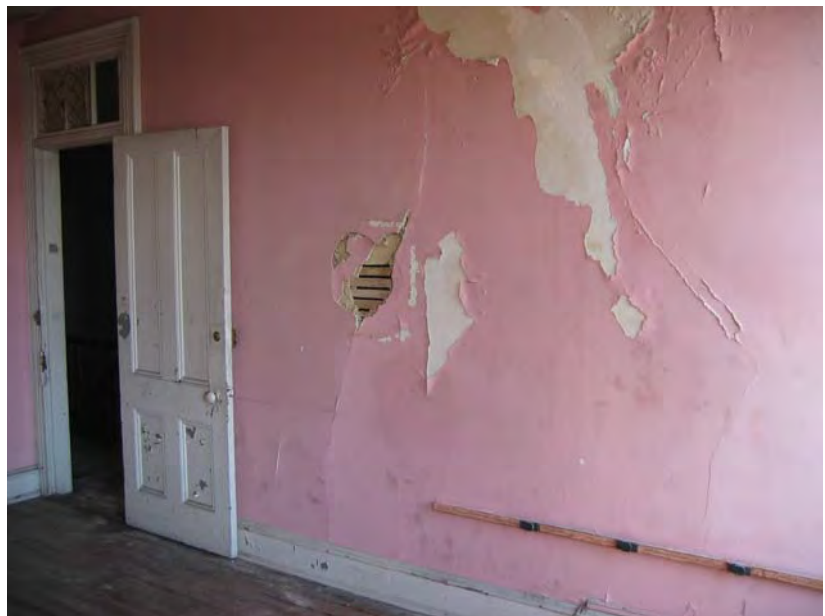
**Figure 3-469:** North wall showing water damage and loss of plaster. (Photo: BBB, 2007)

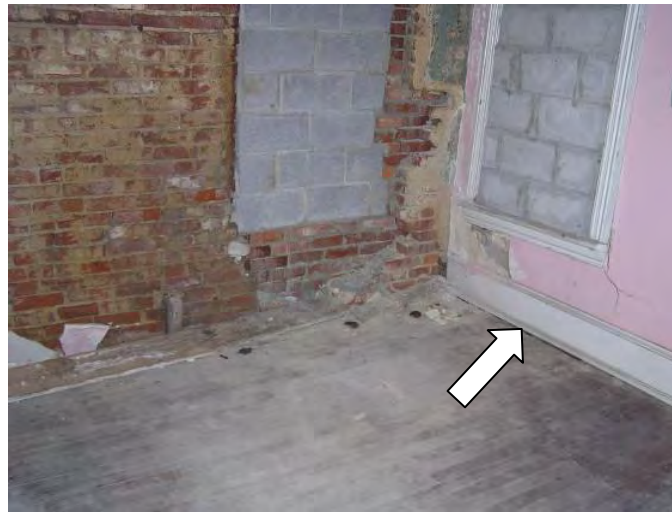
Figure 4-053: Room 210 - Floor sagging. (RSA, 2006)

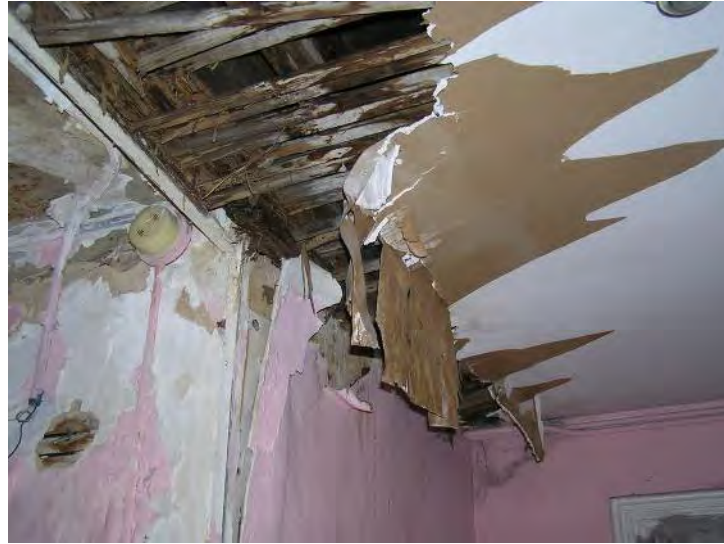
**Figure 4-057:** Room 201 - Fallen plaster ceiling and framing damage. (RSA, 2006)

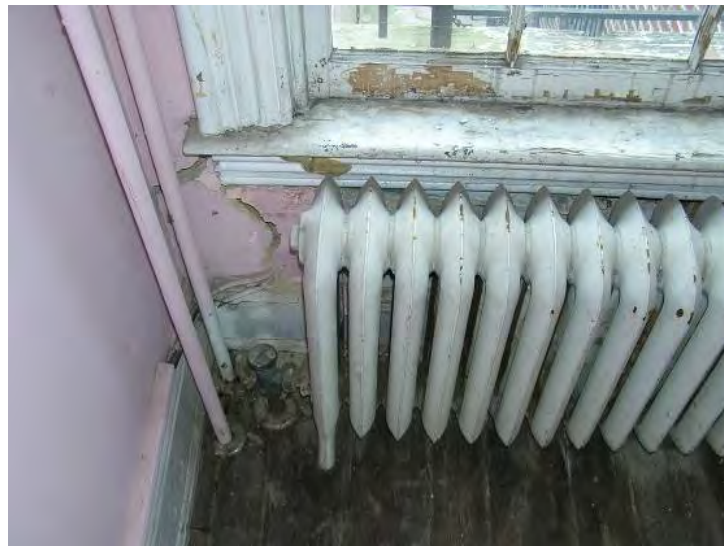
**Figure 4-059:** Room 205 - Cracks in wall. (RSA, 2006)

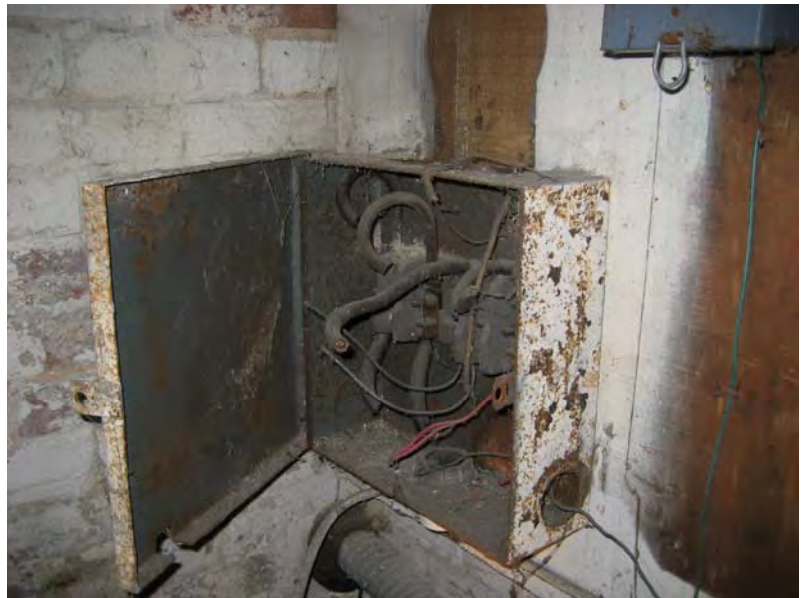
**Figure 4-083:** Old electrical panel. (Photo: GHT, 2007)
