Main Lodge Looking West, September 2010

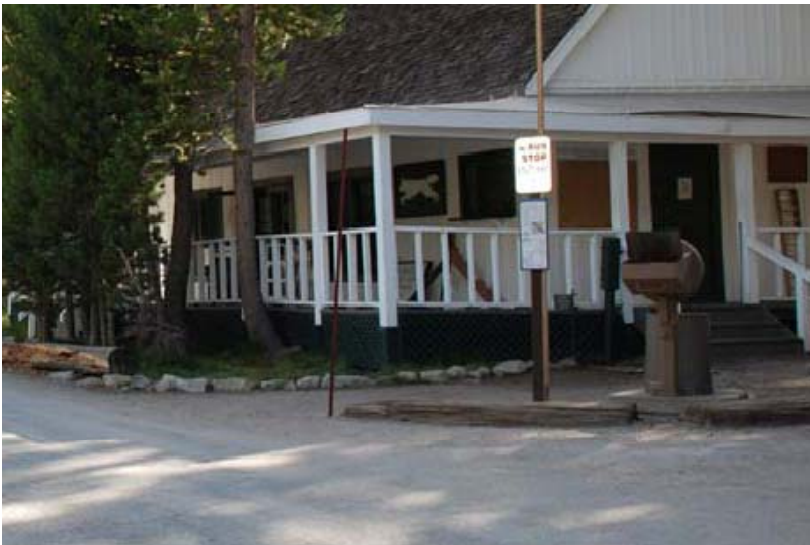
Trees Crowding Foundation and Roofline of the Porch

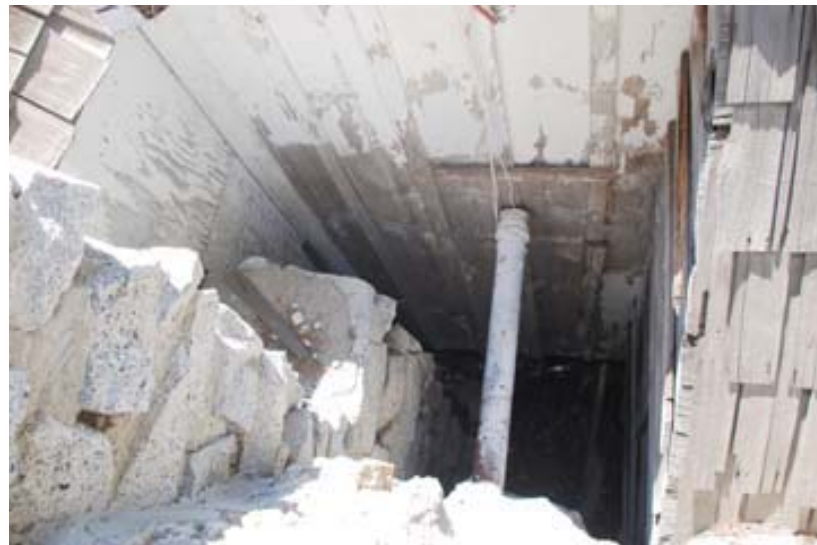
Inaccessible Area Adjacent to Chimney

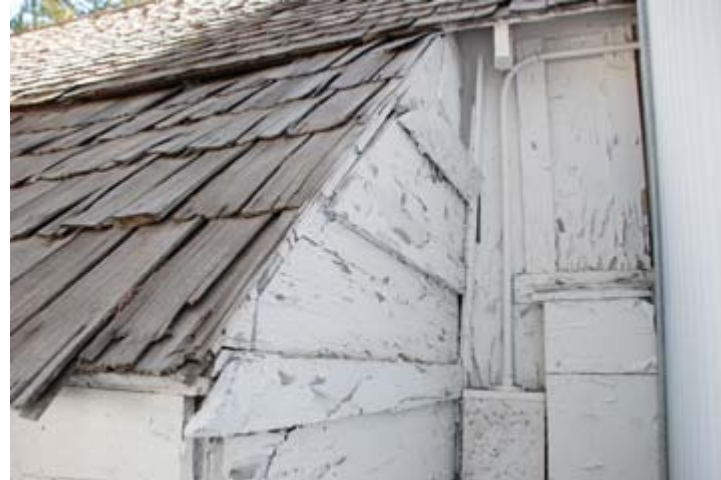
Deterioration of Horizontal Siding, North Shed

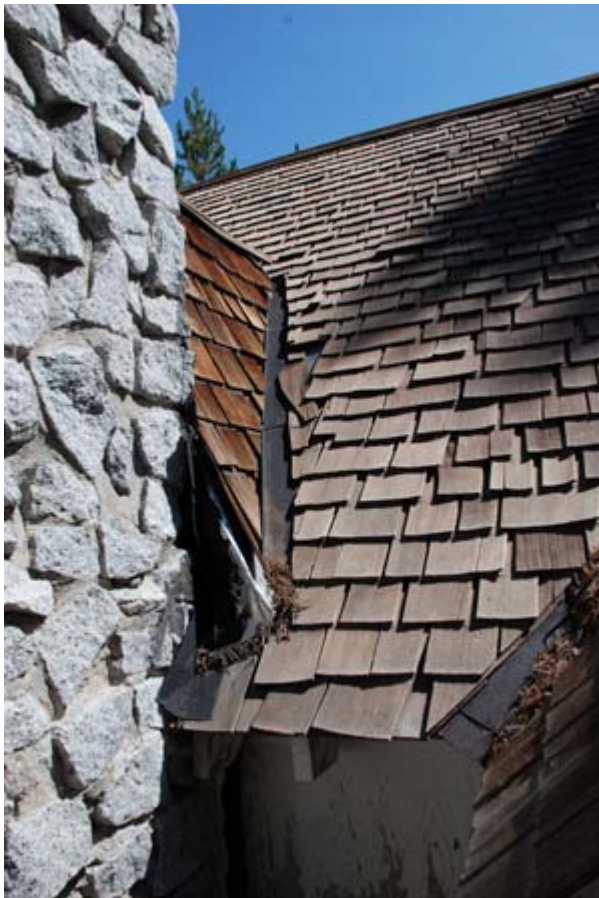
Inadequate Roofing at Chimney

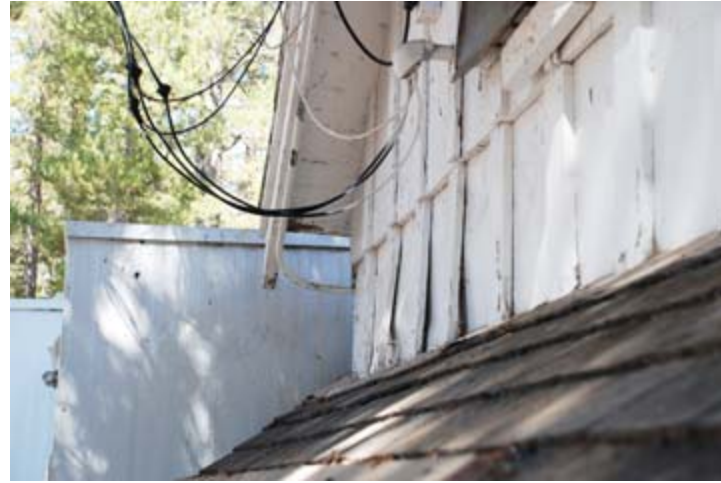
Detached Battens above Storage Space

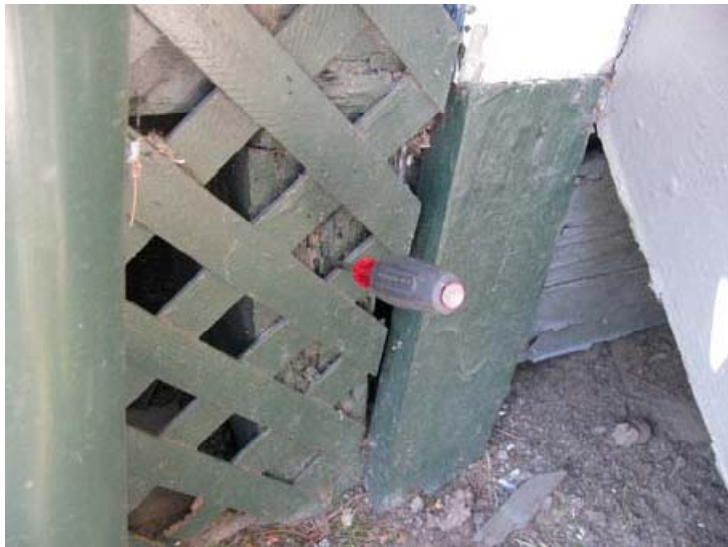
Deterioration of Porch Column

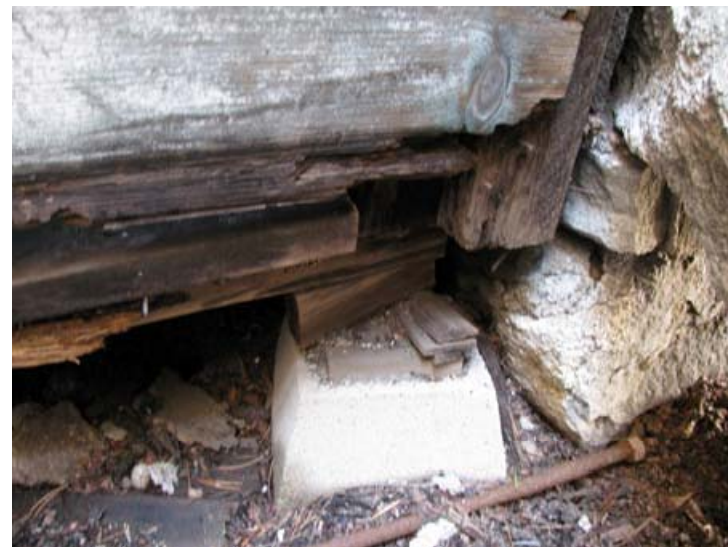
Leaning and Displace Porch Column

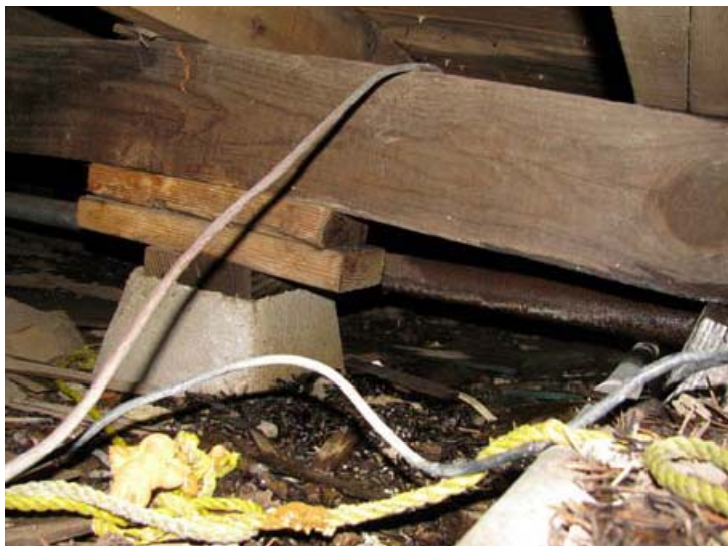
Footing, Shims, and Broken Floor Joists

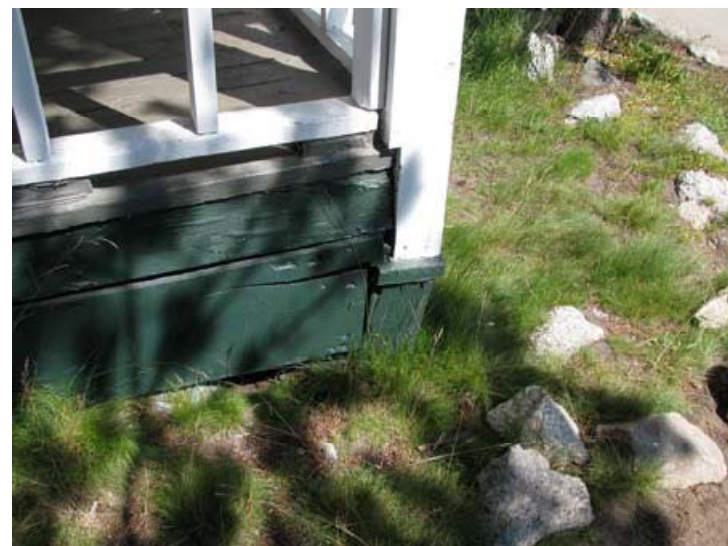
Deteriorated Sill Plate and Column

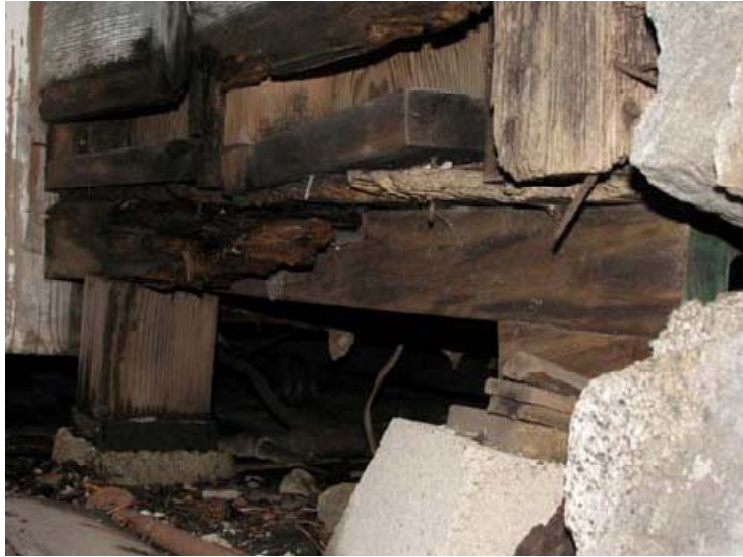
Deterioration of Sill Plate & Wall Studs at North Side of Kitchen

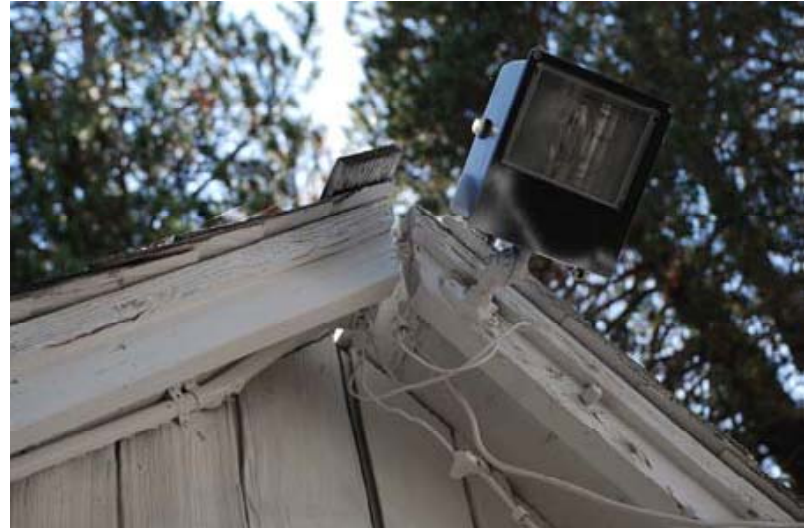
Separation of Structure at North Gable

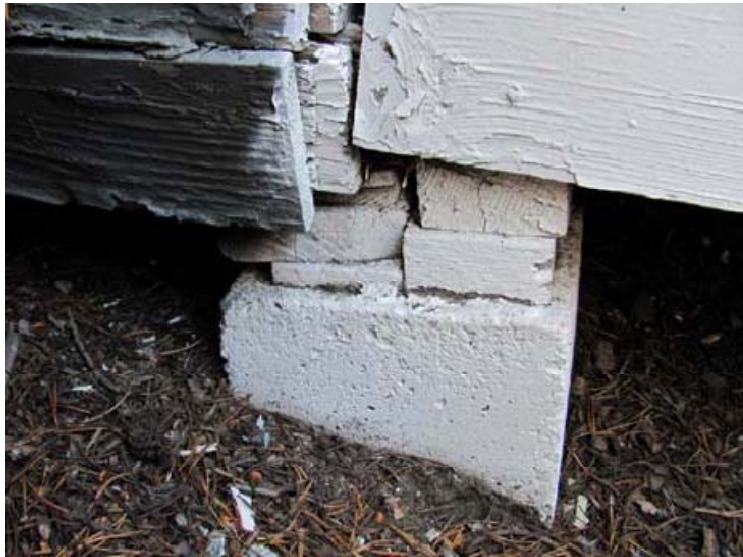
Typical Blocking at Piers

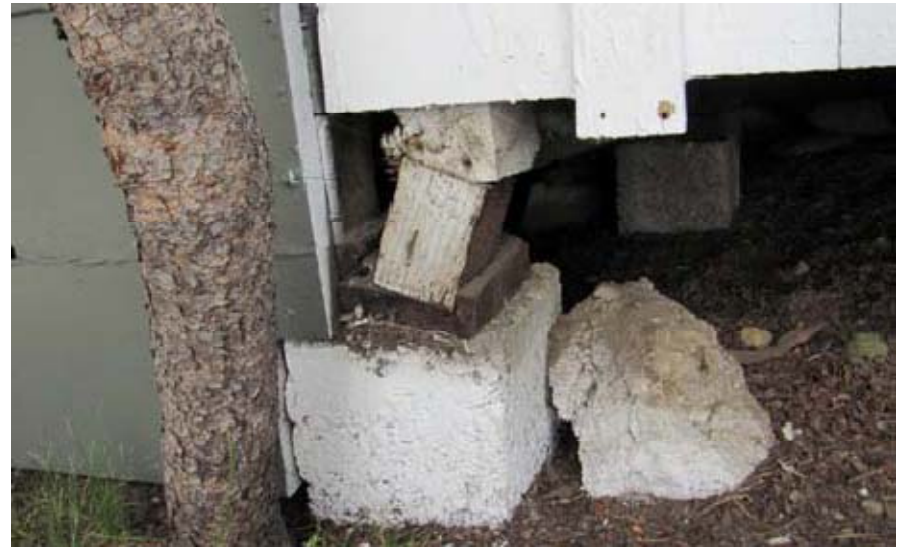
Typical Rotation of at Columns at Piers
