EVALUATION OF THE WASHINGTON MONUMENT

OEHRLIN & ASSOCIATES ARCHITECTS

**EVALUATION OF
THE WASHINGTON MONUMENT
WASHINGTON, DC**

December 1993

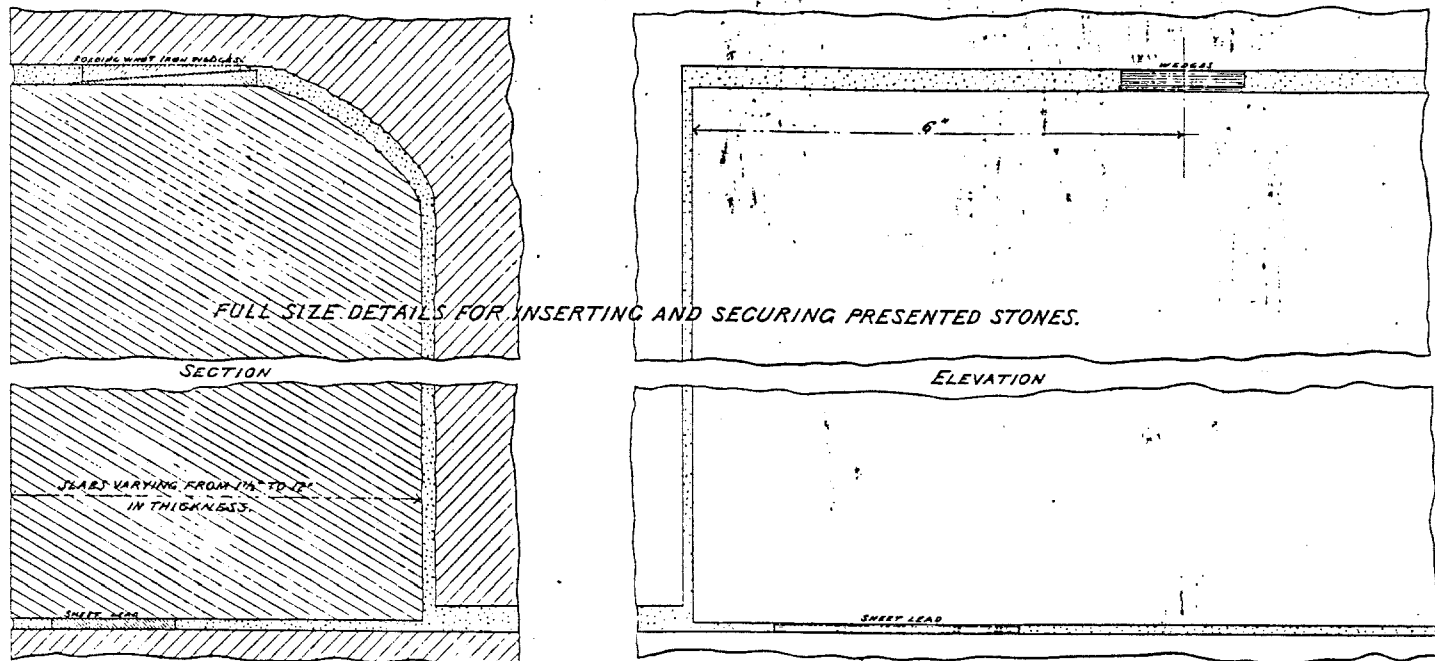
Figure 15. Memorial stone attachment details. Many of the wrought iron wedges shown in this detail have corroded and are damaging the surrounding stone. National Archives, Record Group 79.

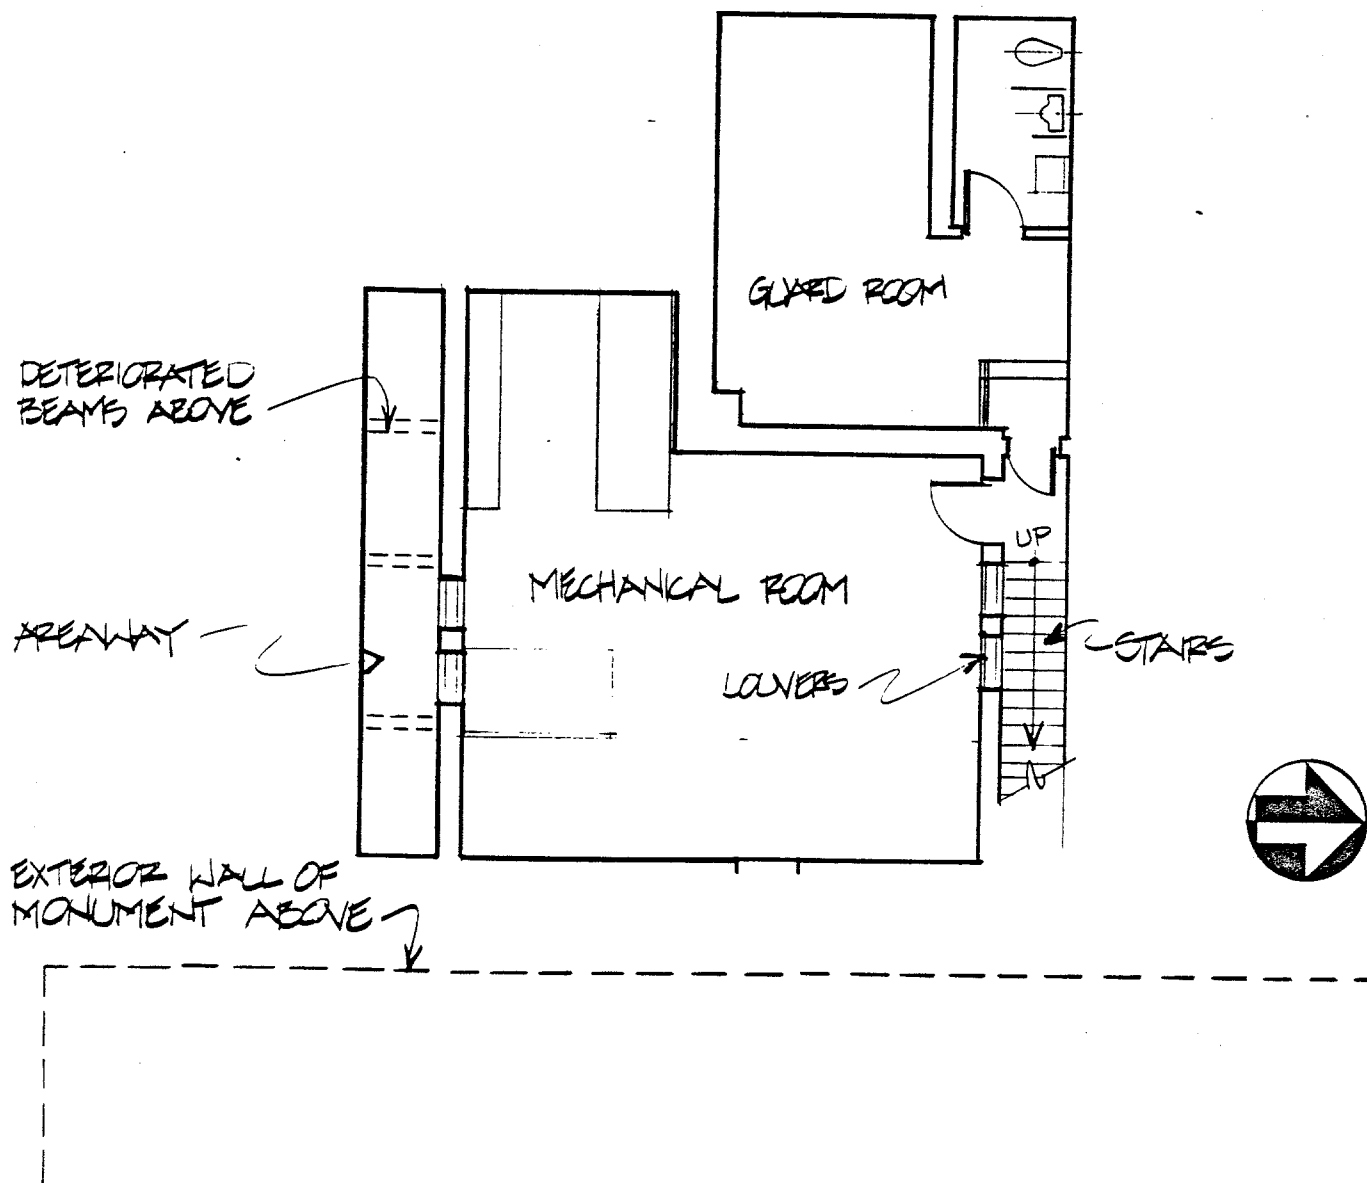
Figure 17.

Plan of underground service area to the west of the Monument. Both the guard room and the mechanical room have exposed friable asbestos. Water infiltration has caused deterioration of stucco walls and concrete beams, walls and steps. Scale 1/8" = 1'-0". Drawing by Oehrlein & Associates Architects.

Deteriorated areas of the underground service areas to the west of the Monument should be repaired. The waterproofing on the roof and walls of the guard room has failed and should be replaced. Concrete beams over the areaway venting the mechanical room are badly deteriorated and should be repaired. Cracks in the concrete and deteriorating stucco at the stair areaway are not structural problems but should also be repaired.

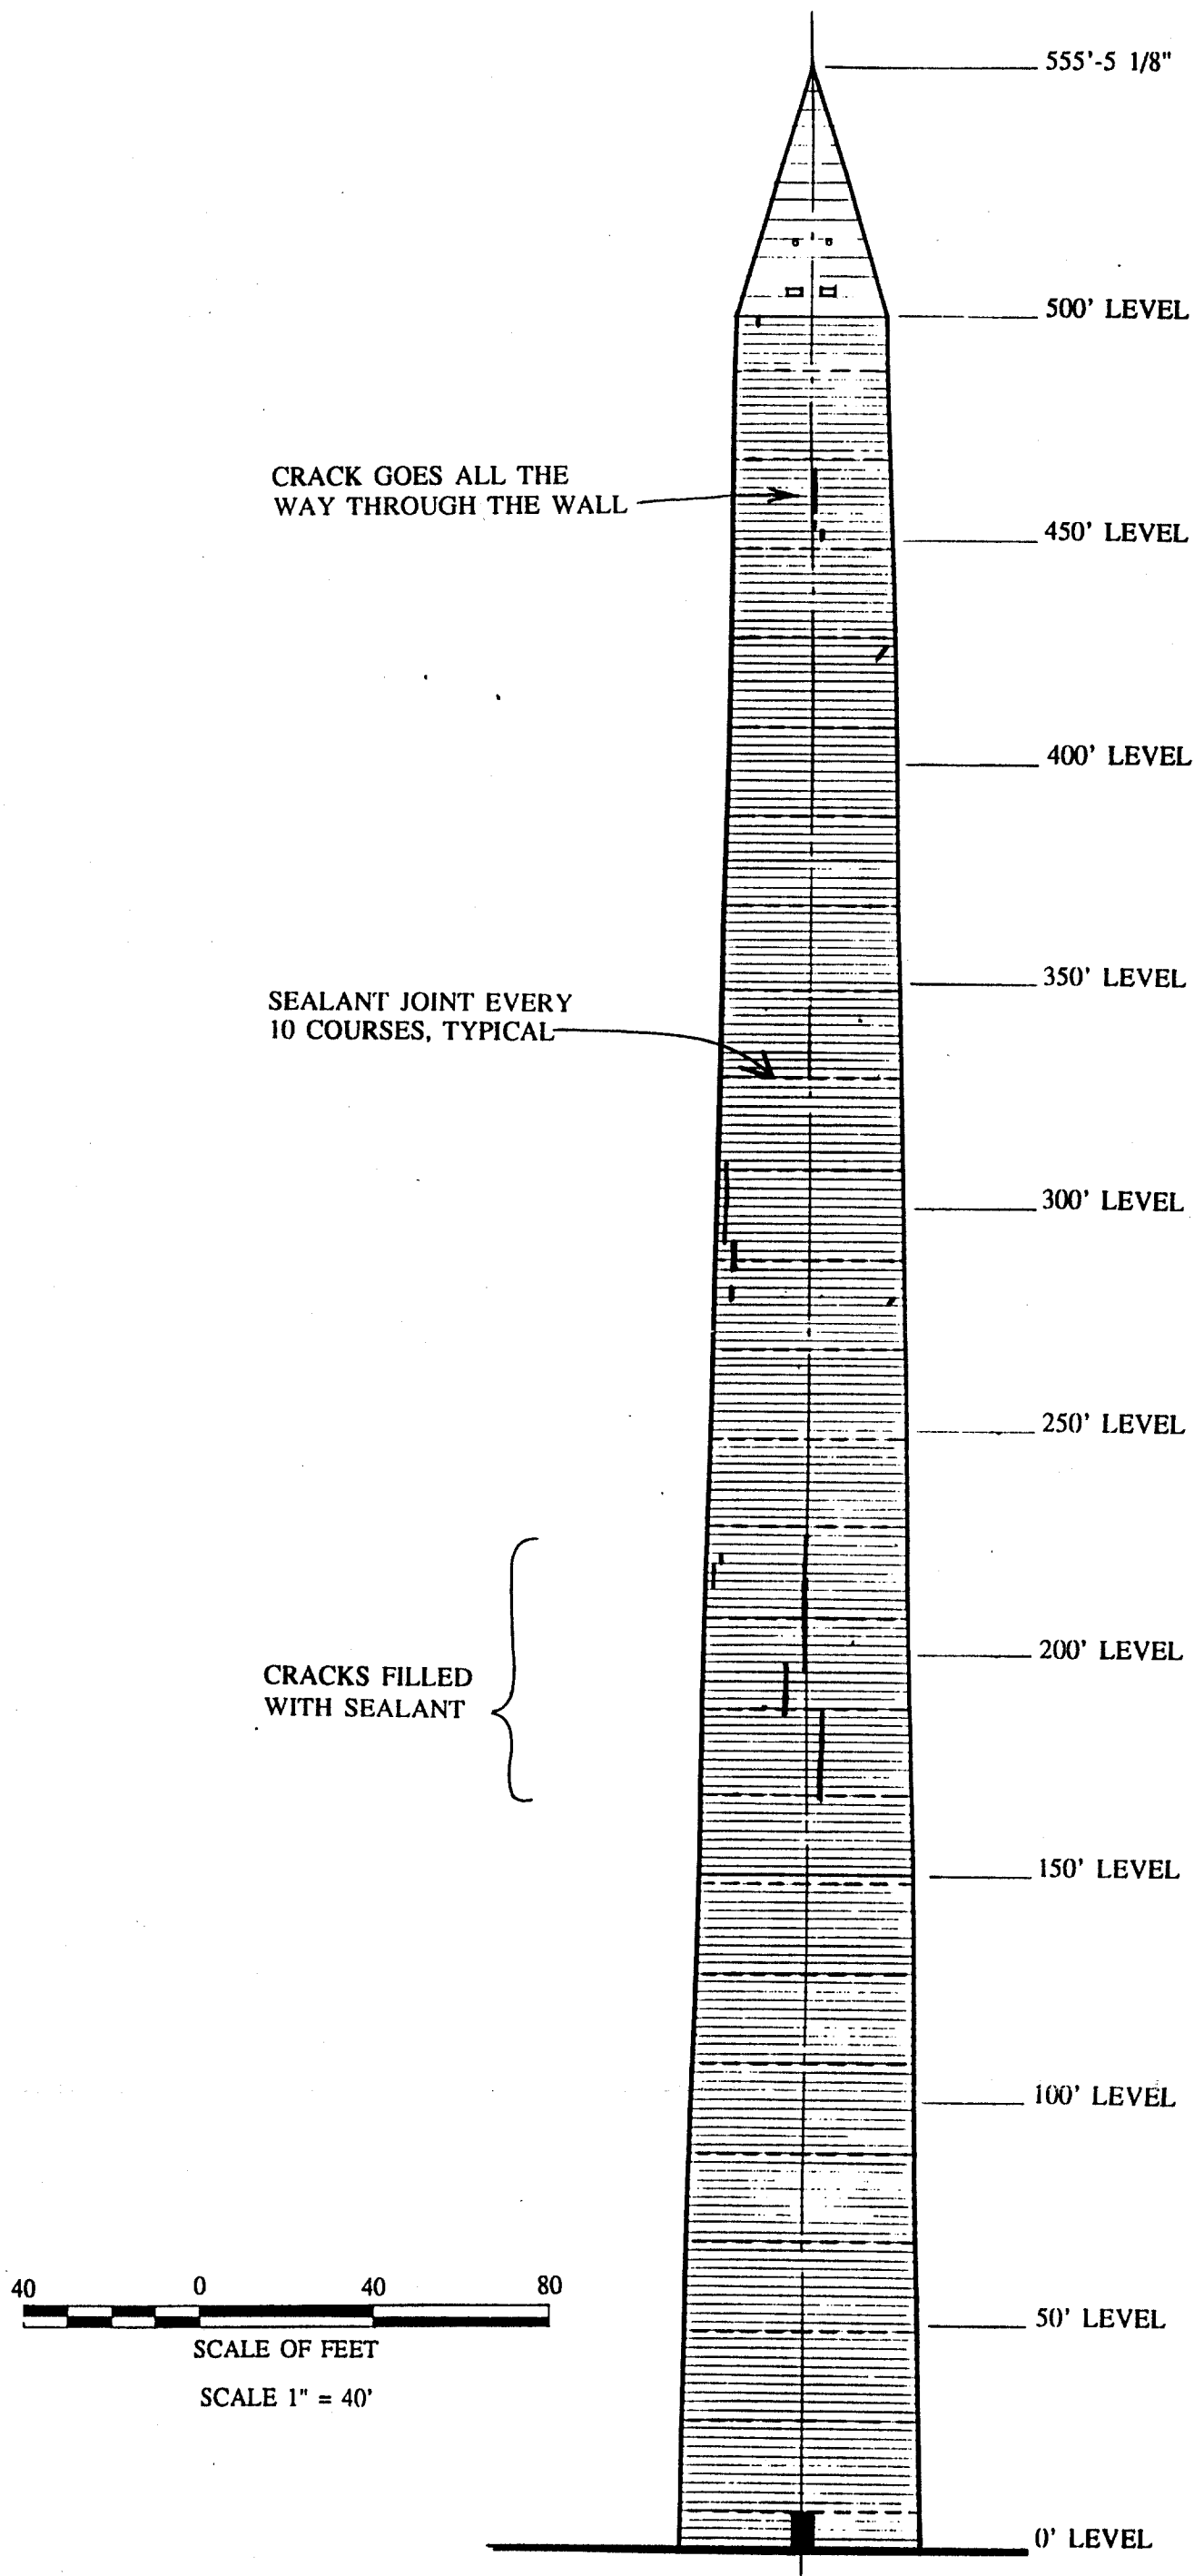
Figure 18. East elevation crack survey, April 23, 1992. The vertical lines indicate cracks which were visible from the ground using 10 x 25 binoculars. Drawing by Oehrlein & Associates Architects.

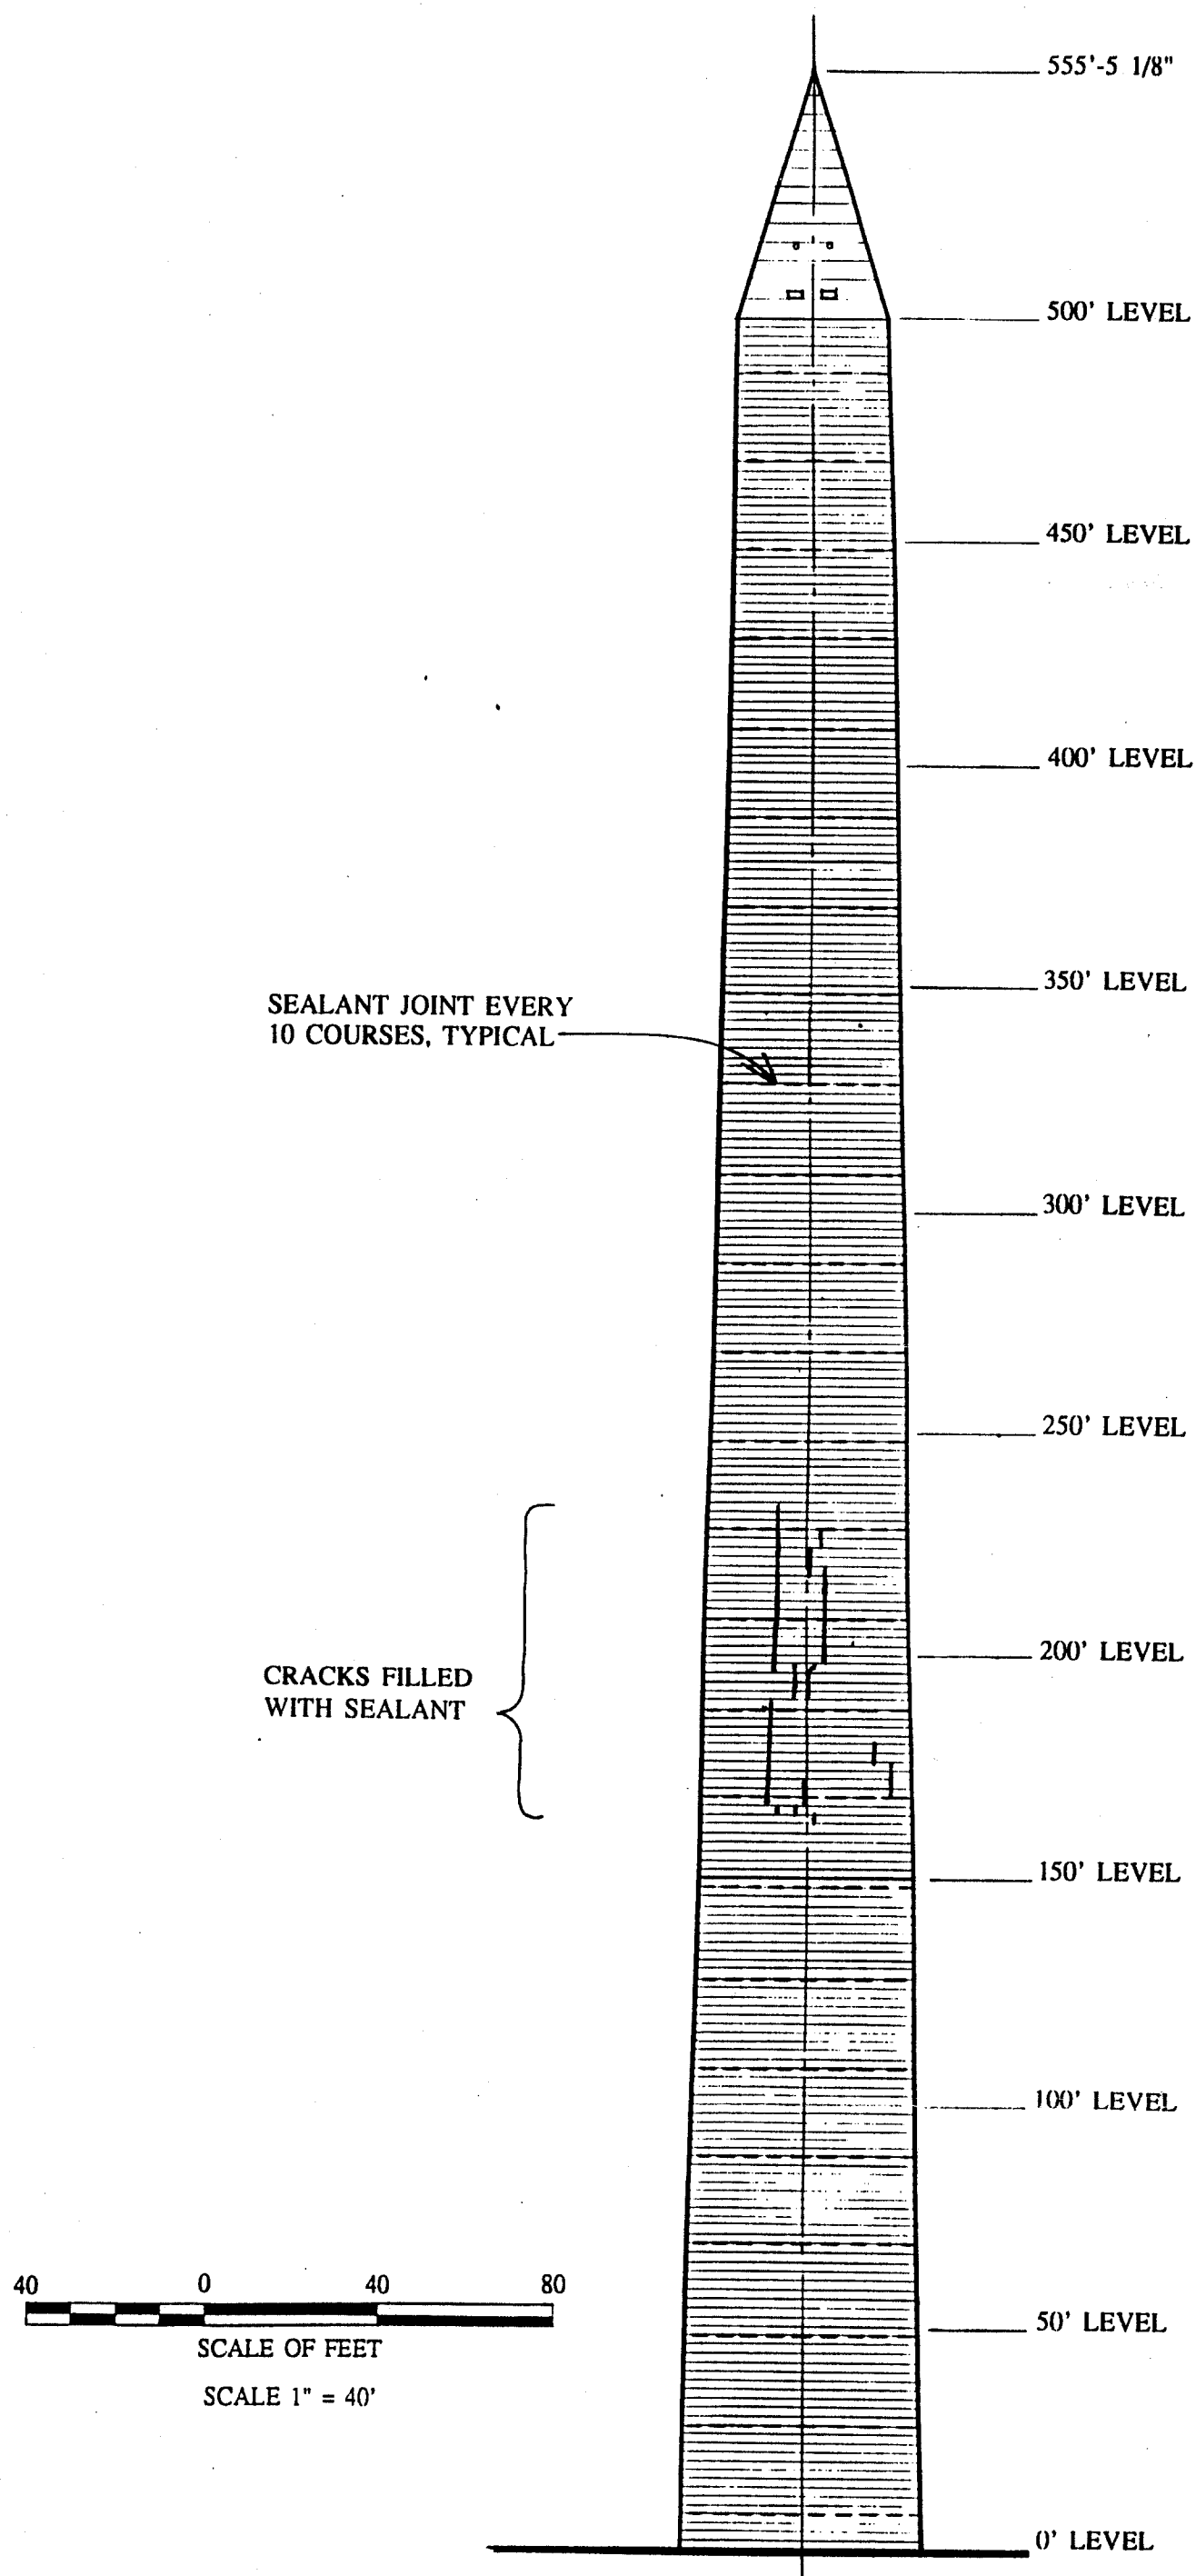
Figure 19. North elevation crack survey, April 23, 1992. The vertical lines indicate cracks which were visible from the ground using 10 x 25 binoculars. Drawing by Oehrlein & Associates Architects.

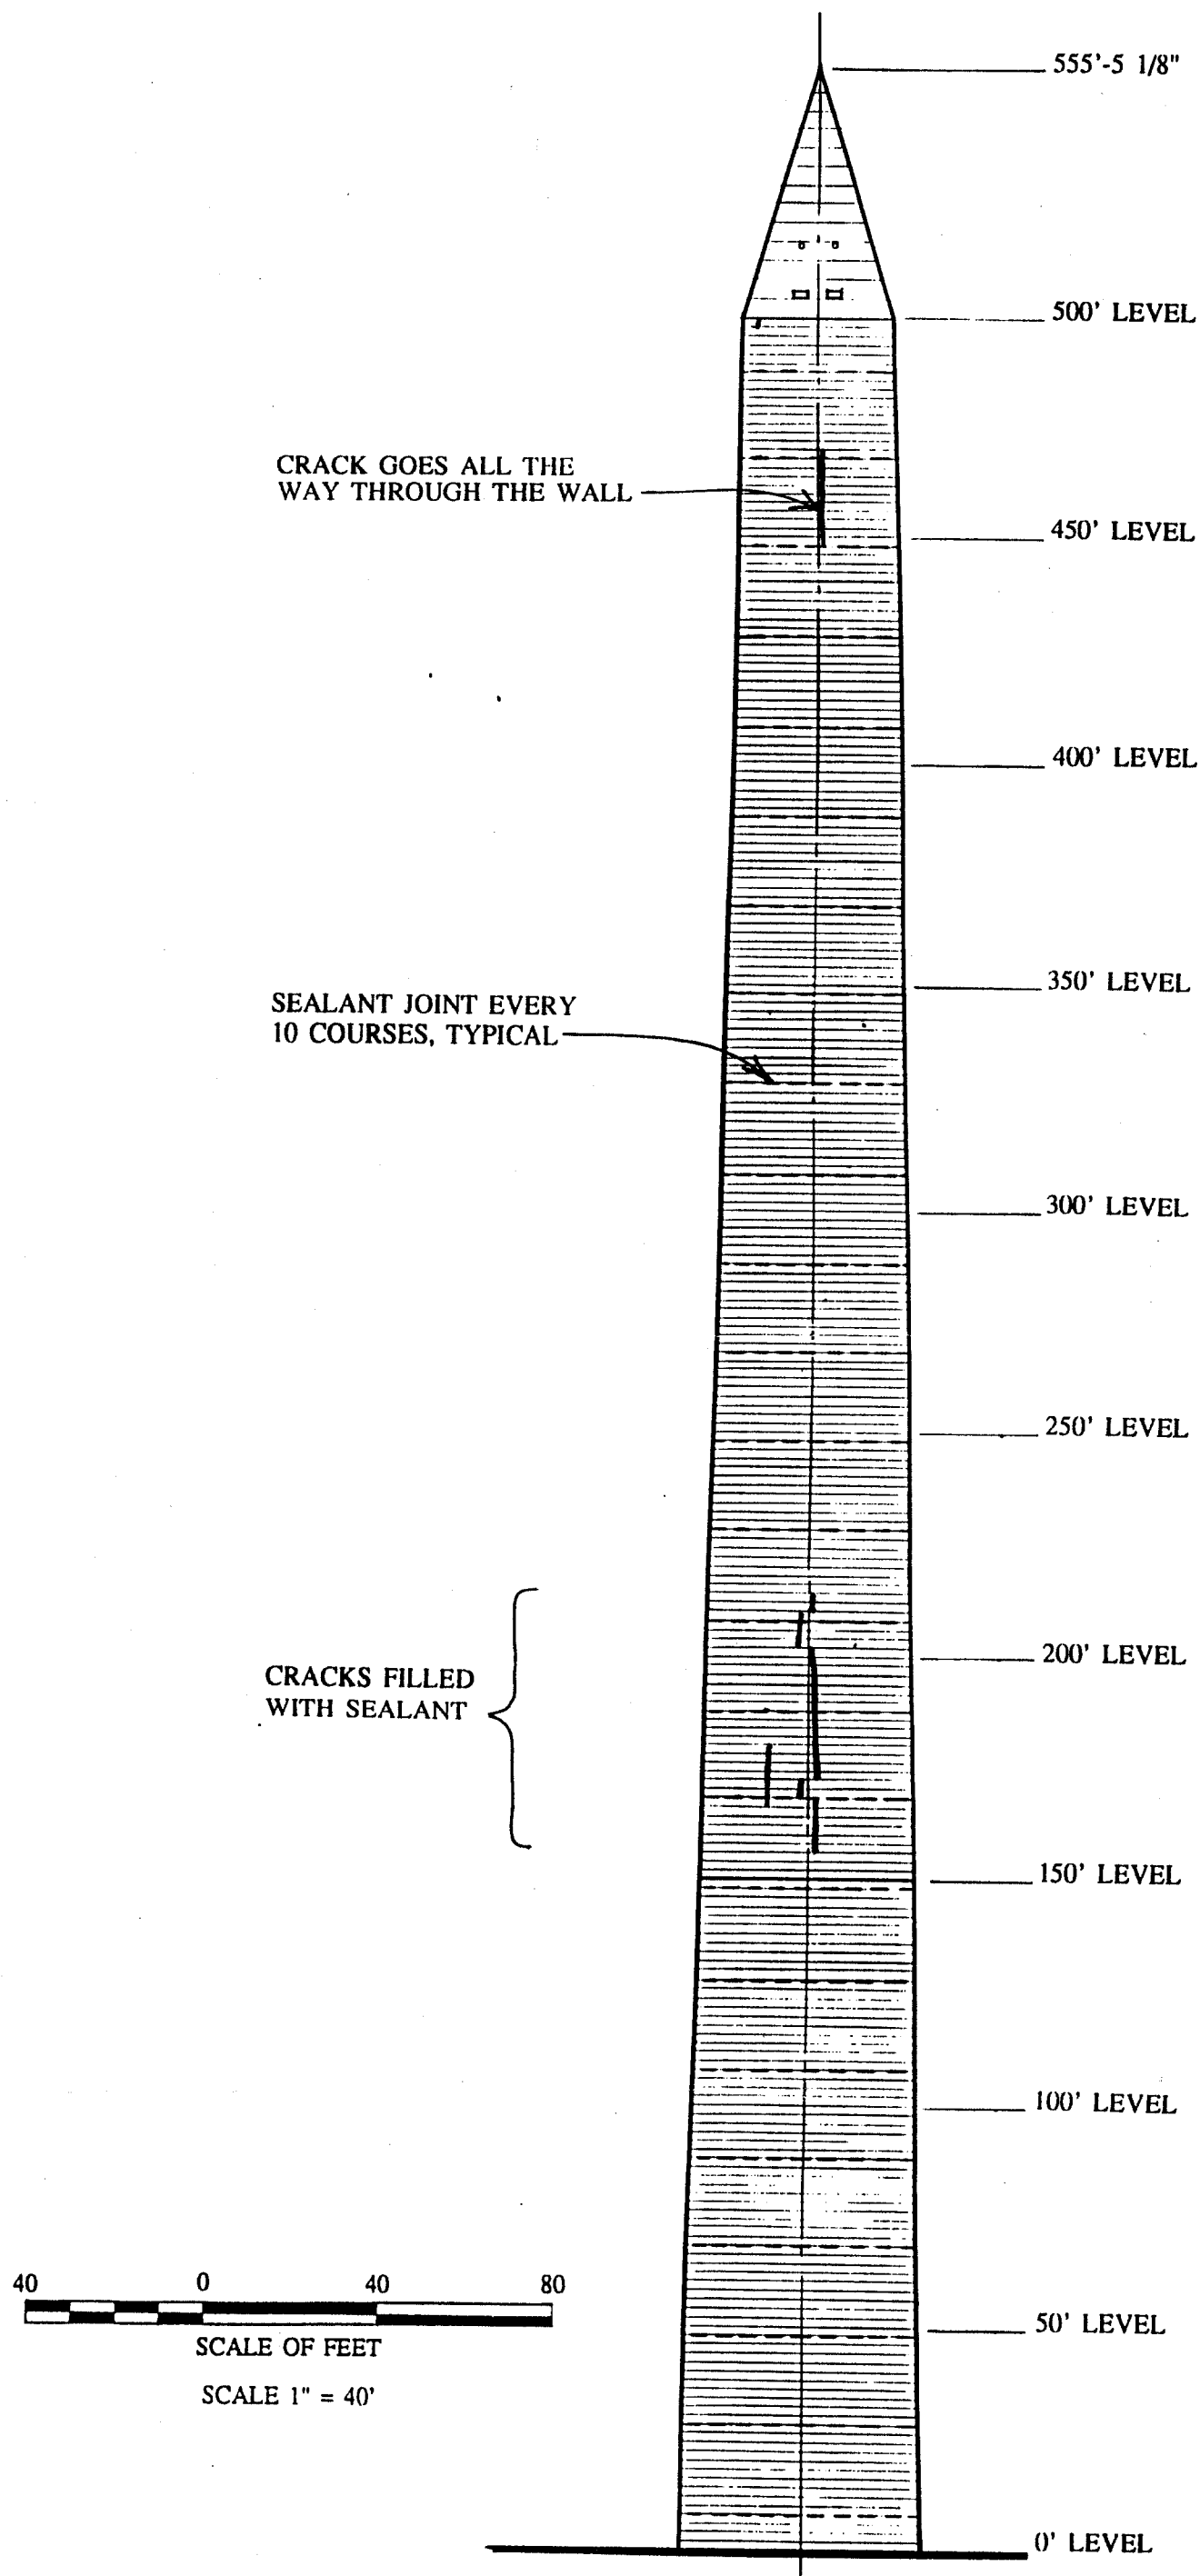
Figure 20. West elevation crack survey, April 23, 1992. The vertical lines indicate cracks which were visible from the ground using 10 x 25 binoculars. Drawing by Oehrlein & Associates Architects.

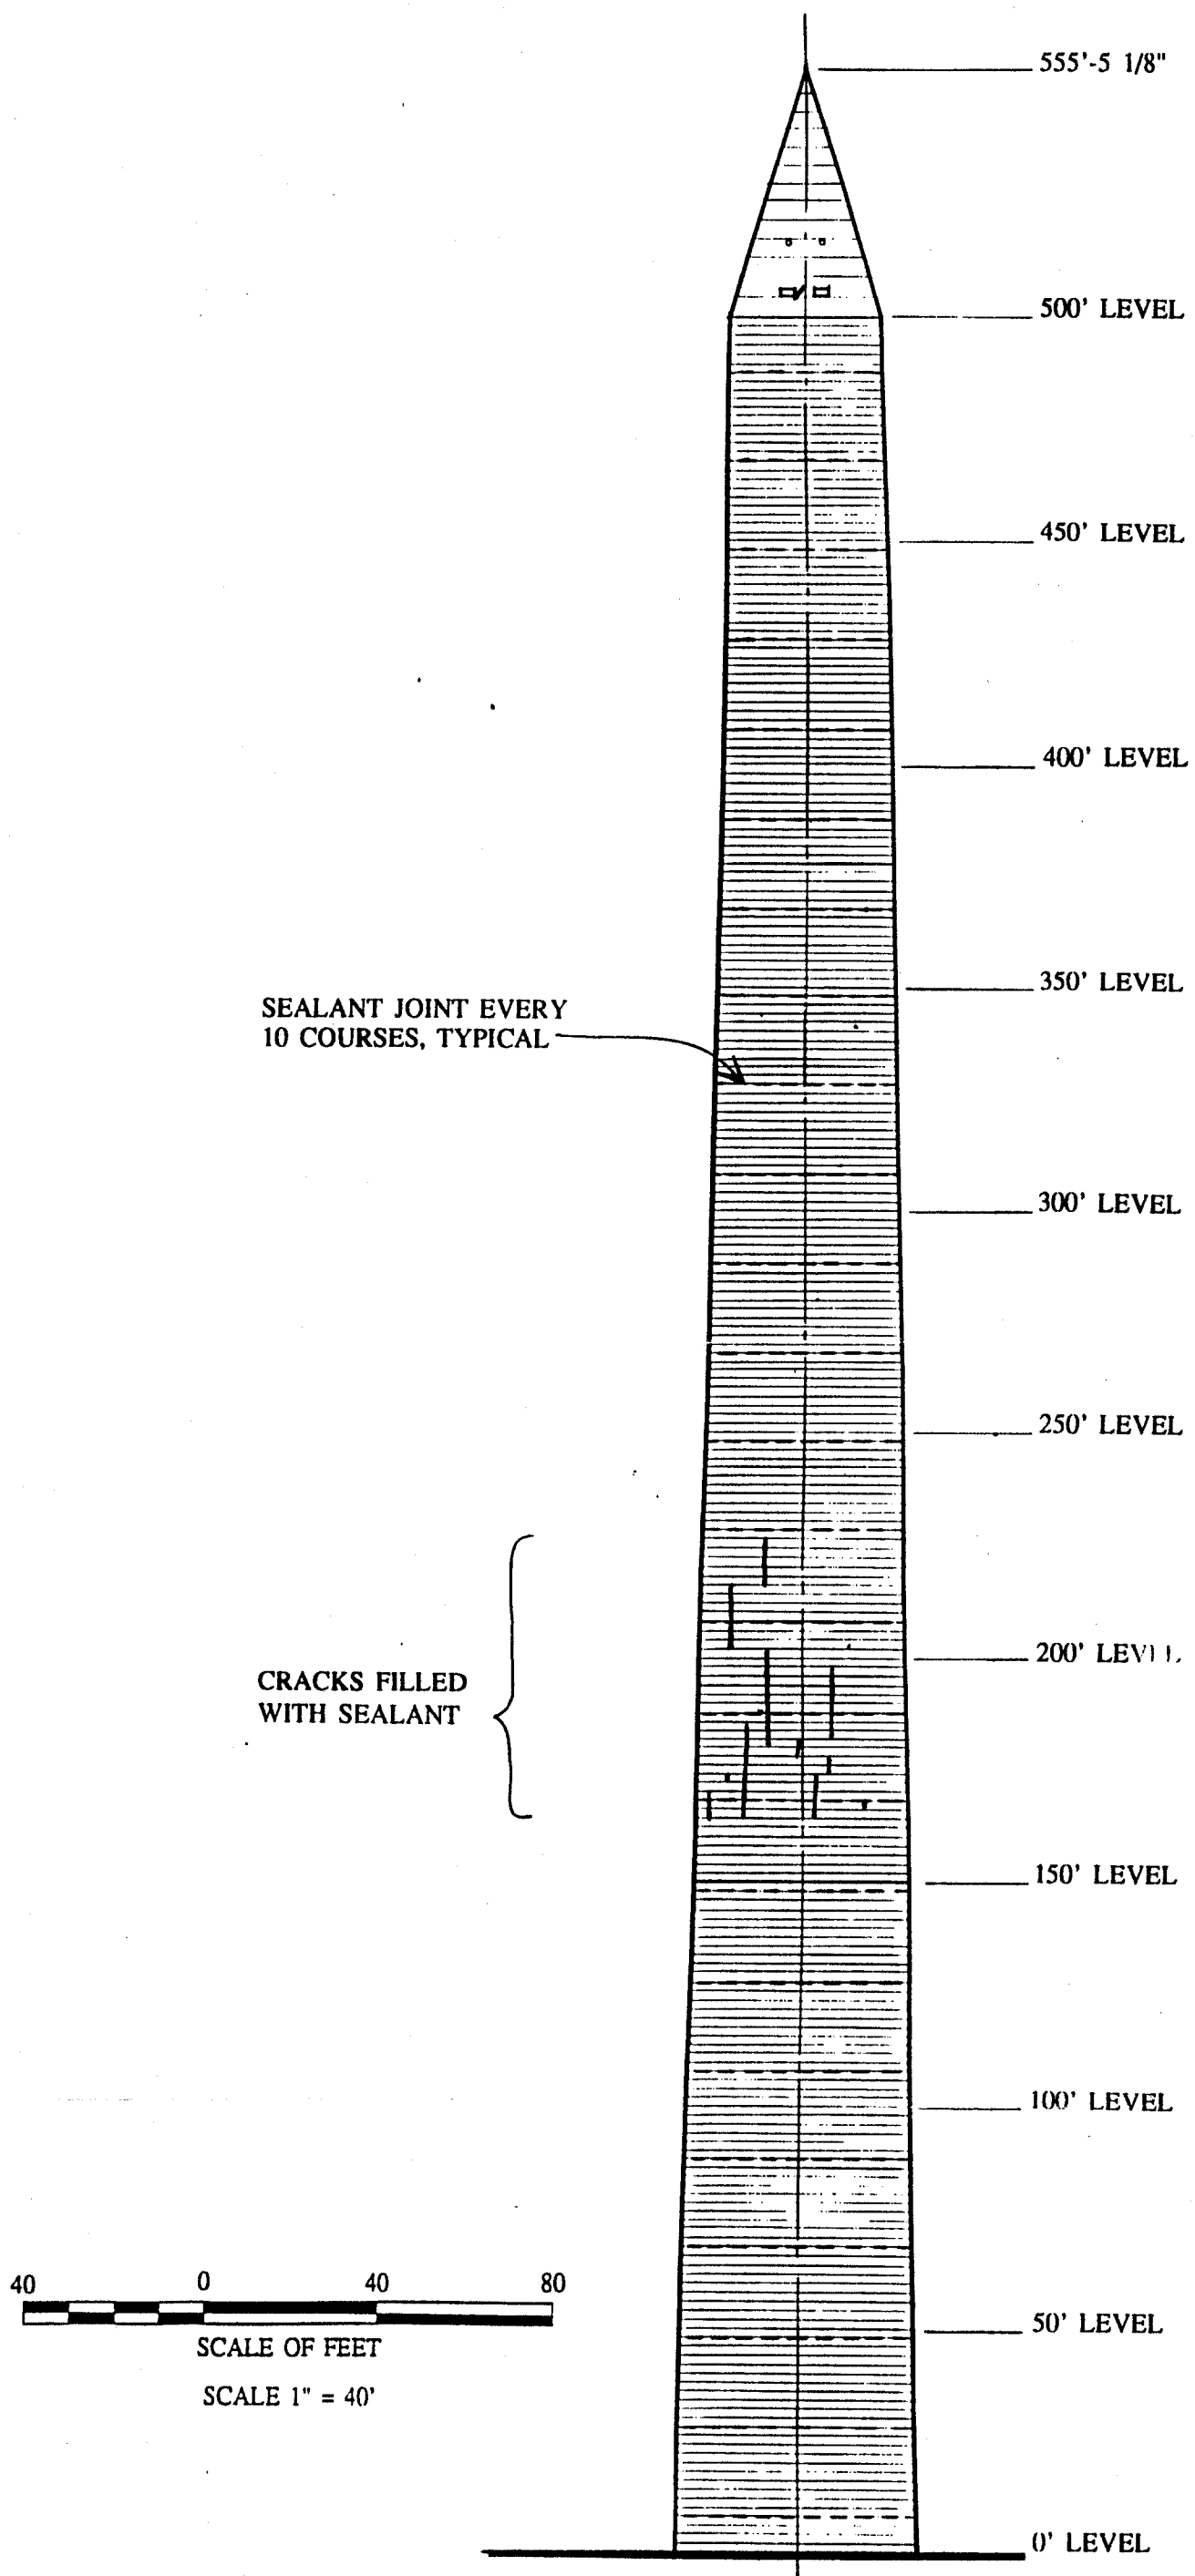
Figure 21. South elevation crack survey, April 23, 1992. The vertical lines indicate cracks which were visible from the ground using 10 x 25 binoculars. Drawing by Oehrlein & Associates Architects.

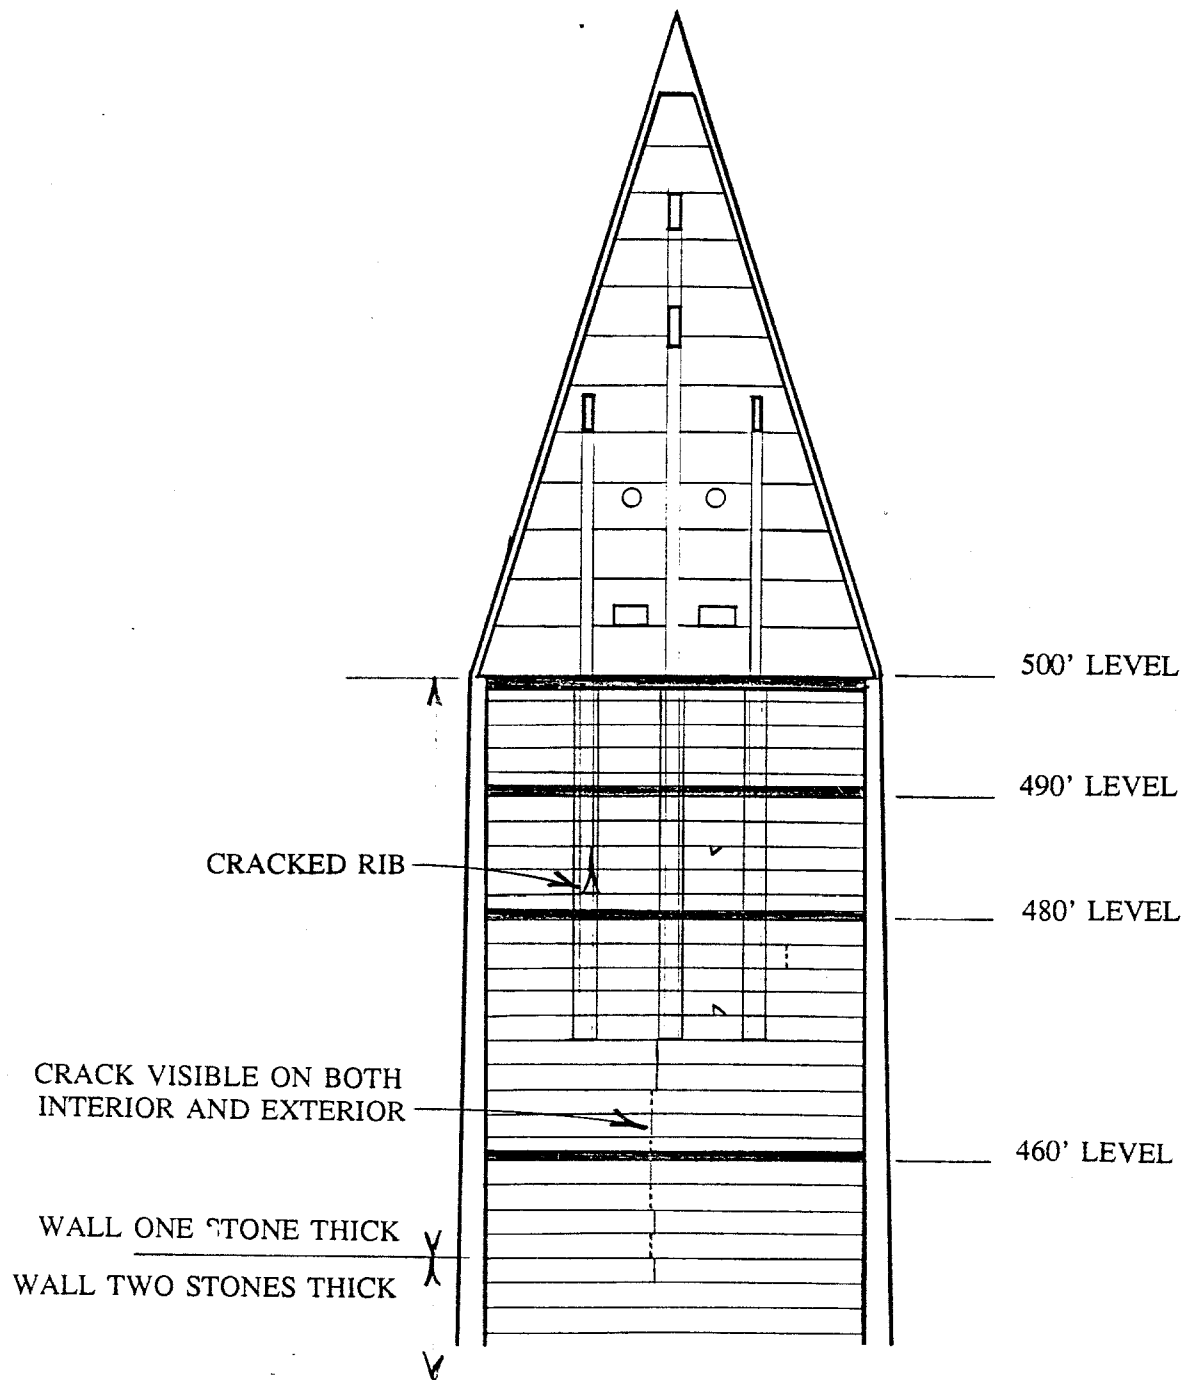
Figure 22.

West wall interior crack survey, August 25, 1992. Dotted lines indicate where a crack follows joints between stones. Scale 1/16" = 1'-0". Drawing by Oehrlein & Associates Architects.

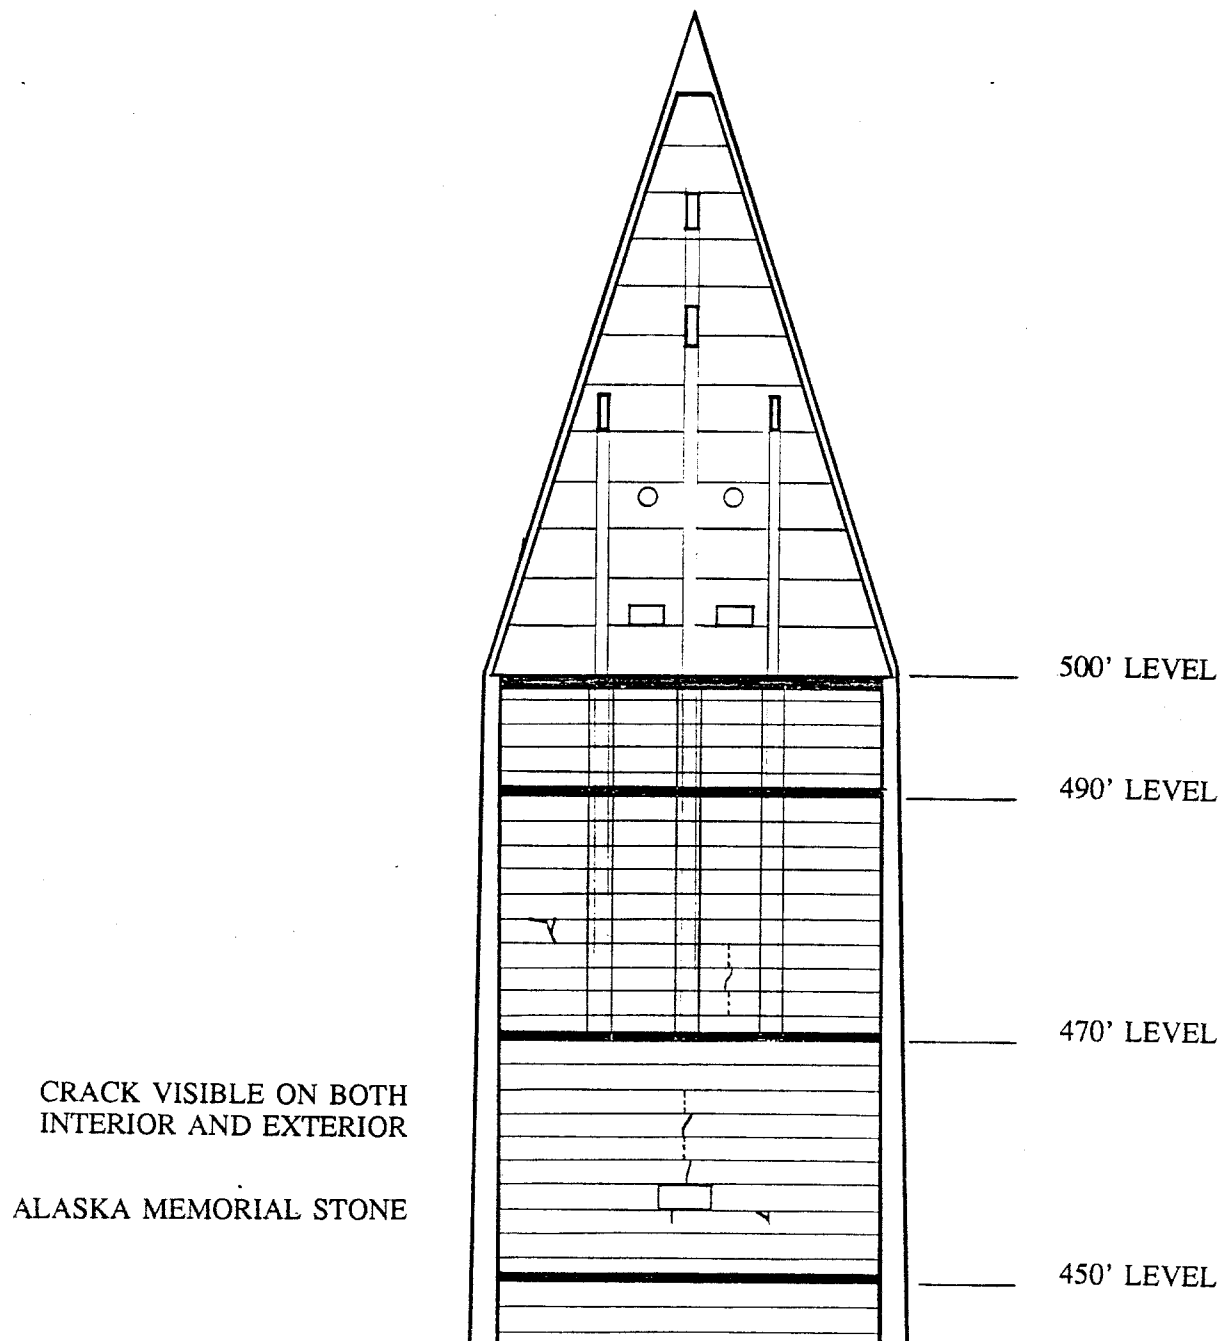
Figure 23.

East wall interior crack survey, August 25, 1992. Dotted lines indicate where a crack follows joints between stones. Scale 1/16" = 1'-0". Drawing by Oehrlein & Associates Architects.

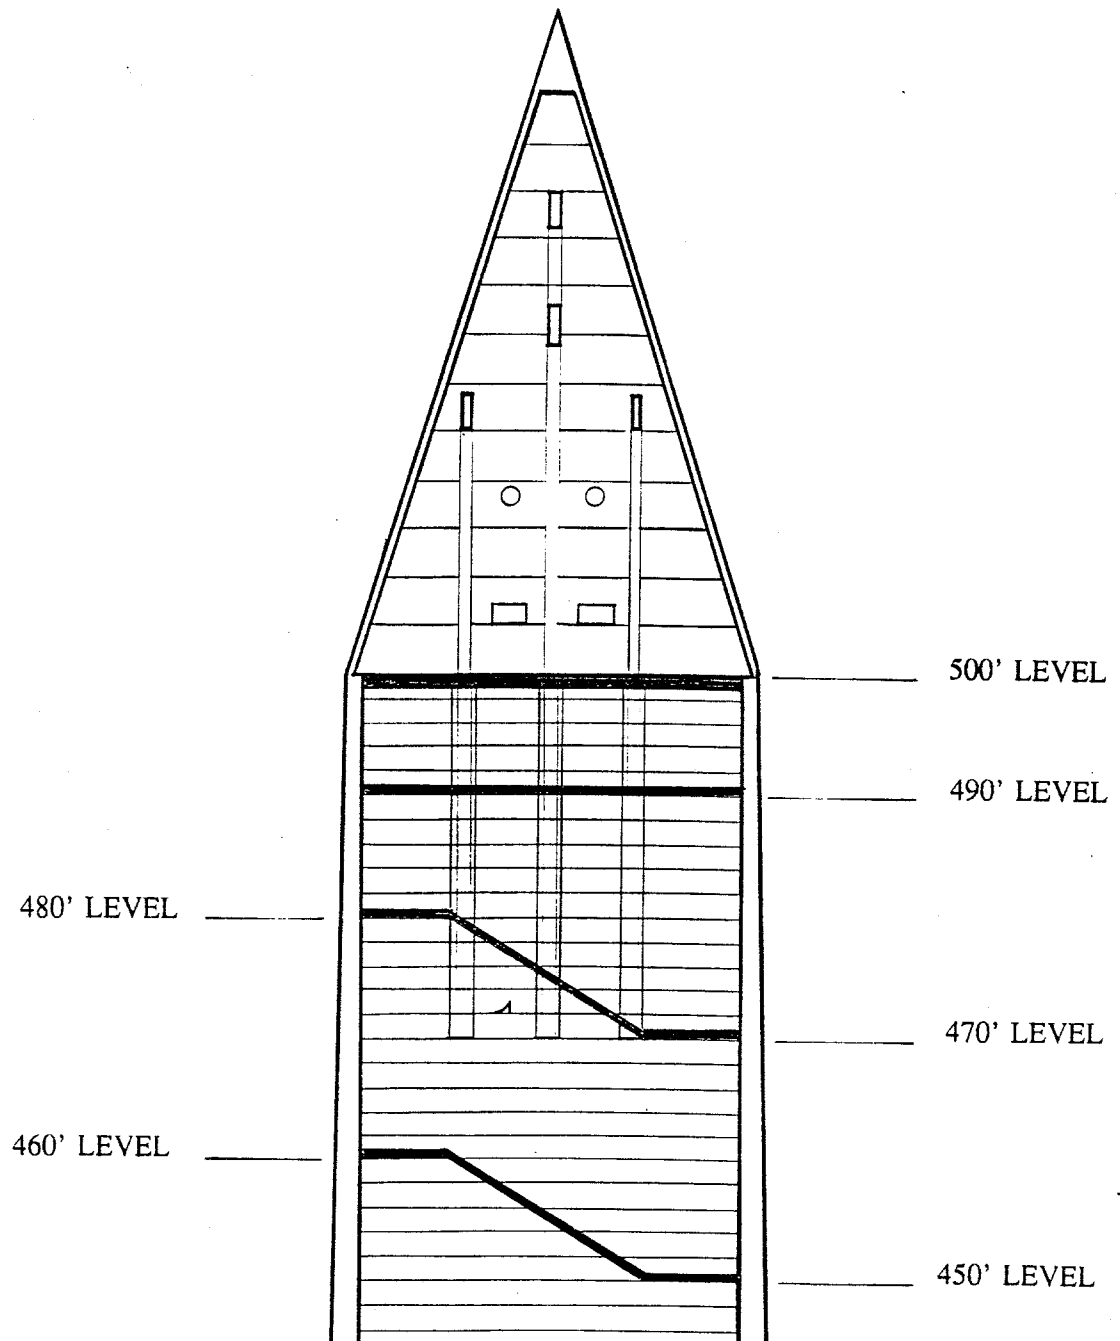
Figure 24. North wall interior crack survey, August 25, 1992. Scale 1/16" = 1'-0". Drawing by Oehrlein & Associates Architects.

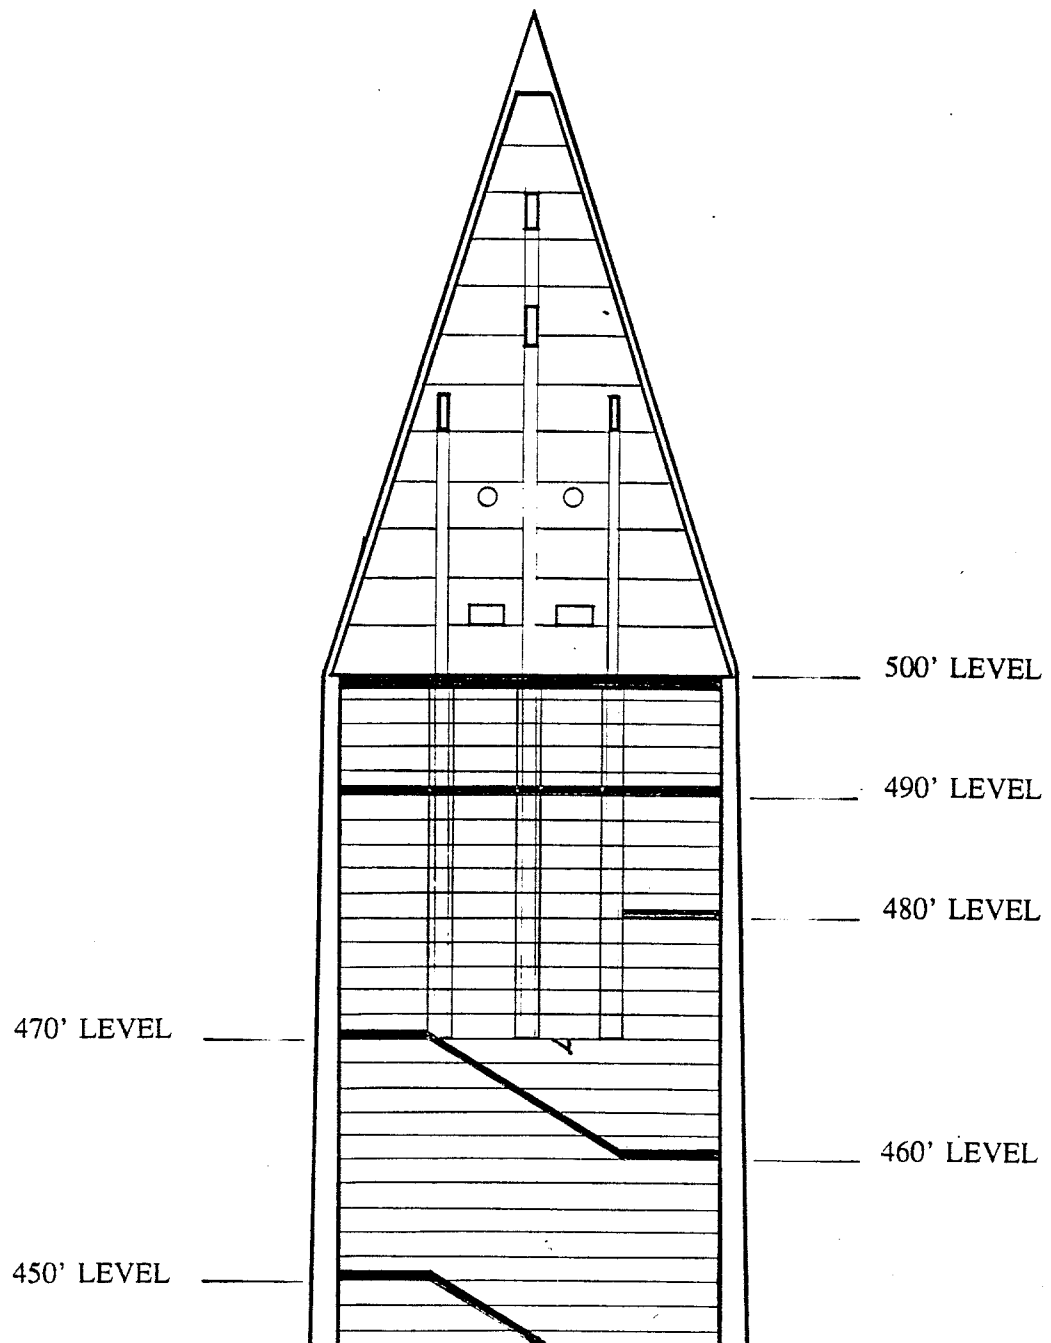
Figure 25.

South wall interior crack survey, August 25, 1992. Scale 1/16" = 1'-0". Drawing by Oehrlein & Associates Architects.

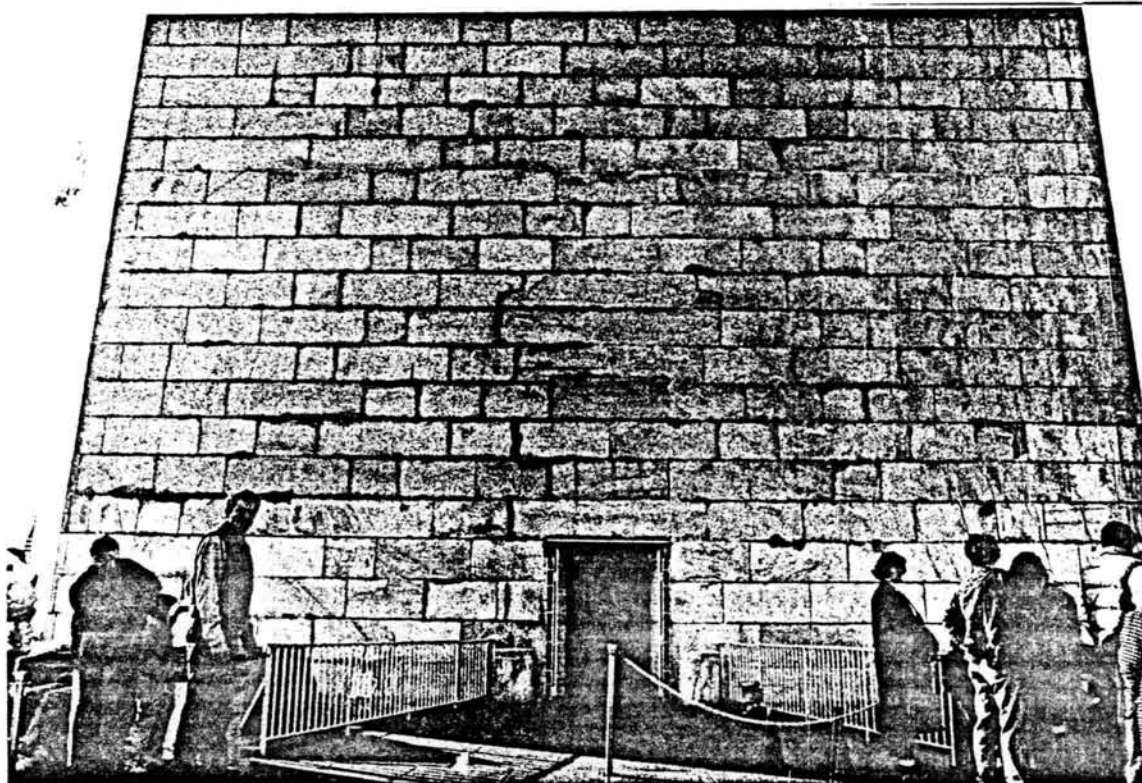
Photo 1.

Exterior view of the east elevation of the Monument. The bottom four courses of stone to the 8' level are of a lighter color. Chips and spalls at the edges of stones have been filled with dark patches of mortar. The stone over the entry has odd coursing where the original 18'-6" high opening was reduced to 8'-0".

Chipped and spalled stones on the exterior of the Monument at the lower levels should be patched when the joints are being pointed. Existing mortar patches should be removed and stains on the stone should be cleaned. Cleaning of the exterior stone should occur only when necessary and should be done with a low-pressure steam cleaner.
