An inspection of the Monument was made on April 23, 1992 as part of your on-going study for the National Park Service. The emphasis of the inspection was to visually observe the numerous vertical cracks which have appeared over the years following completion of the original construction.

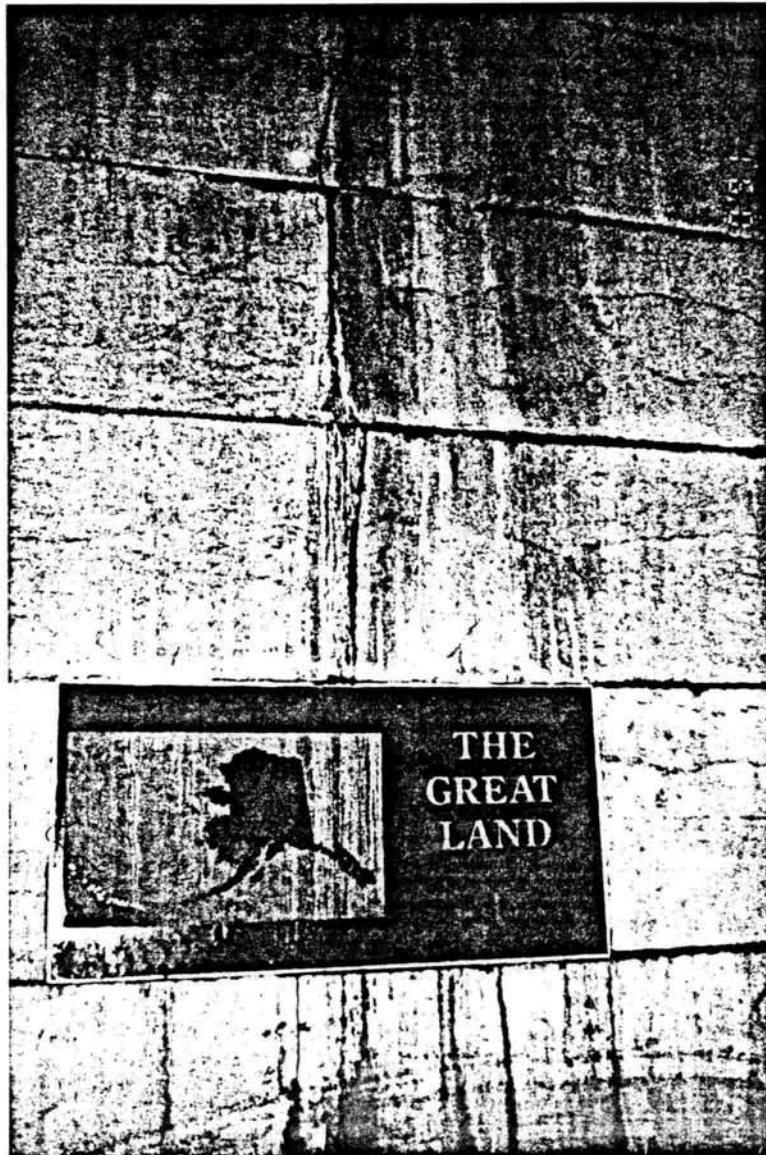
Photo 2.

Interior view of the east elevation of the Monument above the 450' level landing. The crack in the stone runs between the 455' level and the 466' level and penetrates all the way through the stone to the exterior. Deposits of calcium carbonate and stains from corroding iron and steel can be seen on the wall above the Alaska memorial stone.

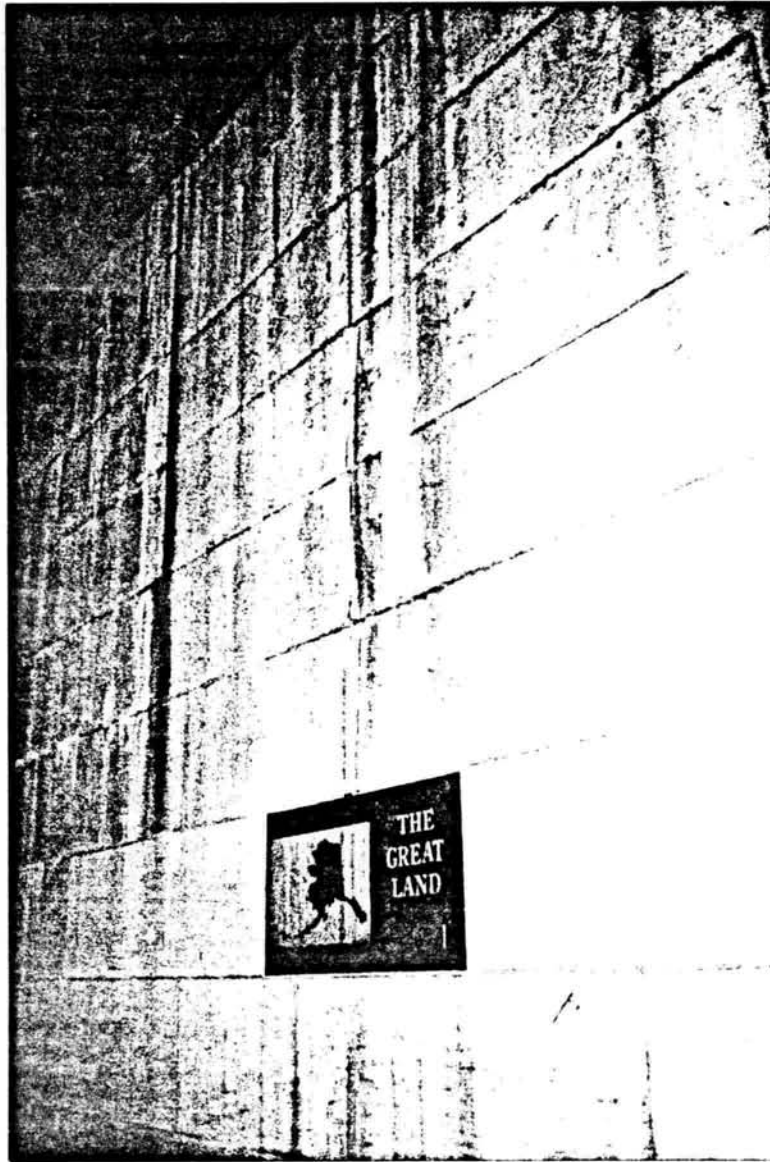
Photo 3. Interior view of the east elevation of the Monument above the 450' level landing. The crack in the stone runs between the 455' level and the 466' level and penetrates all the way through the stone to the exterior.

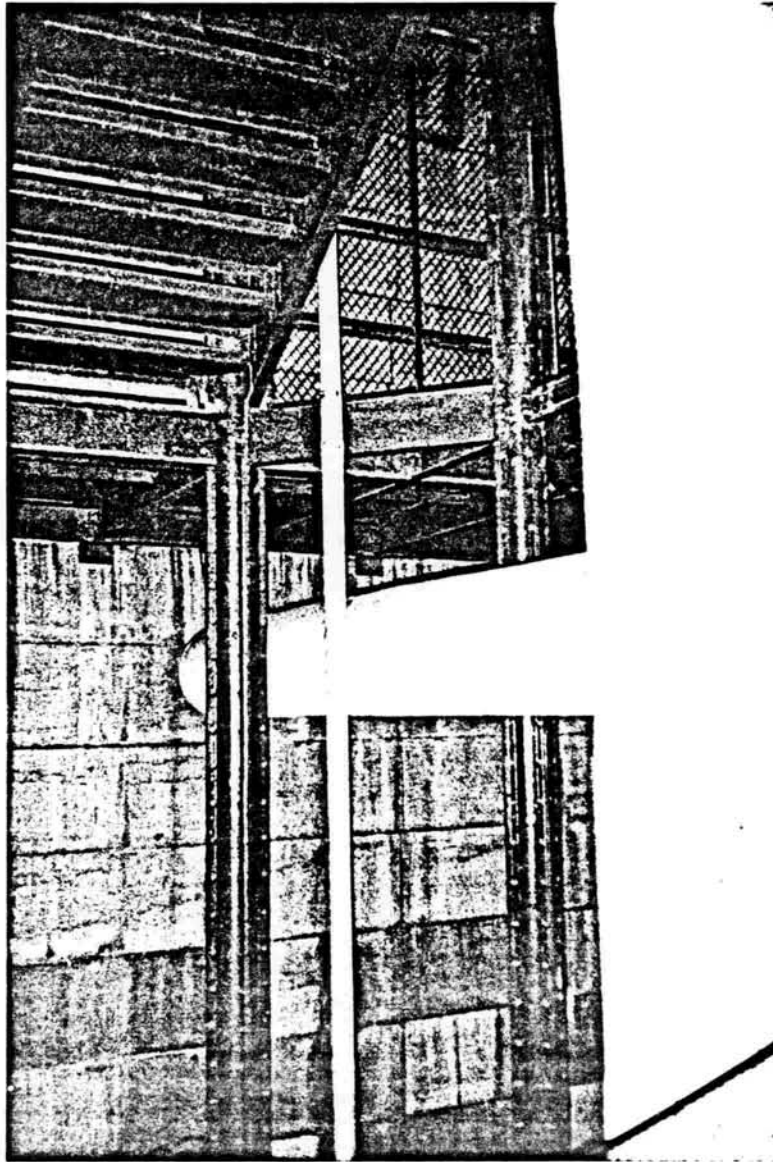
Photo 4.

Interior view of the west elevation of the Monument, with the 460' level landing at the upper part of the photo. The crack visible between the two columns runs from the bottom of the top course of granite at the 450' level to the bottom of the center rib at the 470' level.

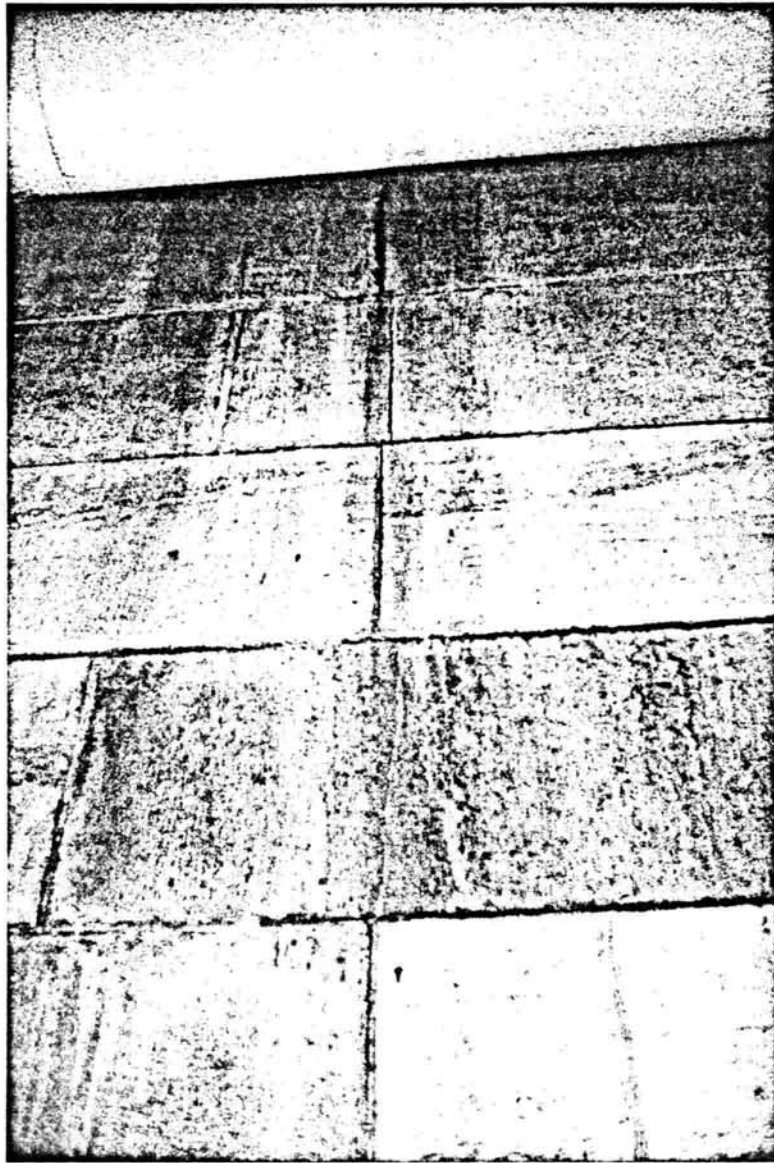
Photo 5.

Interior view of the west elevation of the Monument below the 460' level landing. The crack in the stone runs between the 450' level and the 470' level and includes the top course of granite at the 450' level.

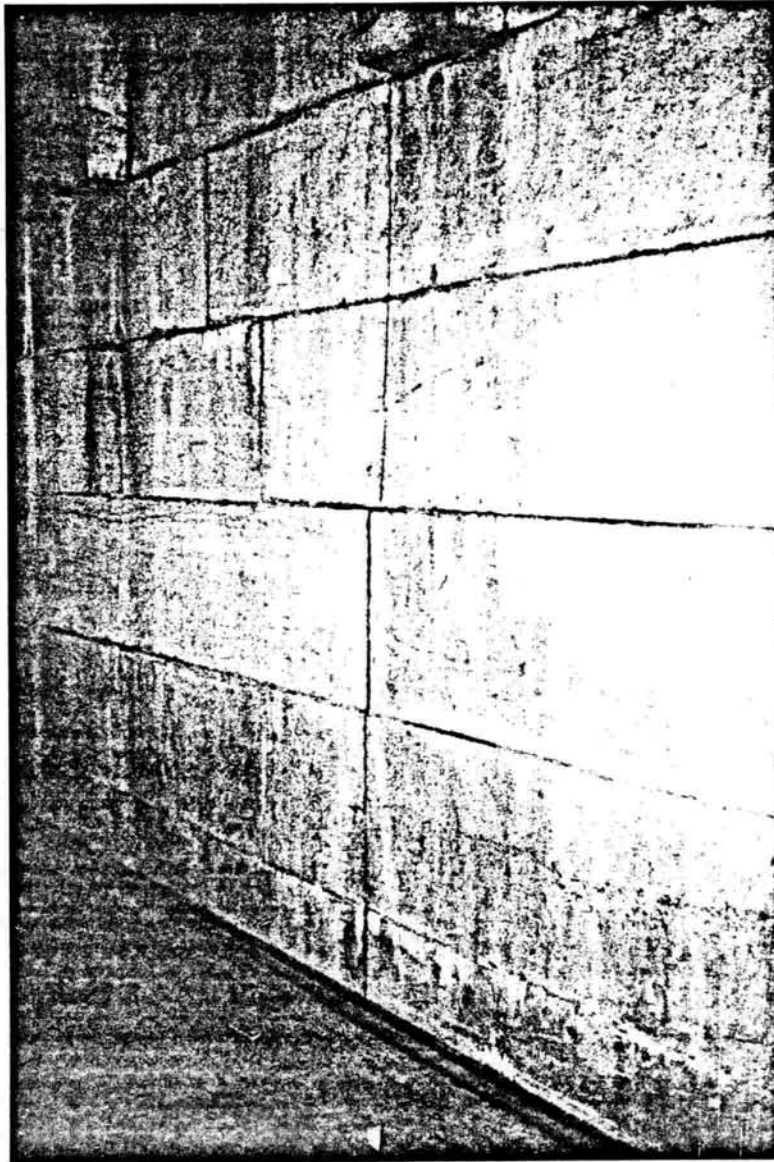
Photo 6. Interior view of the west elevation of the Monument above the 460' landing. The crack runs between the 450' level and the 470' level, going to the bottom of the center rib at the top of the photo.

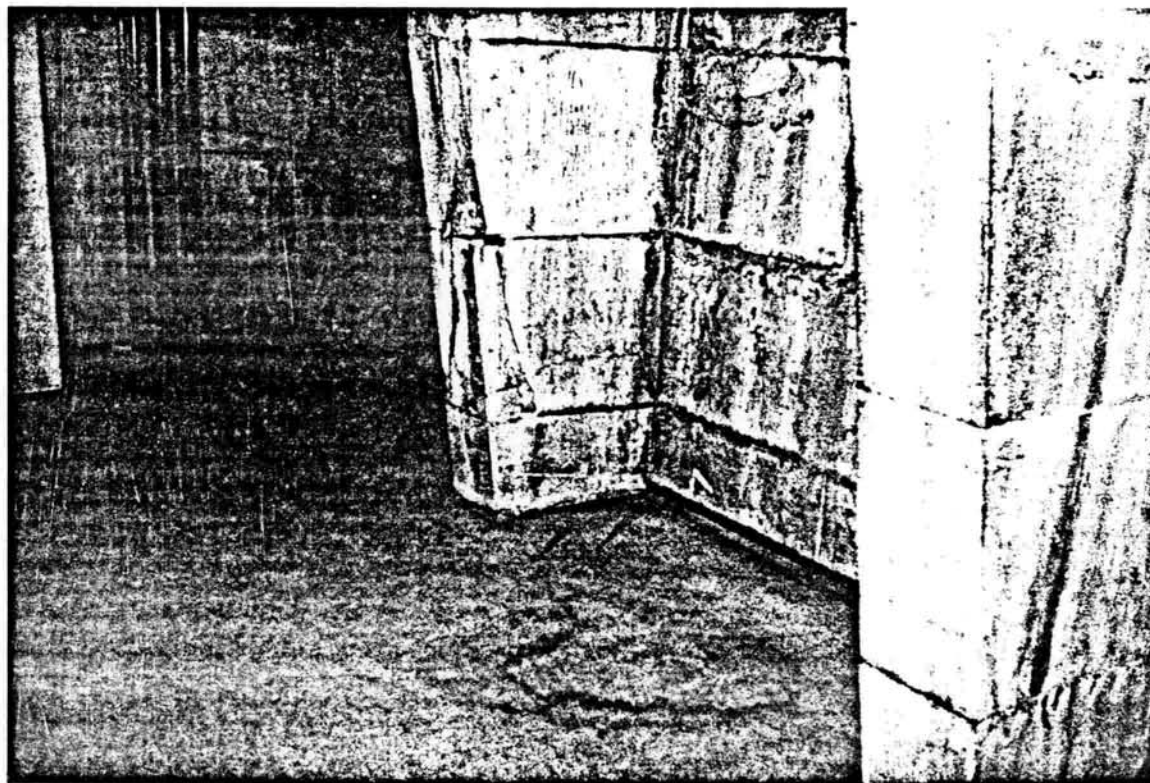
Photo 7.

Interior view of the west elevation of the Monument above the 480' level landing. The south rib is cracked between the 482' level and the 485' level, but the cracked part of the stone is loose and is not bearing any weight.

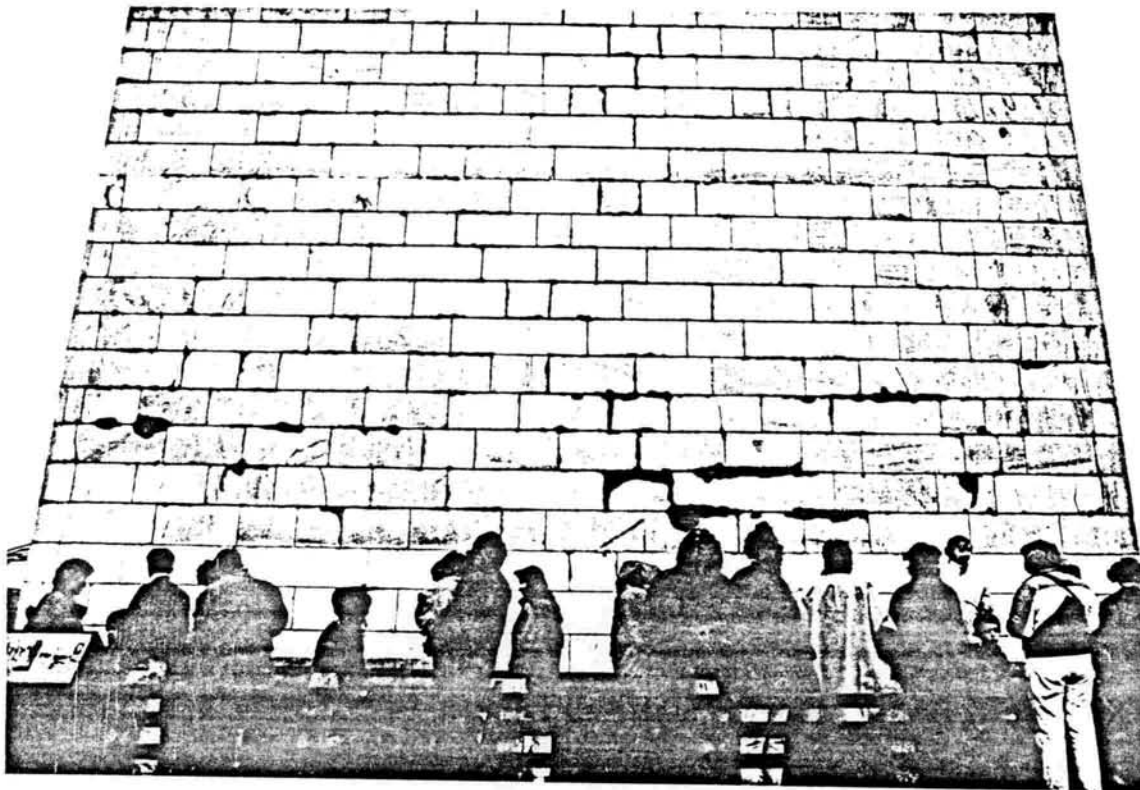
Photo 8.

Exterior view of the north elevation of the Monument. The bottom 4 courses of stone to the 8' level are of a lighter color marble. Chips and spalls at the edges of stone have been filled with dark patches of mortar.

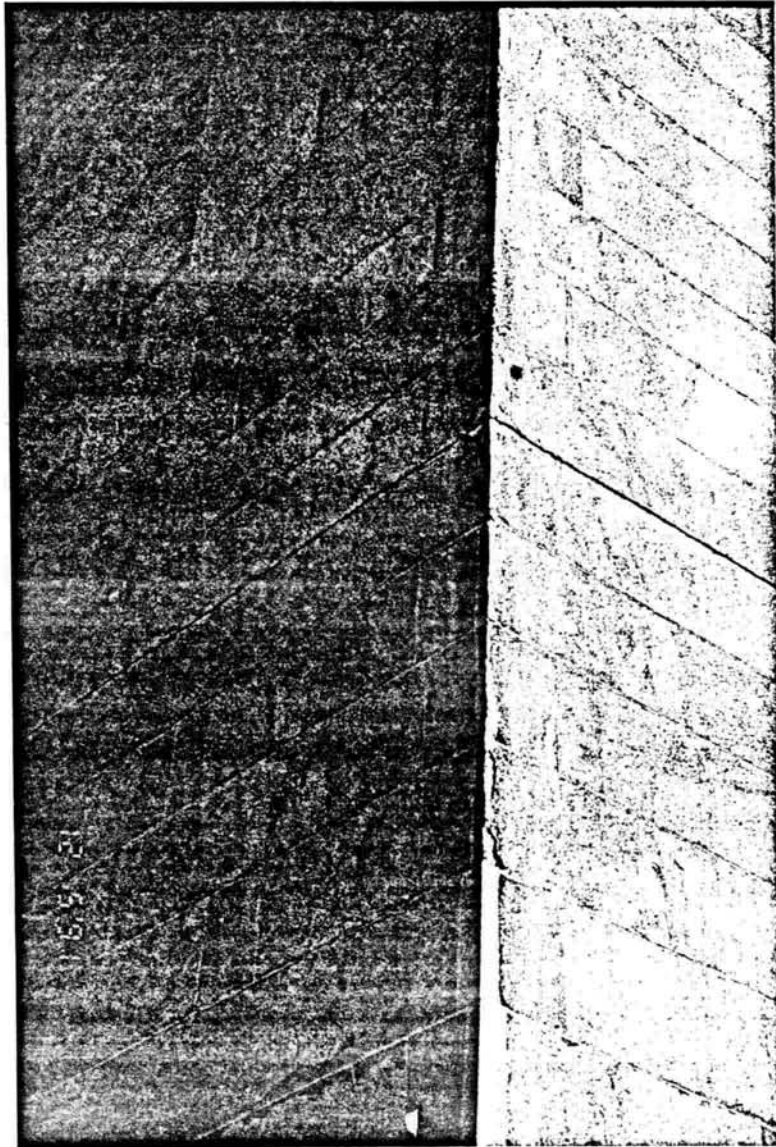
Photo 9.

Southwest corner of the Monument. Chips and spalls at the corner have been patched with mortar and with dutchman repairs, but deterioration continues at unrepaired stones. The dark joint just above the center of the photo is the horizontal sealant joint at the 28' level.

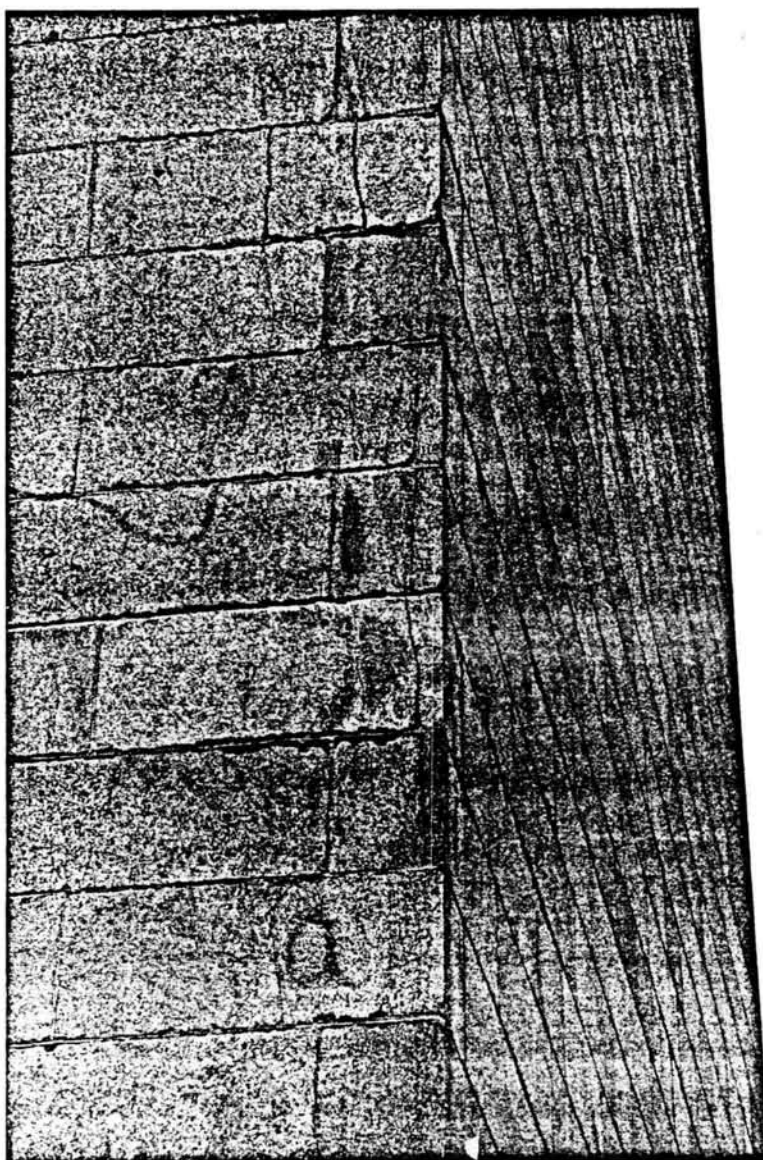
Photo 10.

Northeast corner of the Monument. Chips at the edges of the stones have been filled with dark patches of mortar. Vertical cracks have formed in the stones 4" to 6" in from the corners. The fourth joint from the bottom of the picture is the horizontal sealant joint at the 28' level.

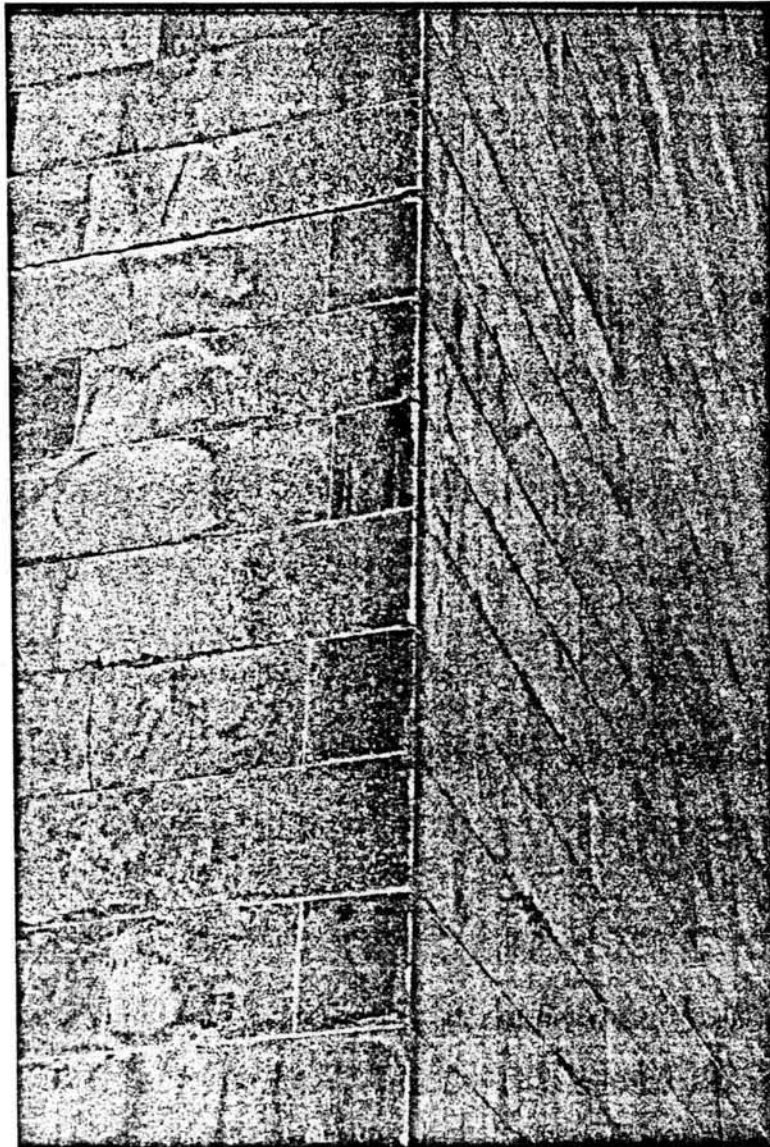
Photo 11.

Southeast corner of the Monument. Chips at the edges and corners of the stones have been patched with mortar. The third joint from the top of the photo is the horizontal sealant joint at the 28' level. Red stains can be seen at the corner.

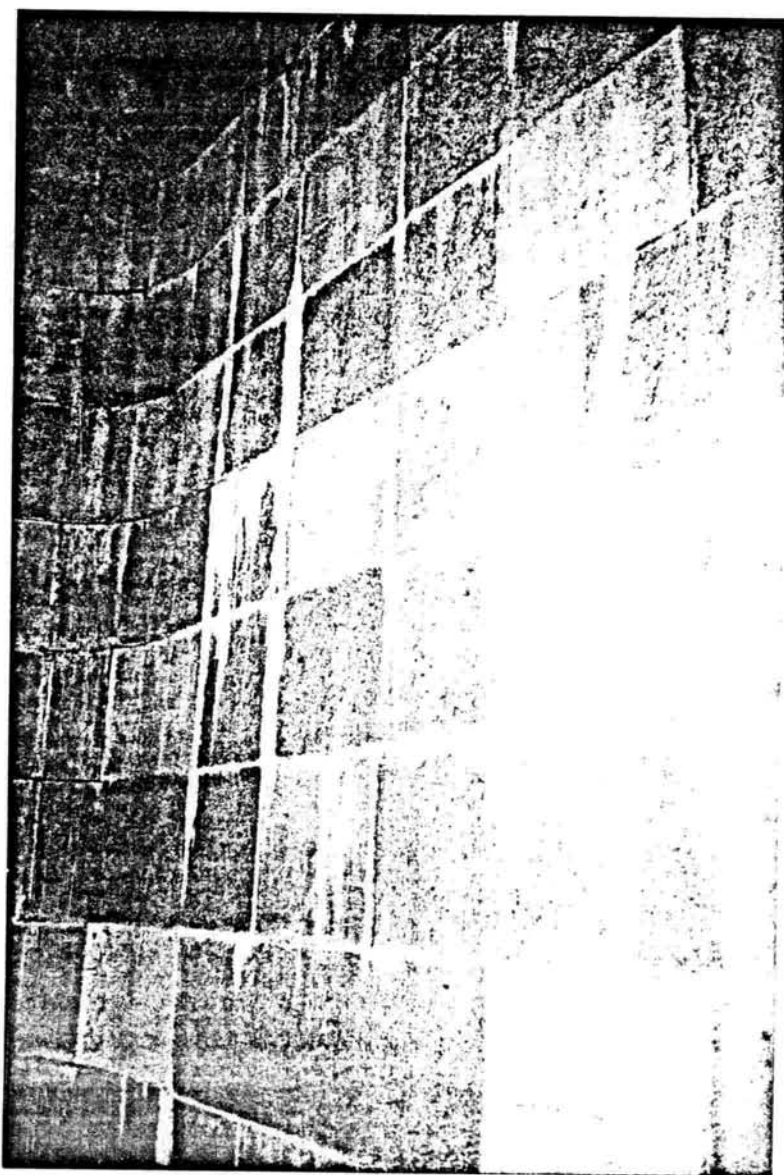
Photo 12. Interior view of the east elevation of the Monument above the 410' level landing. Water leaking through the joints between the stones has leached minerals from the stone and deposited calcium carbonate on the interior walls below the joints.

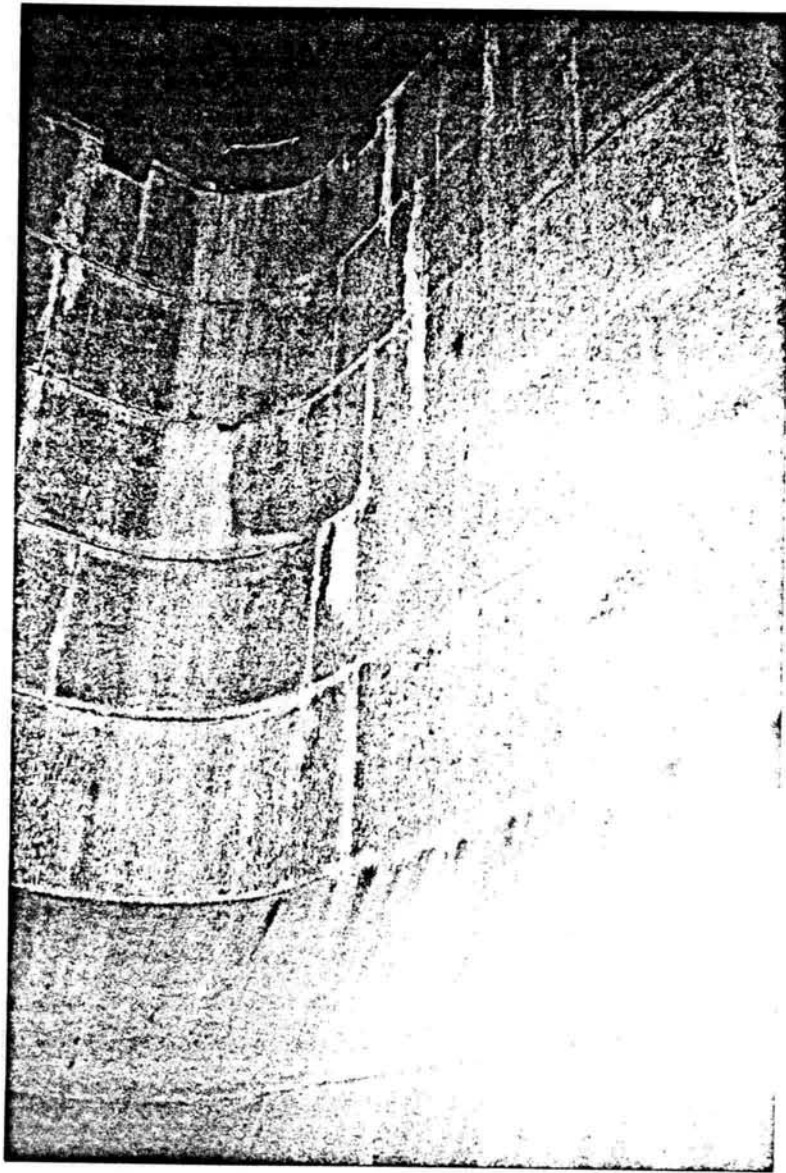
Photo 13.

Interior view of the west elevation of the Monument, with the 170' landing at the top of the photo. Water leaking through the joints between the stones has leached minerals from the stone and deposited calcium carbonate on the interior walls below the joints.

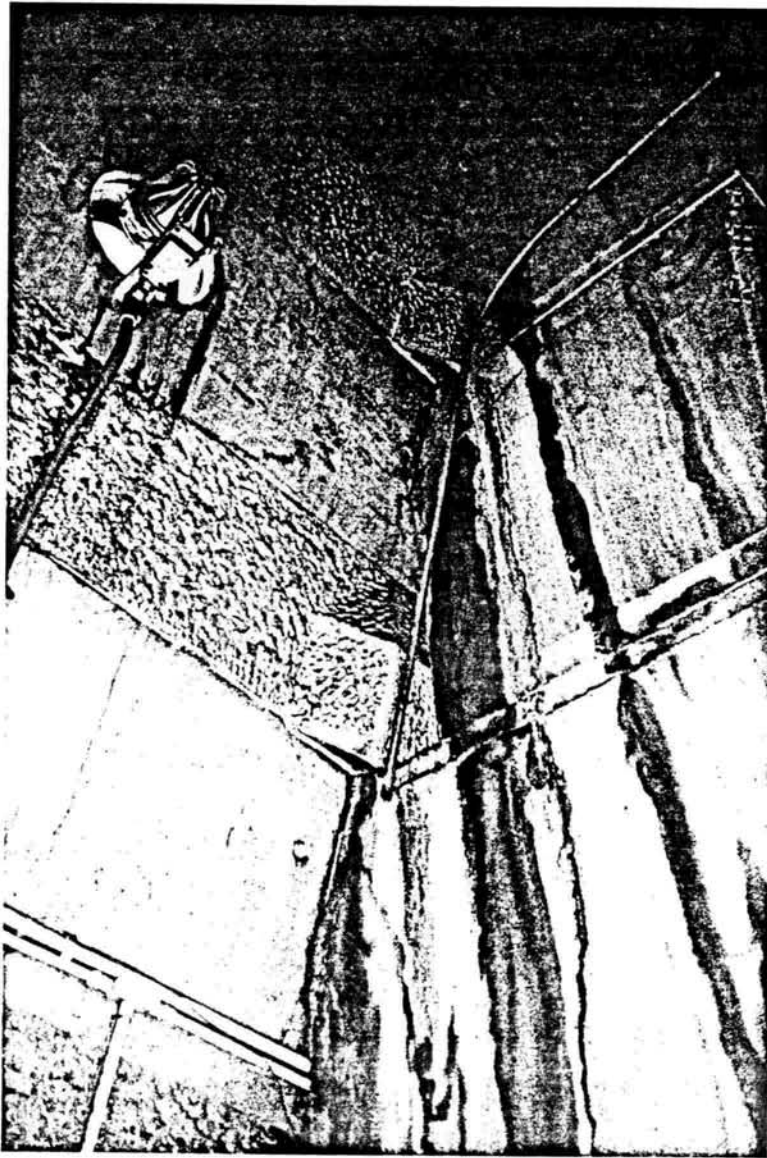
Photo 14.

Interior of west elevation of wall of pyramidion, with aircraft warning light at the 516' level and the north rib supporting the wall. Water leaking through the joints between the stone and from the aircraft warning light has stained the walls.

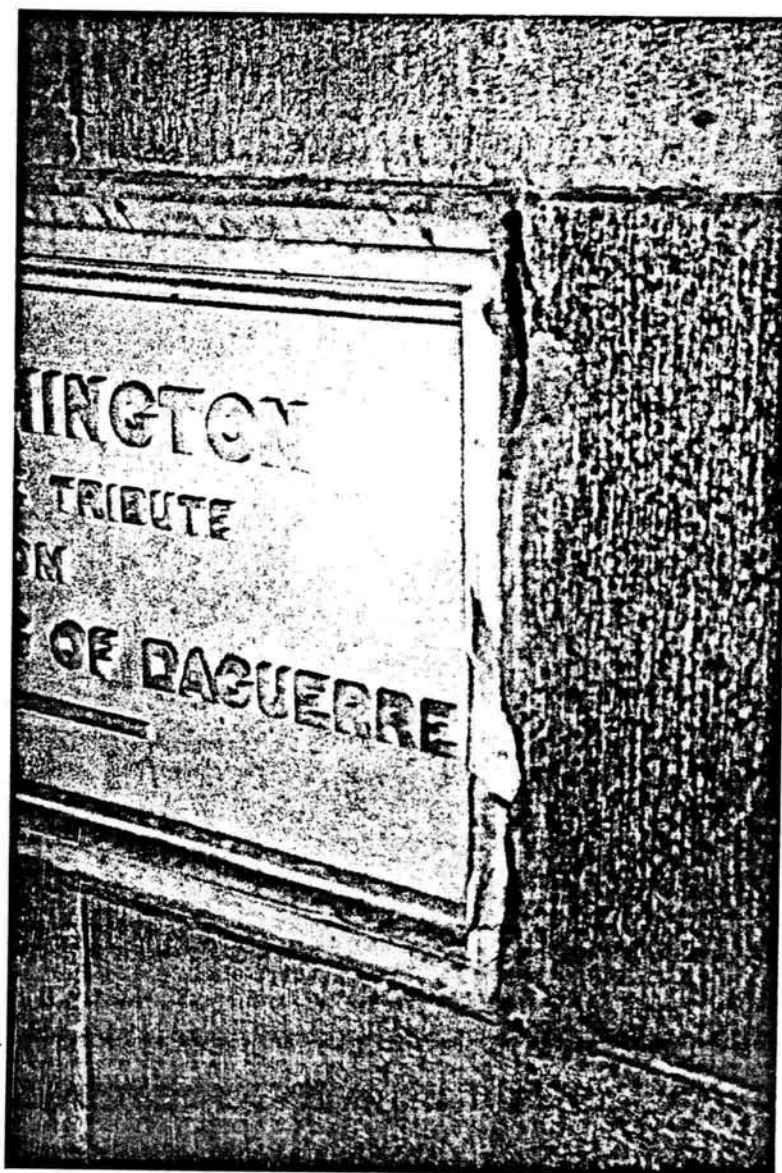
Photo 15.

"Two Disciples of Daguerre" memorial stone at the 280' level. The iron cramp holding the memorial stone in place has corroded and has caused the stone to crack and spall. Comparing the existing condition to 1957 and 1973 photographs of the stone show that the damage is worsening.

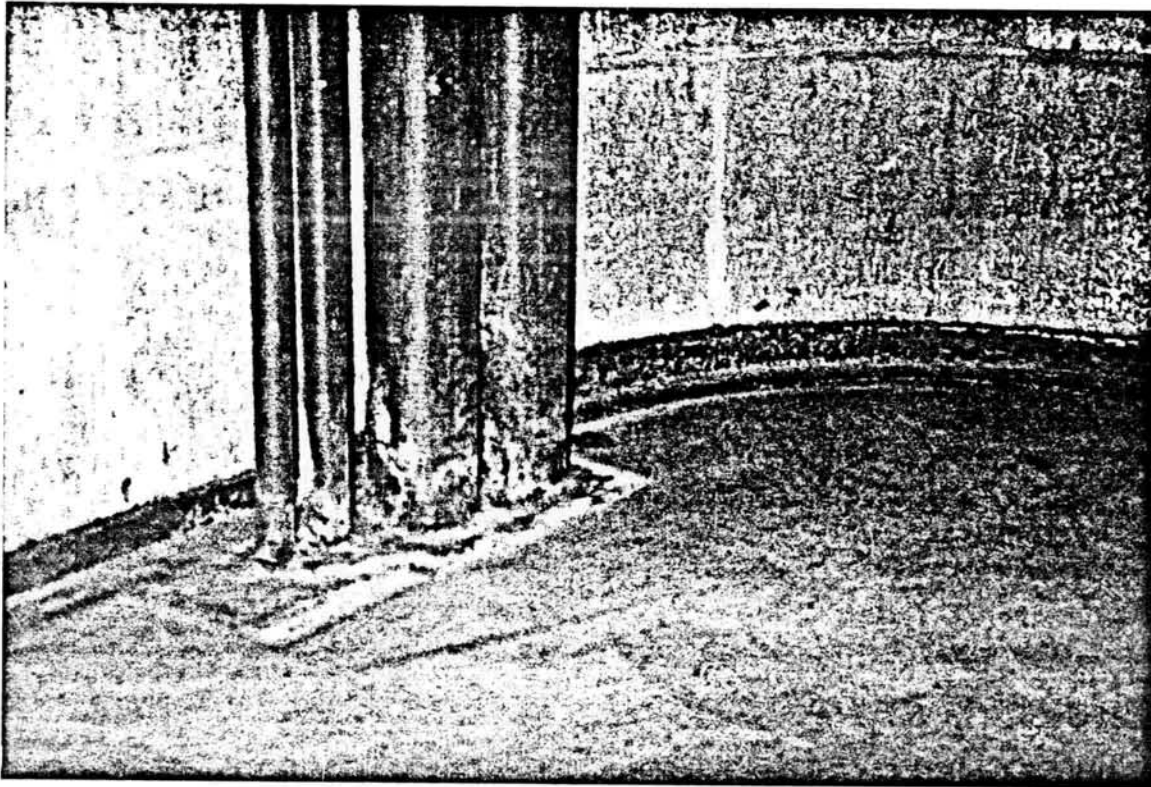
Photo 16. Conduits penetrating the landing at the northeast corner. Corrosion at the four conduits, at the metal plate which holds the conduits and at the angle against the wall is typical at all the landings.

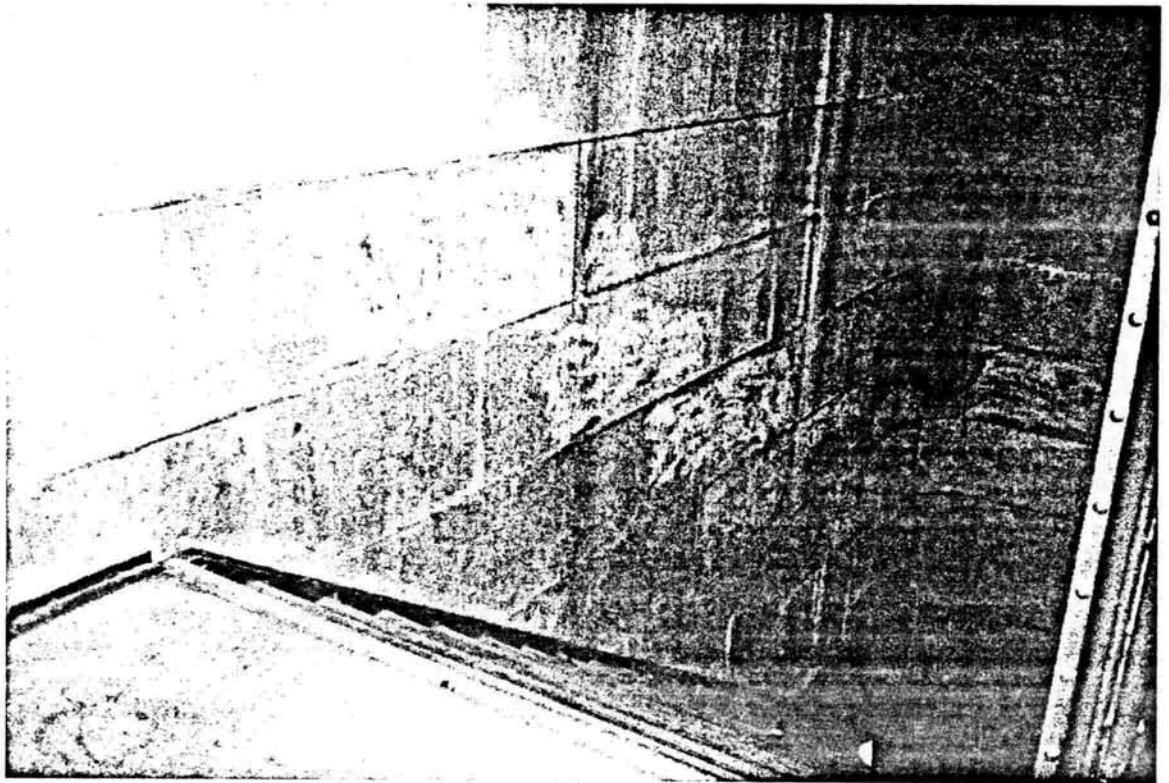
Photo 17. Interior view of west wall of the Monument looking down from the 460' landing. Random scrubbing of the stone has defaced the walls. The angle at the stair stringer is corroded.

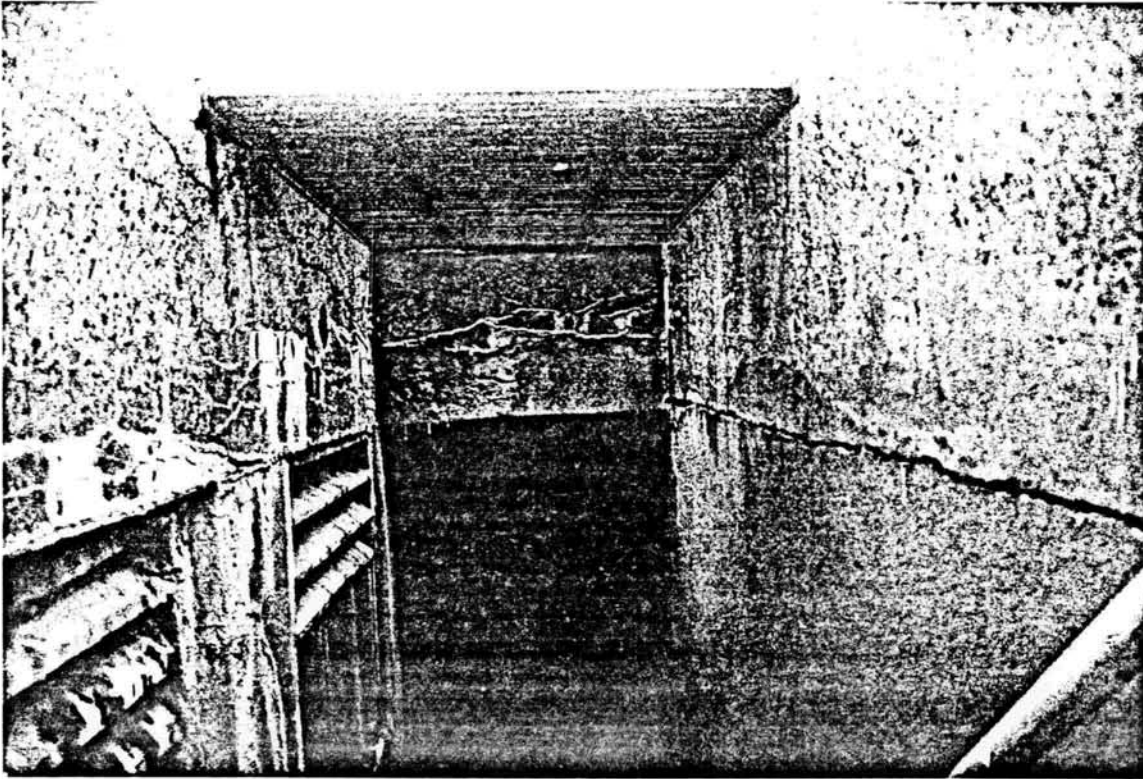
Photo 18. View of areaway for stair to underground service area. Infiltrating water has caused concrete to crack. Metal louvers covering openings to the mechanical room have corroded.

Adjacent to the mechanical space there is a vent shaft or areaway with steel grating covering it at the sidewalk level. The areaway, which is only about three feet wide, has several concrete beams spanning across the opening which have become badly deteriorated through water infiltration.

The loose and spalled concrete should be removed, the sound concrete sand blasted, and a new epoxy concrete applied. In order to insure a long lasting repair we recommend copper or stainless steel flashing be installed over the tops of the beams and along the tops of the areaway curbs.
