Benito Pablo Juarez Monument and Plaza Investigative Condition Assessment and Report

National Mall and Memorial Parks (NAMA)
Washington, DC

**REPORT & REPAIR PLAN
FINAL SUBMISSION**
March 22, 2010

Prepared by:
Oehrlein & Associates Architects
Washington, DC

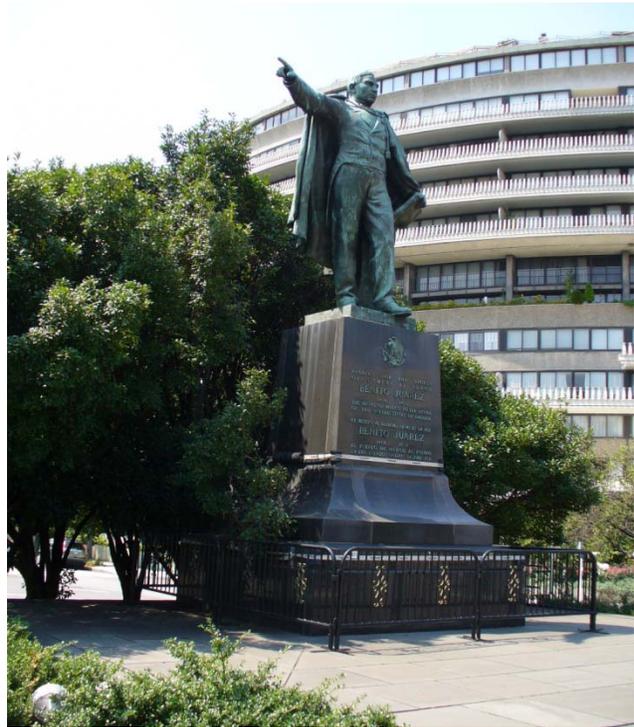
Photograph illustrating the proximity of the trees to the southwest side of the monument and the resulting shade on the plaza.

Additionally, the position of the monument beneath the drip line of the trees makes it possible that the foundation of the plaza is being, or could be impacted, by the root system of the trees. The size of a tree's drip line and root spread are often similar. Without damaging the root structure by excavation, it is not possible to ascertain what impact the tree root system may be having on the monument's foundation. While no damage to the monument is currently visible, as the trees continue to grow, damage may occur in the future.

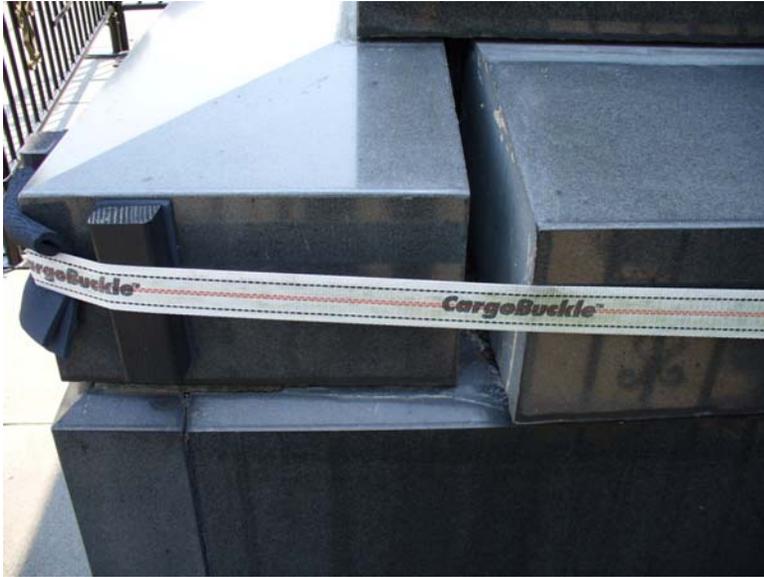
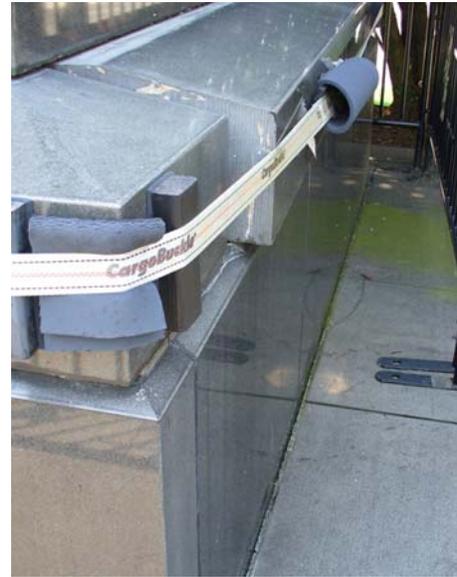
Photographs illustrating the severe stone movement at the north corner of the pedestal subbase. The cargo strap shown was installed by the National Park Service to prevent further displacement.

reaches several inches in some locations. In such instances, the blocks are completely separated from adjacent granite blocks as the pointing has completely failed. The primary cause of the displacement appears to be infiltration of water behind the stones and the subsequent pressure from freeze-thaw cycling. Where the flashing and pointing mortar failed, moisture entered the wall and, due to the lack of weep holes at mortar joints, was trapped between the stone and the concrete substructure. With no path for the water to exit, the trapped water froze and expanded during winter months, exerting pressure on the backside of the stone. As this pressure caused the stone to move, larger gaps were created at the face of the stone and a larger space was created behind the stone. This allowed larger amounts of water to enter, collect and freeze behind the stone, thereby causing additional movement of the stone. As the stones shifted from their original position, the pointing failed further and allowed more water behind the stones, accelerating the entire cycle of displacement and joint deterioration.

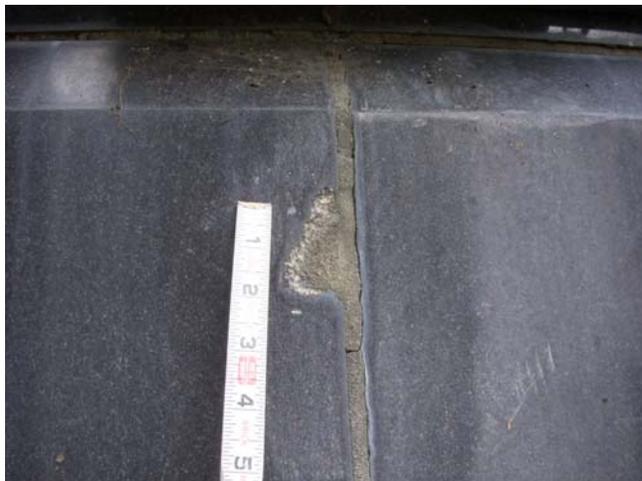
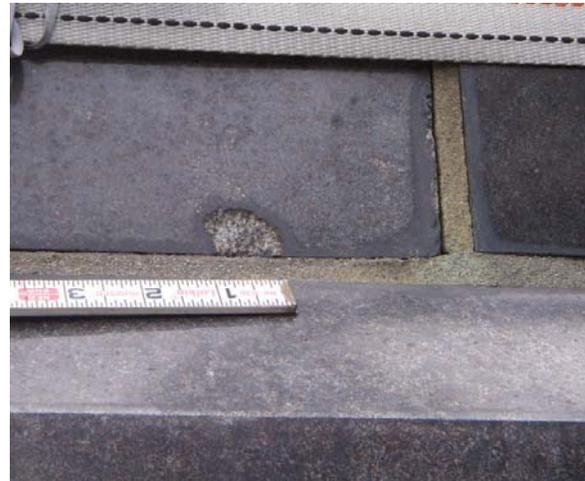
Photographs illustrating two examples of the chipping that has occurred at the edges of individual granite blocks at the pedestal.

The overall condition of the granite at the pedestal is good. There are a few occurrences of minor cracking and four instances of chipped stones. It is unclear if this damage is the result of pressure from the movement described above, an integral flaw in the stone, an impact from an external force, or some combination of the three.

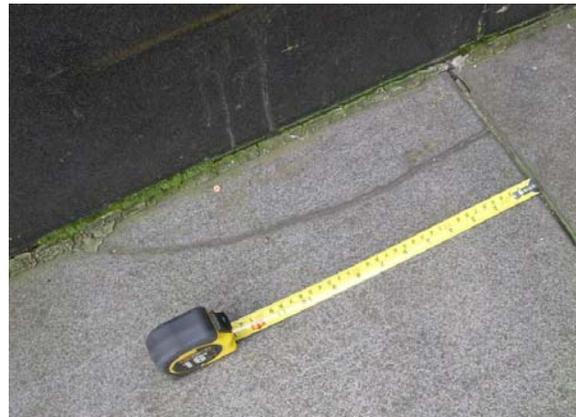
The granite pavers are largely in good condition, but with a few issues that need to be addressed. A small number of pavers have cracked. In most instances, the cracks are hairline cracks, although they likely extend through the depth of the stone. At locations where the mortar

*Cracked paver adjacent to pedestal base. (top)
Area of biological growth at the west corner of the pedestal. (bottom)*

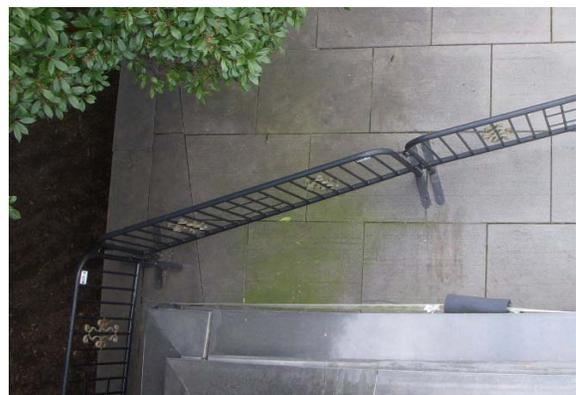
joints have failed, biological growth has taken root and spread onto the granite itself. The heavily shaded west corner of the plaza has widespread algae and moss growing on the pavers near the pedestal. There is general soiling of the types outlined in the section on the granite pedestal as well as dirt from pedestrian foot traffic.

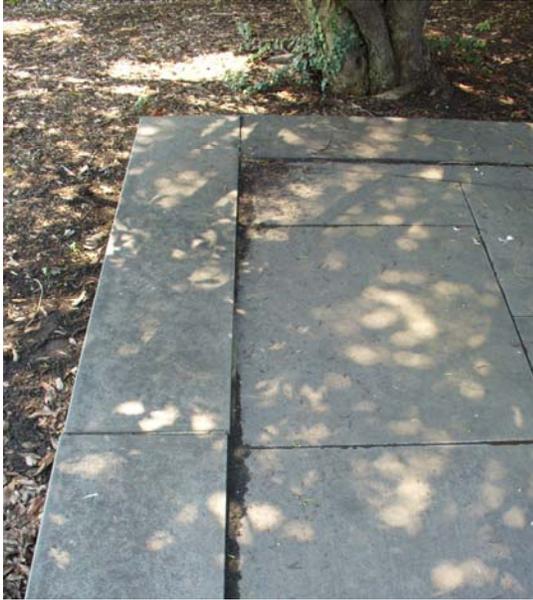
Low spot at the south corner of the monument plaza has resulted in the collection of soil deposits.

In addition to cracking, the pavers have settled creating depressions in the plaza. The settlement is likely the result of shifting and erosion of the setting bed beneath the pavers. The settlement has possibly been made worse over the years as the mortar joints between the pavers have failed and not been replaced. With no mortar in the joints, large amounts of water are allowed to seep into the setting bed contributing to its general deterioration. In winter months, the water

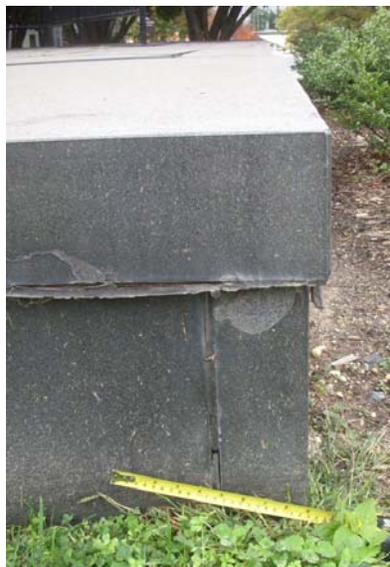
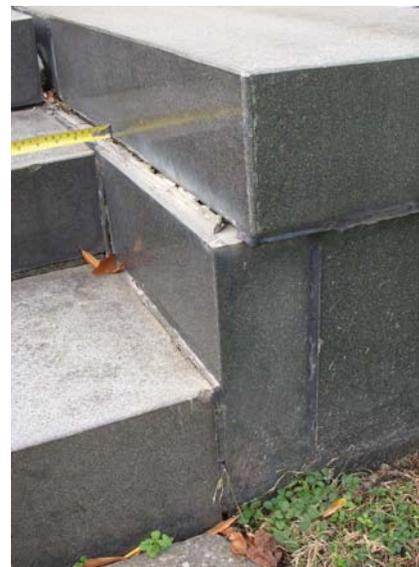
Examples of the shifting and spalling at the granite curbing. Photographs also illustrate the stone displacement at the stair's north cheek wall.

The plaza is bound on three sides by granite curbing with vertical granite facing. The face stone extends down below the adjacent grade. At the northeast side, the curbing terminates at large square granite curbstones that also serve to cap the cheek walls at the plaza steps. The cheek walls also have vertical facing stones. According to the as-built drawings, the curbing and wall cladding are set in mortar beds on a reinforced concrete foundation wall and footing. The granite itself is in good condition with only a small number of cracks and chips. Several of the curbing stones have shifted from their original positions. As the mortar joints at the curbing and plaza pavers have failed, water has infiltrated behind the curbing and collected between the stone and the surface of the concrete structure. Similar to the process that is occurring at the granite pedestal, this water is undergoing a freeze-thaw cycle that is forcing the stone outward. The cycle contributes to the deterioration of the mortar joints and setting beds allowing the intrusion of more water and dirt and thereby accelerating the condition. The curbing and cladding are soiled similar to the pavers. In addition, the vertical wall cladding at grade is heavily soiled due to its close proximity to the soil of the surrounding planting beds.

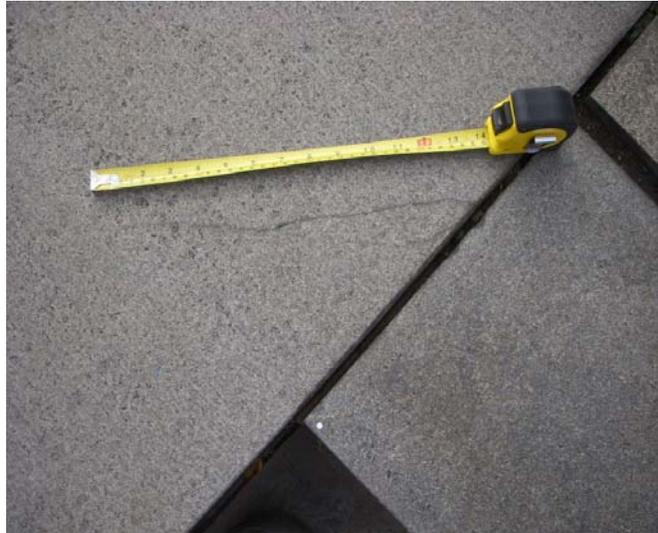
Example of cracking at the granite curbing.

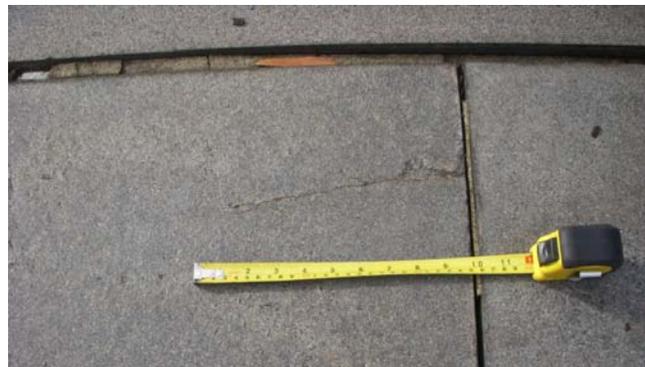
Cracked granite step. Photo also illustrates the mortar joint deterioration. (top)

The granite steps are in good condition with only one crack and one spall. The steps are soiled similar to the plaza pavers and curbing.

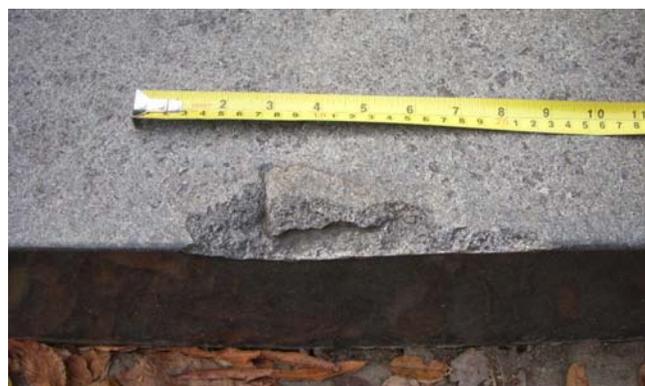
Large impact spall at the nose of a granite step. (bottom)

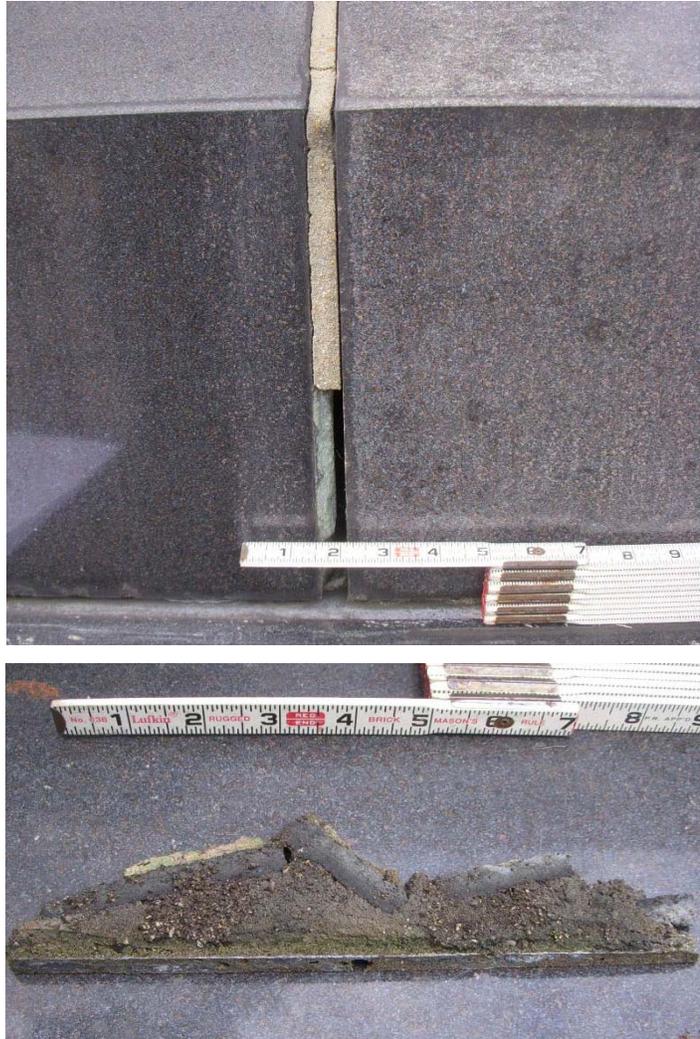
Mortar deterioration at granite pedestal. In many locations, mortar is missing completely. (top) Photograph of a mortar sample taken from a vertical joint in the granite pedestal base on the north elevation. The straight surface on the bottom of the photo was the exterior face of the joint. Evident are several repair campaigns to close the joint, as well as dirt and vegetation. The dark mortar broken into segments at the top of the photo is likely the original mortar. Instead of removing mortar prior to repointing, the existing mortar was simply pushed deeper into the mortar joint. (bottom)

A mortar sample was collected from a vertical joint in the north elevation (see photograph this page). Evident from the mortar sample was that several campaigns to repoint open mortar joints have been performed over time. The original mortar appears to have been a black color. Samples of the original mortar were removed from the granite pedestal base and analyzed for composition. The objective of the analysis was to determine if the original

mortar was appropriate and to determine the composition of the original mortar for matching purposes. The laboratory analysis found that the sample is a pigmented, non-air-entrained Portland cement-sand mortar. The 1:1 proportion of cement to sand does not meet any current industry standard mix proportions (ASTM C 270 *Specification for Mortar for Unit Masonry*). Typical proportions are 1:3 cement to sand. The original mortar was grossly under sanded and would have been very hard and prone to shrinkage. Failure of the bond with the stone could have occurred during curing or shortly after installation. The petrographic analysis indicates that the mortar suffered from expansion fracturing due to freezing and thawing and indicates that the mortar may have been retempered and remixed with other mortar batches at the time of installation. Typically, replacement pointing mortar should match the original mortar composition and color. In this case, however, the original mortar mix was not appropriate and likely resulted in premature failure of the pointing. The original mortar color should be matched, but a better mix design should be used. The full mortar analysis is included in the attached Appendix E.

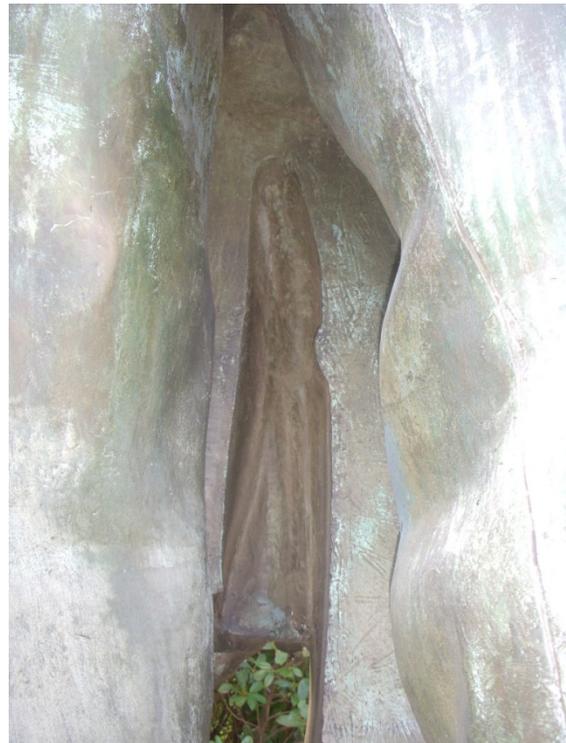
The bronze is generally in good condition with minor deterioration and damage that should be addressed. The bronze likely originally had a dark statuary bronze finish as is typical of monumental statutes of this type. There has been recent refinishing of the statue, probably within the last ten years. The wax used to refinish the statue had dark brown and green pigment additive. Much of the recent wax, however, has deteriorated or worn away completely resulting in streaks and large patches of green oxidation commonly associated with weathered bronze. In archival documents regarding the monument, there is mention of the statue being painted green at one point. The close range survey conducted for this assessment, however, located no remnants of paint on the bronze.

View of the original statuary patination at a protected, recessed area of the bronze. Also visible is the later green and brown pigmented waxes.

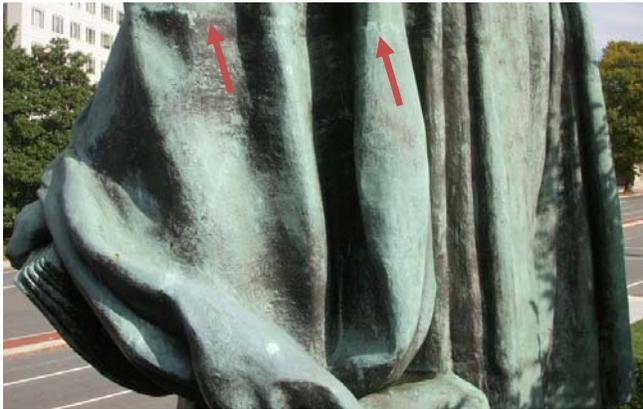
The brazing material used to join together the statue's separately cast pieces has become increasingly apparent as the finish of the statue has weathered. This weathering has highlighted the cold joints between cast pieces making them readily apparent. It also appears that the various sections of the statue were cast with slightly different alloys as the color of bronze varies from piece to piece. This is especially apparent at the base of the support adjacent to Juarez's left leg.

View of the rear of the Juarez statue showing variations in the color of the patina. The lighter areas are where the protective wax coating has weathered and the bronze is oxidized. Note the joint line between the cast sections visible at the top of the photo.

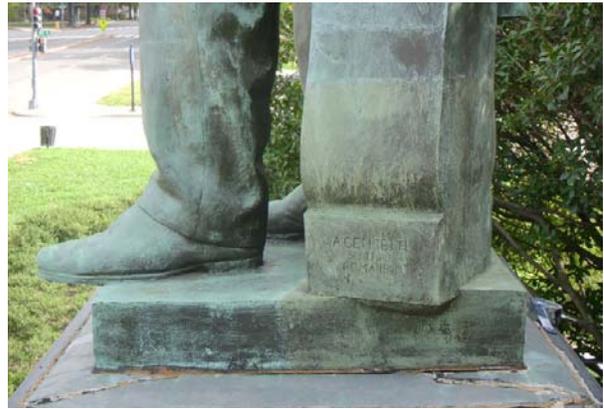
Northwest side of the statue base and support. Note the varying bronze color at the bottom of the support indicates the use of a different bronze alloy.

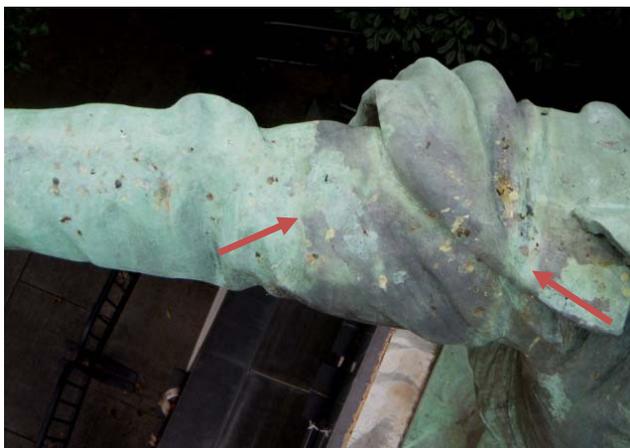
View at the top surface of the right arm showing a brazed seam between cast sections at the left in the photo and brazing repair of shipping damage at the right.

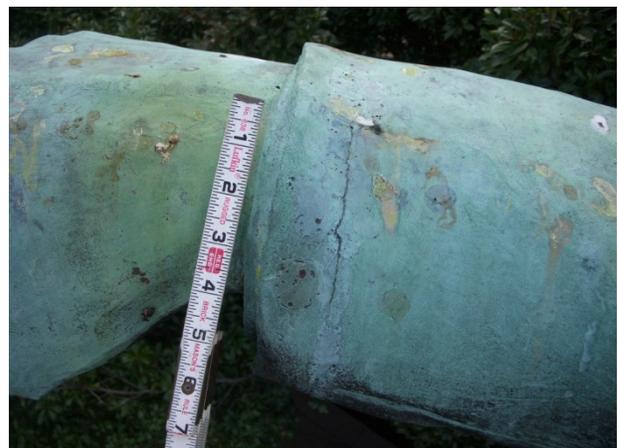
View of the joint between the right arm and hand. The original brazed fabrication joint has cracked and is open.

There are occurrences of cracking at the statue's surface that range from superficial to more significant. The cracks most often occur at the seams between the statue's individually cast pieces, but a number of them exist within the cast sections themselves. A large majority of the cracks are superficial and are likely watertight. It appears that the cracks within the cast pieces are shrinkage cracks that occurred during the casting process and are not a sign of ongoing deterioration. However, there are more significant cracks that are open to varying degrees and expose the bronze to further deterioration. In the area between Juarez's left arm, torso, and cape, there are two large cracks as well as a missing area several square centimeters in size.

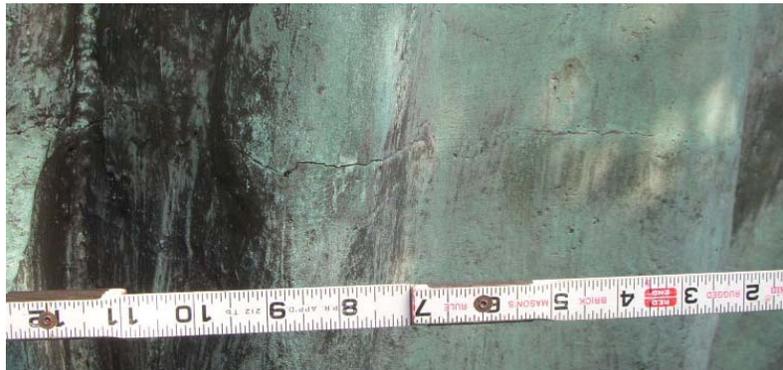
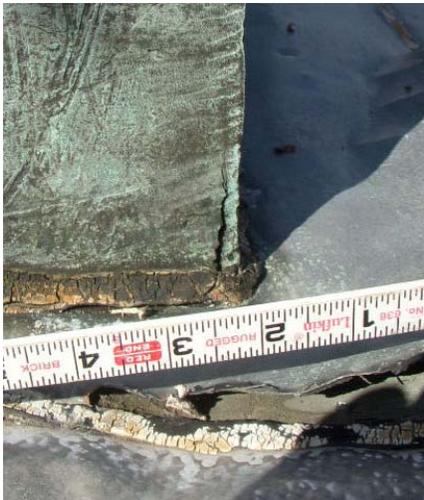
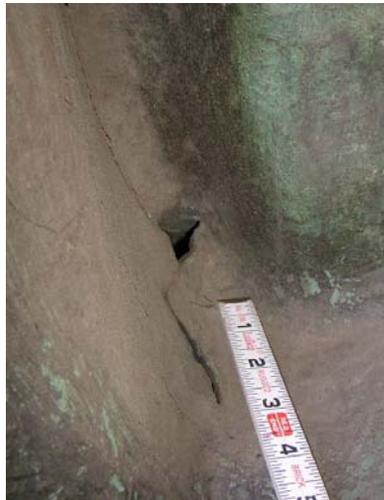
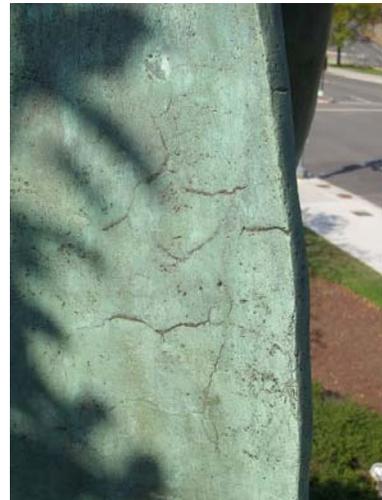
The east corner of the statue's bronze base has a $\pm 2 \frac{1}{2}$ inch high vertical crack through the bronze. The crack is large enough to allow rainwater to enter the interior, thereby increasing the potential of accelerated deterioration of the statue's anchoring system. If the drain through the statue support slab shown on the original as-built drawings is blocked, any rainwater which makes its way into the 9 inch air space between the statue base and the slab will sit on the slab and with time may cause the steel bolts and concrete to deteriorate. This interior condition, however, cannot be observed without removing the statue from the base.

Details of the statue's cape showing surface cracking. (right & bottom right) Detail of the underside of the statue's cape at the left arm showing a crack through the bronze and missing material. (bottom center) Detail of statue base showing a vertical crack through the bronze base. (bottom left)

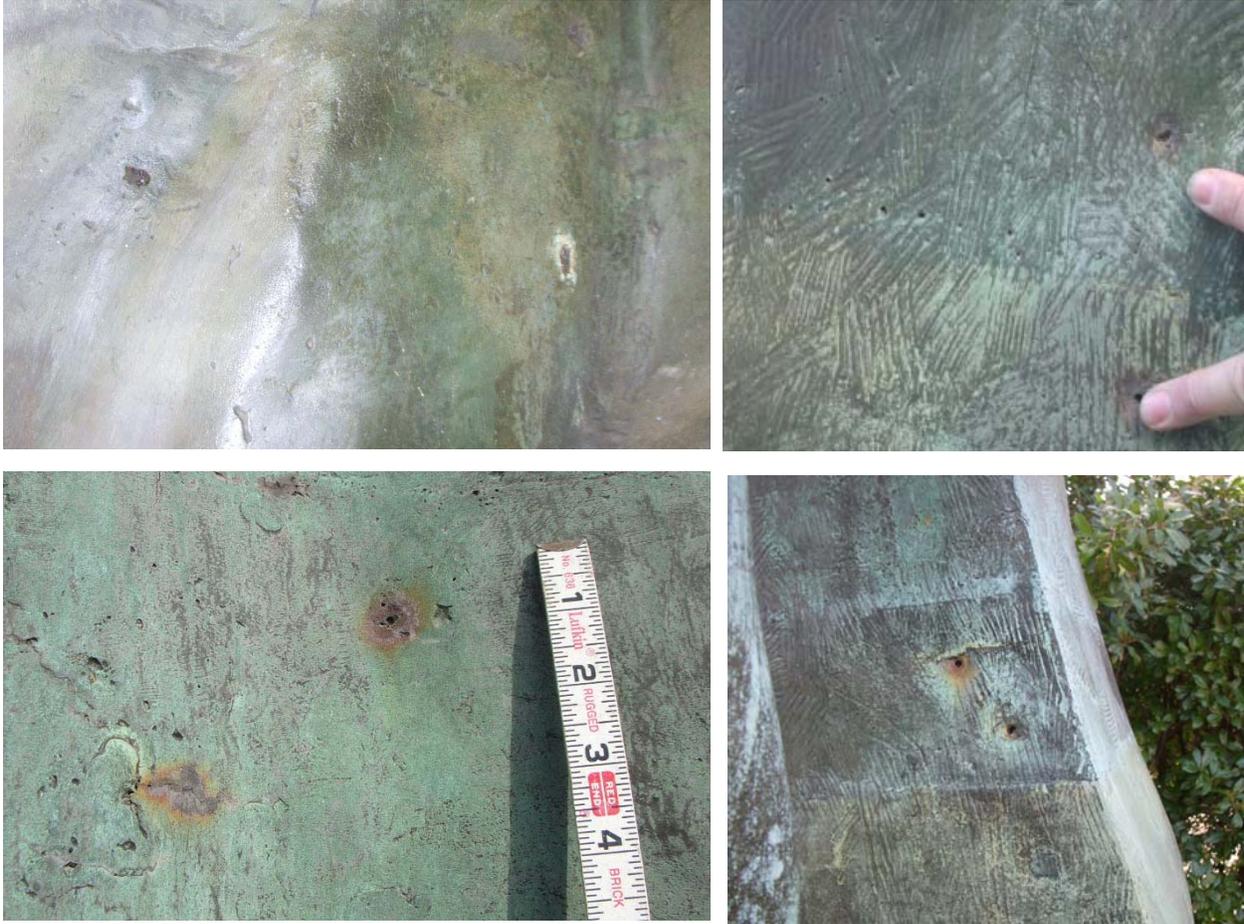
Pitting at the statue's bronze surface is characteristic of the quality of the original casting. (top) What looks like pitting accompanied by rusting may be remnants of the iron pins used in the casting process or may be iron debris that was present in the original casting alloy. (bottom).

There is minor pitting in various locations throughout the statue. Some of this pitting is a result of weathering and corrosion, but most is simply indicative of the quality of the original casting. There are also a number of small areas of rust that are accompanied by mild to moderate pitting. In some spots, the corrosion pitting penetrates the statue surface completely. This rust may be caused by remnants of iron pins used during the casting process that were not properly removed or may be iron debris in the original casting bronze. During the casting, iron pins can be used to hold the mold together and prevent deformation from the weight and pressure of the molten bronze. Once the bronze has hardened and the molds removed, the remaining pins are typically removed and the holes patched. It appears that a number of pins were not completely removed after casting but simply cut off. As the remaining portions of these pins have corroded over the years, the rust has stained the surrounding bronze. In the instances where the rust surrounds a hole in the statue, what appears to be severe pitting is likely a location where the ferrous metal has either rusted away completely or fallen out.

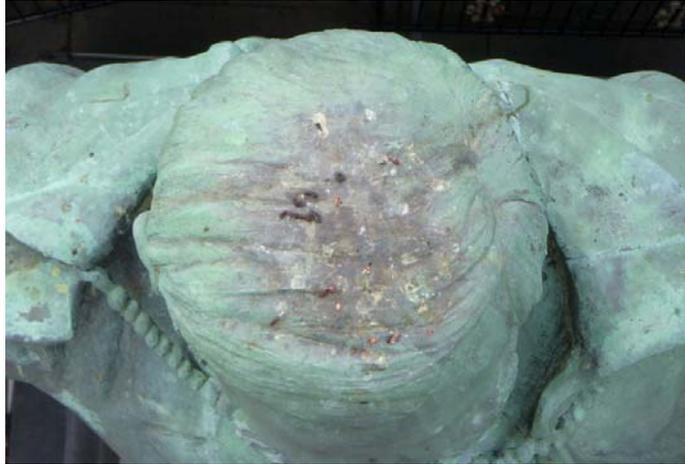
The statue has various types of soiling on its surfaces. Similar to the soiling described in the section on granite above, much of this soiling is likely caused by precipitation running off over the statue and atmospheric settling of dust and pollution. The statue also has a significant amount of bird and animal excrement on the arms, shoulders and head.

Atmospheric and animal soiling on top statue's head.

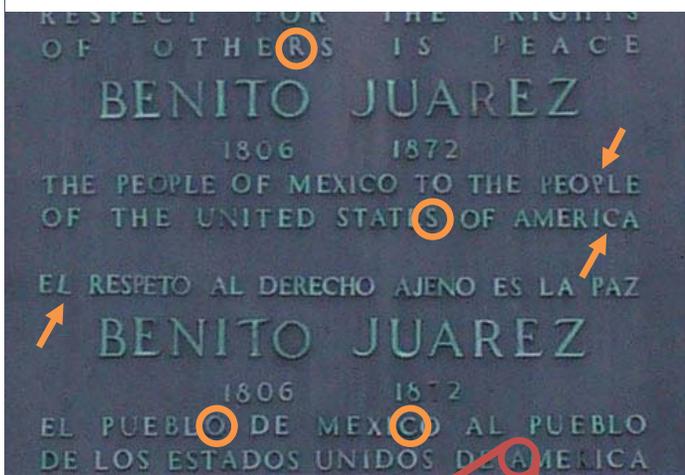
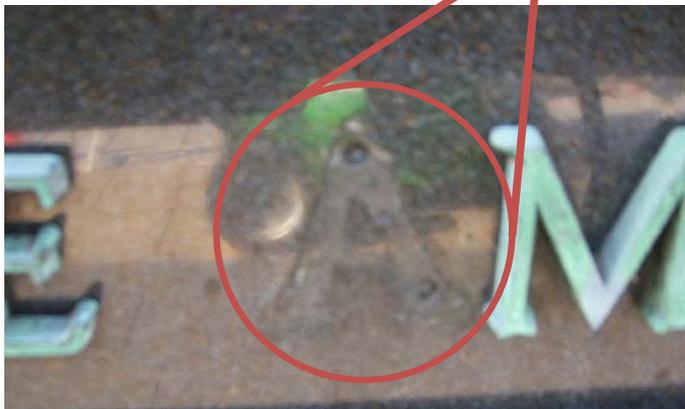
The bronze lettering has developed a green patina similar to that found on the Juarez statue. In addition to this oxidation, many of the individual characters, and the coat of arms, are exhibiting general soiling that is likely caused by precipitation runoff and atmospheric soiling. The adhesive holding the letters in place has begun to fail in some locations. In some cases, the loss of adhesive has resulted in loose letters. In other locations, the bronze pins have broken off of the letter causing them to rotate in place and fall out of alignment with the remainder of the text. During the on-site survey, one letter, the first "A" in "AMERICA," fell

Detail of the pedestal's bronze lettering showing oxidation and soiling. Note the arrows indicating characters that have rotated out of alignment due to failing anchors and circles indicating loose characters. (top) Detail of the pedestal lettering showing the letter that fell off during the survey. (above)

off the granite completely. Jennifer Talken-Spaulling retained the displaced letter on behalf of the National Park Service; the letter is stored at the Cultural Resource Program Office for later reinstallation.

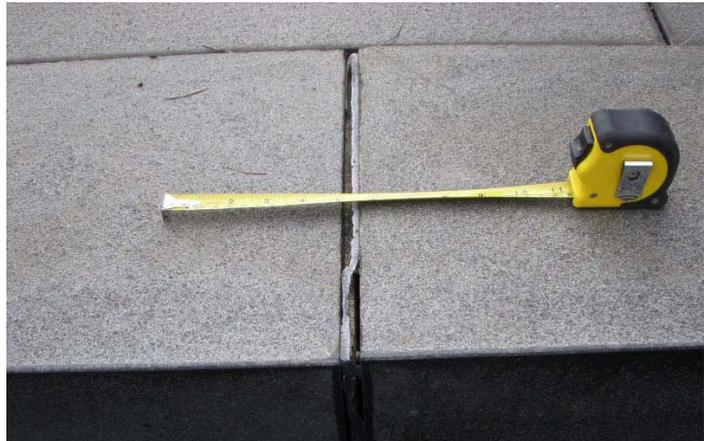
The sealant at the pedestal flashing and at the plaza joints is in poor condition. The sealants exhibit substantial ultraviolet degradation including cracking and discoloration. In some areas, the sealants have become rigid, lost their flexibility and the bond with the stone has failed. It also appears, especially at the statue base flashing joints, that sealant repair campaigns have previously been installed directly on top of older, failed sealants without removal of old sealants and without proper surface

Detail of the granite plaza curbing illustrating failed sealant at stone joint.

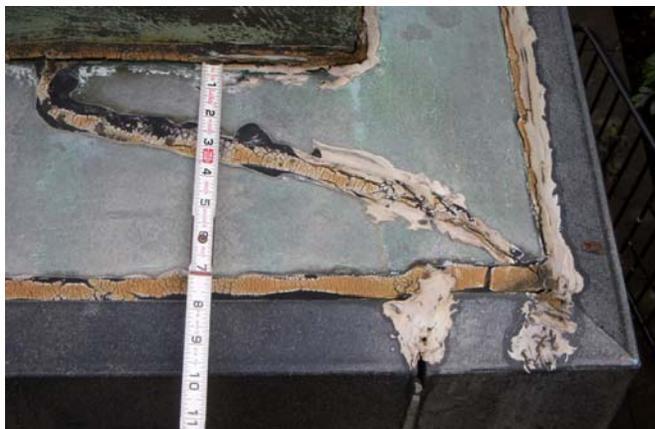
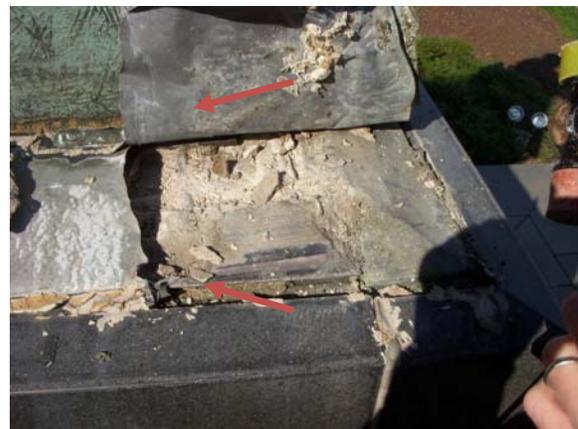
Detail of the flashing at the top of the pedestal showing multiple sealant installations, all failed. (left) Detail of the stone and mortar beneath the pedestal flashing. The arrow indicates the metal cramp embedded in mortar at top of stone. (right)
