Physical Description

CHARACTER DEFINING FEATURES

Figure 3-017: Street elevation. (Photo: BBB, 2007)

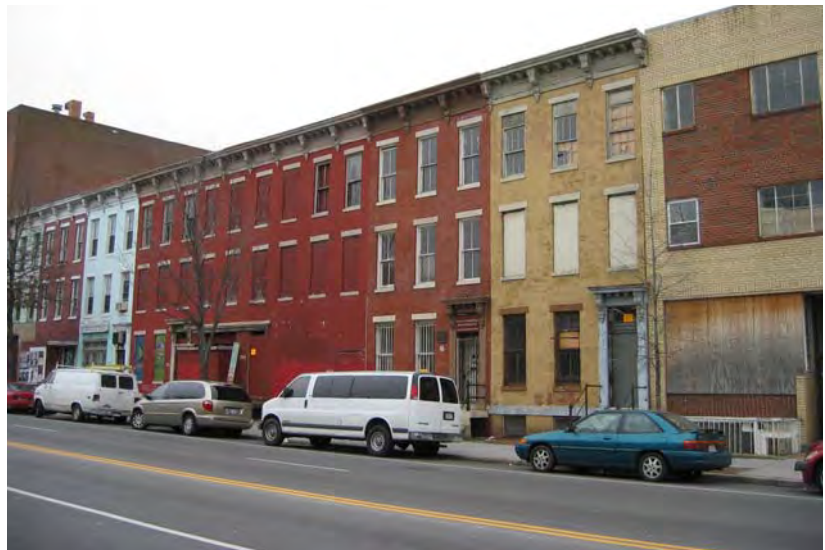
Although the Carter G. Woodson Home has undergone many changes on the inside, the exterior East Elevation has been witness to only a few changes over time. Most of the historic elements from Period 1 are intact with the exception of the front door and the window sashes. The North and South elevations bear clear evidence of the 1880 addition with a visible seam in the brick. The West Elevation of both the two and three story portions of the building show the most significant deterioration due to major structural problems within the building as well as in the building envelope. Due to the lack of visibility of the North, East and South elevations, they have suffered significant damage due to vandalism, weathering and lack of maintenance. The south west corner of the two story addition is close to collapsing.

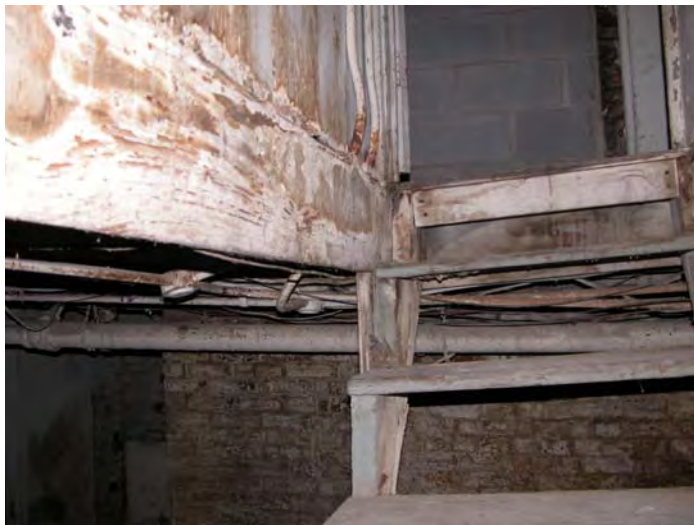
Miscellaneous: The (3) steel columns are spaced approximately 7'-4" apart and run east to west. These columns are rusting at their base as a result of continuous water accumulation on the basement floor. This water enters the building through window opening W003. These columns all have labels on them indicating that they were made by the Phoenix Ironworks. The columns support a steel beam. This additional structure was either installed during Dr. Carter G. Woodson's occupancy (Period 3) to support the increased load of office use on the floors above or installed immediately prior to his purchase of the house (Period 2).

Figure 3-129: Termite damage at stair opening framing. (Photo: BBB, 2007)

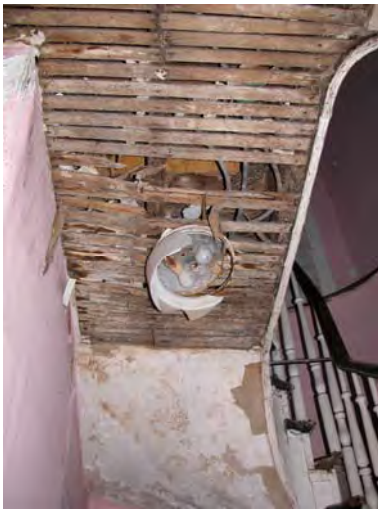
Figure 3-160: Room 103 ceiling damage and incandescent light fixture.
(Photo: BBB, 2006)

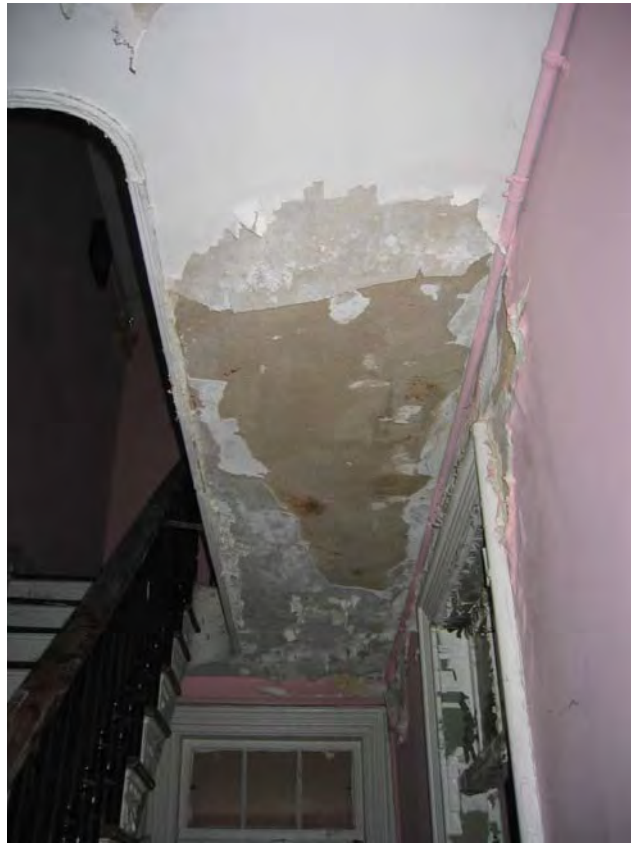
Figure 3-301: Plaster ceiling damage. (Photo: BBB, 2007)

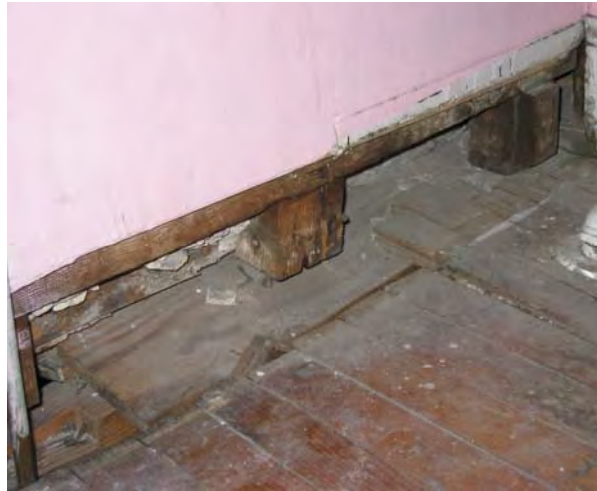
Figure 3-383: Missing base board at east wall exposing timber studs and cut nails.

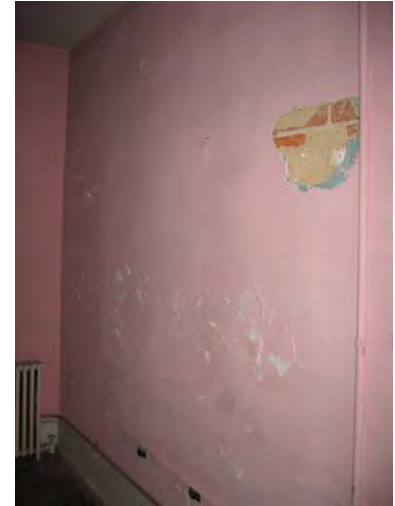
Figure 3-418: North elevation showing water damage to plaster. (Photo: BBB, 2007)

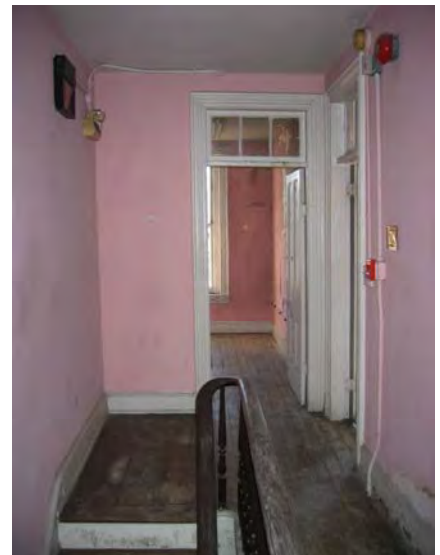
Figure 3-430: Plaster damage at south wall. (Photo: BBB, 2007)

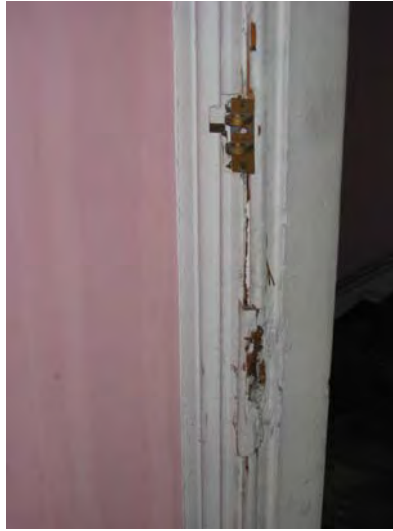
Figure 3-438: Damage to door frame D303A. (Photo: BBB, 2007)

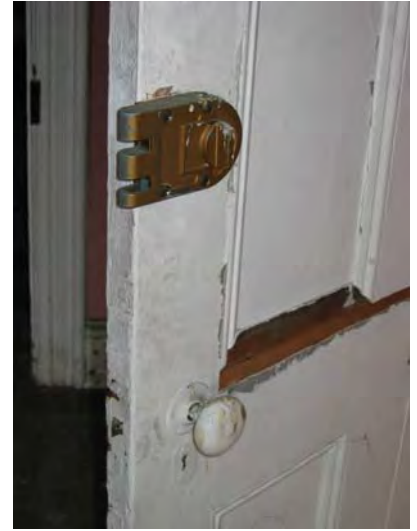
Figure 3-439: Missing wood molding at door D303A from room 303. (Photo: BBB, 2007)

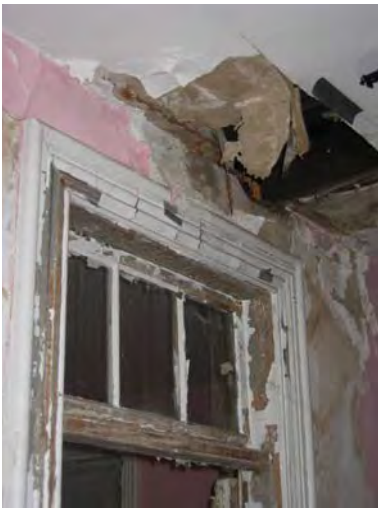
Figure 3-440: Transom damage at door D305. (Photo: BBB, 2007)

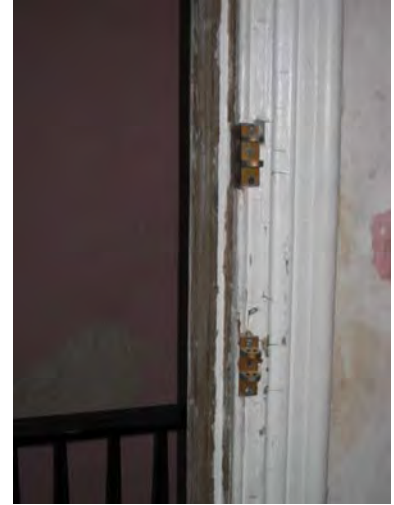
Figure 3-444: Door D305 frame damage. (Photo: BBB, 2007)

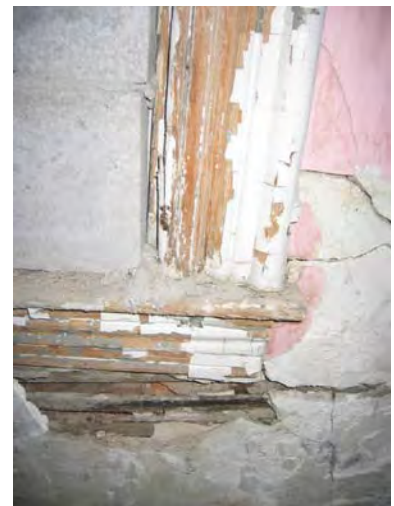
Figure 3-446: Sill condition at W303.
(Photo: BBB, 2007)

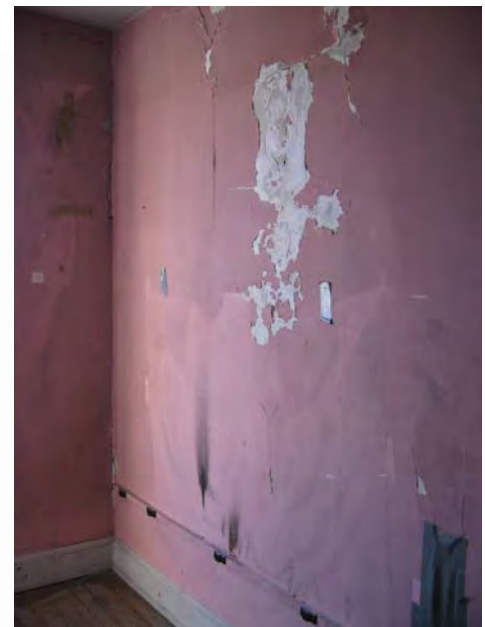
Figure 3-454: Water damage to plaster at south wall. (Photo: BBB, 2007)

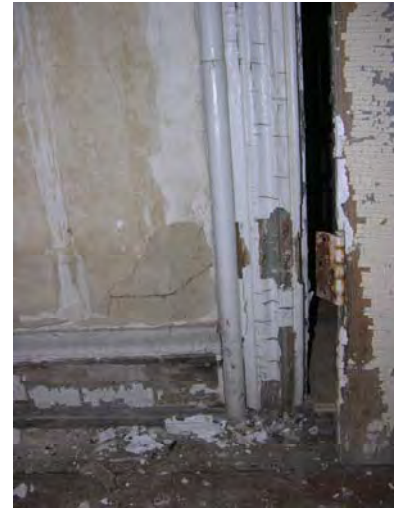
Figure 3-498: Water damage at wood base on north wall. (Photo: BBB, 2007)

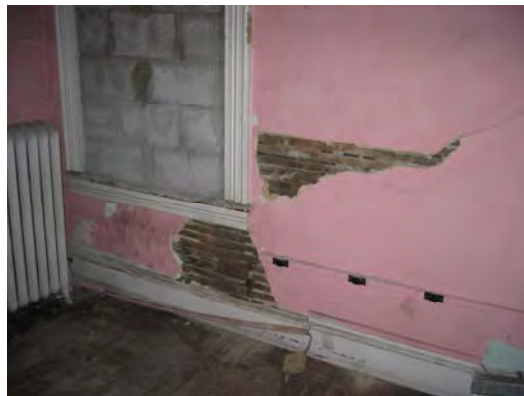
Figure 3-502: Loss of plaster and major cracks at west wall by window W304. (Photo: BBB, 2007)
