Golden Gate National Recreation Area

TITLE I REPORT

Stinson Beach Parking Lot Storm Damage Repairs

August 2015

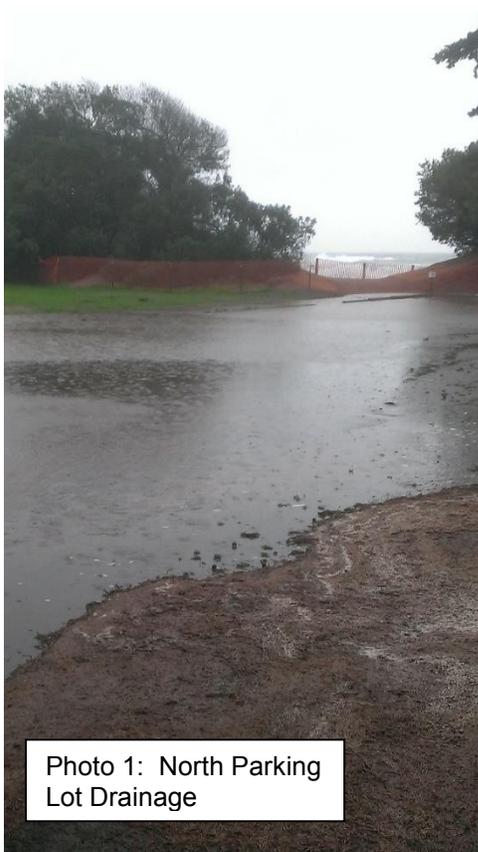
Photo 1: North Parking Lot Drainage

The North and South parking lots have poor grading with respect to site drainage. Water from direct rain fall runs off the uneven asphalt surface randomly onto adjacent grassy areas, but numerous puddles remain on the surface of the asphalt until it evaporates or infiltrates through the pavement (see Photo 1).

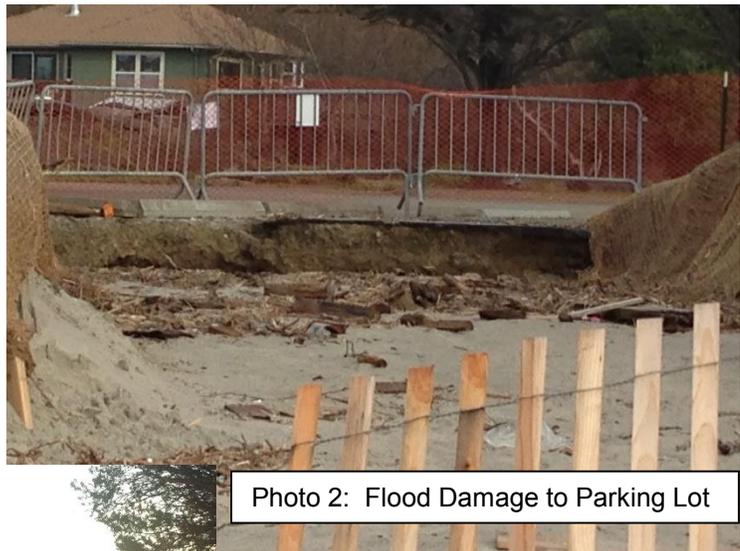
Photo 2: Flood Damage to Parking Lot

similar to the last storm damage in winter of 2013. Flood water eroded sand and silt materials and the sides of the dunes creating an incised channel to a depth of three to five feet. Damage included undermining of the parking lot which in turn caused the asphalt pavement to fail locally around the outfall (see Photos 2 and 3).

Water flowing across the asphalt pavement onto the sand will rapidly erode the sand and/or gravel at the edge of the asphalt and then rapidly undermine the edge of the asphalt even at relatively low flows. The berm across the outfall and subsequent ponding of water above the parking lot surface during the December 2014 flood added additional energy which increased erosion at the outfall when the berm was breached. We expect that even without the berm, the water flowing through the outfall would have damaged the edge of the parking lot. An armored outfall is required to protect the parking lot during flood events.

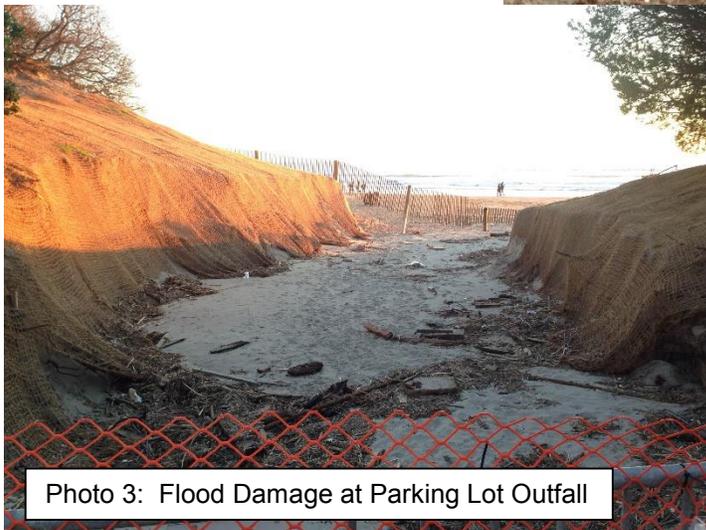
Photo 3: Flood Damage at Parking Lot Outfall

constructed outfall/beach access. Ponding occurred at the new outfall, but as the water continued to rise it became apparent that the height of the outfall berm was not correct or had shifted over time and that over-topping of the berm along the north side of the North parking lot might occur. In response, park personnel breached the outfall berm with hand tools. The resulting damage was

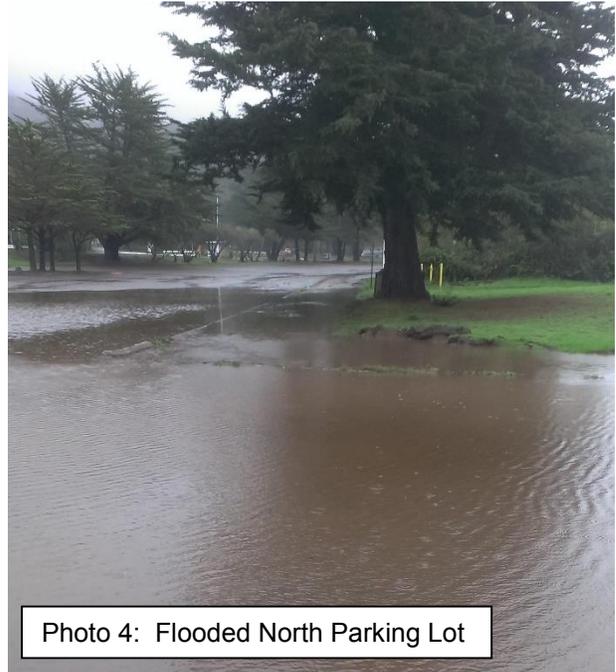
Photo 4: Flooded North Parking Lot

2. The present width of the outfall channel is approximately 16 feet at the base.
3. The depth of the pond over the parking surface was approximately one to two feet deep based on reports from Park personnel who observed the area during the December 2014 flood event. Park personnel then breached the berm in the outfall so that water would not flow over the berm along the north side of the North parking lot.

4. The top of the berm, located along the north edge of the North parking lot, was observed to be irregular and variable in height. The top of the berm appeared to be approximately one to two feet above the surface of the adjacent asphalt at the time of our June 1, 2015 site visit. Subsequent Park survey measurements of the berm and parking lot confirmed this estimate.

The berm along the north side of the North parking lot is variable in height and is not well constructed. An improved berm should be constructed to contain the design flows within the parking lot until the water can pass through the outfall.
