**RE: REPORT- CANEEL BAY EMERGENCY RESPONSE  
ST. JOHN, USVI  
ERTEC PROJECT: E-104290**

**REPORT  
CANEEL BAY EMERGENCY RESPONSE  
ST. JOHN, USVI**

**ERTEC JOB: E-104290**

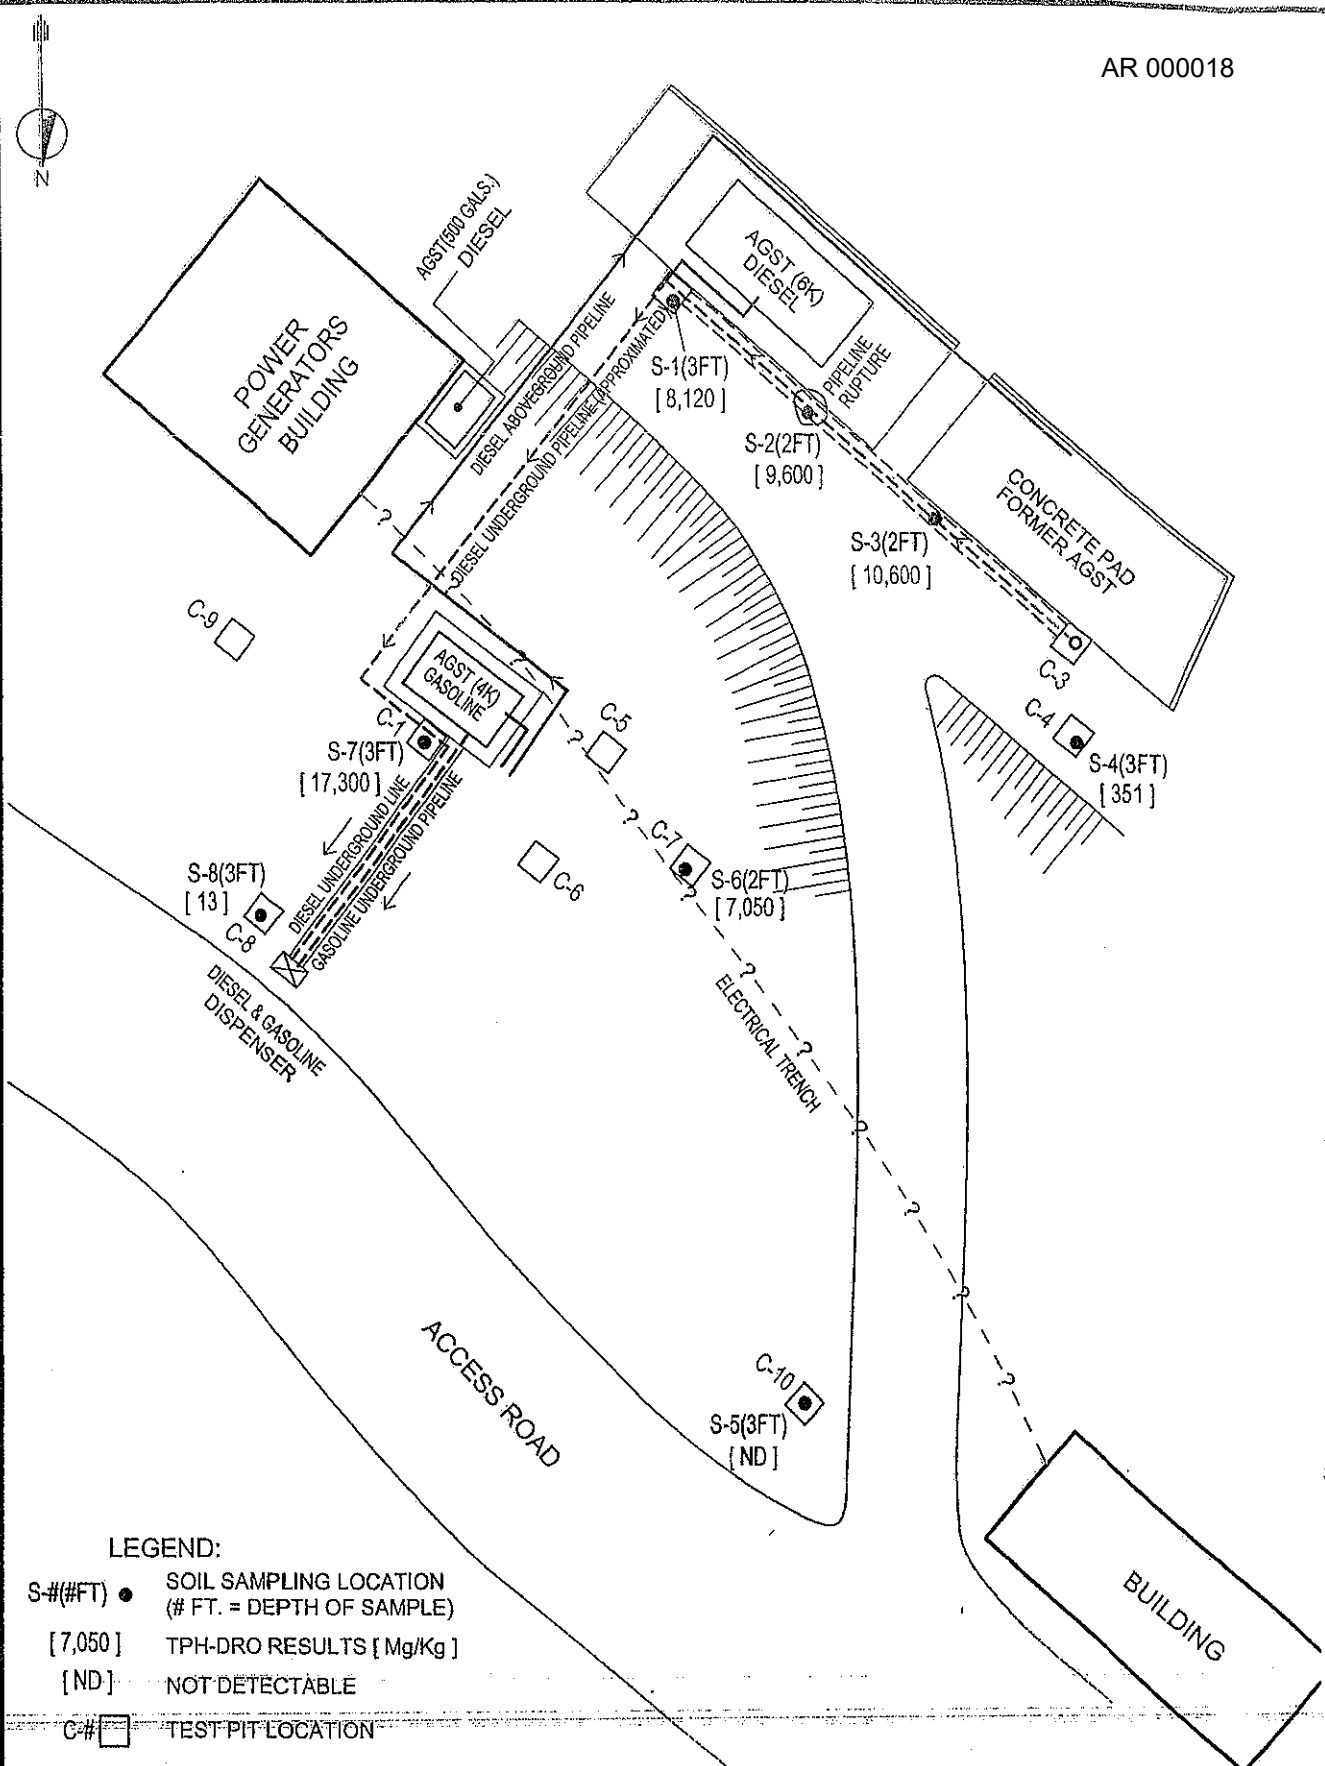
FIGURE 5 - ANALYTICAL SAMPLING LOCATION & RESULTS FOR TPH-DRO  
 EMERGENCY RESPONSE  
 TEXACO INDUSTRIAL - CANEEL BAY  
 ST. JOHN USVI

- S-1 8,120 mg/kg;
- S-2 9,600 mg/kg;
- S-3 10,500 mg/kg;
- S-4 351 mg/kg;
- S-5 ND;
- S-6 7,050 mg/kg;
- S-7 17,300 mg/kg; and
- S-8 13 mg/kg.

Five (5) of the detected concentrations exceeded 7,000 mg/kg. Three (3) of these soil samples were collected from the trench where the ruptured segment of the diesel fuel line was found, one soil sample was collected from the diesel fuel line adjacent to the gasoline AGST, and one soil sample was collected from the electrical line trench that begins at the emergency generator building extending to the northwest.

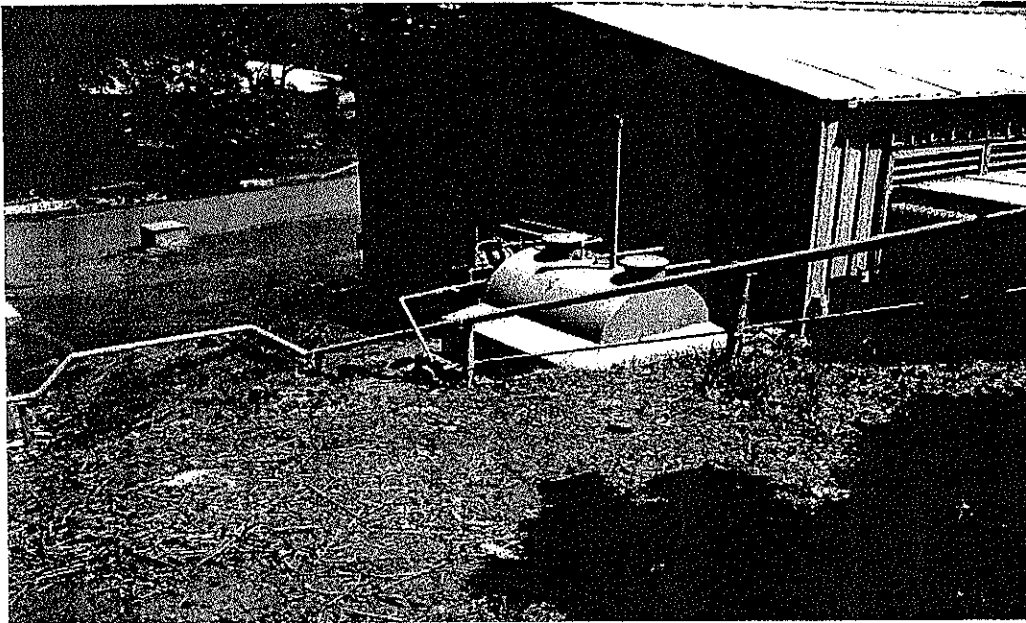
**Photo 3- 500 Gallons AGST for Generator Use, Observe Aerial Steel Pipe used as Remote Filler for 6,000 Gallons Diesel Tank**

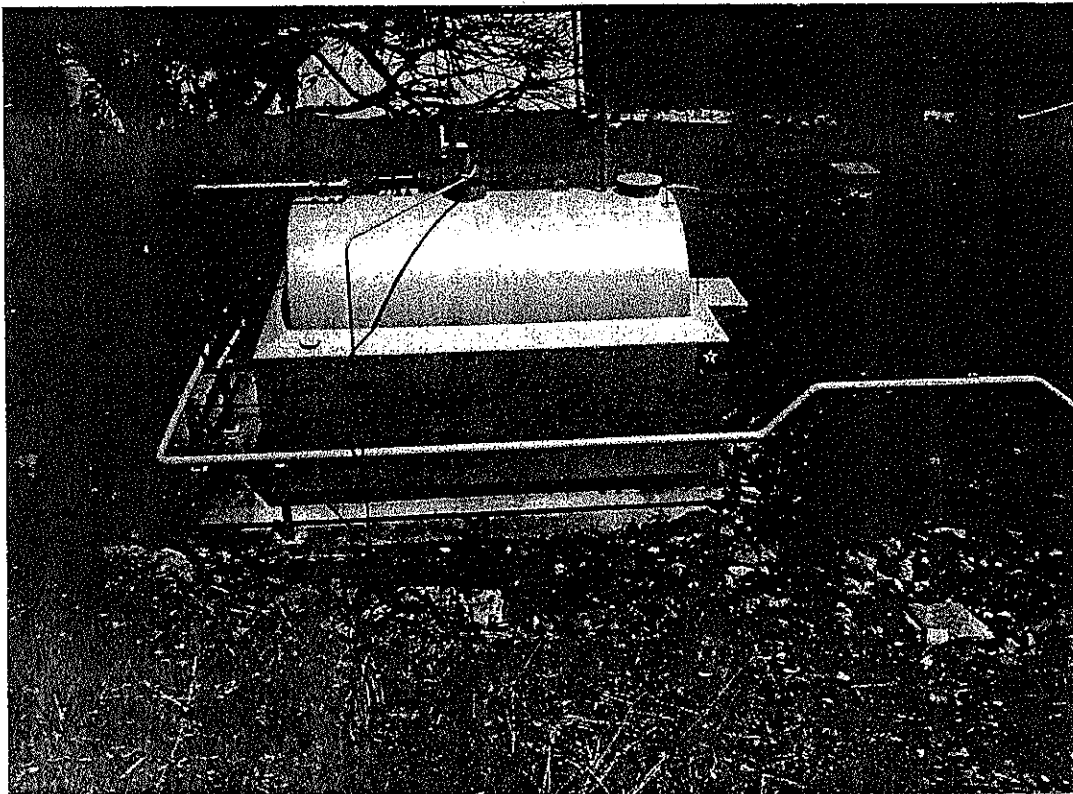
**Photo 4- 4,000 Gallons Gasoline AGST, Observe Diesel Stains in Soil West and North of Tank.**

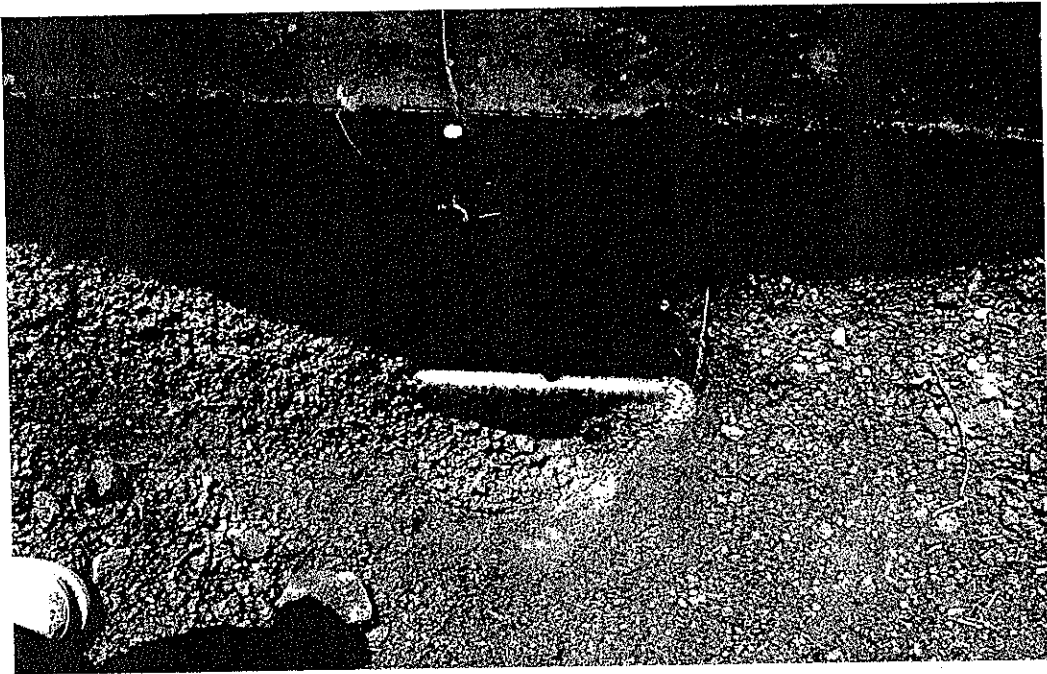
On March 5, 2010, a local contractor, RAMVAR, visited the Site to install a grounding rod for the existing 6,000-gallon diesel fuel AGST. As the grounding rod was installed, it punctured the fiberglass diesel fuel line, which is buried at a depth of less than one foot, at the location shown on **Figure 3**. However, according to Eng. Carlos Fuentes of Chevron, the occurrence of the puncture was not known until March 15, 2010 when Caneel Bay personnel visually observed diesel fuel stains on the ground surface. Based on fuel inventory information, it is estimated that approximately 1,000 gallons of diesel fuel was released to the shallow subsurface soil (the depth of the diesel fuel line is approximately one foot). Diesel fuel stains are present on the ground surface at several locations in the "area of concern". The photographs in **Appendix A** show examples of the stained areas. The locations and direction of the photographs are provided on **Figure 4**.

- The source of the impacted soils at the site is the shallow fiberglass line ruptured during the installation of a grounding rod near the 6,000-gallon diesel AGST.

**Photo 5- Perforated Diesel Fuel Pipe (Fiberglass) and Ground Rod**

Ramvar excavated a shallow trench to expose the point of rupture of the diesel fuel line as shown on **Figure 2**. The excavated soil consisted of fill material composed mainly of sandy silt. The line was then cut at a point between the rupture and the diesel AGST and the AGST end of the line was capped. No residual diesel fuel was present in the line. The remaining portion of the line, toward the northwest, was excavated and removed. Impacted soil was excavated and placed on the concrete slab (previously used as a foundation for an AGST that was removed in the past) located adjacent to and southwest of the ruptured line (**Figure 3**). The concrete slab was first lined with polyethylene sheeting, and additional polyethylene sheeting was placed on top of the impacted soil. The open trench was subsequently backfilled with clean sandy silt fill material. The ground surface at the area of rupture line was covered with polyethylene sheeting to prevent migration of residual diesel should a rain event occur.

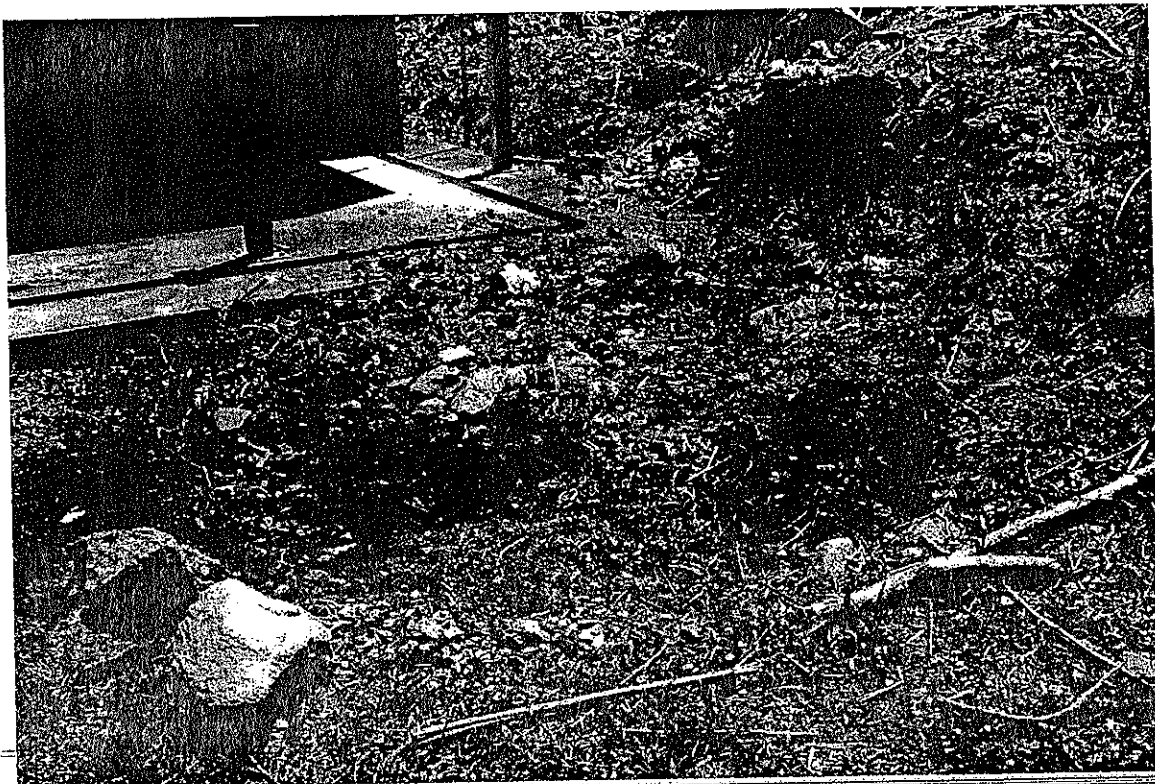
**Photo 6- Stained Soil with Diesel Fuel, located North of Gasline AGST**

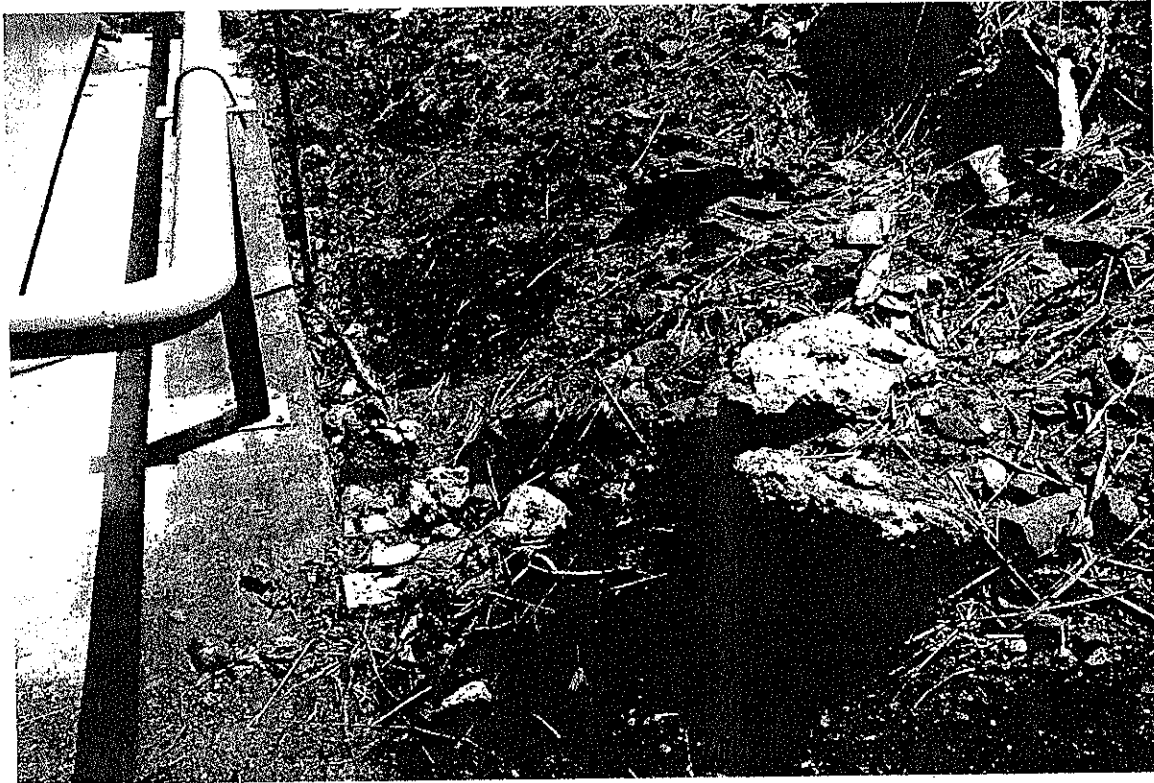
**Photo 7- Stained Soil with Diesel Fuel, located West of Gasoline AGST**

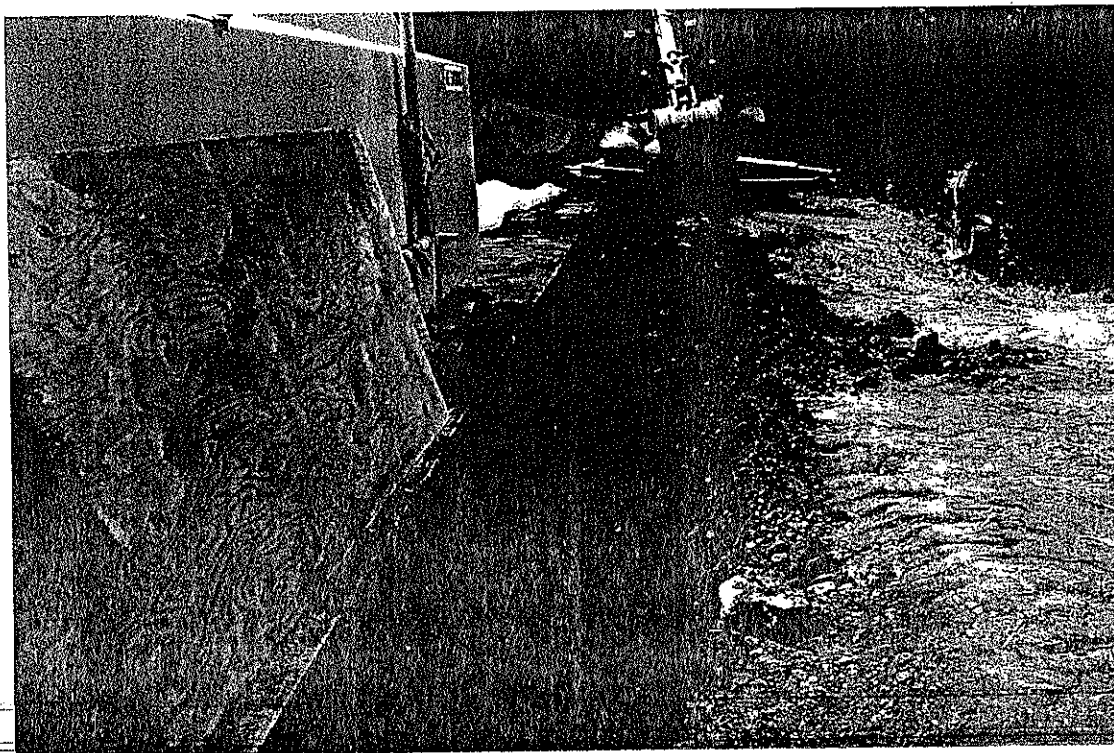
**Photo 8- Trench Located East of 6,000 Gallons Diesel AGST. Former Location of Perforated Fiberglass Pipe**

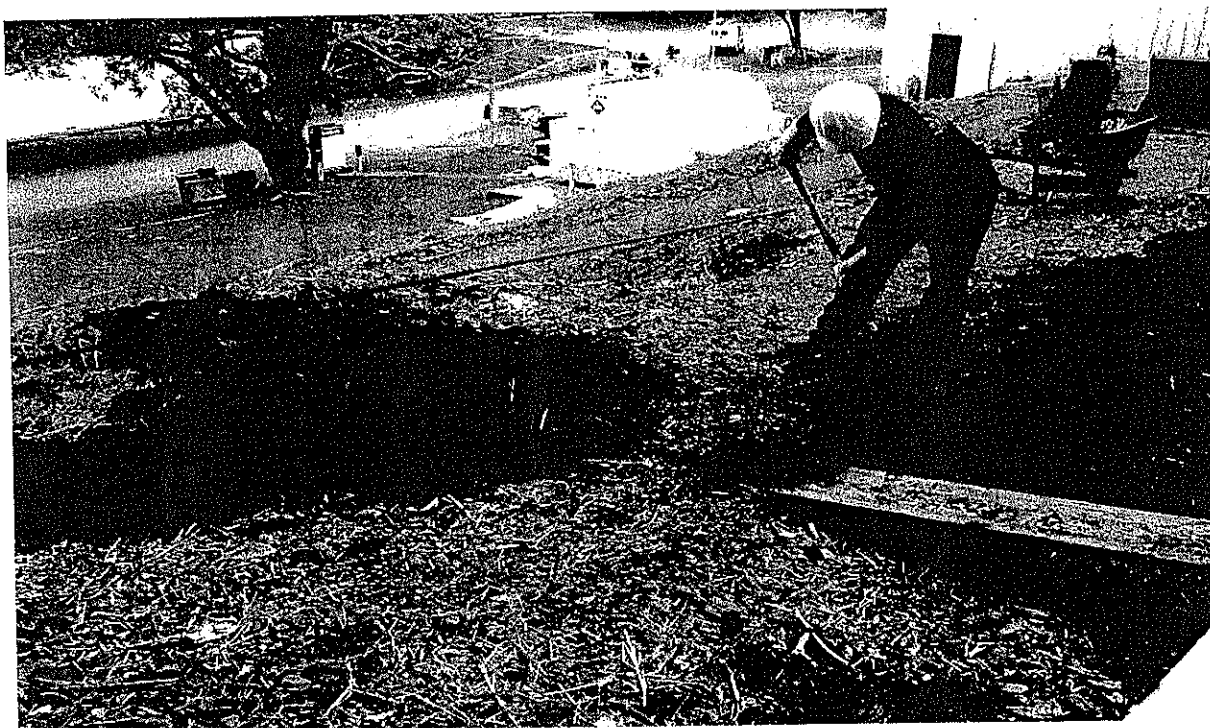
- **Pit C-3:** Located at the northwest end of the ruptured portion of the diesel fuel line to evaluate whether diesel has migrated along the line backfill.

- **Pit C-4:** Located north of the northwest end of the ruptured portion of the diesel fuel line to evaluate whether diesel has migrated away from the line.

**Photo 9- Test Pits (C-3) and (C-4) Location North-east of 6,000 Gallons Diesel AGST**

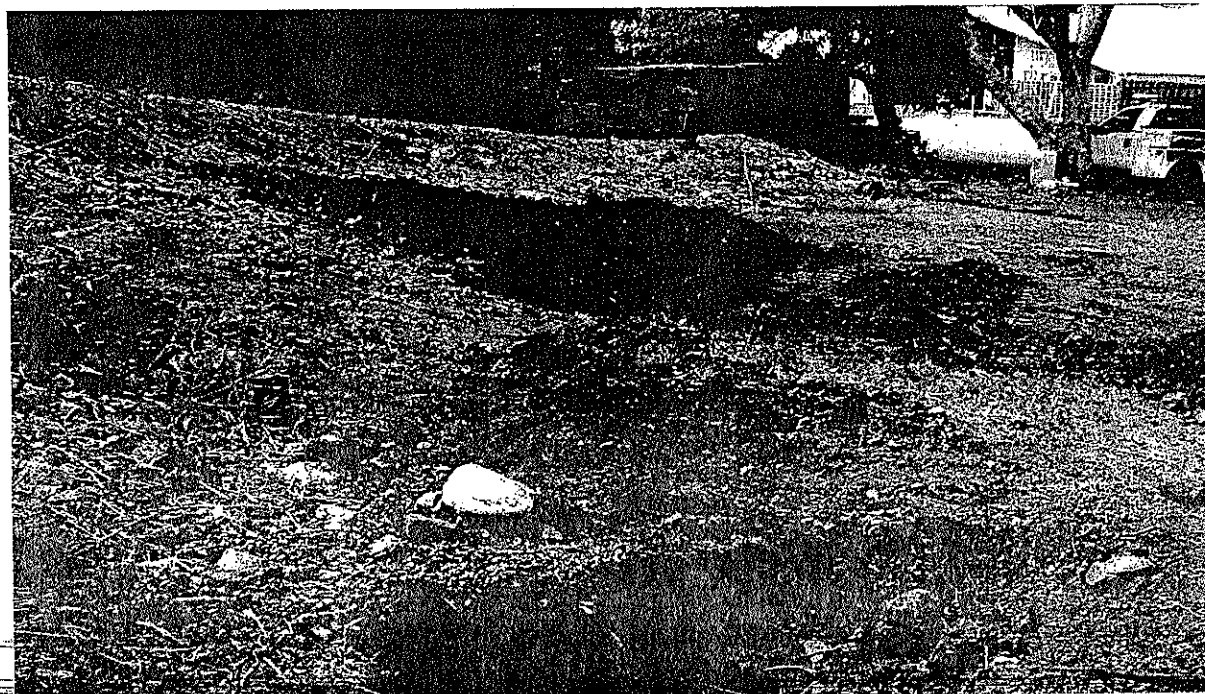
**Photo 12- Test Pit (C-7) Located North of 4,000 Gallons Gasoline AGST and Sixteen Feet from Test Pit (C-5) south**

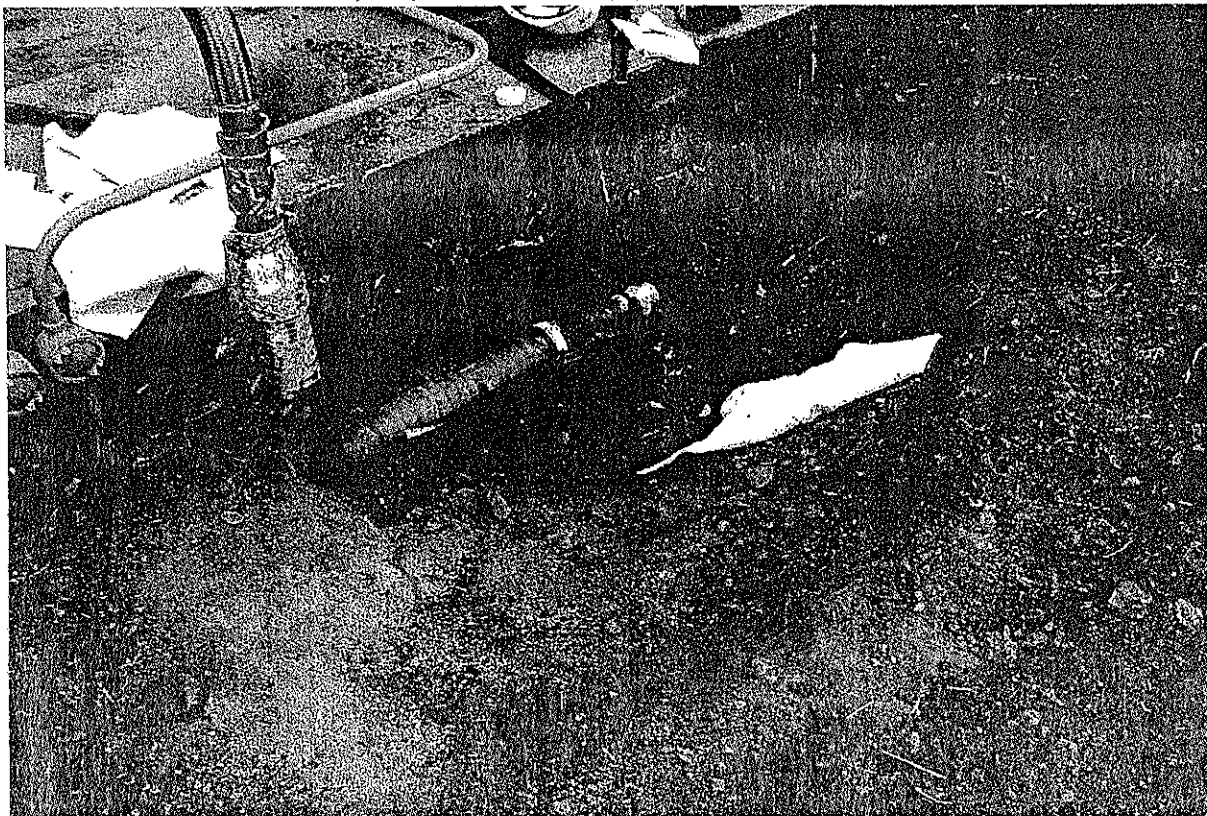
**Photo 18- Test Pit (C-2) Located East 6,000 Gallons Diesel AGST, Observe  
Former Fiberglass Pipe Capped.**

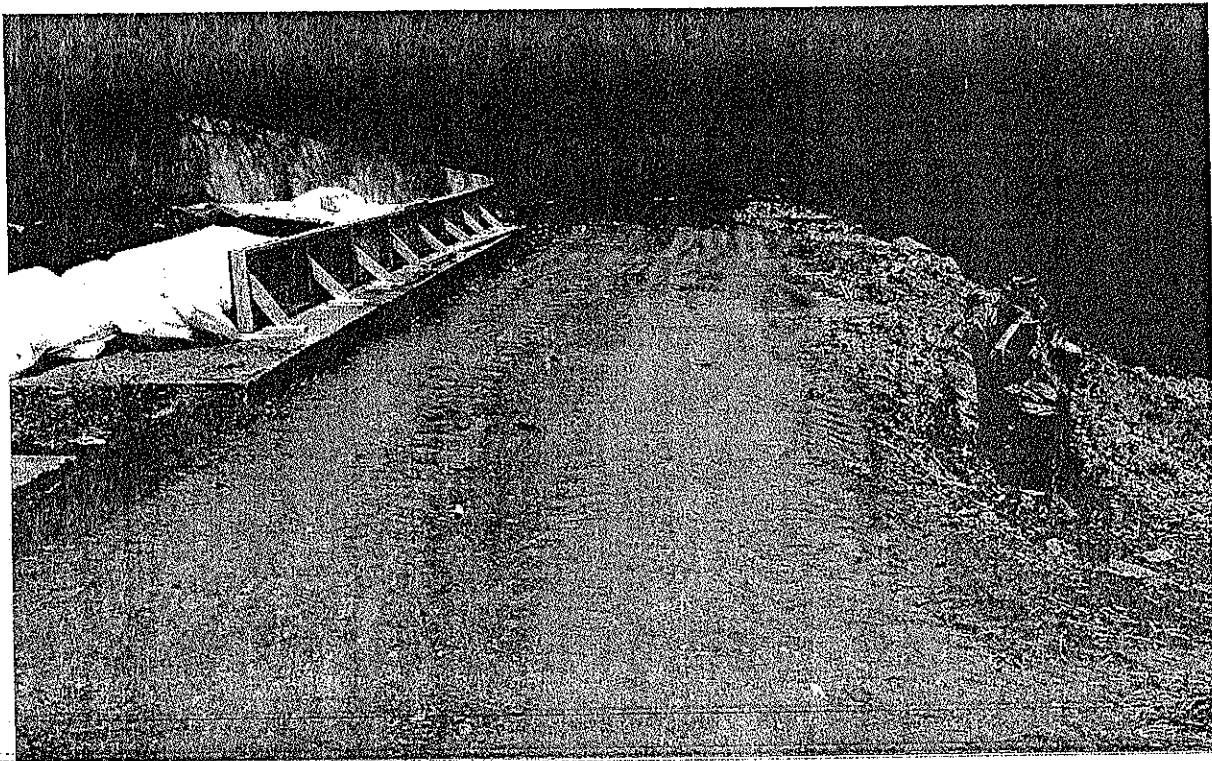
**Photo 20- Former Trench Located East of 6,000 Gallons Diesel AGST. Observe  
Removed Soil Pile in Wood and Concrete Dike.**

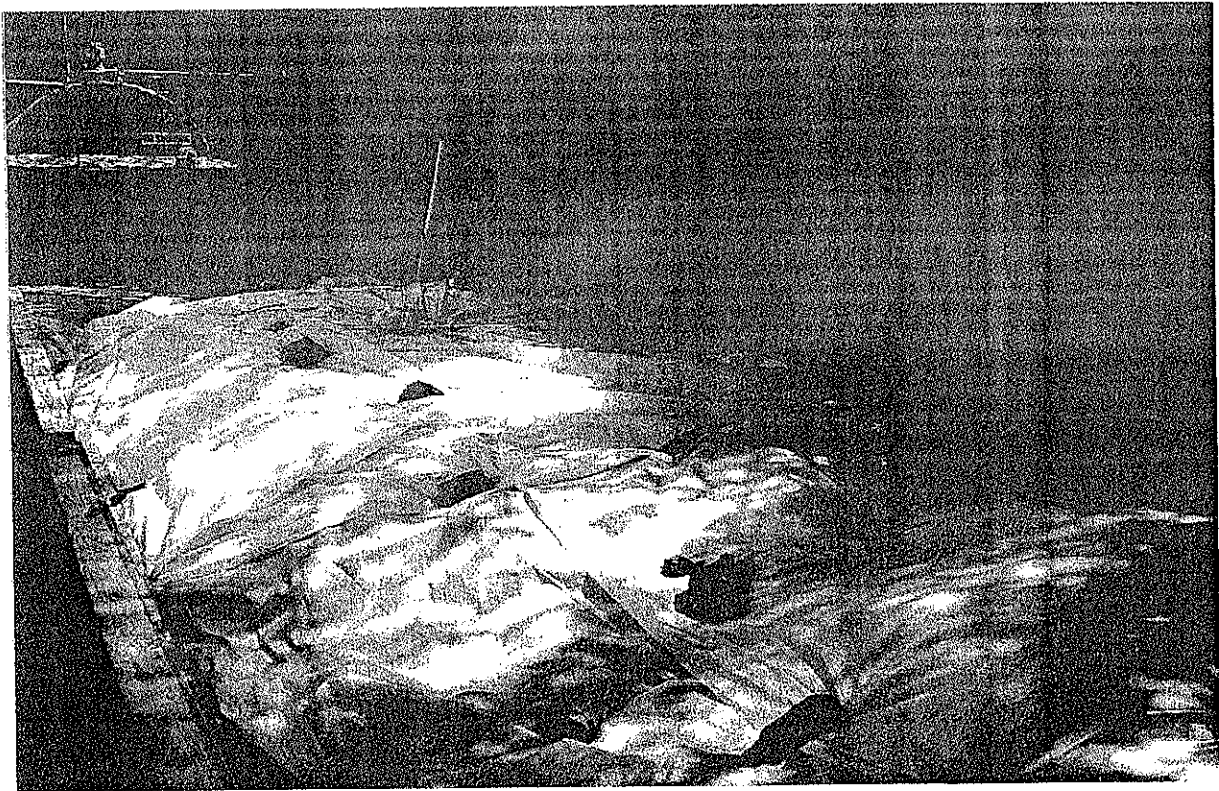
**Photo 21- Removed Soil Pile Covered with polyethylene liner**

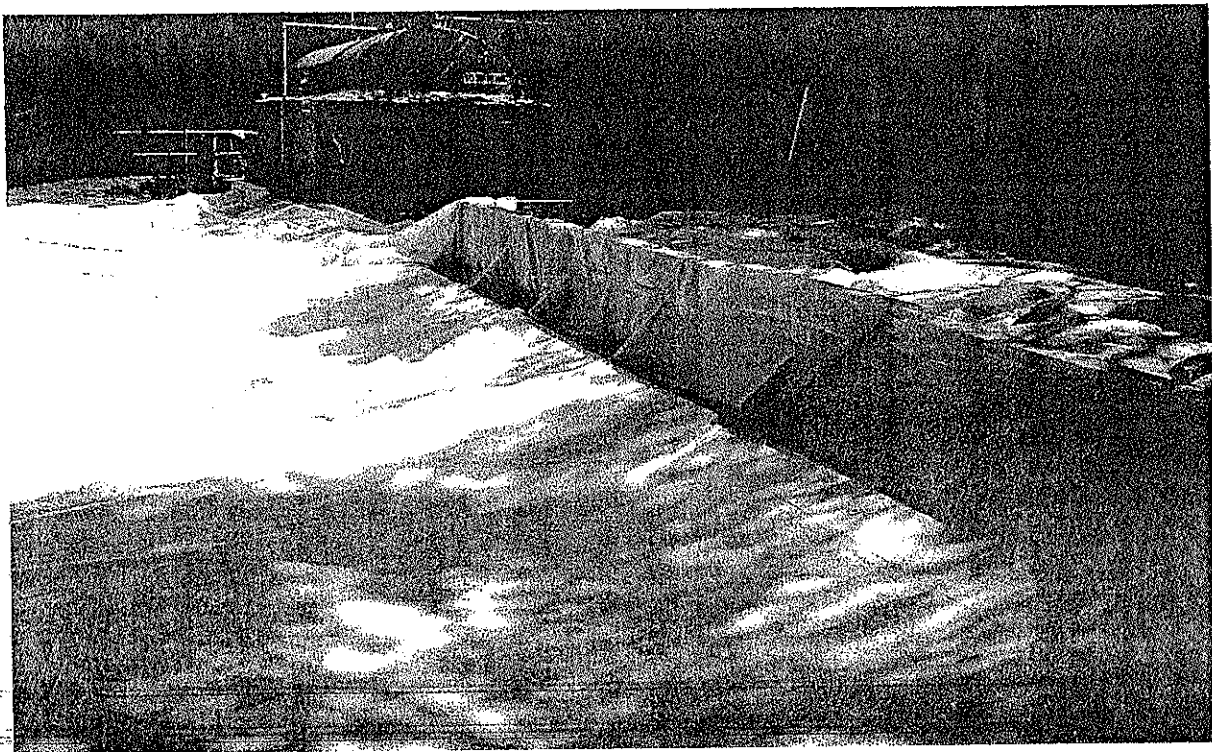
**Photo 22- Former Trench Located East of 6,000 Gallons Diesel AGST and Formers  
Test Pits C-2, C-3 and C-4 Covered with polyethylene liner**

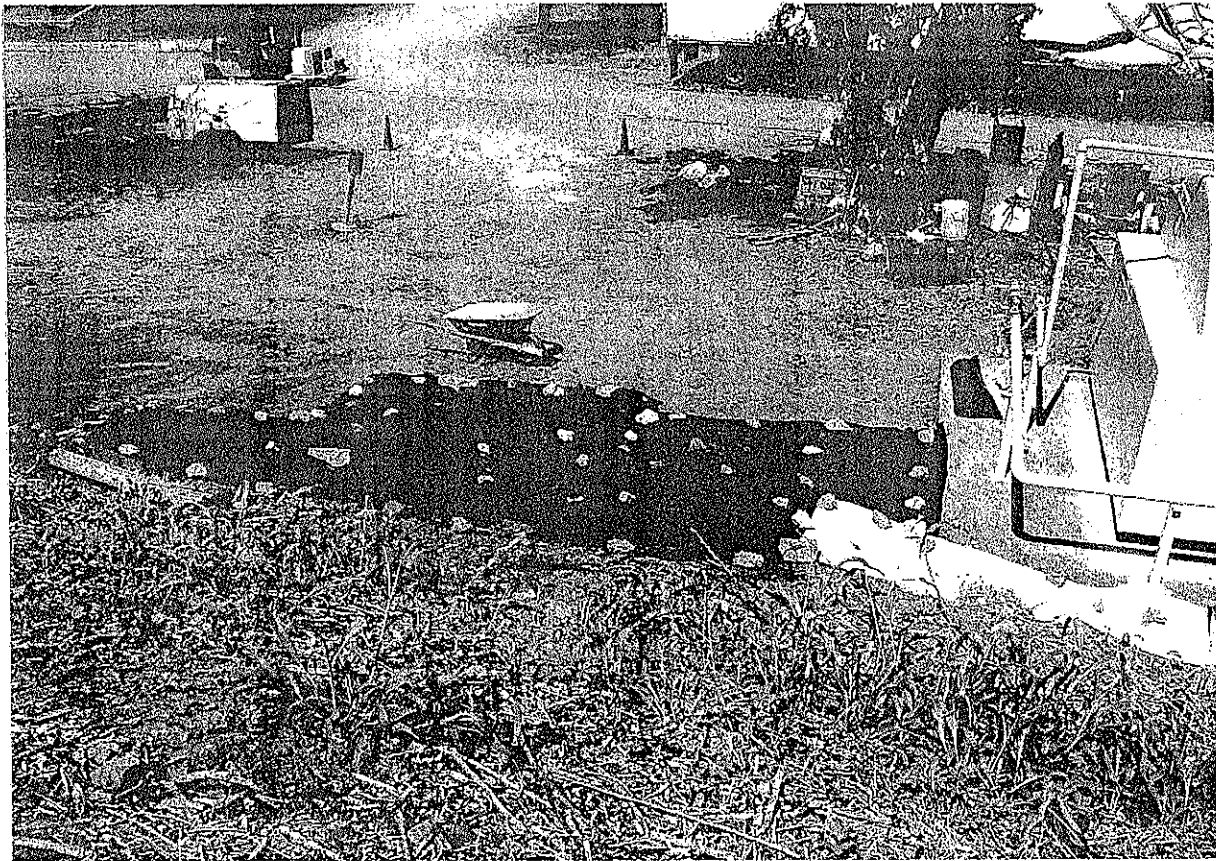
**Photo 23- Diesel Stained Areas near Gasoline AGST and Formers Test Pits C-5, C-6 and C-7 Covered with polyethylene liner**
