RESTORE THE DISTRICT OF COLUMBIA WAR MEMORIAL

PMIS #150359
NATIONAL PARK SERVICE
NPS-NAMA
HORD COPLAN MACHT

EXISTING CONDITIONS

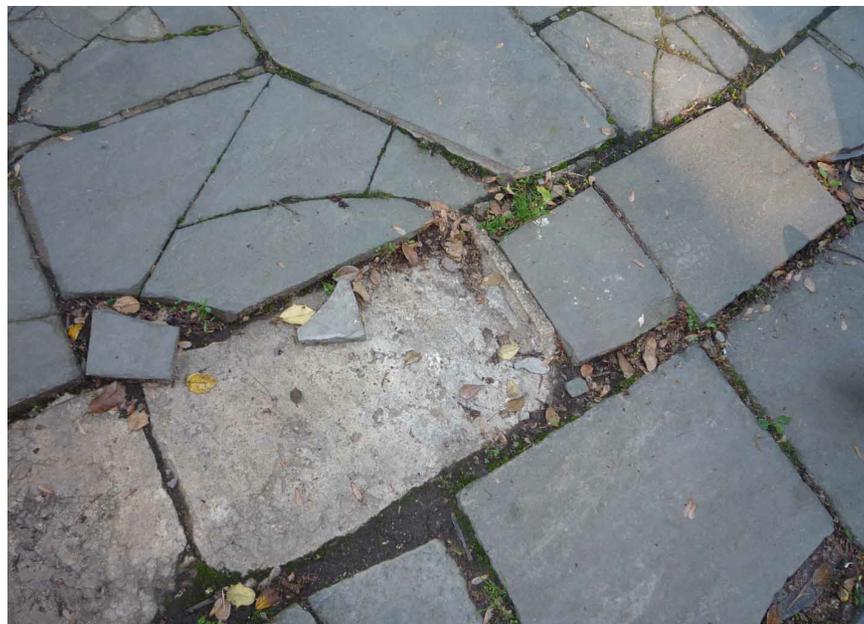
Deteriorated Bluestone paving

- Replace historic 8' wide bluestone paving encircling the base of the Memorial; retain historic ornamental pattern
- Replace existing outer ring of non-historic paving around memorial
- Replace bluestone walkways with new bluestone or granite paving, designed to support occasional vehicular traffic for access and maintenance.

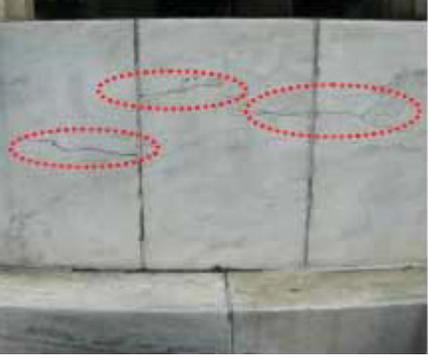
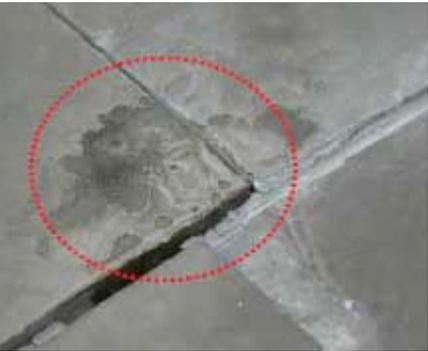
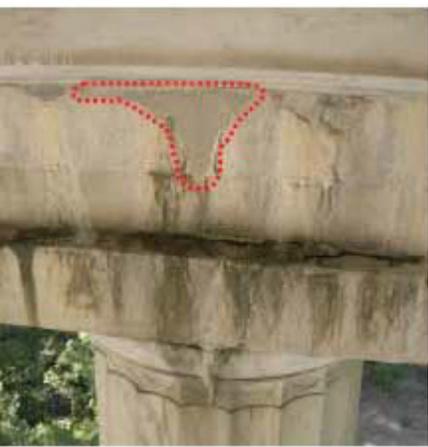
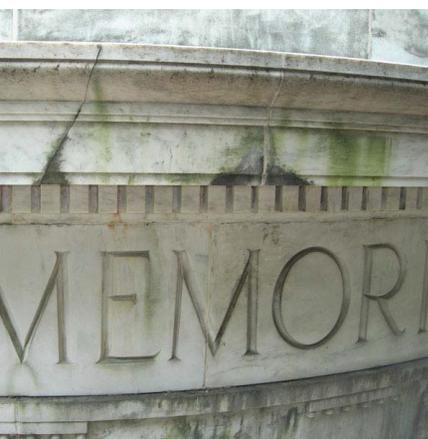
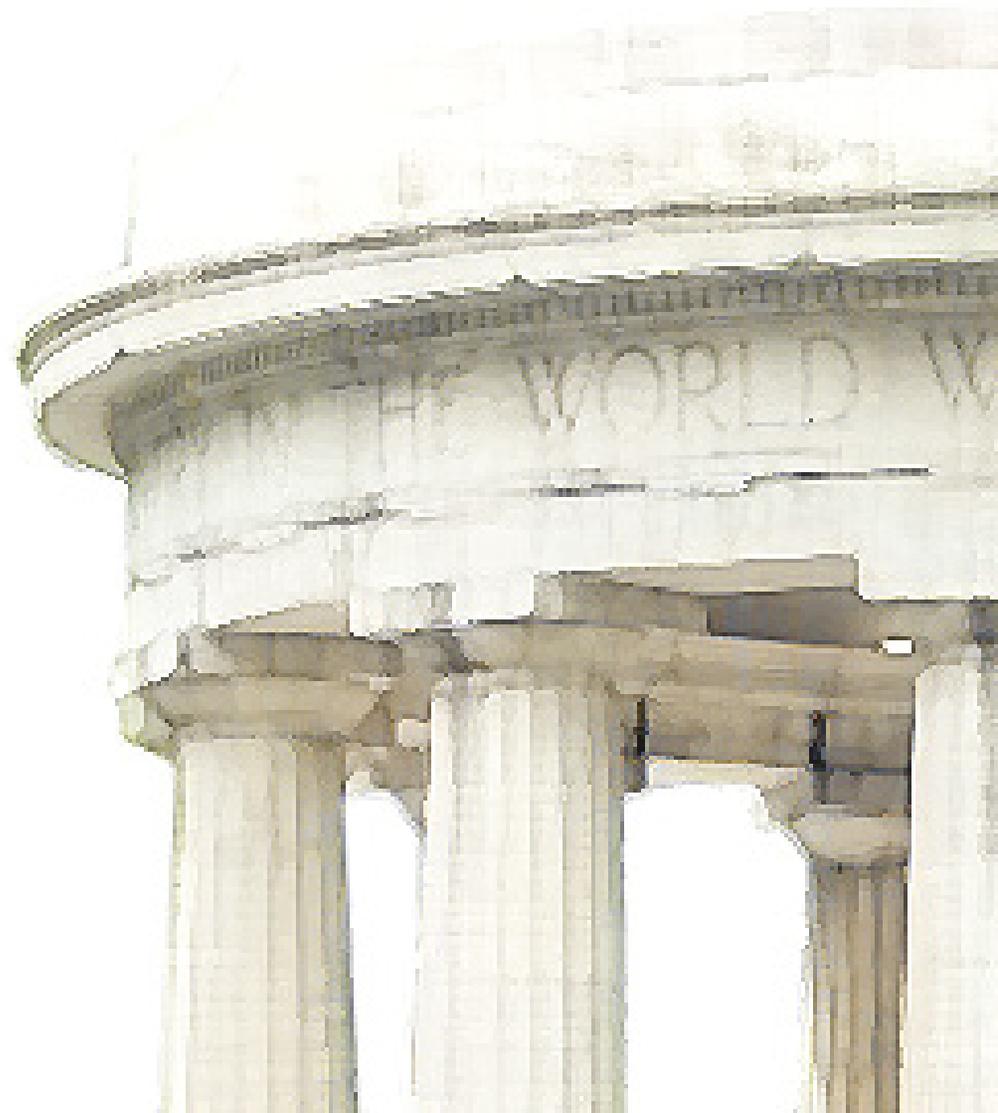
- Cracks and micro-cracks
- Spalled Stone
- Cementitious Fill
- Displaced Stone
- Soiling: Heavy Soiling, Calcium Carbonate Deposits, Biological Stains, Gray/Brown Stains, Pink/Red Stains and Orange /Red Stains

- Repair the structure by re-pointing open mortar joints, repairing cracks, micro-cracks and spalled stone. Displaced stones of a significant dimension will be evaluated to warrant removal and reinstallation.

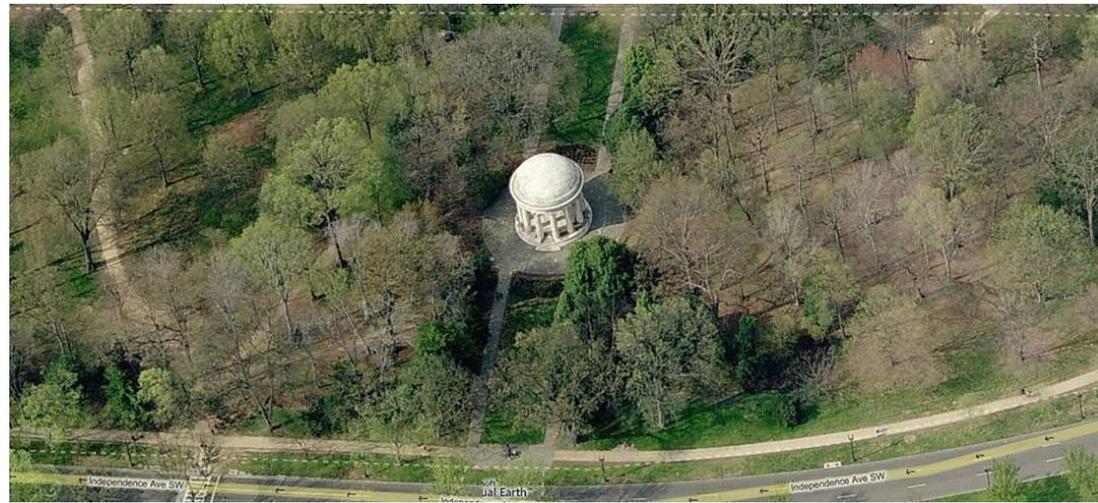
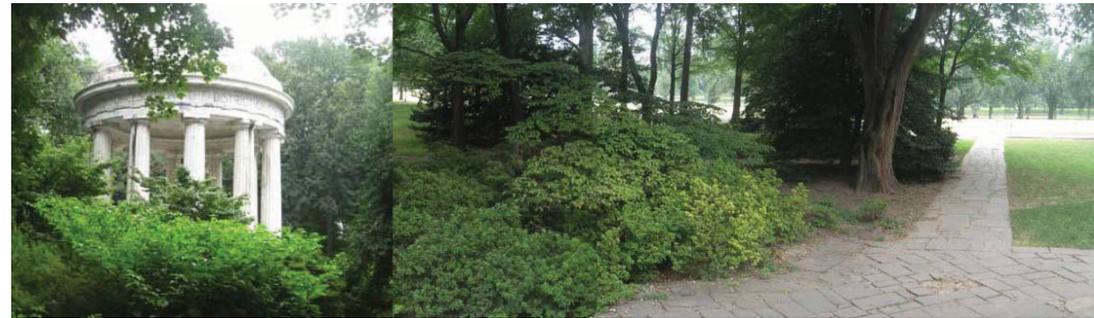
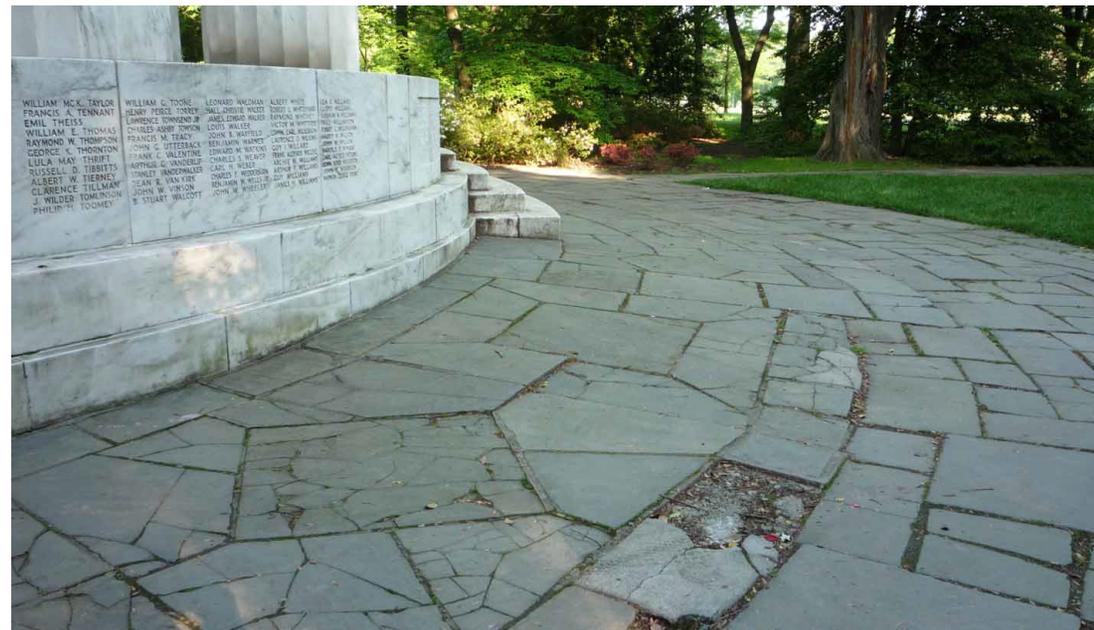
- Addition of understory plantings over time has degraded and compromised the character of the 1930's plan.
- The remnant memorial hardwood grove is devolved into a mix of canopy hardwoods, evergreens, understory plantings, and non-native volunteers.
- Unclear organization of the site due to the encroachment of the landscape into the original 50' open turf area.
- The open lawn area has been lost, preventing the use of the memorial as a bandstand and gathering place.
- Views have become shrouded along the Memorial axis. There is sparse visibility of the Memorial from the adjacent groves of trees.

- Remove select non-historic hardwoods, evergreens, understory plantings, and non-native plants.
- Restore 50' wide vista of open lawn around Memorial
- Improve the grading and storm water drainage
- Replant Elm trees to reinforce site edges and restore the historic memorial grove
- Replace and reinforce lawn areas

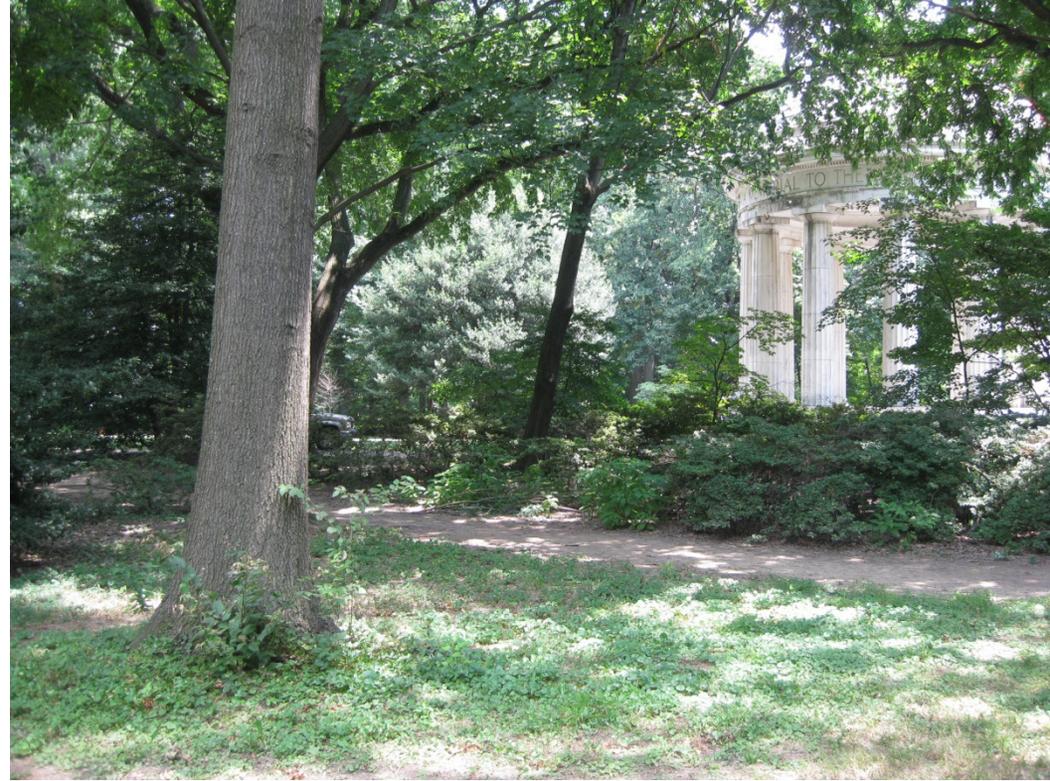
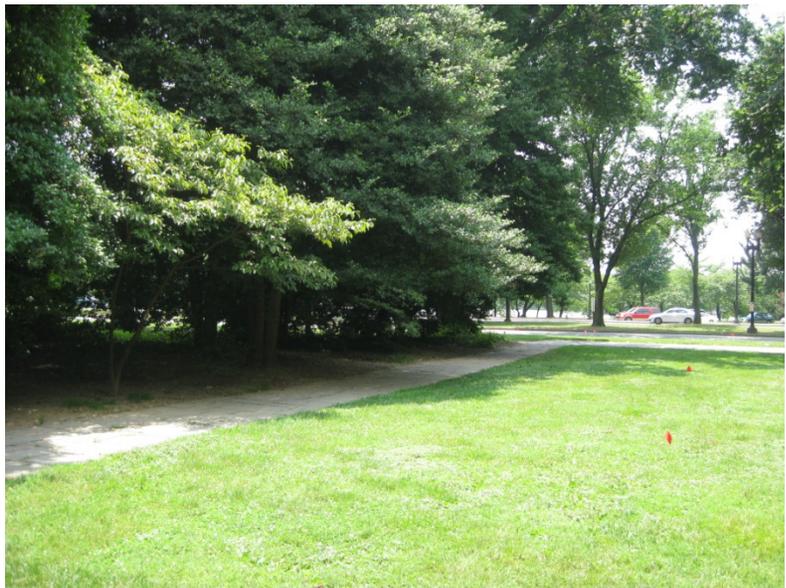
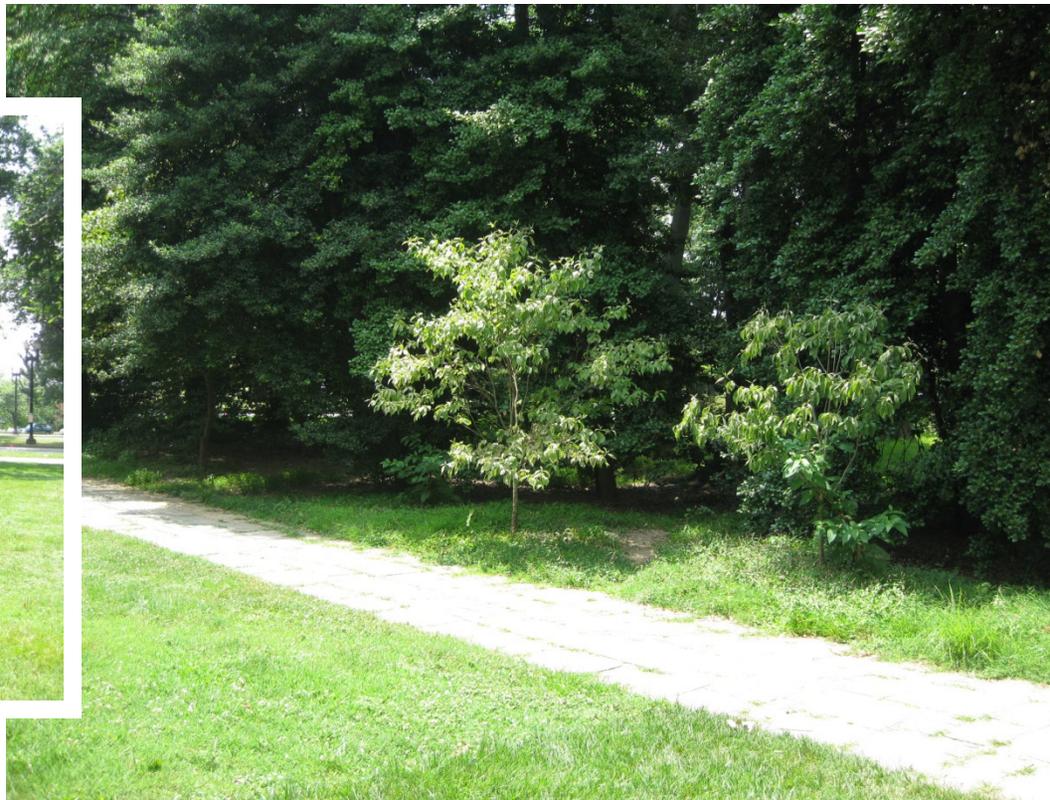
- The North-South turf panels remain in place.
- Poor soils and slow percolation rates have resulted in the ponding of water; soil erosion evident in other areas.
- Non-original pattern of walkways with additional bluestone paving around the original 8' wide Memorial paving.
- Network of broad, degrading social paths within the grove
- Deteriorated bluestone walks

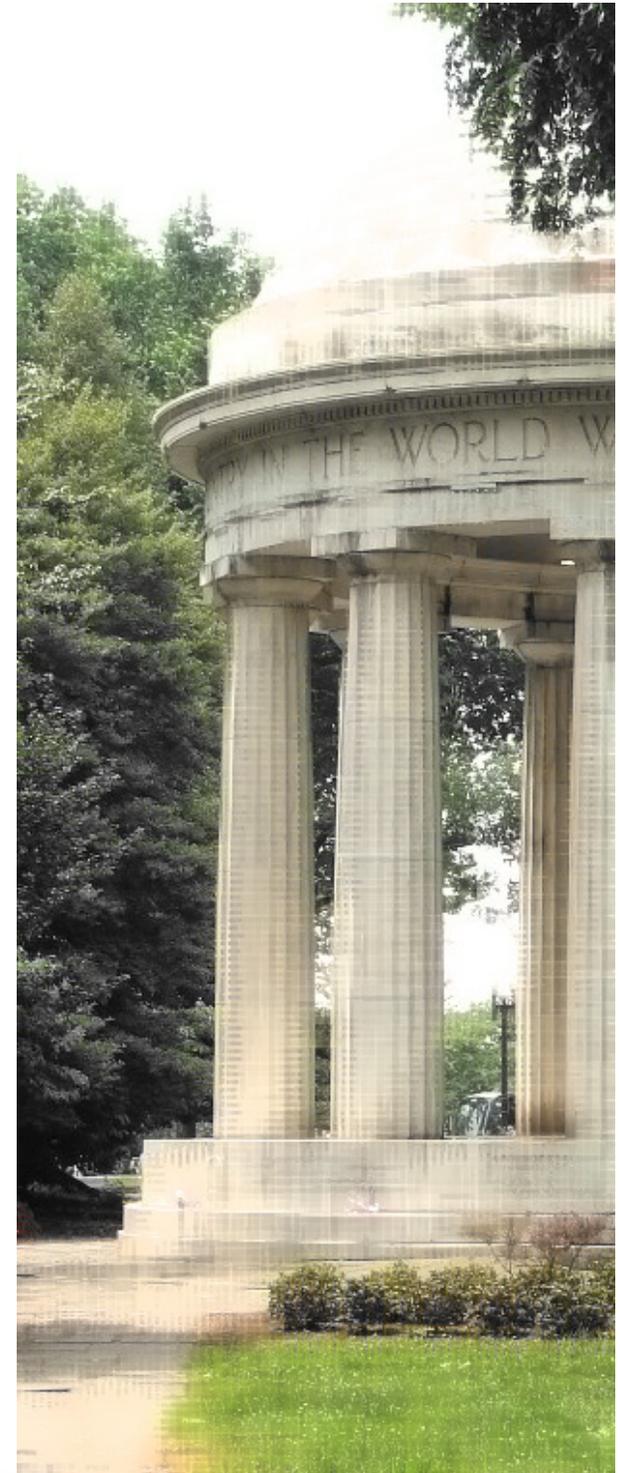
PLAN OF VEGETATION TO BE REMOVED

Existing Non-historic Understory
Vegetation to be Removed (Hollies,
Dogwoods & Shrubs)
