# Merced River Riparian Corridor Restoration in Yosemite Valley

Restoration Concept  
Designs

March 2016

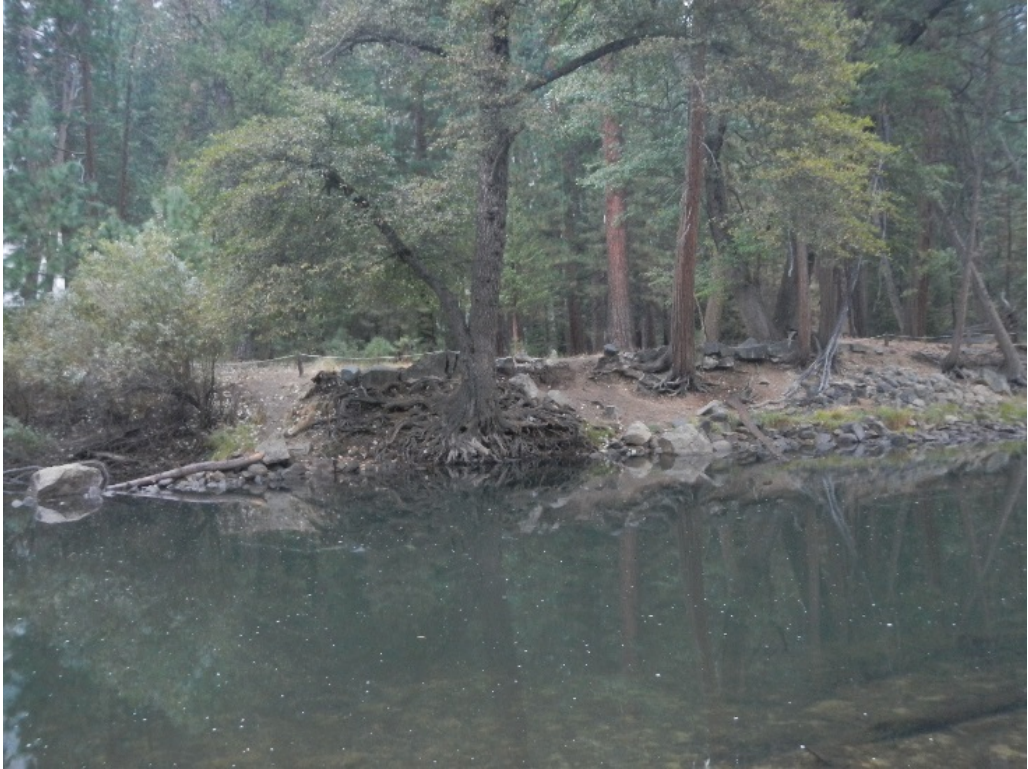
<p data-bbox="365 974 1520 1031">RB facing DS: Artificial bank protection along overflow channel return area; bank face erosion on upper bank; toe of bank erosion under mature tree roots</p>
0.05 (RB)

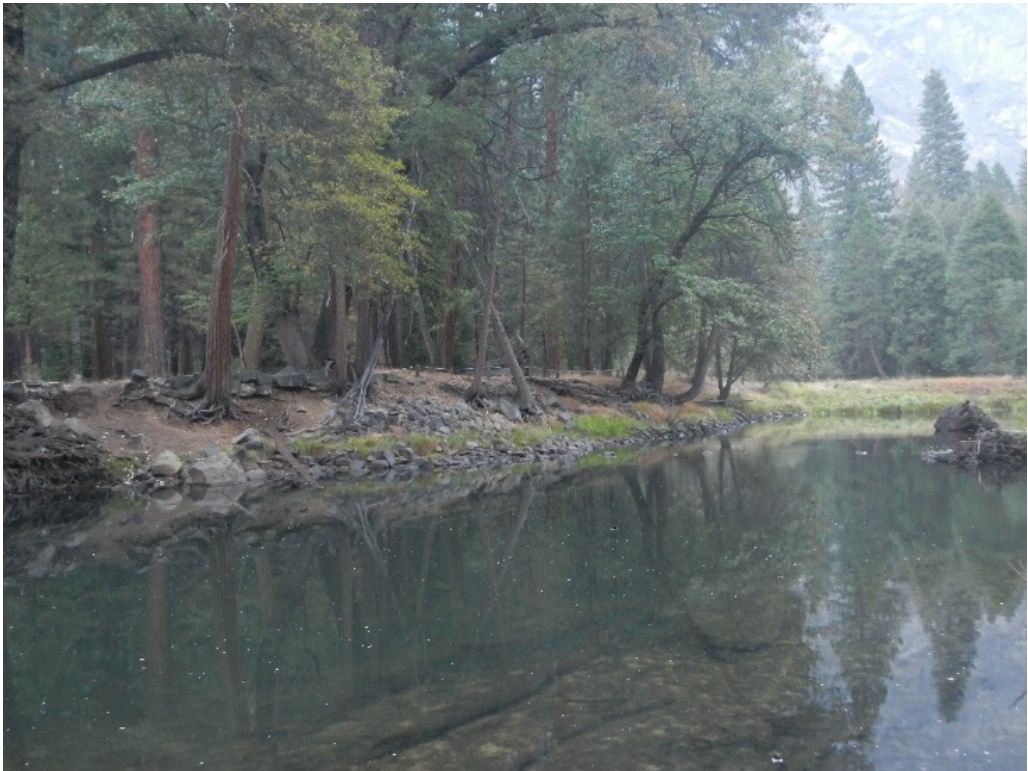
<p data-bbox="347 1850 1536 1906">RB view up overflow channel: Artificial bank protection along overflow channel return area; Bank face erosion on upper bank</p>

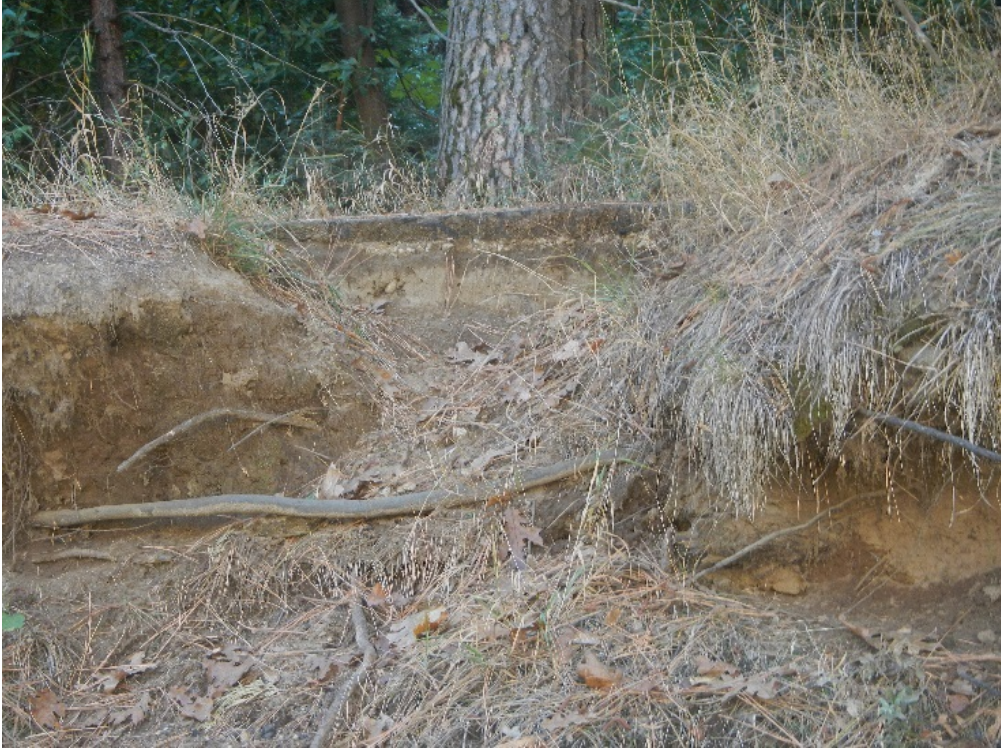
<p>LB view up bank face: Lack of bank vegetation, bank erosion and lateral retreat undermining bike trail</p>
<b>RM 0.19-0.35</b>	<b><i>Reach 2 – RM 0.19 to RM 0.35 (the downstream extent of Housekeeping Camp)</i></b>
0.19-0.25 (LB)

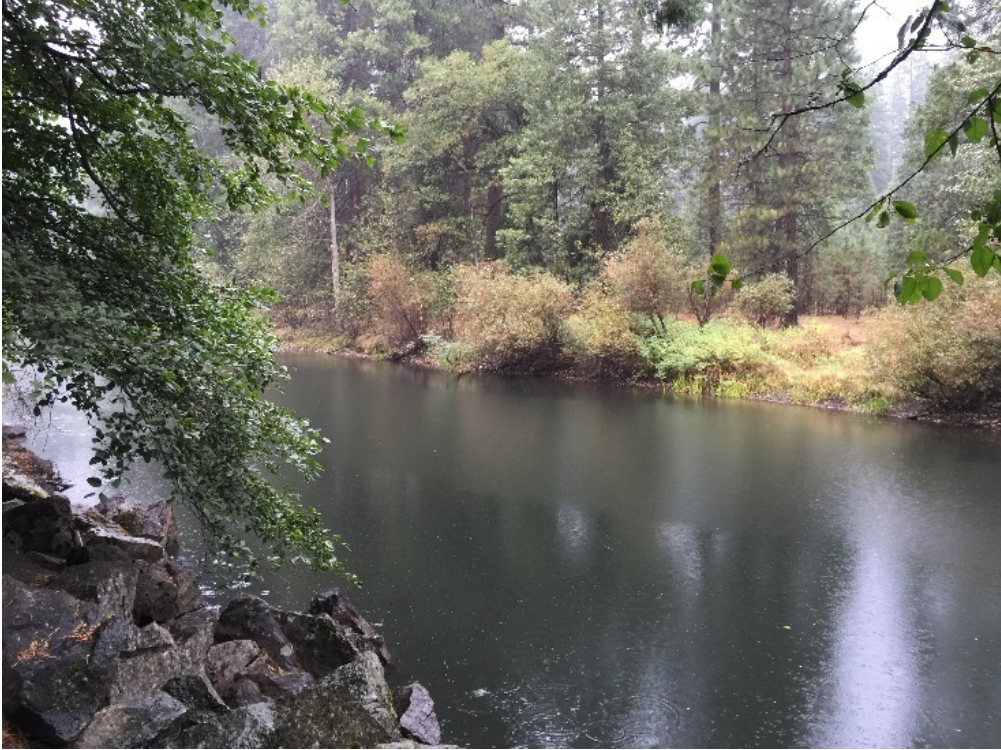
<p>RB view DS to LB: Artificial bank protection (foreground) and lateral confinement; floodplain fill removal opportunities in the right overbank (background)</p>

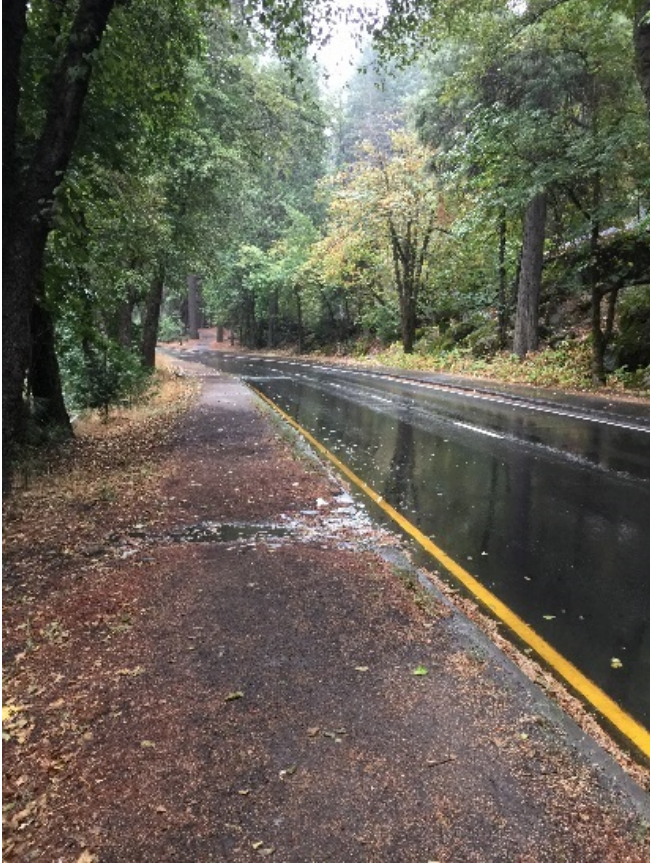
<p data-bbox="483 1087 1398 1115">LB view US: Lack of stormwater capture and pre-treatment, direct surface runoff paths</p>
0.19-0.33 (LB)

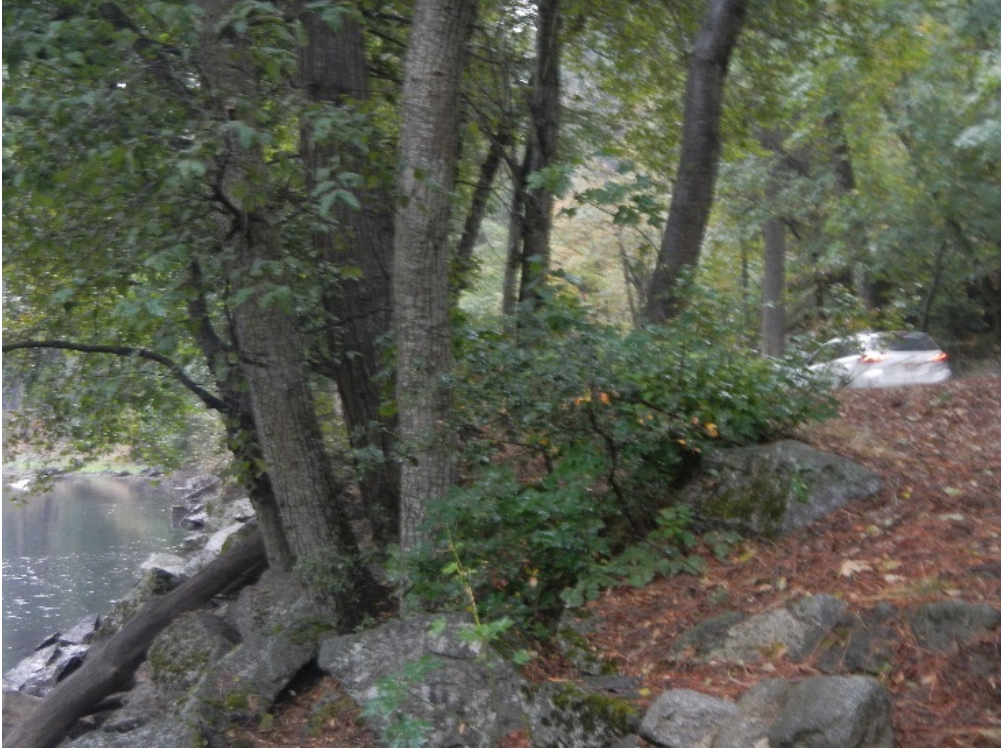
<p data-bbox="386 1915 1495 1969">LB view US: Artificial bank protection and lateral confinement (road in background); mature vegetation on compacted soils; limited recruitment, low species diversity and simplified structure</p>

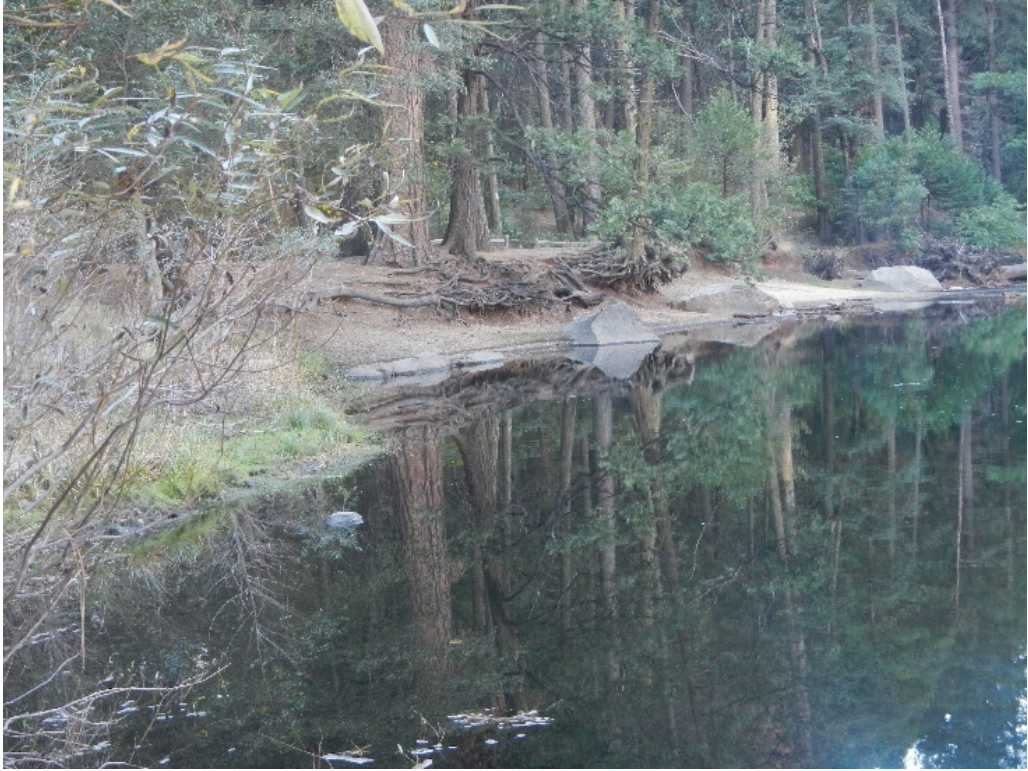
<p data-bbox="354 989 1531 1045">LB view from US: Eroding banks with denuded and compacted soils and lack of vegetation; boulders suitable to integrate in reconstructed bank</p>
0.47-0.50 (RB)

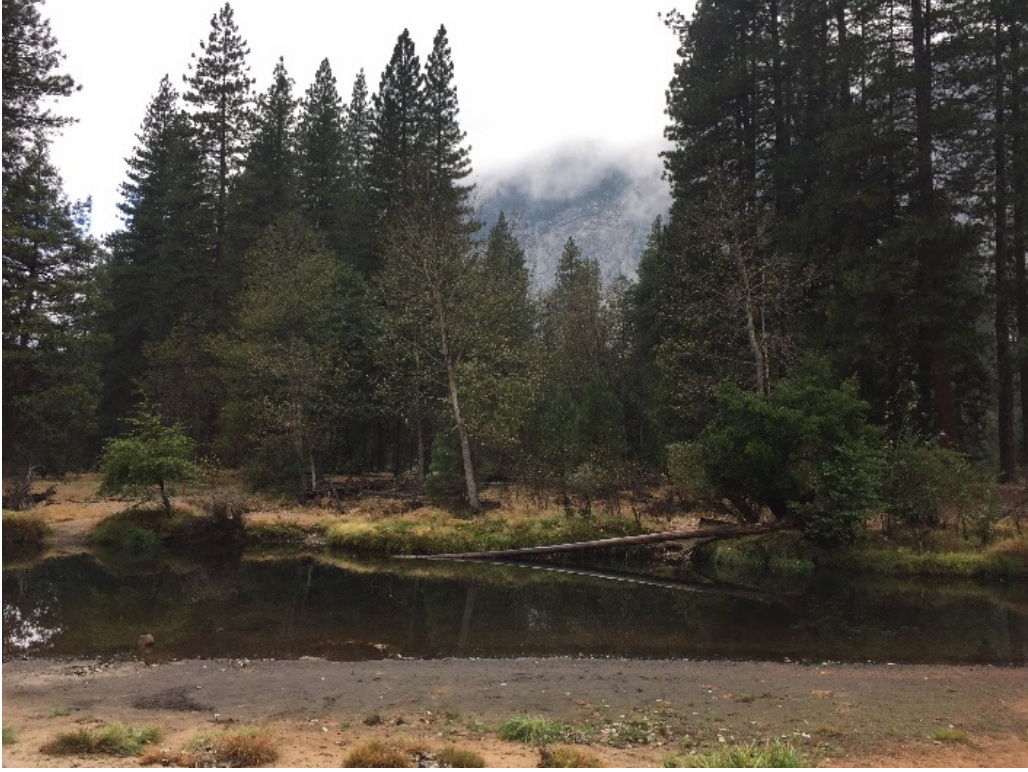
<p data-bbox="448 1866 1433 1894">RB viewed from point bar: Overflow swale entrance and surrounding, disconnected floodplain</p>

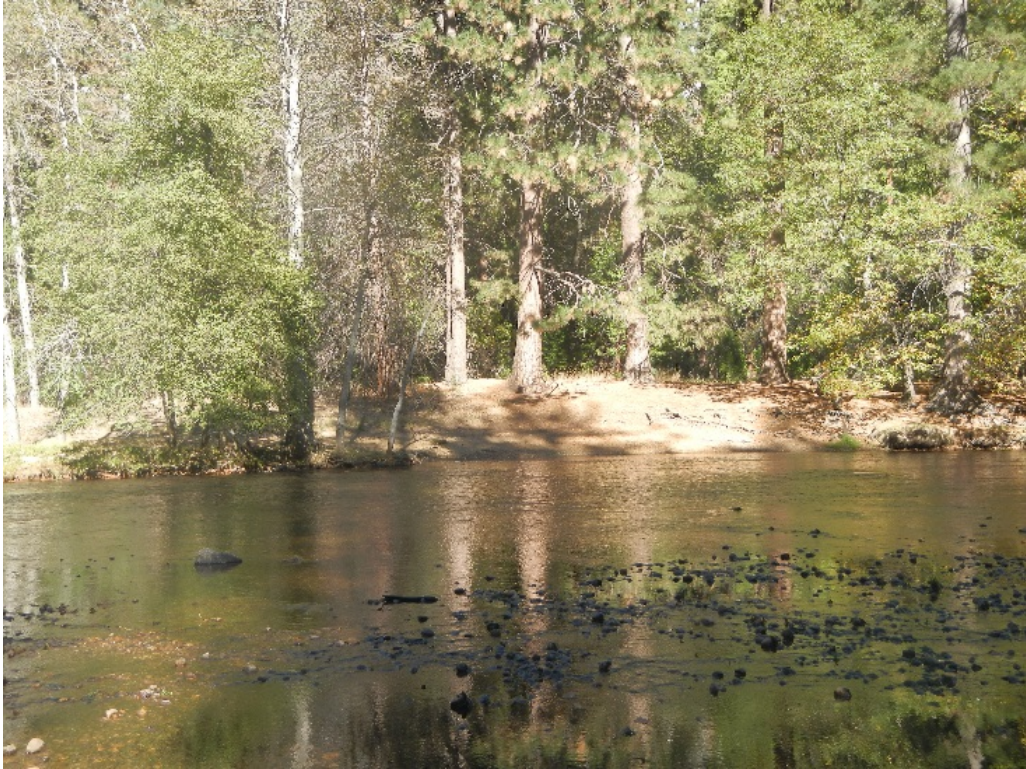
<p data-bbox="743 989 1138 1016">Bank damage from recreation access</p>
0.67 (RB)

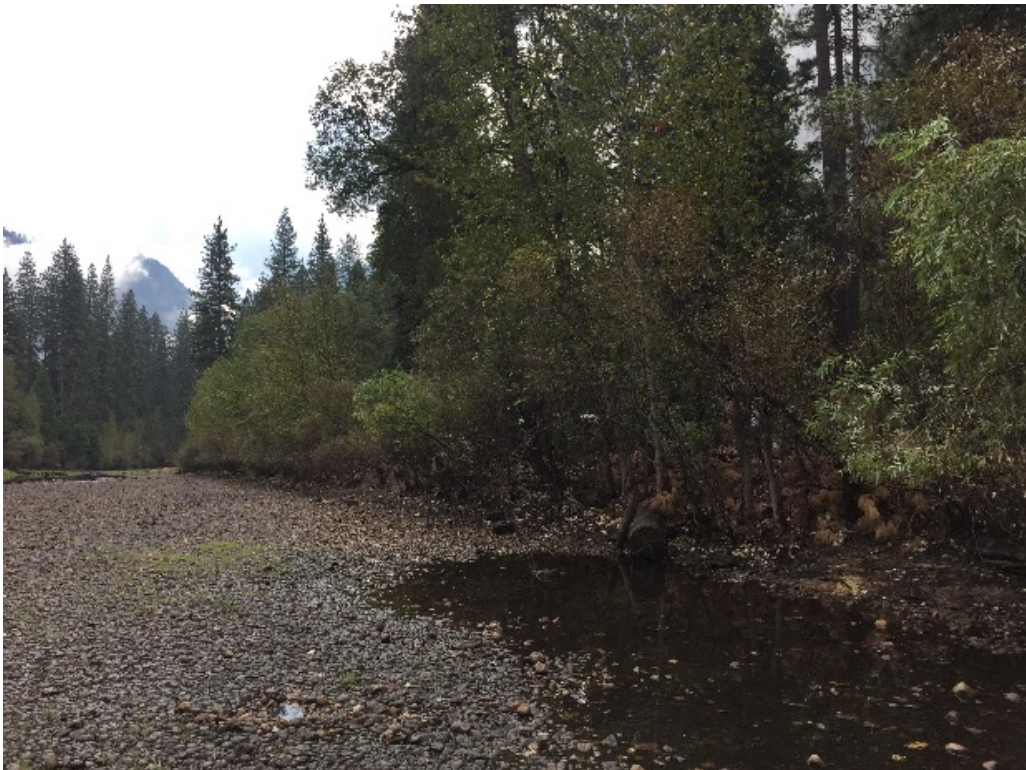
<p data-bbox="378 1835 1503 1892">DS view of planar bed channel and disconnected floodplain (RB foreground); possible channel reactivation (background)</p>

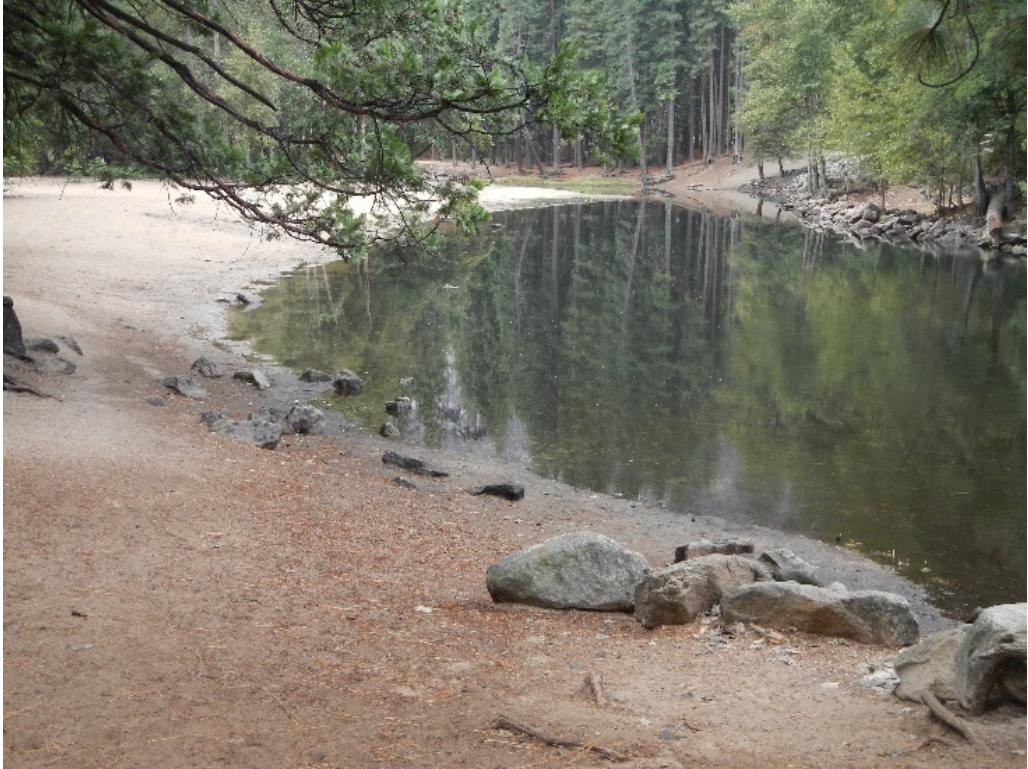
<p data-bbox="347 989 1536 1045">RB view US above Housekeeping Bridge: Damaged artificial bank protection and denuded bank with compacted soils (foreground); overflow channel/active point bar (background)</p>
0.92-0.94 (LB)	  <p data-bbox="337 1879 1544 1936">LB view from RB: Point bar stabilization and incipient floodplain building (foreground); artificial bank protection and denuded and compacted soils due to heavy visitor use (background)</p>

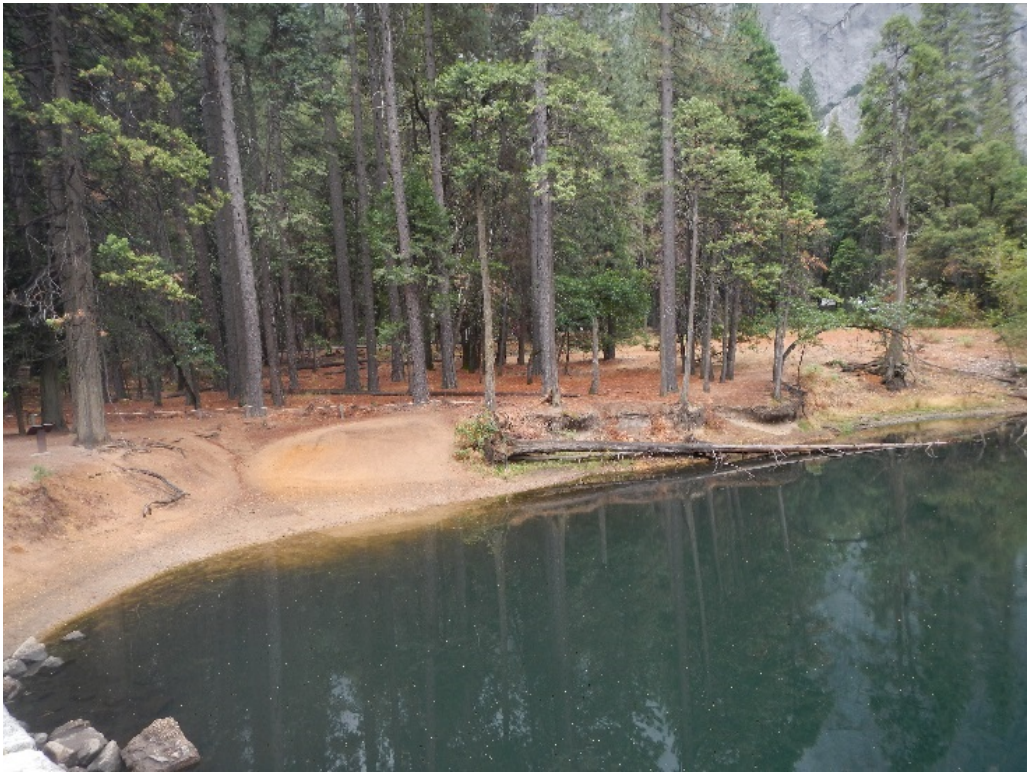
<p data-bbox="349 1837 1534 1921">LB viewed DS from Stoneman Bridge: High, eroding banks; localized scour downstream of bridge; denuded and compacted soils from recreation/boat access; simplified vegetation structure, low species diversity and minimal recruitment</p>

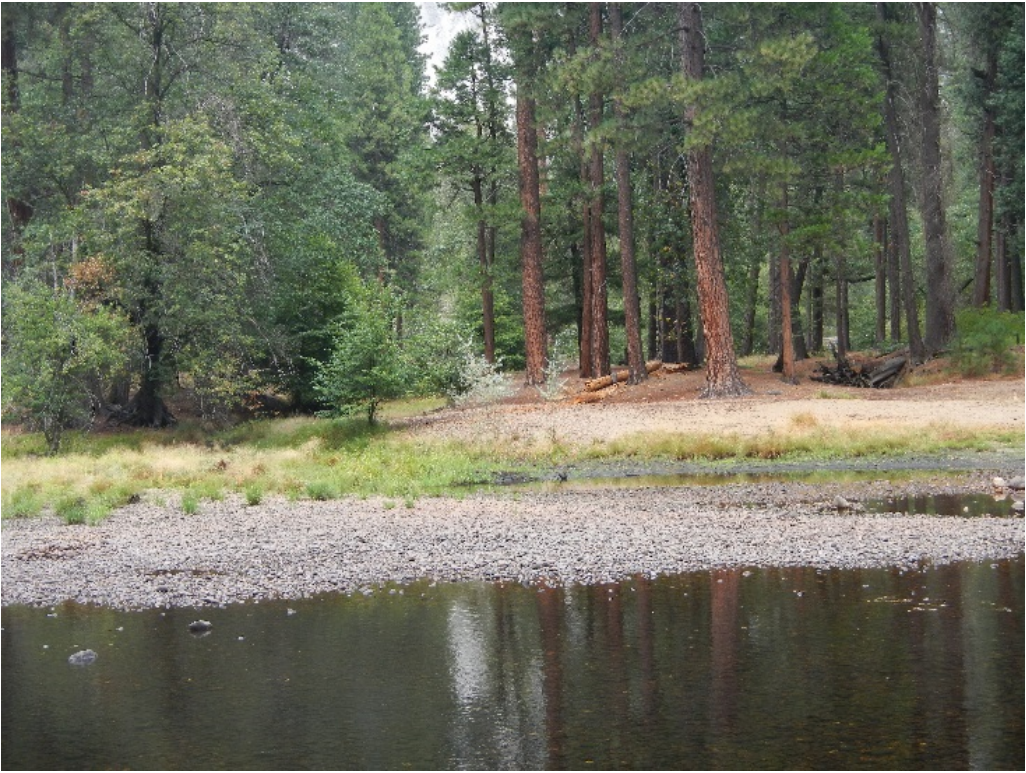
<p data-bbox="386 1493 1495 1545">View of RB from LB: Simplified vegetation structure, minimal vegetation recruitment, and denuded and/or compacted soils in the overbank</p>

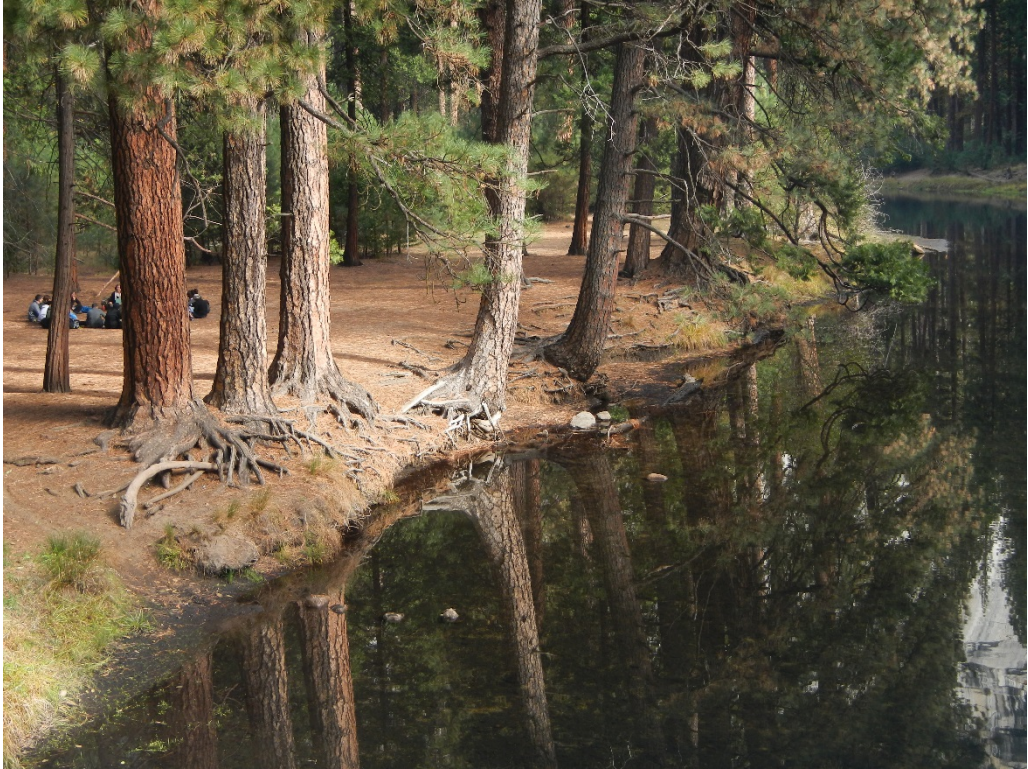
<p data-bbox="391 989 1495 1016">US view of RB from Stoneman Bridge: Denuded and compacted soils and lack of vegetation recruitment</p>
1.23-1.28 (LB)

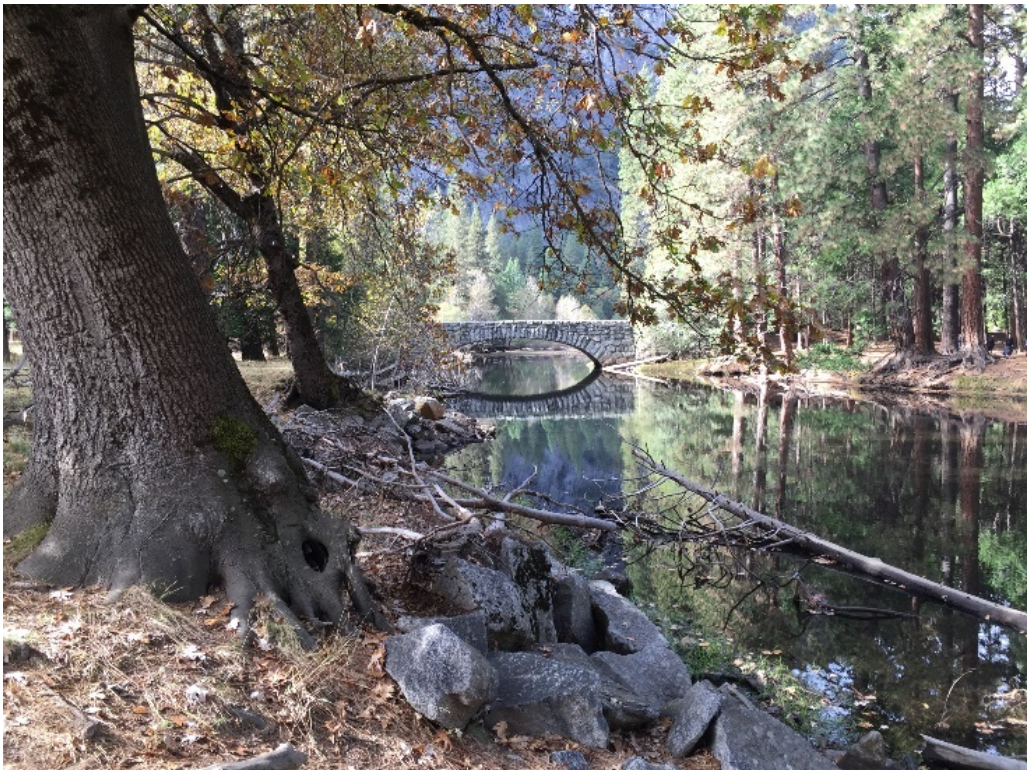
<p data-bbox="342 1835 1544 1892">LB view DS to Stoneman Bridge: Lateral confinement by artificial bank protection with mature vegetation at top of bank</p>

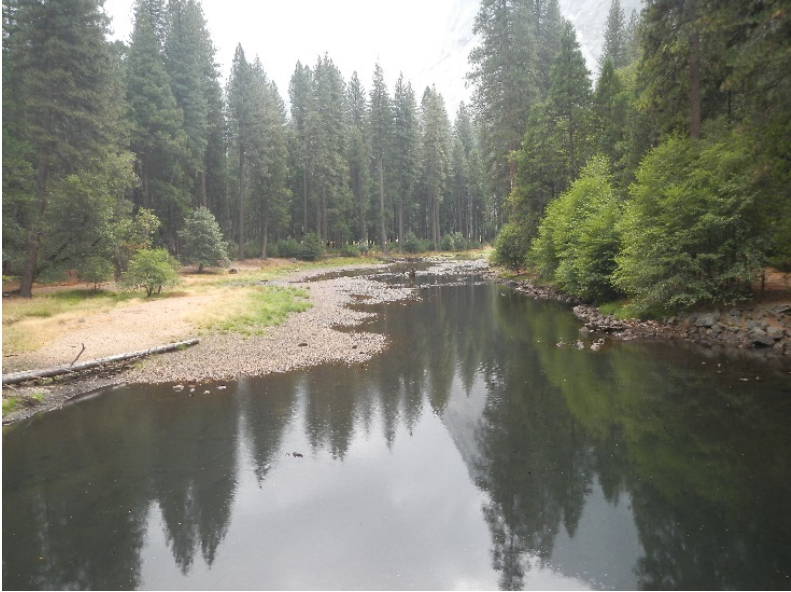
<p data-bbox="354 814 1531 873">DS view from Ahwahnee Bridge: Asymmetrical channel shape upstream of LB overflow channel outfall opposite vegetated artificial protection on RB</p>
<b>RM 1.51 – 1.74</b>	<b><i>Reach 6 – Ahwahnee Bridge to Sugar Pine Bridge</i></b>
	Pending investigation of reach-specific study
<b>RM 1.74 – 1.97</b>	<b><i>Reach 7 – Sugar Pine Bridge to RM 1.97<sup>2</sup></i></b>
1.81-1.83 (RB)

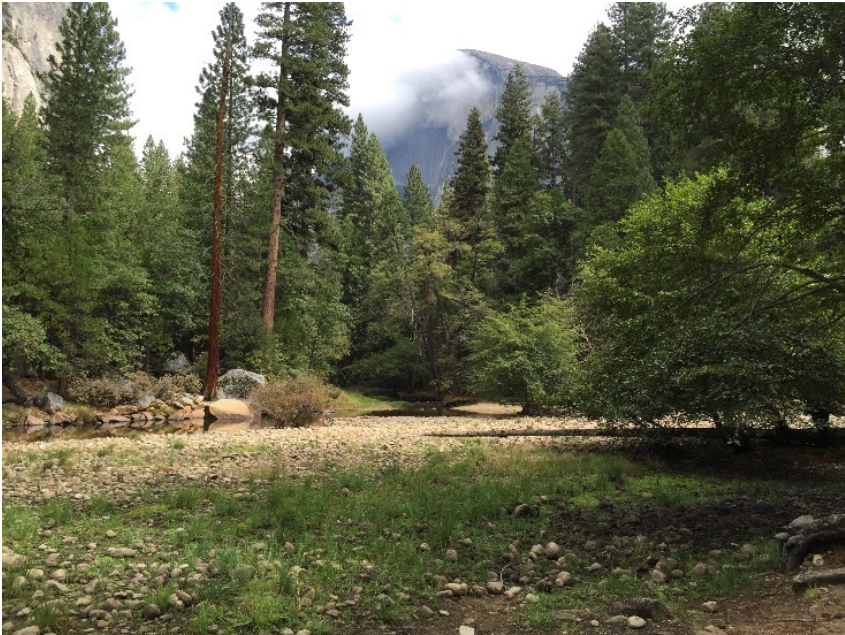
<p data-bbox="342 1738 1539 1797">US view to RB and Tenaya Creek from LB: Areas along RB with erosion and bank retreat between Tenaya Creek and Sugar Pine bridge</p>

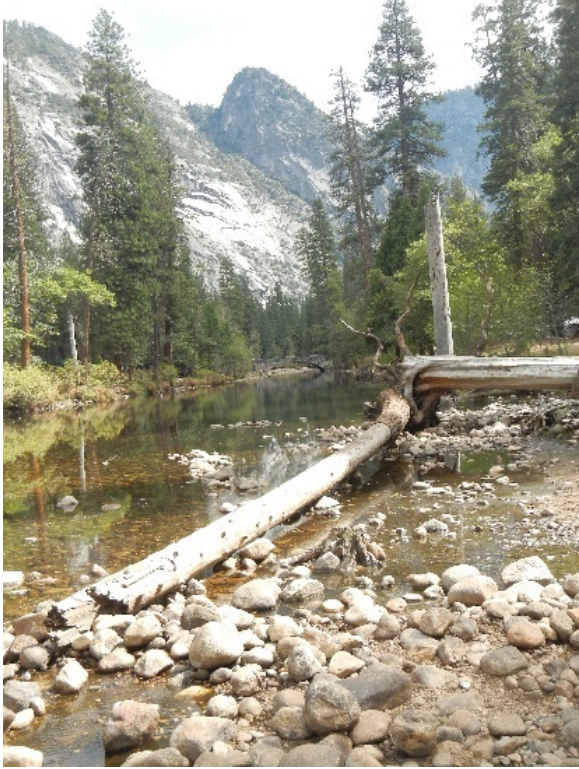
<p data-bbox="337 989 1544 1045">US view along LB: Overwide channel with remnant standing and fallen trees, limited sediment storage; opportunity for reconstructed bank</p>
1.95-1.98 (RB)

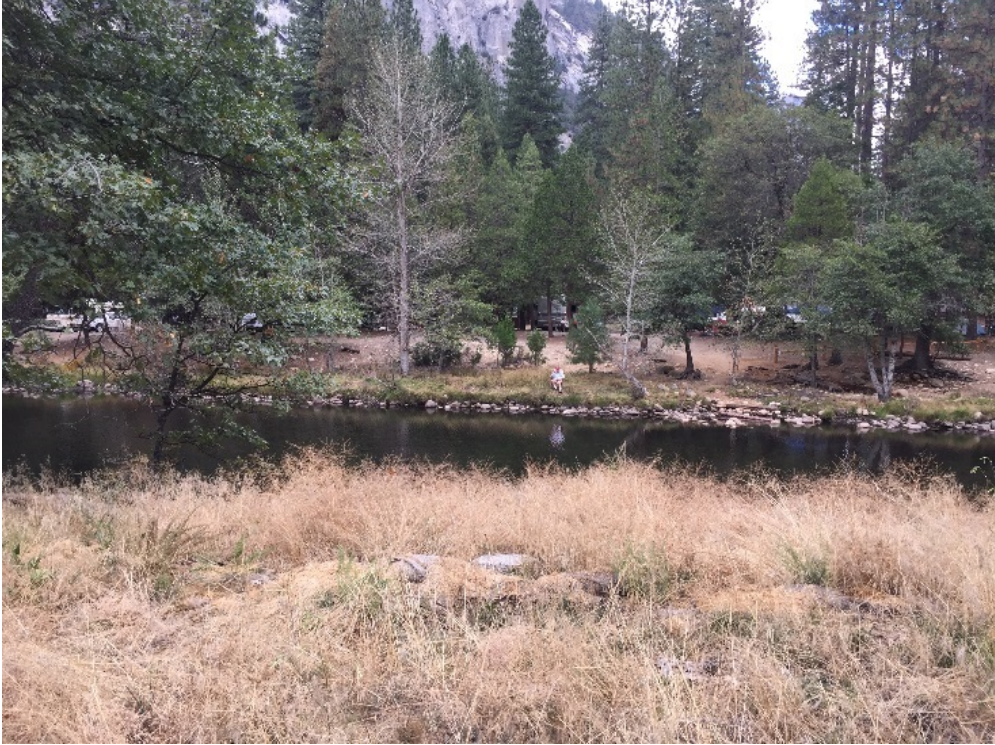
<p data-bbox="431 1839 1451 1871">View RB to LB: Recreation access impacts on floodplain soils and vegetation and within channel</p>

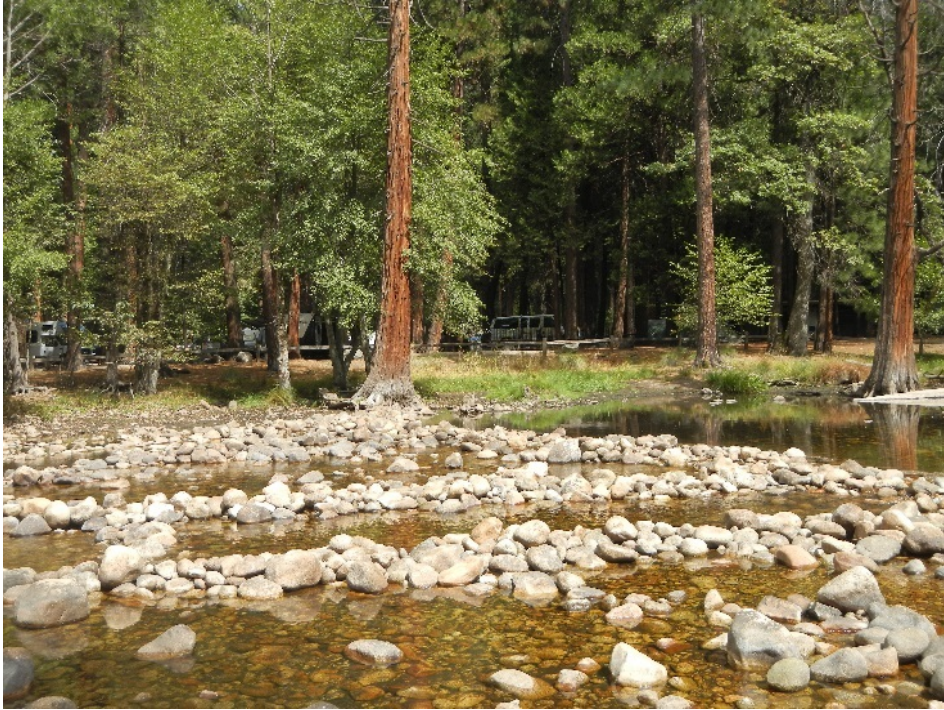
<p data-bbox="431 930 1451 957">View RB to LB: Recreation access impacts on floodplain soils and vegetation and within channel</p>
<b>RM 1.97 – 2.18</b>	<b><i>Reach 8 – RM 1.97 to Clarks Bridge</i></b>
1.97-2.14 (RB)

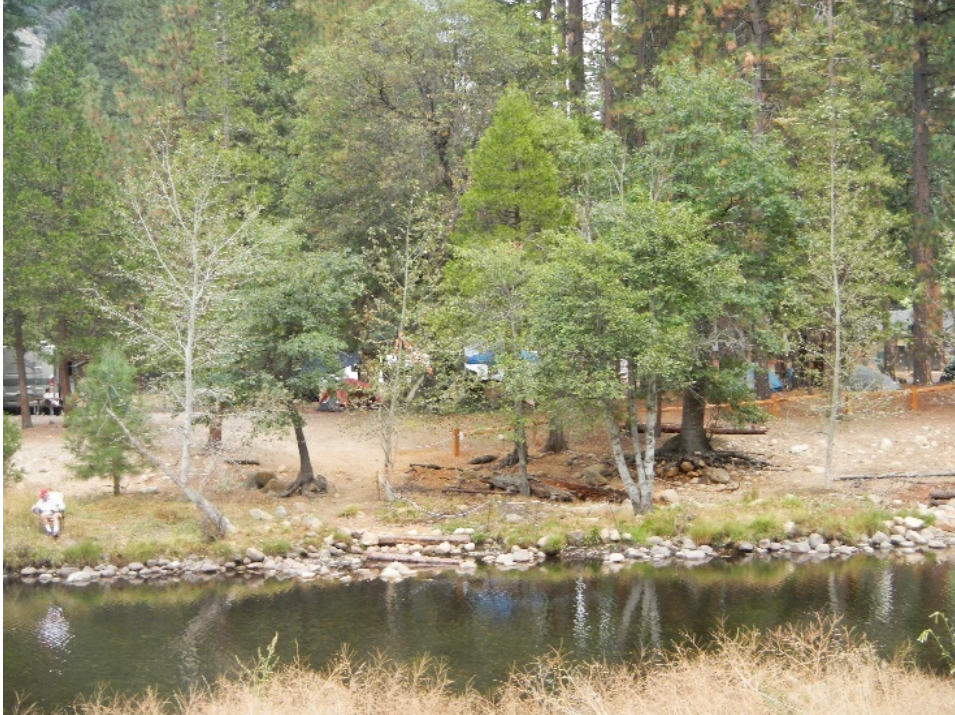
<p data-bbox="362 1759 1520 1816">RB viewed from LB: Stabilized bank toe and plantings (foreground); denuded and compacted soils, recreation access impacts (background)</p>

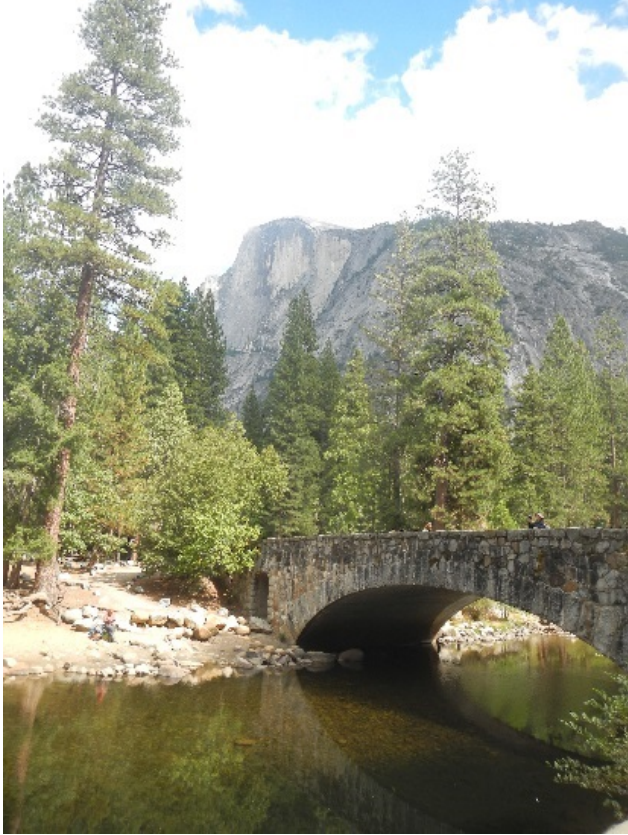
<p data-bbox="516 1056 1369 1087">RB viewed from LB: Denuded and compacted soils downstream of Clarks Bridge</p>
2.14-2.18 (RB)

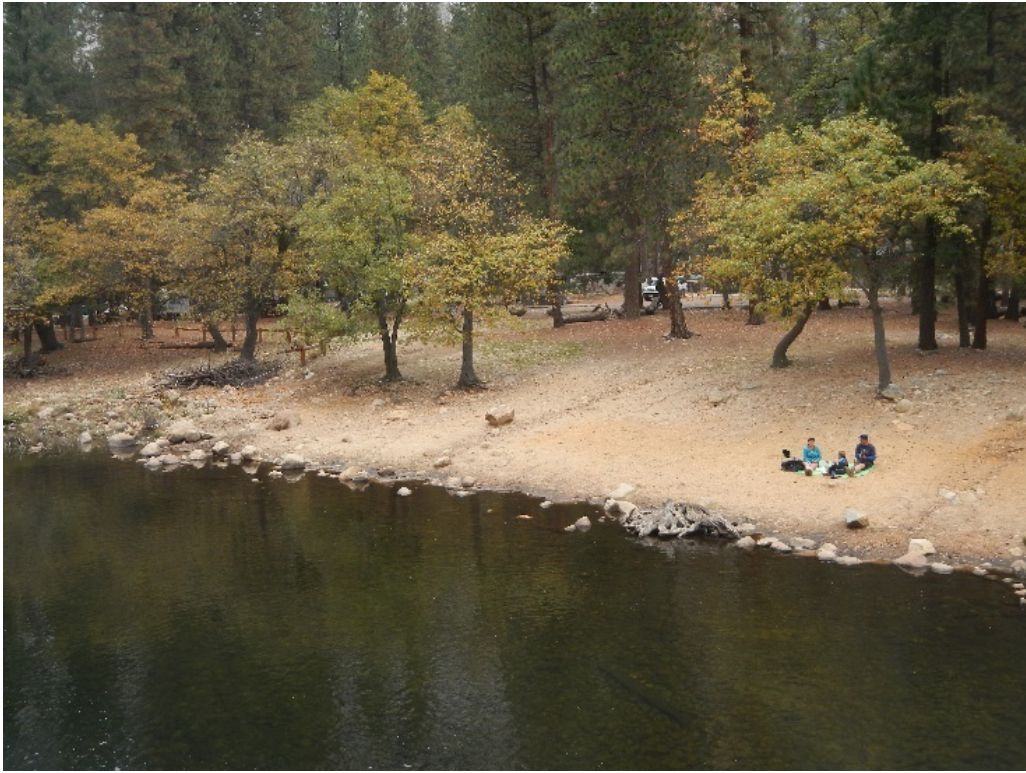
<p data-bbox="349 1906 1536 1959">View DS to RB from Clark's Bridge: Denuded and compacted soils downstream of Clarks Bridge; hardened river access needs</p>

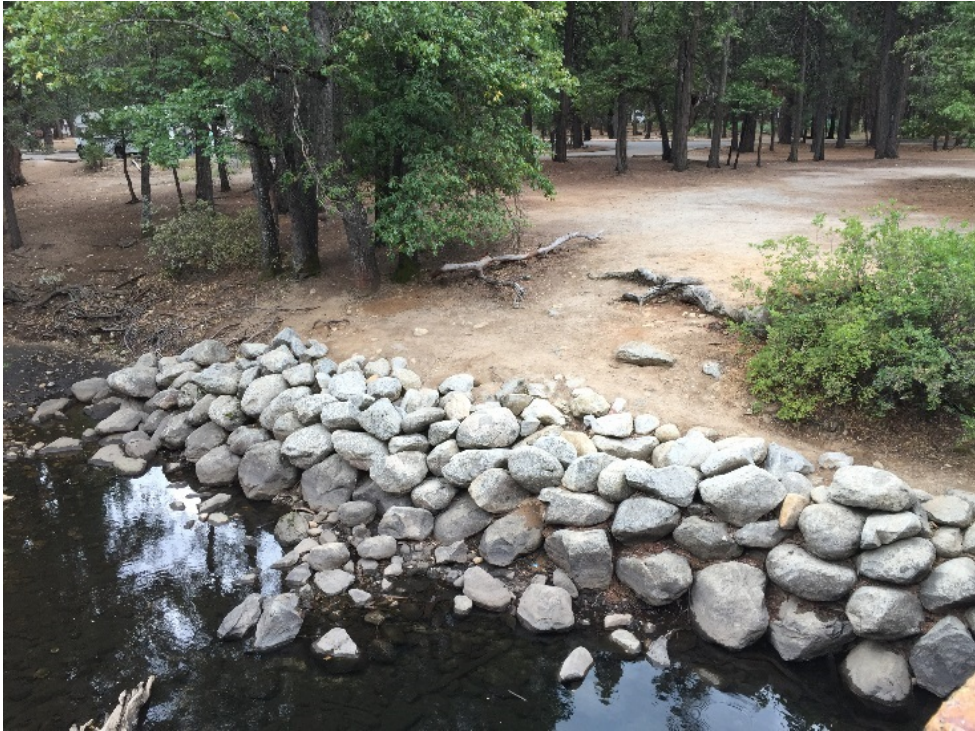
<p data-bbox="376 1856 1484 1913">US view from Clarks Bridge to LB: Bank riprap to retain (foreground); denuded and compacted soils from recreation access; Dump station removal and stormwater management issues (background)</p>

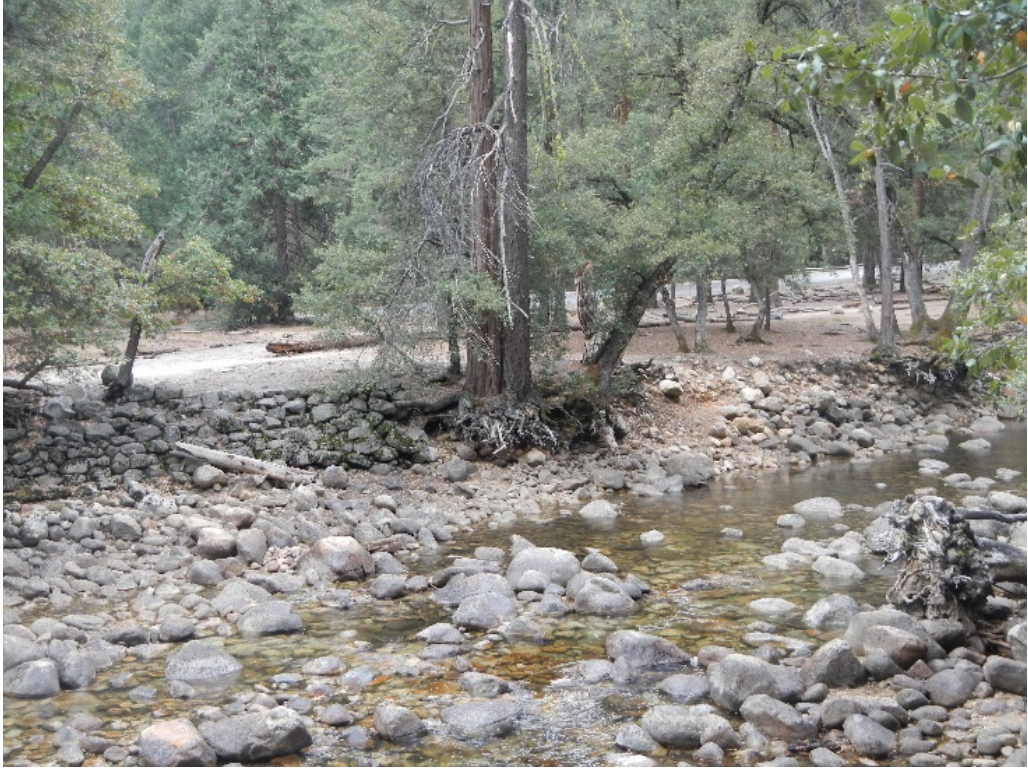
<p data-bbox="342 989 1539 1045">View from LB to RB: Artificial bank protection and bank face erosion (foreground); denuded and compacted soils, lack of vegetation recruitment and simplified vegetation structure</p>
2.93-2.95 (RB)

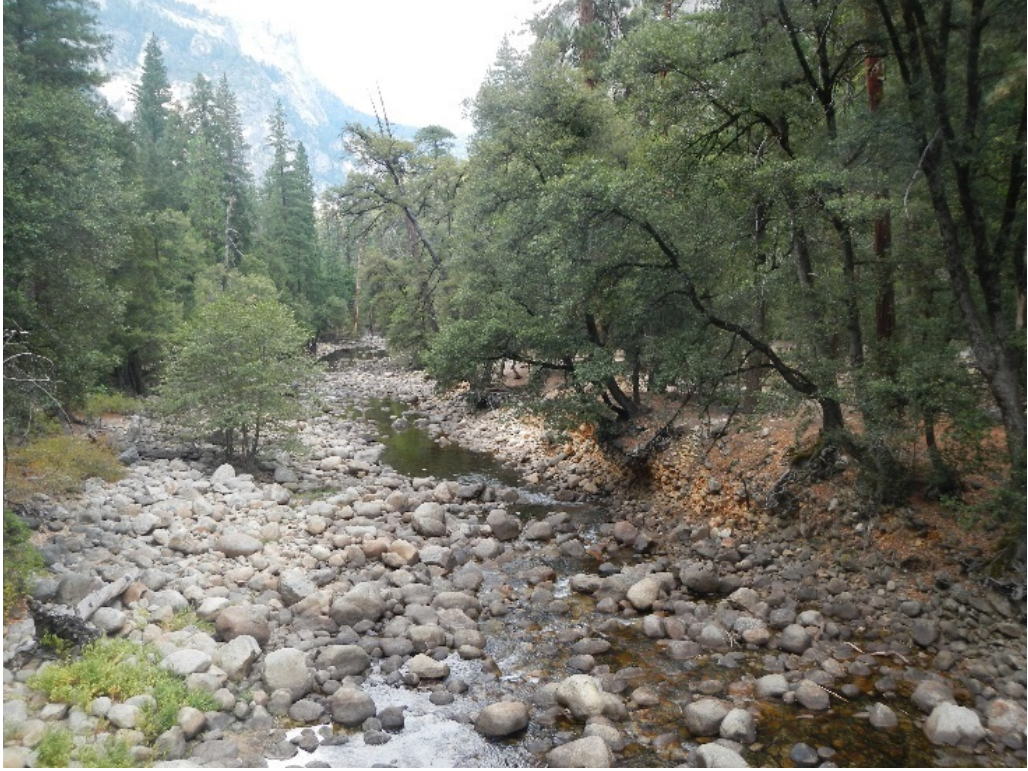
<p data-bbox="329 1864 1555 1921">DS view of RB from Happy Isles Bridge: Entrenched channel with high, eroding banks, artificial bank protection, and minimal vegetation recruitment</p>

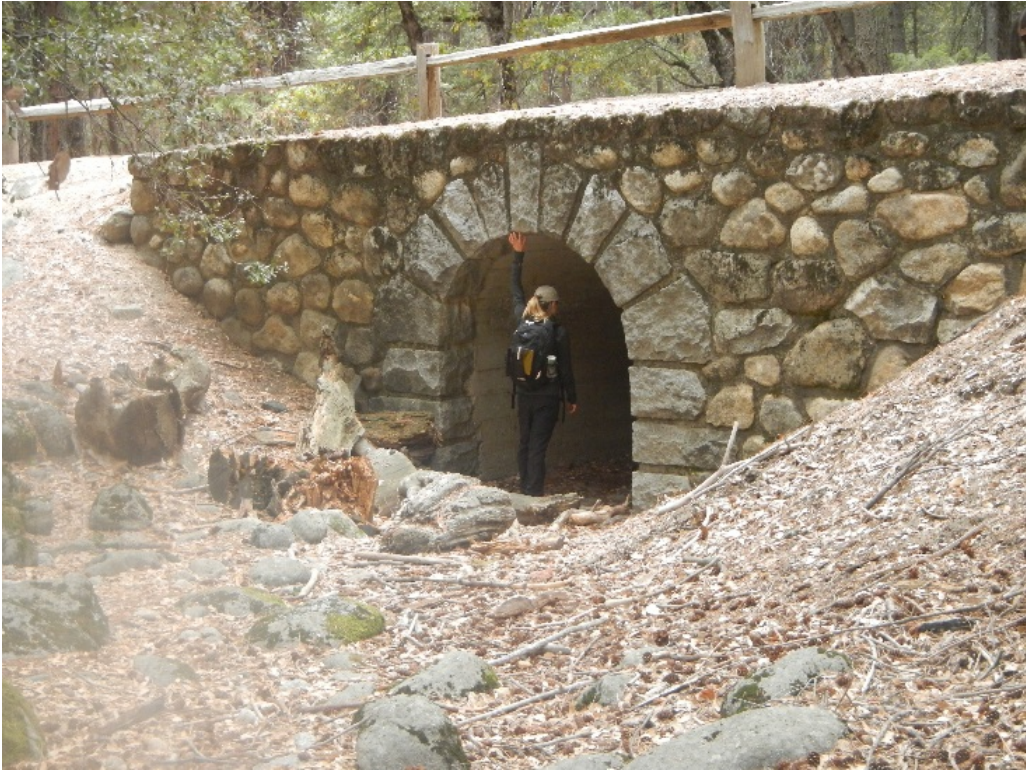
</div> <p data-bbox="688 982 1195 1008">DS view of the blocked overflow channel culvert</p>
