Point Bonita Bridge Replacement Project

Proposed Project

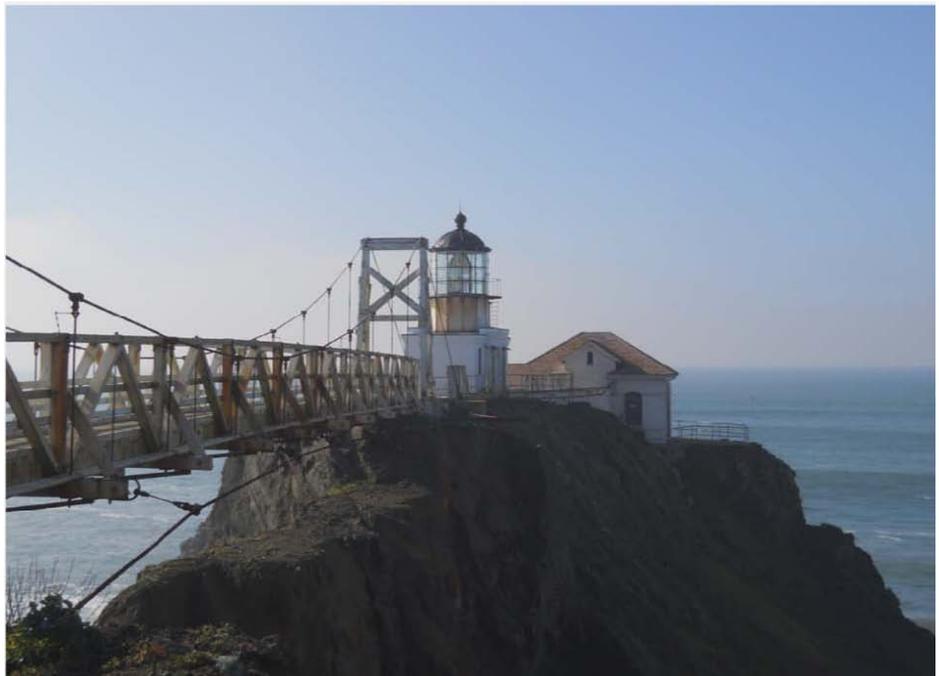
Figure 1. Point Bonita Bridge and Lighthouse - Marin Headlands

The pedestrian bridge at the Point Bonita Lighthouse provides access to the lighthouse for the United States Coast Guard, National Park personnel and the public. The lighthouse sits on a promontory that is accessible only by using the bridge (Figure 1). The existing wooden bridge was constructed in 1954 when recurring slope failures made overland access to the lighthouse impossible. The lighthouse exists in harsh conditions exposed continually to the marine environment. This exposure has resulted in considerable corrosion and weathering which has compromised the integrity of some of the bridge components. Currently, due to its deteriorated condition the bridge is closed to the public and has a "two person" weight limit for worker access.

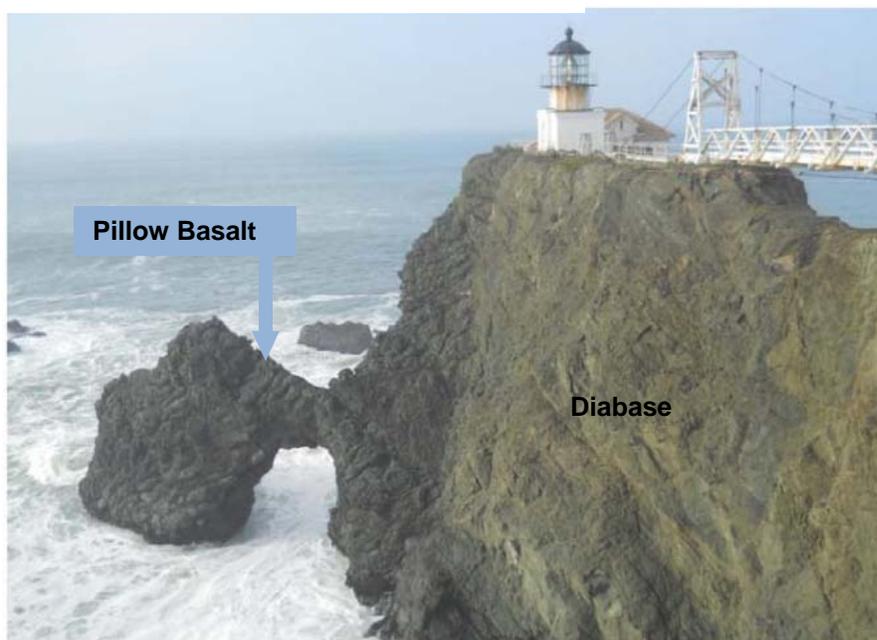
Figure 2. Bluff Geology

The geology of the bluffs surrounding the bridge location are Cretaceous aged meta-dabase, meta-basalt and meta-pillow basalt that exhibit a low degree of metamorphism. The meta-pillow basalts form the base of Point Bonita and can clearly be seen from the bluffs at the site (Figure 2). The meta-dabase lies above the pillow basalt and is the material directly underlying the western end of

of the bridge. Both the western bridge tower and anchor block are founded in the diabase. Based upon visual observations at the surface and examination of rock core from the exploratory boring. The diabase is

weathered, hard, and moderately fractured. These features are creating wedge failures resulting in oversteepened slopes and potentially unstable conditions of the bridge.

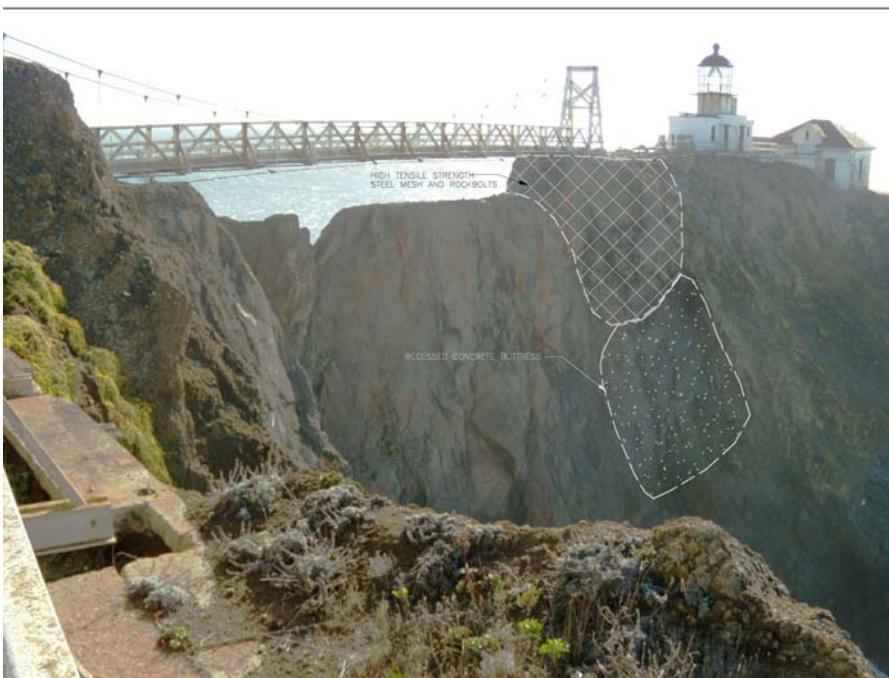
Figure 3. Mesh and Buttress

Along the north side of the western abutment rock slope failures have occurred leaving an unstable overhanging rockmass (Figure 3). And, because the south side of the western abutment is also displaying fracturing and instability, it is recommended that the entire west abutment be stabilized.

- installing a high strength stainless steel mesh net with tensioned rock bolts of staggered length and pattern; and
- placement of a shotcrete buttress recessed into the existing wedge failure area below the rock overhang (block A) on the north facing slope (see Figure 3).

Investigations have determined that the east abutment of the bridge does not appear to pose any imminent rock stability issues and therefore bluff stabilization is not needed in this area. However, the west abutment will require rock stabilization and reinforcement.

To address this instability engineers have recommended that the bluff be stabilized using two stabilization techniques:
