Appendix A: Mortar Analysis

APPENDIX A: CONSERVATION REPORT

MORTAR ANALYSIS

Eight samples of mortar from the exterior of the Carter Woodson Home at 1538 9th Street NW located in Washington, D.C. were removed and analyzed. Two samples were taken from the east façade of the marble and brick pointing mortar. Two samples were taken of the brick pointing mortar on the rear of the main structure, one at ground level on the south façade and the second at the third floor of the west façade. Two samples were taken of the brick pointing mortar from the kitchen wing on the south façade. One sample was taken of the brick pointing mortar from the third addition to the house off the kitchen wing. One sample was taken of the bedding mortar in this section of the addition.

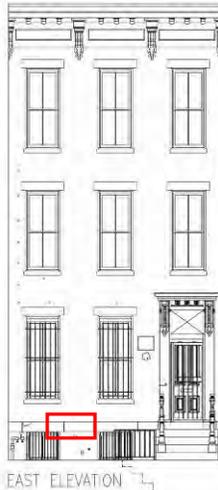
EAST ELEVATION

Mortar Sample 1: Marble Pointing Mortar

The freshly broken sample was white (Munsell N 8) in color and was easily crushed. The mortar joints were narrow (1/8") and heavily soiled.

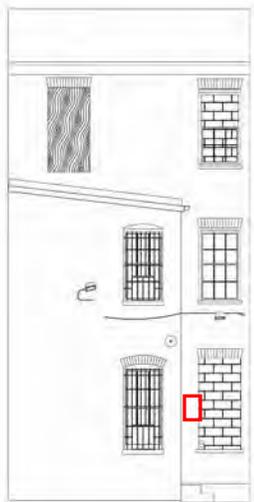
WEST ELEVATION

Mortar Sample 2: West Façade Brick Pointing Mortar 1st Floor

The freshly broken sample was pale yellow (Munsell 2.5Y 8/2) in color and was easily crushed. The mortar joints were narrow (1/4-1/2").

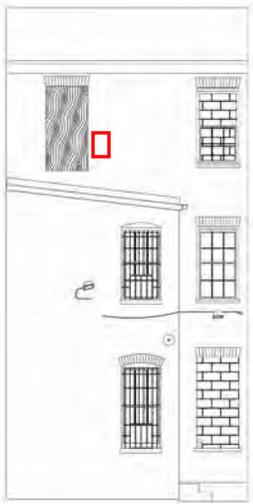
WEST ELEVATION

Mortar Sample 3: West Façade Brick Pointing Mortar 3rd Floor

The freshly broken sample was very pale brown (Munsell 10YR 8/2) in color and was very easily crushed.

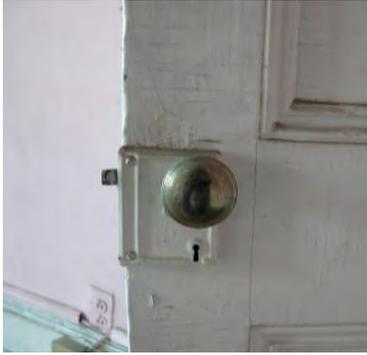
Figure 8-001: Rim Lock on Door 204.
(Photo: BBB, 2006)

Door 204 has a rim lock mounted on the door. Rim locks were commonly used between 1840 and the early decades of the twentieth century. They were gradually replaced by mortise locks which were installed within the door rather than mounted on the surface. As most of the locks in the house are mortise lock types, this lock is therefore among the oldest in the house.

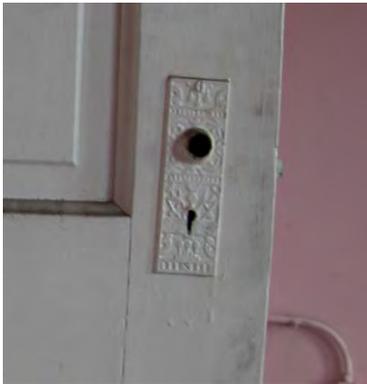
Figure 8-002: Decorative backplate on
Door 203. (Photo: BBB, 2006)

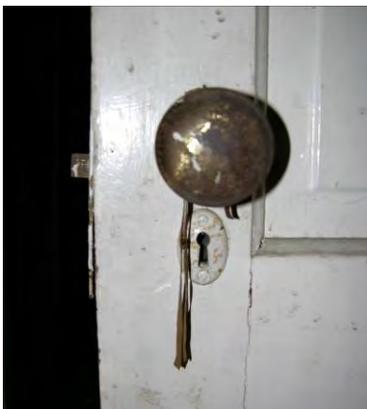
Figure 8-003: Knob and Keyhole
Cover on Door 103.
(Photo: BBB, 2006)

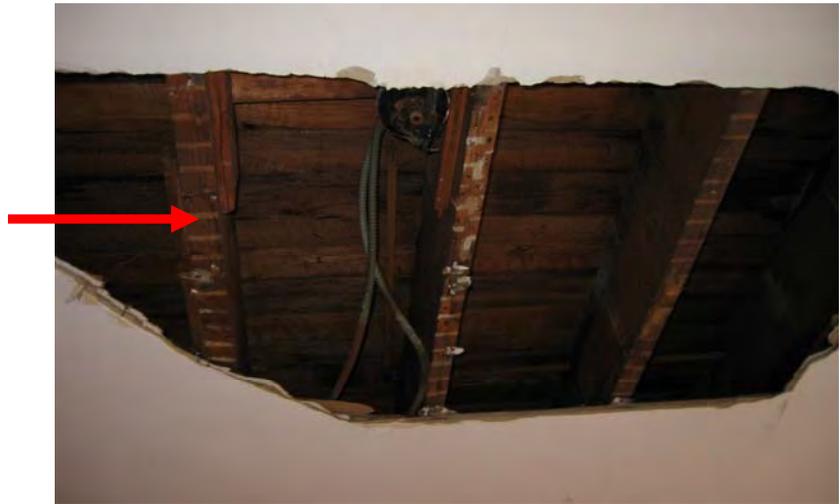
Figure 8-XXX: Ghosting from plaster keys on ceiling joists behind plaster board. (Photo: BBB, 2006)

The ceilings in the house were originally plastered with traditional wood lath as evidenced by the ghosting of the lath keys on the wood joists. During alterations, the plaster ceilings were removed and replaced with wallboard or expanded metal lath. There are at least two campaigns of ceiling replacement. Three different materials were used to replace the earlier wood lath and plaster ceilings. In some rooms expanded metal lath was found, other rooms were finished with an early form of plaster lath wallboard, sometimes referred to as "rock lath," while other rooms have modern gypsum board, which was mounted on top of the earlier wood lath.

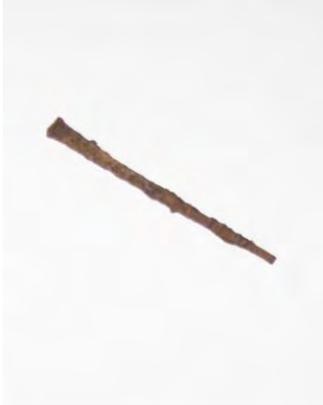
Figure 8-005: Cut nail from entry surround pilaster

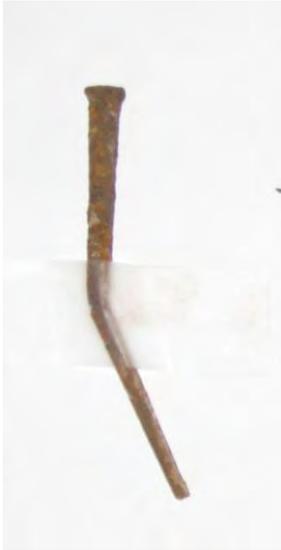
Figure 8-006: Cut nail from Door 103A

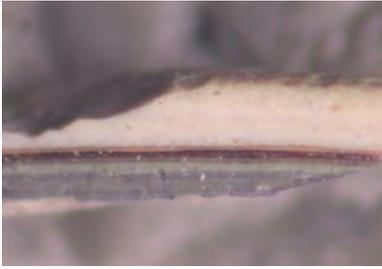
Figure 8-007: Sample CW104-002 micrograph with multiple dark bluish gray finish layers. (Photo: JB, 2007)

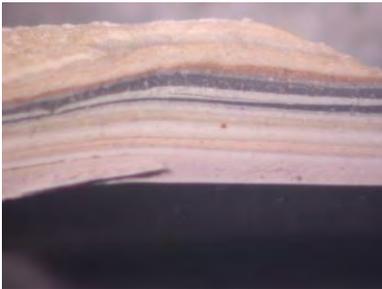
Figure 8-008: Sample CW201-008 micrograph. (Photo: JB, 2007)

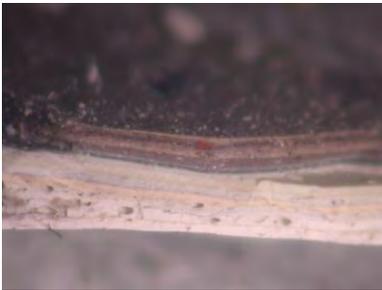
Figure 8-009: Sample CW203-001 micrograph. (Photo: JB, 2007)

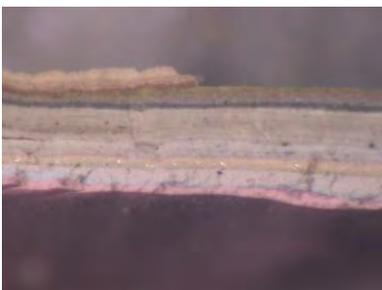
Figure 8-010: Sample CW207-001 micrograph. (Photo: JB, 2007)

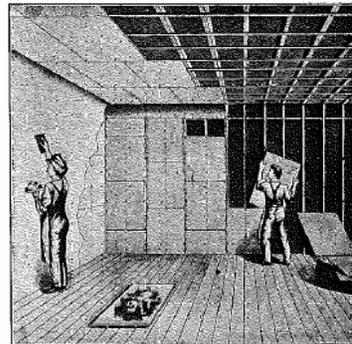
In NAILING use 1 1/4 inch Wire Nails with large head, set 4 to 6 inches apart, with each nail driven home firm and tight to prevent any working under the Plaster Coat. SPACE BOARDS one-fourth of an inch apart, BREAKING JOINTS horizontally on the walls and at right angles with the furring on the ceiling, as shown in Fig. 3.

FIG. 3. METHOD OF APPLYING PLASTER BOARD

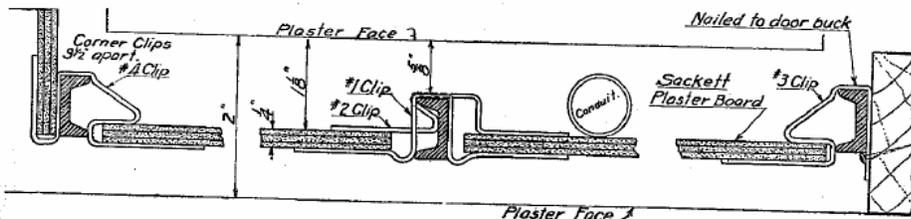
Cross Section through Wall.

DETAILS OF JESTER-SACKETT 2-IN. SOLID PARTITION
