WASHINGTON MONUMENT Seismic Assessment

National Mall, Washington DC

Final Report
August 29, 2012

Prepared for:
National Park Service, Denver Service Center

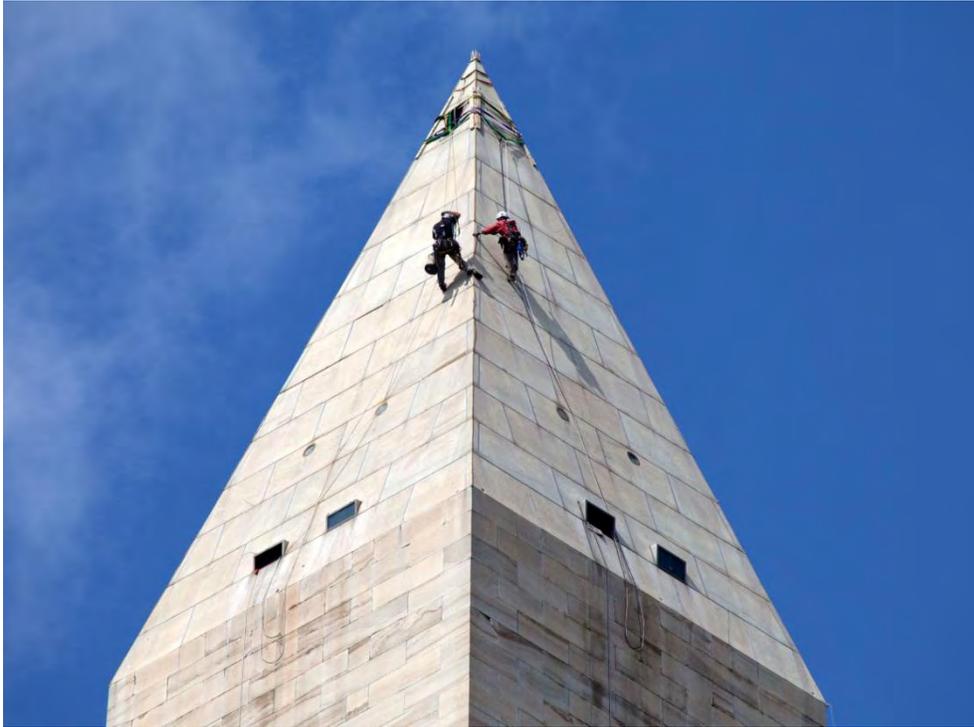
Figure 1. Pyramidion and upper portion of the shaft of the Monument

The Monument remained in a partially complete, unfinished state until after the Civil War. Approaching the nation's centennial, renewed interest in the completion of the Monument took shape and ownership was transferred to the federal government in 1876. The Army Corps of Engineers was commissioned to study the integrity of the foundations. Their studies led to structural modifications, which began in 1878 under the direction of Lieutenant Colonel Thomas Lincoln Casey, Chief Engineer of the Monument construction project. The foundation-strengthening work, which increased the footprint of the foundation, was completed in 1880, and construction resumed on the superstructure of the Monument that year. Six feet of previous construction from the top of the existing walls was found to be inadequate and was removed prior to work commencing on the shaft from the 150-foot level. Casey developed an internal iron structure for the Monument to support work platforms and a steam-powered hoist. He redesigned the Monument somewhat by adjusting the proportions of the pyramidion to conform to those of known ancient Egyptian obelisks, a design strategy which also influenced the design of the final height of the structure. The final design of the obelisk consisted of a 500-foot shaft, topped by a steeply-sloped pyramidion 55-feet in height (Figure 1).

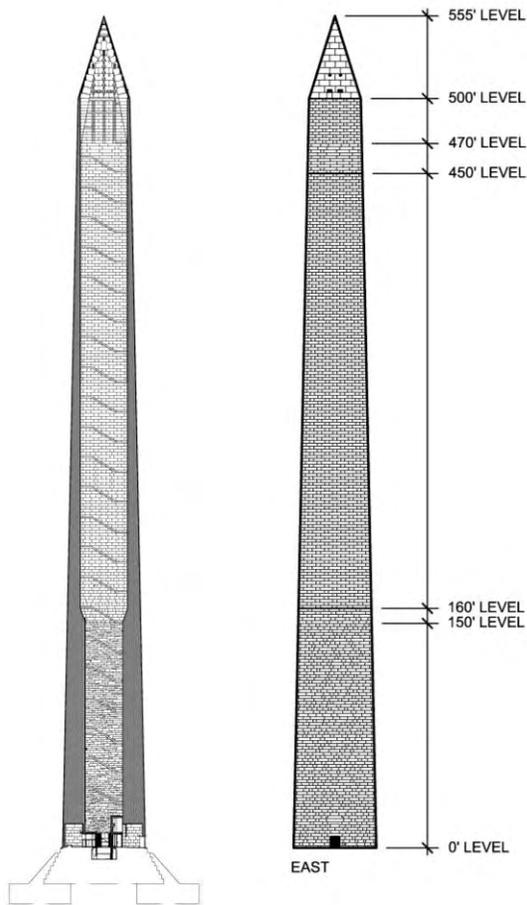
Figure 2. Cross-section and elevation of the Monument

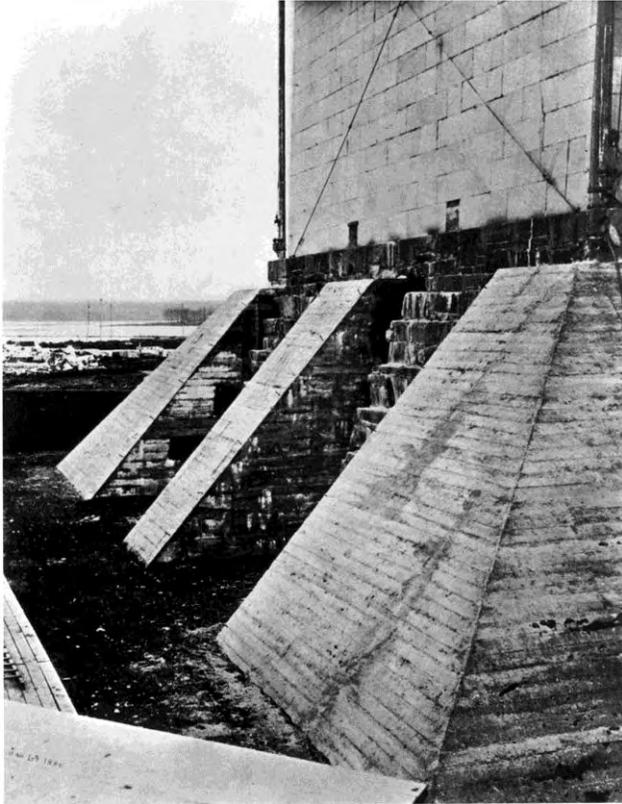
Figure 3. In-progress concrete buttressing, circa 1880

Structurally, the Monument is a stone-masonry bearing wall structure consisting of four exterior walls. It is largely a hollow shaft, with archaic iron interior framing that supports the elevator structure and the interior stair structure. The foundation of the Monument was originally constructed from stone masonry, with plan dimensions of 80 feet by 80 feet. Significant underpinning and widening of the foundation with concrete, as well as integrating of the widened footprint into the existing construction with concrete buttressing, was performed by the Army Corps of Engineers prior to re-initiating construction to complete the shaft. The widened footprint of the foundation is roughly 126 feet by 126 feet. A photograph of the in-progress concrete foundation work is shown in Figure 3 with completed buttressing shown in Figure 4.

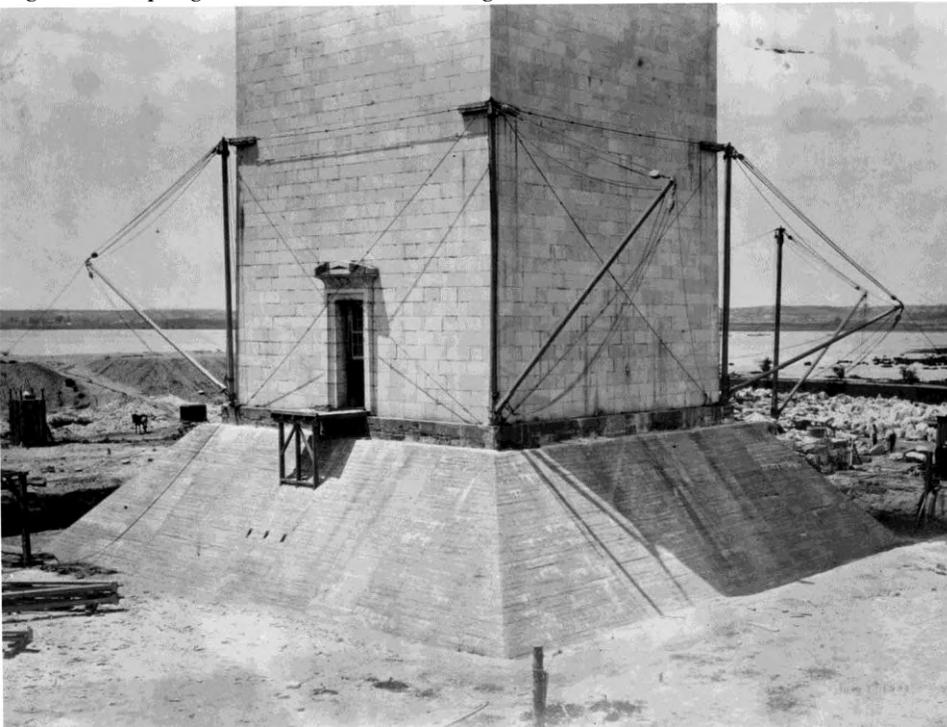
Figure 4. Washington Monument foundation after underpinning and buttressing, prior to backfilling, circa 1880

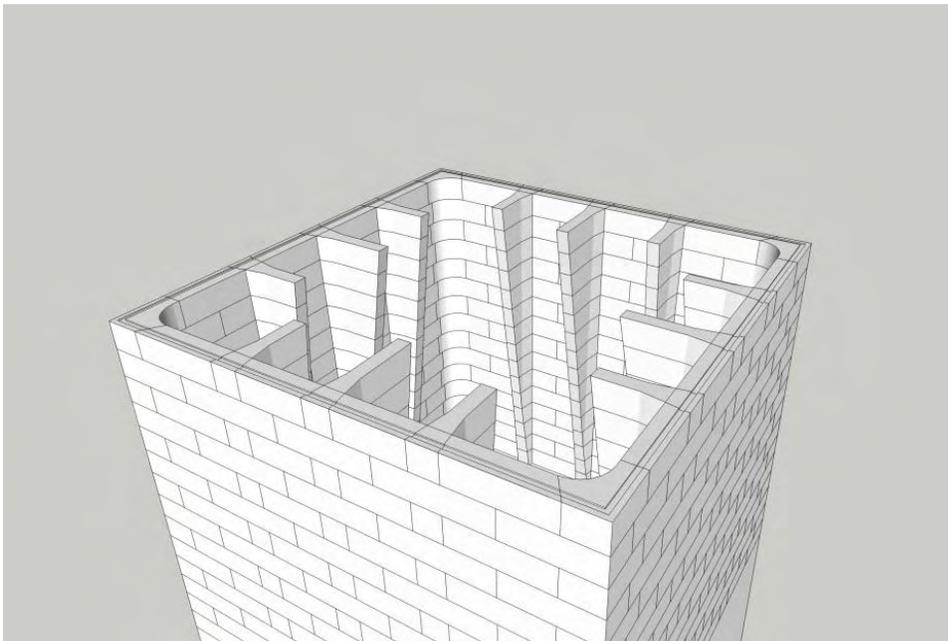
Figure 5. Rendering of rib structure cut at the 500-foot level of the shaft with the pyramidion above not shown for clarity

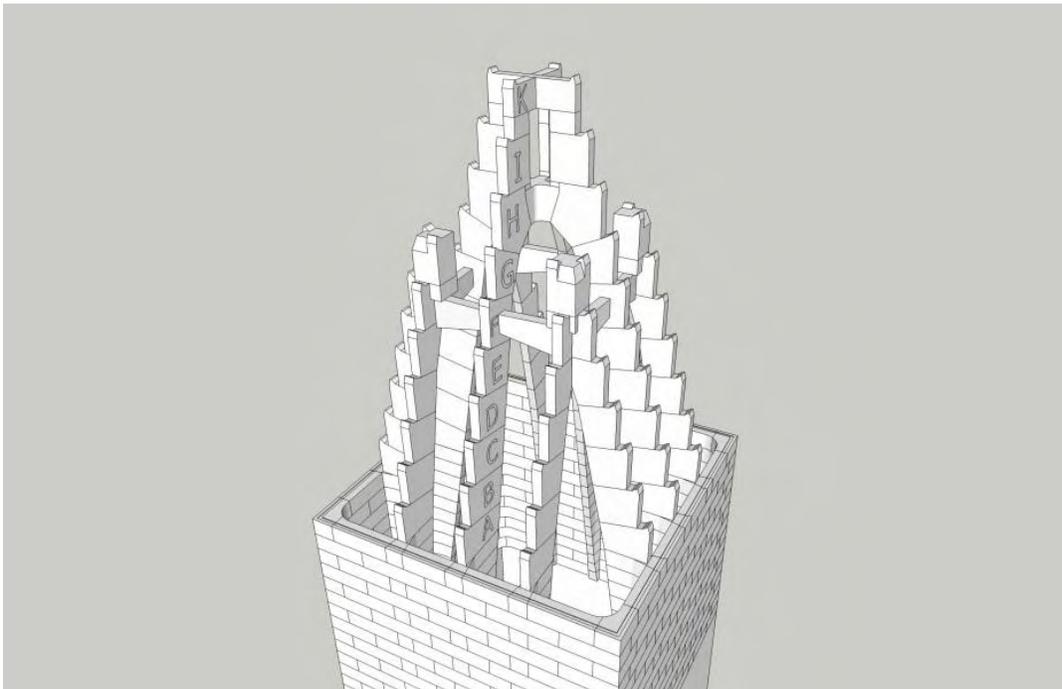
Figure 6. Rendering of the upper portion of the rib structure with the exterior panels not shown for clarity

As shown in Figure 6, the corner ribs do not reach the full height of the pyramidion, but truncate in course “F”. Adjacent corner ribs join together in a complex mitered joint condition that stretches from the upper portion of course “E” through course “F”. This joint also includes mitered joinery with the haunched tie beams that extend around the interior perimeter of the pyramidion. These corner joints are each capped by a two-piece corner stone, both being 2 feet 8 inches square in plan, and a combined 5 feet 8 inches in approximate height. Of note, in plan, the tie beams do not exactly parallel the pyramidion wall planes. The tie beams are instead canted in plan such that an apex is formed at the common center rib stones to which the smaller ends opposing tie beams are joined with a mortise and tenon joints, thus providing additional out-of-plane support for the pyramidion wall panels (Figure 7).

Also as shown in Figure 6, at course “H”, the relatively small plan dimensions of the pyramidion cause opposing center ribs to approach closely enough to permit the cruciform stone to span the gaps between opposing ribs. The center rib stones at course “H” are joined to the cruciform and to course “G” below with mortise and tenon joints. The cruciform acts as the keystone for the intersecting arch-frames of the center ribs and has sloped joint surfaces typical of masonry keystones. While the cruciform acts as a keystone, it is not the highest point of the rib structure. Courses “I” and “K” of the center ribs continue up and terminate at course “K” with a single cross-lintel stone that runs east to west. The north and south center ribs key into this cross lintel stone with a vertical mortise and tenon joint.

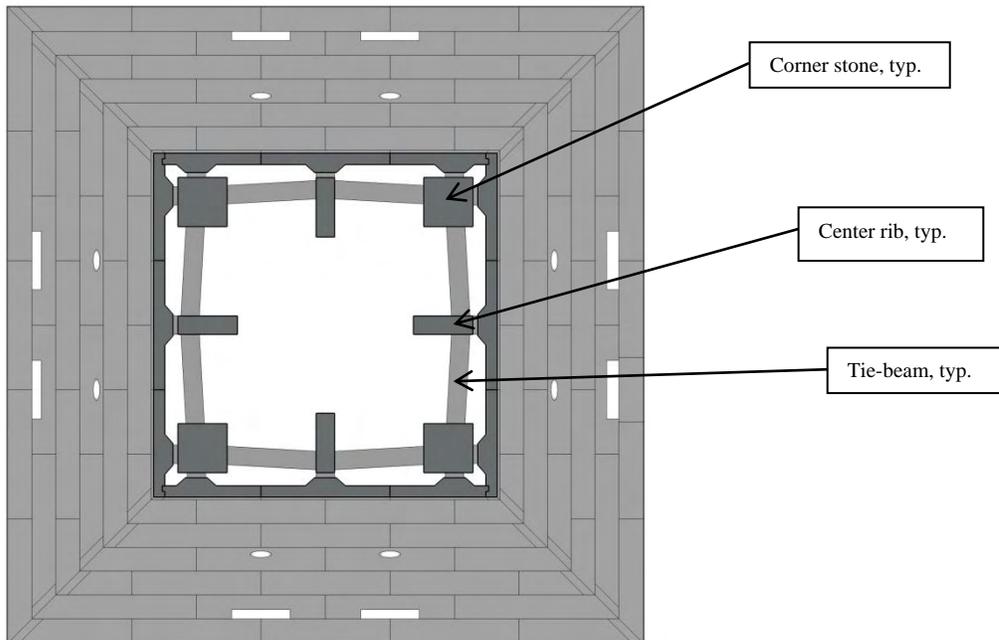
Figure 7. Plan section of pyramidion at tie beam elevation showing cant and apex at center ribs

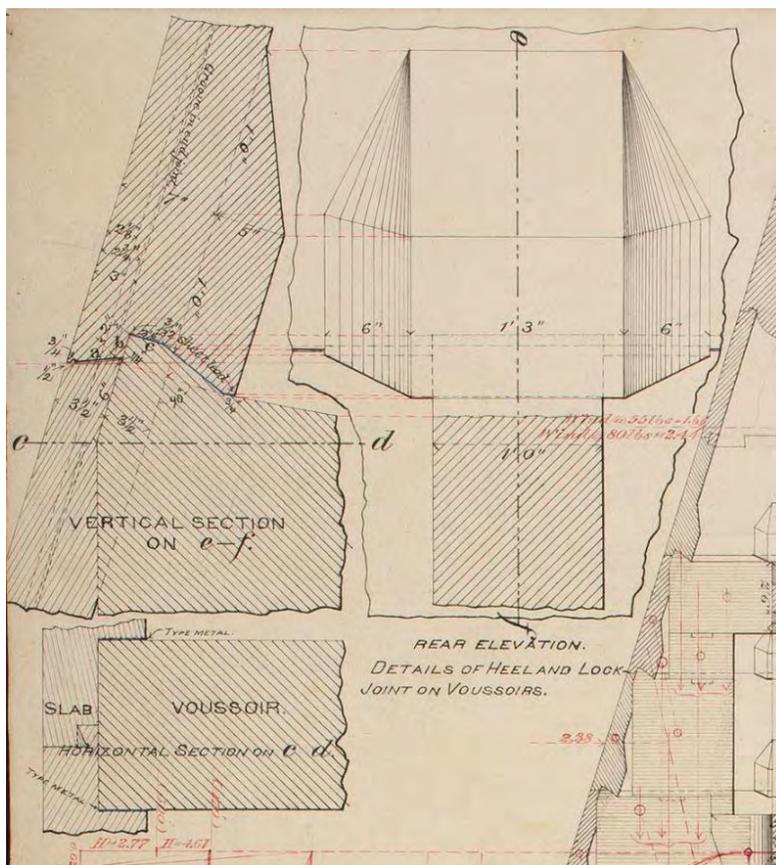
Figure 8. Army Corps of Engineers sketch circa 1880 of rib-stone-to-panel connection, from National Archives

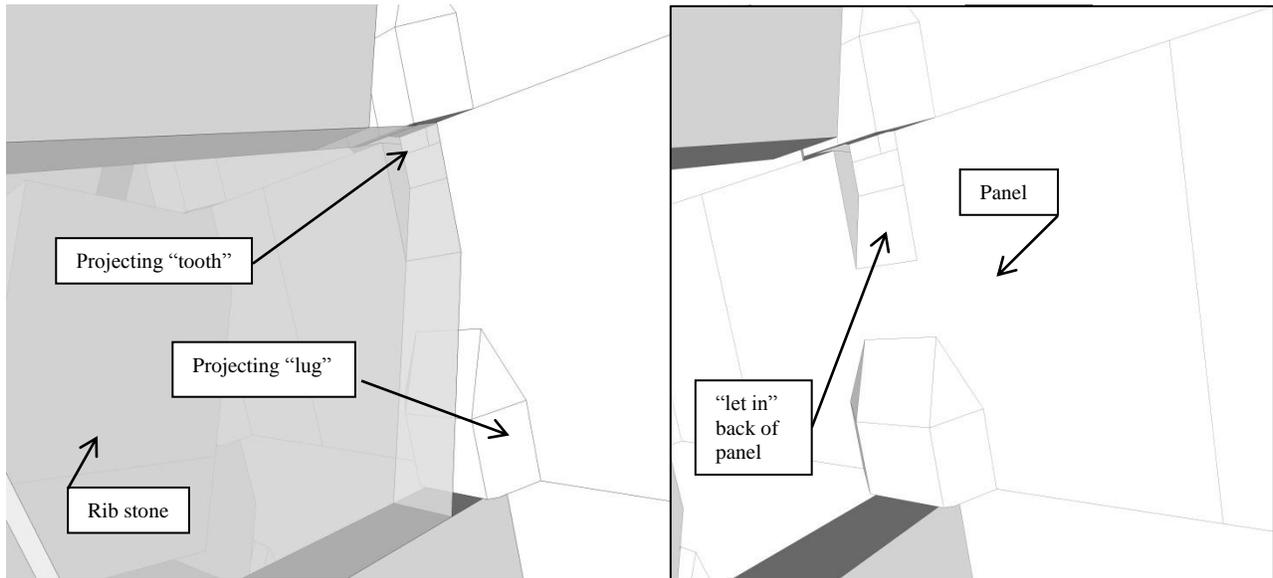
Figure 9. Images of projecting panel "lug" and projecting rib "tooth" at panel-to-rib bearing connections (Left with rib stone, Right without rib stone for clarity)

teeth provide interlocking action, both in-plane and out-of-plane, between the rib stones and the panels. Very substantial in-plane interlocking is the result of the letting of the tooth on each rib into a chase cut into the adjacent panel or panels. The chase locks the rib stone into the panel relative to the in-plane direction of the exterior wall, particularly where the chase is cut into a single panel. Where vertical panel joints line up at ribs, the sides of the chase still interlock with the ribs, but only in one-direction. To make the connection tight, the small gaps between the sides of the chases and the rib stones necessary for fitting the stones together were filled with molten lead --- identified as “type metal” on the drawings --- after the placement of the panels (Figure 8). Out-of-plane support is provided by interlocking of the teeth that project upward and into the lugs and resist outward movement of the panels relative to the rib stones, as well as by the lap joint with the panel above (Figure 9).

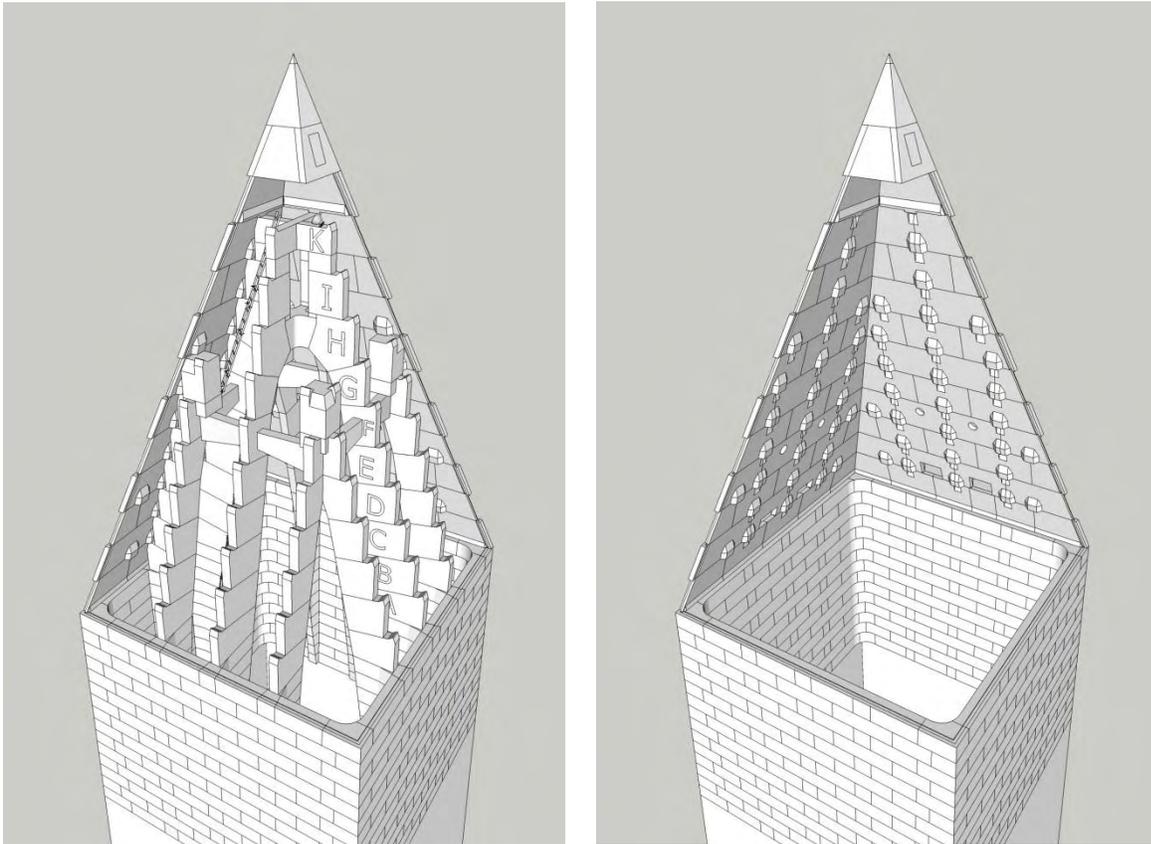
Figure 10. Left: Rendering of the pyramidion masonry with two exterior faces not shown for clarity. Right: Rendering of the interior face of the pyramidion panels showing the layout of lugs

The panels of the course at the 546-foot elevation rest on top of the cross lintel of course "K" of the rib structure, this is the last exterior panel course that is supported by the rib structure. Course 550 rests directly on Course 546 and has an approximately 1 foot 7 inches wide by 2 feet 4 inches tall opening in the southern panel for access to the exterior of the Monument. The lower interior edges of courses 546 and 550 have a thickened edge similar to a lug, although this thickened condition runs the entire width of the bottom of each panel, and is mitered on either end. The final stone course, 555 is a solid block with a projection on the underside. This 3,300 pound stone is penetrated through the center by the lightning protection system and is capped by an engraved piece of solid aluminum approximately 9 inches tall. Figure 10 shows two cutaway renderings of the relative positioning of the ribs and the panels, as well as the layout of the lugs.

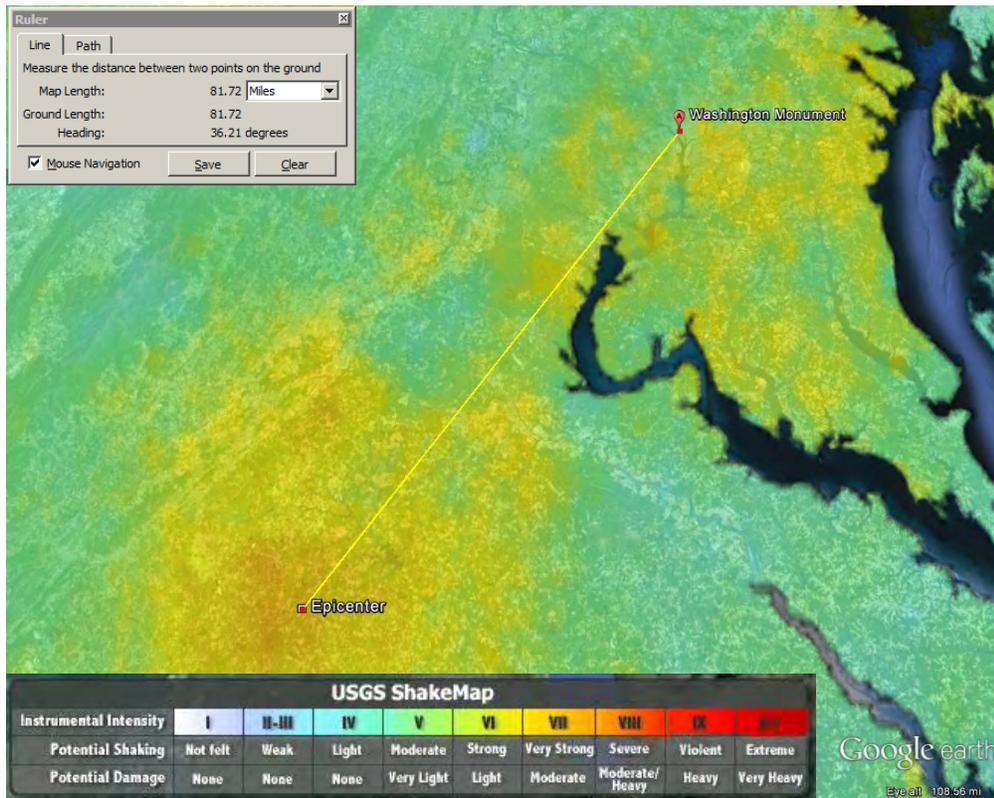
Figure 11. USGS Shake Map of August 23, 2011 for the Mineral, Virginia earthquake

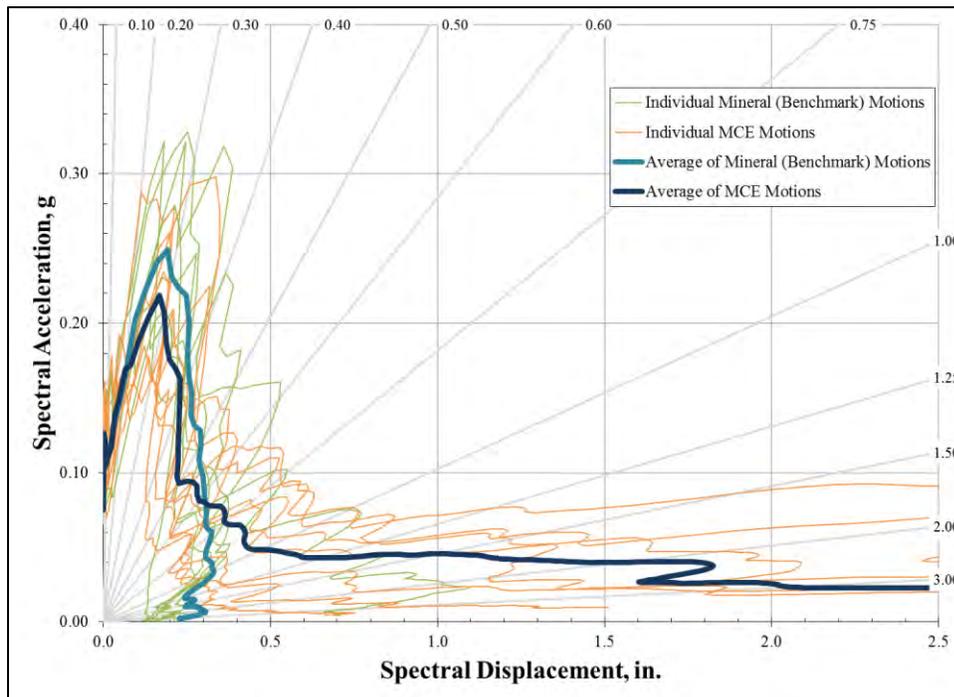
Figure 12. ADRS plot of Mineral (Benchmark) and MCE seismic demands

period line can be followed from the origin until it intersects the plotted curve, from which it can be determined that the Mineral event would have imposed a spectral acceleration of almost 0.25g and a spectral displacement at the effective height of the structure of approximately 0.2 inches. Similarly, from the 0.75 second period line, it can be determined that for a structure with a period of vibration of 0.75 seconds, the Mineral event would have imposed a spectral acceleration of about 0.056g and a spectral displacement at the effective height of the structure of approximately 0.3 inches. The plot also shows that the displacement demands from the Mineral event were nearly constant for structures with periods greater than about 0.35 seconds. For example, for a structure with a period of vibration, of either 1.0, 2.0, or 3.0 seconds, the Mineral event would have imposed a spectral displacement at the effective height of the structure of approximately 0.25 inches.

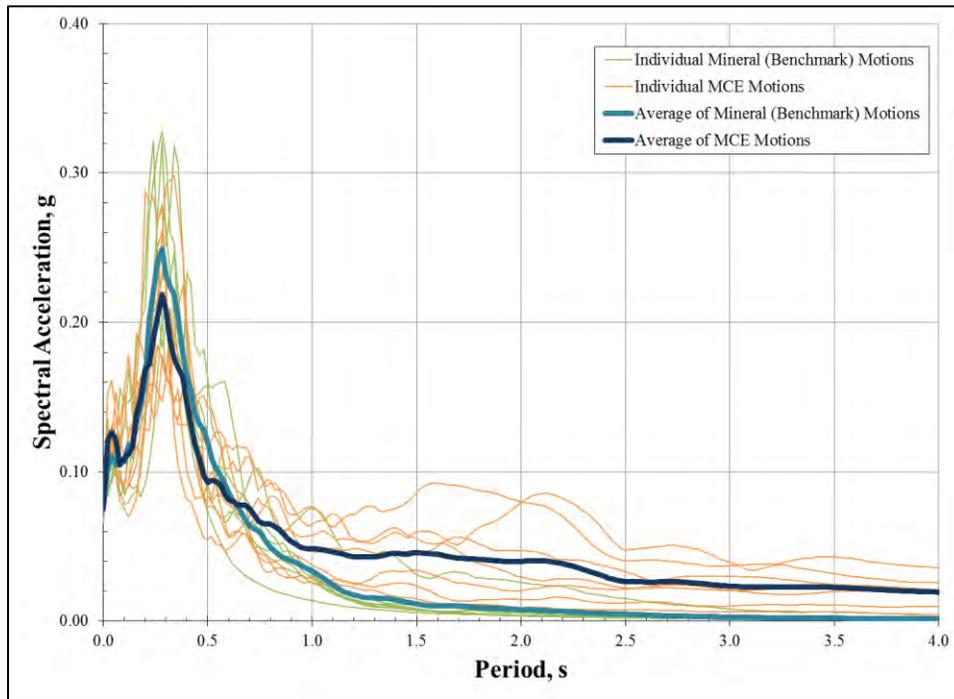
Figure 13. Response Spectrum of Mineral (Benchmark) and MCE seismic demands

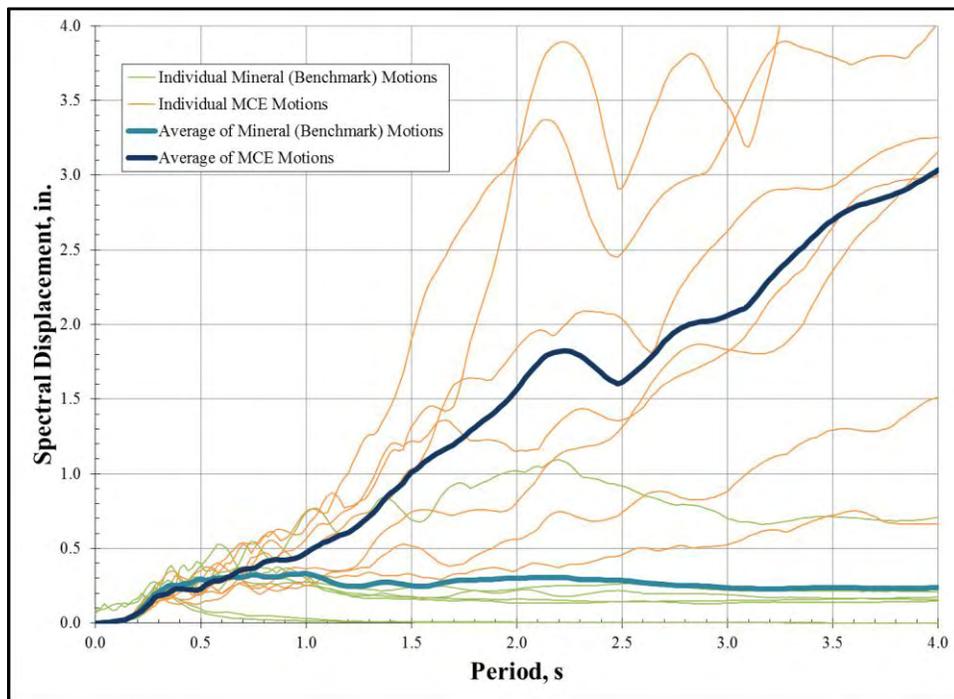
Figure 14. Displacement demand of Mineral (Benchmark) and MCE ground motions

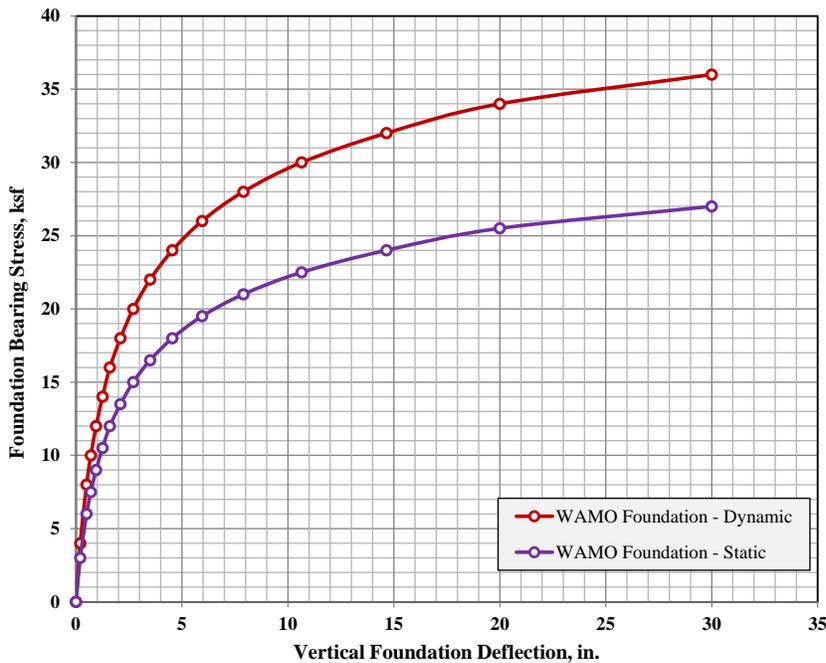
Figure 15. AMEC provided soil load-displacement relationship

The Monument was modeled with the as-built geometry of its stone and concrete foundation bearing on compressible soil. The properties of the compressible soil were provided by AMEC based on various historic and contemporary logs of soil borings taken from nearby on the National Mall. AMEC defined the load-displacement response of the soil for both static (gravity loading only) and dynamic (transient loading due to seismic response) from zero to 30 inches of vertical displacement (Figure 15). The vertical component of soil response was judged to be the only mode of soil response with potentially significant influence on the global behavior of the Monument.

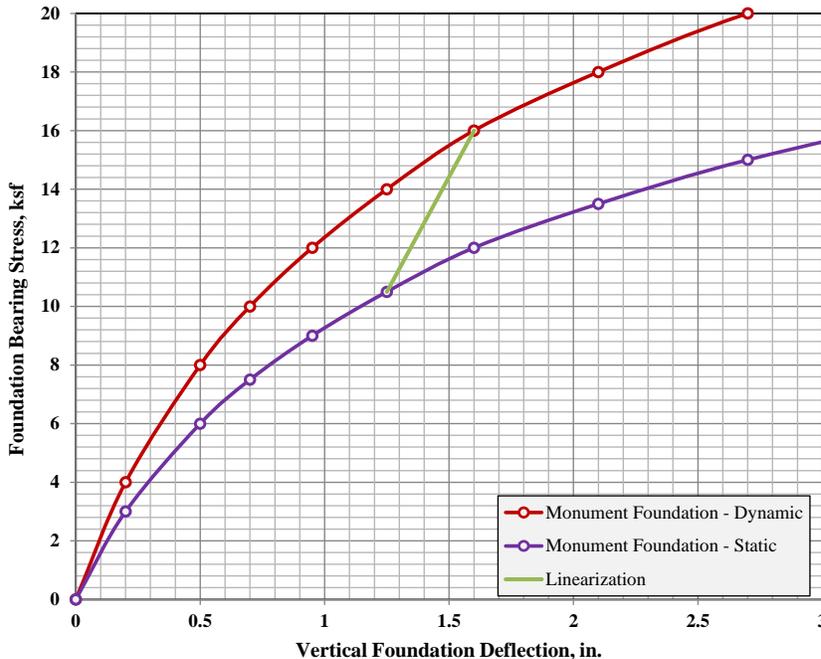
Figure 16. Linearization of static-to-dynamic soil behavior

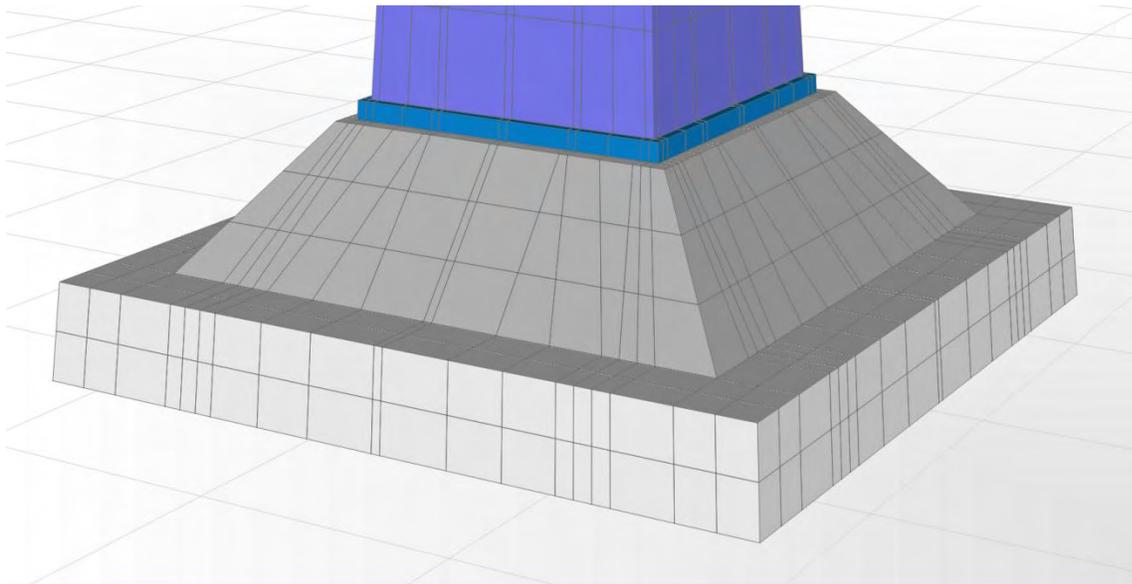
Figure 17. The Monument foundation in SAP2000

The influence of the flexibility of the foundation on the overall behavior of the Monument is minor compared to the flexibility of the soil. The foundation was modeled as having two different elastic moduli, the blue gneiss stone and mortar composite having an effective elastic modulus of 1200 ksi and the concrete portion of the foundation having an elastic modulus of 2500 ksi. The two vintages of foundation construction were meshed using three-dimensional solid elements meshed together as a single linear-elastic deformable object.

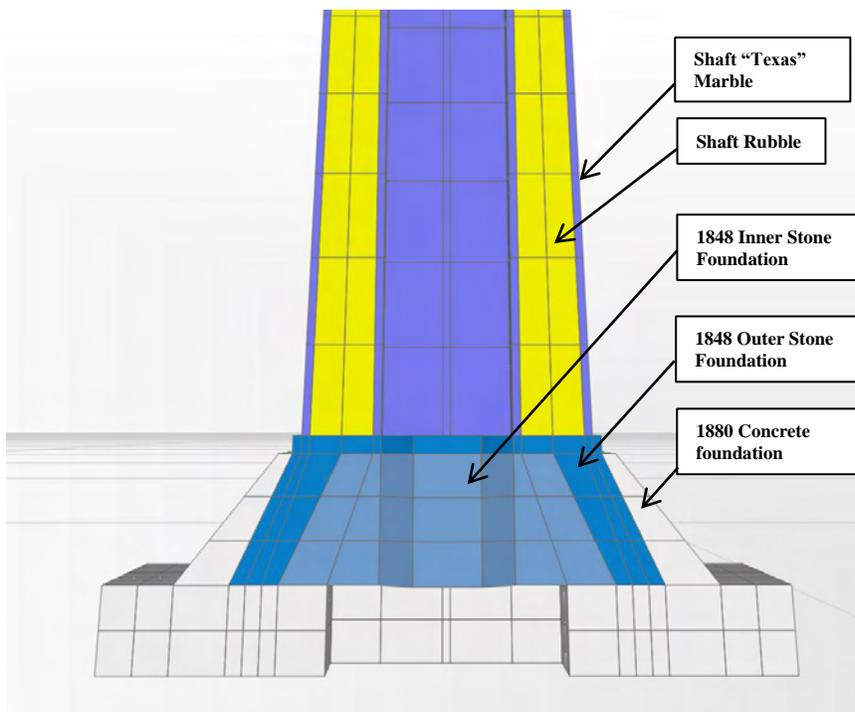
Figure 18. Cross-section of the Monument foundation and lower portion of shaft in SAP2000

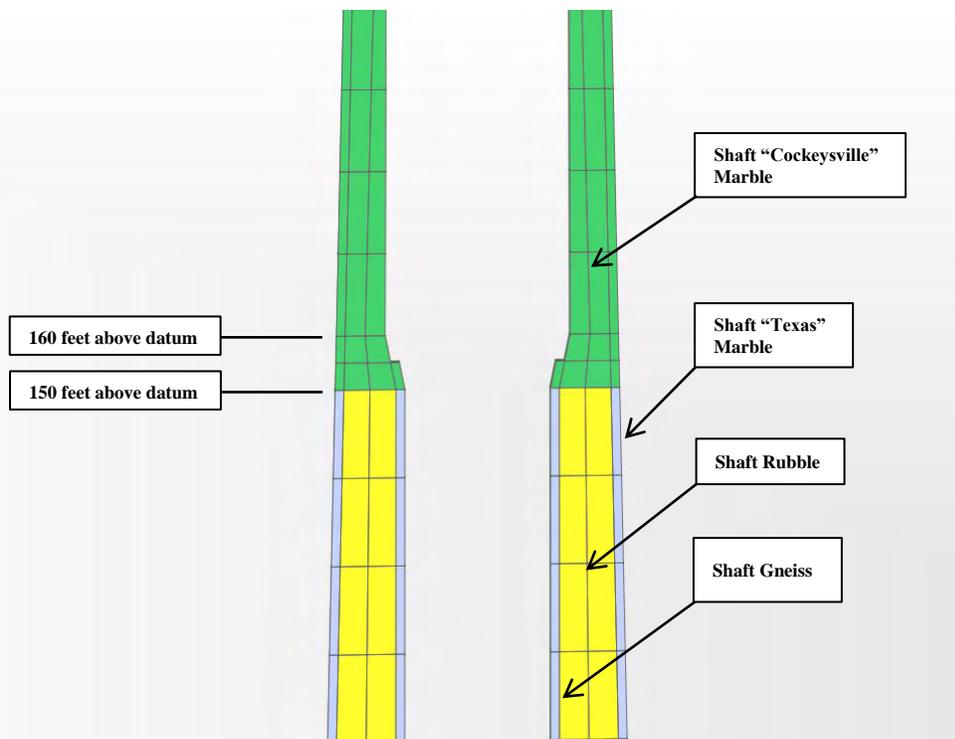
Figure 19. Cross-section of the Monument at 150 foot transition level

From ground level to an elevation of 150 feet the masonry shaft of the Monument consists of three well-integrated wythes of different construction: an outer wythe of high-quality stacked ashlar “Texas” white marble, an inner wythe of gneiss, and an inner cavity filled with stone rubble masonry (Figures 18 and 19). The masonry in this portion of the shaft was constructed with natural cement mortar. Although the stone in the various wythes has different properties, the properties of the natural cement mortar dominate the behavior of the masonry in general and the interior rubble wythe --- which contains a far greater amount of mortar than the exterior wythes --- dominates the behavior of the wall construction overall. Recognizing the highly variable nature of masonry, even within an individual wythe, and after studying the effects of modeling each wythe with a different material property on the model behavior, as a base value, an elastic modulus of 1000 ksi was assumed for all materials. It is our judgment, based on our prior experience in testing masonry structures, with additional insight provided by other industry standards and codes, including ACI 530 (American Concrete Institute 2011), that this value is a reasonable average property for the masonry stiffness. Each of the different masonry layers was modeled using a continuous mesh of three-dimensional solid elements, which was intended to capture the high degree of articulation and keying that exists between the two exterior stone layers and the rubble masonry.

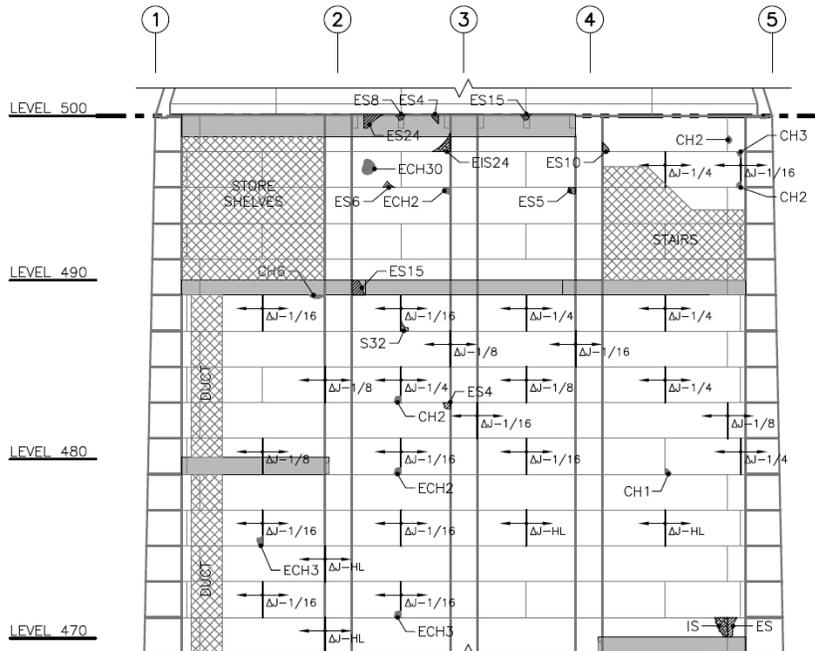
Figure 22. Typical interior elevation of WJE earthquake damage survey from 470 feet to 500 feet

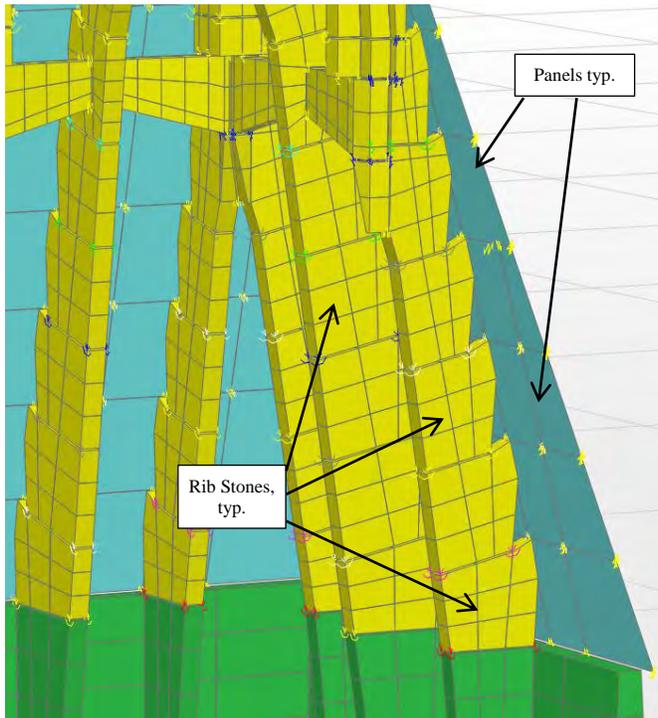
Figure 23. Isometric cross-section of lower pyramidion

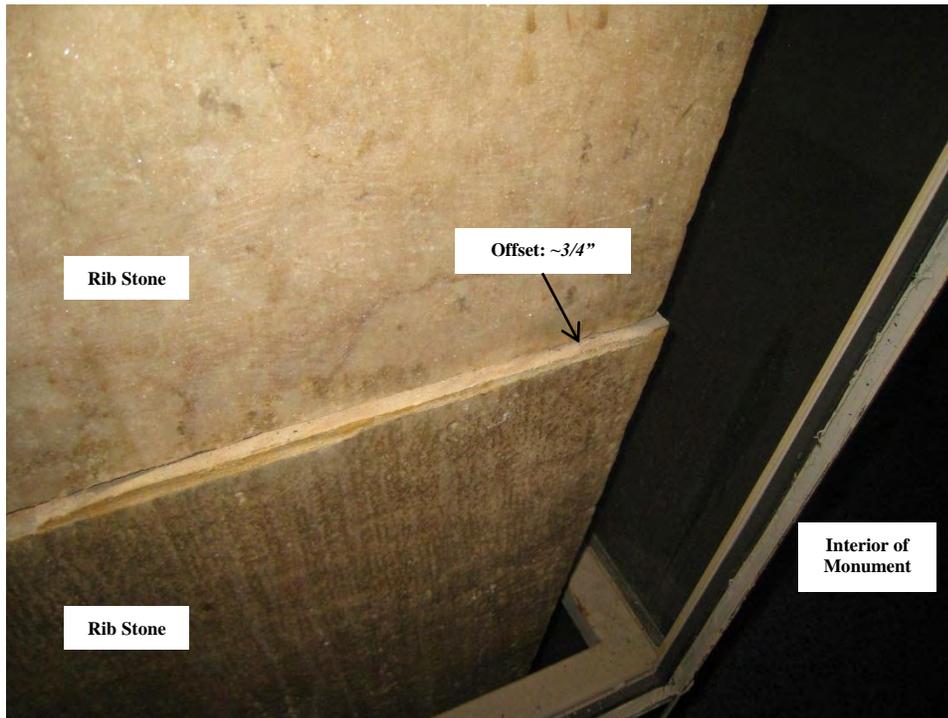
Figure 24. Horizontal offset between rib stones documented at the observation level

During the post-earthquake damage survey, we observed a number of locations where relatively small horizontal offsets, up to a maximum of 3/4-inch, occurred between adjacent rib stones (Figure 24). These offsets appear to be the manifestation of sliding, a dominant mode of response within the pyramidion. This type of behavior poses an interesting problem from a structural engineering standpoint in that it is a type of non-linear behavior that is not easily captured by traditional computer modeling techniques. The slipping and resulting residual relative displacement, for the purposes of this model, was idealized as behaving in accordance with the Coulomb model for frictional response. Functionally, the model simulates an interaction between axial force across the bed joints and the frictional resistance provided by the bed joint. Specifically, friction-pendulum isolators, which obey the load-displacement curve shown in Figure 25, were used to model the interface between rib stones. The properties of the friction-pendulum isolators are such that, for a given axial load and coefficient of friction, there is a critical value of lateral load at which additional deformation can occur without any additional lateral load. This is the point at which “slip” occurs. When the lateral load is removed, the elastic deformation is recovered, but a residual plastic deformation can remain.

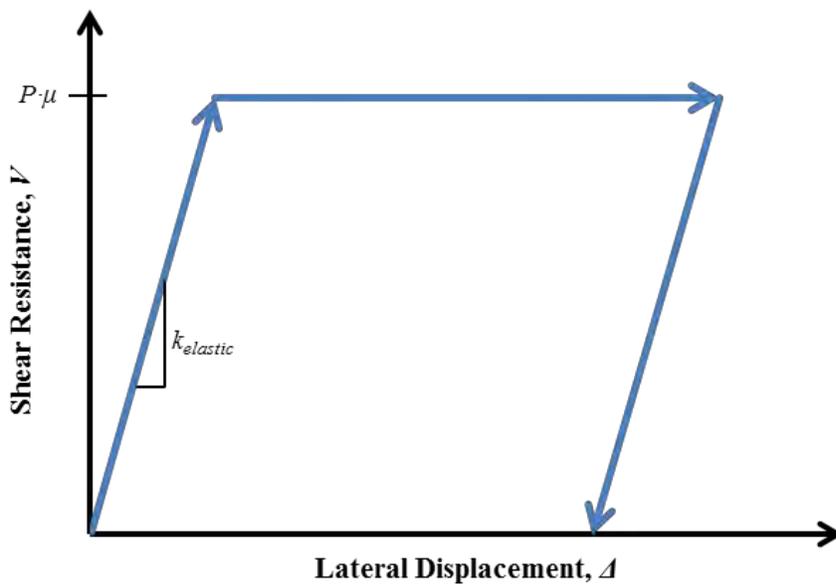
Figure 25. Diagrammatic representation of response of friction-pendulum damper to axial and lateral loads; P = axial load, μ = coefficient of friction, V = lateral load, $k_{elastic}$ = elastic stiffness, and Δ = lateral displacement of the friction-pendulum damper

In order to facilitate modeling of this sliding behavior, one-inch gaps were provided between the discretely modeled rib stones to allow for the inclusion of the friction-pendulum isolator links (Figure 26). A total of four isolators were placed in the gaps between all rib stones, which permitted the rib stones to translate in any direction, uplift at any corner or side, and rotate torsionally. They were generally placed in (or near) the corners of the stones. To facilitate the connection between the three-dimensional solids and the link element, rigid body constraints were applied to each node on all faces of rib stones in contact with other rib stones (Figure 27). The result of applying the body constraints was that the mated faces of rib stones in contact with one another were forced to stay planar (though the two faces were not constrained to stay parallel or square to each other). Since the modeled stiffness of the rib stones, at 5,700 ksi, is already much larger than that of the bed joint isolators, this is not an unreasonable assumption.

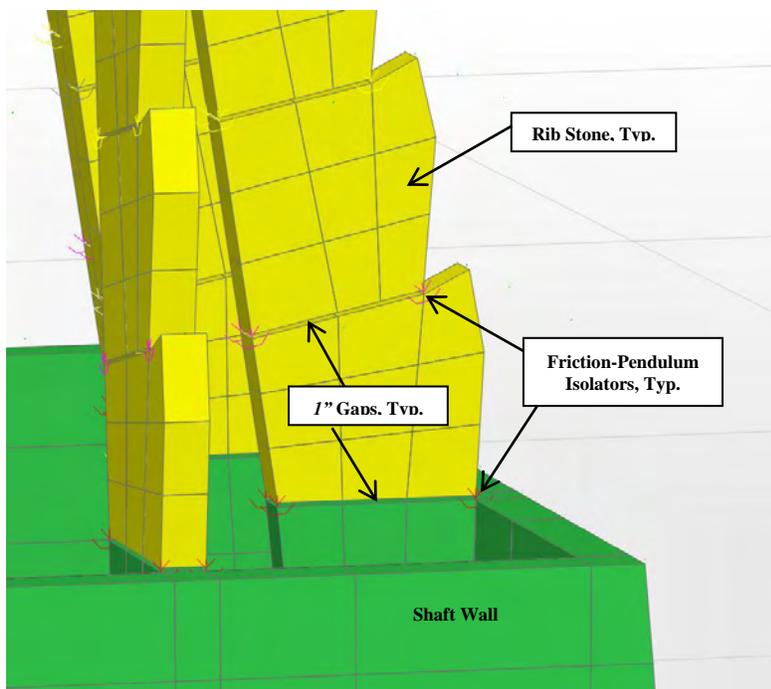
Figure 26. Cut-away view of model at 500-foot level showing as-modeled connections from rib stone to rib stone, and from rib stone to shaft wall. Panels not shown for clarity

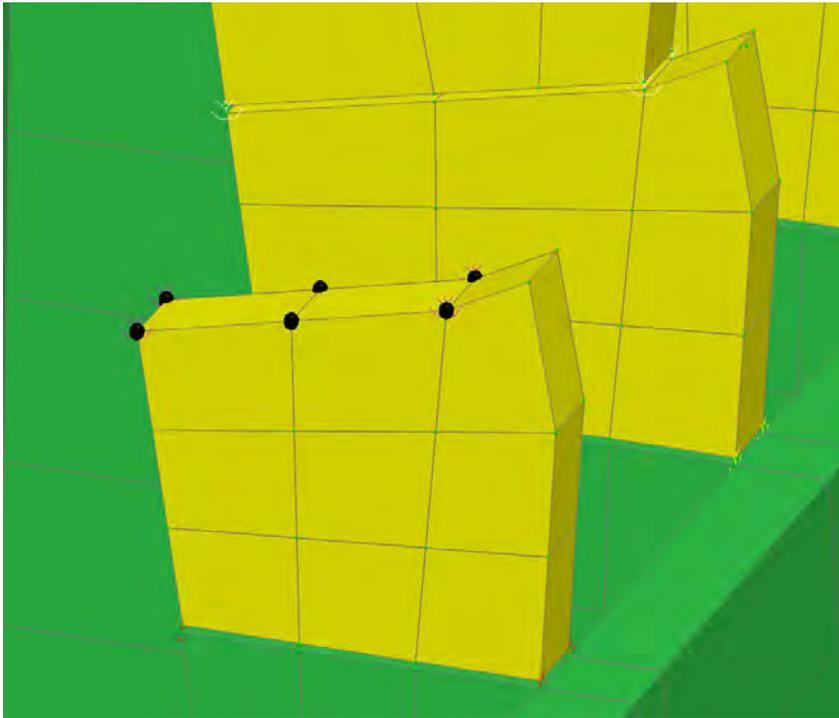
Figure 27. Rib stone showing nodes with a rigid body constraint applied (black dots); rib stone above and panels not shown for clarity

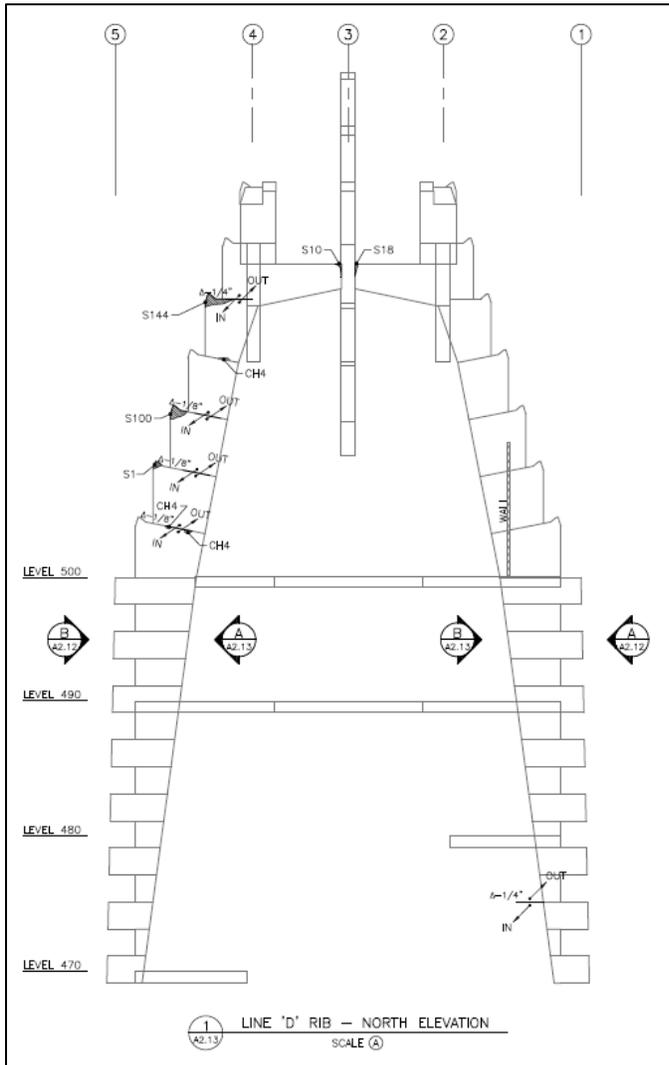
Figure 28. Typical elevation for WJE rib stone damage survey

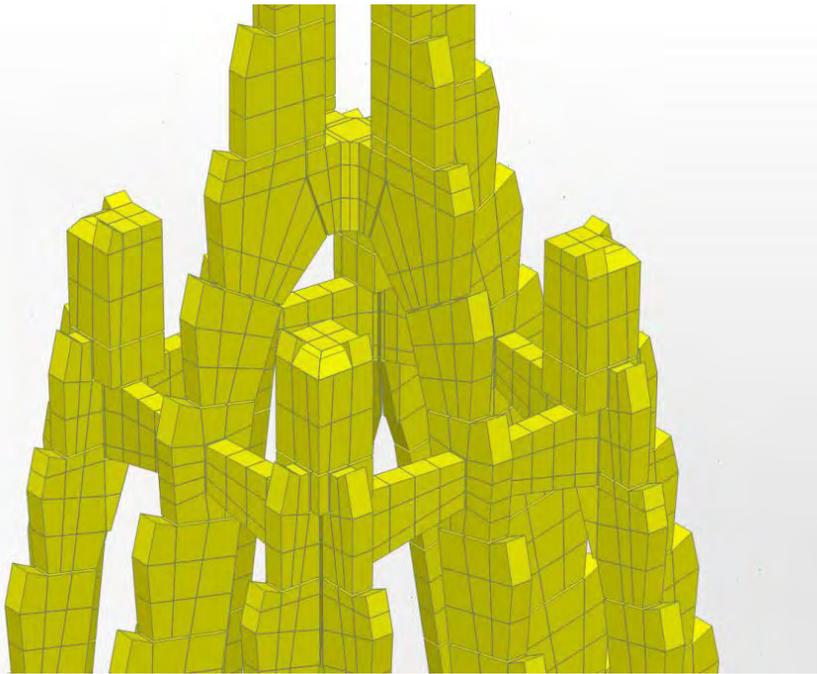
Figure 29. Upper portion of pyramidion; pyramidion panels and link elements not shown

1. Tie beam to center rib - gap elements
2. Cruciform stone to center rib connection - friction-pendulum isolators
3. Side rib to tie beam - linear-elastic springs
4. Corner stone to side ribs - friction-pendulum isolators

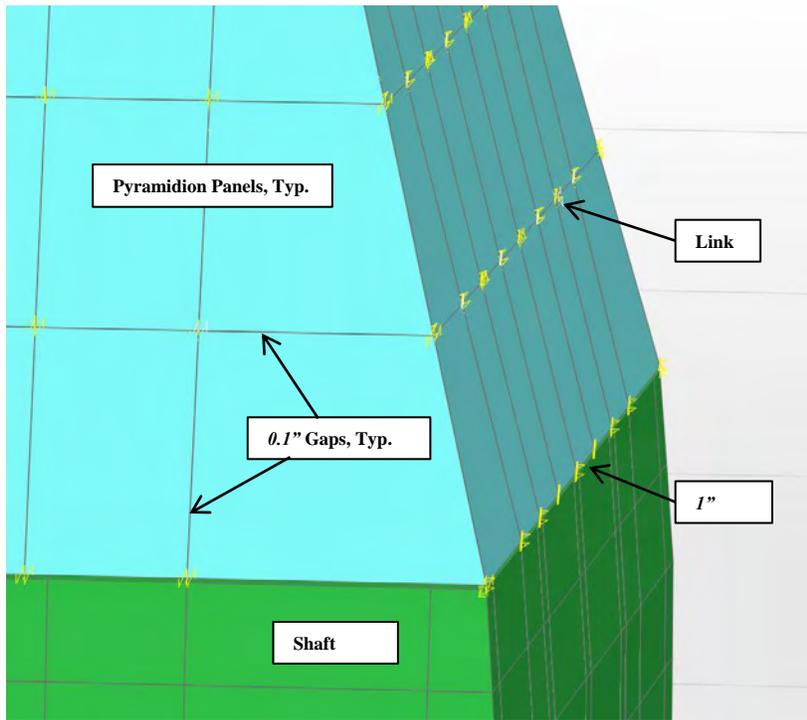
Figure 30. Pyramidion panels above shaft
