WASHINGTON MONUMENT Seismic Assessment

National Mall, Washington DC

Final Report
August 29, 2012

Prepared for:
National Park Service, Denver Service Center

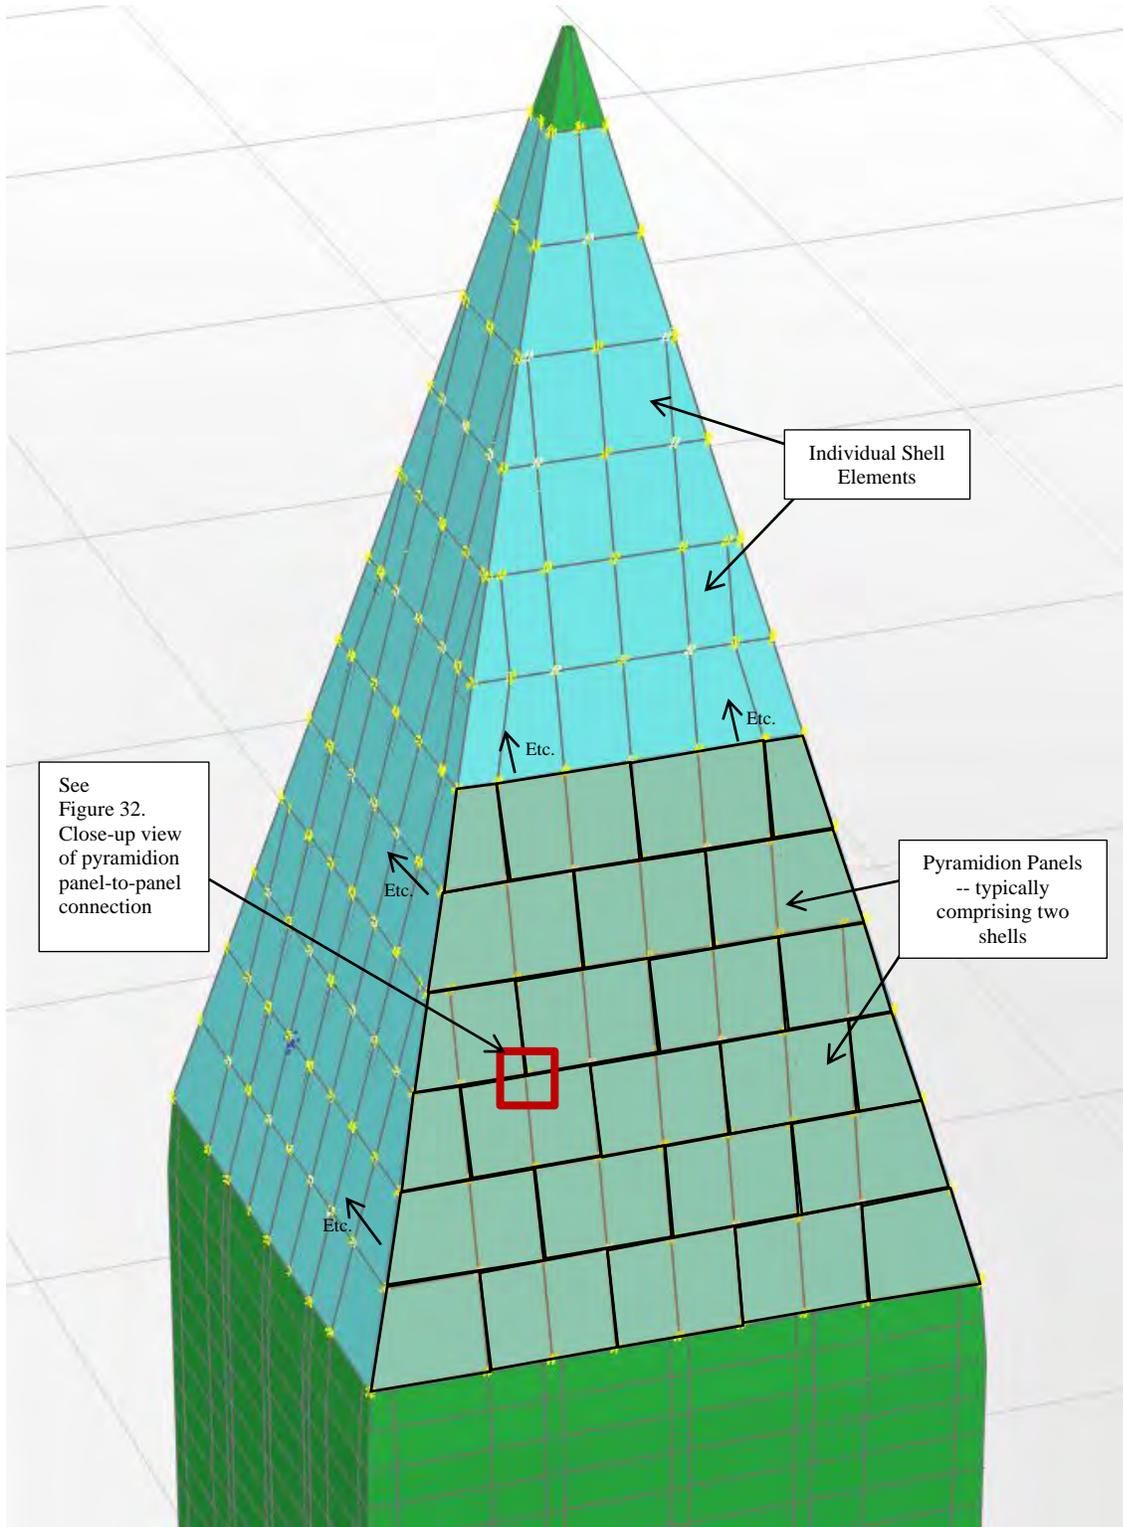
Figure 31. View of pyramidion showing panels in running bond superimposed on mesh

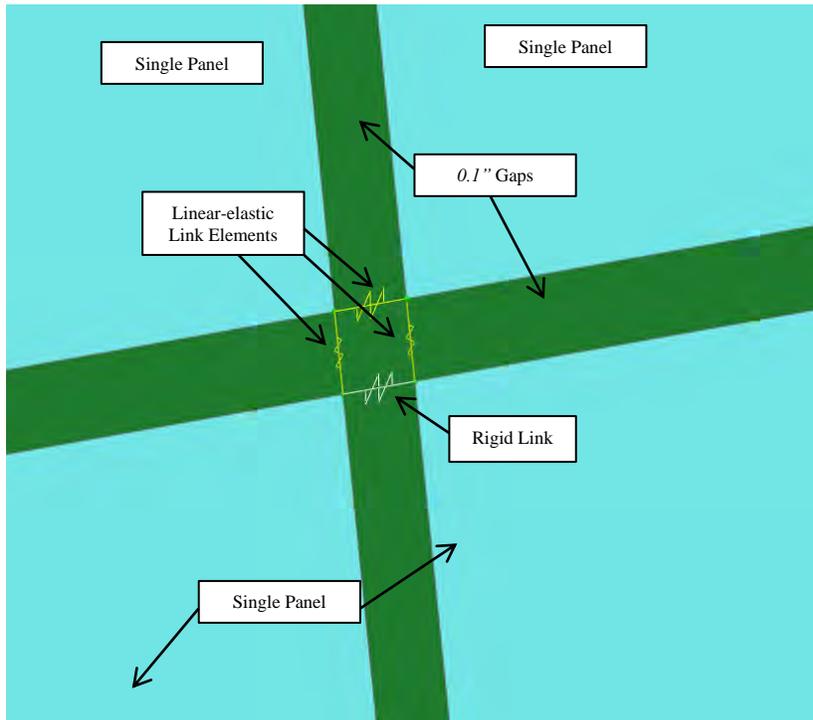
Figure 32. Close-up view of pyramidion panel-to-panel connection

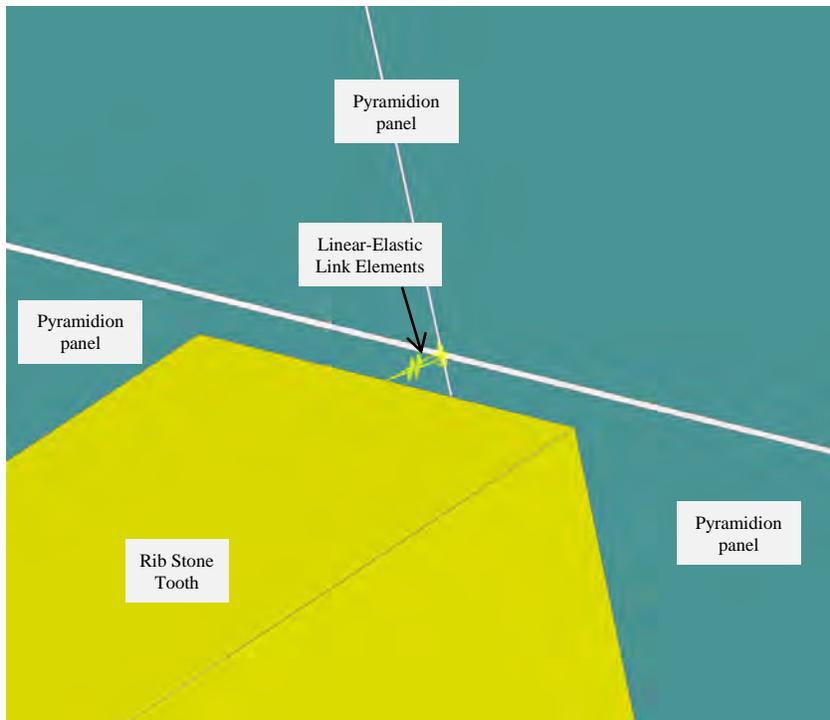
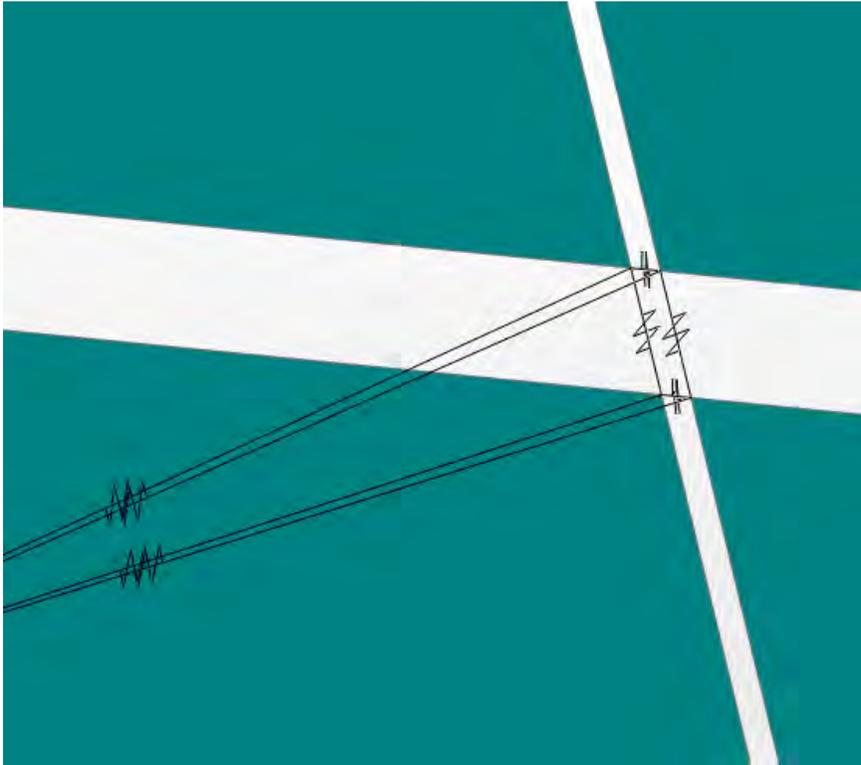
Figure 33. Rib-to-panel connection

Figure 34. Rib-to-panel connection

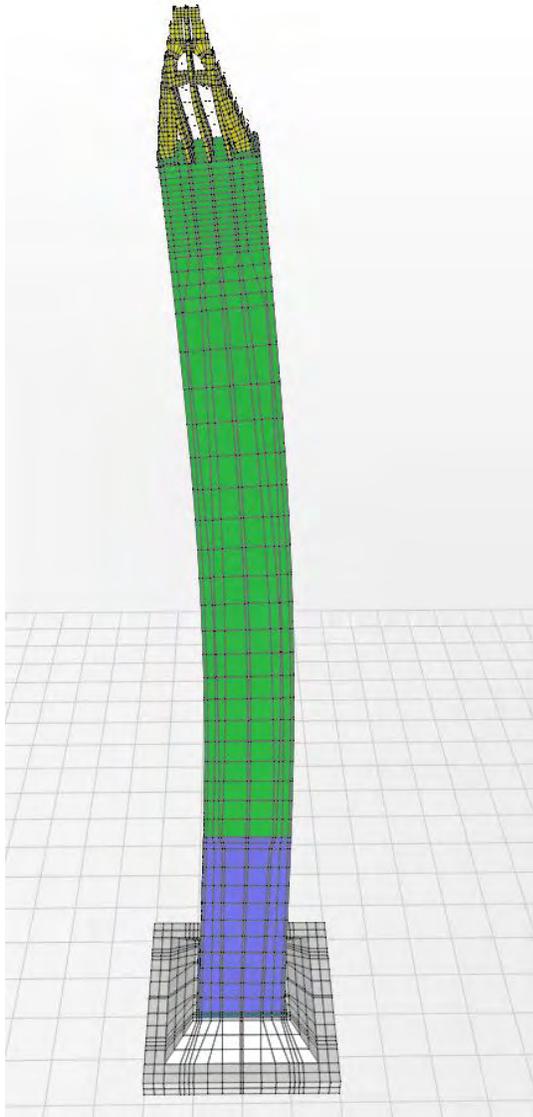
Figure 35. Second mode behavior of Monument from modal analysis, $T=0.89$ seconds (displaced shape greatly exaggerated for clarity)

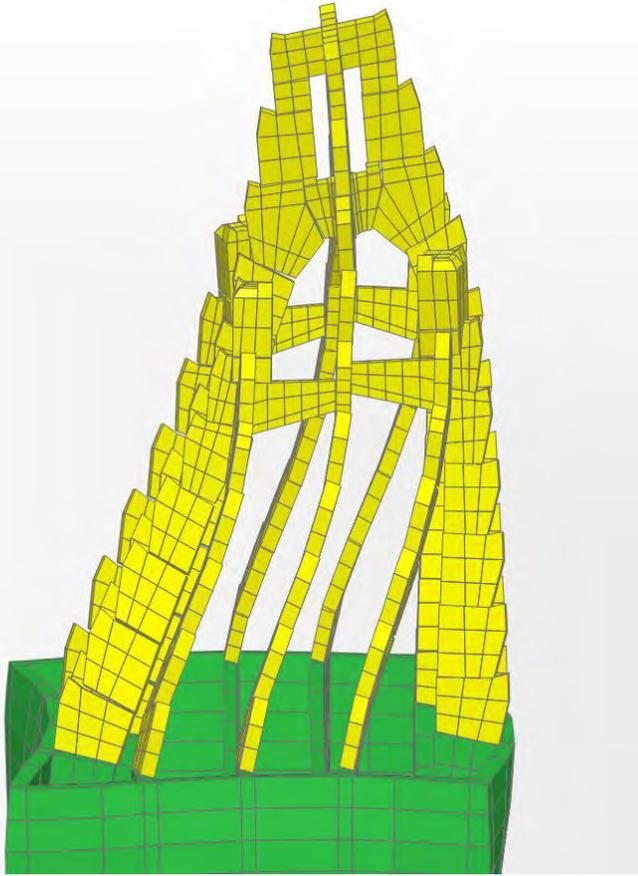
Figure 36. Fourth mode behavior, pyramidion “whipped” towards corner of shaft, $T=0.32$ seconds (displaced shape greatly exaggerated for clarity)

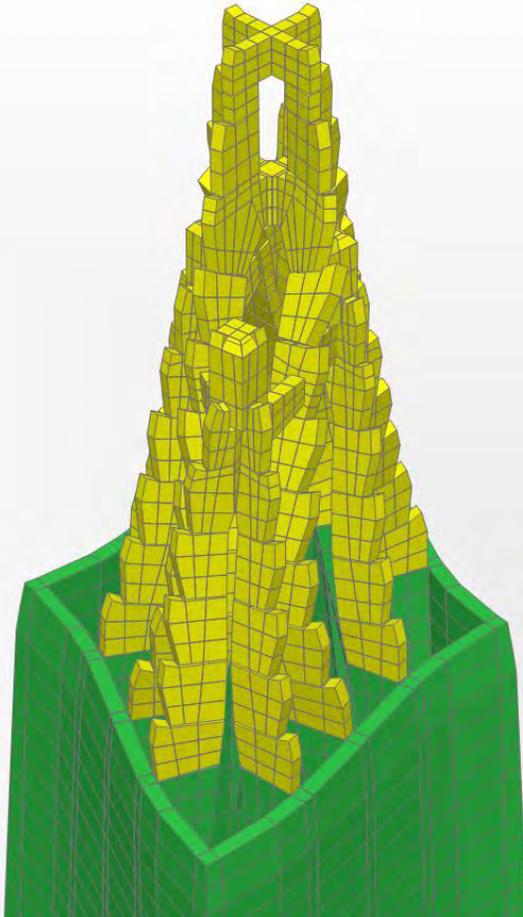
Figure 37. "Pinching" behavior at top of shaft walls in mode 9, $T=0.32$ seconds (displaced shape greatly exaggerated for clarity)

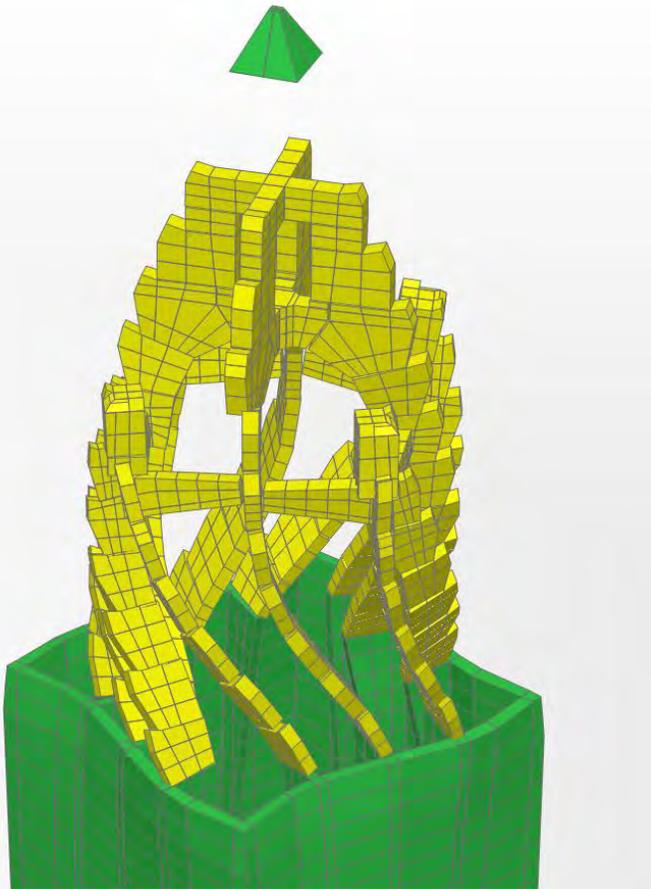
Figure 38. Torsional mode at pyramidion in mode 12, $T=0.27$ seconds (displaced shape greatly exaggerated for clarity)

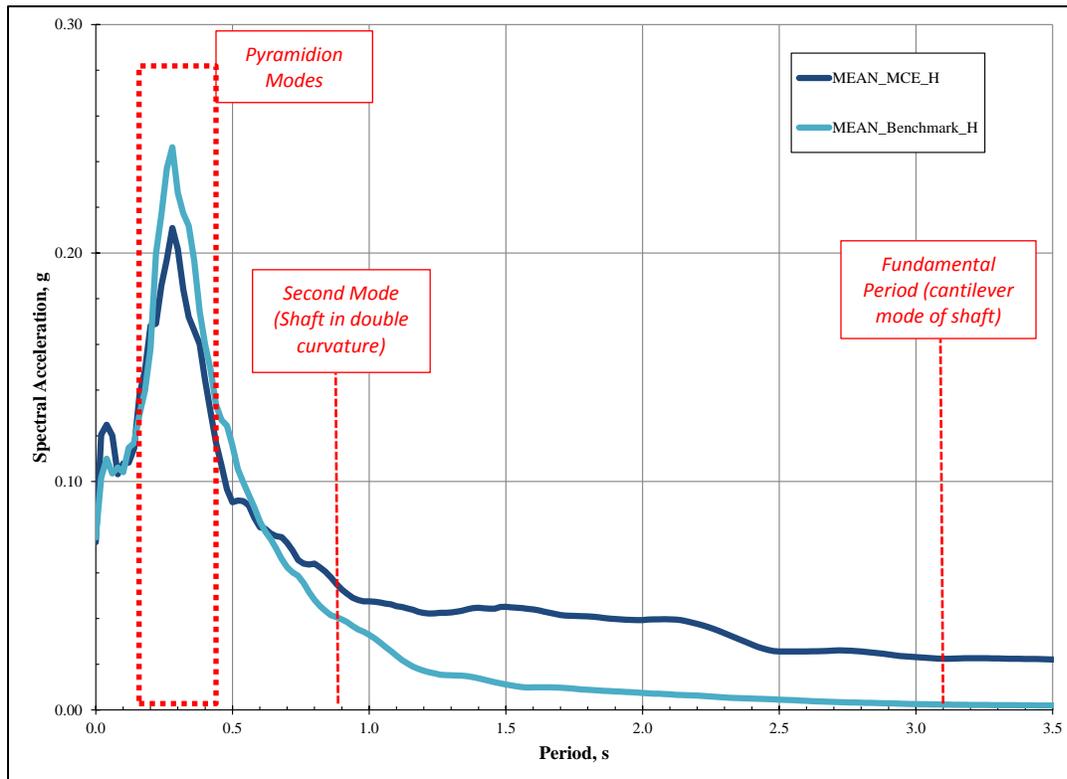
Figure 39. S_a versus T plot of Benchmark versus MCE

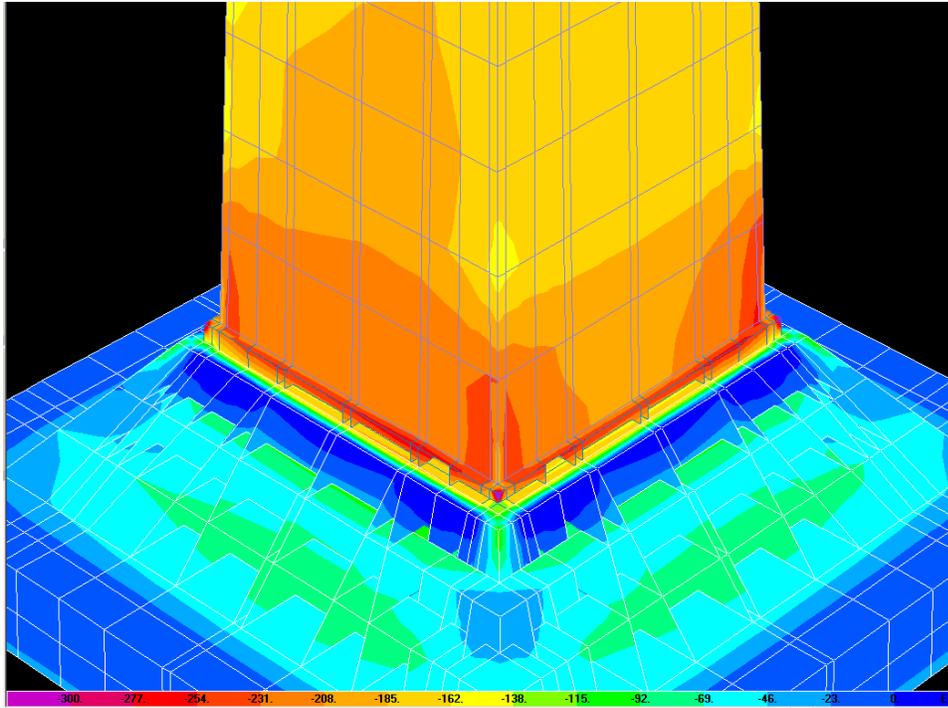
Figure 40. Envelope compressive stresses in vertical direction of the shaft due to MCE motion ChiChi2

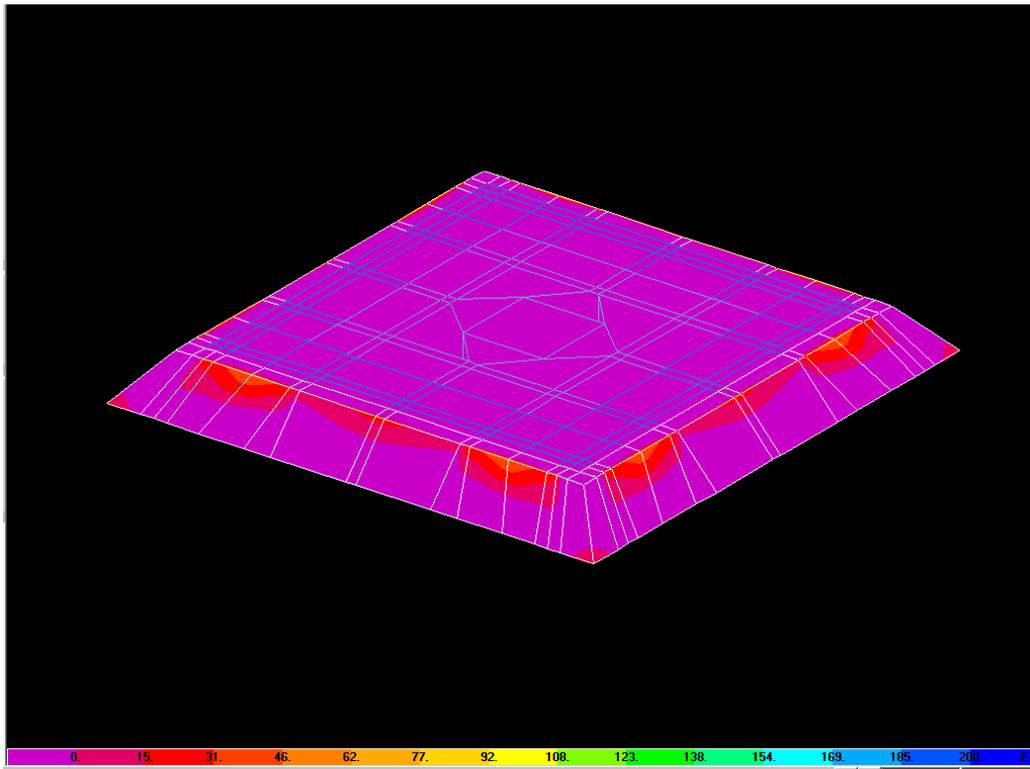
Figure 41. Envelope tensile stresses at cross section of solids at the top of foundation due to Benchmark motion Whittier2

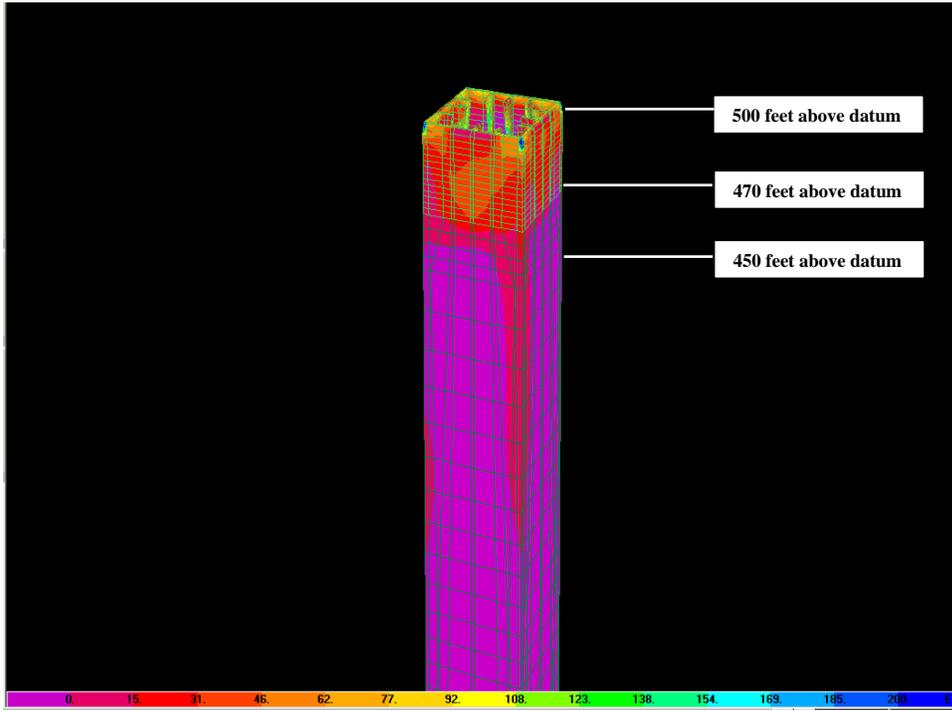
Figure 42. Envelope tensile stresses in vertical direction of the shaft due to Mineral benchmark motion Whittier 2

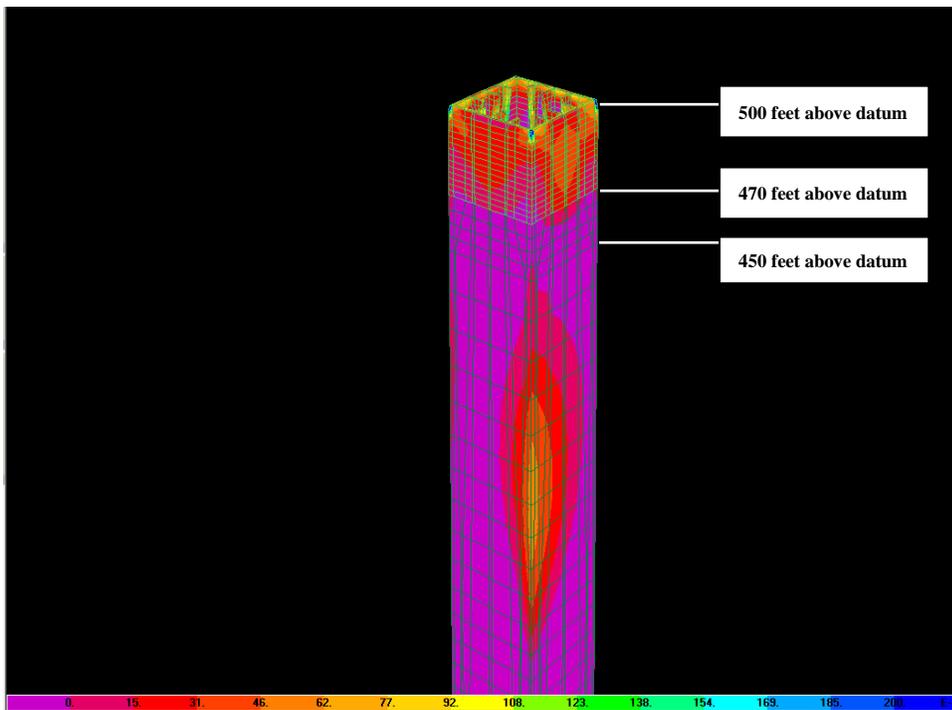
Figure 43. Envelope tensile stresses in vertical direction of the shaft due to MCE motion ChiChi2

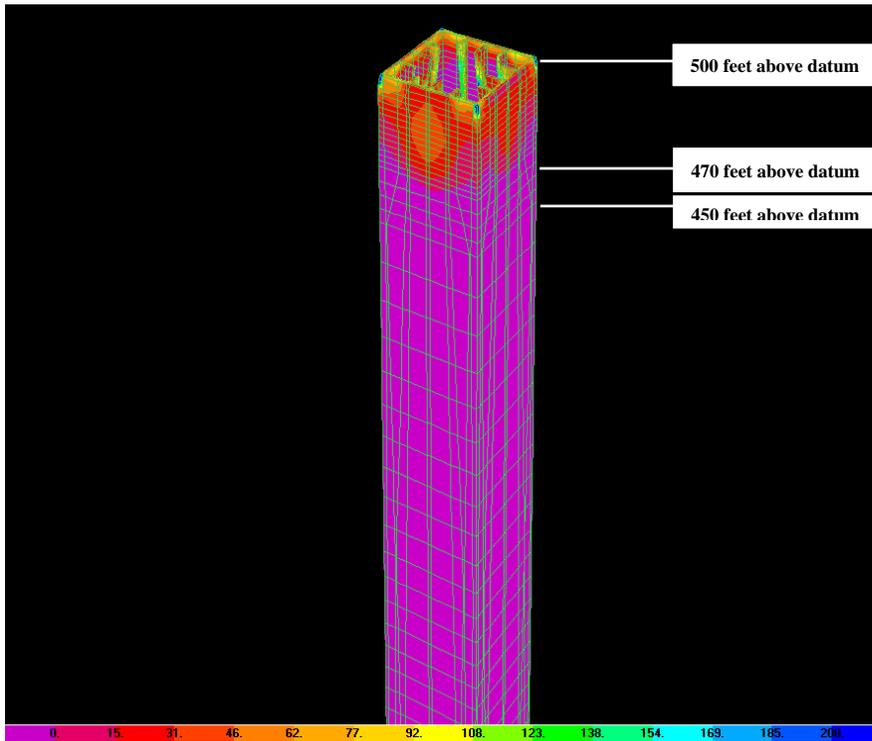
Figure 44. Envelope tensile stresses in vertical direction of the shaft due to MCE motion ChiChi2 for softened shaft stiffness

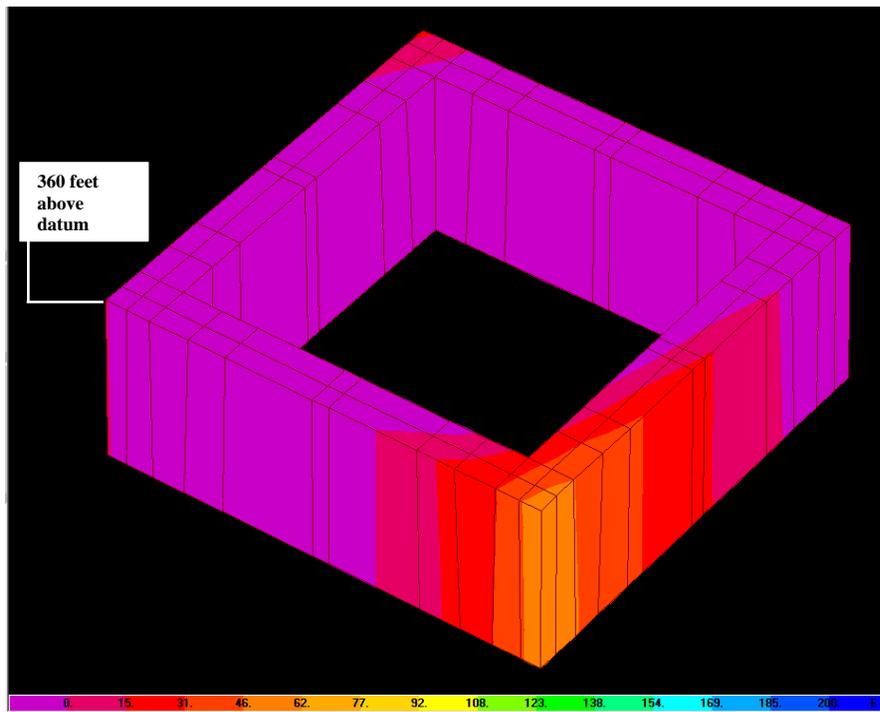
Figure 45. Envelope tensile stresses in vertical direction of a cross section of the shaft around 360 feet above the datum due to MCE motion ChiChi2

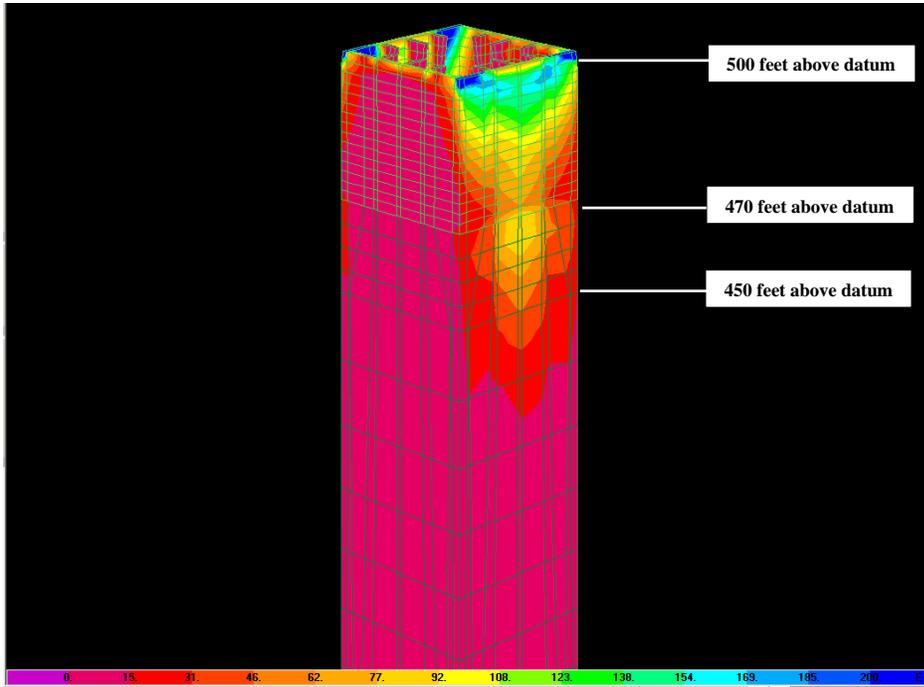
Figure 46. Envelope horizontal tension stresses in the shaft due to the Benchmark motion Whittier2

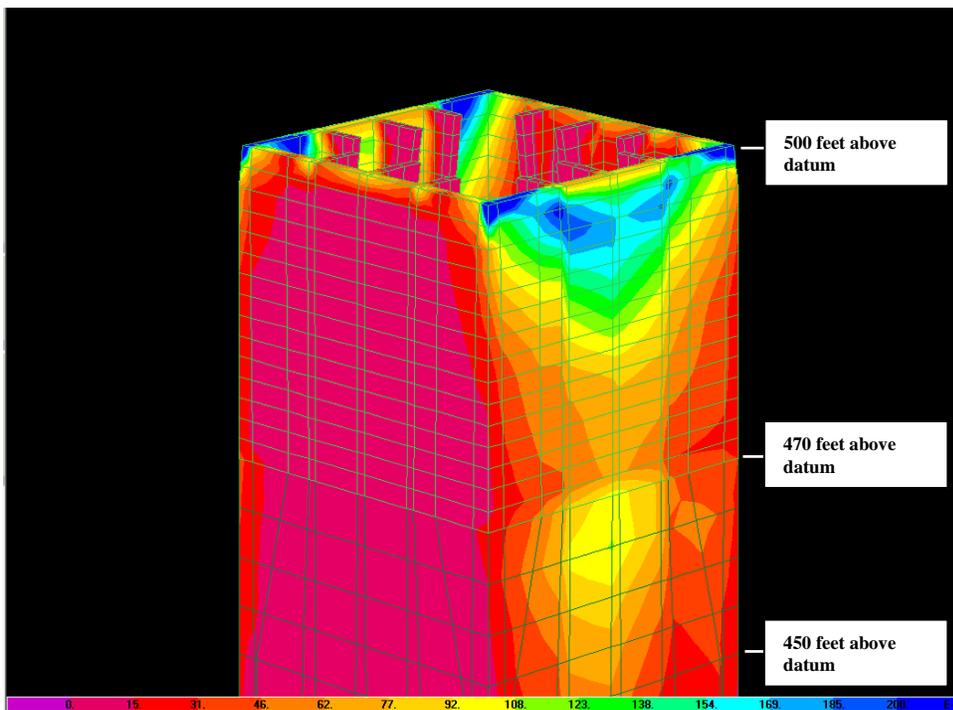
Figure 47. Envelope horizontal tension stresses in the shaft due to the MCE motion ChiChi2

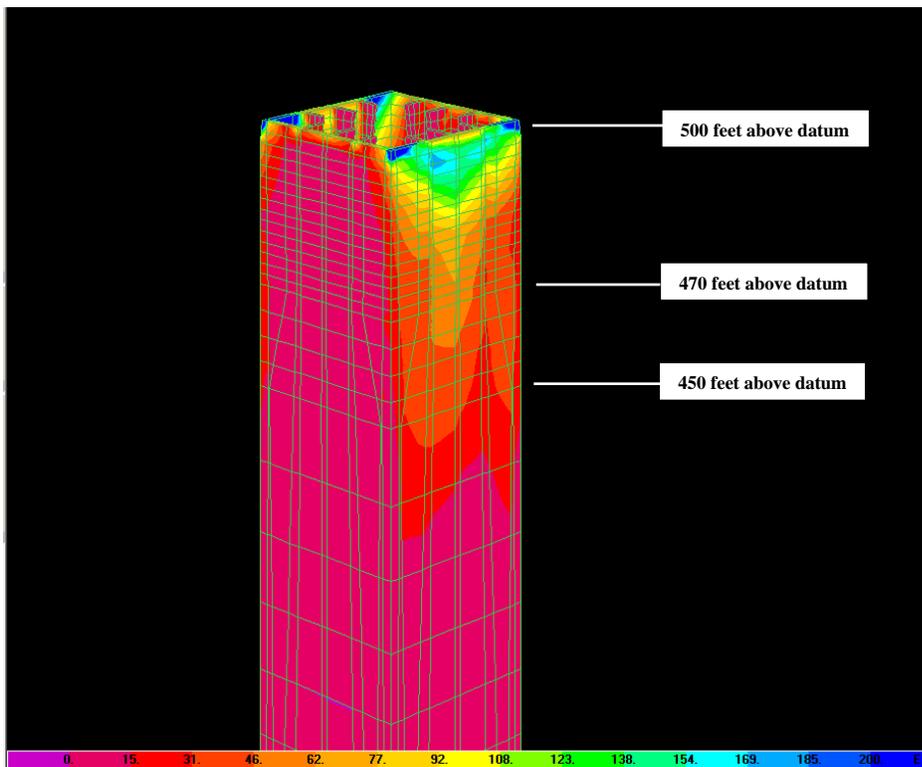
Figure 48. Envelope horizontal tension stresses in the shaft due to the MCE motion ChiChi2 for softened shaft stiffness

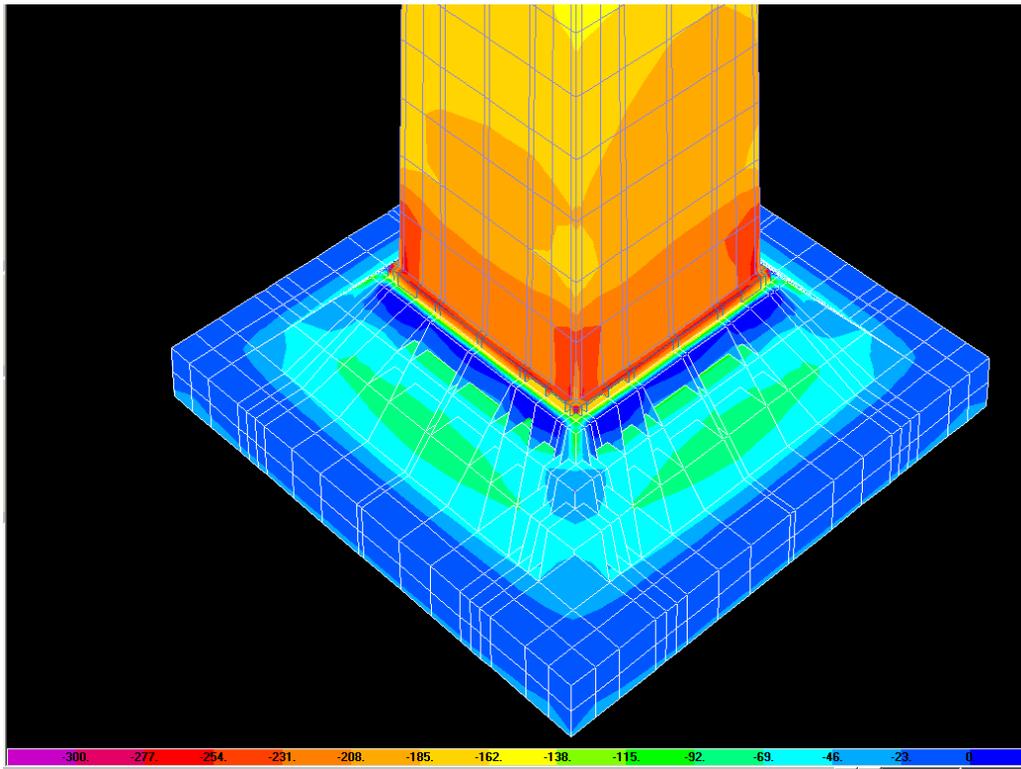
Figure 49. Envelope vertically-oriented compressive stresses at the base of the Monument due to the MCE motion ChiChi2

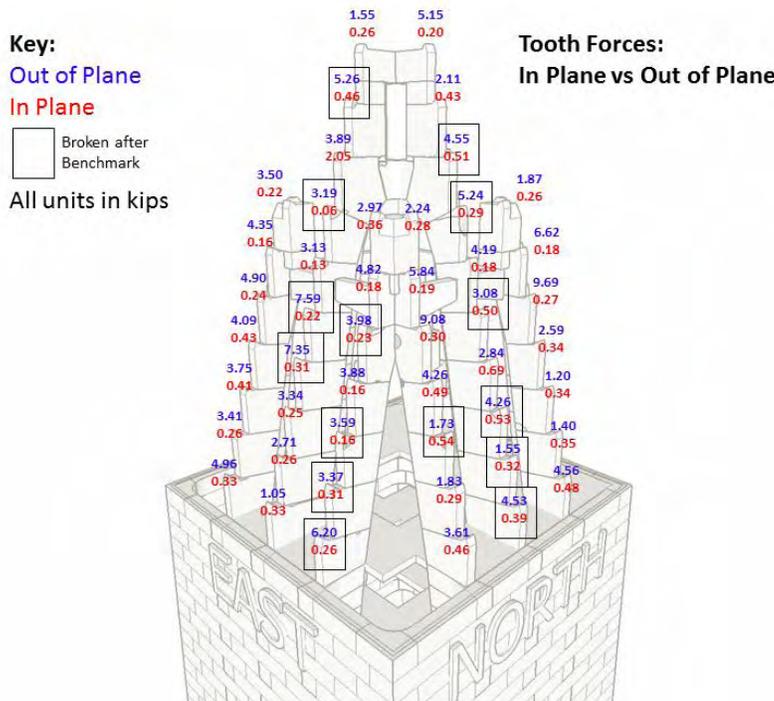
Figure 50. Typical in-plane versus out-of-plane tooth forces

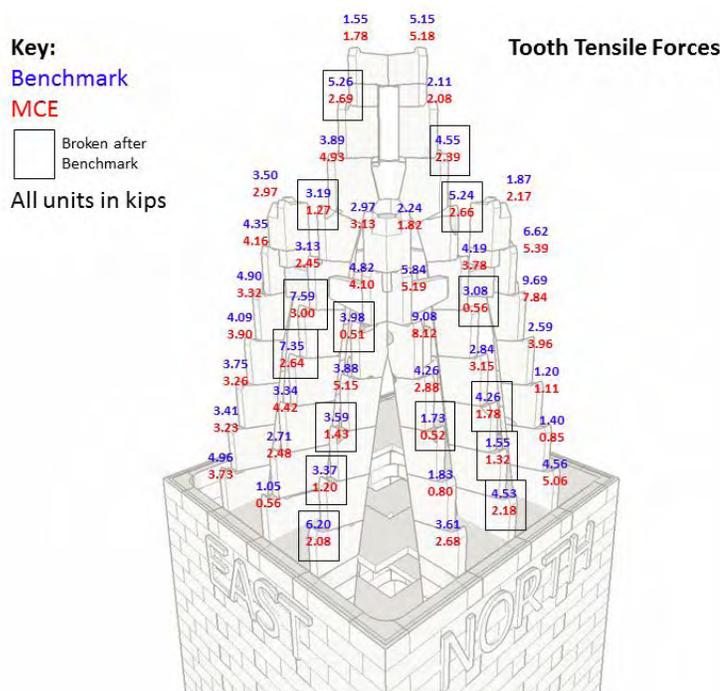
Figure 51. Typical out-of-plane tooth forces in the pyramidion East and North facing ribs

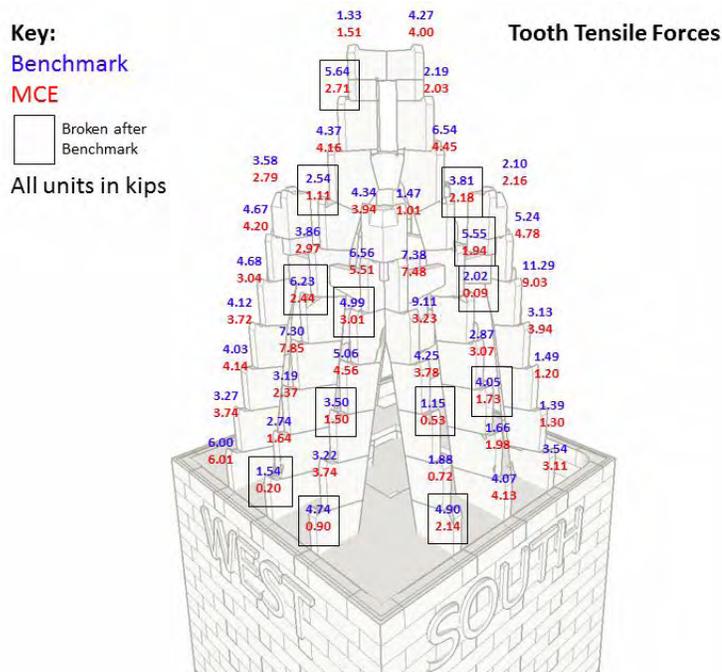
Figure 52. Typical out-of-plane tooth forces in the pyramidion West and South facing ribs

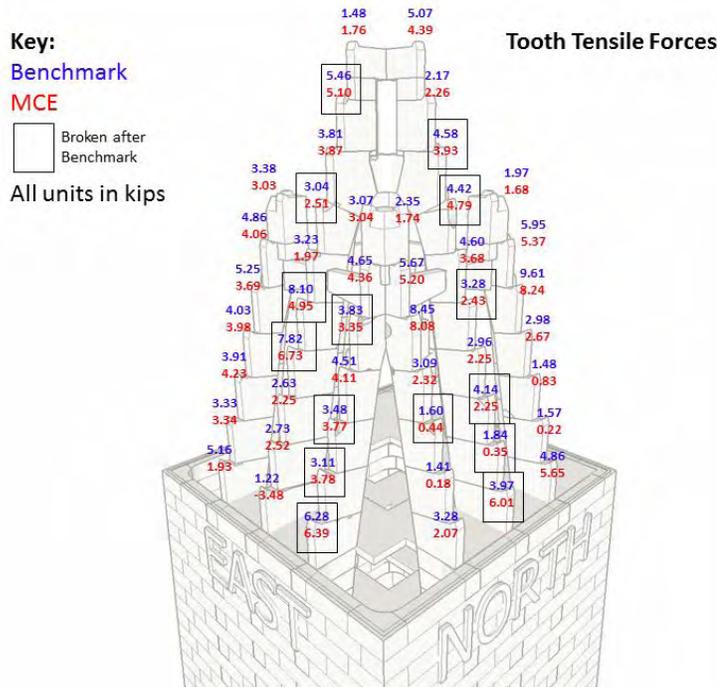
Figure 53. Typical out-of-plane tooth forces in the pyramidion for Benchmark v. MCE load-sequenced analysis (“softened” shaft)

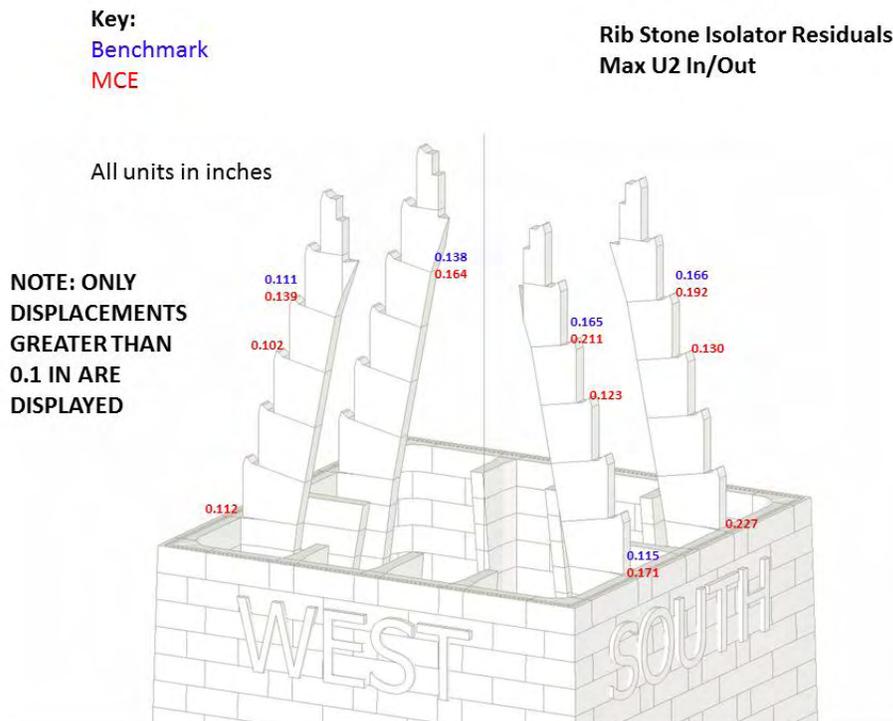
Figure 54. Typical side-rib isolator in/out residuals

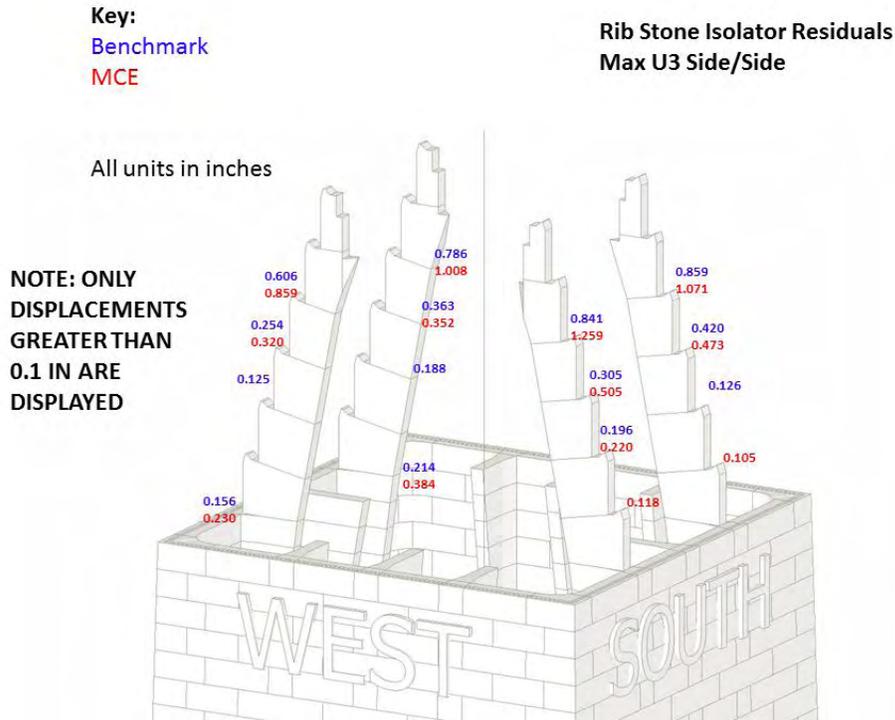
Figure 55. Typical side-rib isolator side/side residuals

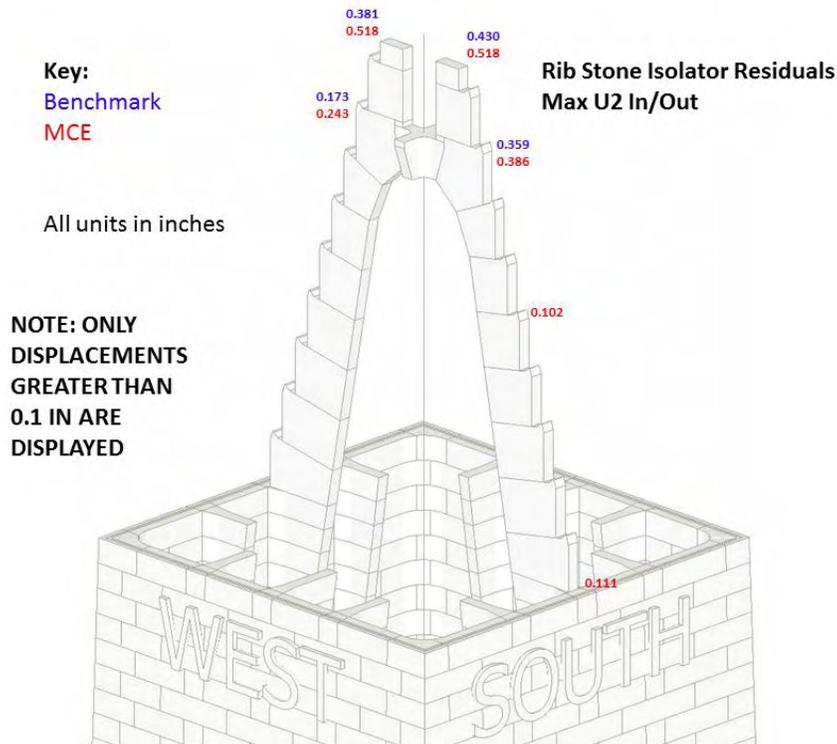
Figure 56. Typical center-rib isolator in/out residuals

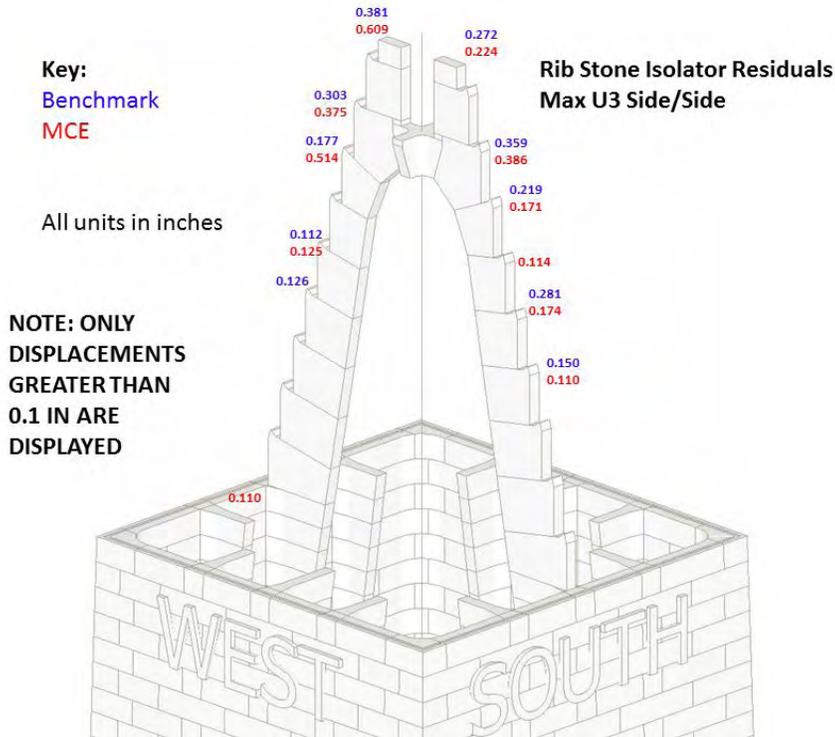
Figure 57. Typical center-rib isolator side/side residuals

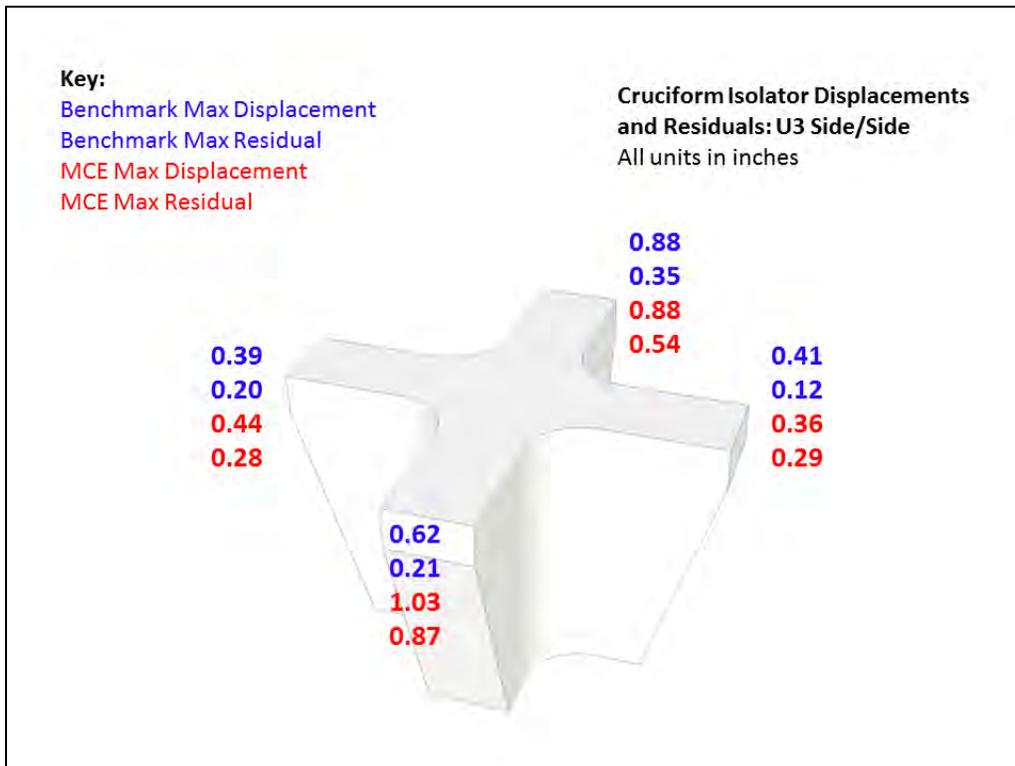
Figure 59. Typical center-rib isolator side/side residuals

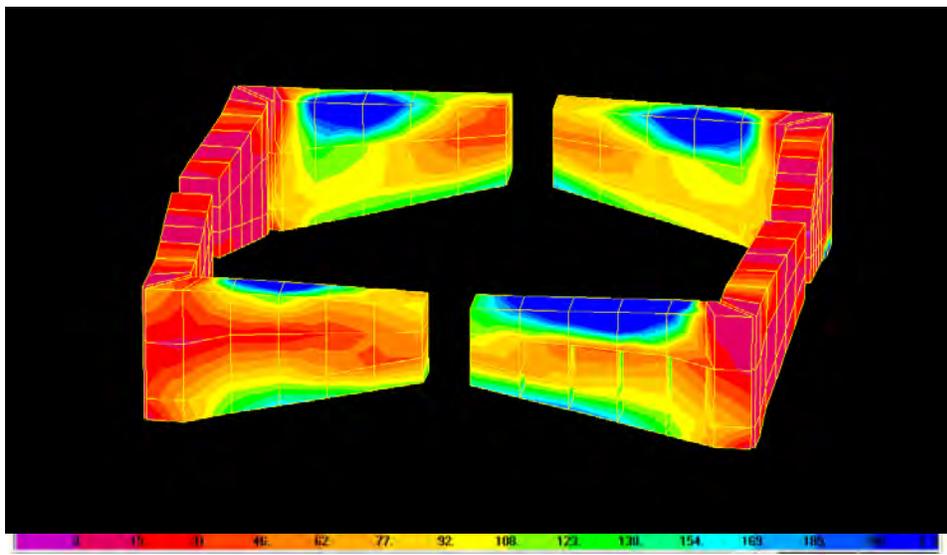
Figure 60. Envelope of horizontally-oriented tensile stresses in tie-beam for Whittier2 (Mineral) ground motion

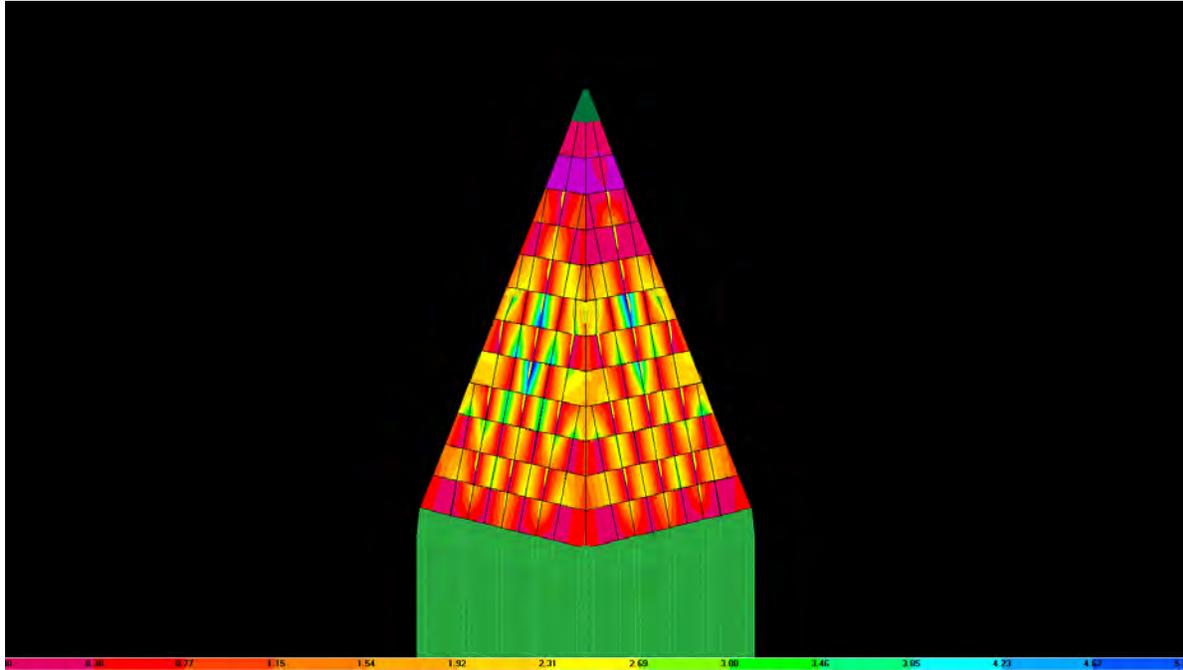
Figure 61. Maximum envelope moments about the horizontal axis for Whittier2 Mineral ground motion

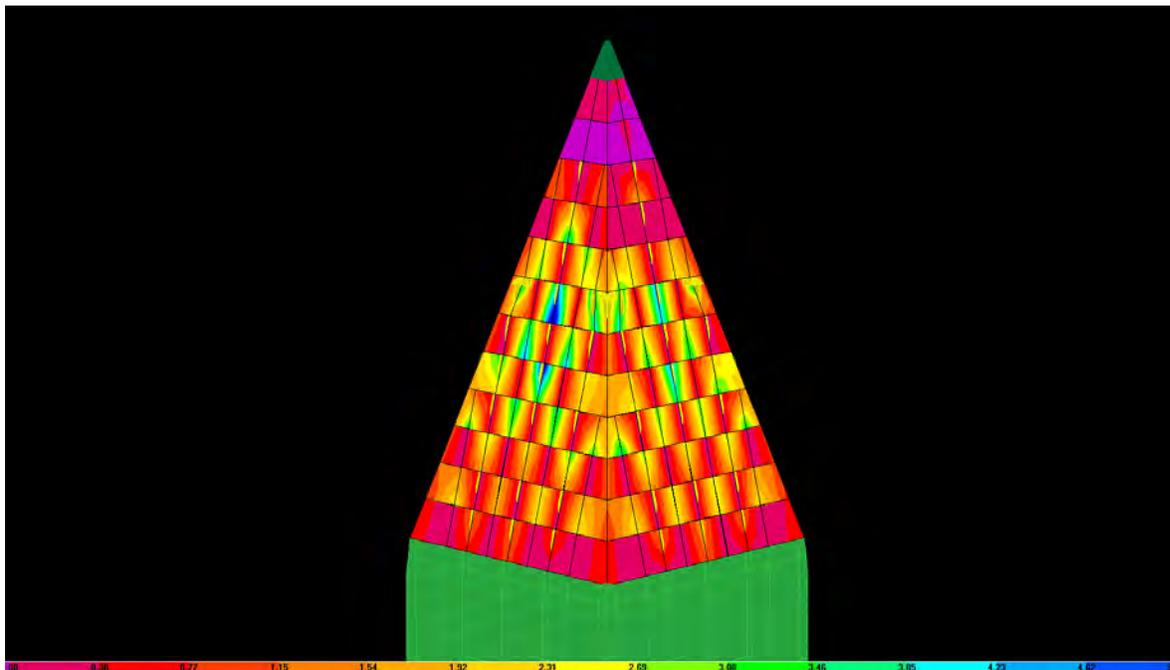
Figure 62. Maximum envelope moments about the horizontal axis for ChiChi2 MCE ground motion

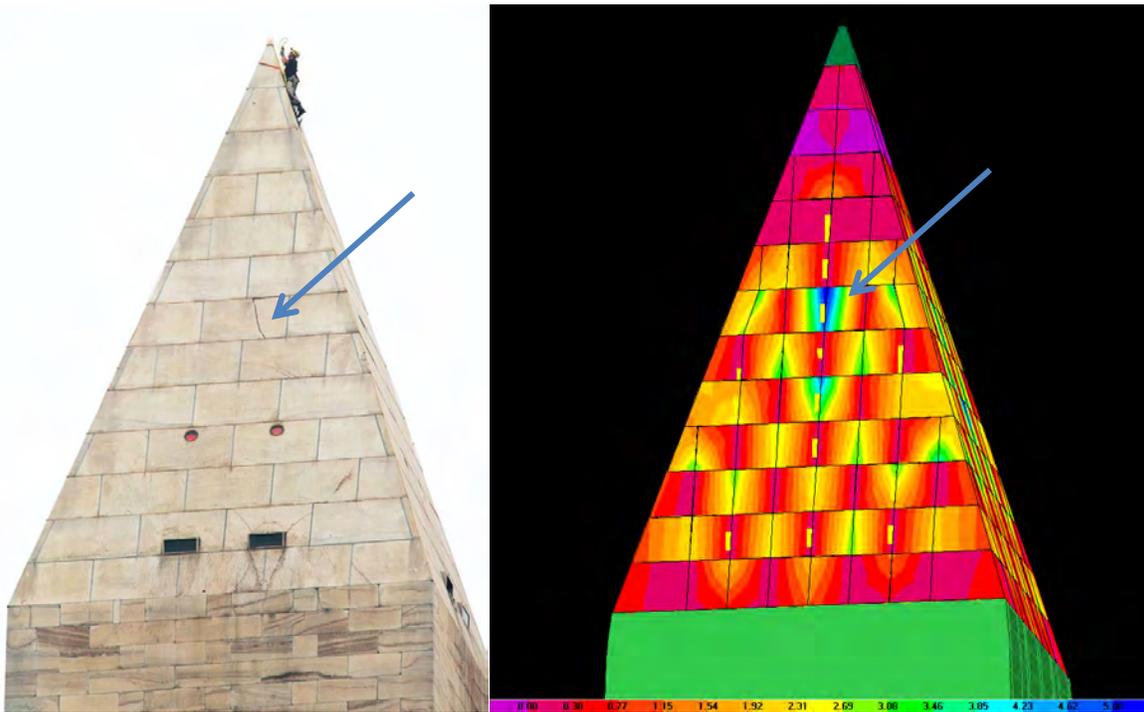
Figure 63. Comparison between a photograph of the pyramidion after the Mineral earthquake to the predicted maximum envelope moment

elevation after the earthquake (Figure 63). Simple hand calculations indicate that 5 k-ft/ft is sufficient demand to crack the stone panels.
