Stehekin River Corridor Implementation Plan

Current Information About the Stehekin River

II – Hydrology and Flooding on the Stehekin River

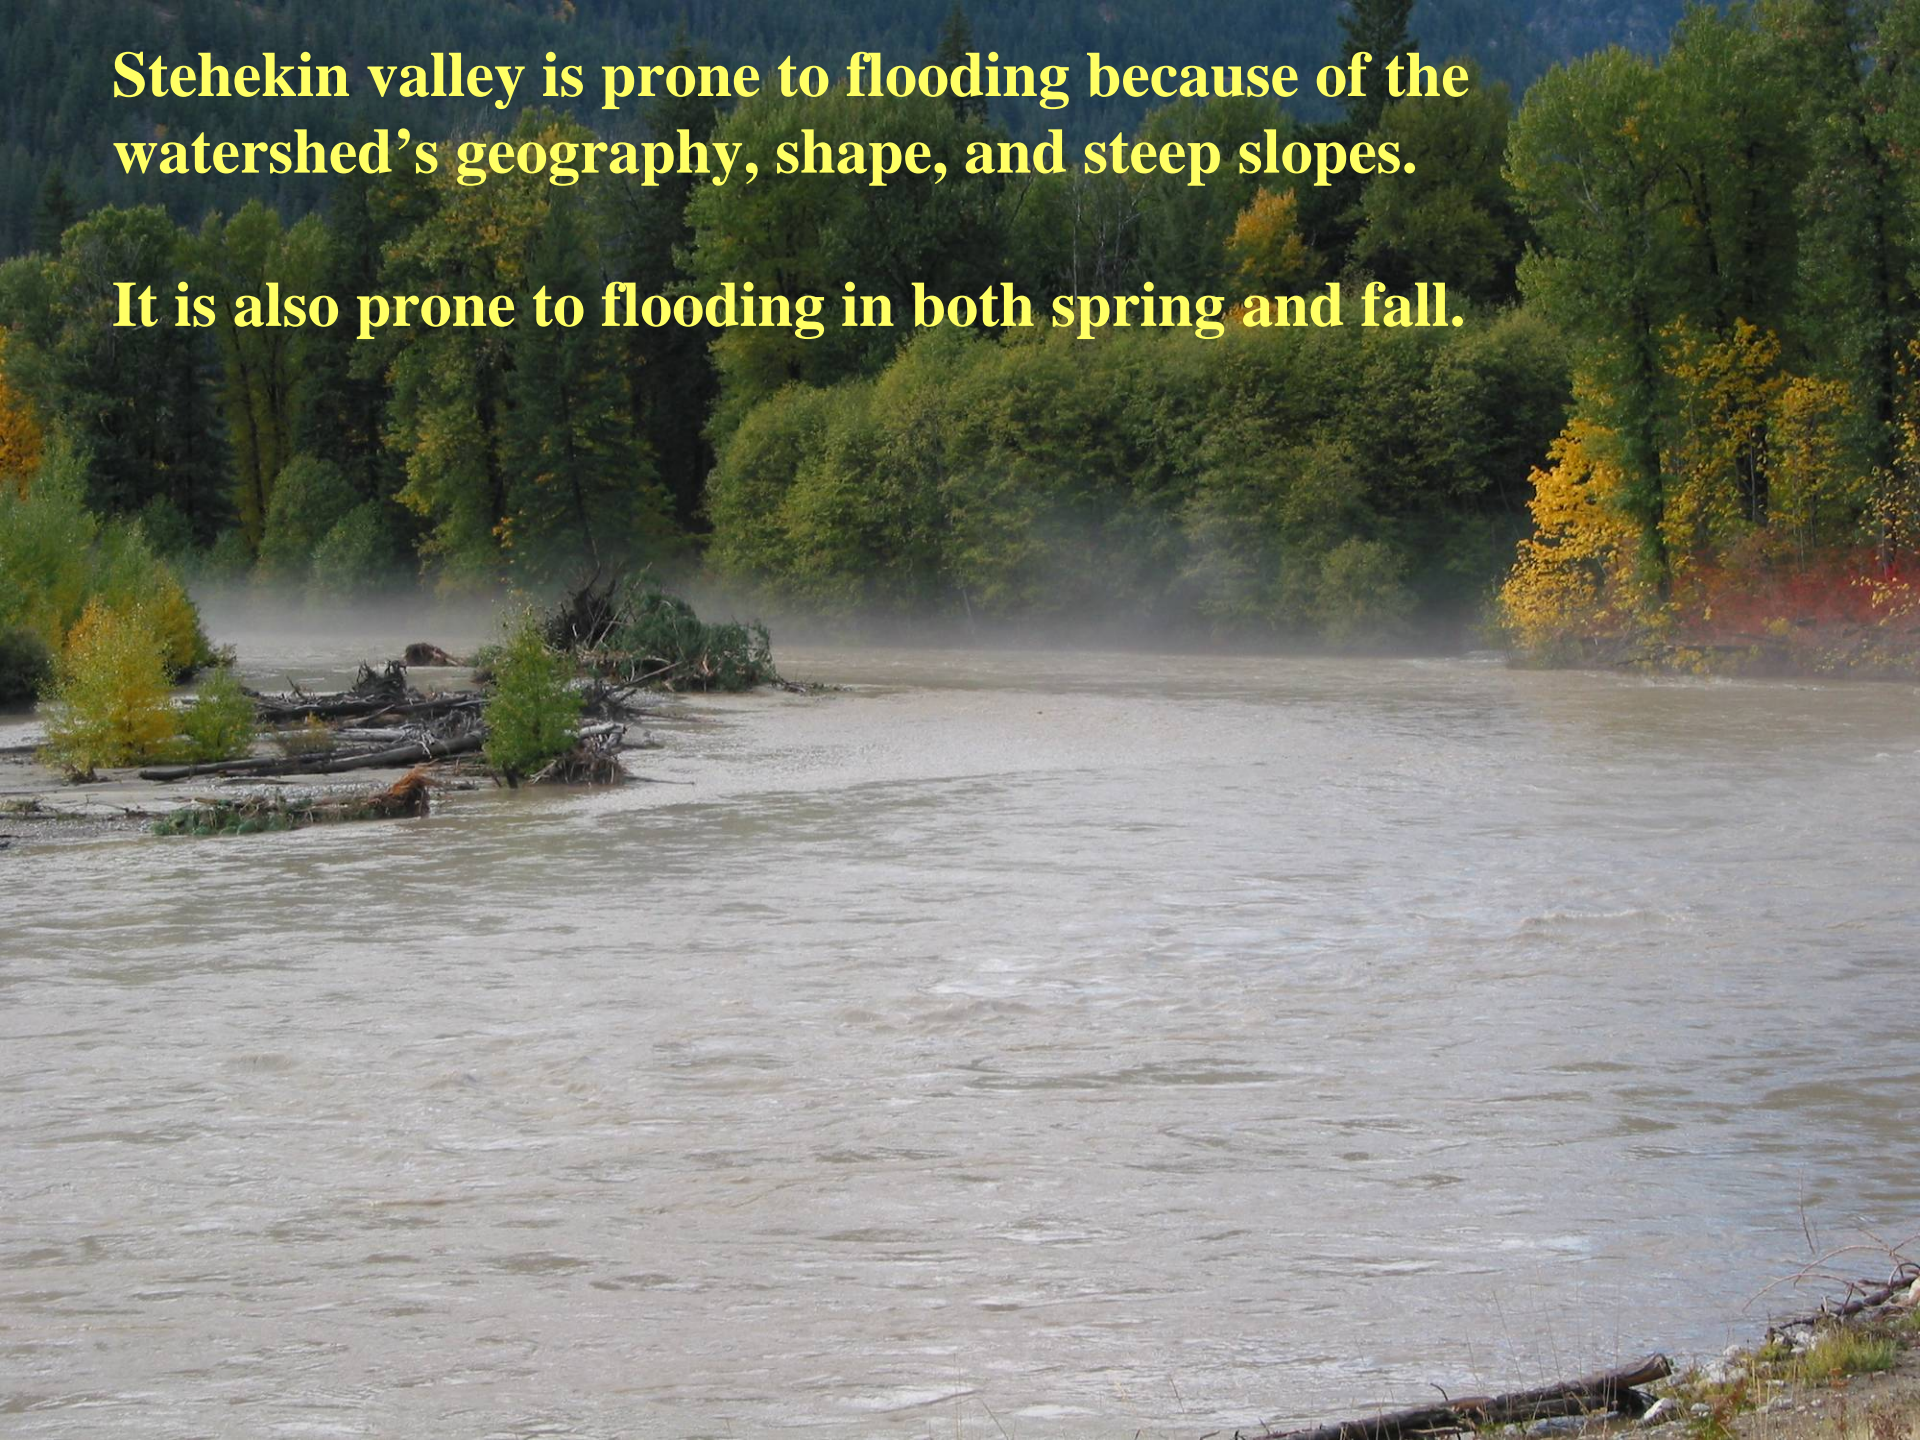
Stehekin valley is prone to flooding because of the watershed's geography, shape, and steep slopes.

It is also prone to flooding in both spring and fall.

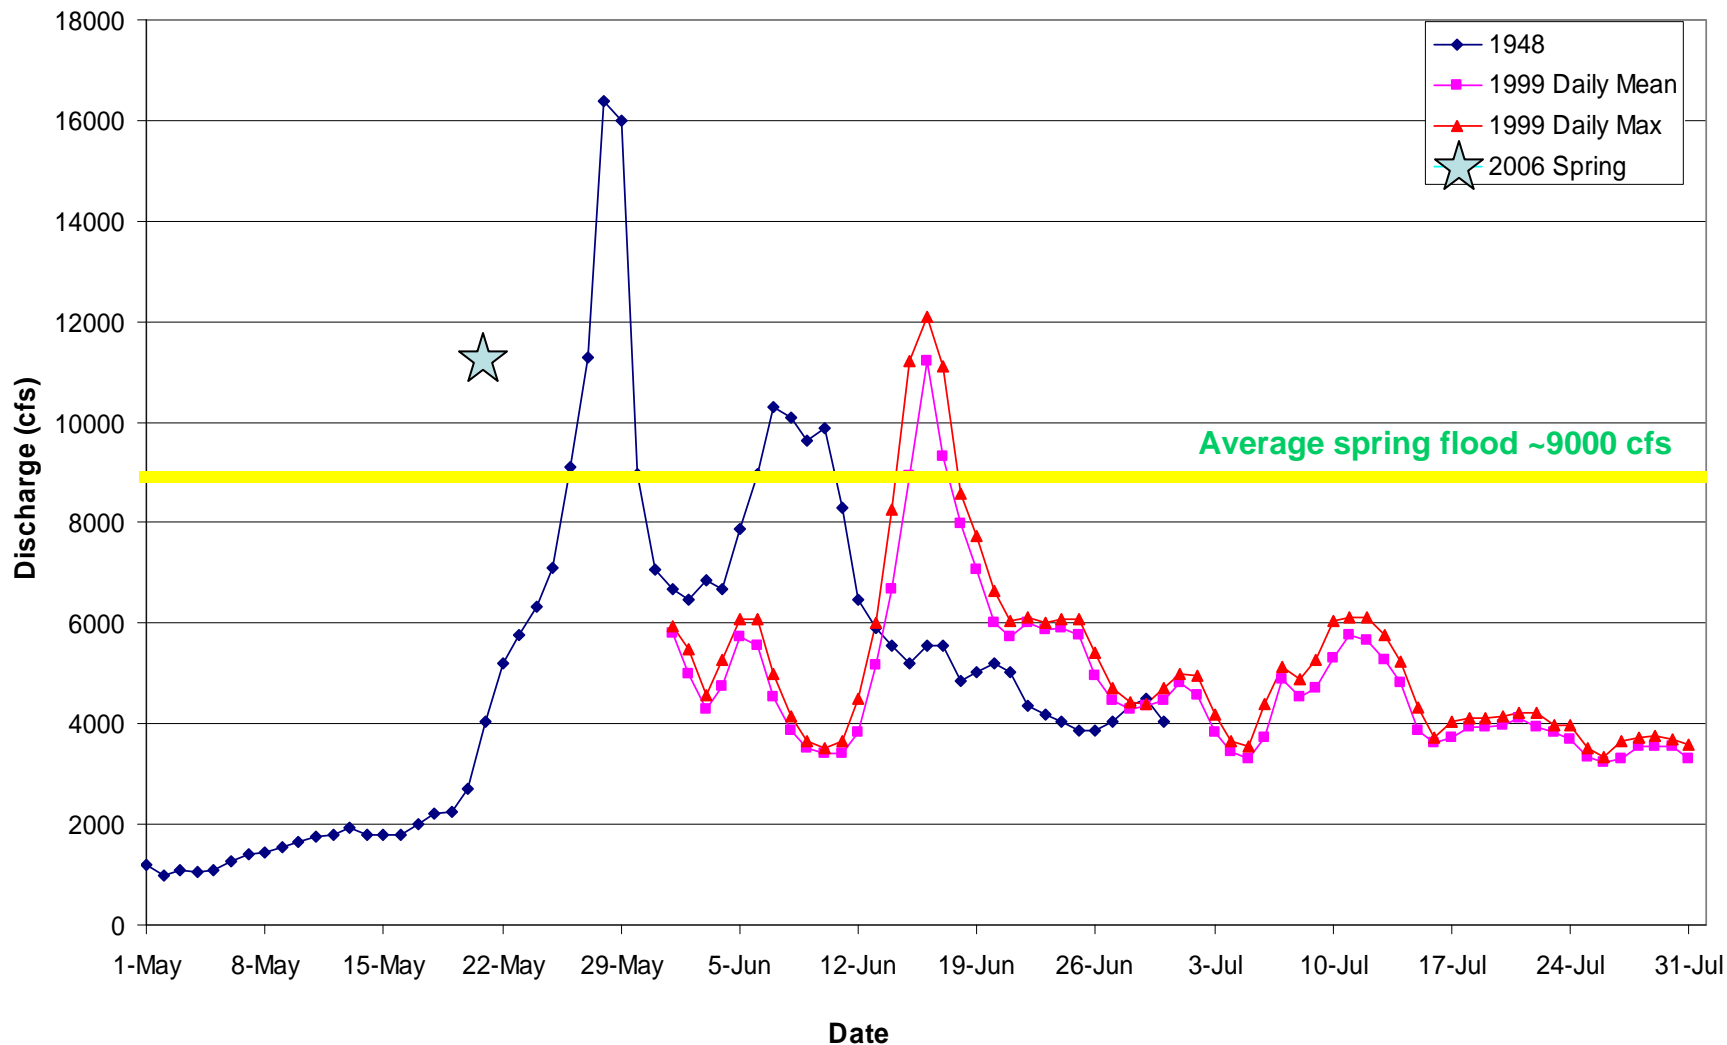
Spring Flood Hydrographs, Stehekin River, WA 1948, 1999, and 2006

Daily Mean Discharge

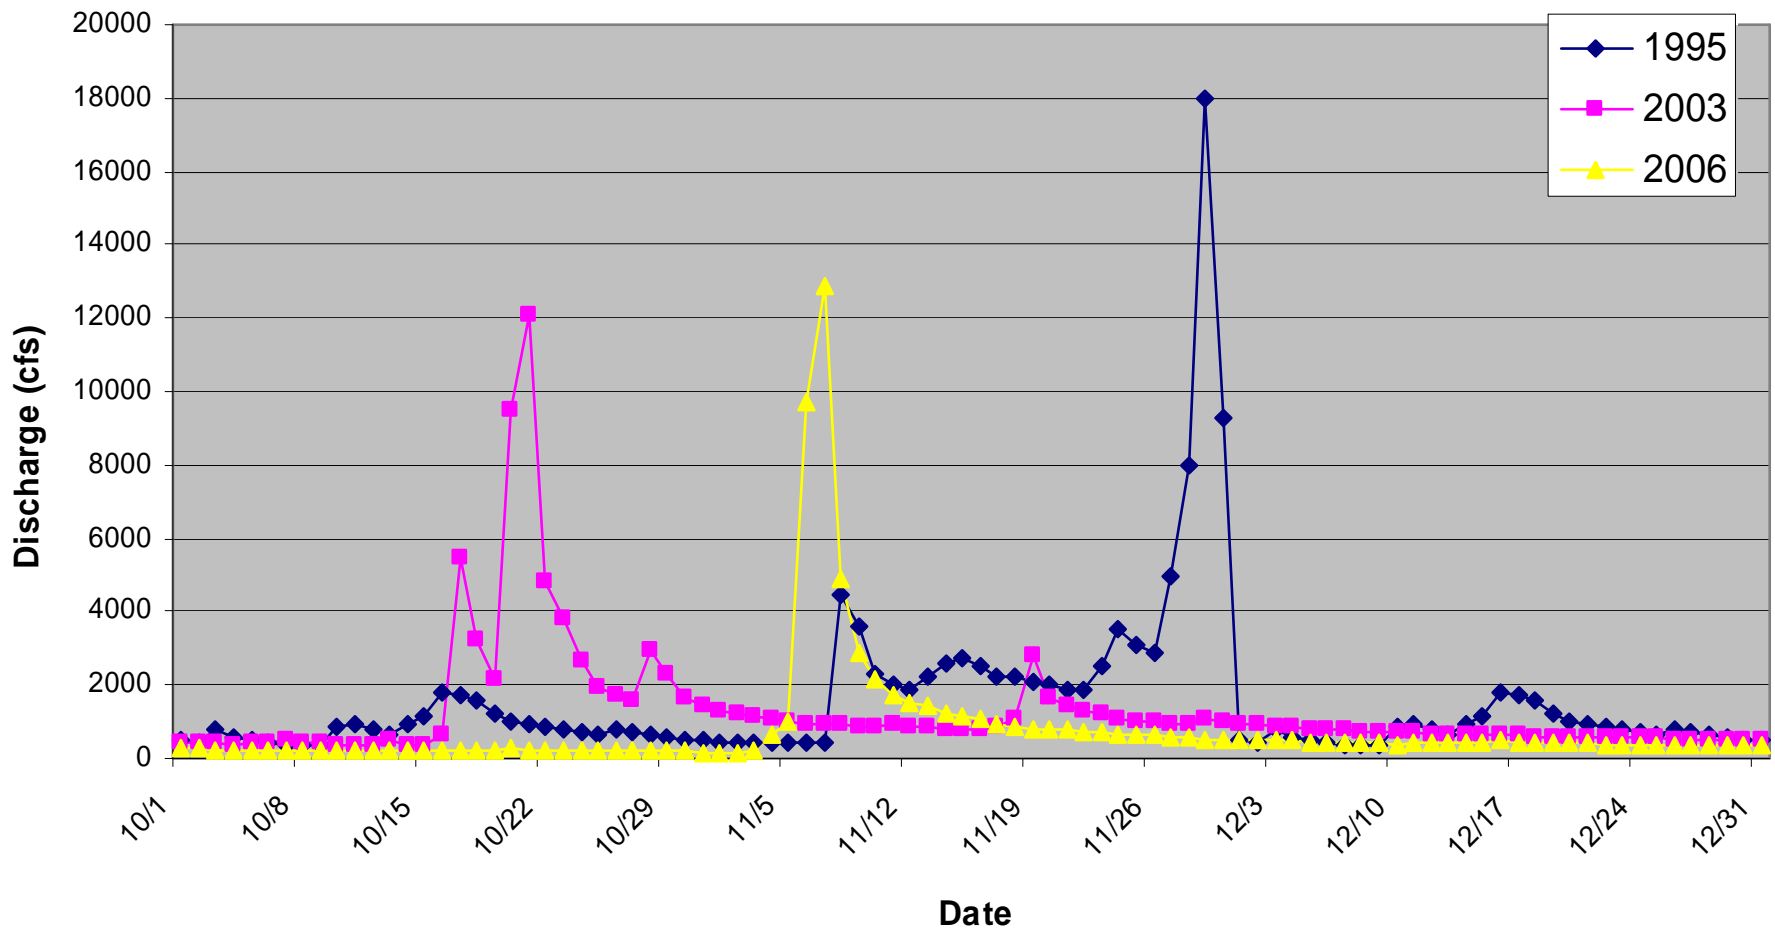
Fall Rain on Snow Event Flood Hydrographs, Stehekin River, WA

1995, 2003 and 2006 Mean Daily Discharge

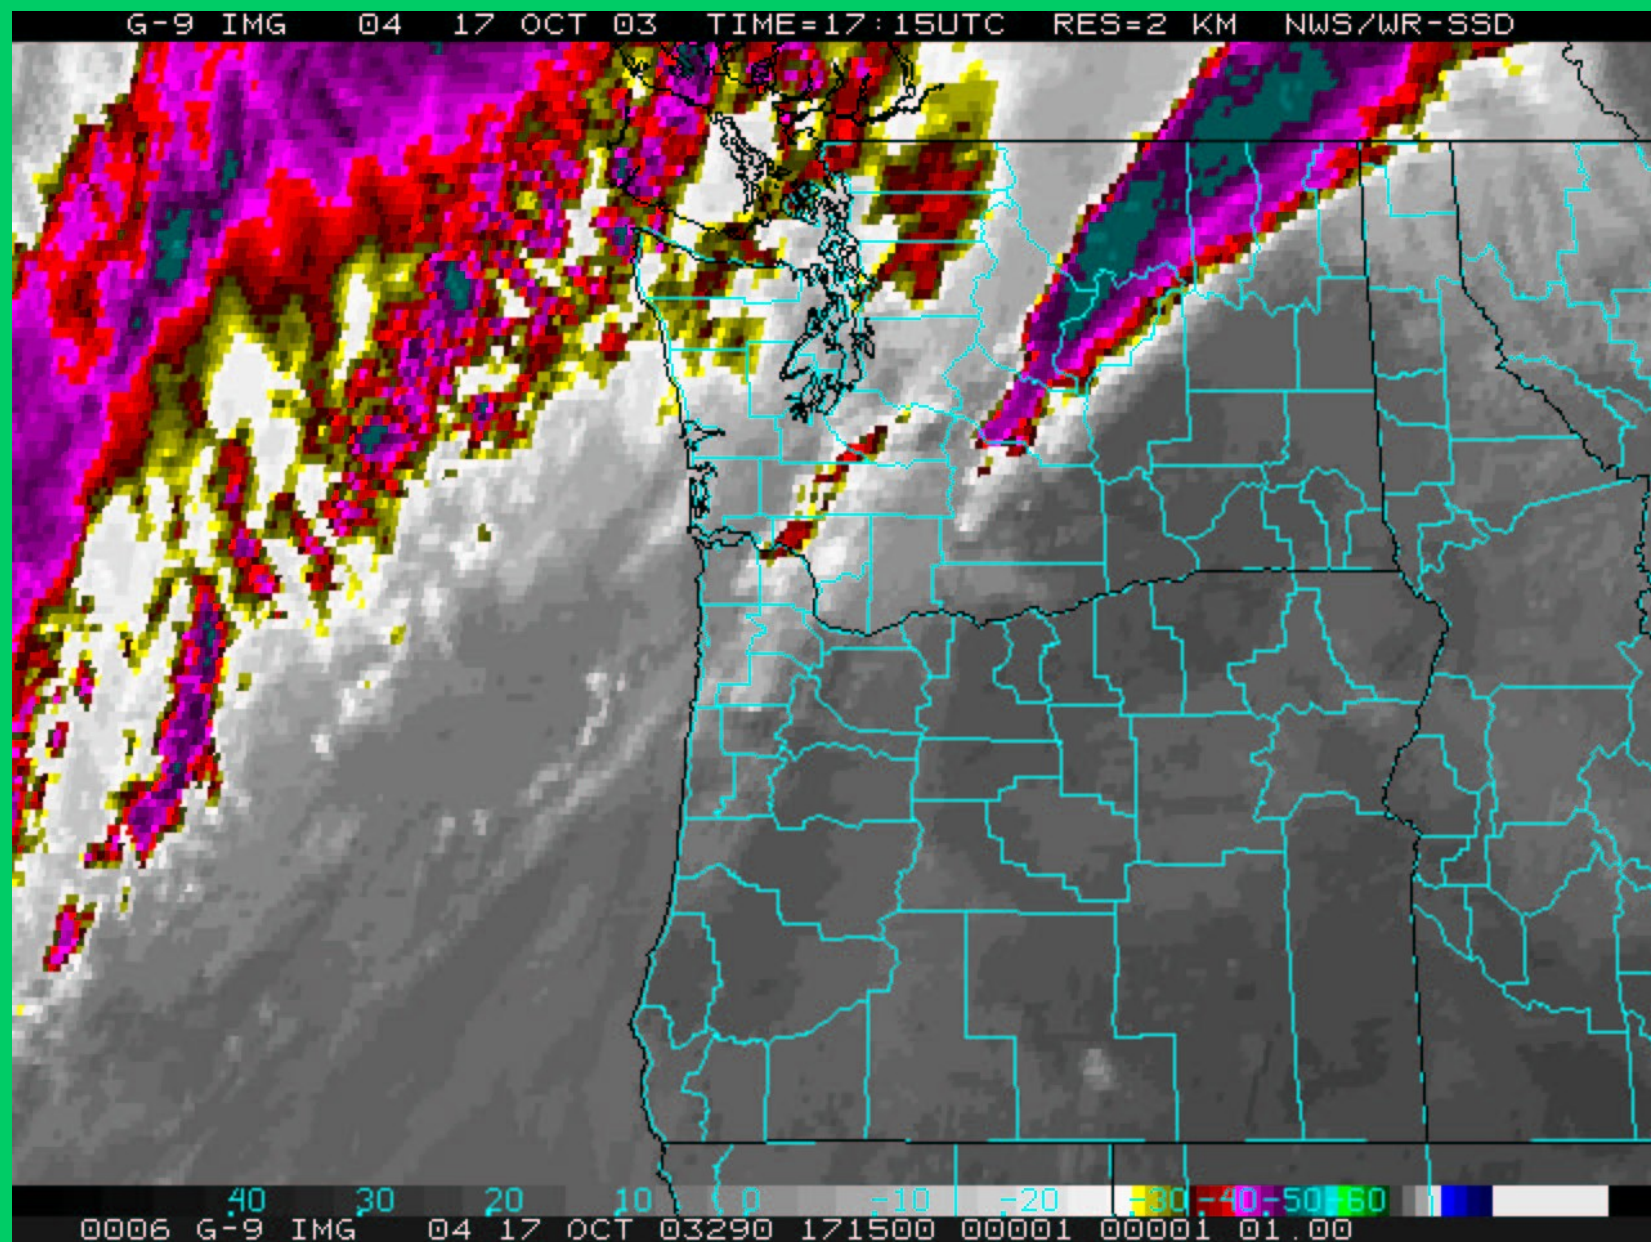
Satellite (IR) views of October 17 and 20, 2003 storms

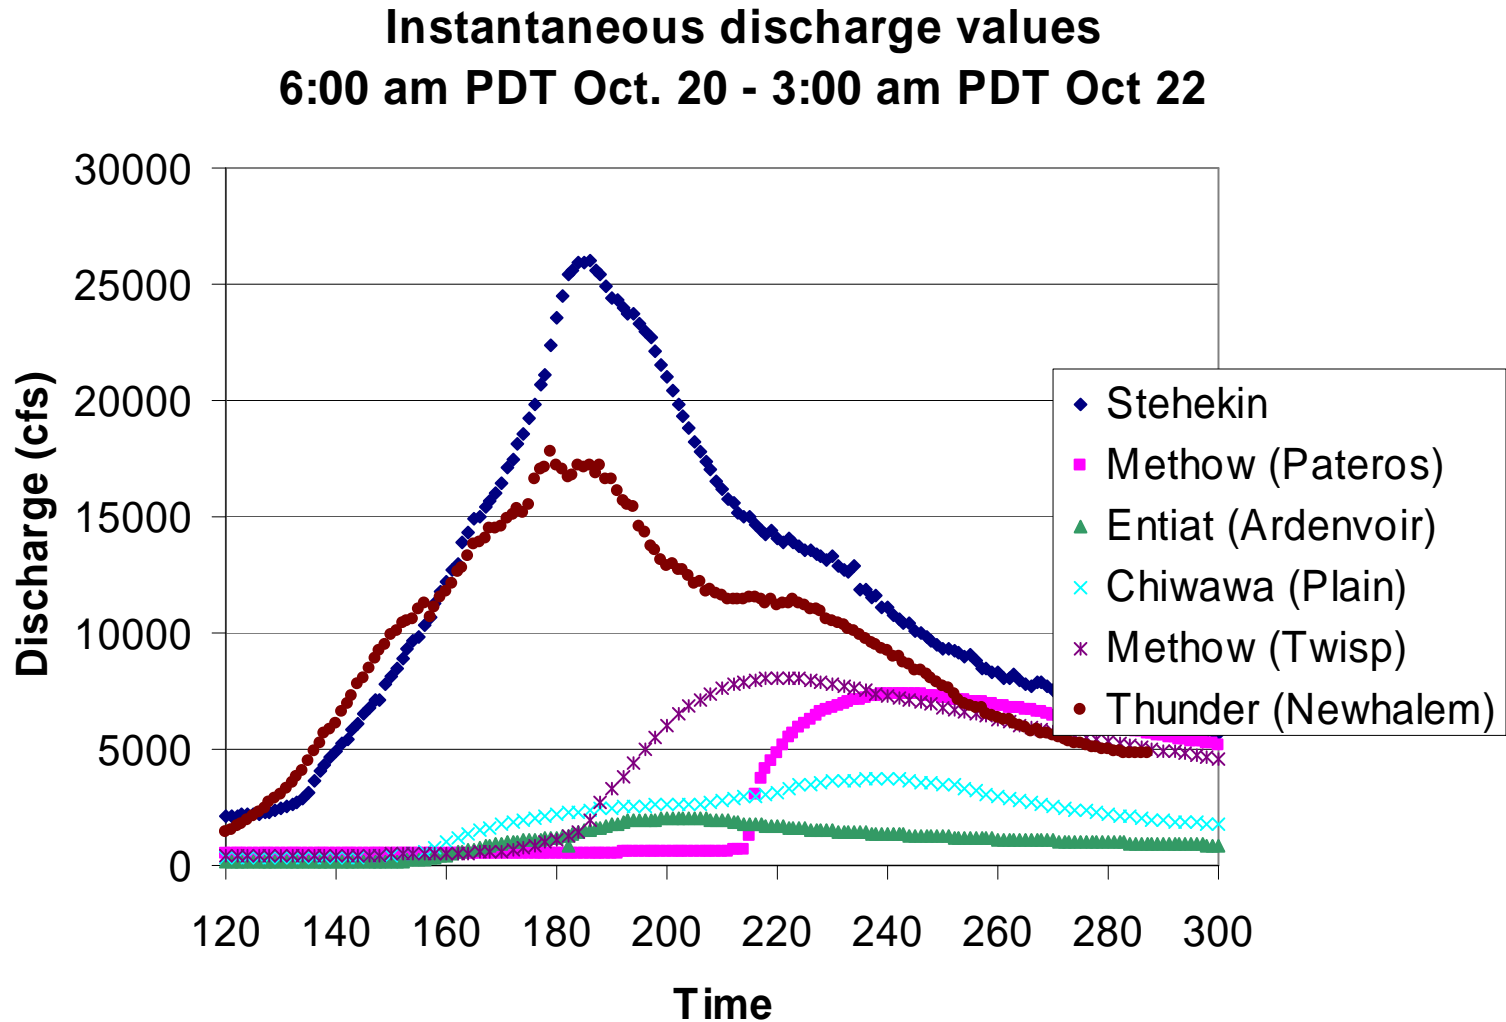
Comparison of 2003 flood size between six north-central Washington Rivers

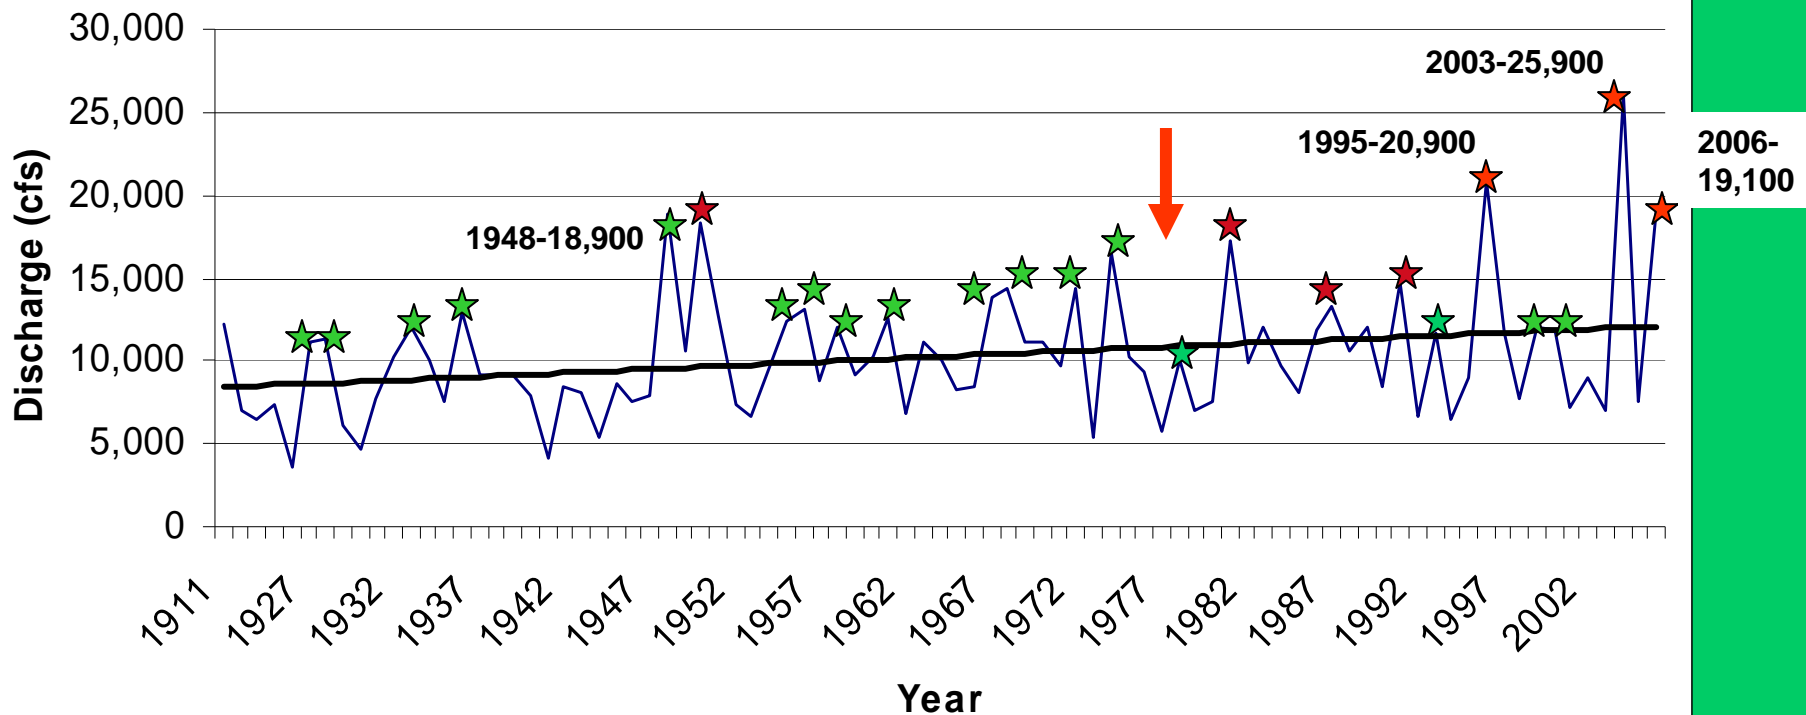
Stehekin River Flood History

Spring flood

Fall flood

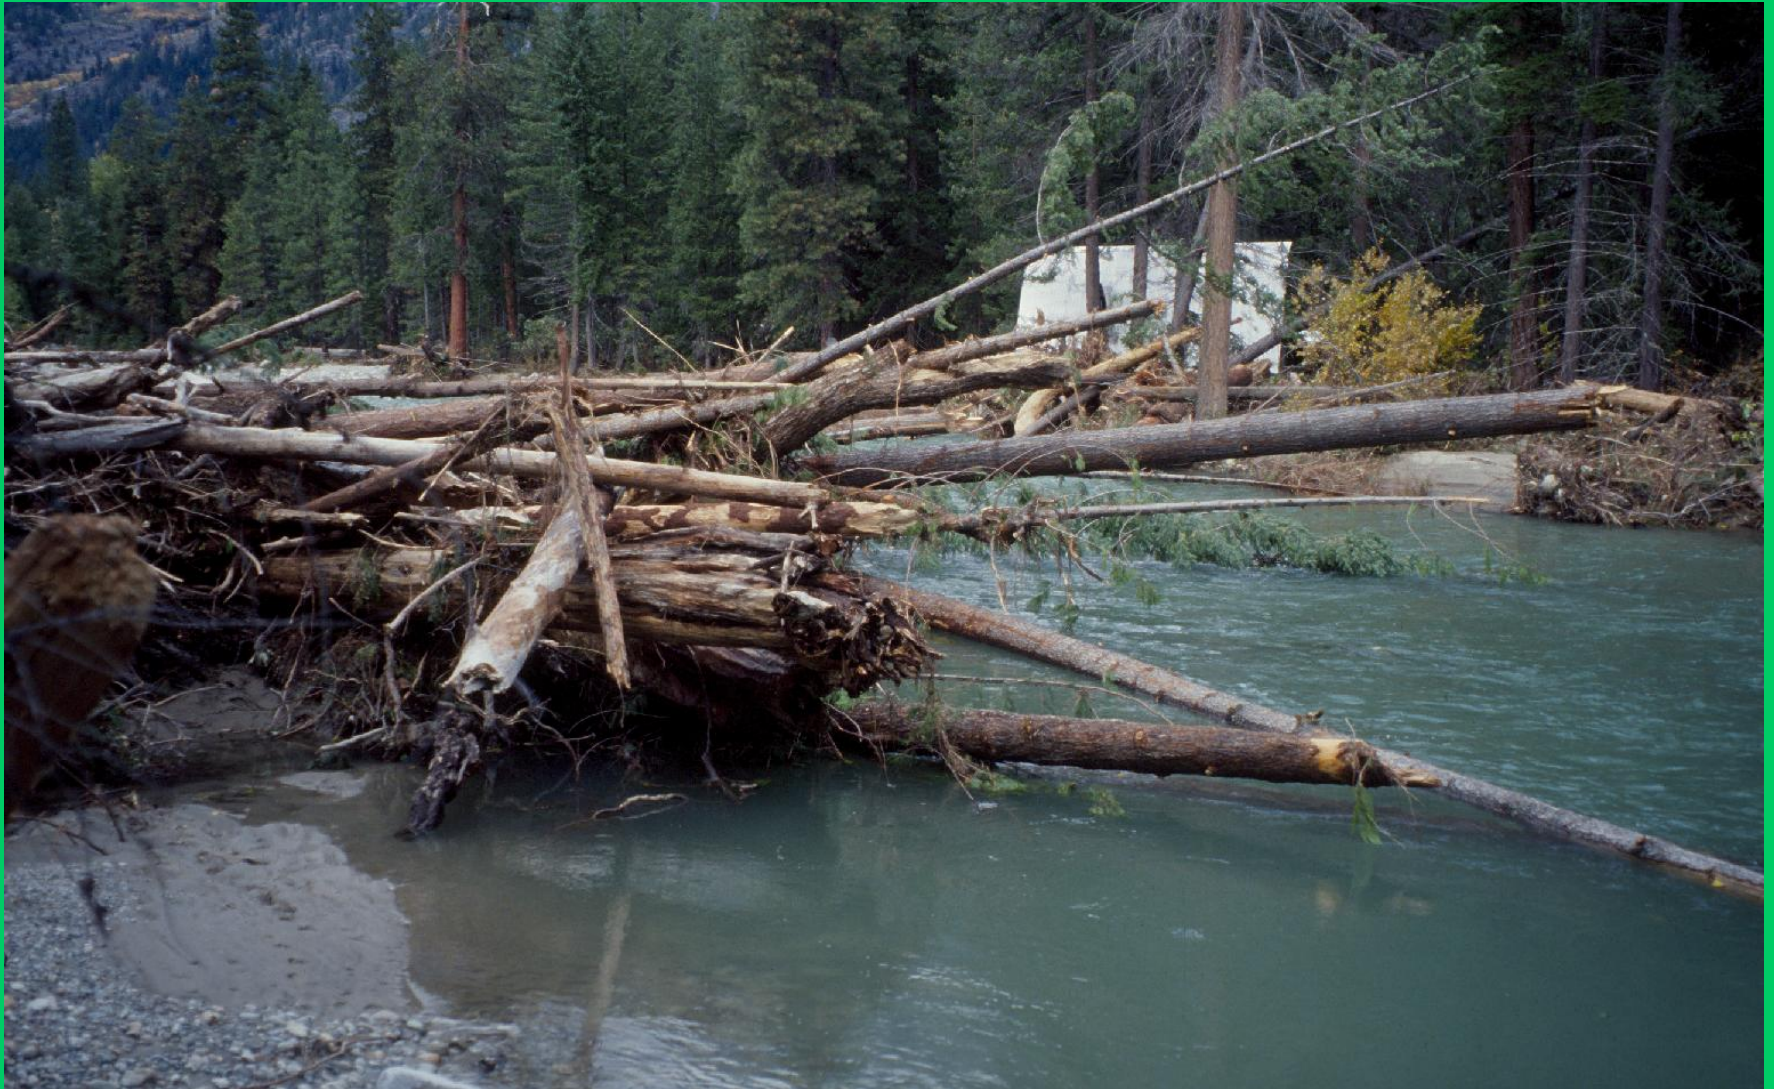
Accumulation of Large Woody Debris on the lower Stehekin River

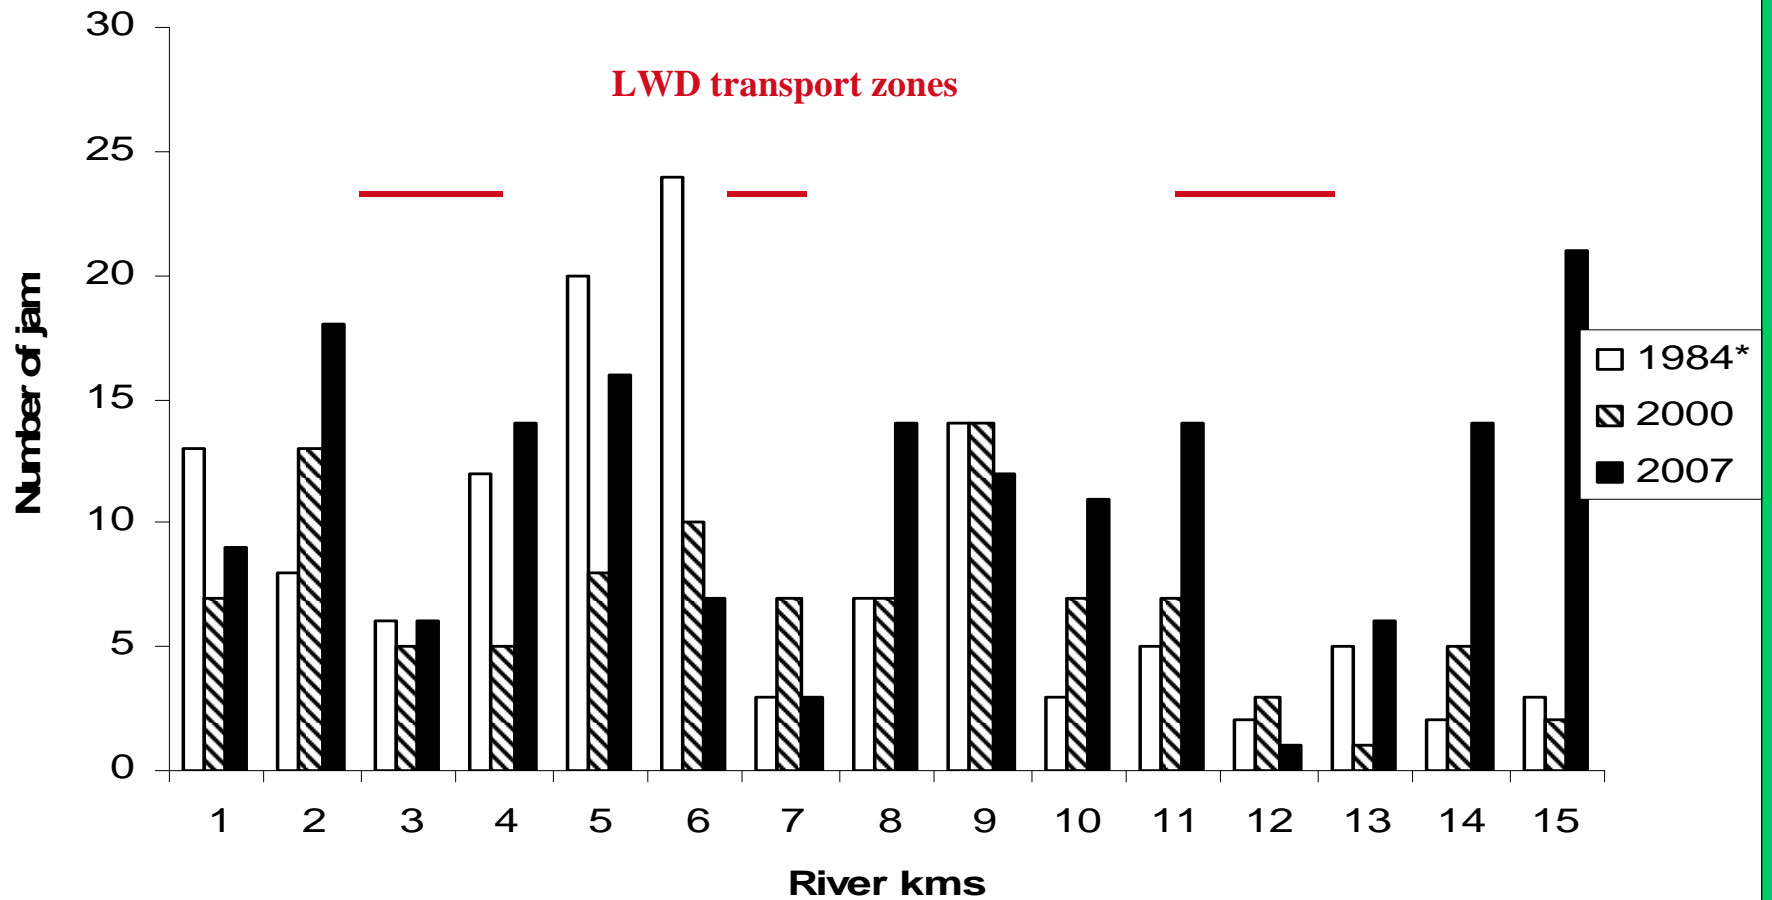
Comparison of number of jams per km

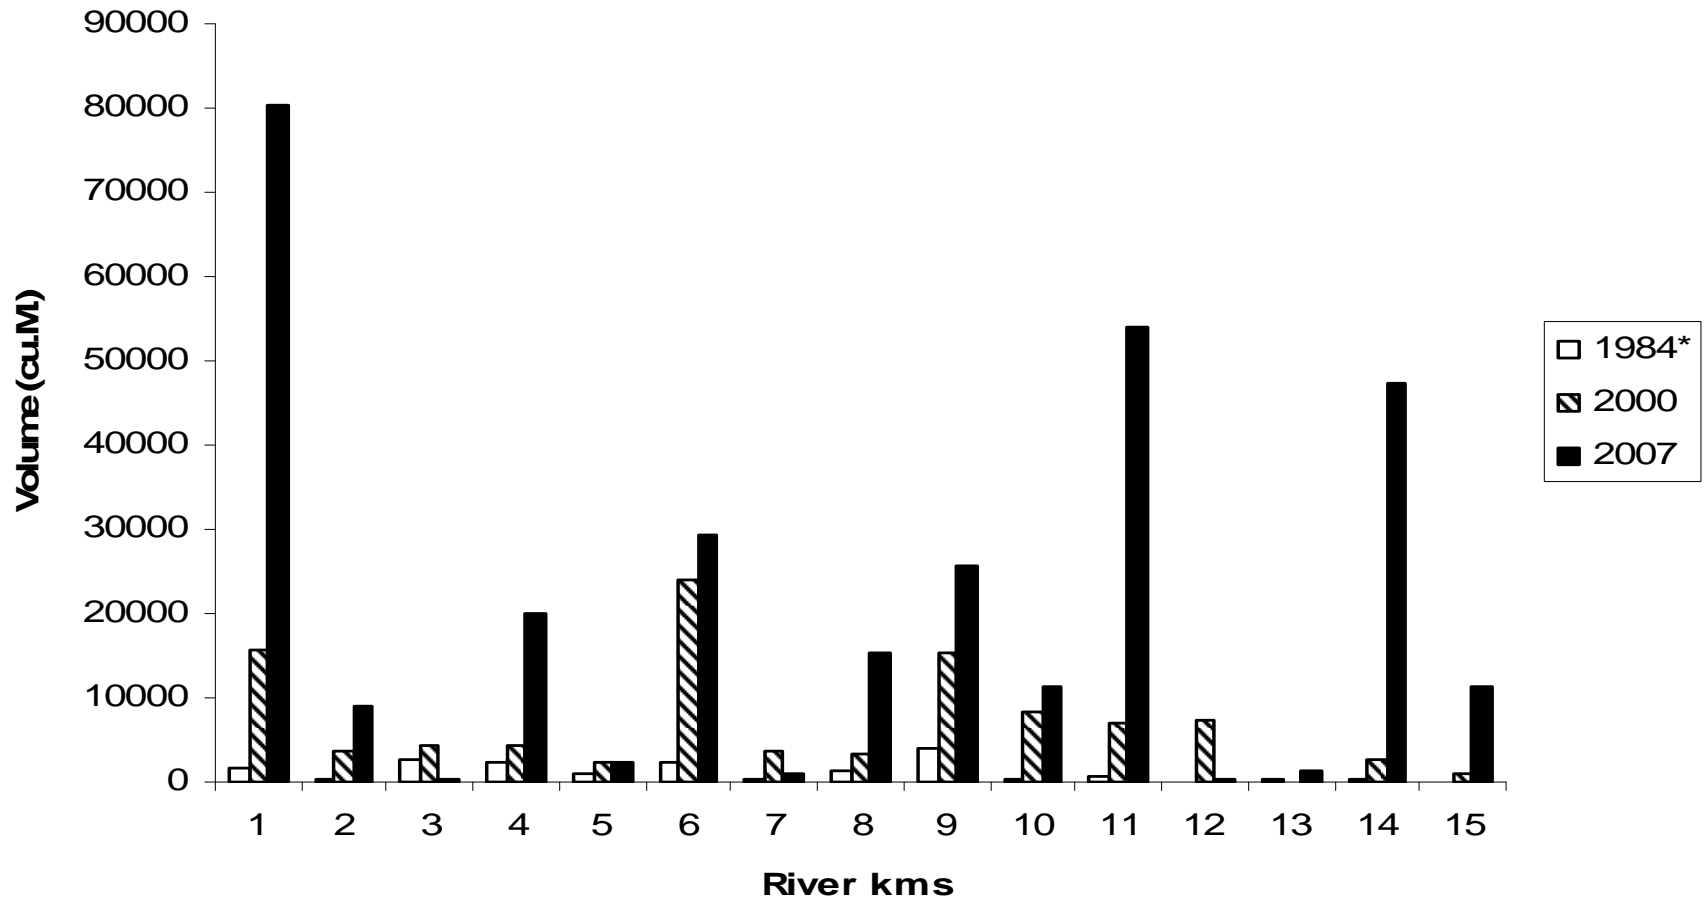
Comparison of jam volume per river km.

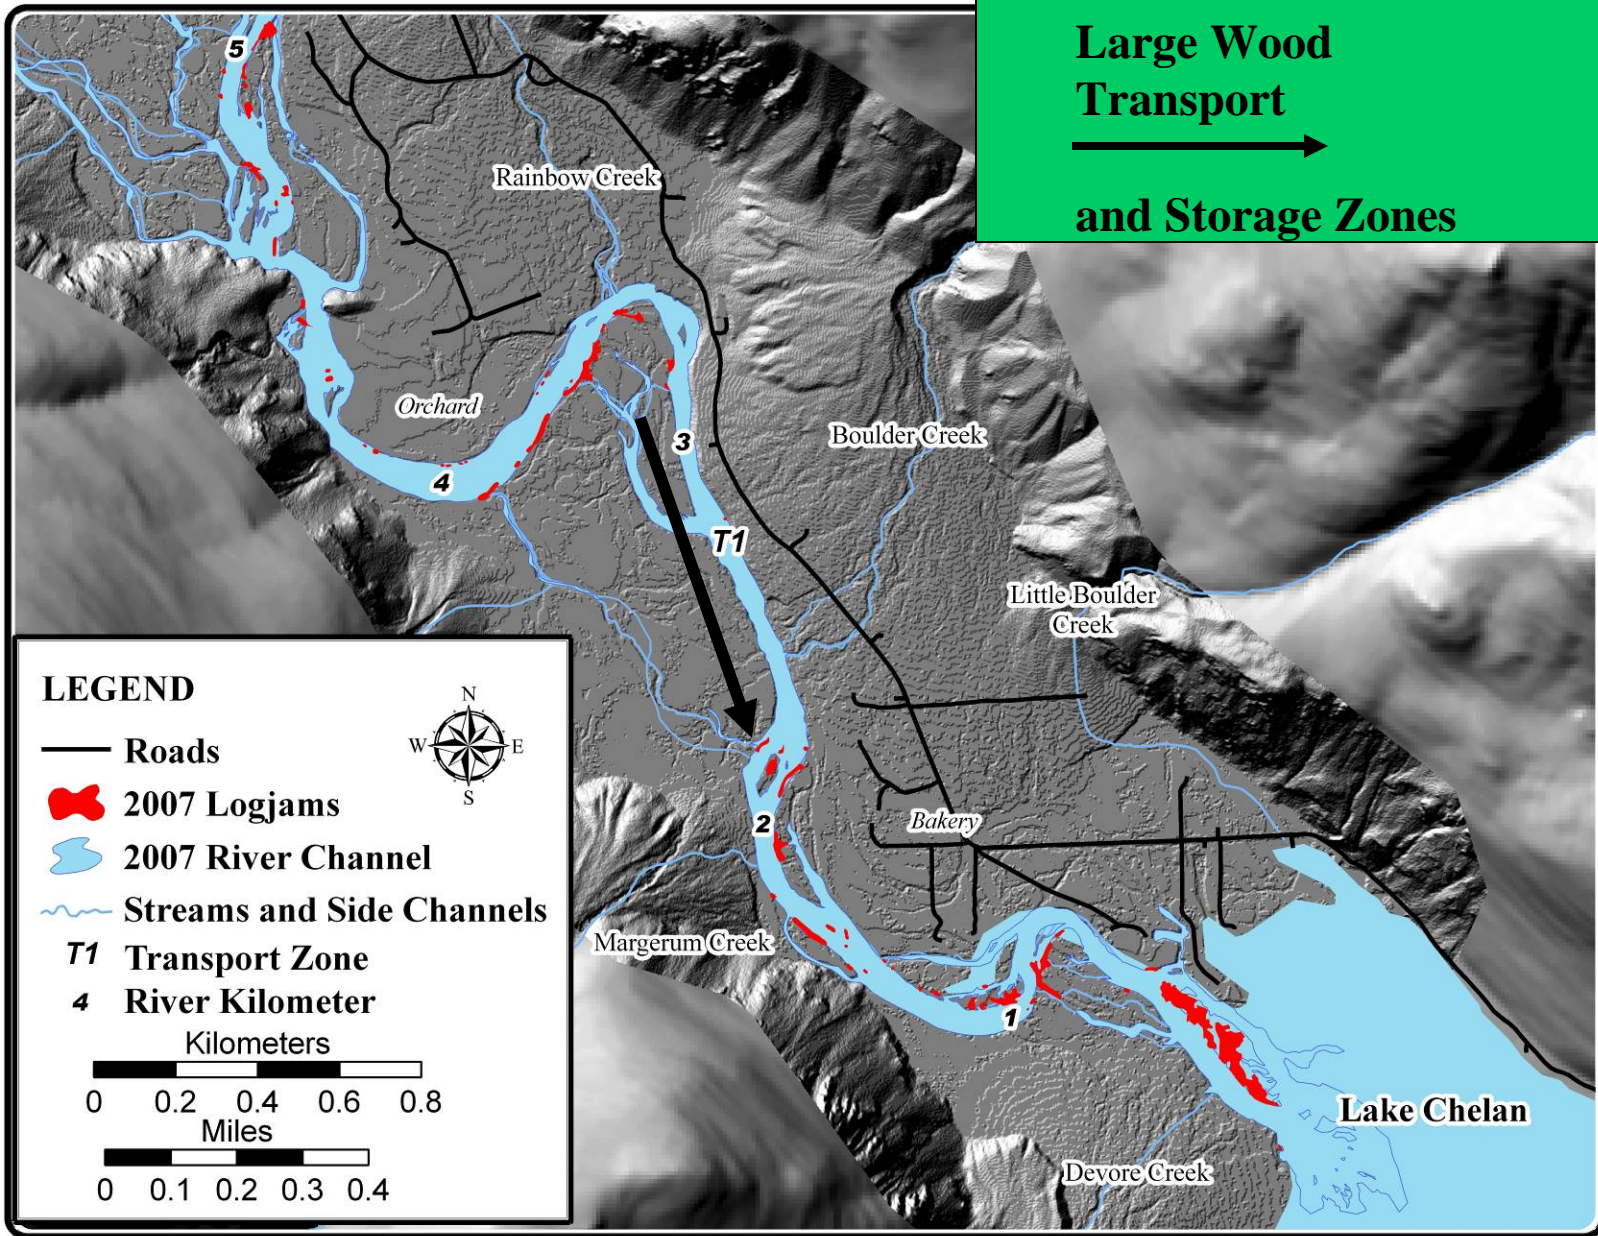
Large Wood Transport and Storage Zones

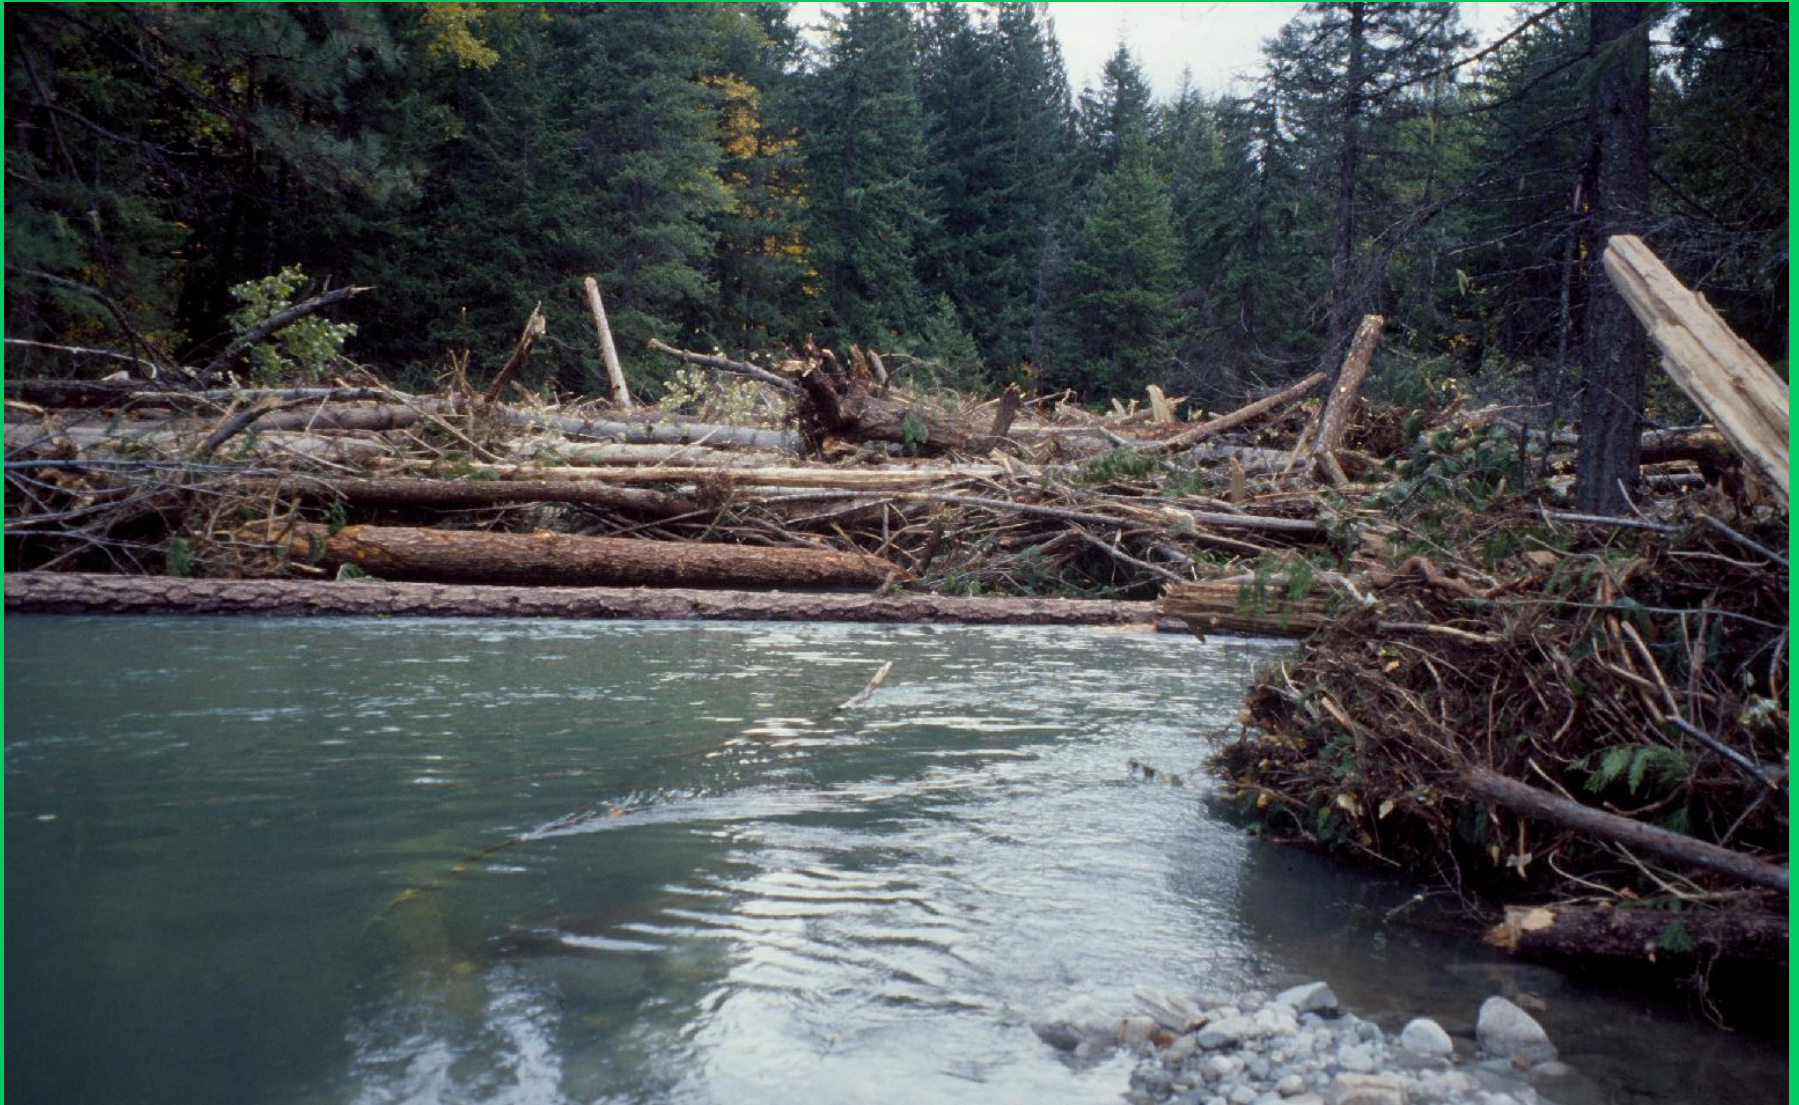
McGregor Meadows Log Jam Contains >2,000 Logs

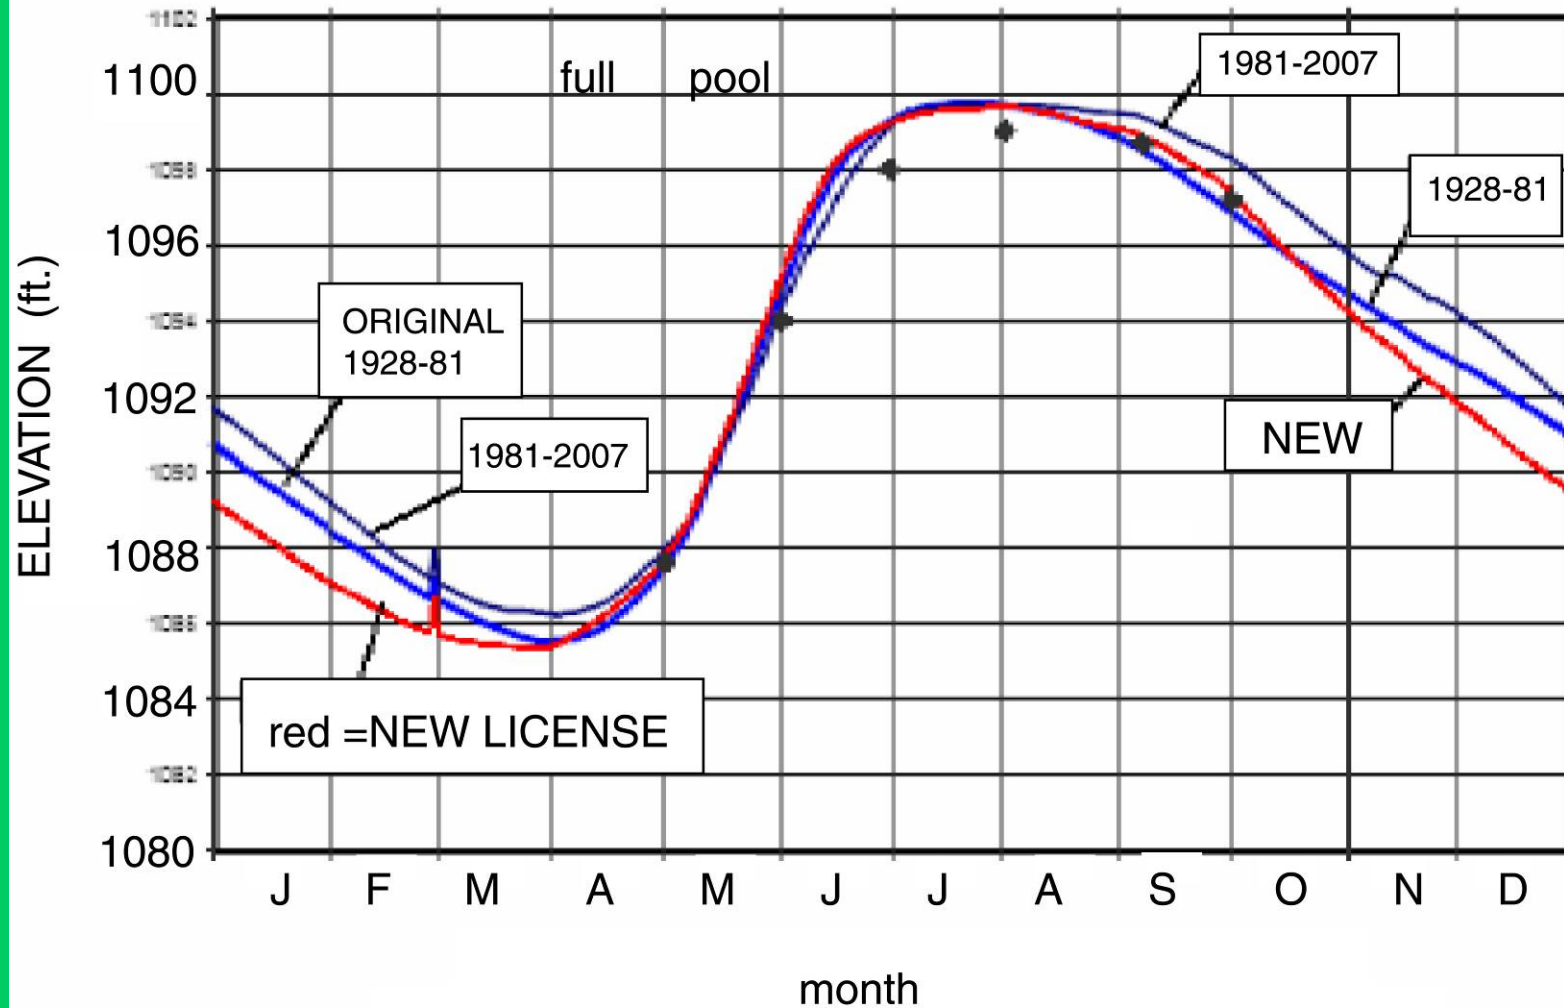
Lake Chelan Average Monthly Elevation
