# **Stehekin River Information Base**

## **Lake Chelan National Recreation Area**

### **White Paper #1 – Stehekin River Corridor Implementation Plan**

#### **National Park Service**

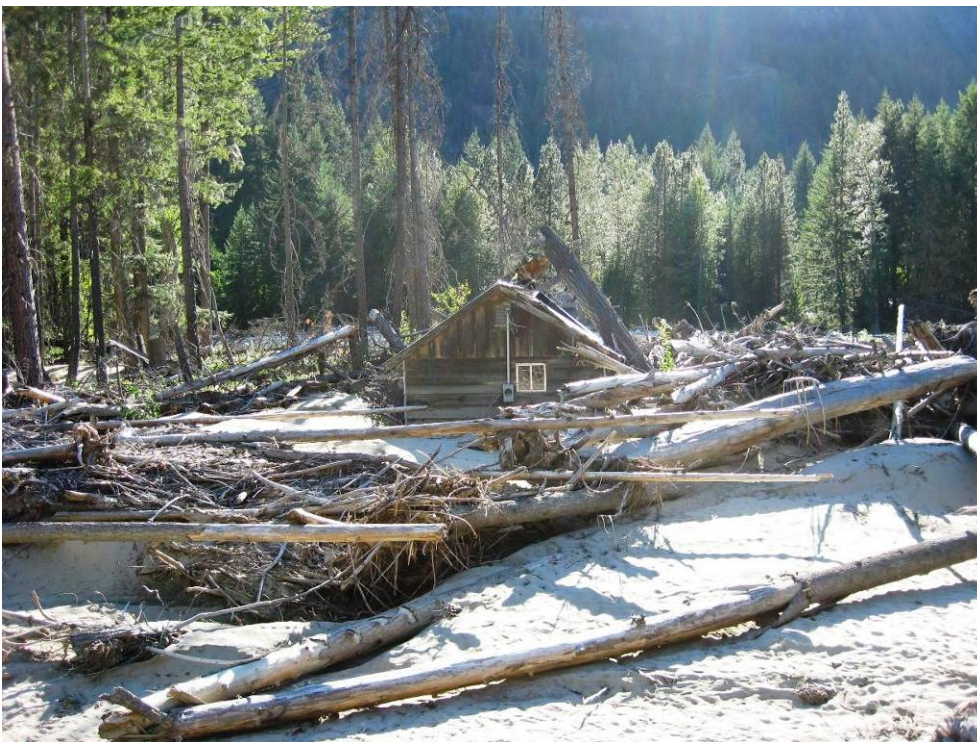
Figure 14. Photo of the 1900 piece logjam at McGregor Meadows (see Figure 11B).
