*Rehabilitation the War Department Log Garage for Curatorial Storage*  
**Photos**

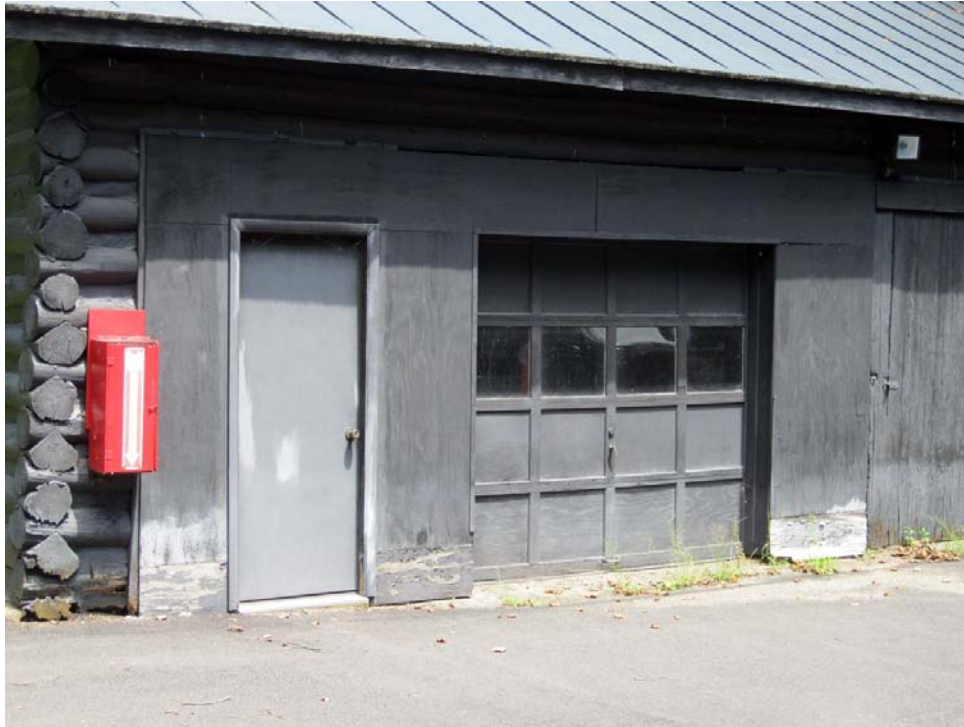
Log Garage -2013

Note the 1970s alteration of the left sliding-door entrance on the western facade.  
Turn-coated steel gutters and downspouts will be added to assist with rainwater runoff management.

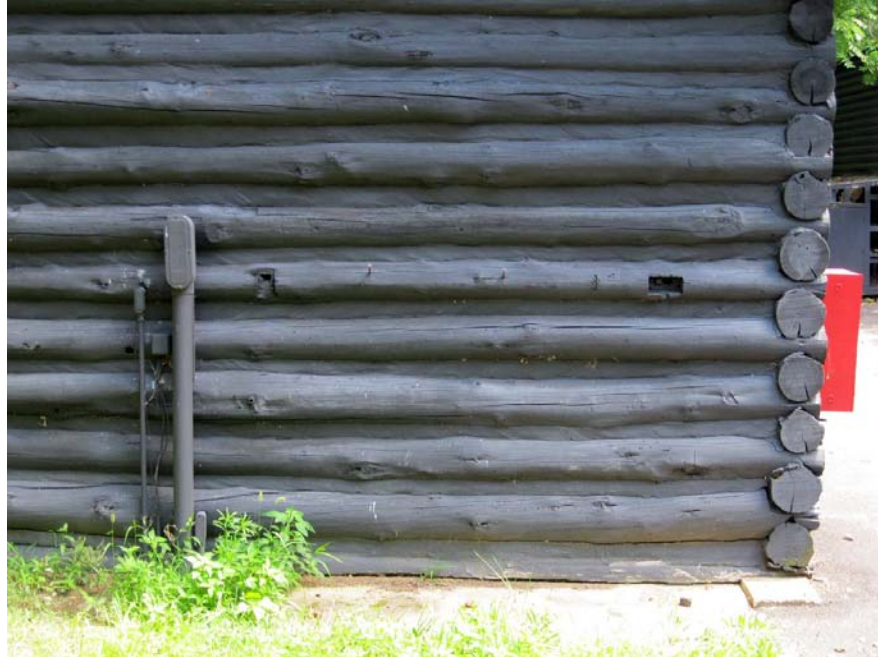
Log Garage - 2013

The 1970s alteration of the left sliding-door entrance on the western facade.

The alteration will be dismantled and rebuilt to allow for a double-door access, all of which would be painted the same color as the log garage. The modern overhead garage door would be removed. As the existing fabric dates from the 1970s, no historic fabric would be impacted through this construction.

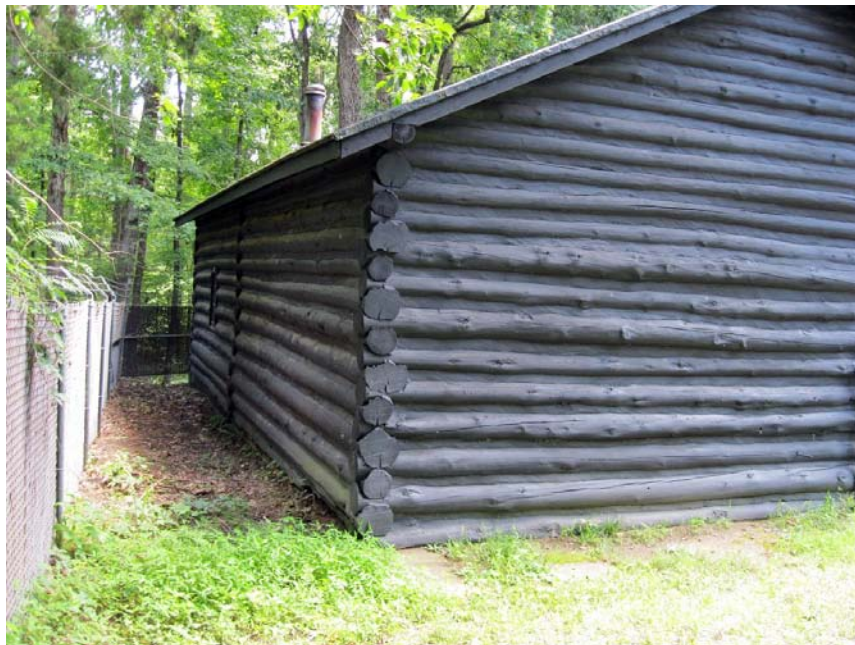
Log Garage – 2013

Electrical conduits on the northern facade. Utility access will remain the same.

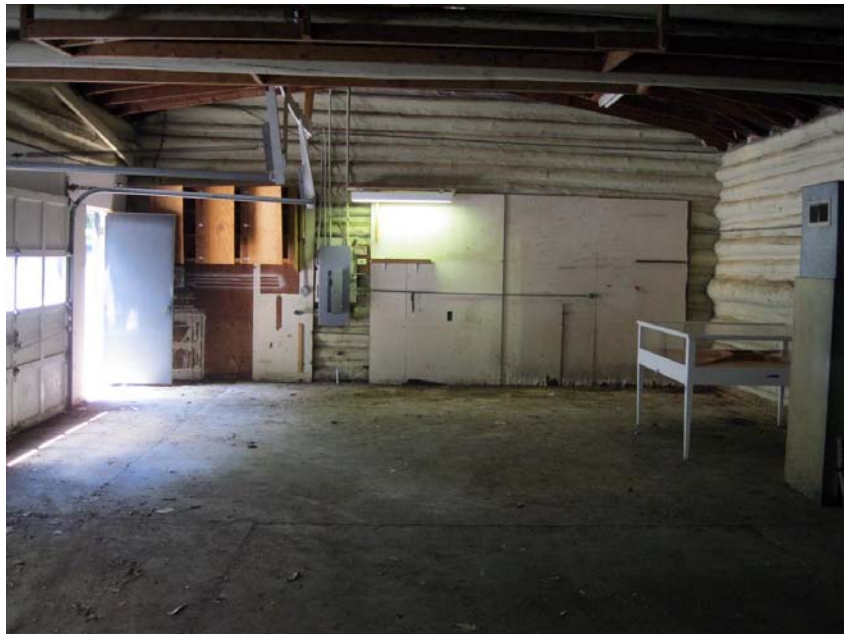
Log Garage – 2013

Interior view of the open space. The modern furnace will be removed. The pre-fabricated building will be constructed inside the existing open space. An eight-inch space will exist between the walls of the log garage and the pre-fabricated building. No historic fabric will be affected. HVAC and fire suppression system will run along the rafters.
