CHAPTER 3 – AFFECTED ENVIRONMENT – EXISTING CONDITIONS

COASTAL RESOURCES (INCLUDING LITTORAL PROCESSES)

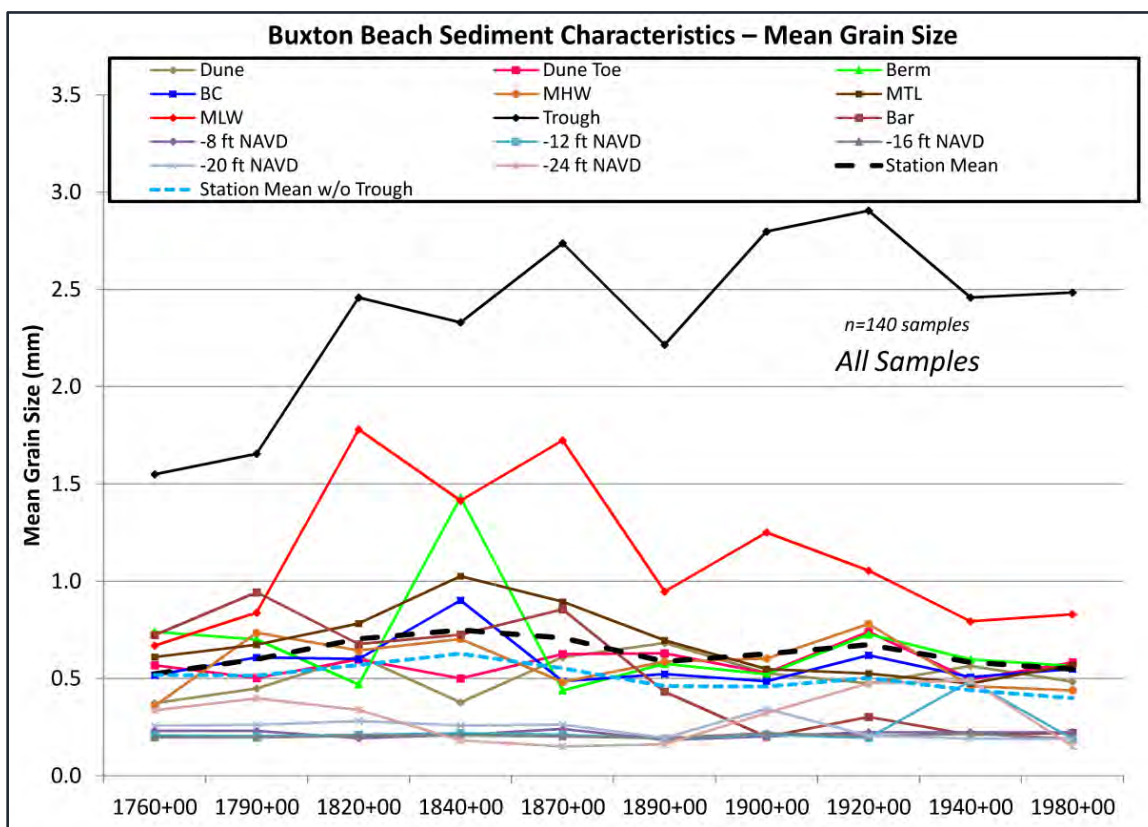
Figure 3.6. Graph showing mean grain size in millimeters (y-axis) by station for all beach samples along the Buxton Action Area. Results represent ten transects with 14 samples per transect between the foredune and the -24-foot depth contour. Samples were obtained in October 2014. Note outlier coarse sample results (grain size ~1–3 millimeters, typical) for the trough area (between the beach and the bar). The mean low-water (MLW) samples also tested much coarser than the remaining samples. [BC – berm crest. MTL – mean tide level. NAVD – North American Vertical Datum of 1988.]

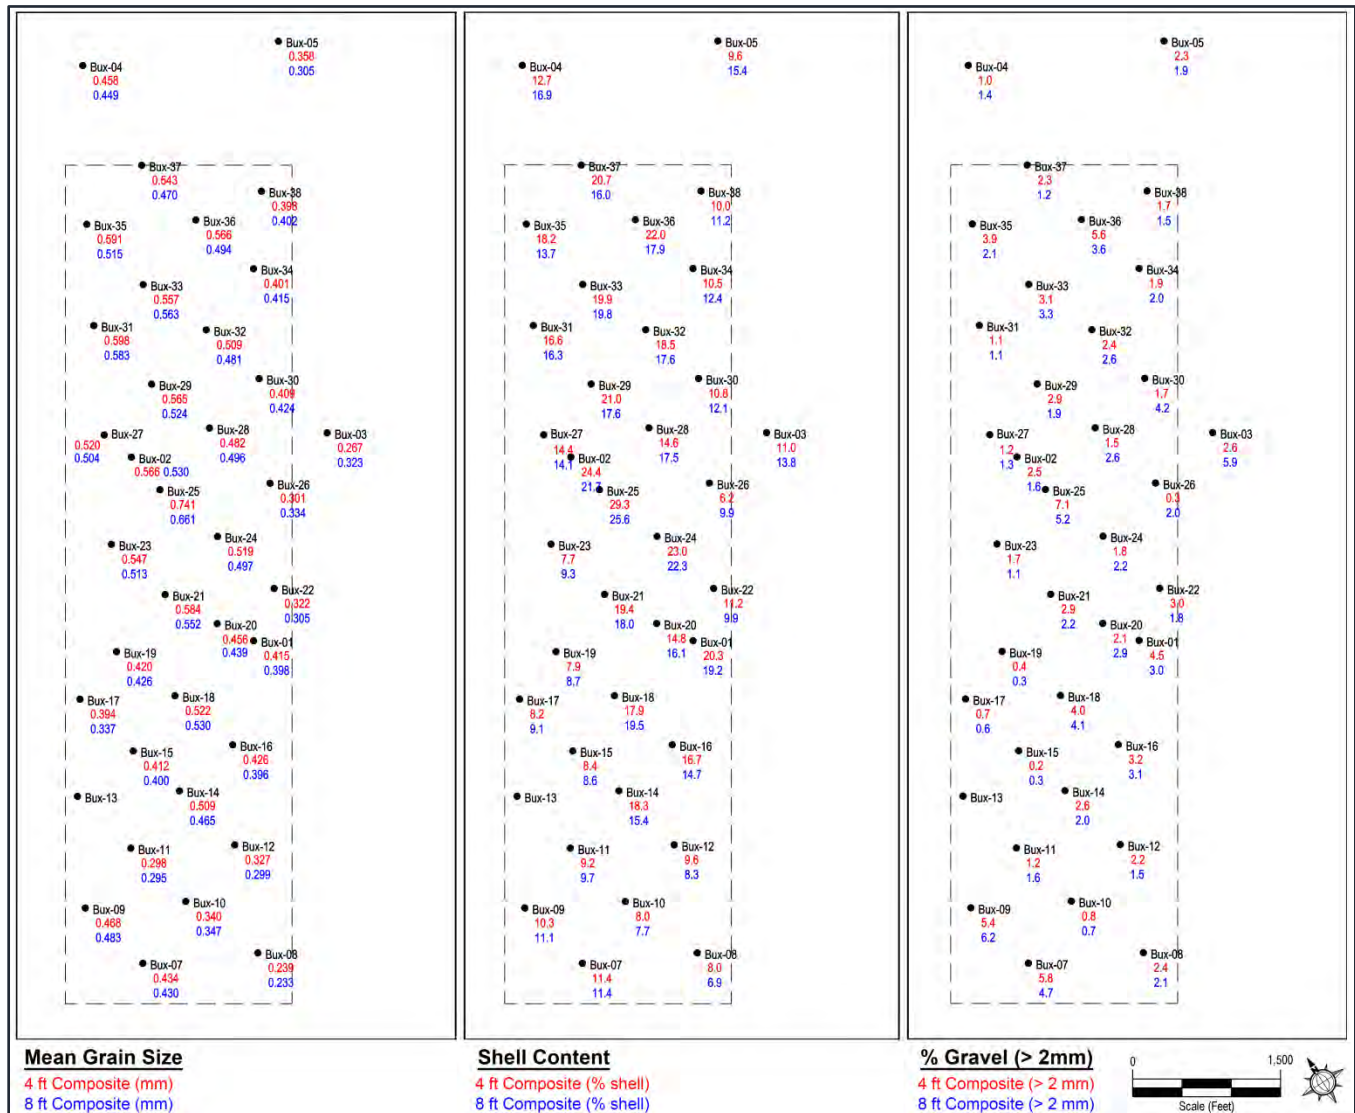
Figure 3.10. Maps of the core locations within the proposed borrow area (three panels) showing mean grain size, percent shell, and percent gravel for core composite samples to 4 feet and 8 feet in the Buxton offshore sand search area based on borings obtained in October 2014. Bux-13 was attempted but not recovered. Composite results to 6 feet (not shown) fall between the results for 4 feet and 8 feet.

Figure 3.10 summarizes key statistics for each core in the offshore borrows area. Weighted composites to 4 feet, 6 feet, and 8 feet of core section were developed from random-length, individual samples. These data provide an indication of the degree of similarity between the upper and lower layers of each core. One of the environmental concerns of using offshore borrow areas is the possibility that underlying sediments after excavation would be dissimilar and would not provide the same substrate for recolonization by benthic organisms (USACE 2010, NPS 2012). The Buxton borings exhibit highly similar mean sizes, shell content, and gravel percentages in each vertical composite. This is also confirmed via color-coded isopach maps of the sets of composites (see Appendix C, Figs 4.5–4.7).

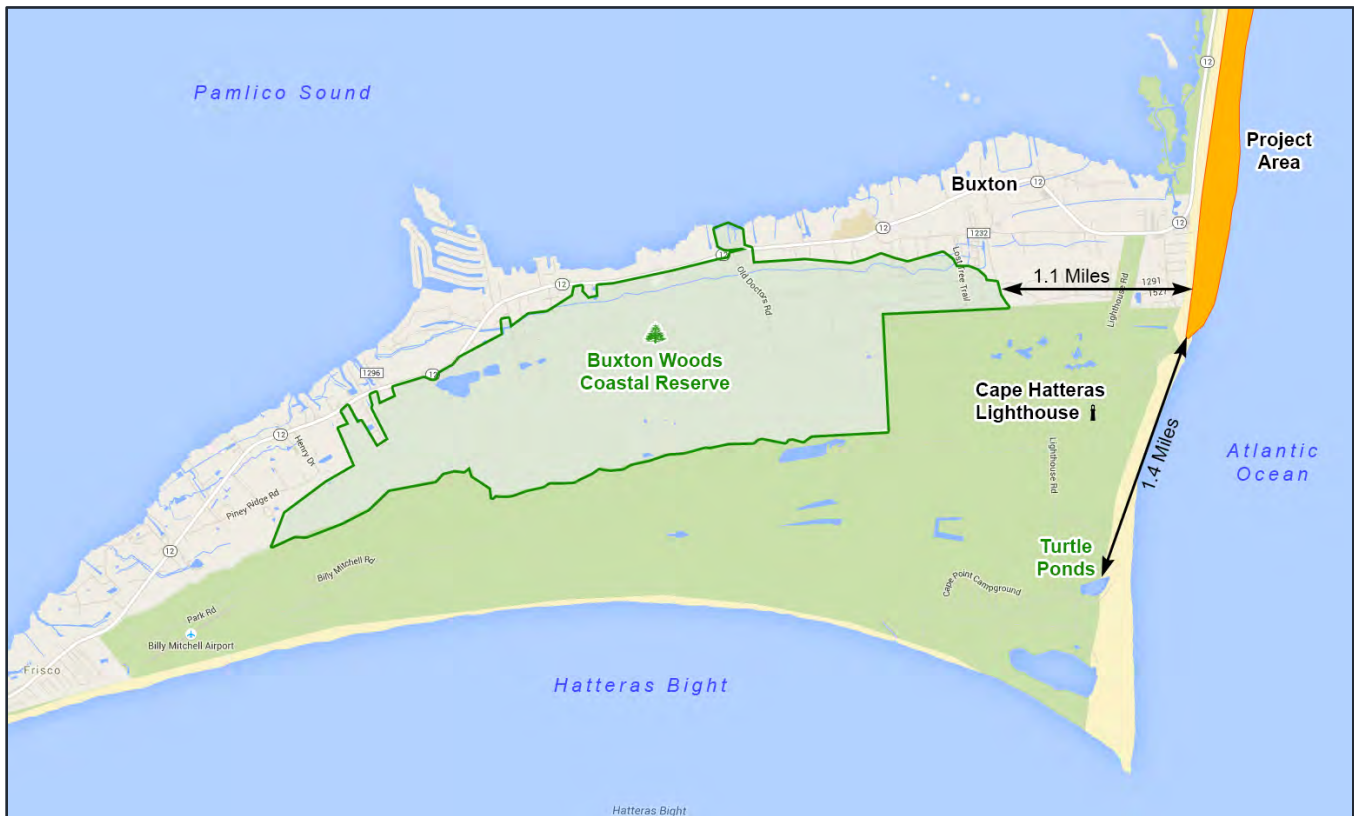
Figure 3.11. Map of Buxton–Cape Hatteras area showing the approximate boundaries of the Buxton Woods Coastal Reserve and Turtle Ponds, the two Natural Heritage sites located about 1 mile from the Proposed Action Area.

The Turtle Pond and Cape Hatteras Lighthouse natural area is a Registered Natural Heritage Area (RHA) under an agreement between the National Park Service and NC Department of Environment & Natural Resources. Within the Turtle Pond RHA an Interdune Pond natural community has been documented. The Buxton Woods Natural area is located just west and southwest of the Turtle Pond RHA and a portion of the Woods is also an RHA. The following natural communities have also been documented within the Buxton Woods Natural Area: Interdune Marsh, Interdune Pond, Maritime Evergreen Forest (Mid-Atlantic Subtype), Maritime Shrub Swamp (Dogwood Subtype), and Maritime Swamp Forest (Typic Subtype). These Natural Heritage Areas are depicted on Figure 3.11.

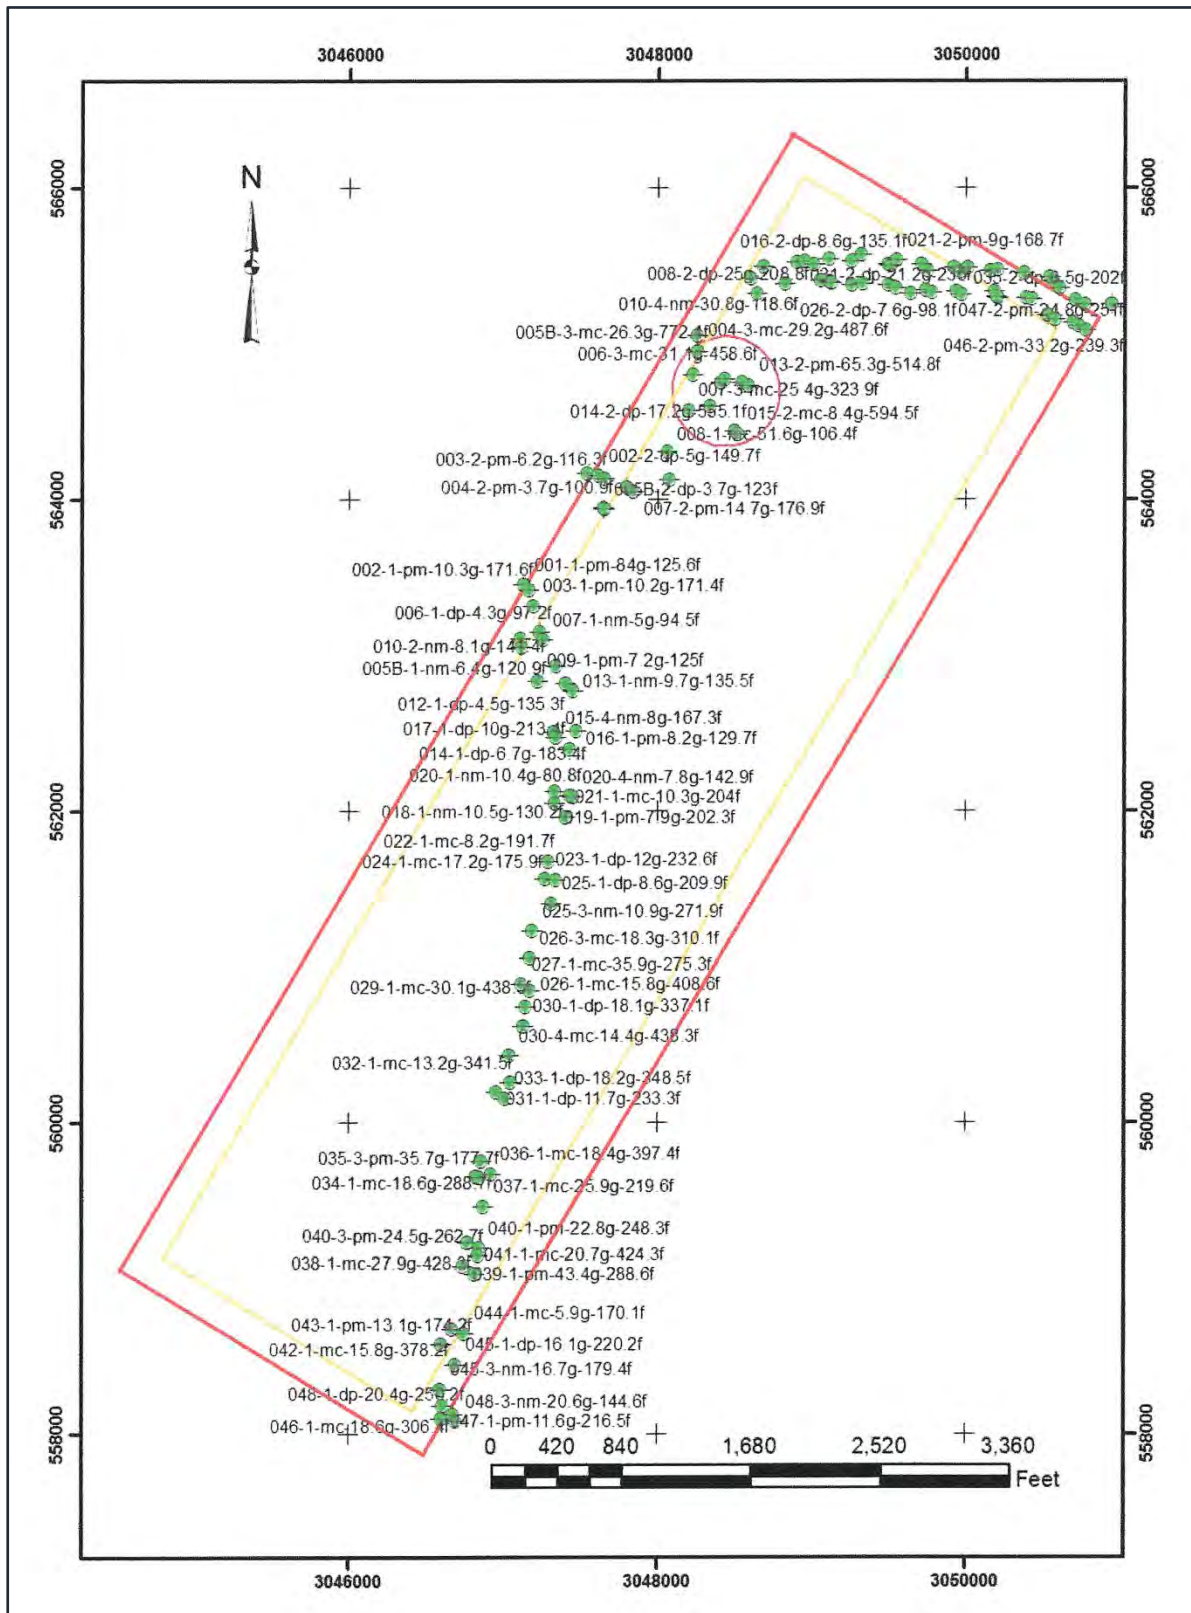
Figure 3.13. Map of the offshore sand search area showing magnetic anomalies (green dots) identified by Tidewater Atlantic Research (2015) in the Proposed Action Area. The majority of anomalies have an acoustic signature that is representative of cable, wire, or small-diameter pipe, except for the 10 anomalies circled near the northern end of the grid. See Appendix F – *Cultural Resources* for details.
