**BEACH RESTORATION TO PROTECT NC HIGHWAY 12  
AT BUXTON, DARE COUNTY, NORTH CAROLINA**

**BIOLOGICAL ASSESSMENT**

**CAPE HATTERAS NATIONAL SEASHORE**

**SEPTEMBER 2015**

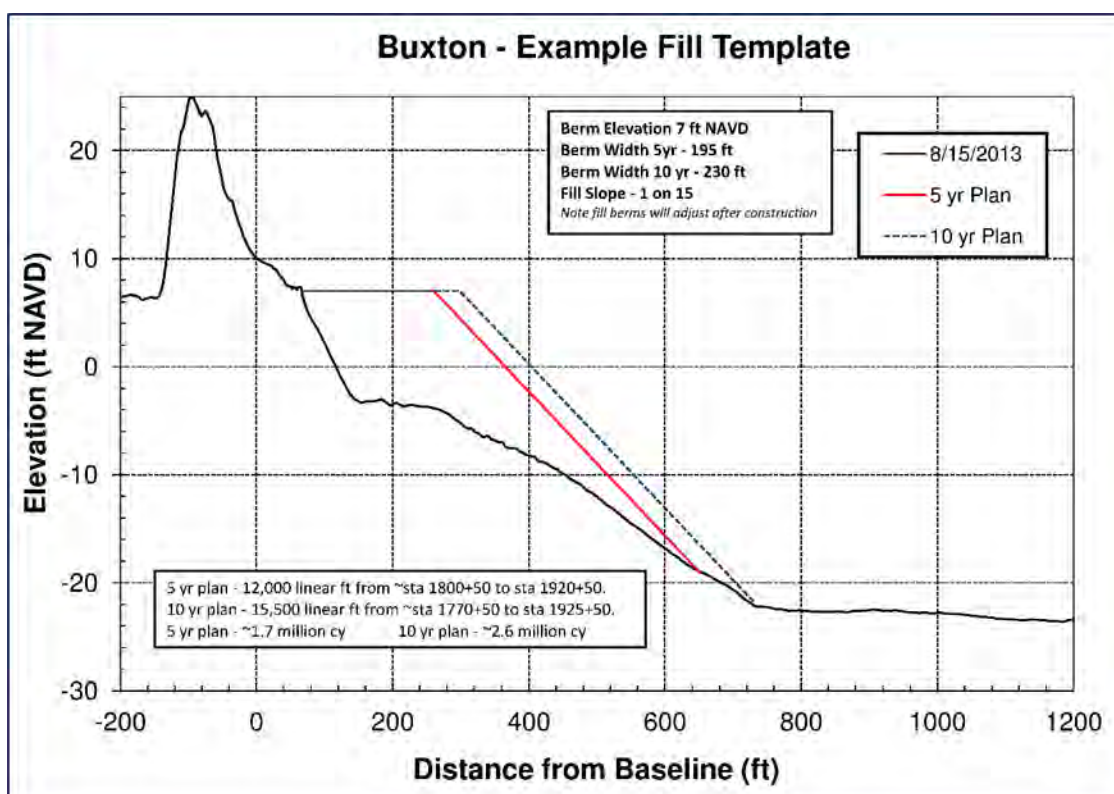
**FIGURE 3.7.** Representative beach nourishment fill template superimposed on a representative profile before profile adjustment. Highway NC 12 is positioned immediately adjacent to the foredune which was pushed up after the dunes breached in some areas during Hurricane *Irene* (27 August 2011) and Hurricane *Sandy* (27 October 2013). The average dry beach width after adjustment will be ~80 to 140 ft, depending on the section and final volume placed (constrained by fixed budget). No sand would be placed above +7-ft NAVD, on the upper beach foredune, or on any sandbags in place at the time of construction.

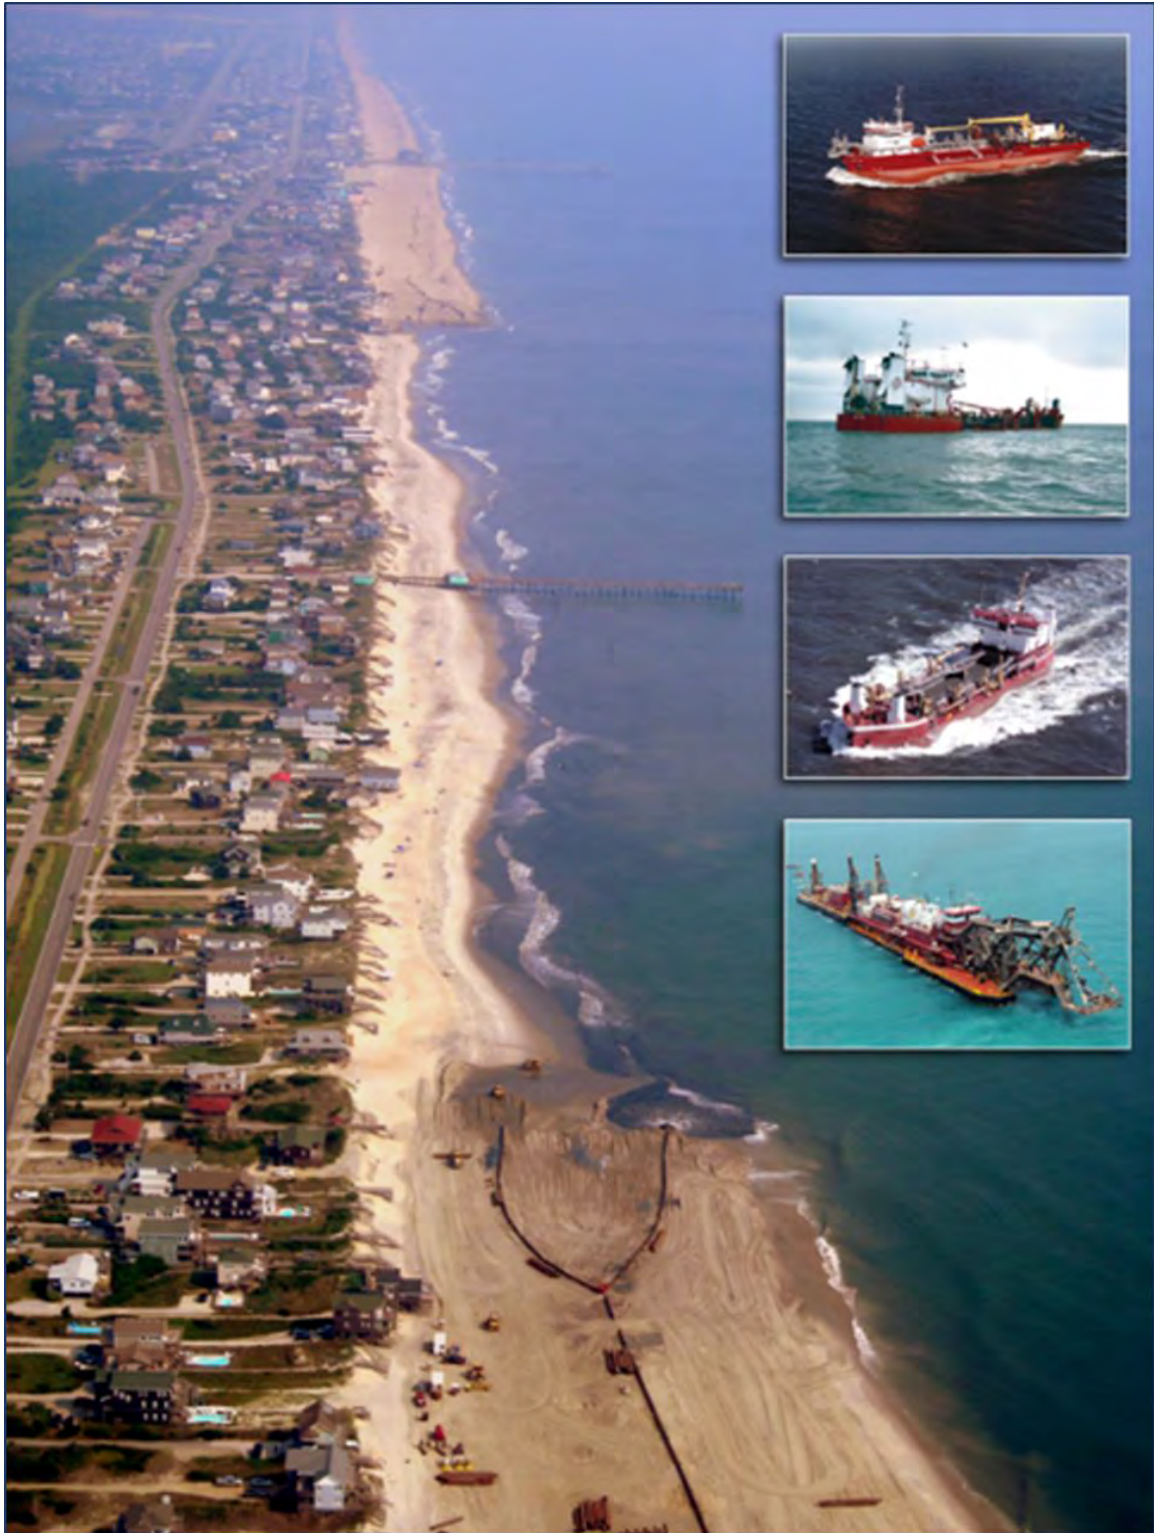
**FIGURE 3.11.** Three hopper dredges and one suction cutterhead dredge (inset photos) were used to construct the Nags Head (NC) beach nourishment project (24 May to 27 October 2011). Image shows nourishment construction in progress working south to north toward Outer Banks Pier in south Nags Head. [Photos by CSE and Great Lakes Dredge & Dock Co.]

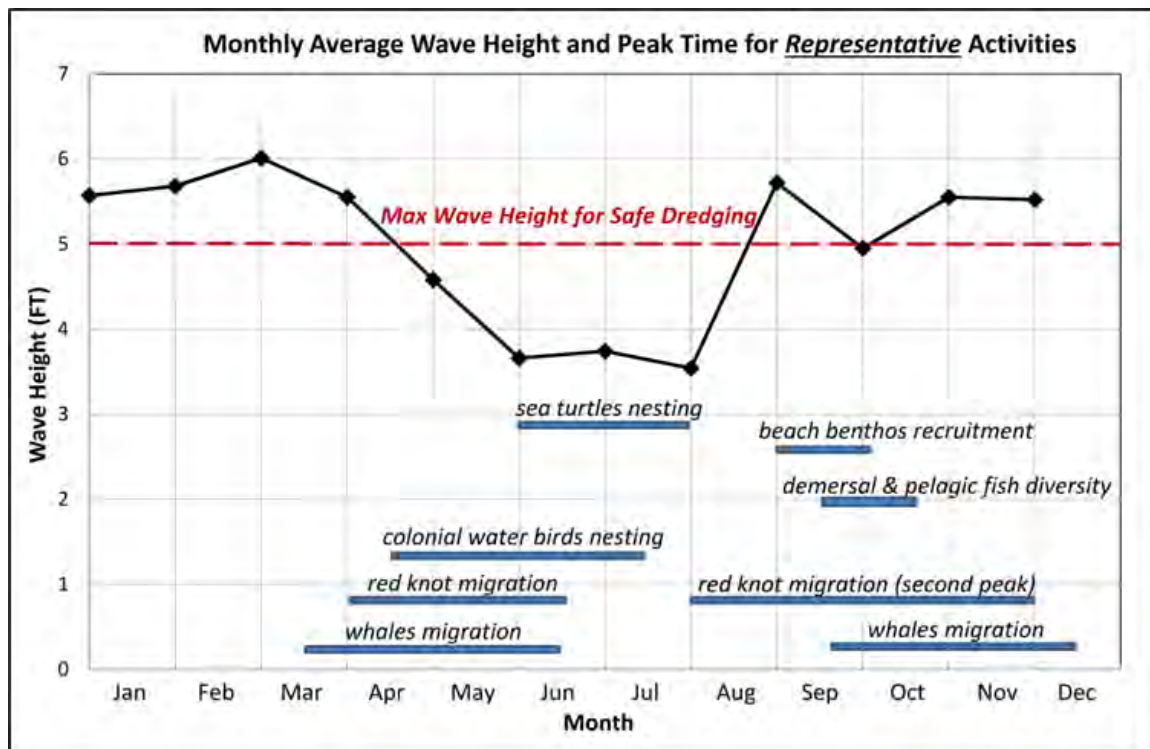
**FIGURE 3.16.** Graph showing the monthly average wave climate from 2003–2013 at NDBC Wave Buoy Station 41025 at Diamond Shoals (NC) near Buxton compared with the wave climate at the USACE Field Research Facility at Duck (NC). The criteria for safe dredging apply to hopper-dredge operations using ocean-certified equipment per informal guidance by dredging contractors. Suction-cutterhead dredges generally cannot operate safely in waves >3 feet (USACE 2010). The graph shows that average monthly wave height exceeds 5 feet from September to April in the Proposed Action Area. Calmest conditions occur in June and July when average wave heights are ~3.7 feet. The bars at the bottom of the graph show approximate range of dates when certain protected species may be present in or near the Action Area. (Source: NDBC)

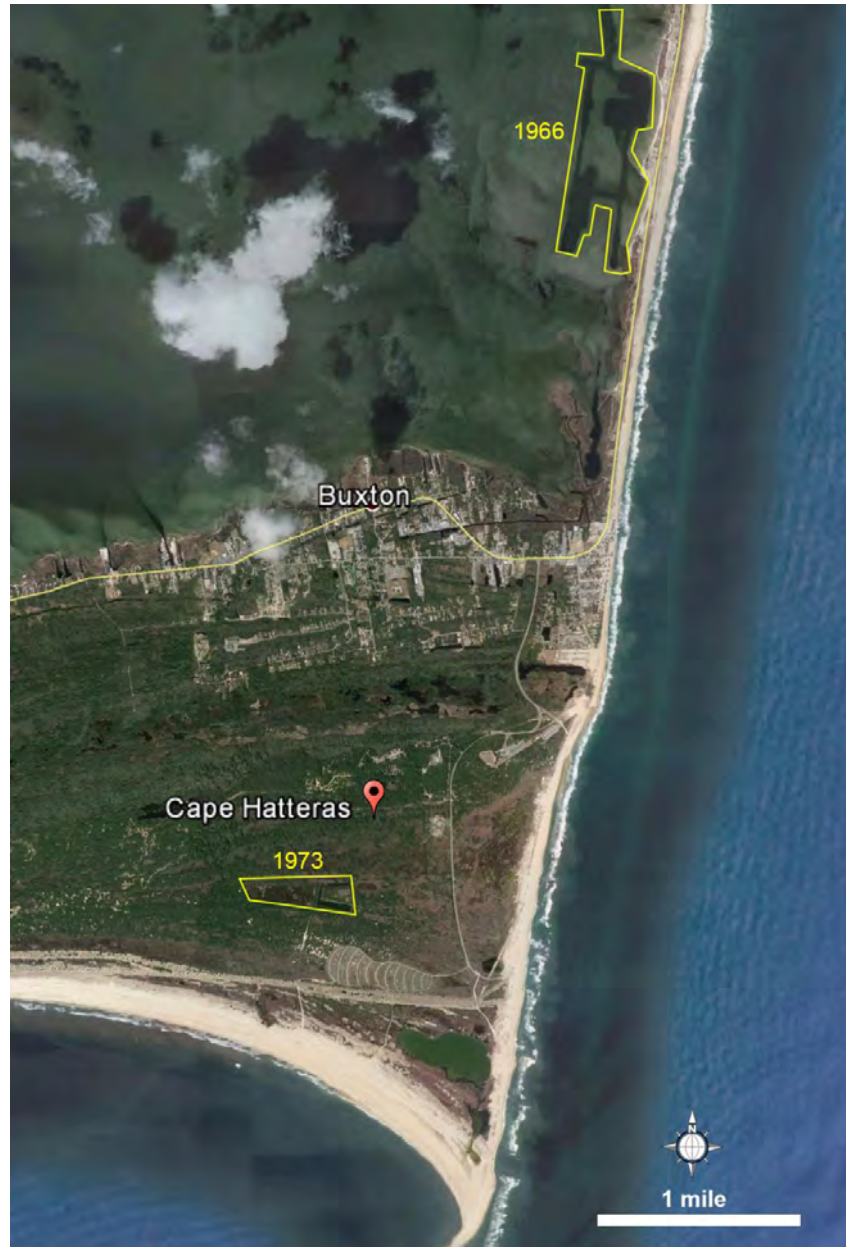
**FIGURE 8.1.** Aerial image of the project area in January 2014 showing relict borrow areas in Pamlico Sound likely used in a 1966 beach nourishment project (source: Google Earth). An inland pit within the Cape Point area of Seashore was excavated and used for borrow material during the 1971 and 1973 nourishment projects.

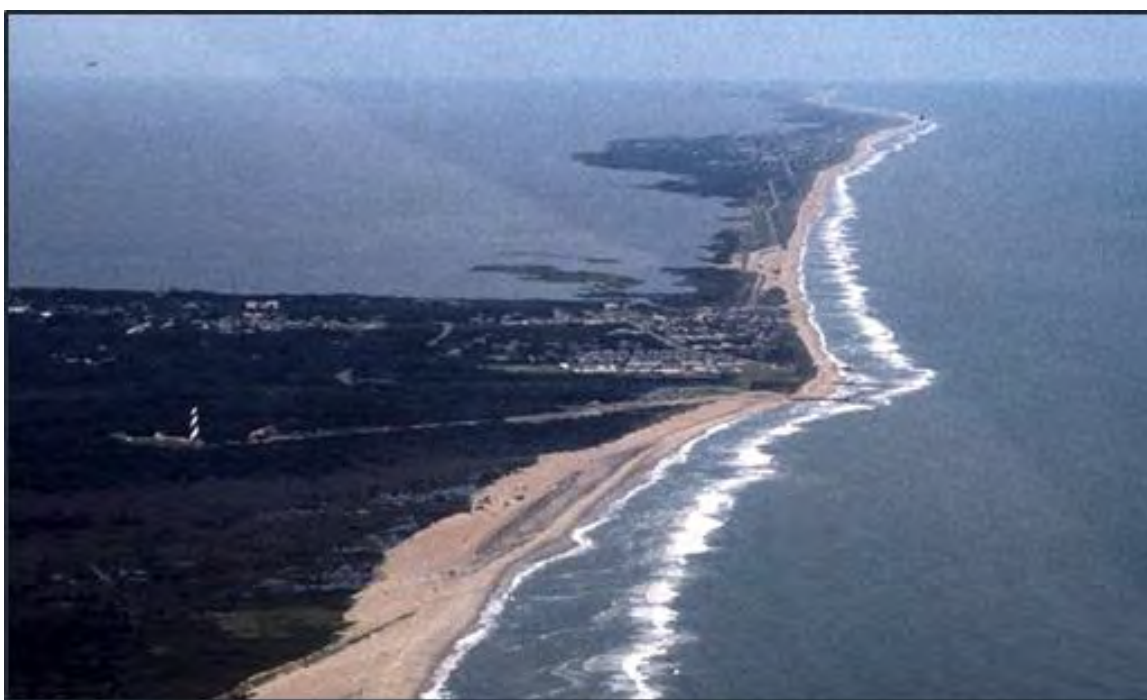
**FIGURE 8.4.** Oblique aerial photograph looking north of the shoreline “salient” (bulge) produced by three groins fronting the former US Naval Facility and old Cape Hatteras Lighthouse location. [Image courtesy of USACE–Wilmington District taken on 9 September 2000]

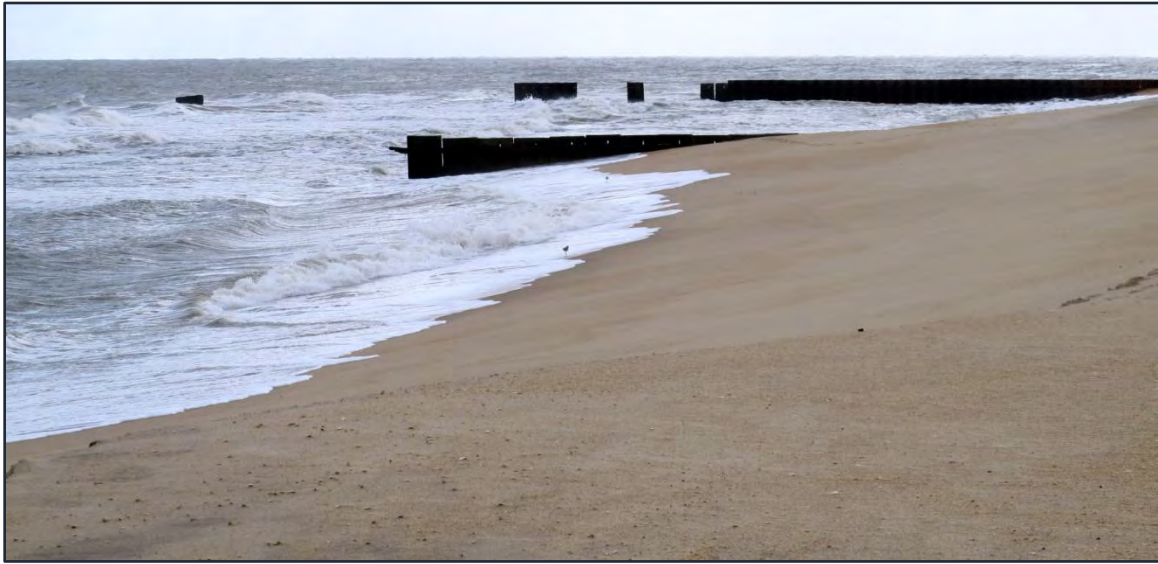
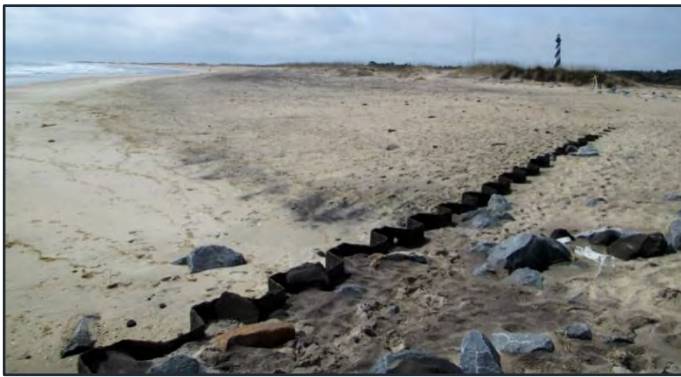
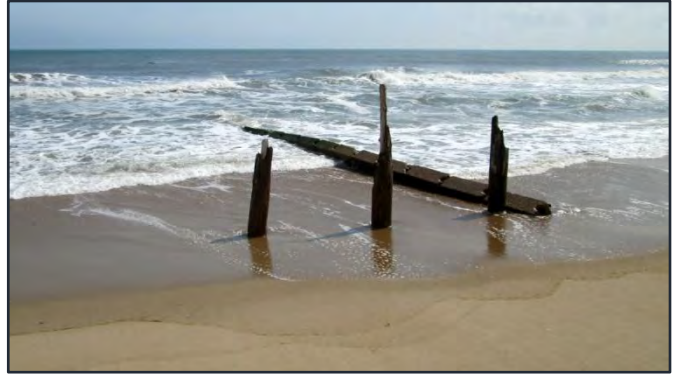
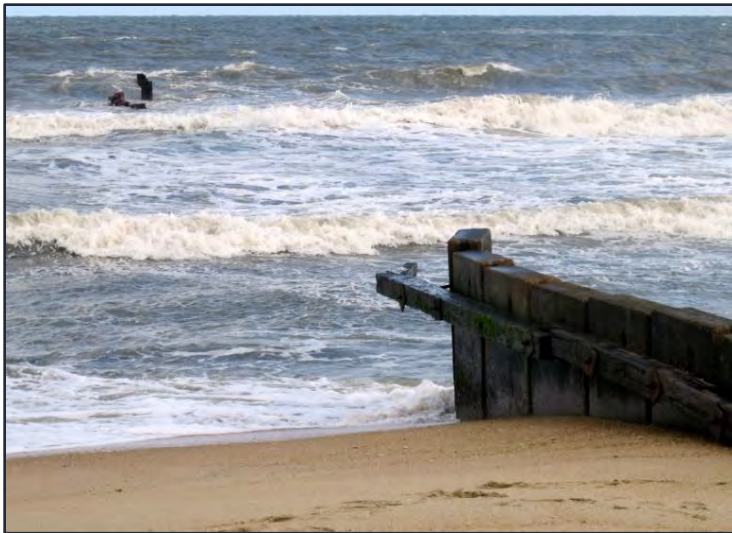
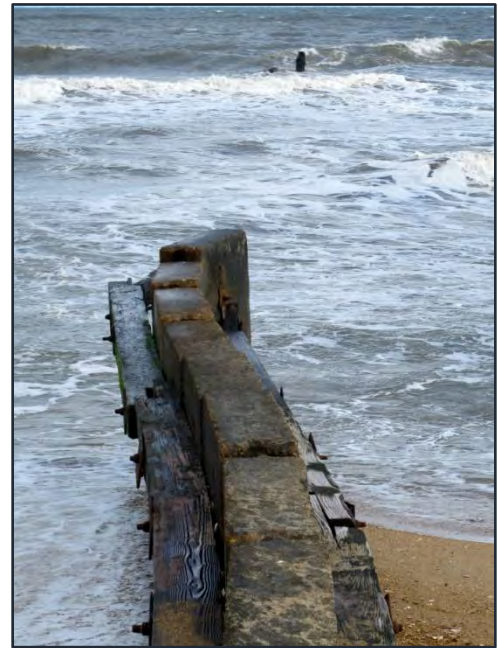
**FIGURE 8.5.** Cape Hatteras Groins. **[UPPER]** Groins 2 and 3 on 4 November 2013. **[MIDDLE LEFT]** Groin 3 – wing wall with Hatteras Lighthouse in the distance on 19 March 2013. **[MIDDLE RIGHT]** Groin 1 – visible remnant section in the surf zone on 19 March 2013. **[LOWER]** Groin 2 – missing sheet piles, damage and deflection at seaward end on 4 November 2013. [CSE 2013]

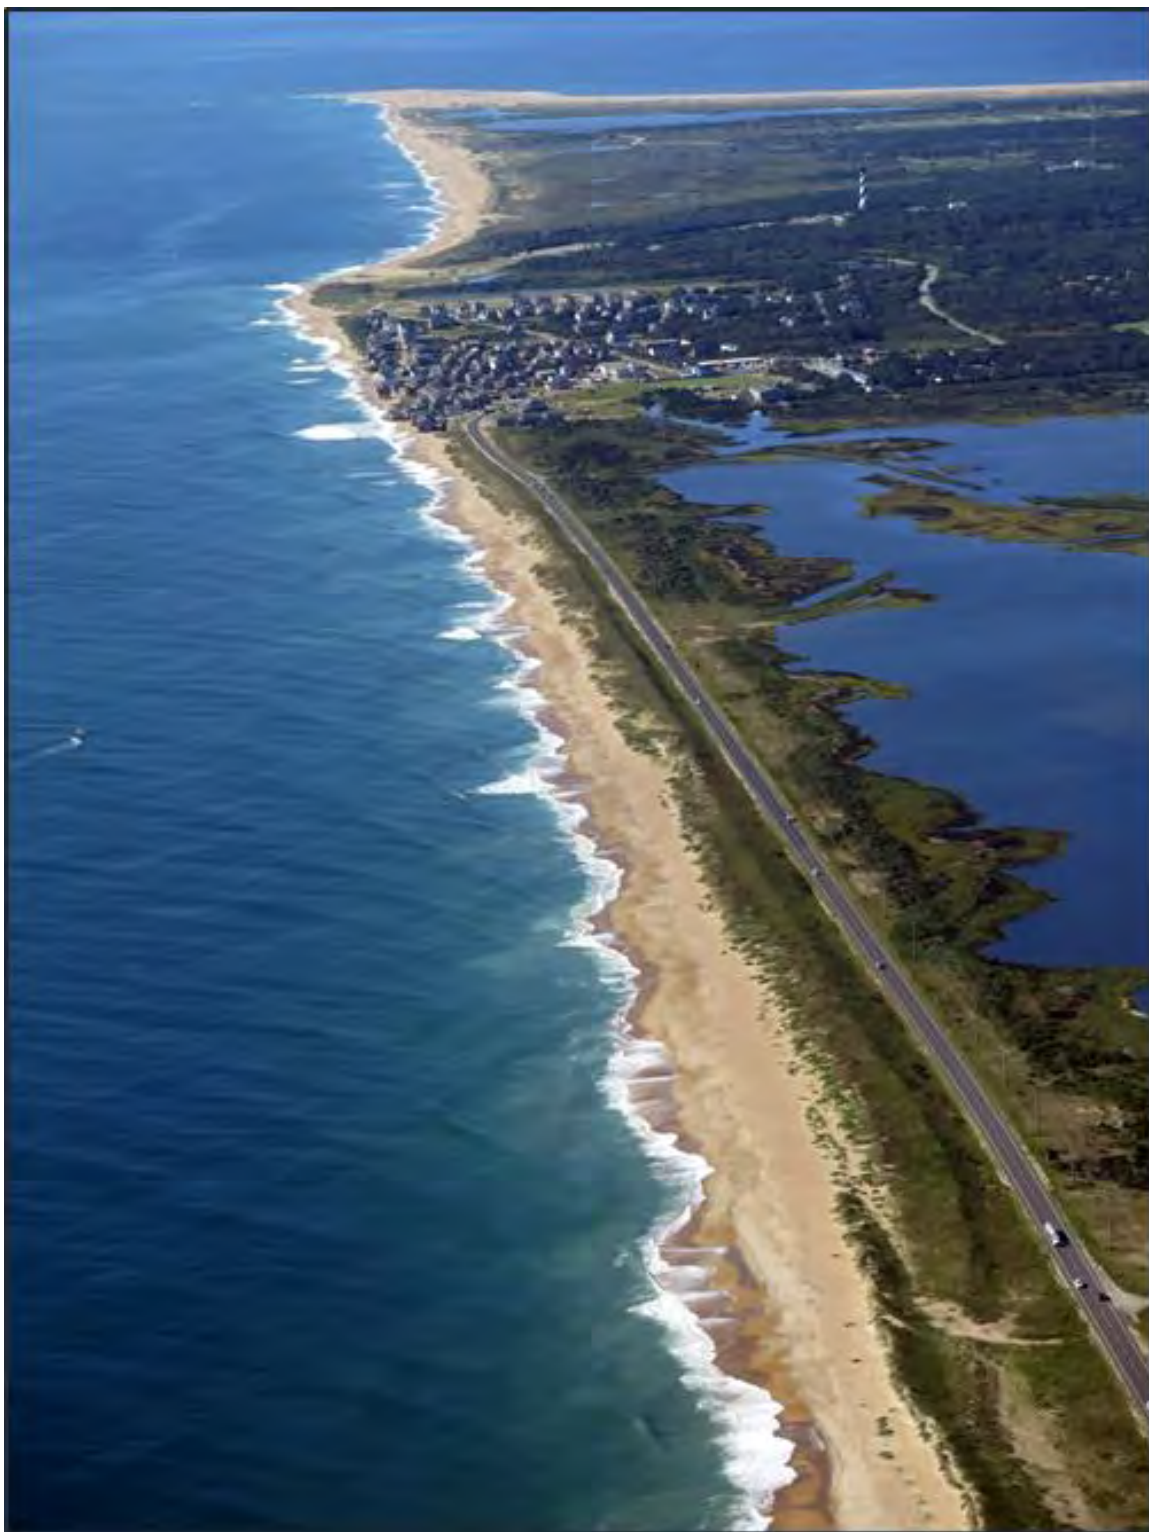
**FIGURE 8.6.** Project area on 11 September 2014 looking south. The “salient” (bulge) in the shoreline is situated at the south end of Buxton Village at the former site of Cape Hatteras Lighthouse and three groins which were constructed in 1970 by the US Navy. [Image by CSE]
