Subject: NEPA and NHPA Clearance: 2017-034 South Fork Fire BAER Plan (75169)

Project: 2017-034 South Fork Fire BAER Plan

SOUTH FORK FIRE BAER PLAN

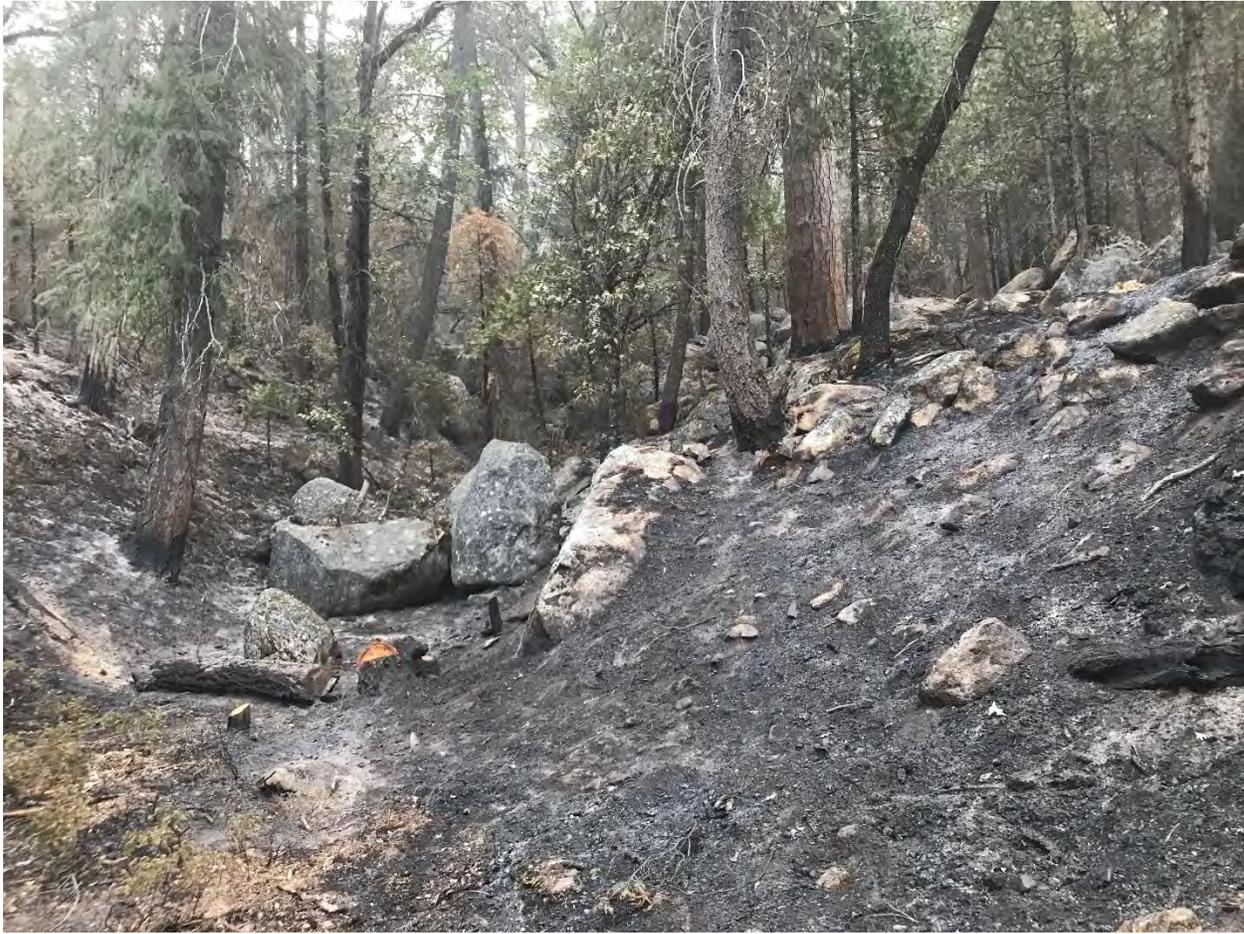
Photo 5. Debris flow levees upstream of water diversion.

Evidence of historic debris flows was observed in two drainages upgradient of the Wawona water intake (Photo 5), and is assumed to be present in additional watersheds that the team was not able to access. According to Yosemite Park geologist, Greg Stock, these debris flows likely occurred immediately following glacial retreat over 10,000 years ago.

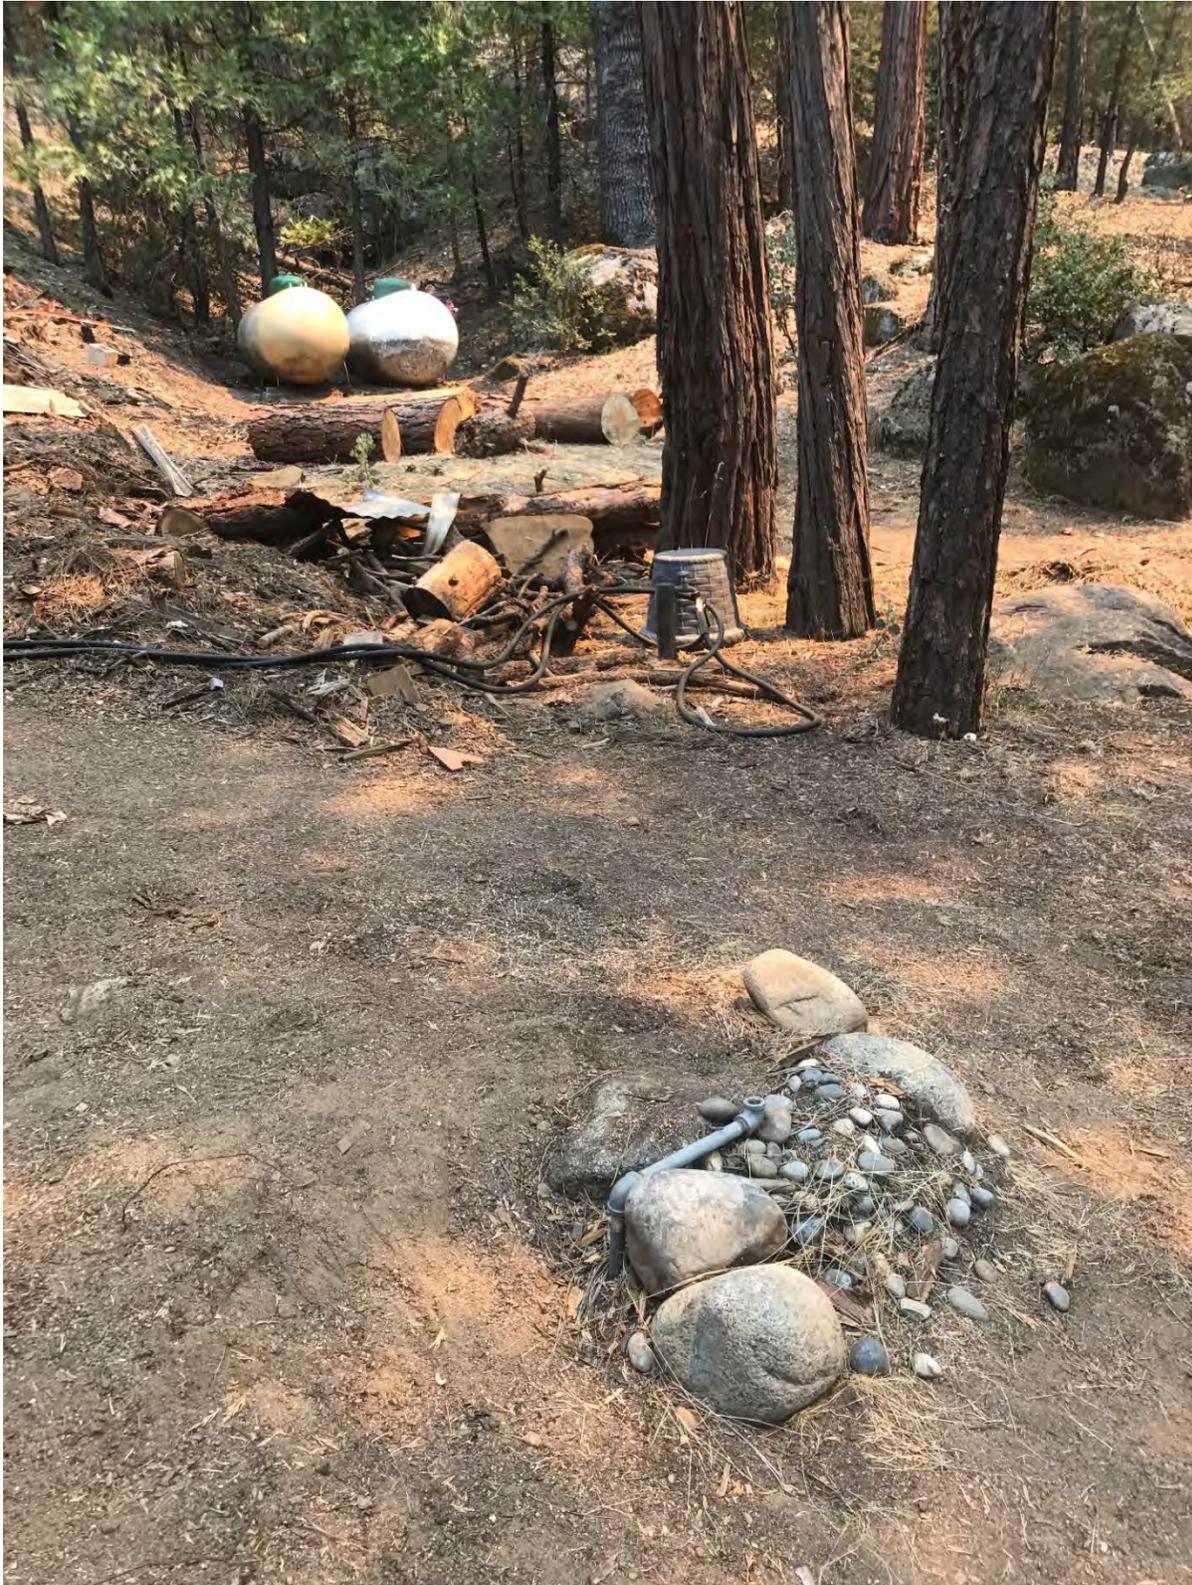
Photo 6. Propane tanks and water infrastructure installed in the bottom of a gully in East Wawona.

A risk of debris flow not captured by the model was identified on the slope above East Wawona. As discussed in the observations section, two small and one larger gully are present on this slope and exhibit characteristics of historic debris flow activity. The southernmost gully is largest and of greatest concern. The mouth of the gully sits between two privately owned residences (Houses

2 and 3) (See Chilnualna Houses of Concern Map), and two propane tanks are installed in the center of the gully with additional water infrastructure immediately down gradient. The corner of house 3 is in the flowpath for the gully. Floatable debris present in the gully could exacerbate a debris flow.

- 1) Place a temporary V-shaped sandbag dike in the back of and upstream from the house (W1).
- 2) Post a sign in the house describing the additional post-fire risk of flooding at the house and the need to be alert and evacuate during major rain events.
- 3) Remove floatable debris from channel between houses (W2).

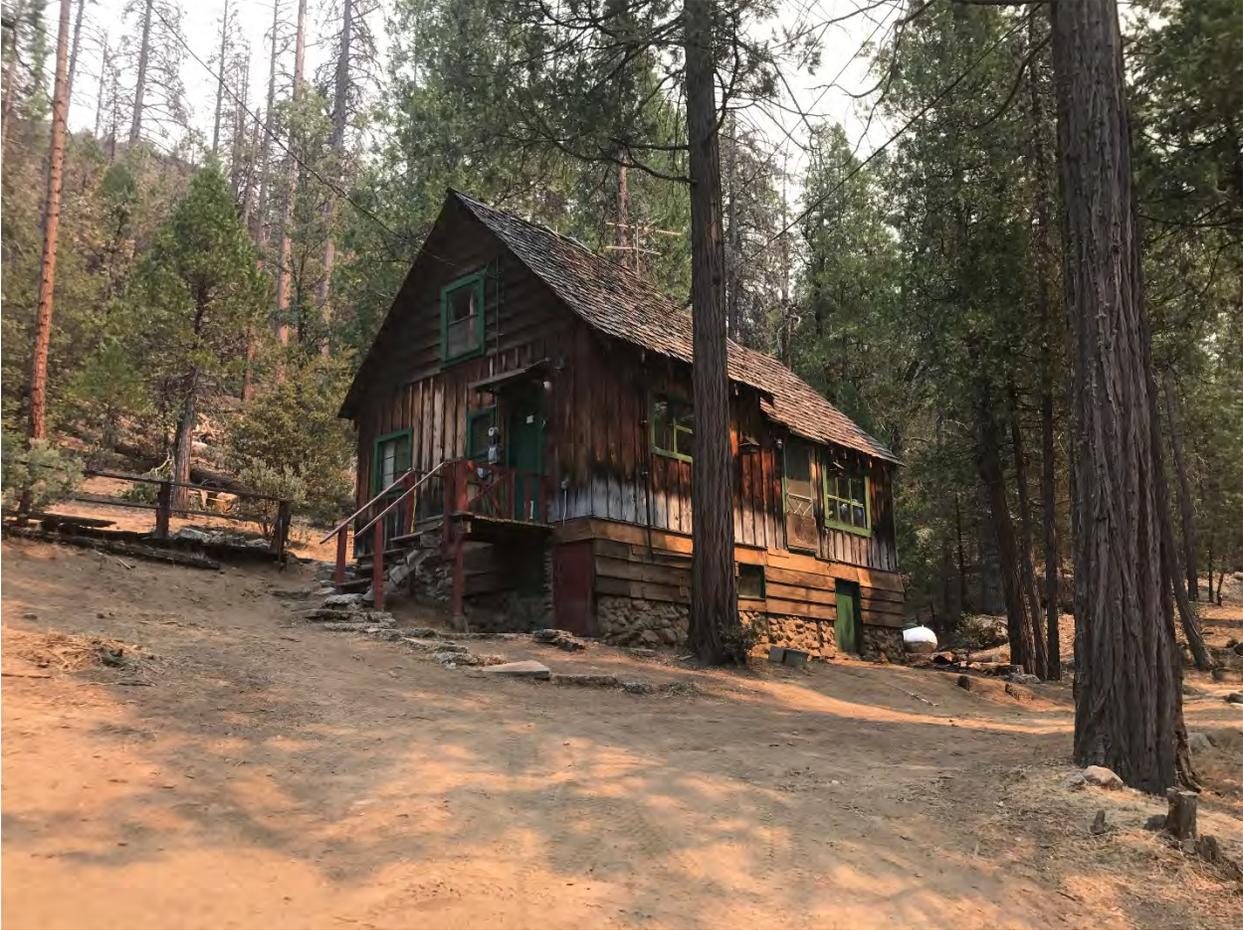
Photo 7. The corner of house 3 sits in the flowpath of the gully. Propane tanks in the mouth of the gully are visible to the right of the house.

Based on the steepness of the slope (average gradient = approximately 50%) and the soil burn severity observed, the residences at the toe of the slope are at risk for flooding and debris from a storm event of magnitude equal or lesser to the design storms discussed above.

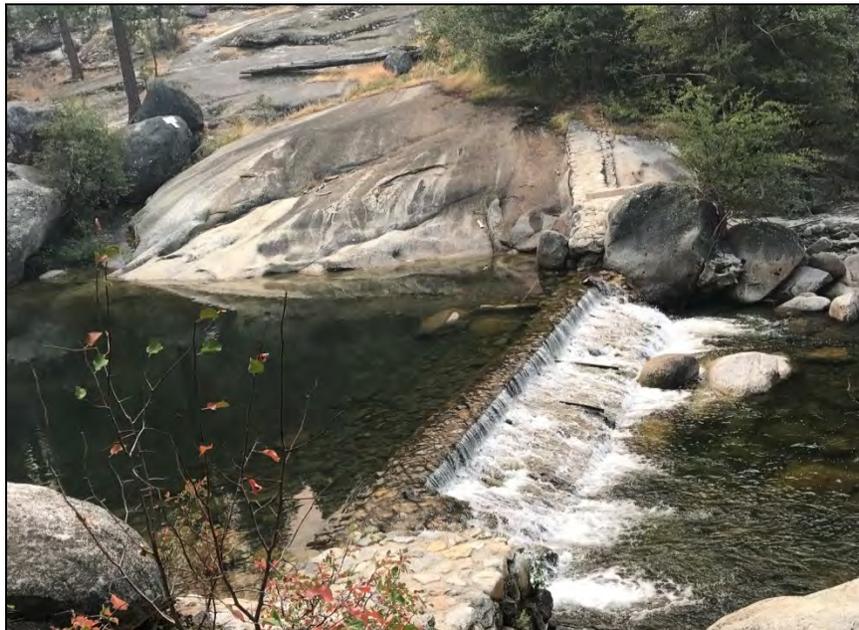
Photo 8. Water supply diversion dam from north bank.

Water utilities. The town of Wawona relies on the South Fork Merced River for its water supply and it is essential for the community. The water utility is owned and operated by the NPS. The source for the water supply is a small diversion dam in the river about ½ mile upstream from the town. The dam is a masonry gravity dam about 4-feet high and 55-feet long.

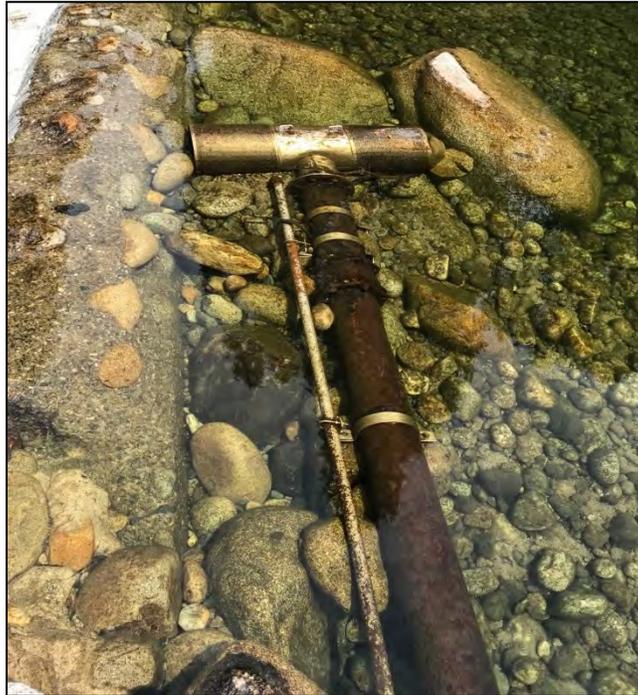
Photo 9 T-shaped inlet screen and pipe. Water flows from right to left and then over the dam.

Water from the river enters a T-shaped inlet, 8-inch diameter pipe. The top of the “T” is a stainless steel screen. Two large boulders have been placed adjacent to the inlet screen in an effort to keep rocks and other debris from damaging the screen. However, the screen has been bent in the past due to debris impacting the screen.

This action will achieve better protection of the screened inlet by extending it about 18-inches toward the north and lowering the inlet about 4 inches. This will put the inlet more behind two large boulders that were previously installed for inlet protection. The work involves removal of cobbles under the pipe, extension of the 2 inch compressed air line, and loosening the coupling. Chipping of the concrete anchors may be required.

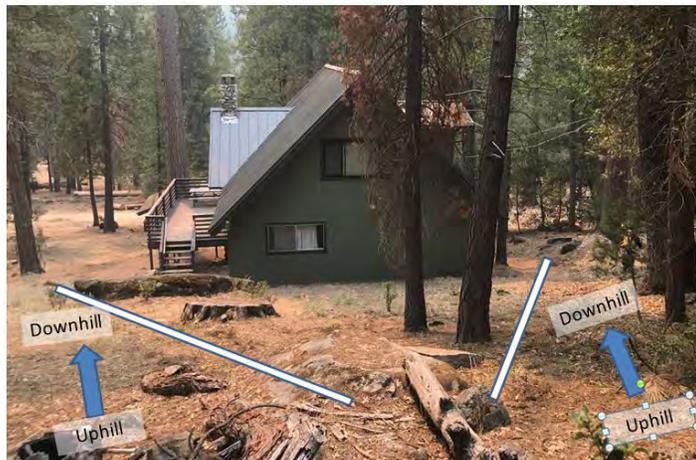
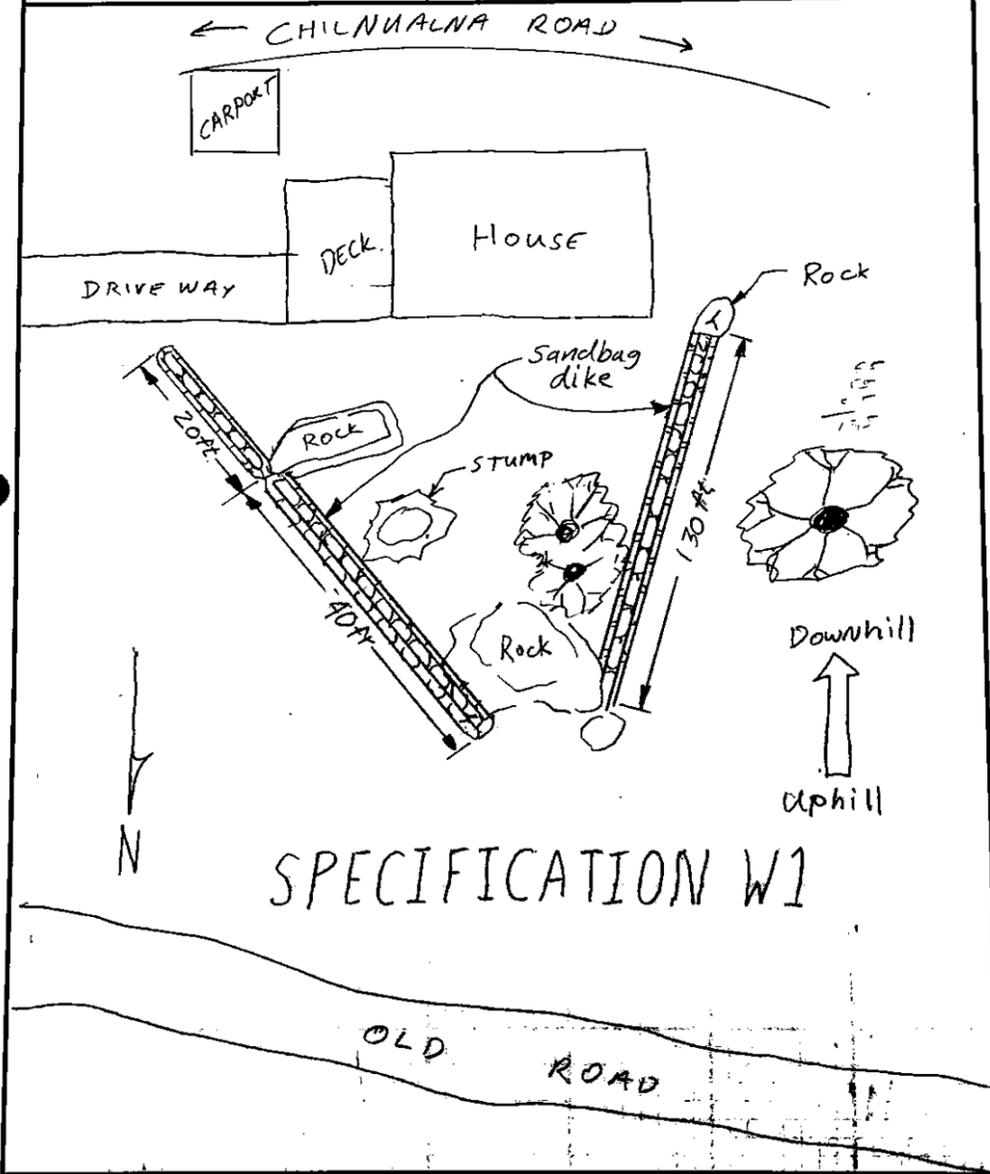
Figure: Levee placement location drawing

This project is to send a team of laborers and a foreman to construct

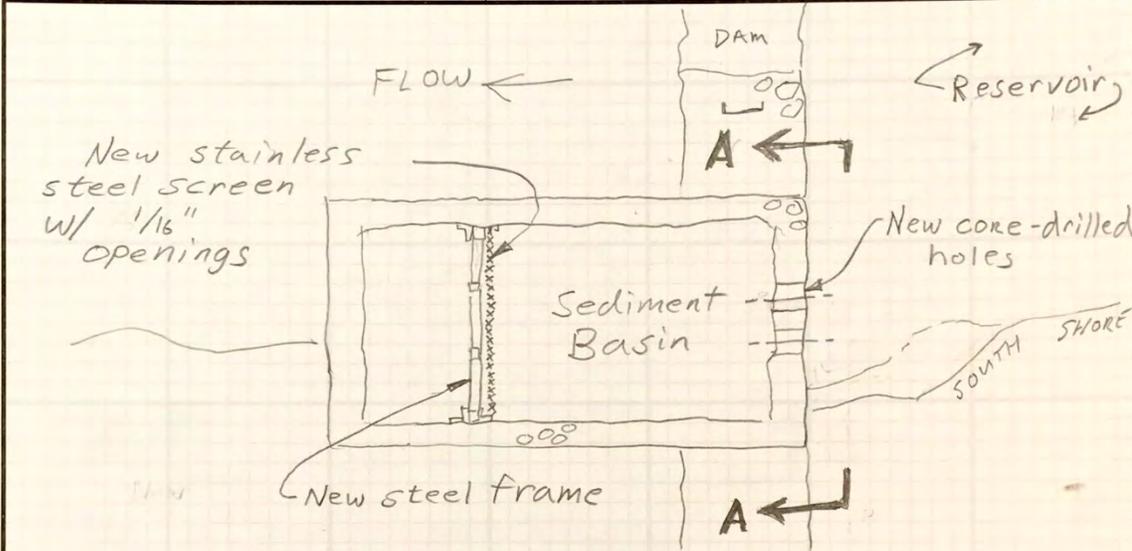
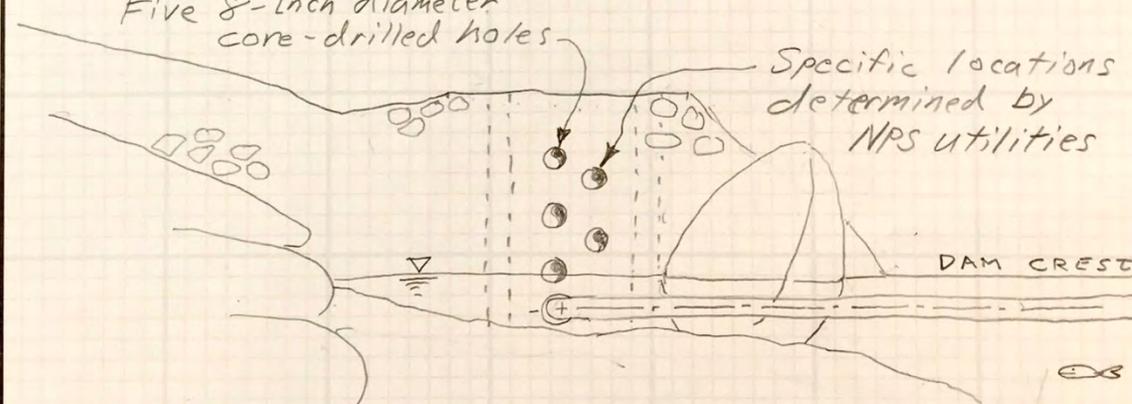
SPECIFICATION W3-B

SECTION A-A

A rock/concrete boring tool will be utilized to construct five holes in the east side of the sediment settling basin. The specific locations of the holes will be identified by NPS Wawona water utility staff. Hole locations should consider minimum and maximum water withdrawal elevations required and adequate distance between holes to minimize cracking during drilling. Five plugs shall be installed from inside the settlement basin. The outside east end of the holes shall be covered with a 1/8th inch stainless steel screen. The screen shall be mounted to the masonry wall with steel strap.

A new screen will be built and installed in the sediment settlement basin. The screen shall be removable. The screen will consist of a steel frame with additional vertical and horizontal members to support a stainless steel screen. The screen shall be constructed of stainless steel with small openings (e.g. 1/16th inch).

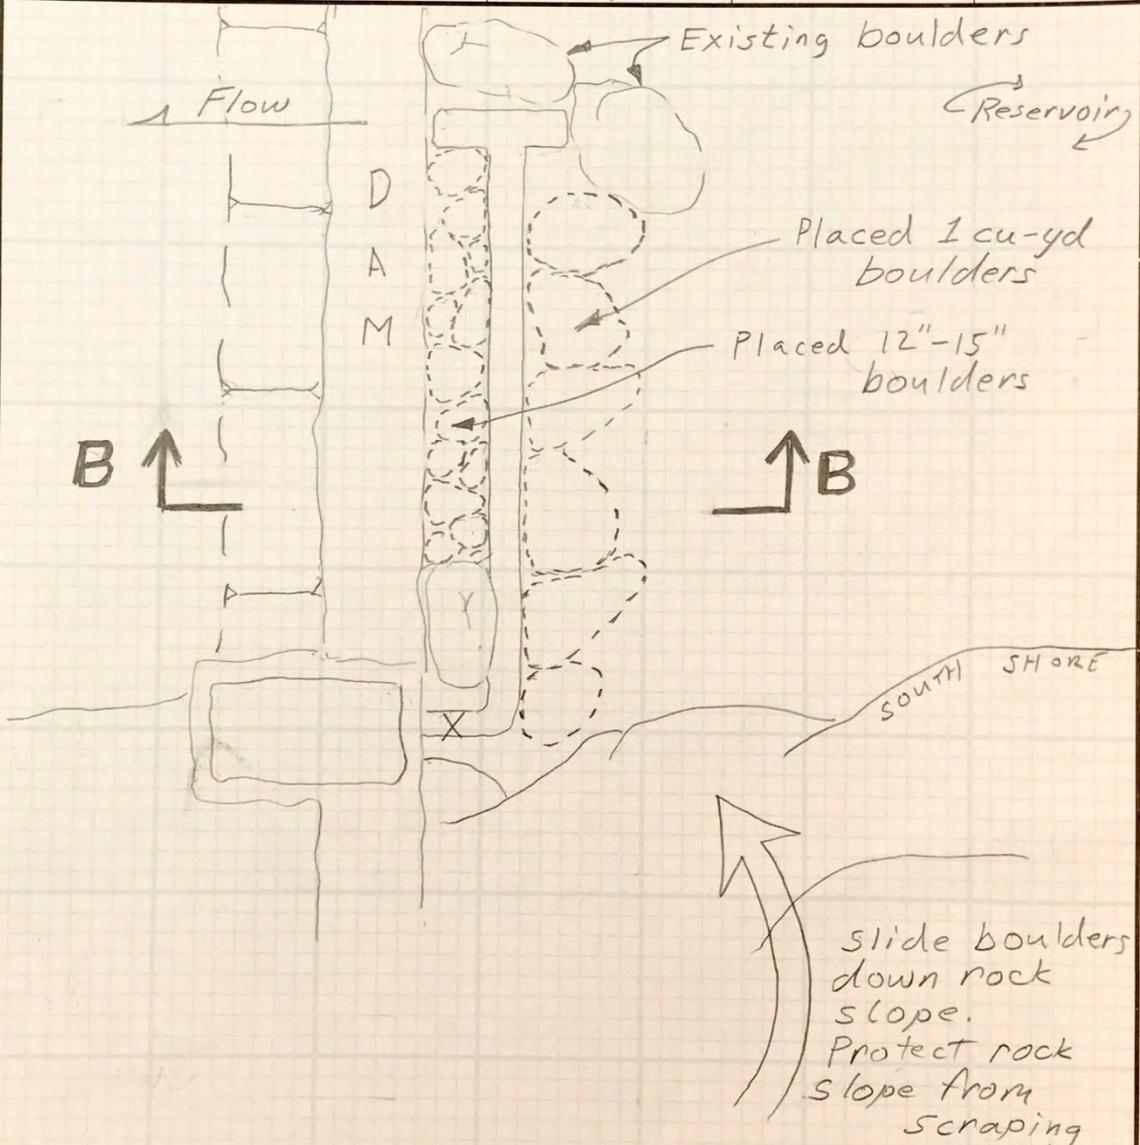
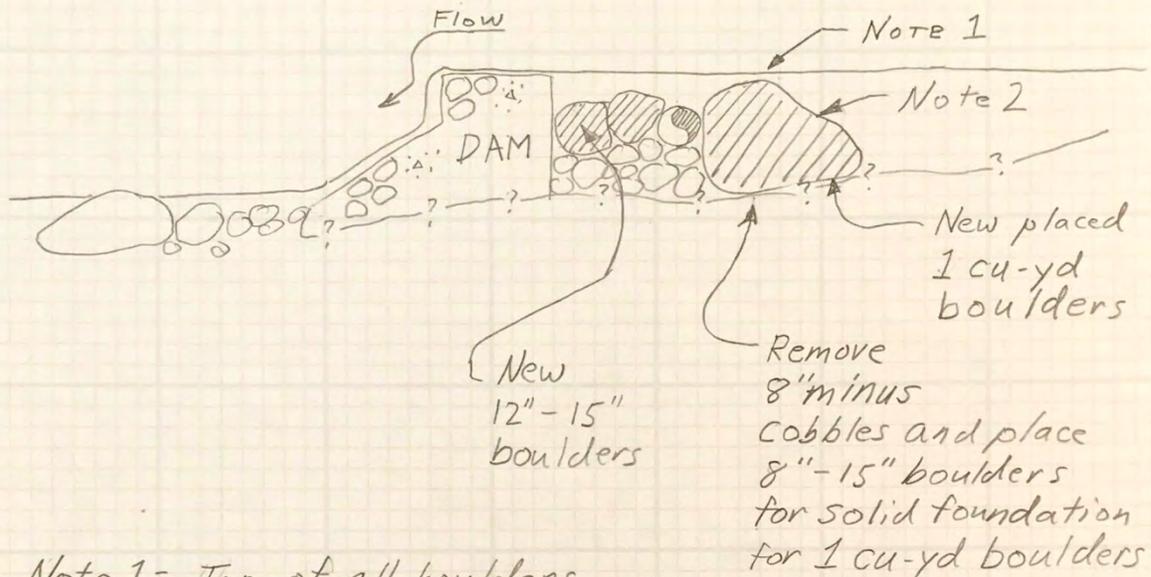
SPECIFICATION W3-C (1 of 2)
 Inlet Boulder Armoring
 N.T.S.

Note 1 - Top of all boulders shall be submerged and below top of dam.

Note 2 - When possible face angled boulder surface upstream to direct debris up and over the dam.

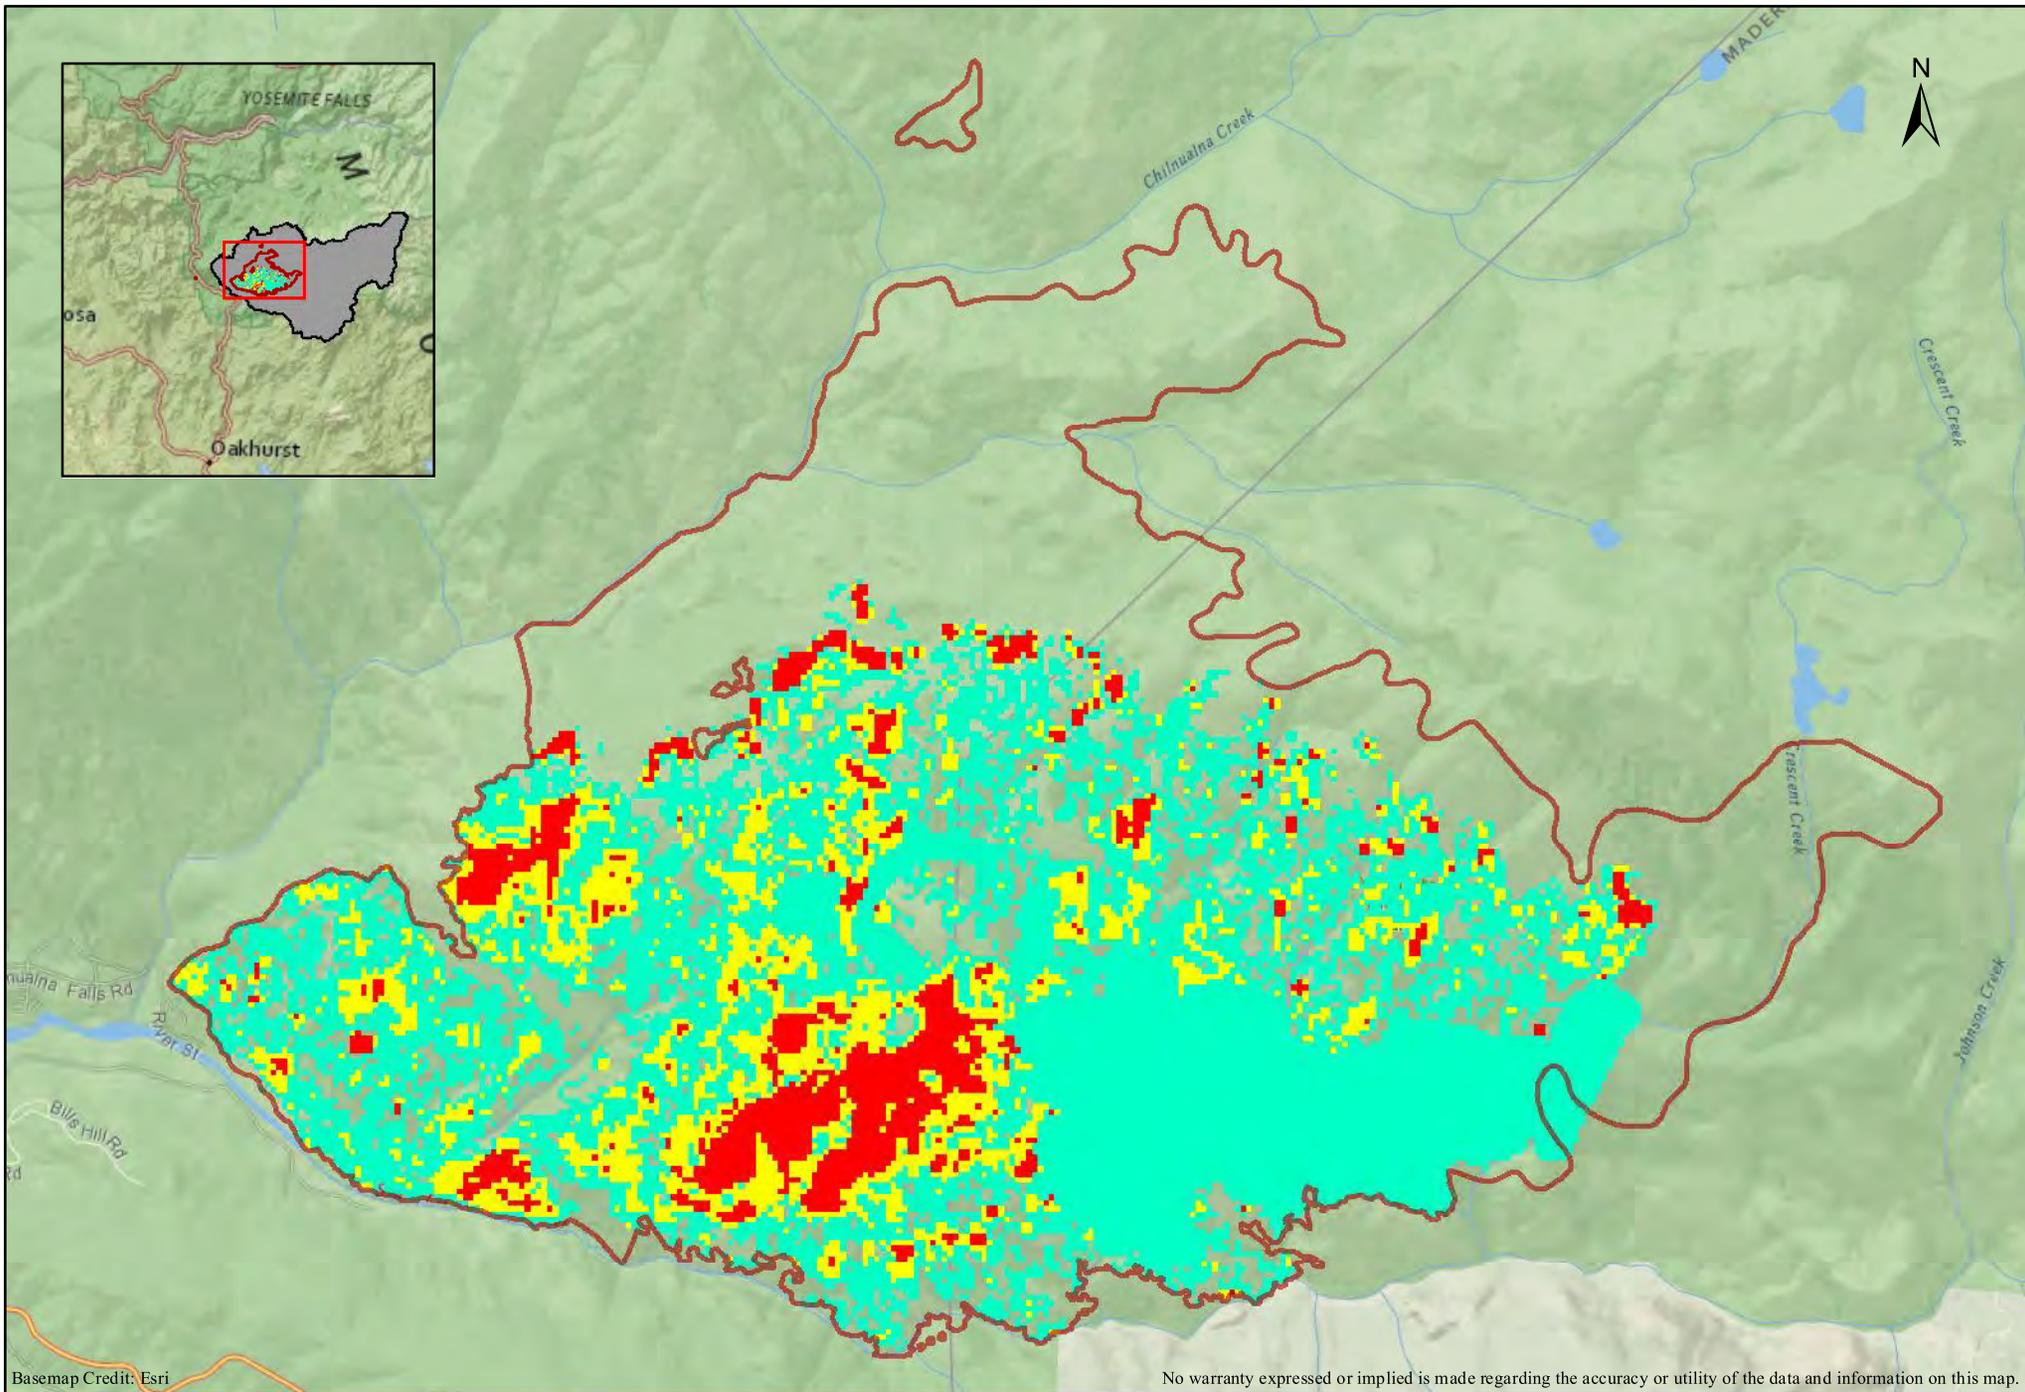
South Fork Fire Soil Burn Severity

- Fire Perimeter - 6,673 Acres
- Moderate Soil Burn Severity
- Low Soil Burn Severity
- High Soil Burn Severity

The BARC was found to over-estimate the amount of moderate soil burn severity and underestimate the amounts of low and high soil burn severity. It was adjusted to align with field observations. The final Soil Burn Severity Map is presented in the maps section of this report. In general, areas classified as high exhibited hydrophobicity similar to unburned areas with infiltration taking 10-30 seconds at the mineral soil surface and greater than 30 seconds at 1 cm. Soil burn severity classification by watershed is presented on the Soil Burn Severity Map and in Table 1.

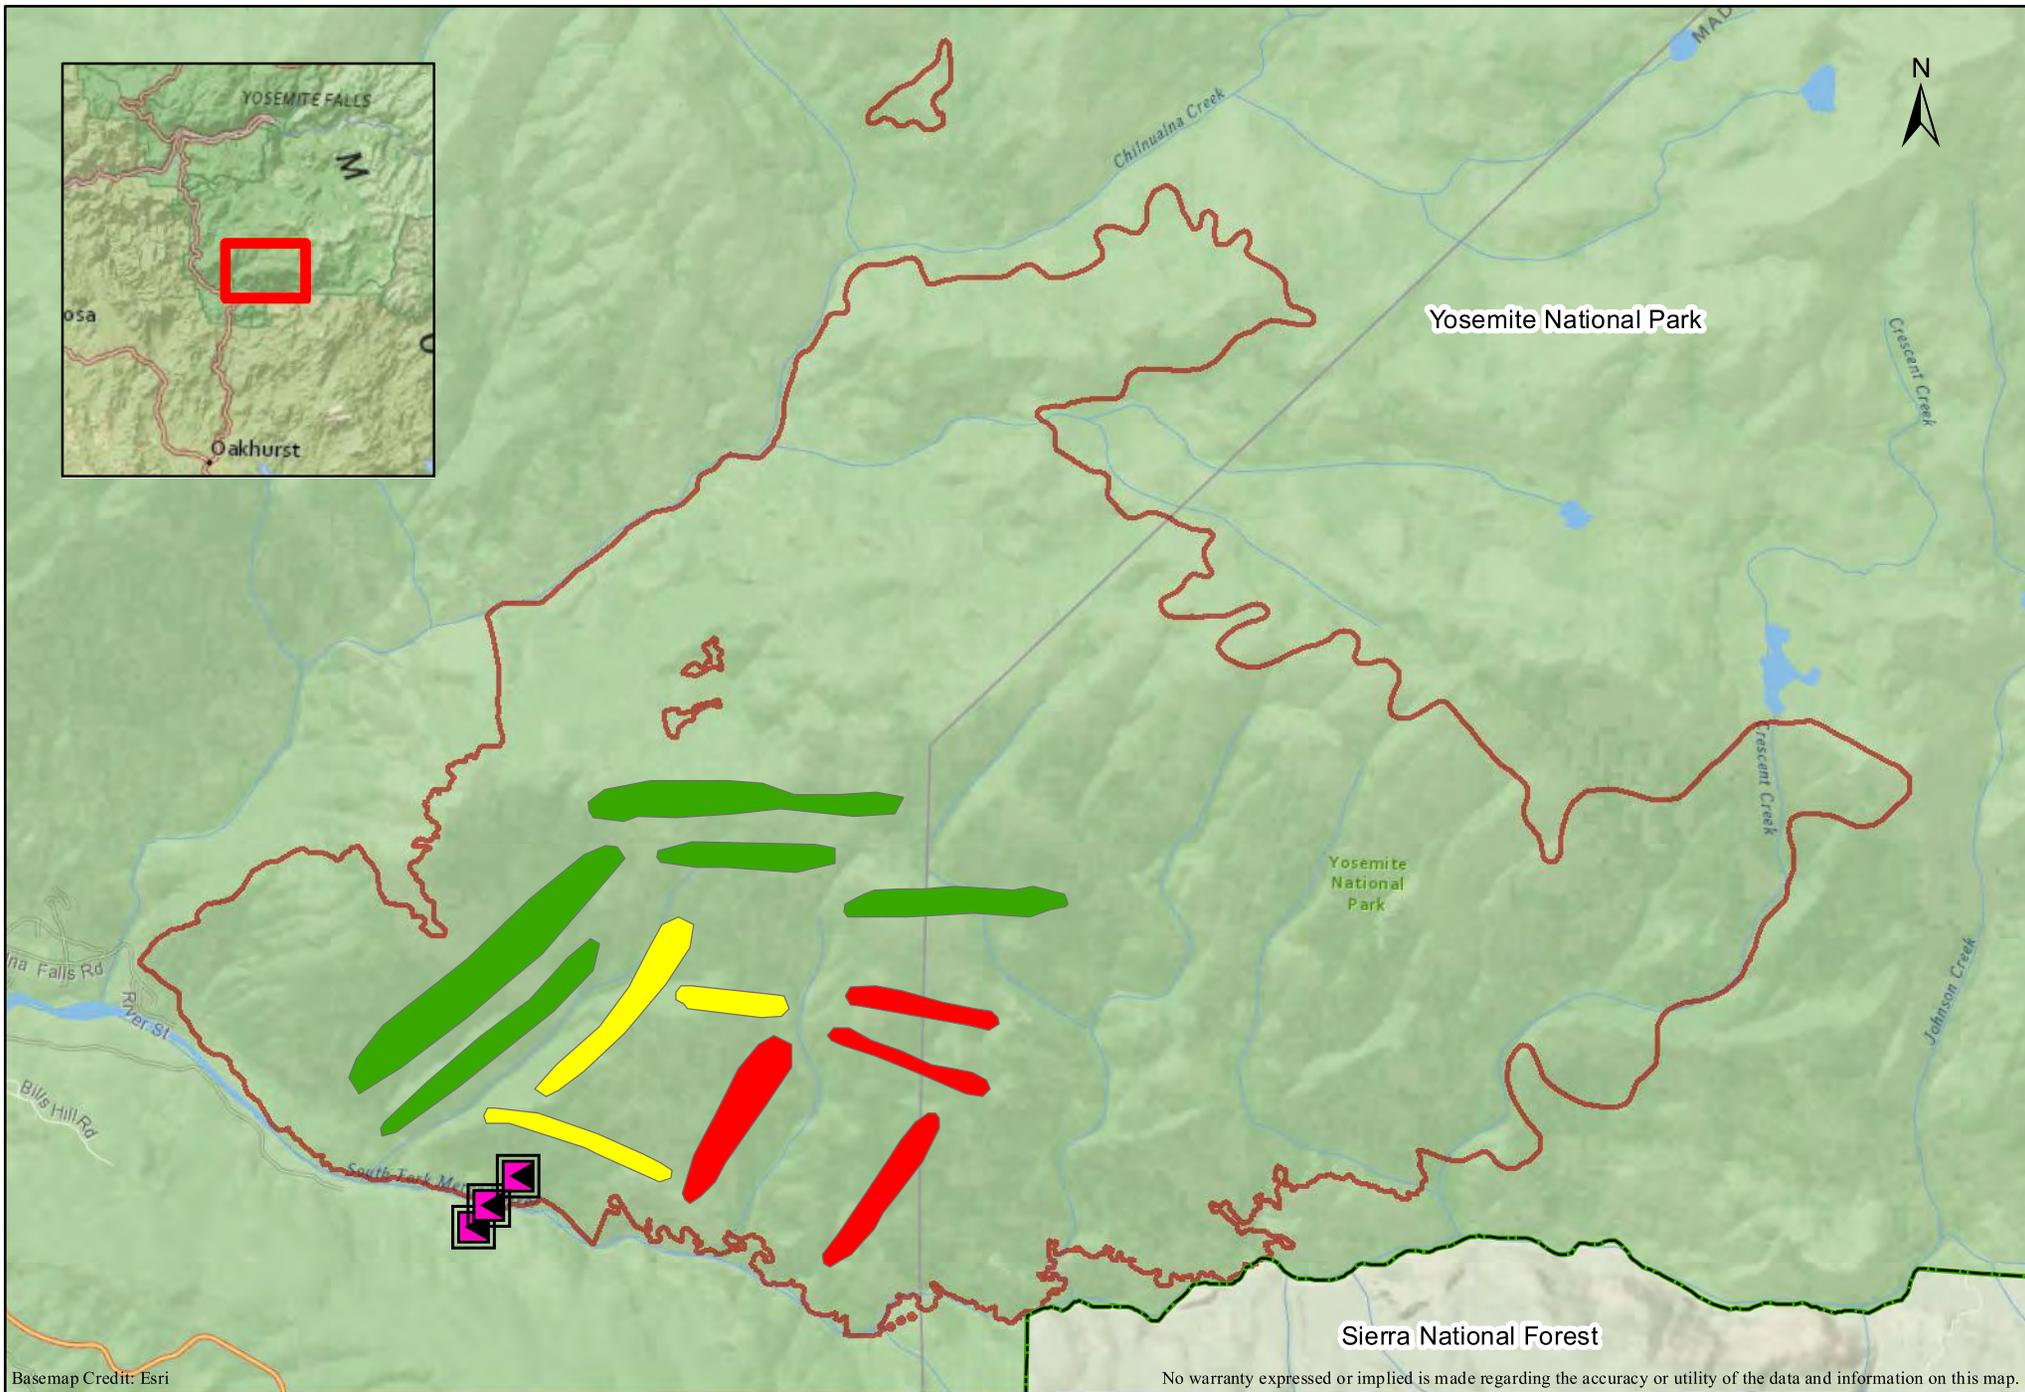
- Yosemite Boundary
- Fire Perimeter - 6,673 Acres
- 8/13/2017 Drops
- 8/14/2017 Drops
- 8/15/2017 Drops
- Retardant Detected

Multiple loads of fire retardant were dropped on the South Fork Fire. Some of the drops were close to waterways and drift across the South Fork Merced River was observed by the READ (See South Fork Fire Retardant Drops Map). Thus, there is a potential for chemicals in the retardant to enter the stream system.

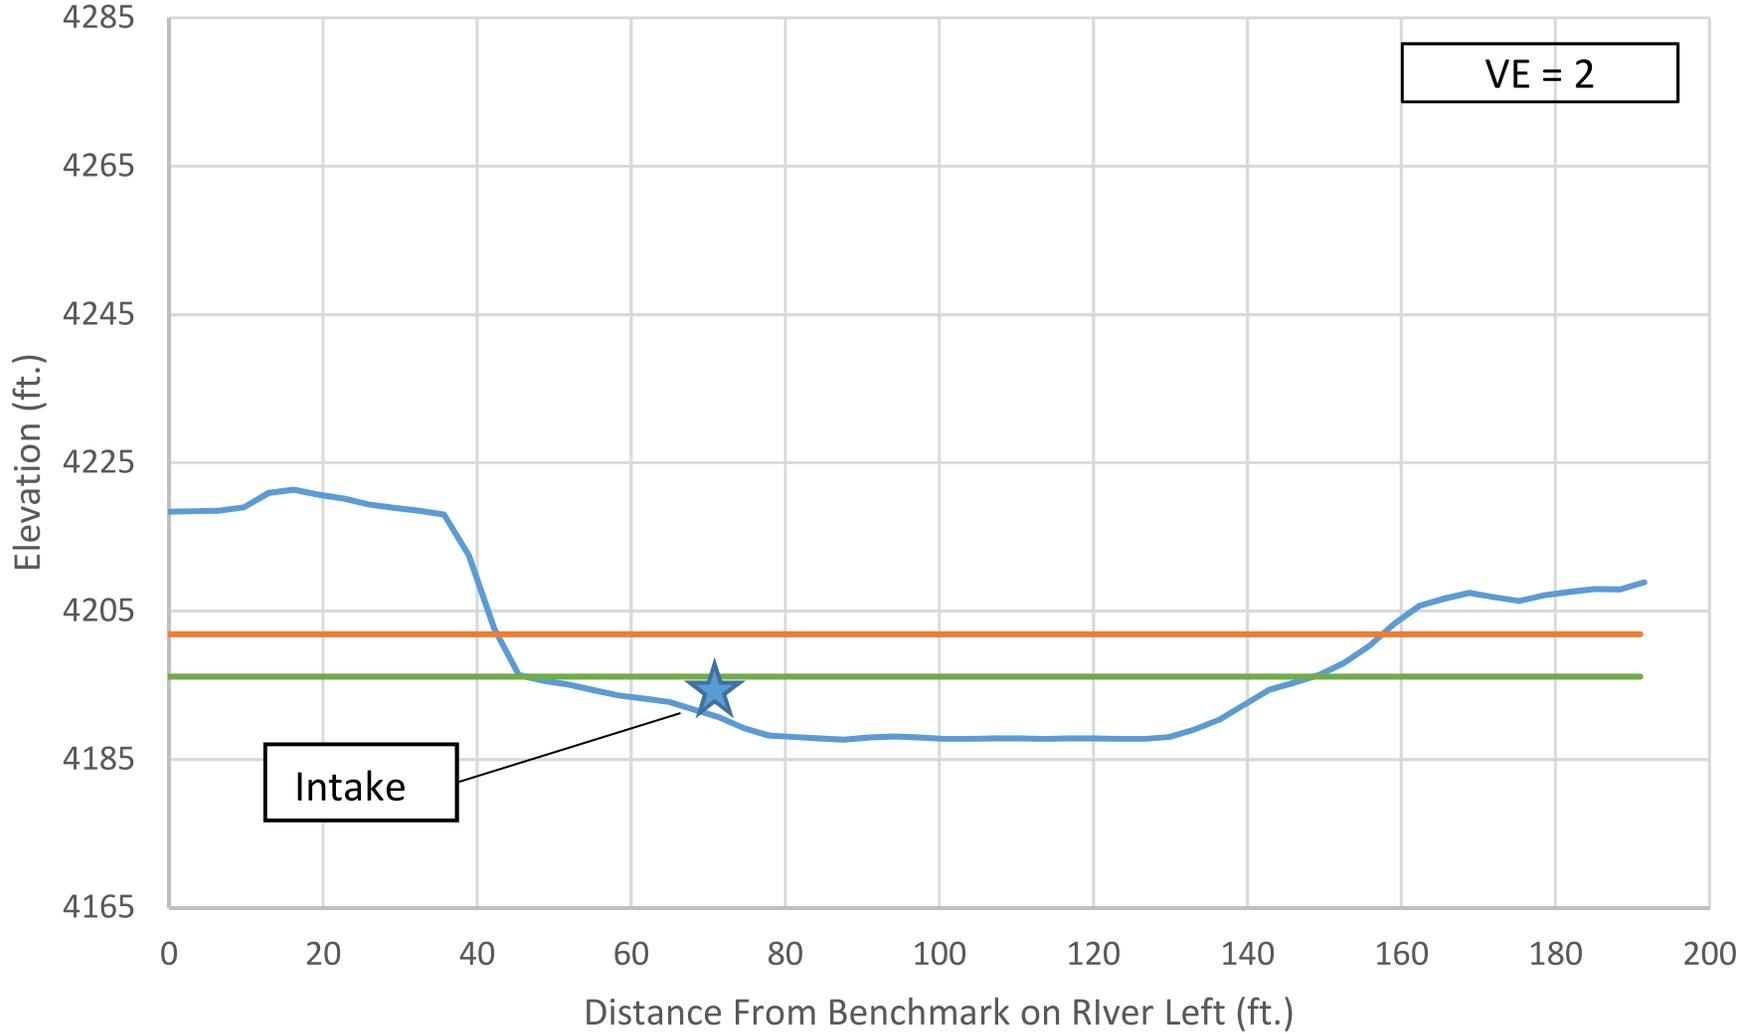
Channel Cross Section at Wawona Water Intake

— Channel Cross Section at Intake — Q25 (Pre-Fire) — Q25 (Post-Fire)
