Environmental Assessment

Minimize Erosion on the Upper Company Creek Road

September 2007

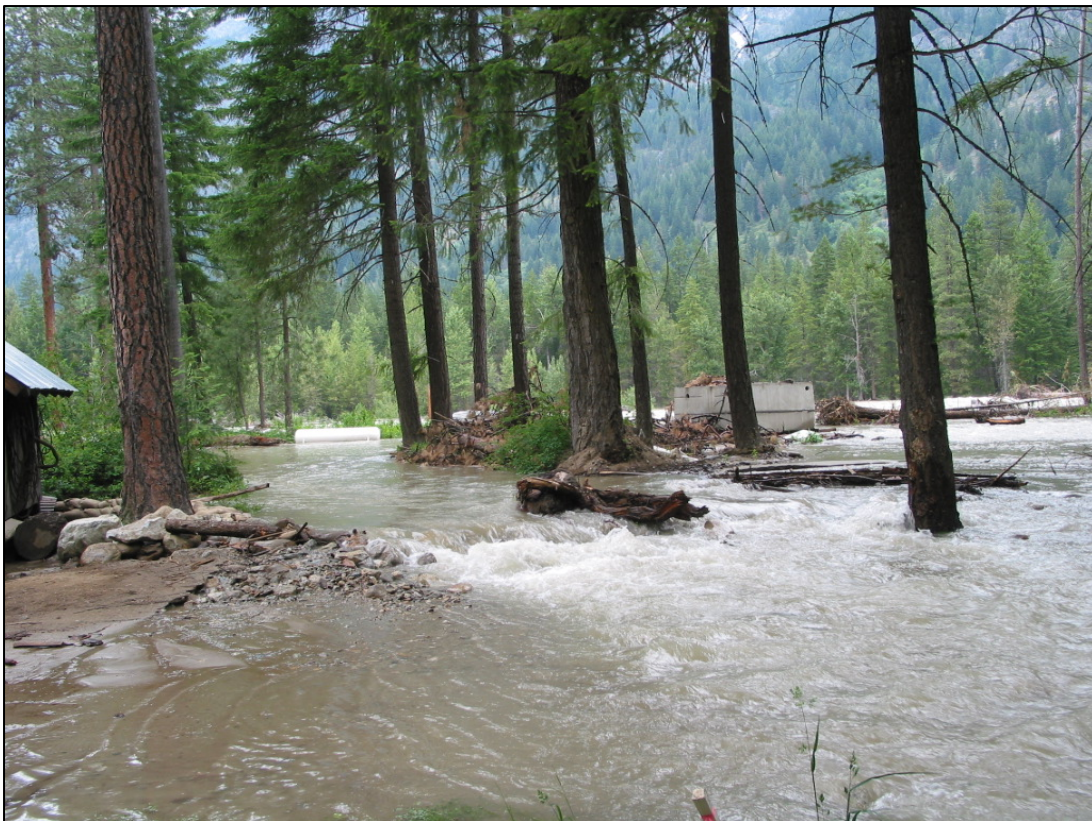
Upper Company Creek Road during spring 2007 snowmelt (9,600 cfs). The road now floods when river flows exceed 8000 cfs.

The Stehekin River now floods with much greater frequency and intensity than in years past. There have been three floods of magnitude equal or greater to a 100-year event in the last twelve years, and two of the three largest flood of record have occurred in the last four years. These floods have caused river conditions in the vicinity of the Upper Company Creek Road to change substantially. The riverbed has aggraded 3-4 feet, the shoreline has eroded substantially toward the road, and massive log jams have formed, causing patterns of flow to shift substantially, especially during floods. One house has washed away, and areas that have never flooded before (such as the end of the road and adjacent private properties) are now threatened at relatively moderate flow rates, such as those that often exceed 8000 cfs during spring snowmelt (Cover photo and Figure 1).

Riverbed aggradation adjacent to the Upper Company Creek Road has increased the risk of flooding not only during severe floods but also from spring snowmelt (cover photo). The road presently floods when flows exceed 8000 cfs. In May 2006, the spring snowmelt peaked at 11,300 cfs, and in June 2007 the snowmelt peaked at 10,200 cfs.

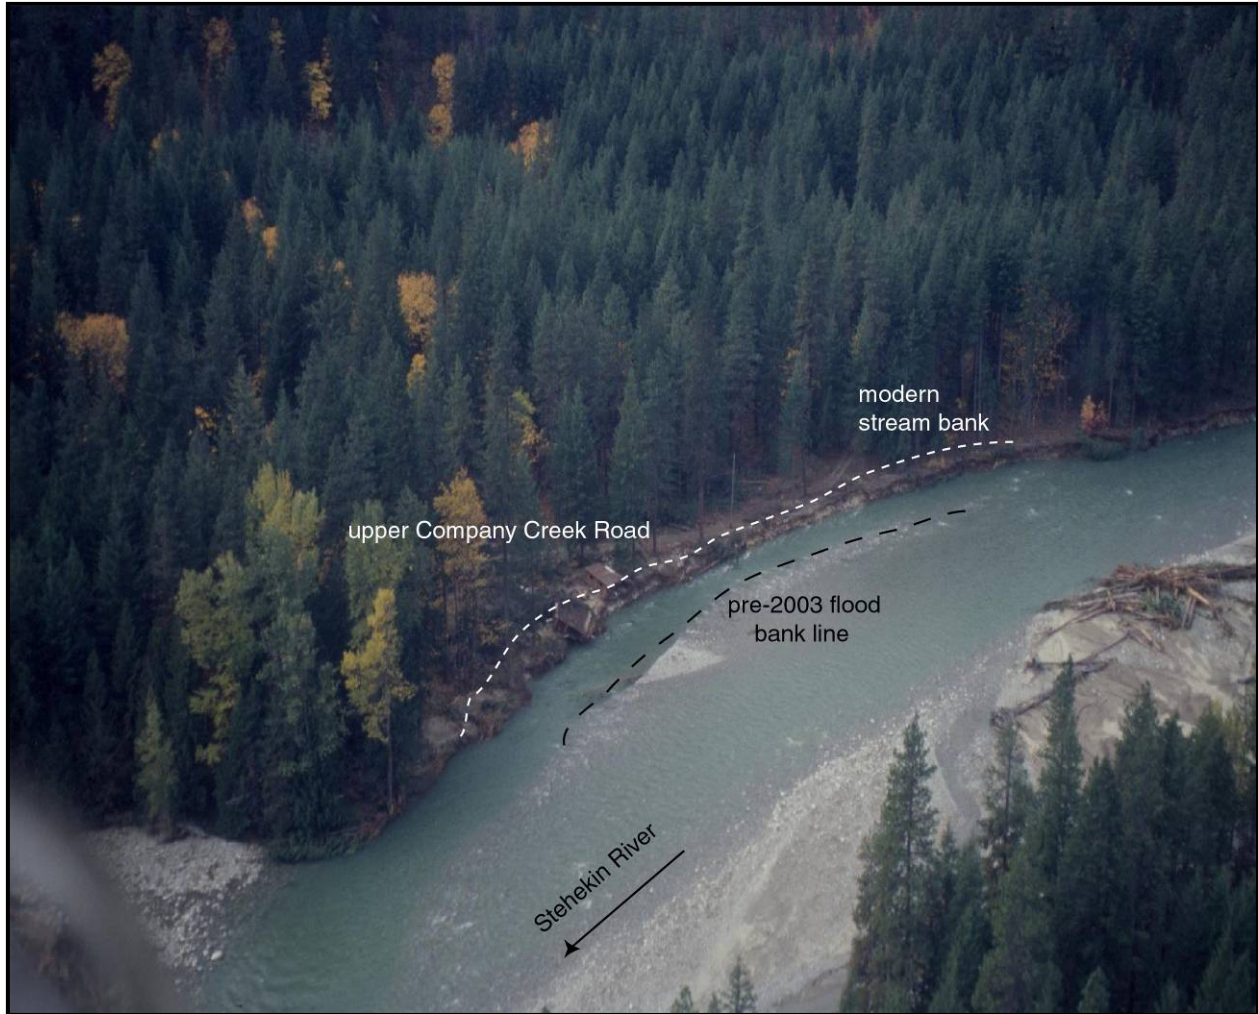
Figure 1. Photograph of the Upper Company Creek Road taken from a helicopter following the October 2003 flood. The dark dashed line indicates the approximate location of the streambank before the flood. The white dashed line indicates the current location of the streambank. The house, shown bisected by the white dashed line, has since fallen into the river.

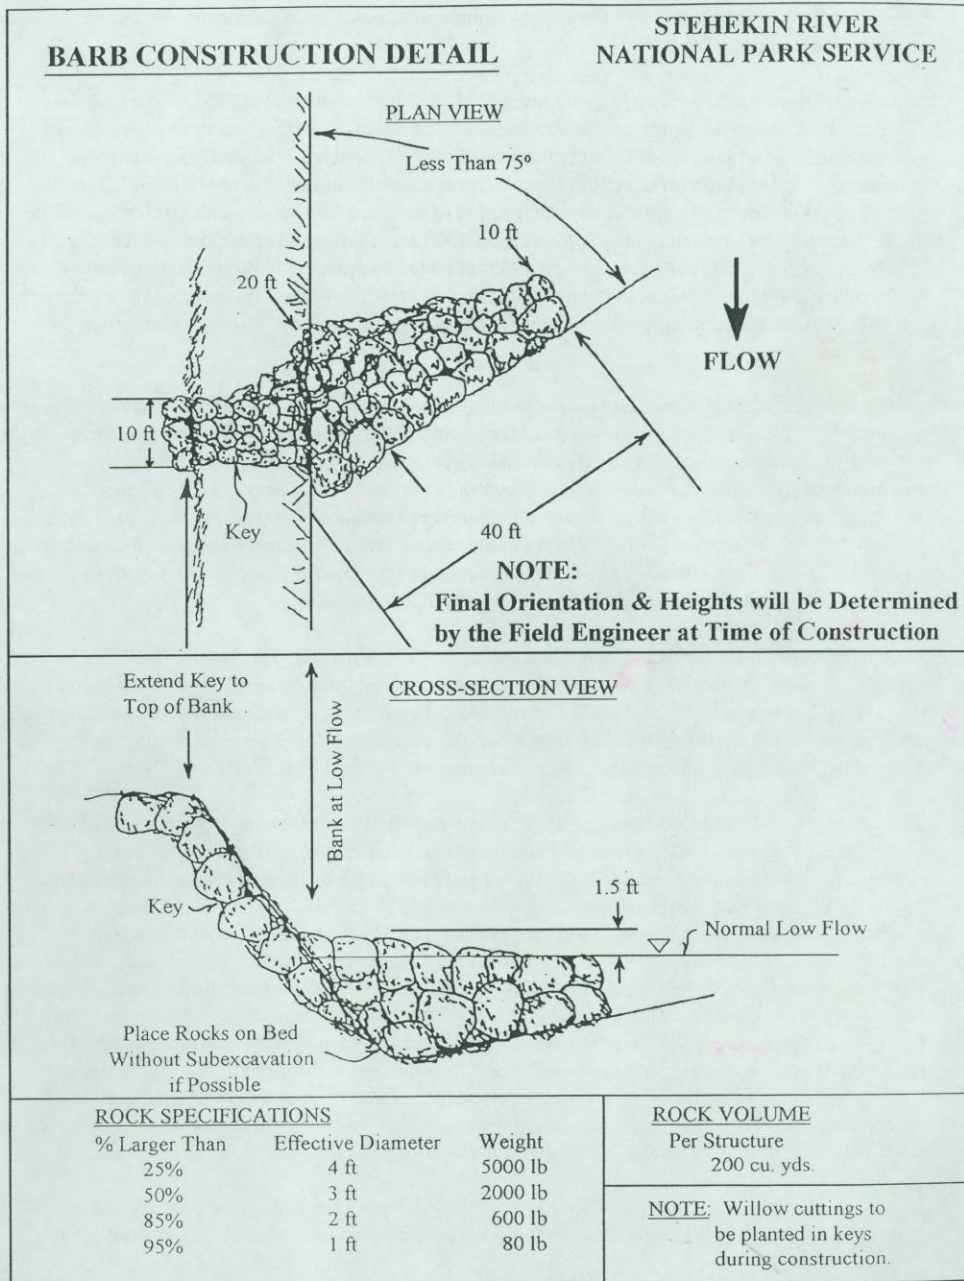
Figure 3. Bank barb construction details.

Figure 7. Rock barb design cross-section.

The NPS would construct four bank barbs (Figure 3), place large woody debris between the barbs, and densely plant native vegetation along approximately 500 linear feet of shoreline (Figure 4). Each bank barb would be constructed using about 100 cubic yards of rock spalls and fragments weighing up to 3,500 lbs (DOT, 1992). An additional 100 cubic yards of large angular rock would be placed between the barbs and amongst the woody debris to anchor the materials. The total volume of rock placed along the Stehekin River shoreline would not exceed 500 cubic yards. The rock would be obtained from sources outside the valley, because large angular rock is not available in the Company Creek pit.

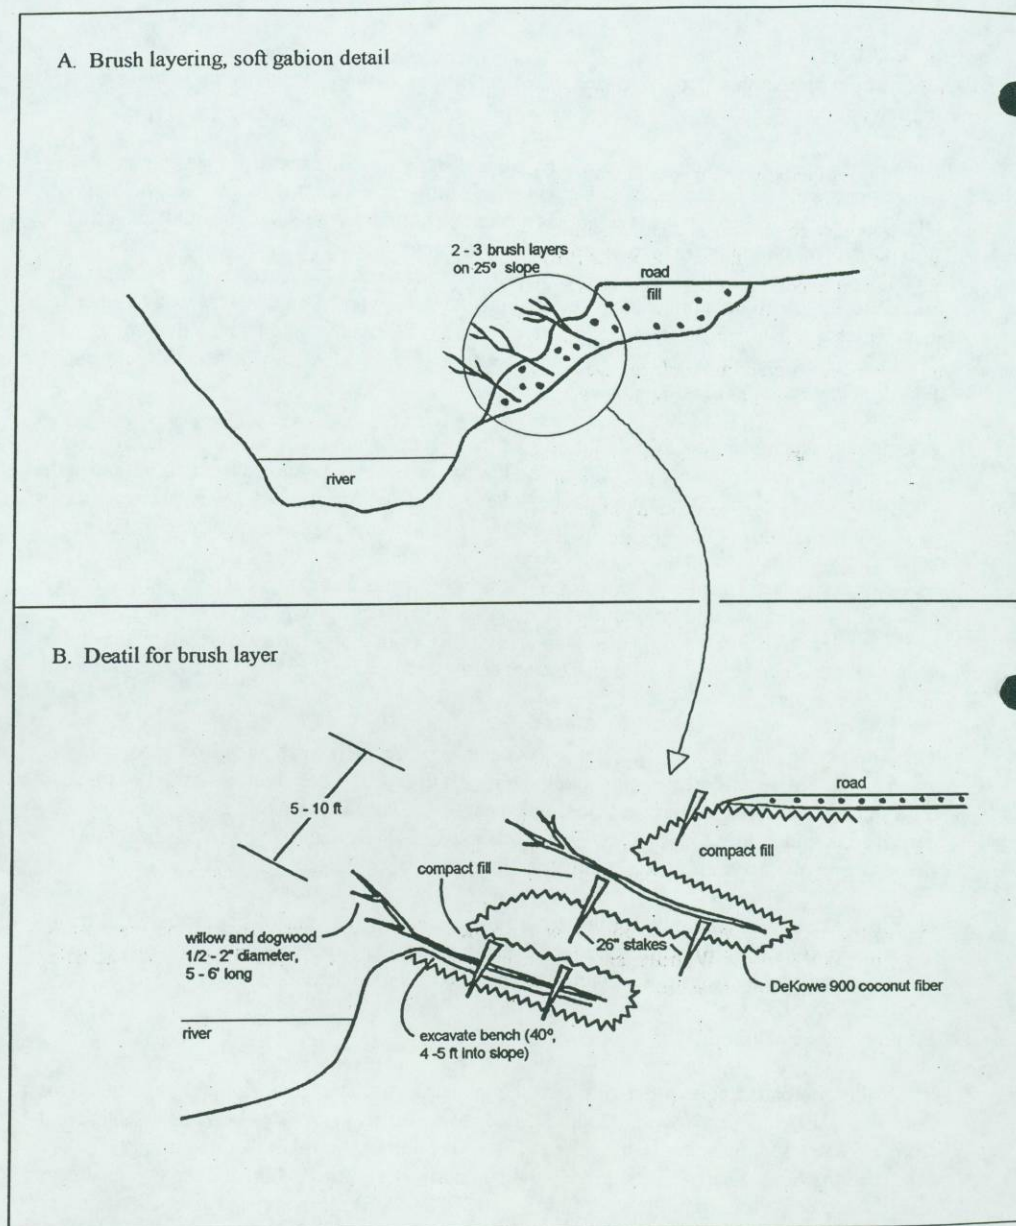
Figure 4. Bioengineering design details

Figure 10 Bioengineering design cross-sections.

Approximately 100 cubic yards of rock and large logs (with root wads attached for stability) would be placed between the barbs, from the toe of the bank up to the ordinary high water mark. The logs would be anchored with duckbill-type steel anchors and rock, and partly buried in the bank. Holes or weak points would be fortified with additional rock. No large trees would be felled during construction, although some riparian vegetation would be inadvertently damaged by heavy equipment. Following installation, the slope of the bank would be graded to an angle of repose between 1.5:1 – 2:1, then planted with riparian vegetation.

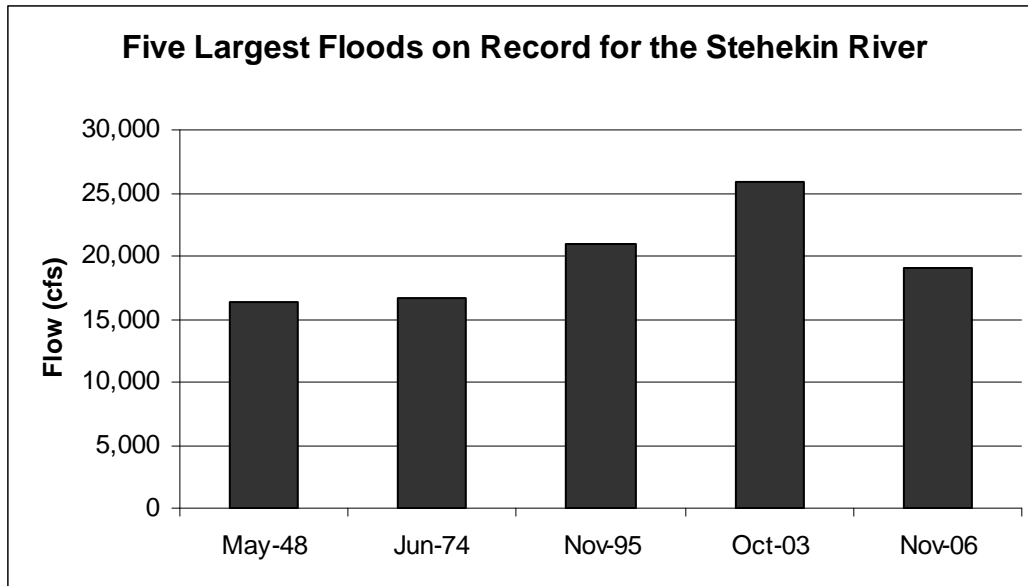
Figure 5. Five largest floods of record for the Stehekin River. The largest three floods have occurred within the last 12 years.

Flows on the Stehekin River have been gauged almost continuously since 1911. The flood history on the river contains both fall rain-on-snow and spring snow melt floods. In 2003, the largest flood of record had a peak discharge of 25,900 cfs and was estimated to have been a 500 year event. The river flooded again in November 2006 and that flood was the 3rd largest flood of record. The most notable trend is that the three largest floods of record, all equal to or exceeding a 100-year flood event, have occurred roughly within the last 12 years (Figure 5).

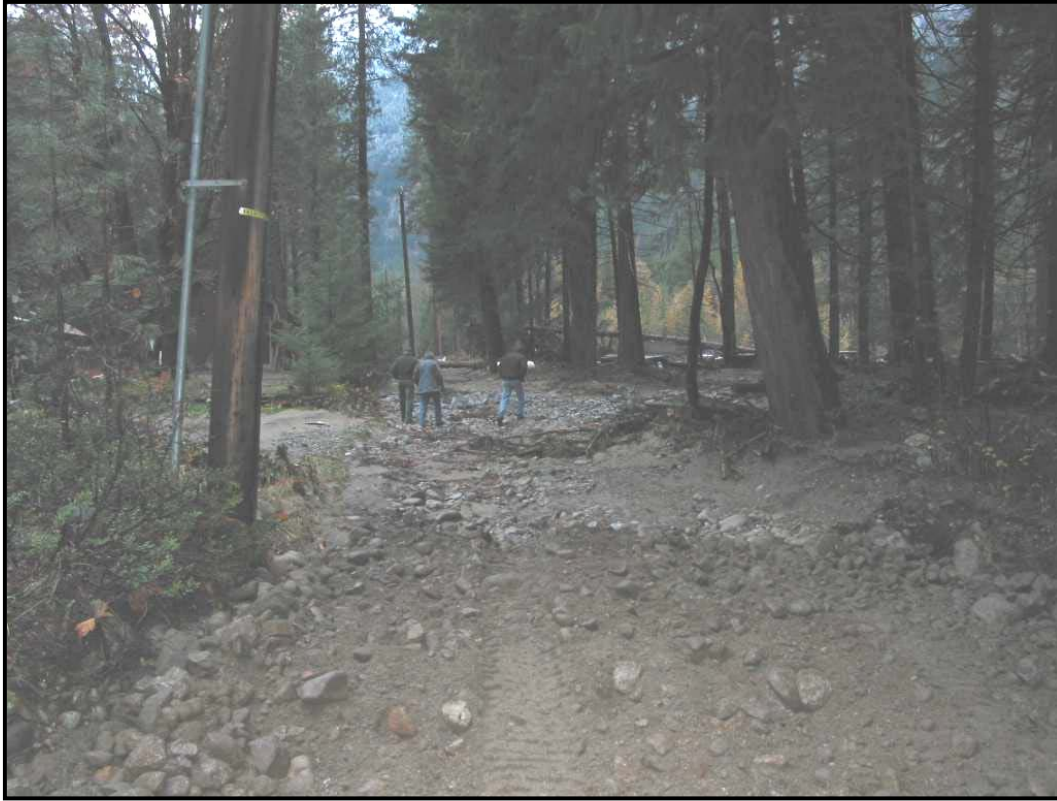
Figure 9. November 2006 flood damage to Upper Company Creek Road, near road end.
