Stickfoot Branch Stream Restoration Project

Public Scoping Virtual Presentation

February 24, 2021

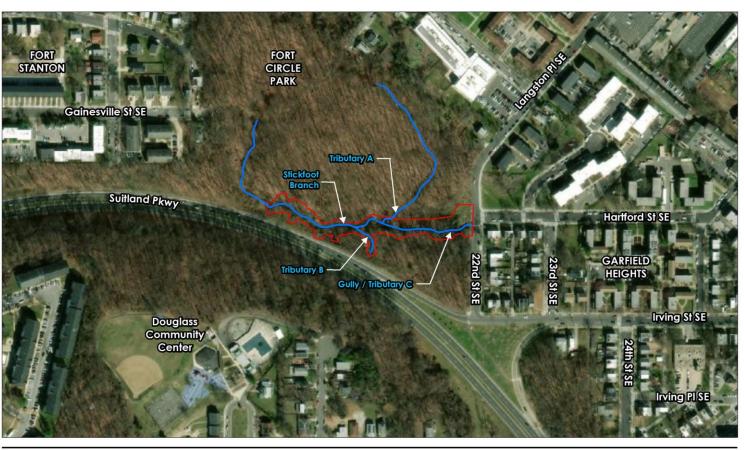
Study Area Map

Several outfalls drain stormwater from Suitland Parkway and three unnamed tributaries (labeled Tributary A, B, and C on the map to the right) flow into Stickfoot Branch within the study area.

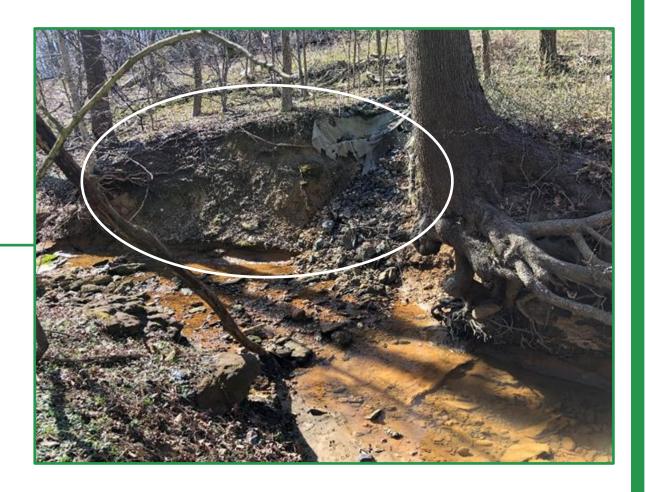
Active streambank erosion and channel incision are occurring within the stream segment.

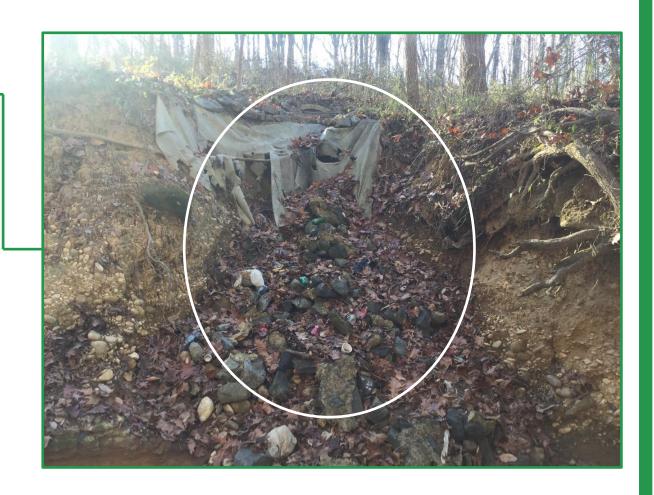
Headcuts are occurring at the tributaries and drainage channels primarily from unmanaged stormwater flows.

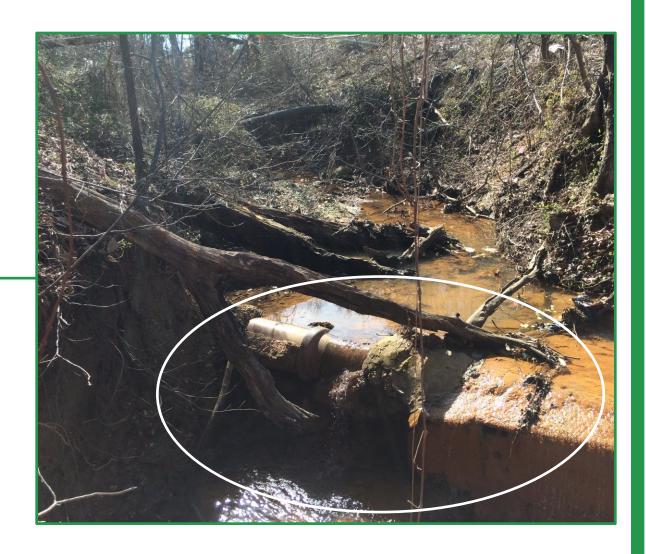
Concrete encased sewer lines that cross Stickfoot Branch have become exposed.

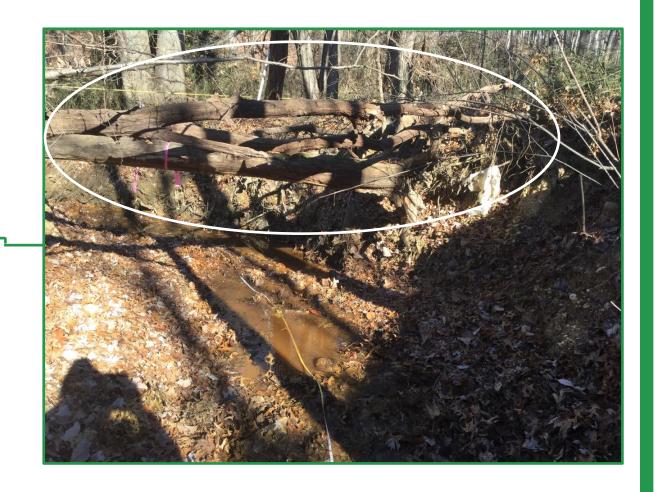
Trees along the stream have fallen due to channel widening.

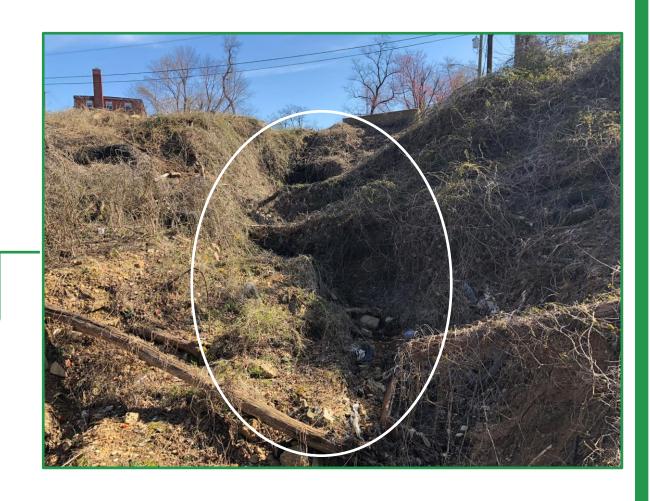
A large gully has formed on the embankment of 22nd Street SE due to unmanaged stormwater flows.

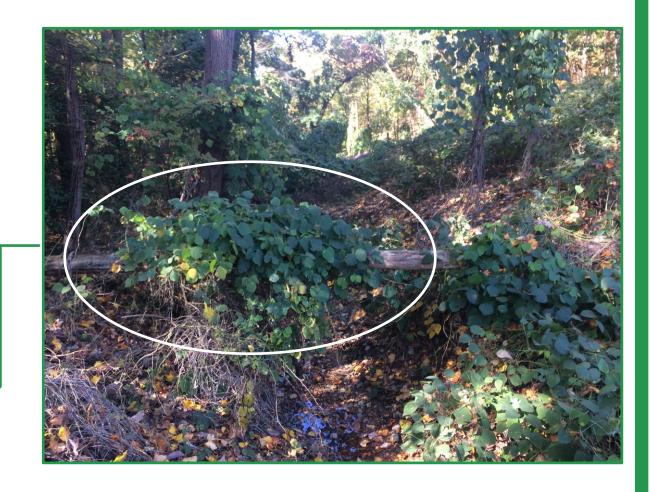
Kudzu, a highly invasive plant species, has overtaken the northeast portion of the study area.

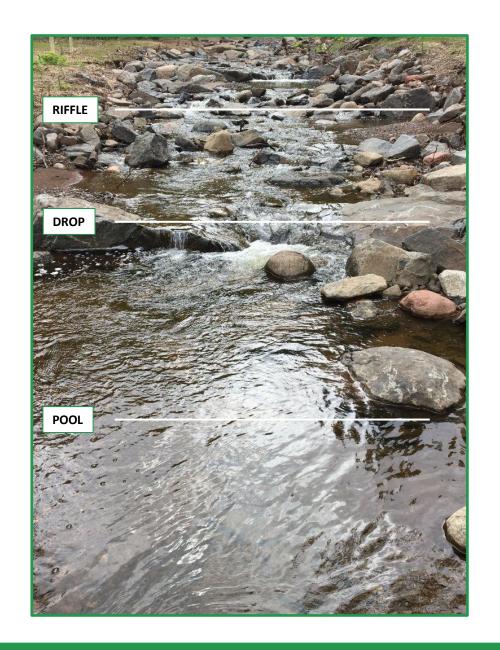
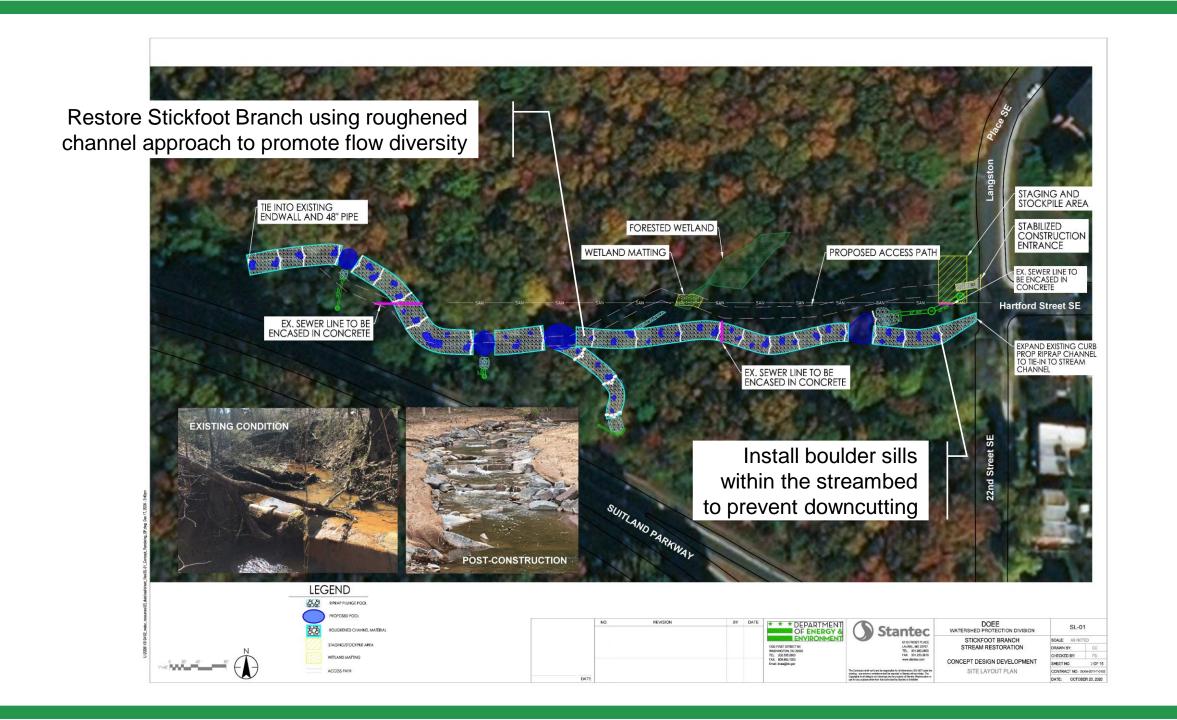
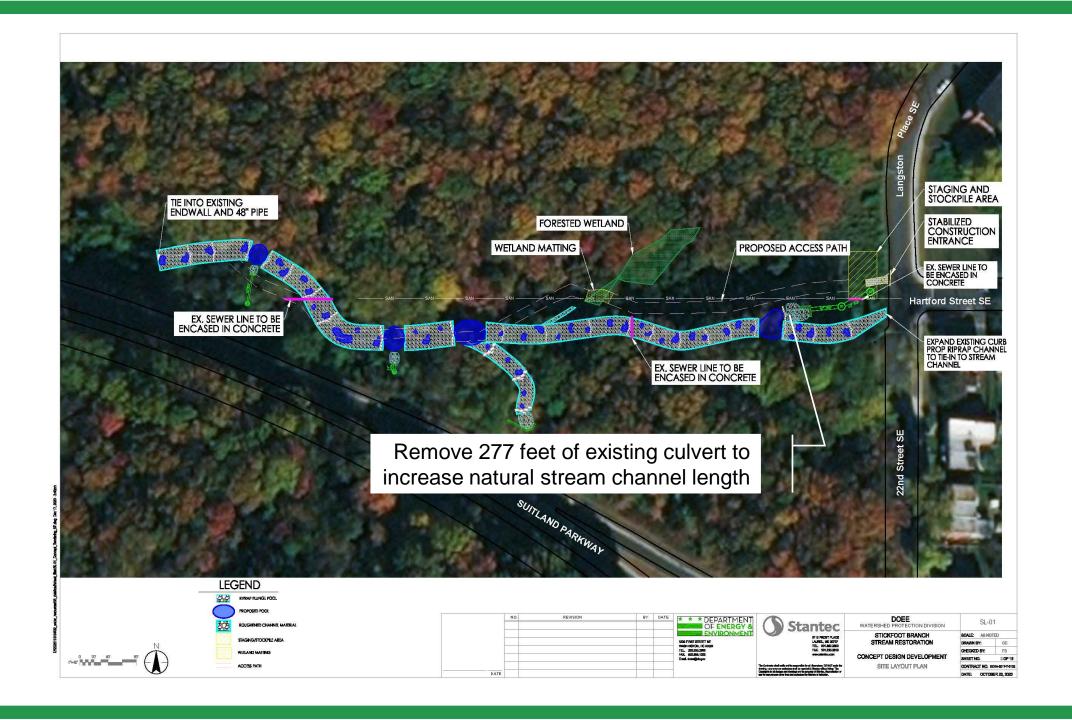
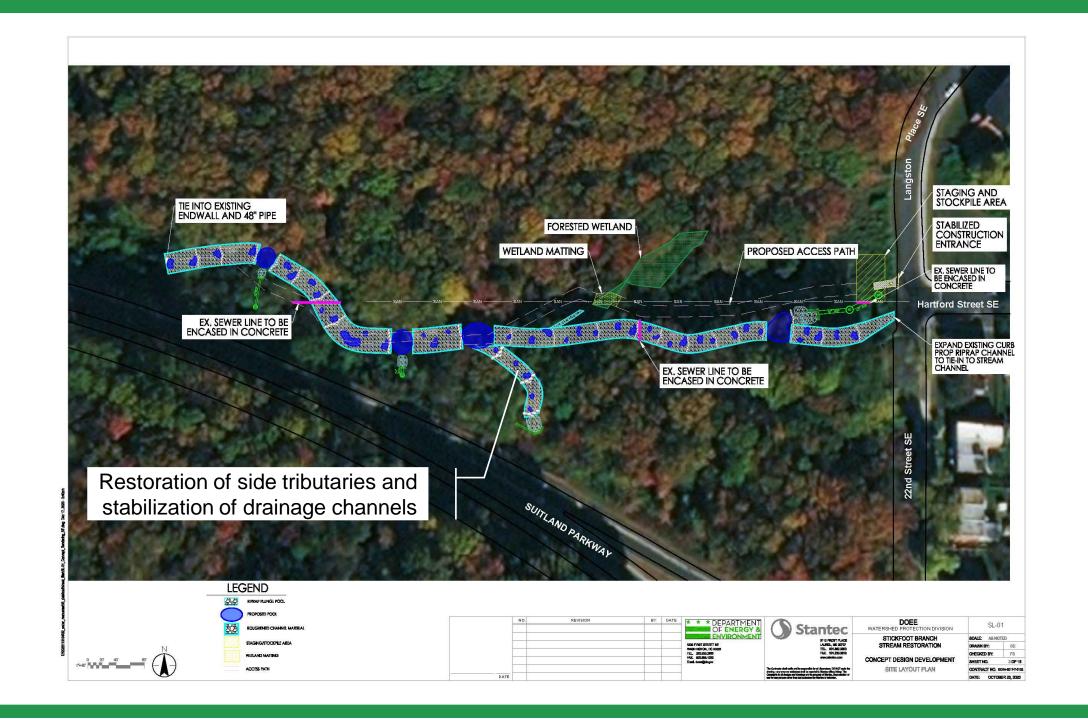
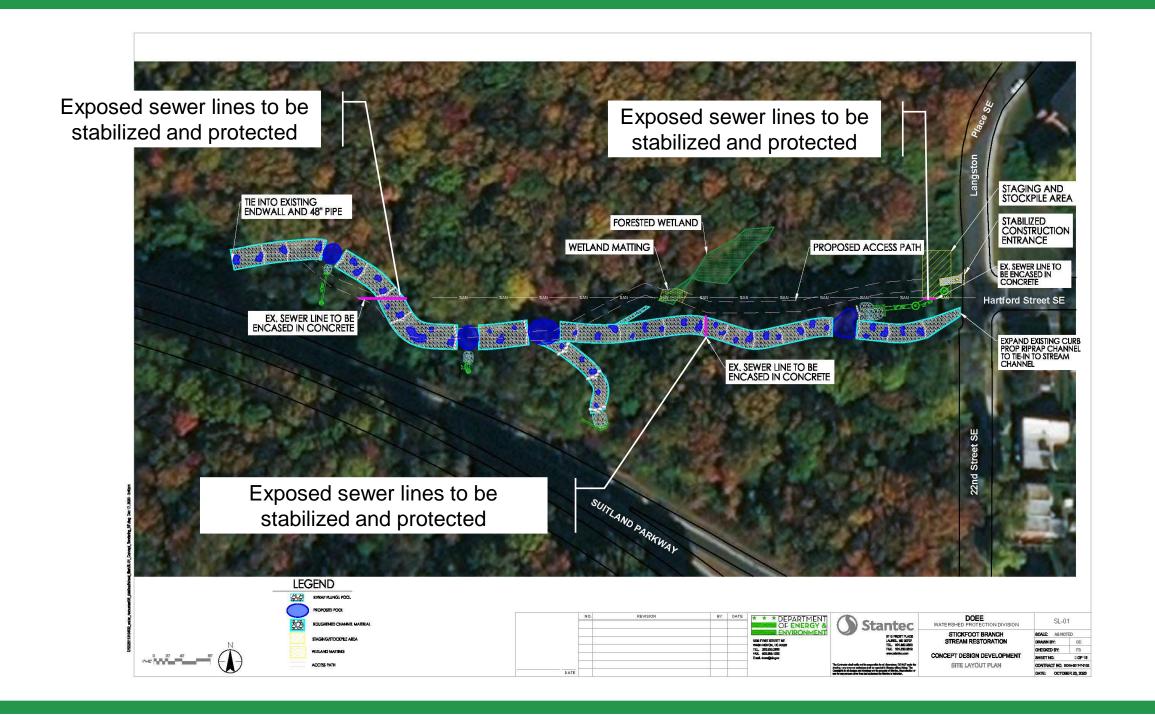
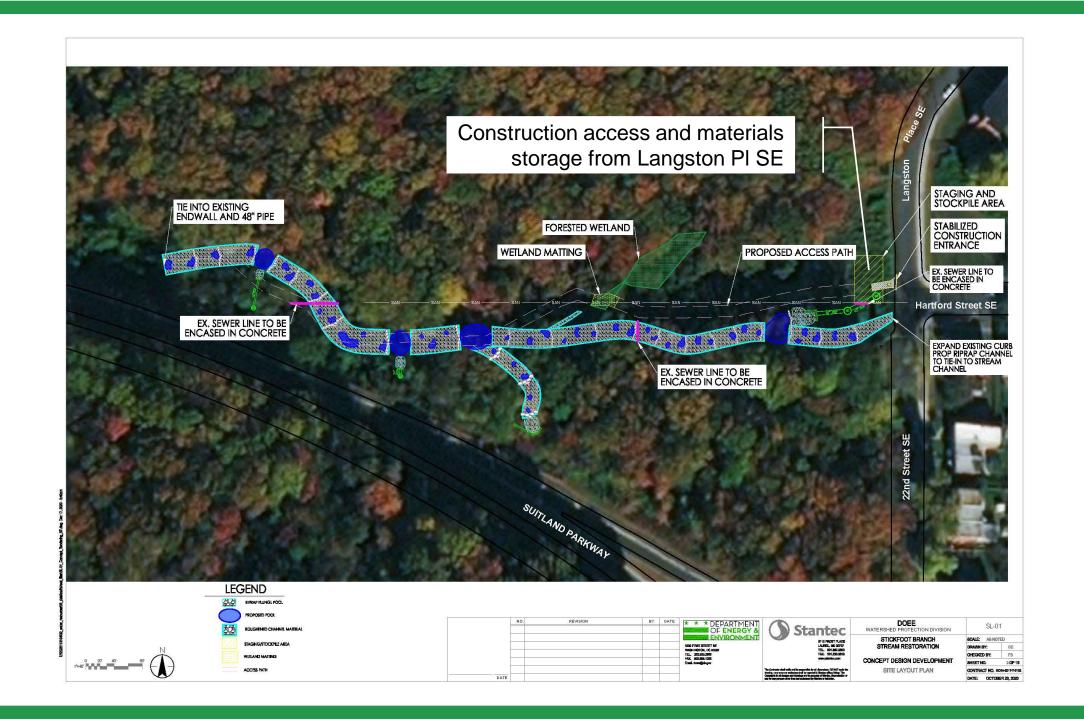
- Restore Stickfoot Branch using a roughened channel design approach that mimics natural stream channels
- Install buried boulder sills to prevent channel downcutting and to protect sewer infrastructure
- Place rocks to promote flow diversity (drops, pools, and riffles)
- Remove piped sections of stream to increase length of natural channel design
- Restore side tributaries and drainage channels
- Implement invasive species management practices to control kudzu
