Tuolumne Meadows Campground
Yosemite National Park

Cultural Landscape Report

January 31, 2021

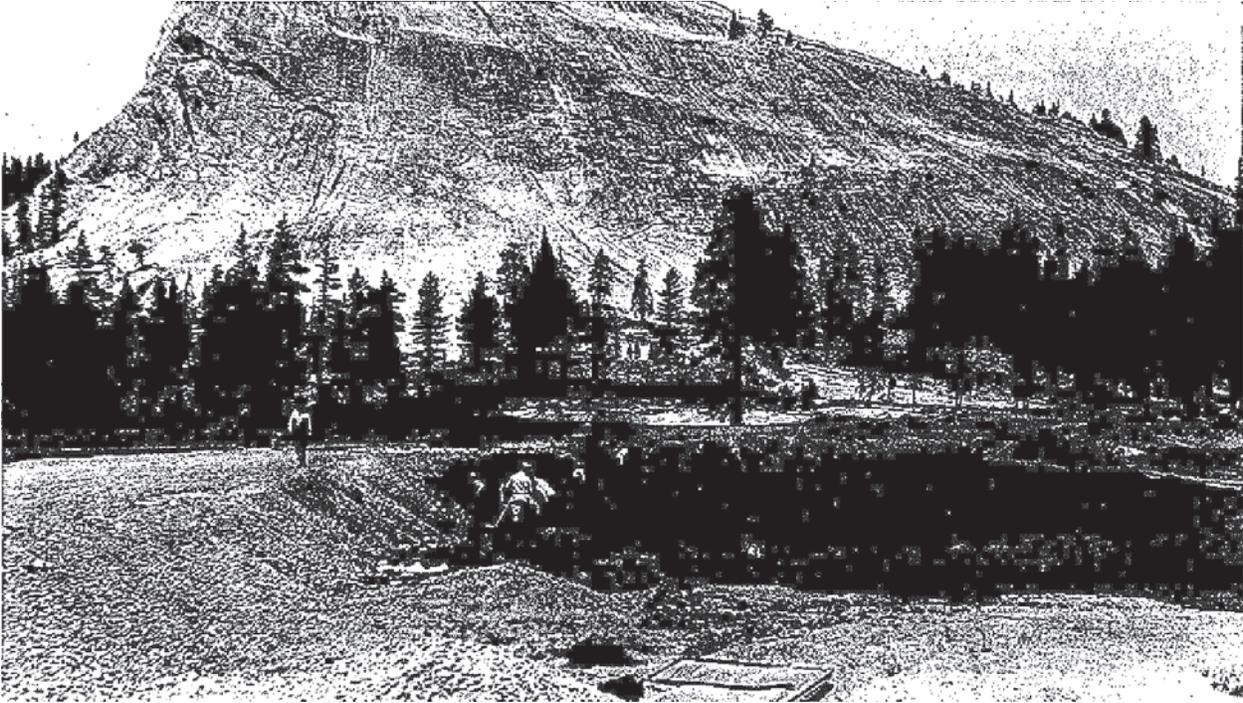
Figure 2-16. A crew building Tuolumne Meadows Bridge in 1932 (source: YOSE 1932 Superintendent's Report).

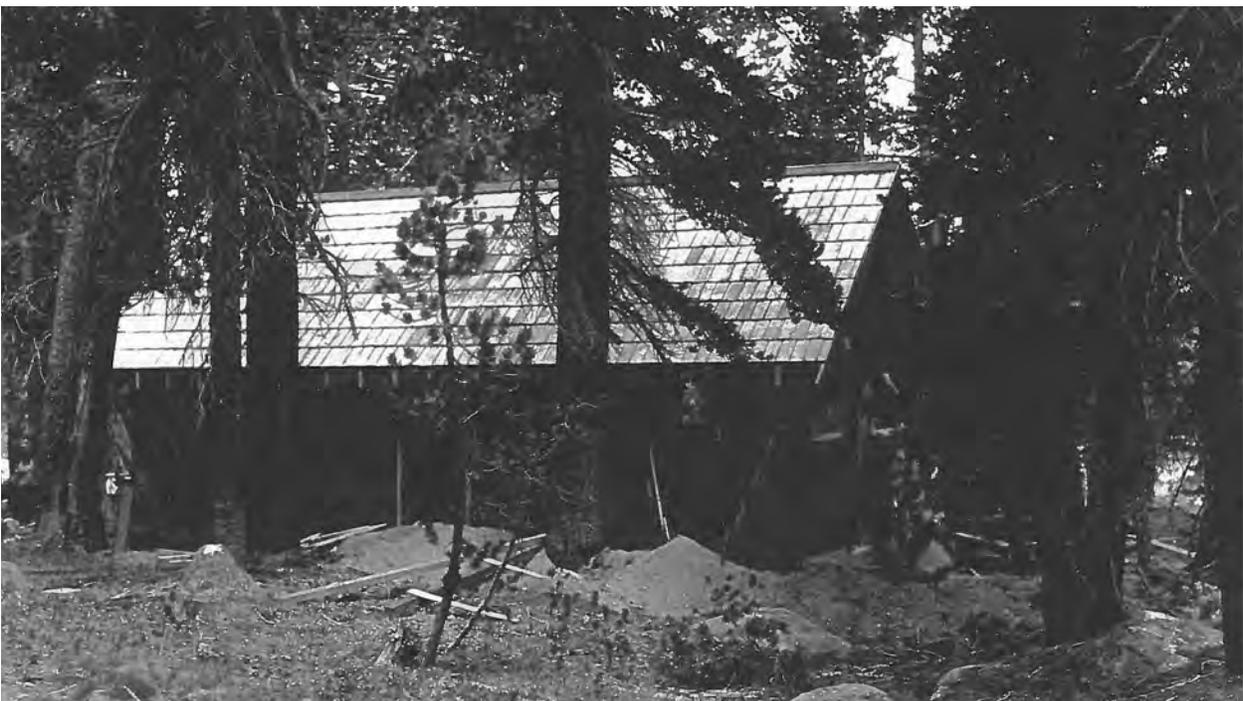
Figure 2-17. Comfort Station (CS3024) under construction in 1932. The building was one of several designed in the park rustic style by the NPS Western Field Office (source: YOSE 1932 Superintendent's Report).

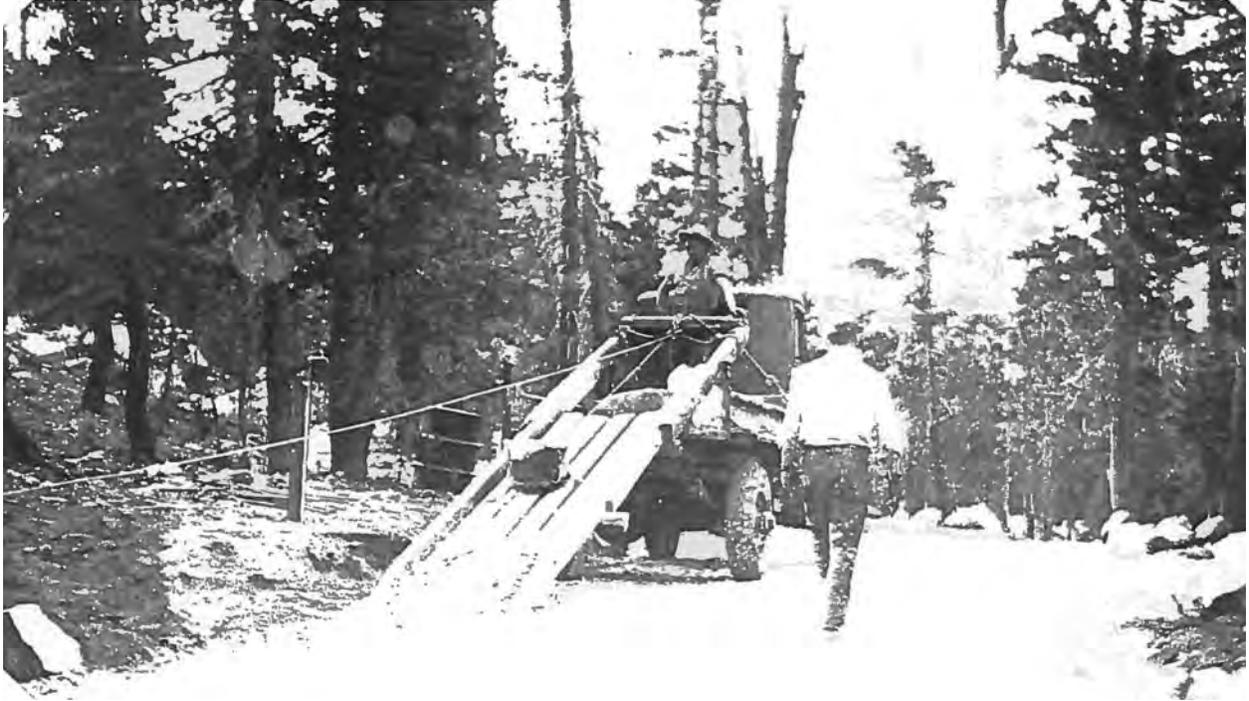
Figure 2-18. Rock removal from campground roads in 1932 (source: YOSE 1932 Superintendent's Report).

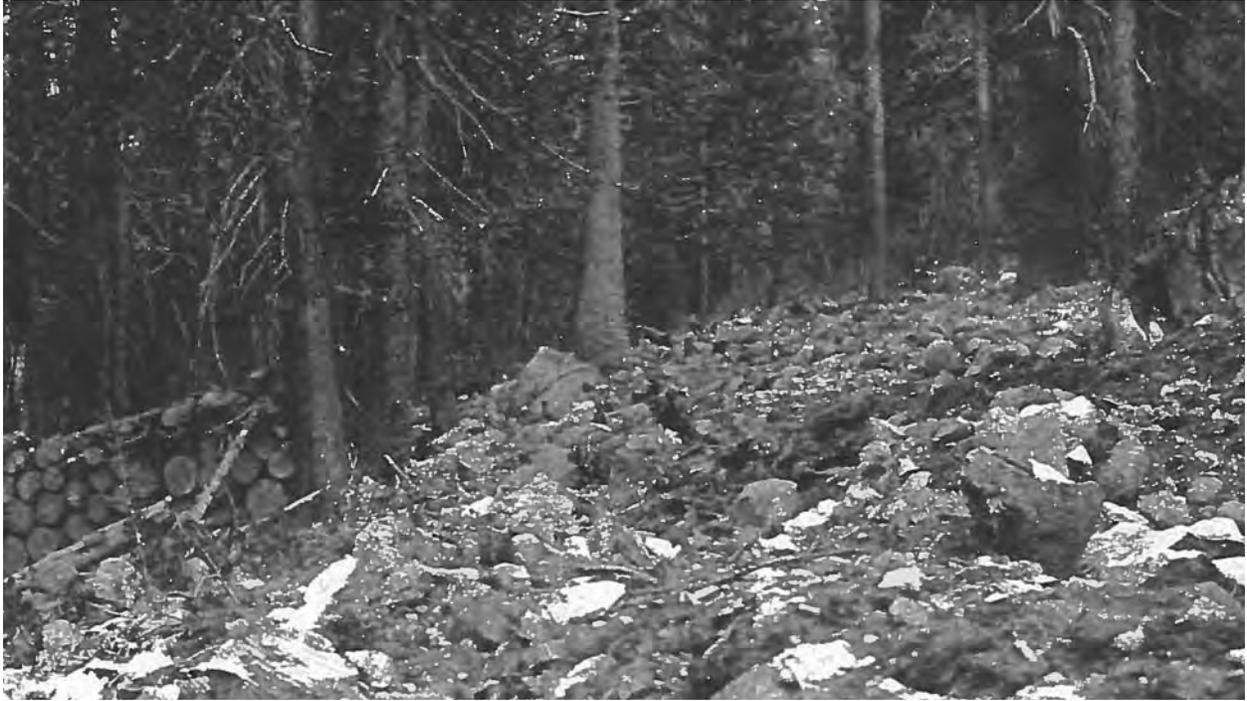
Figure 2-20. Electric blasting was used in rocky sections as in construction of Campground Road D in 1932 (source: YOSE 1932 Superintendent's Report).

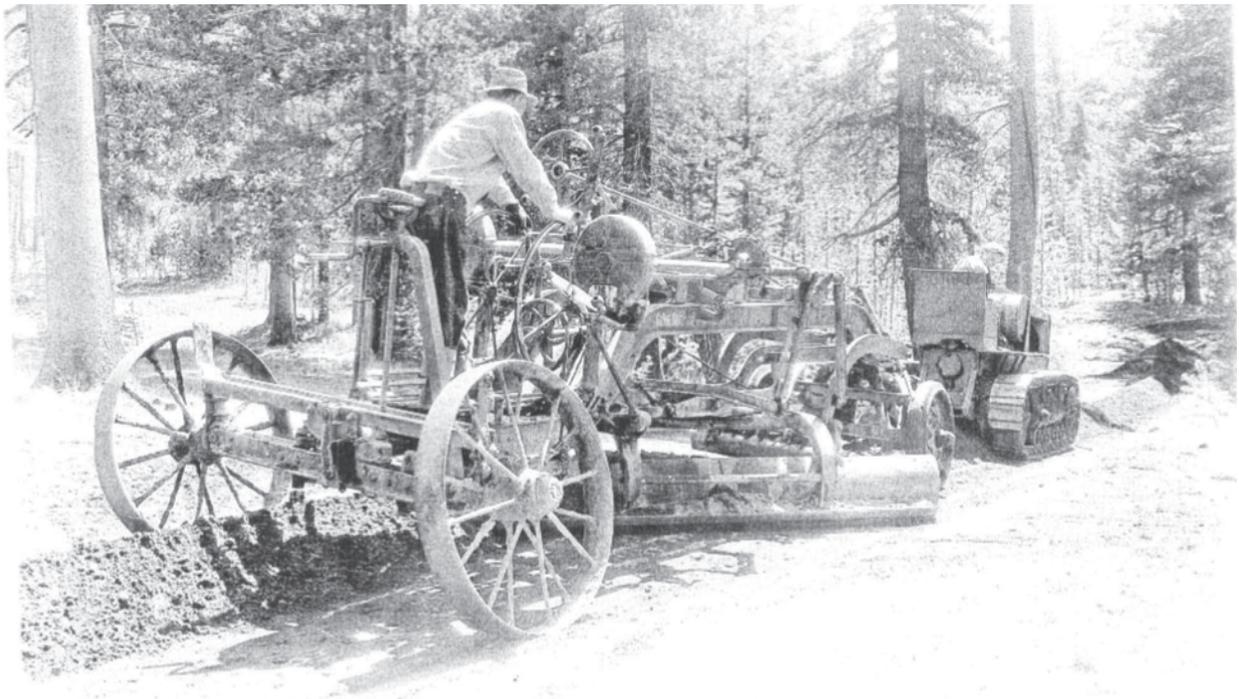
Figure 2-21. Windrowing oil mix along Campground Road B in 1934 (source: YOSE 1934 Superintendent's Report).

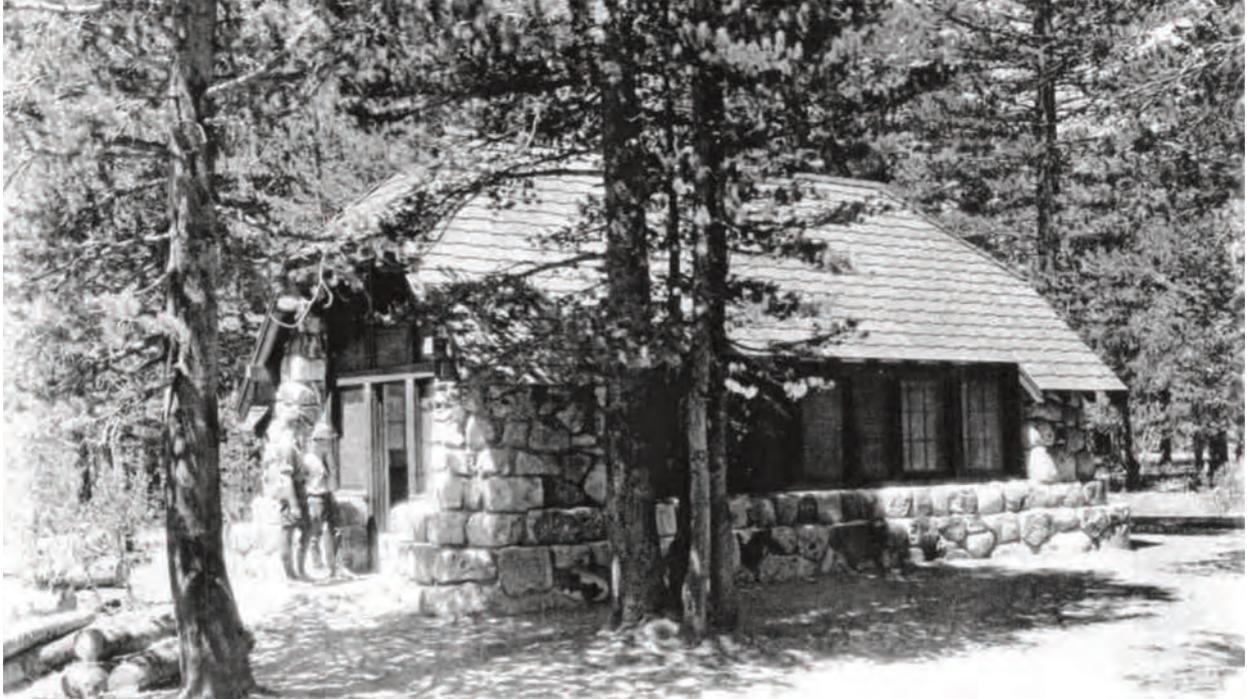
Figure 2-27. CCC Comfort Station, 1934 (source: YOSE 1934 Superintendent's Report).

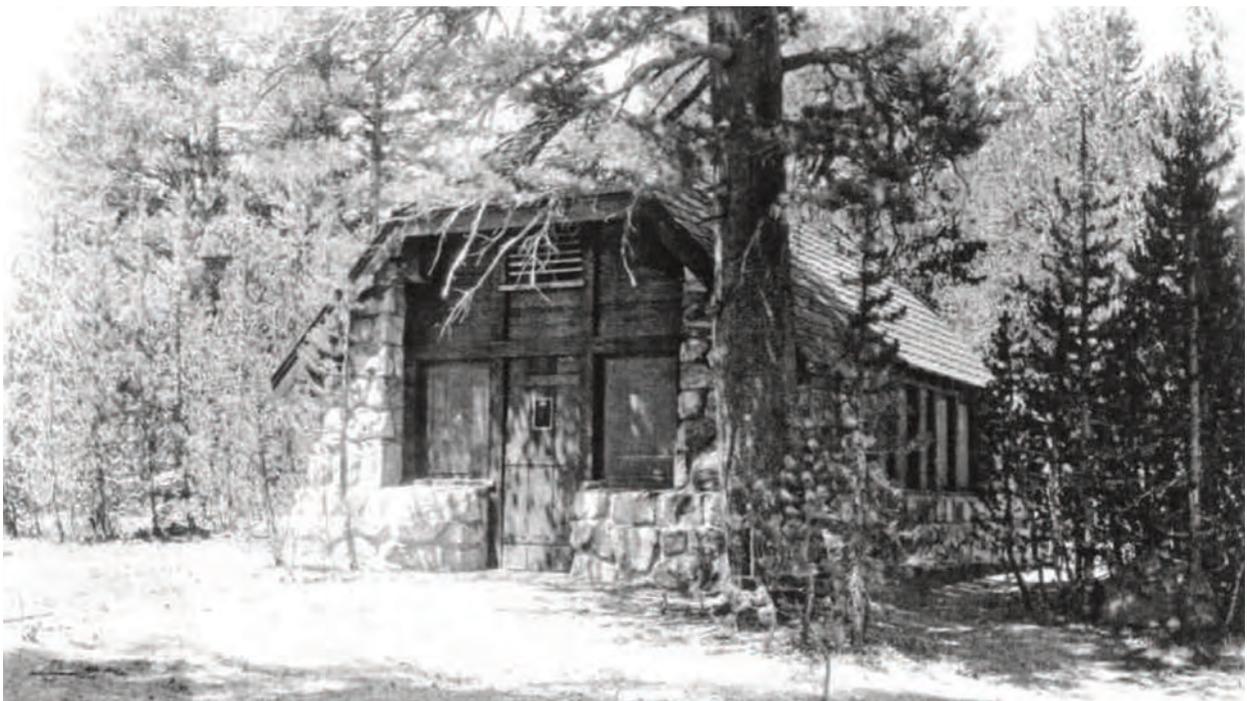
Figure 2-28. CCC Comfort Station, 1934 (source: YOSE 1934 Superintendent's Report).

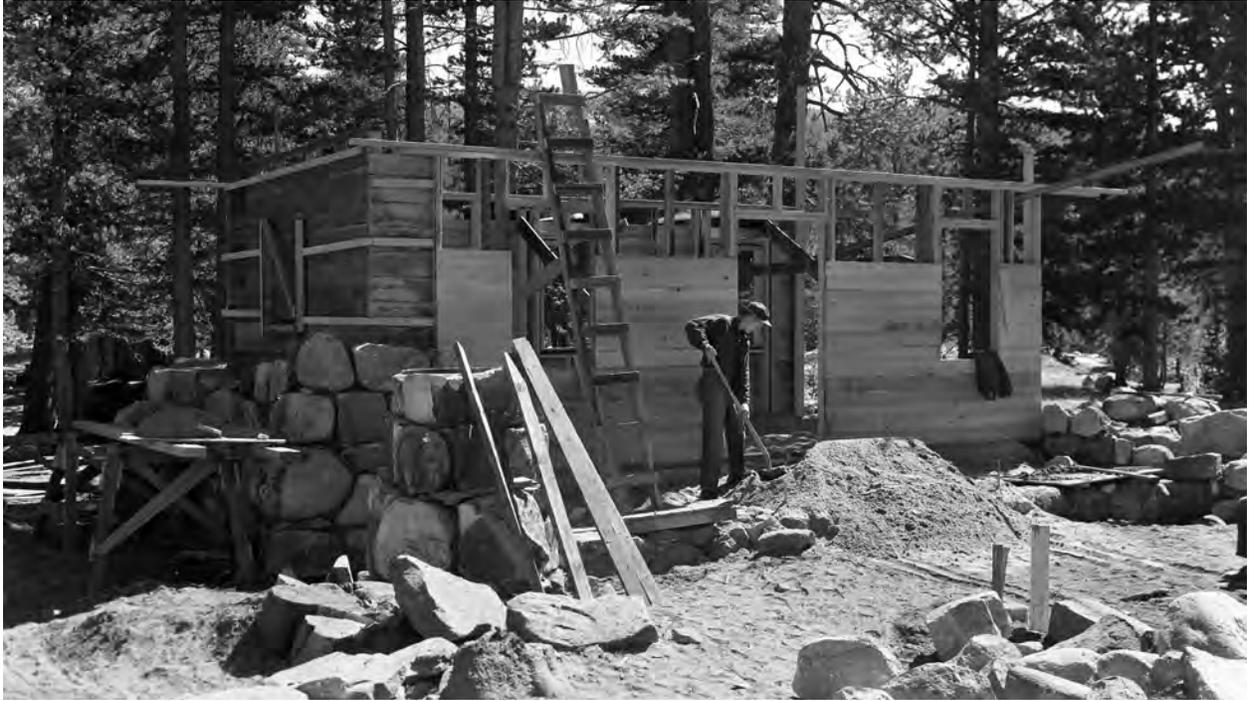
Figure 2-29. Construction of Contact Station 3005 in 1936 (source: YOSE Archives R-1422).

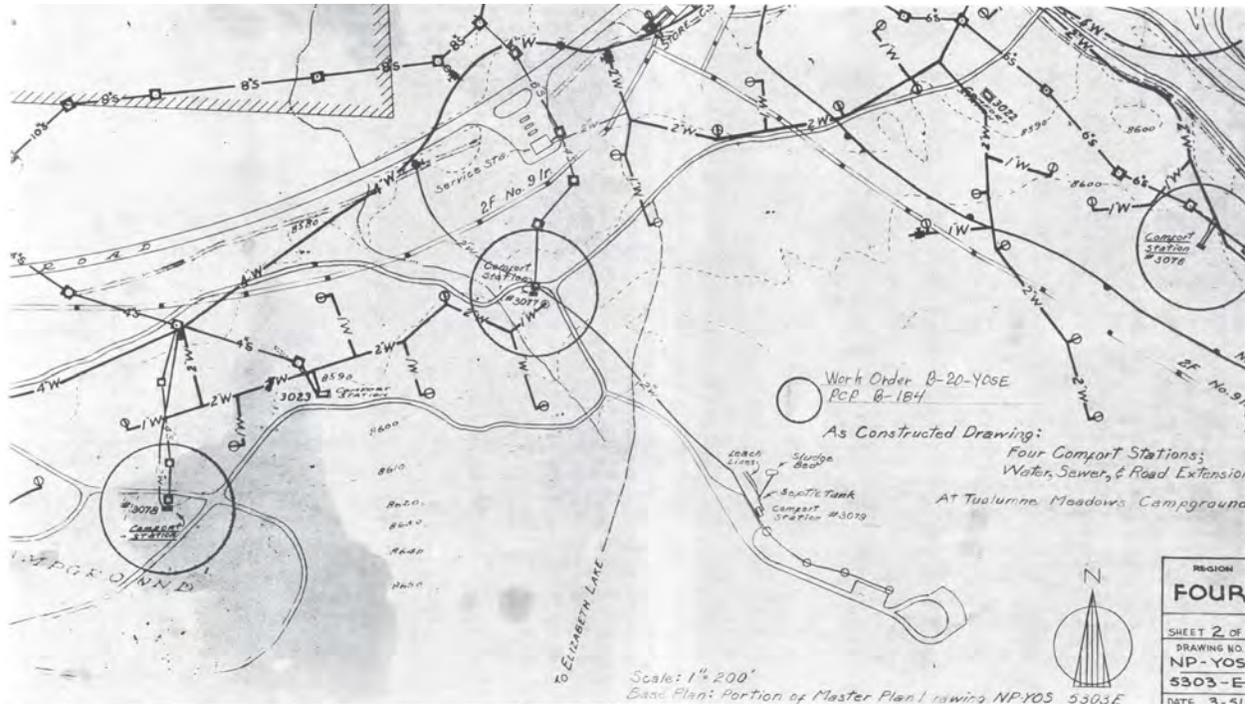
Figure 2-43. As-built drawings indicating construction of comfort stations (CS3076, CS3077, CS3078) and associated water and sewer lines. The campground road extension Campground Road B was built at this time, circa 1951 (source: Work Order B-20-YOSE, PCP B-184, As Constructed Drawing: Four Comfort Stations; water, sewer, & road extensions at Tuolumne Meadows Campground. YOSE 1961 Superintendent's Report).

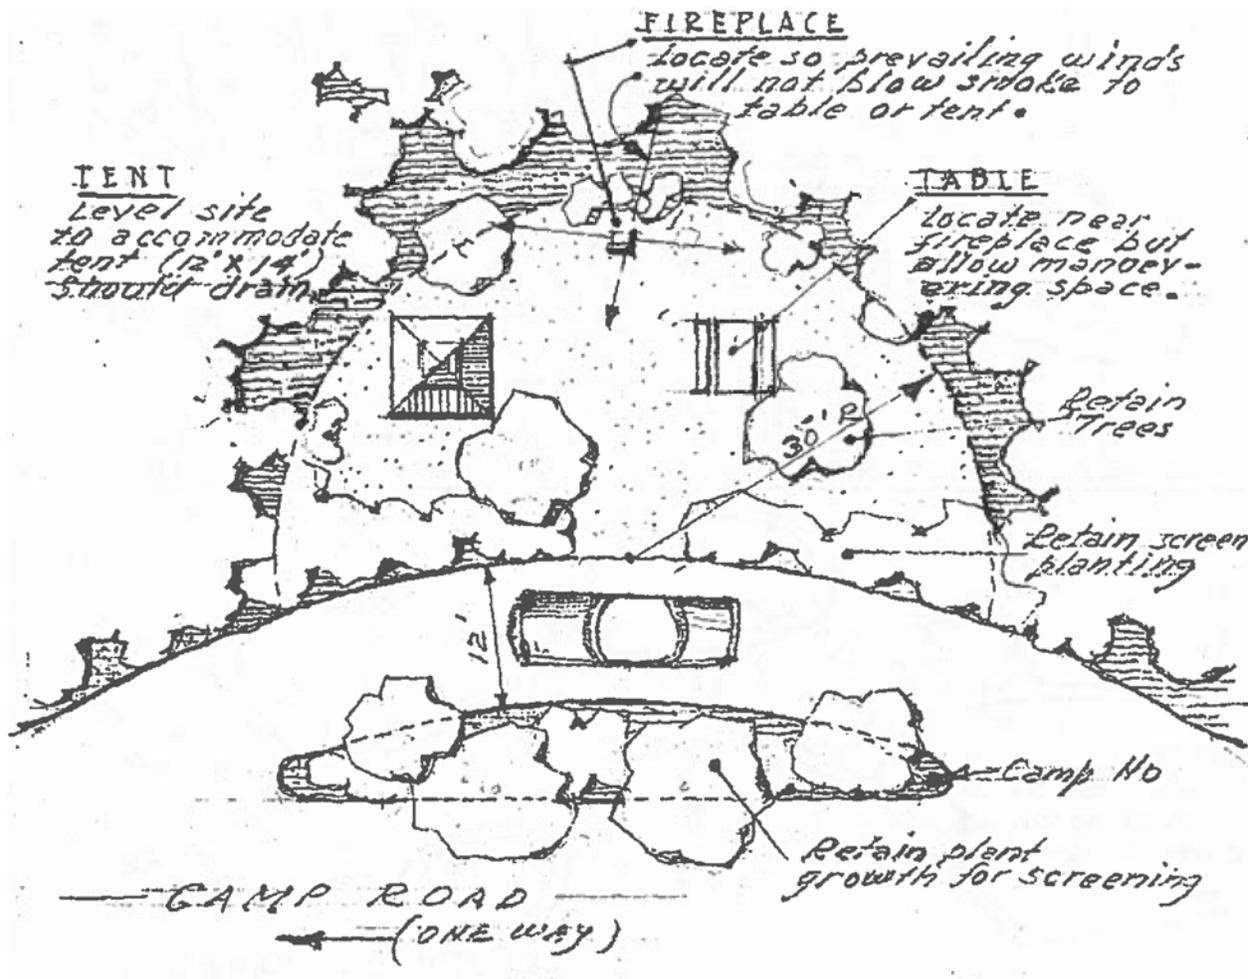
Figure 2-45. 'A Typical Campsite' reflected the Mission 66 approach to organizing campsites and providing amenities. This was likely the approach undertaken for the 250 campsites improved within Tuolumne Meadows Campground in 1957 (source: NPS, Campground Study, Region Four, 1959).^{2.164}

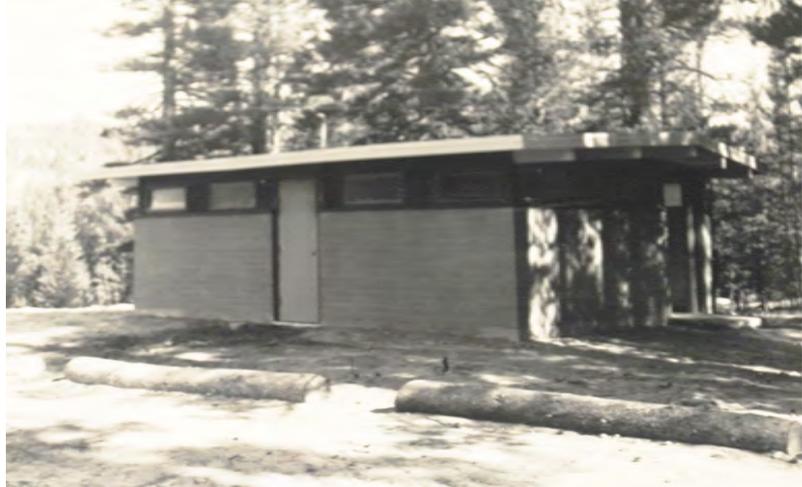
Figure 2-52. Construction of the comfort stations in 1961 (source: YOSE 1961 Superintendent's Report).

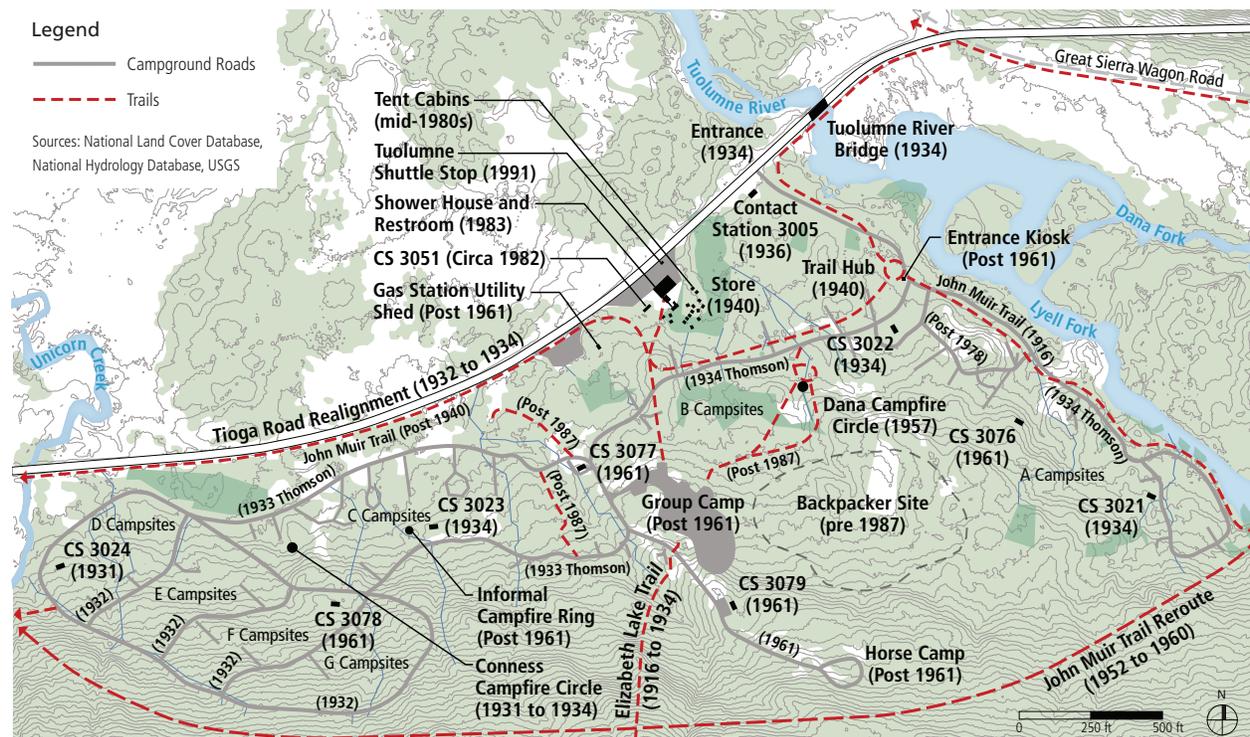
Figure 3-1. Tuolumne Meadows Campground Existing Condition (source: Mundus Bishop, 2020).

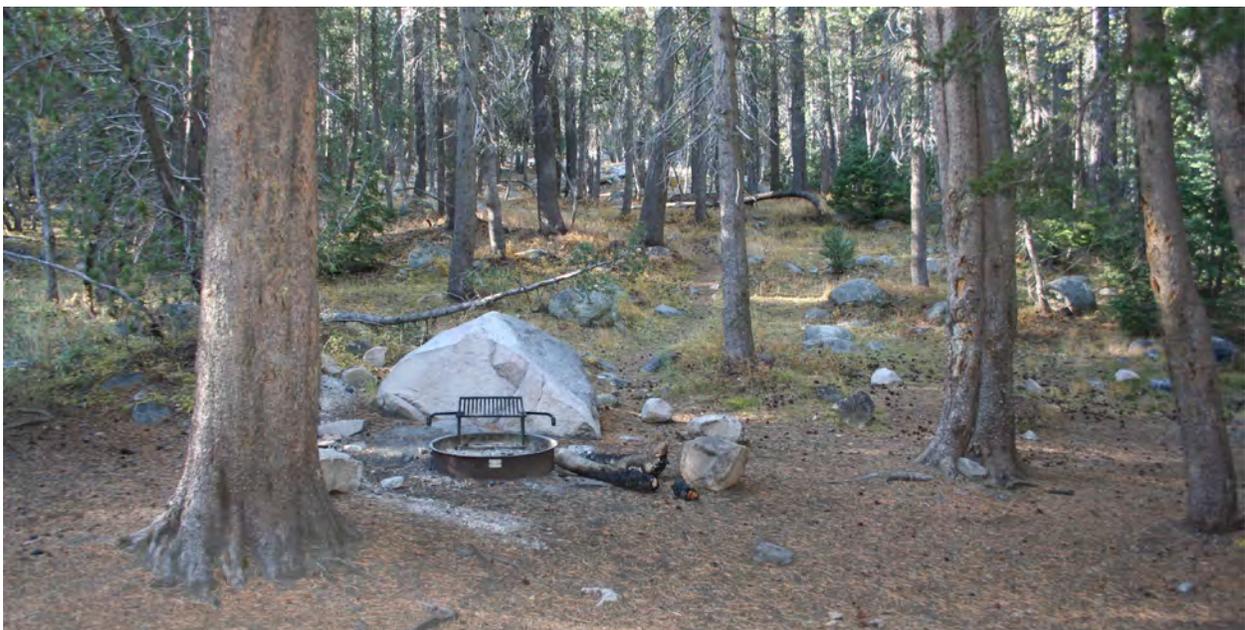
Figure 3-2. Tuolumne Meadows Campground retains integrity in location, setting, feeling, materials, workmanship, and design and association. (source: Mundus Bishop, 2020).

Integrity is the ability of a cultural landscape to convey its significance. Tuolumne Meadows Campground was assessed to determine if the landscape characteristics that shaped the cultural landscape during the period of significance are present today. Integrity was evaluated according to seven aspects or qualities.

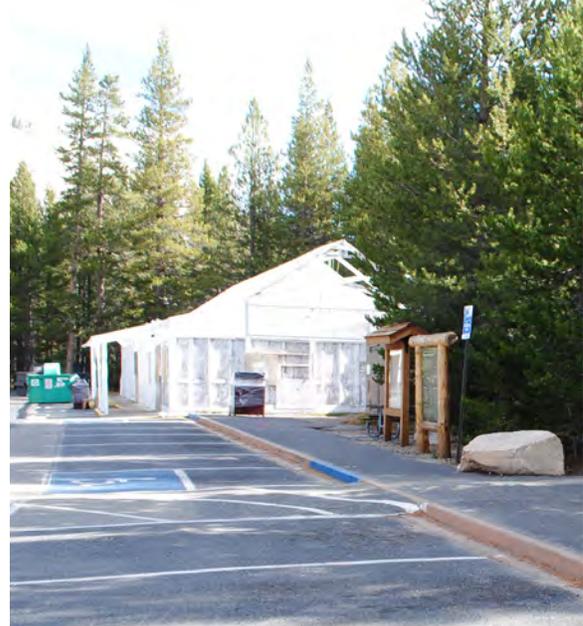
Figure 3-16. Tioga Road Cluster includes the developed area parallel to Tioga Road (source: Mundus Bishop, 2019).

Tioga Road Cluster is on the south side of Tioga Road near the campground entrance. The cluster includes two parking areas, Contact Station (CS3005), Tuolumne Meadows Store, Comfort Station (CS3051), Shower House and Restroom, Laundry, tent cabins, and the Gas Station Utility Shed. Parking includes forty spaces at Tuolumne Meadows Store, fifteen spaces within the western most parking area (previous site of non-extant service station).

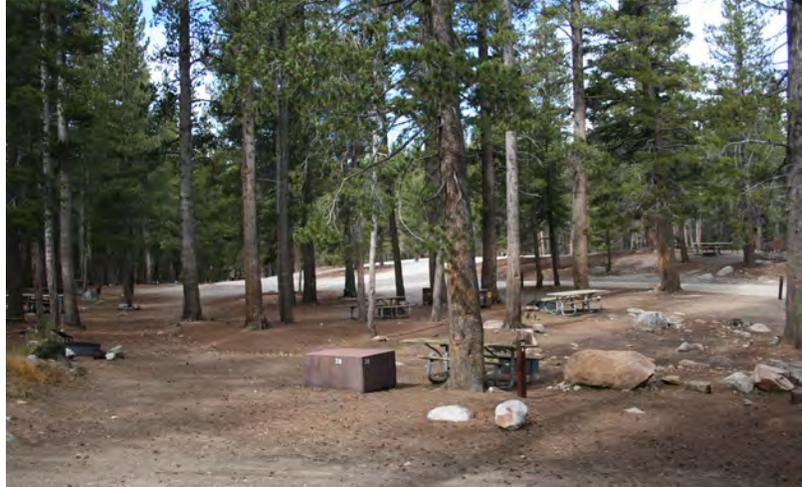
Figure 3-20. Campground Cluster A campsites along Tuolumne River at the campground's south end have well defined edges between campsites (campsites 66 to 87) (source: Mundus Bishop, 2019).

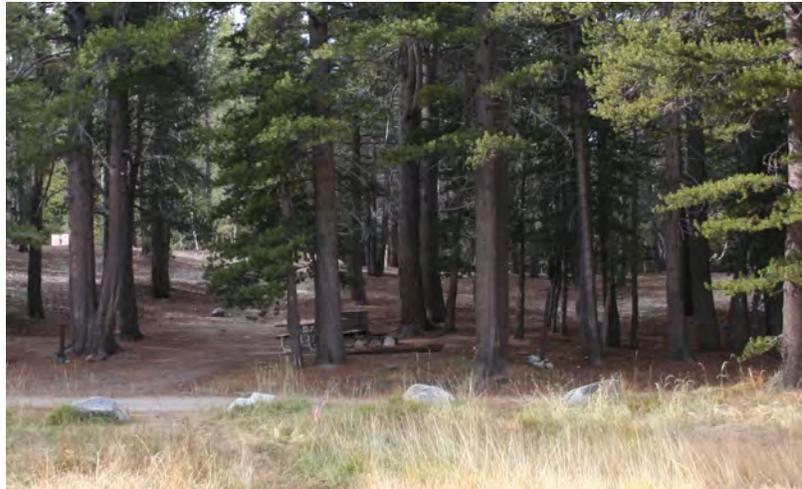
Figure 3-21. Campground Cluster A campsites on the south loop have more understory vegetation between adjacent campsites (source: Mundus Bishop, 2019).

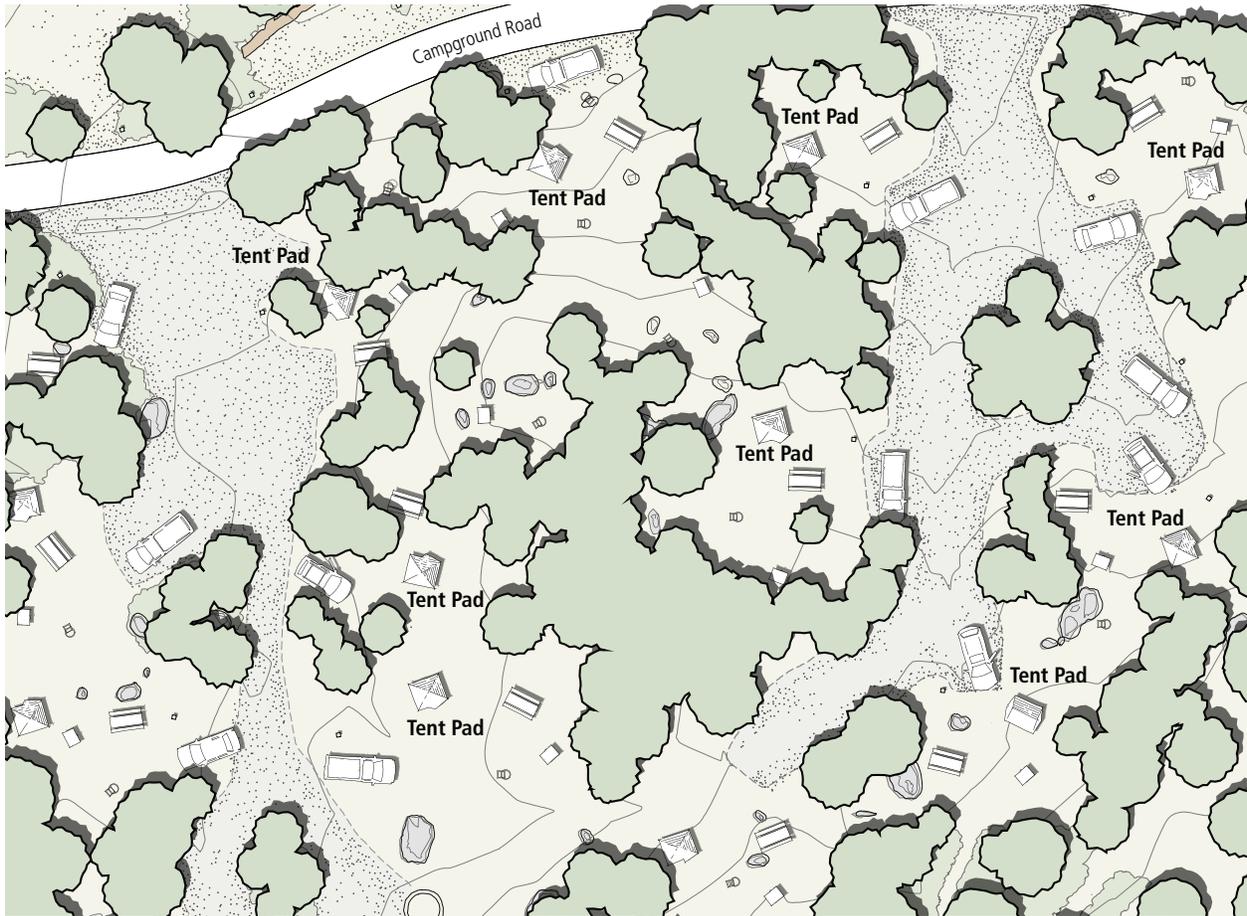
Figure 3-23. A typical arrangement of Campground Cluster B with little definition between parking and camping (source: Mundus Bishop, 2020).

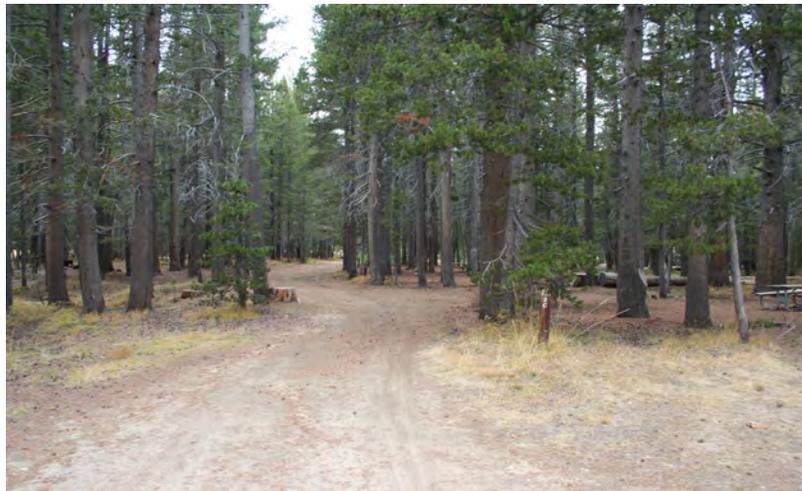
Figure 3-28. Campground Cluster C campsite with little understory vegetation (source: Mundus Bishop, 2019).

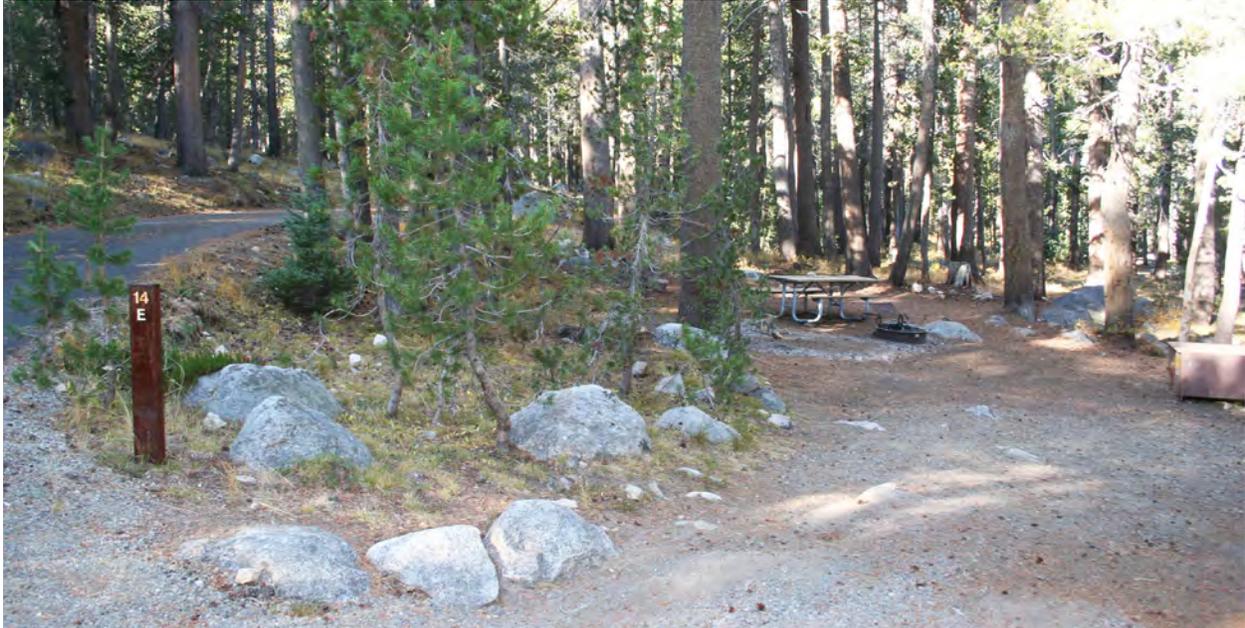
Figure 3-30. Campground Cluster D, E, F, G individual campsites respond to the topography of the forest and are set into the native vegetation (source: Mundus Bishop, 2019).

Campground Cluster D, E, F, G is the first cluster of campsites and campground roads built (1931 to 1932). This cluster and most of its campsites respond to the topography of the forest and are nestled into the natural vegetation. This cluster consists of seventy campsites within approximately 16.9 acres.

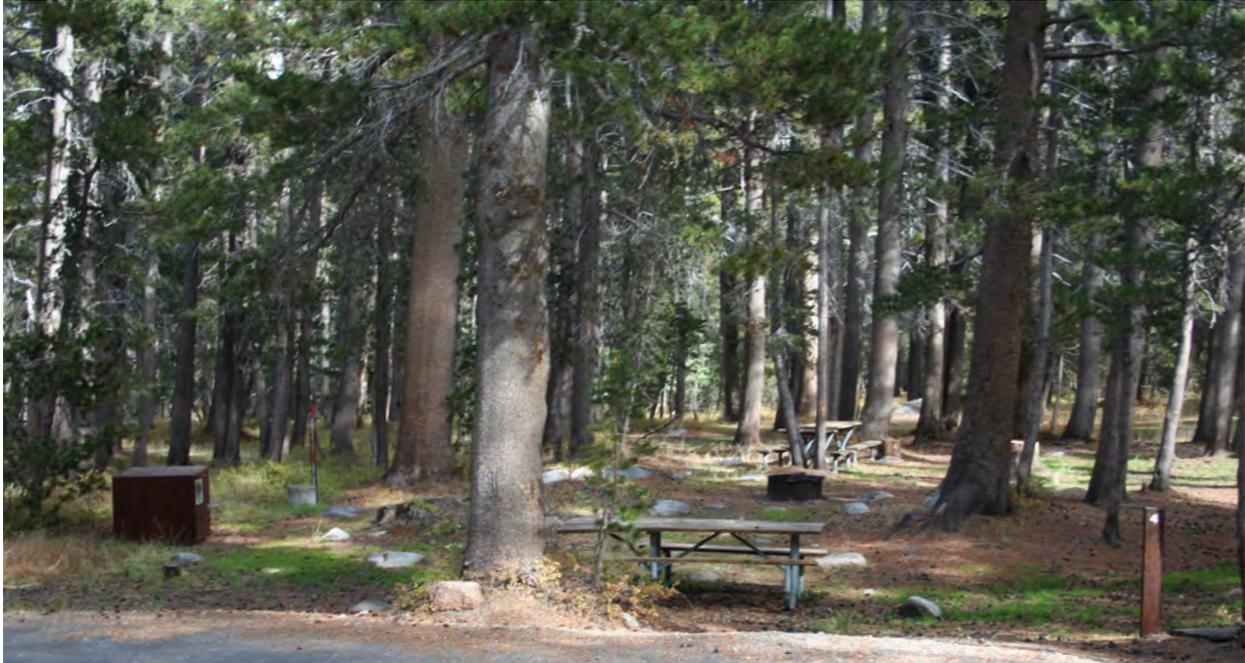
Figure 3-32. Campsites within Campground Cluster B at Horse Camp are within a heavily forested area with campsites along a low ridge that were originally developed as group campsites during Mission 66 development (source: Mundus Bishop, 2019).

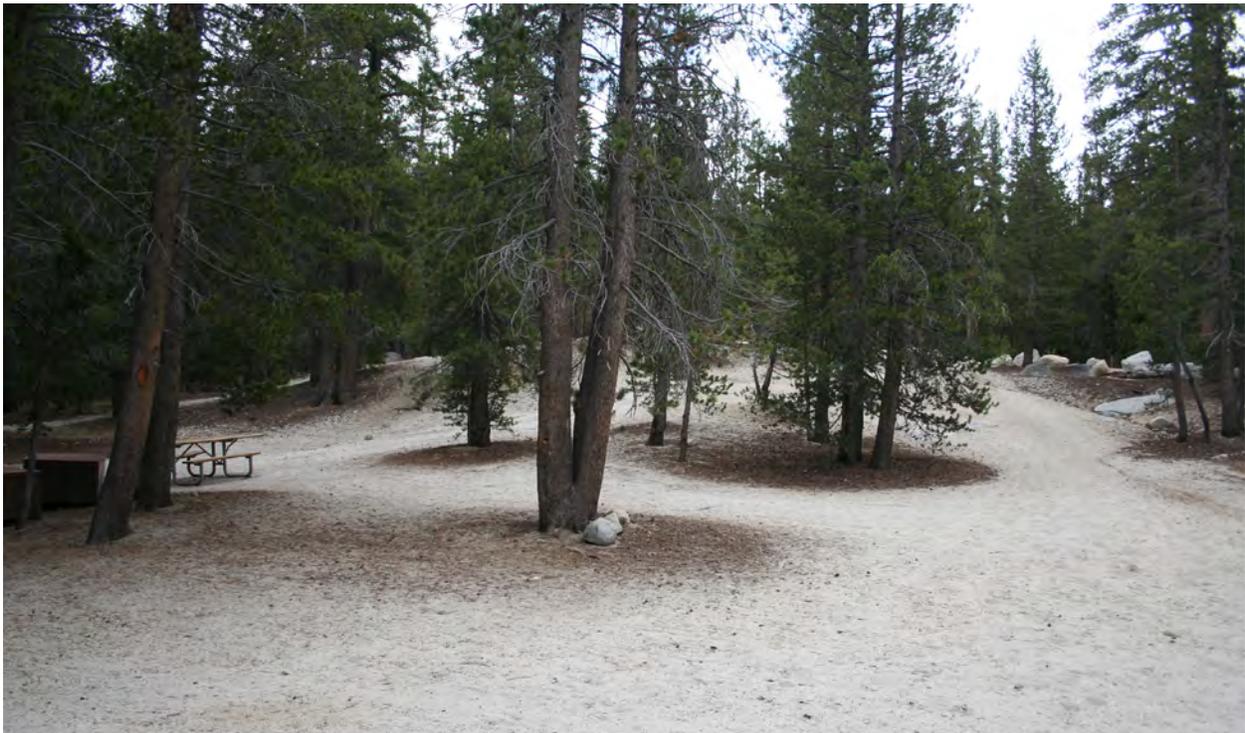
Figure 3-34. Group Camp is a large gravel paved area with extreme soil compaction and erosion (source: Mundus Bishop, 2019).

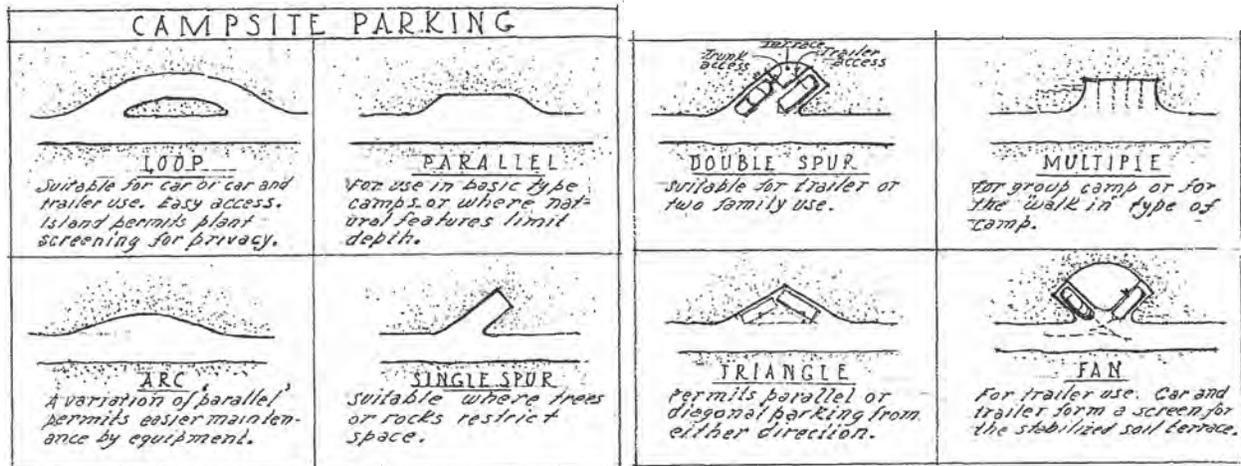
Figure 3-35. Mission 66 recommended campsite parking adjacent to campground roads (not parking spurs for multiple cars). The 'single spur' is characteristic of Tuolumne Meadows Campground at campsites. The 'multiple spur' is characteristic of Tuolumne Meadows Group Camp. (source: NPS, Campground Study, Region Four, 1959).

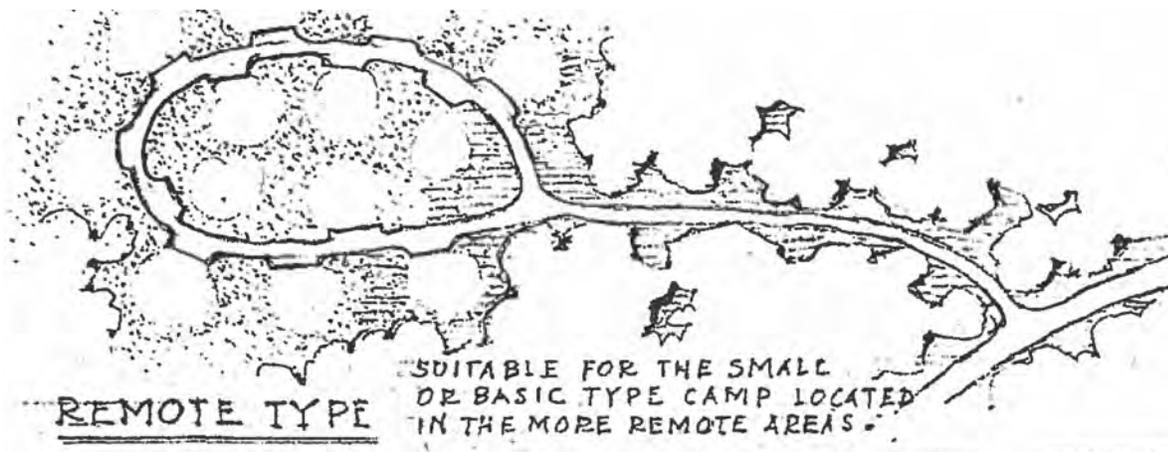
Figure 3-36. The 1961 Campground Road B extension for group campsites is consistent with general Mission 66 standards (source: NPS, Campground Study, Region Four, 1959).

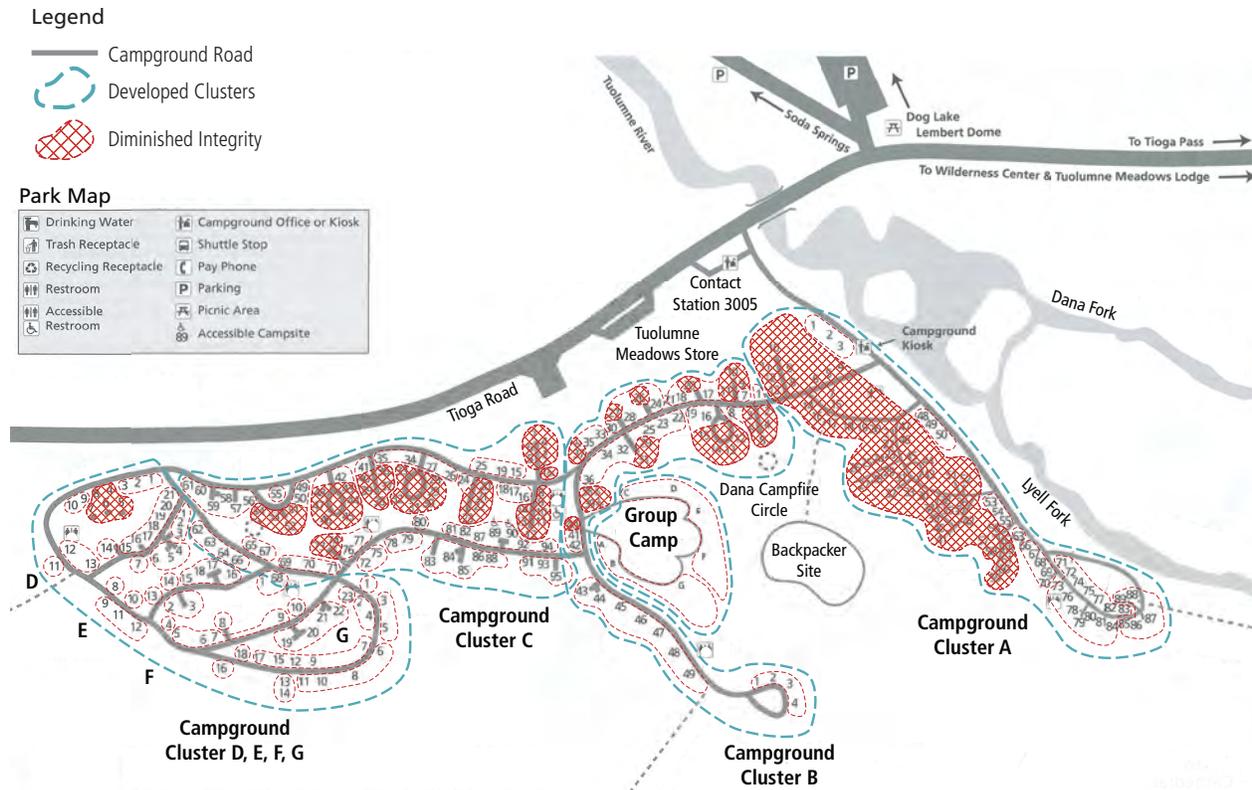
Figure 3-37. Campground Clusters A, B, and C have small clusters of campsites additions of drive spurs and campsites which diminished the integrity of the campground cluster (source: NPS YOSE Tuolumne Meadows Park Map, Mundus Bishop, 2020).

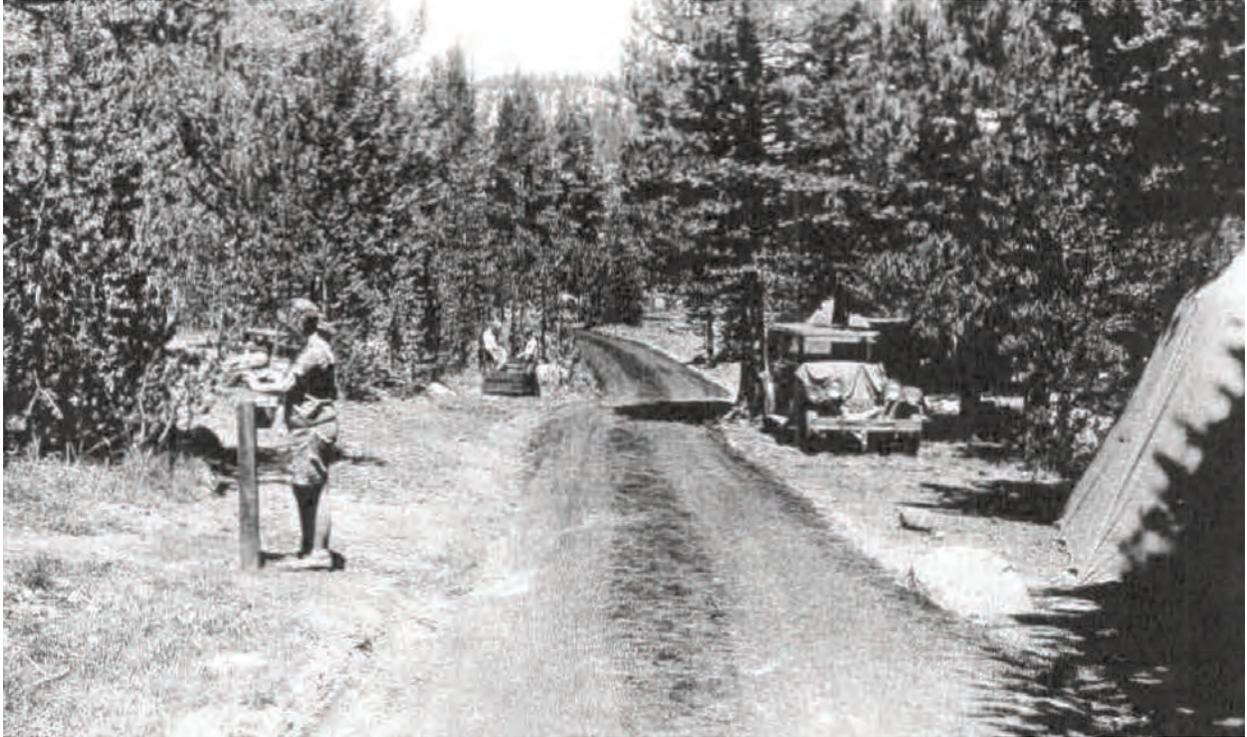
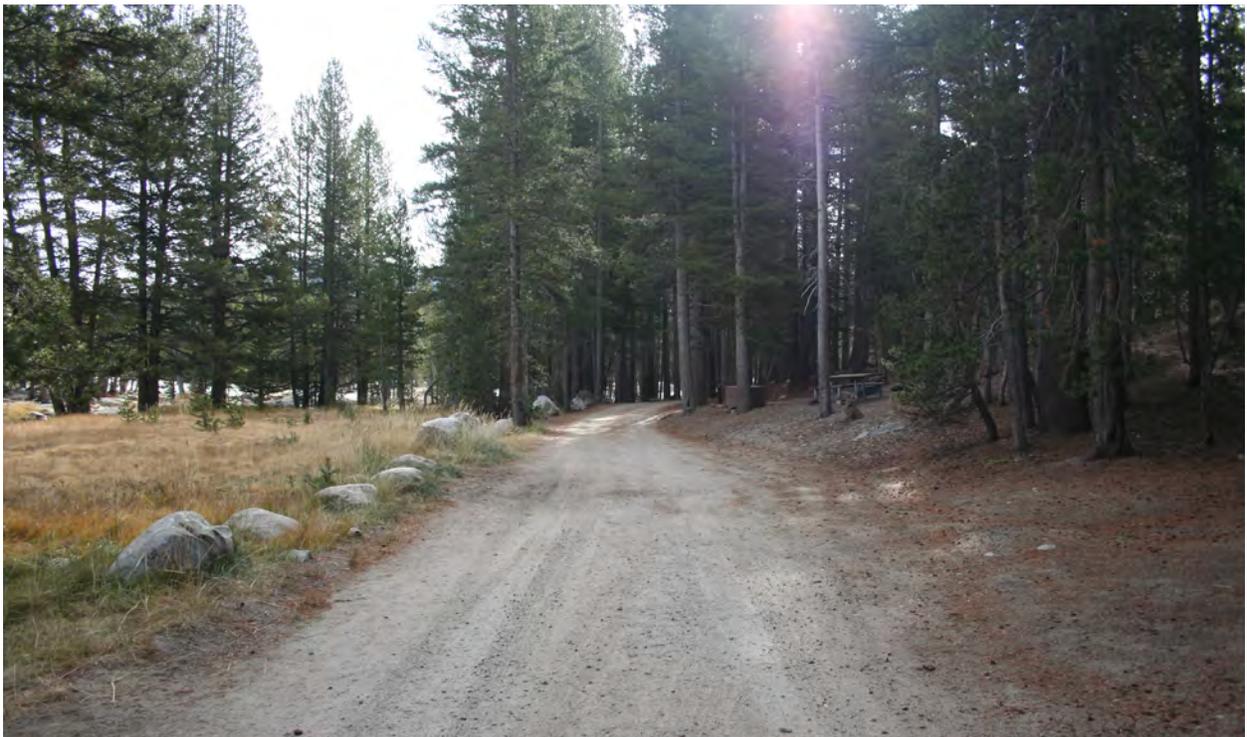
Figure 3-42. Campground Road A (Lyell Fork Road), shortly after completion in 1934 and present-day (source: YOSE 1934 Superintendent's Report, Mundus Bishop, 2019).

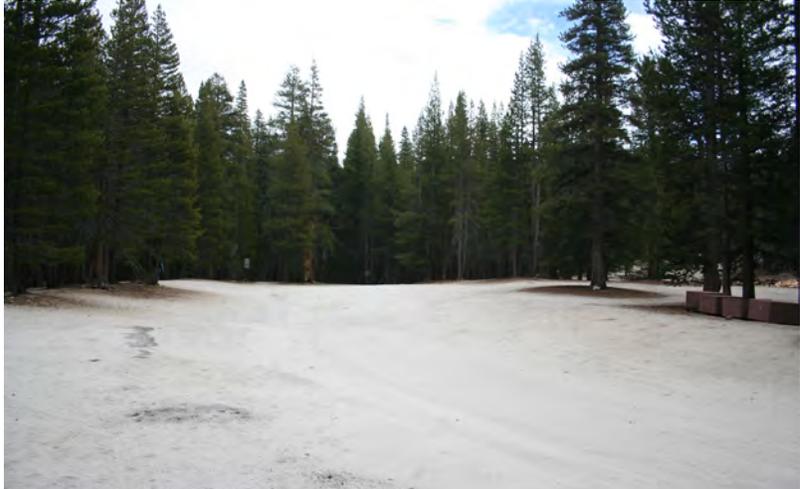
Figure 3-52. John Muir Trail (source: Mundus Bishop, 2019).

Trails include John Muir Trail and Elizabeth Lake Trail. John Muir Trail extends through Tuolumne Meadows Campground and is part of the 211-mile John Muir Trail, which is part of the larger 2,650-mile Pacific Crest National Scenic Trail. Elizabeth Lake Trail begins near Group Camp and continues five miles to a lake at the base of Unicorn Peak.

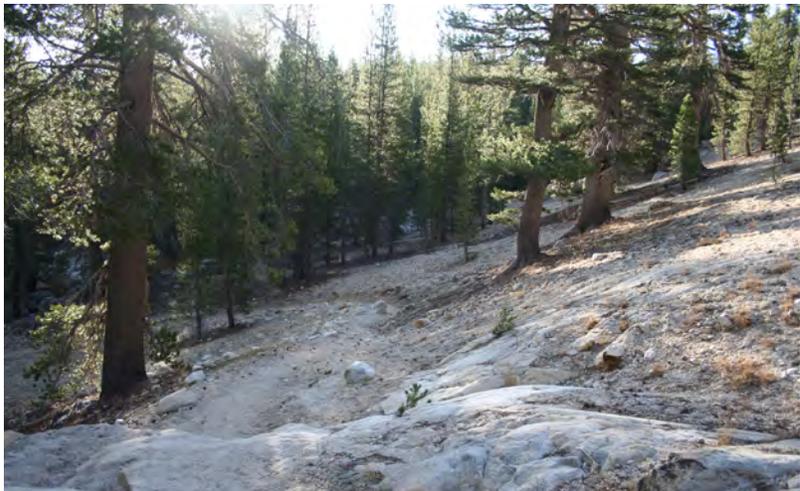
Figure 3-53. Elizabeth Lake Trail (source: Mundus Bishop, 2019).

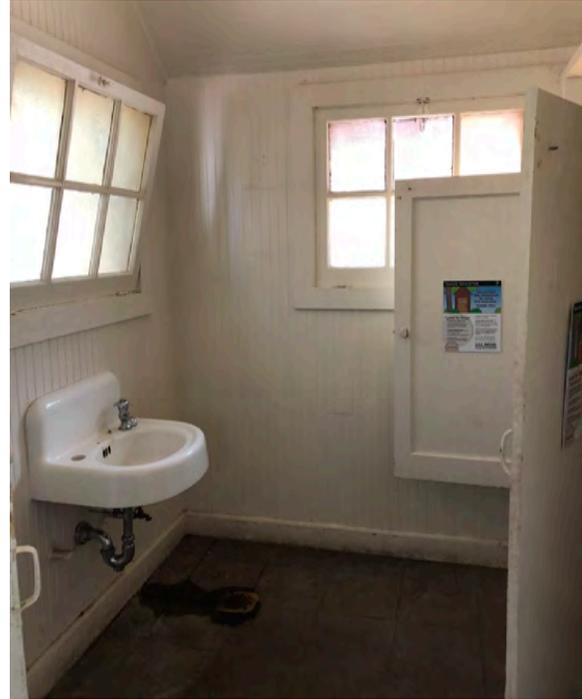
Figure 3-57. Intact original interior finishes in Building 3024 (source: Anderson Hallas Architects, 2019).
