Tuolumne Meadows Campground
Yosemite National Park

Cultural Landscape Report

January 31, 2021

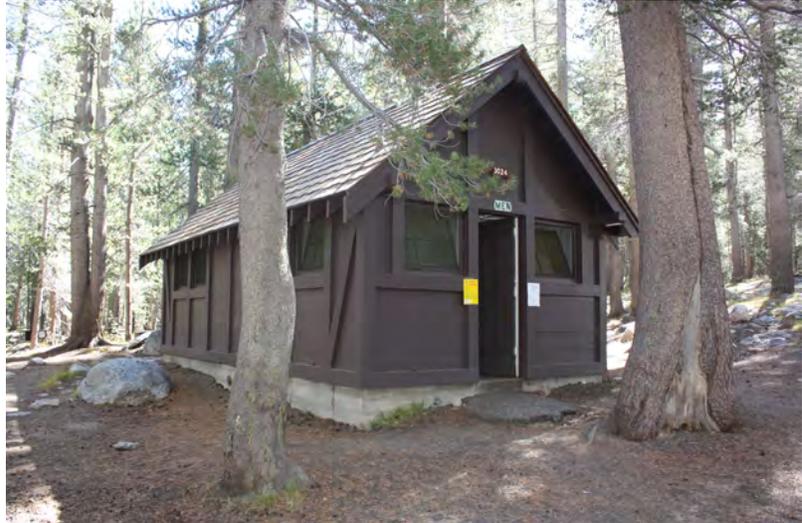
Figure 3-59. Comfort Station (CS3024) was the first comfort station built in the campground and the only building built in 1931 (source: NPS, Campground Completion Report 1932).

Built in 1931 to serve the original campground cluster (D, E, F, and G), this comfort station is the only wood building of this style in the campground. The design is the typical NPS rustic style comfort station design from 1931, modified to address Tuolumne Meadows Campground's high altitude.

The building is a wood, exterior framed building with a rectangular 13'-0" x 26'-0" floor plan and gable roof. Men's and women's spaces are located on opposite sides of the building, accessed by doors on each gable end, and separated by an unfinished plumbing chase. Roofing is wood shingle. Exterior walls are shiplap wood boards oriented horizontally and installed interior to the exposed wood structure. All are painted. A board-form concrete foundation is visible below the framing and is unpainted. Windows are single pane, six lite, inward opening hoppers with textured amber tinted glass and exterior screens. Exterior doors are vertical wood boards with metal strap hinges.

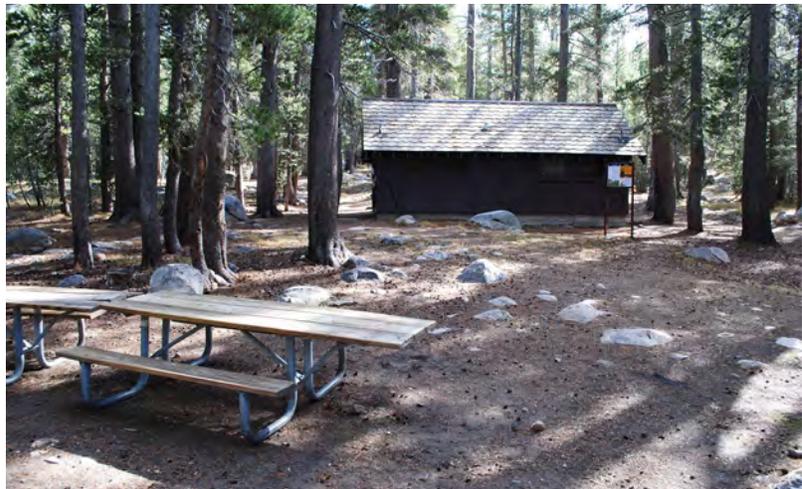
Figure 3-60. Comfort Station (CS3024) setting (Anderson Hallas Architects, 2019).

The setting of Comfort Station (CS3024) is degraded due to soil compaction and erosion due to multiple social routes, campsites set immediately adjacent to the comfort station and lack of clear delineation for parking.

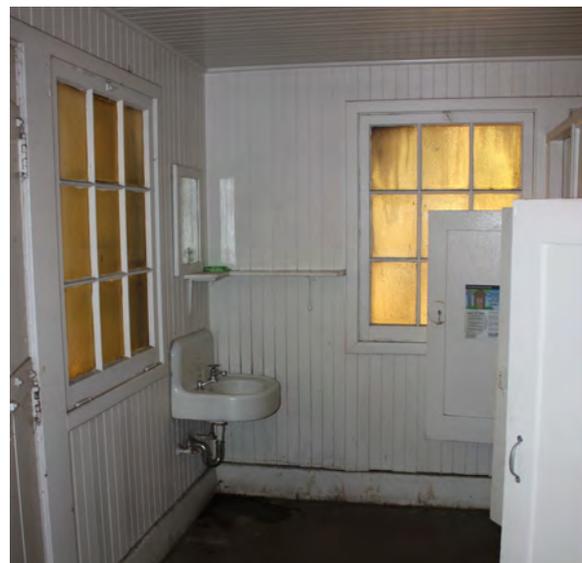
Figure 3-61. Intact original interior finishes in Building 3022 (source: Anderson Hallas Architects, 2019).

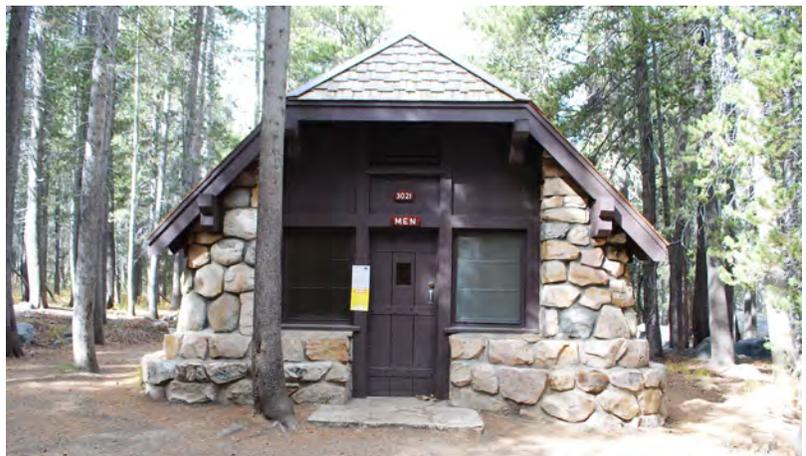
Figure 3-64. Comfort Station (CS3022) (source: Anderson Hallas Architects, 2019).

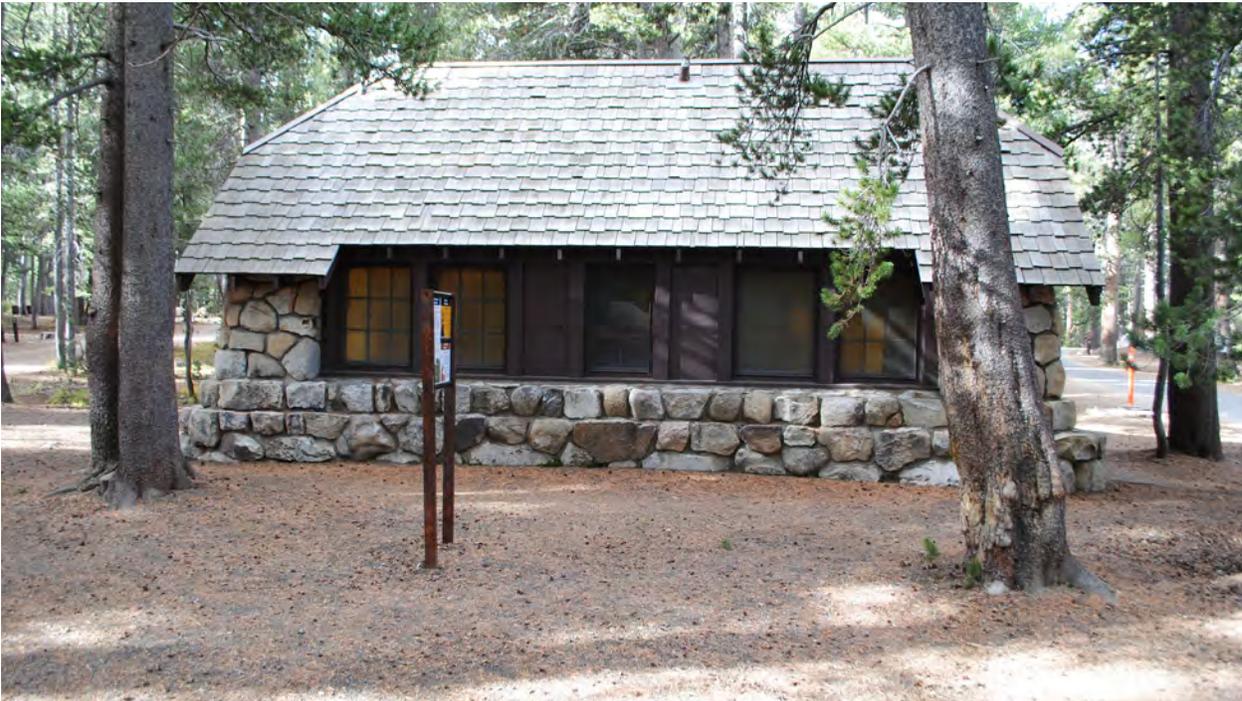
Figure 3-65. Comfort Station (CS3022) (source: Anderson Hallas Architects, 2019).

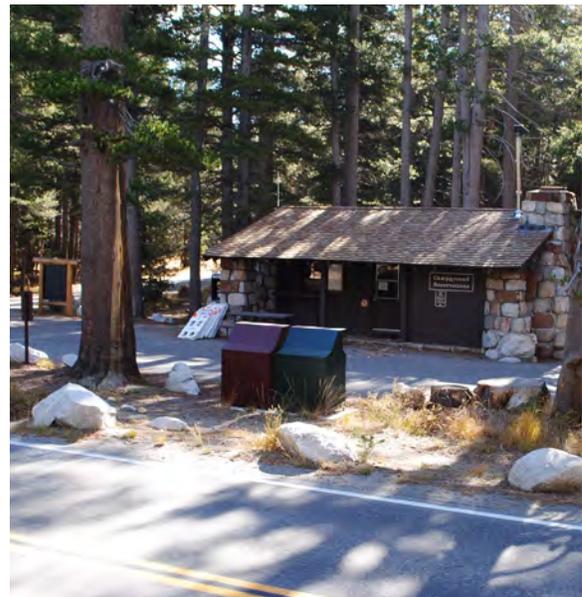
Figure 3-69. Contact Station (CS3005)
(source: Anderson Hallas Architects, 2019).

Contact Station (CS3005) was designed by the NPS in the park rustic style with large stone walls at the rear elevation and gable ends with wood siding infill.

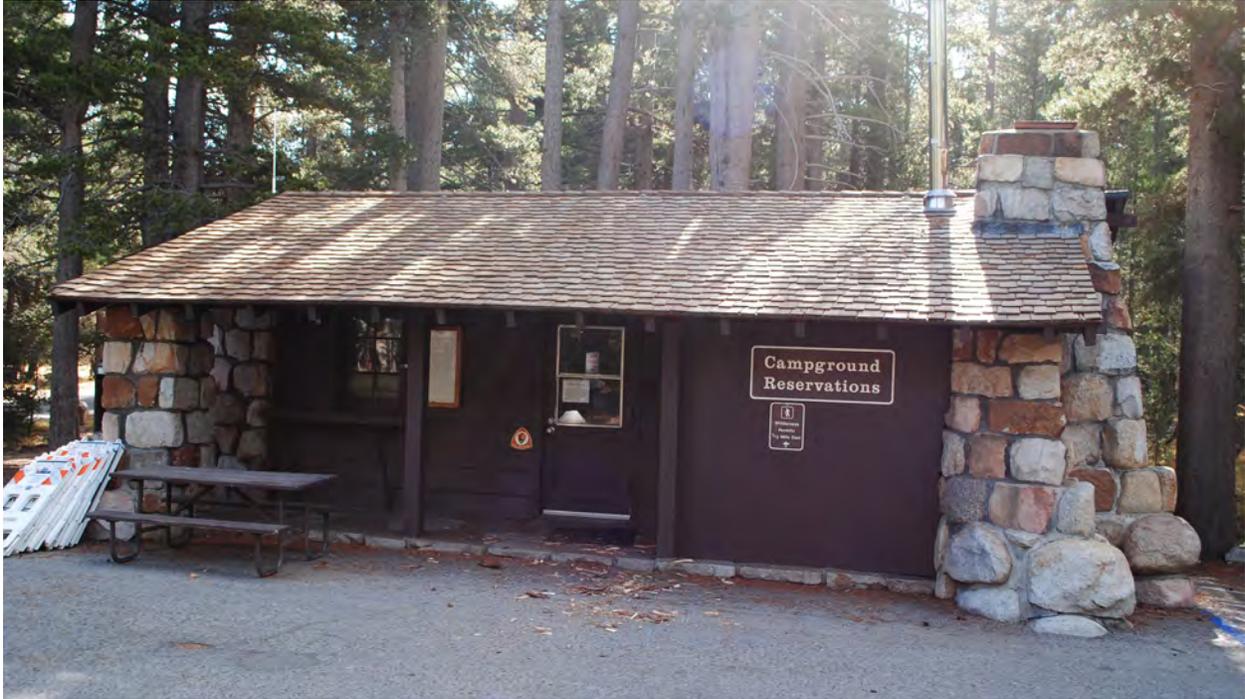
Figure 3-70. Porch extending the full width of the front elevation (source: Mundus Bishop, 2019).

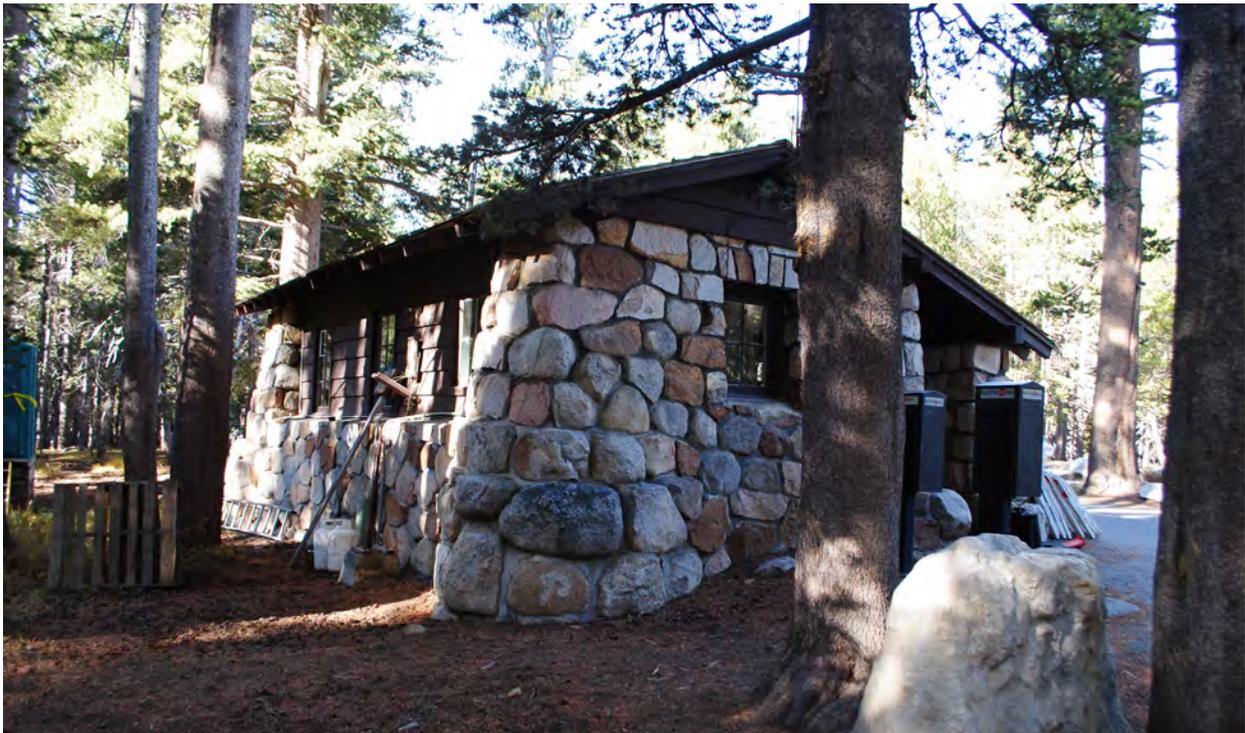
Figure 3-71. Large stone walls on the side and rear façade of the Contact Station (source: Mundus Bishop, 2019).

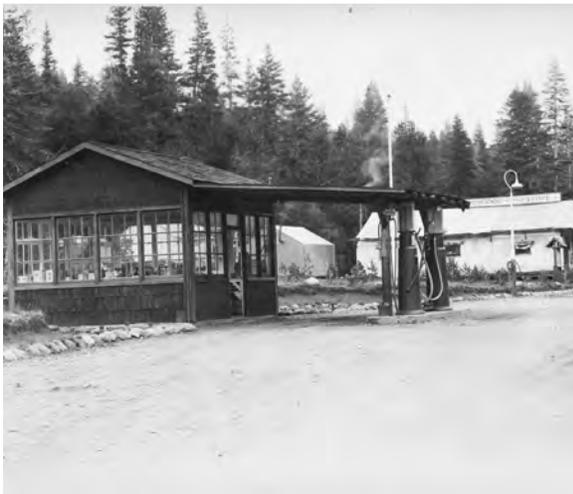
Figure 3-72. Service Station, date unknown, with gable and low slope roof. Background buildings are non-extant and were later replaced by the store, date unknown. (source: NPS).

Service Station is non-extant but it was documented on a plat dated 1940, located just east of the Tuolumne Meadows Store. The building was wood framed with shingle siding and a continuous ribbon of tall windows on all sides. Early photographs show the roof over the store portion of the building to be gently sloped with wood shingles. The roof extending out over the pumps was a much lower slope. Later photographs show that by 1954 the roof was replaced with a hipped roof with standing seam metal roofing. The date of this roofing change is unknown.

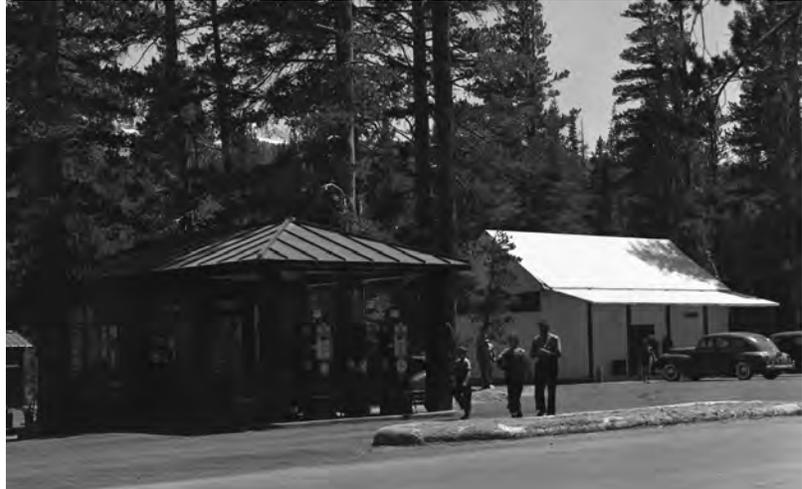
Figure 3-74. Tuolumne Meadows Store, 1954 (source: YOSE Archives X-129, 1954).

Photographs from 1954 show the exterior walls were painted plywood that extended up the gable end walls. Roofing appears to be a fabric stretched over the rafters in a similar style to platform tent structures. At the time of the site visit, the roofing fabric had been removed for winterization and plywood was installed on the exterior side of the window and door openings so these elements were not observed.

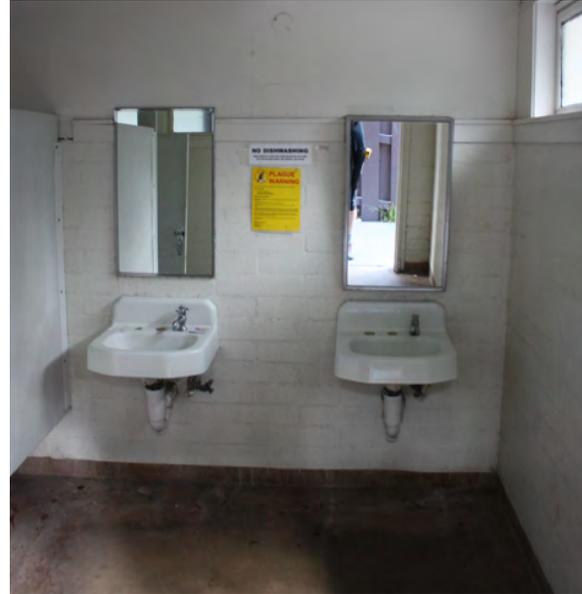
Figure 3-76. Typical interior finishes in Mission 66 comfort stations (source: Anderson Hallas Architects, 2019).

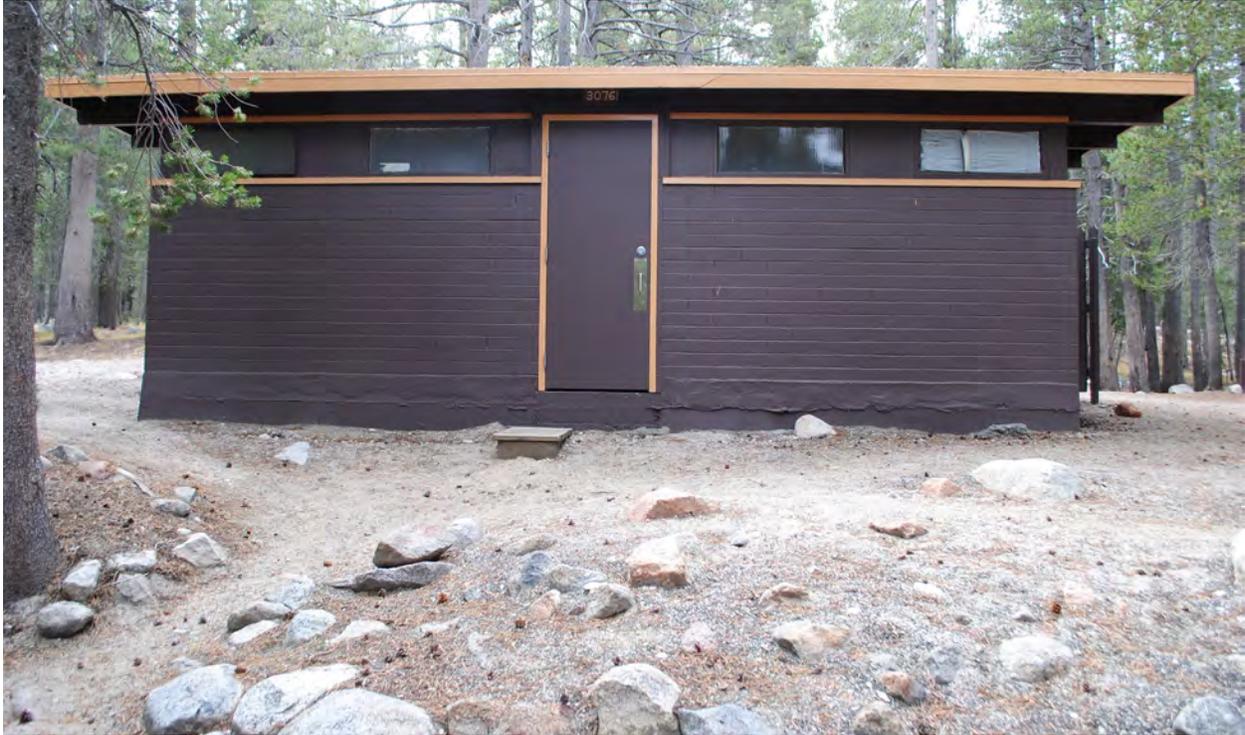
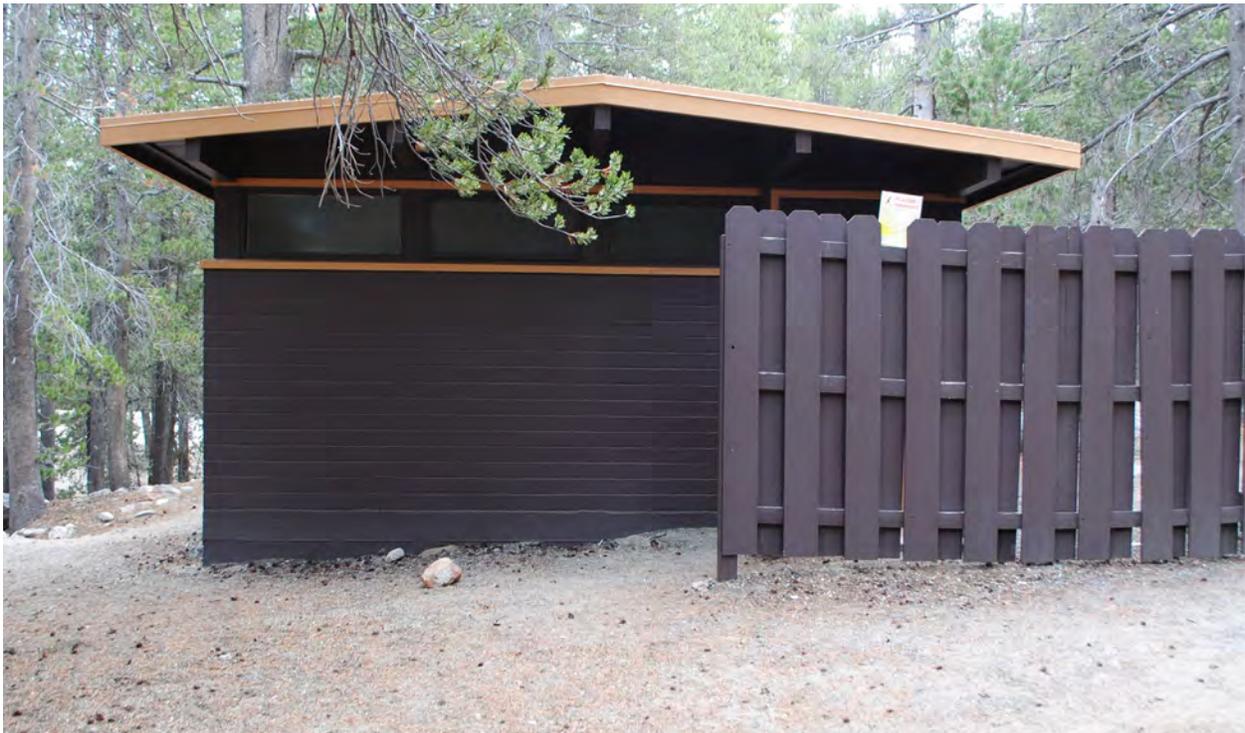
Figure 3-77. Comfort Station (CS3076) (source: Anderson Hallas Architects, 2019).

On the interior, ceiling finish is comprised of exposed structural beams and tongue and groove roof sheathing, all painted. Walls are concrete block up to the window sill level, above which finishes are painted wood. Floors have an epoxy finish that wraps up the wall to form the wall base. Partitions have been replaced in some comfort stations to accommodate modified fixture layouts.

In general, the Mission 66 comfort stations are in good condition with select elements requiring repairs. However, at the northeast corner of CS3077, the roof eave has collapsed due to failure of the structural beam.

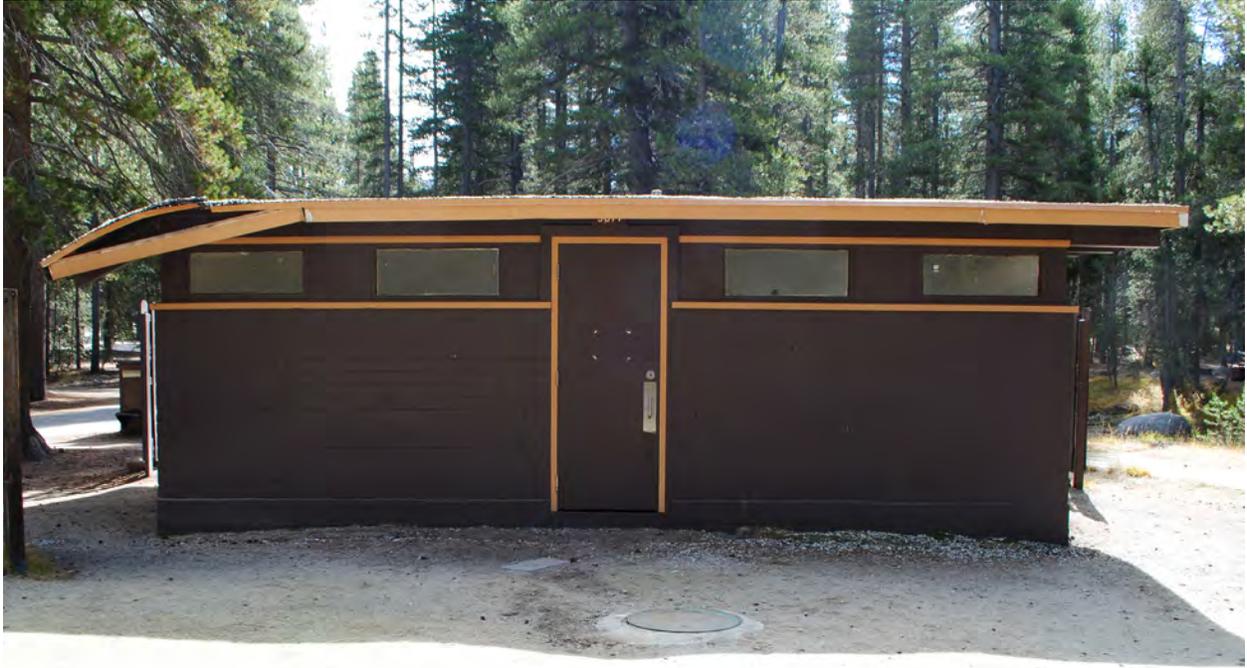
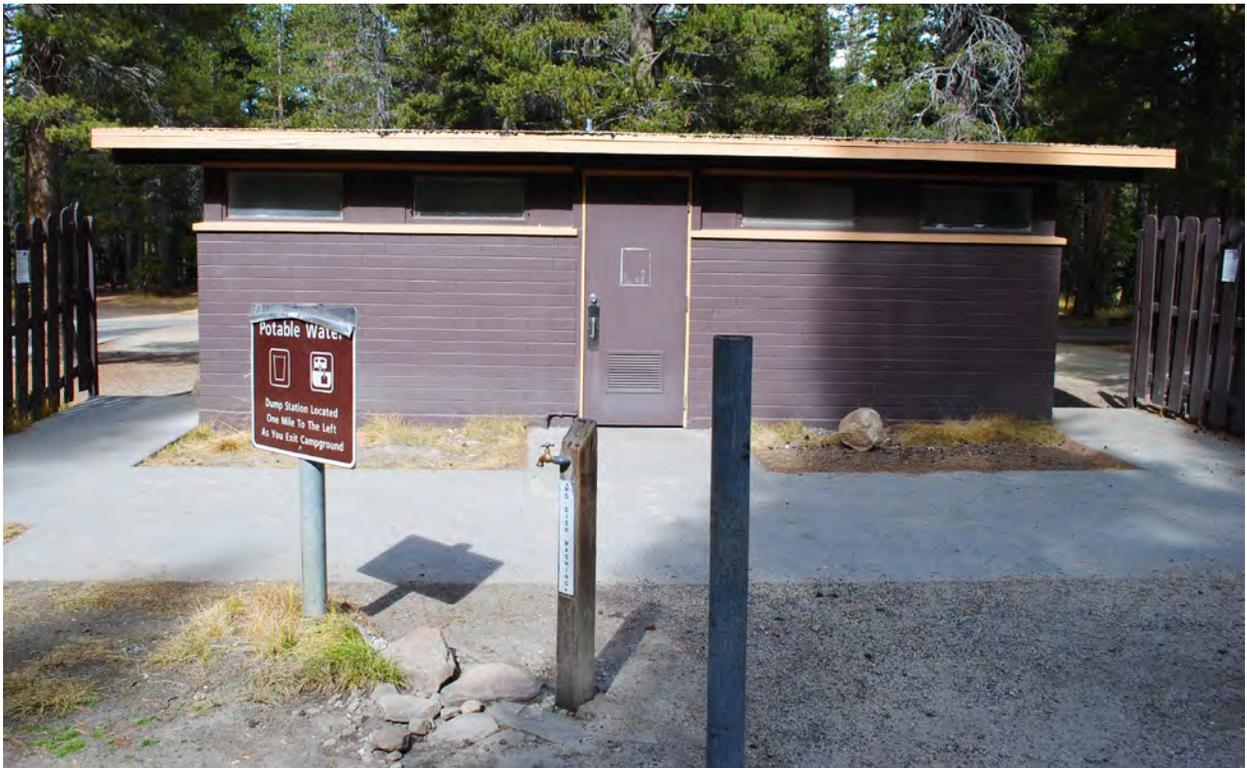
Figure 3-79. Comfort Station (CS3077) (source: Anderson Hallas Architects, 2019).

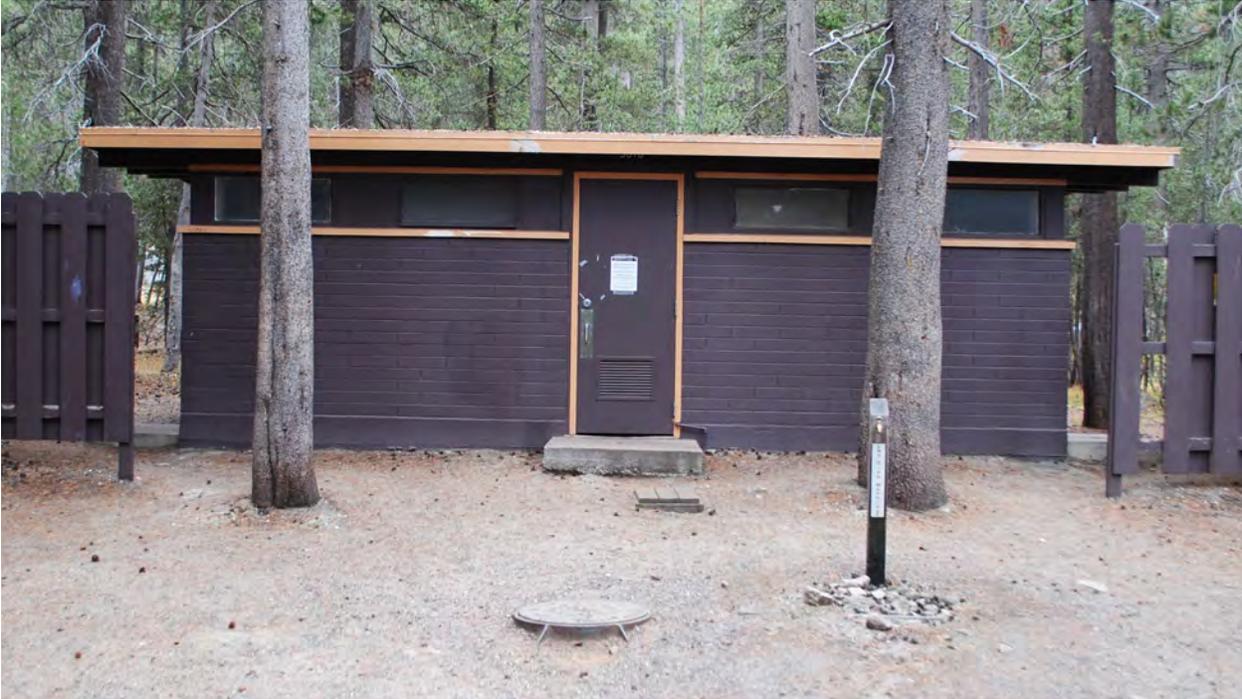
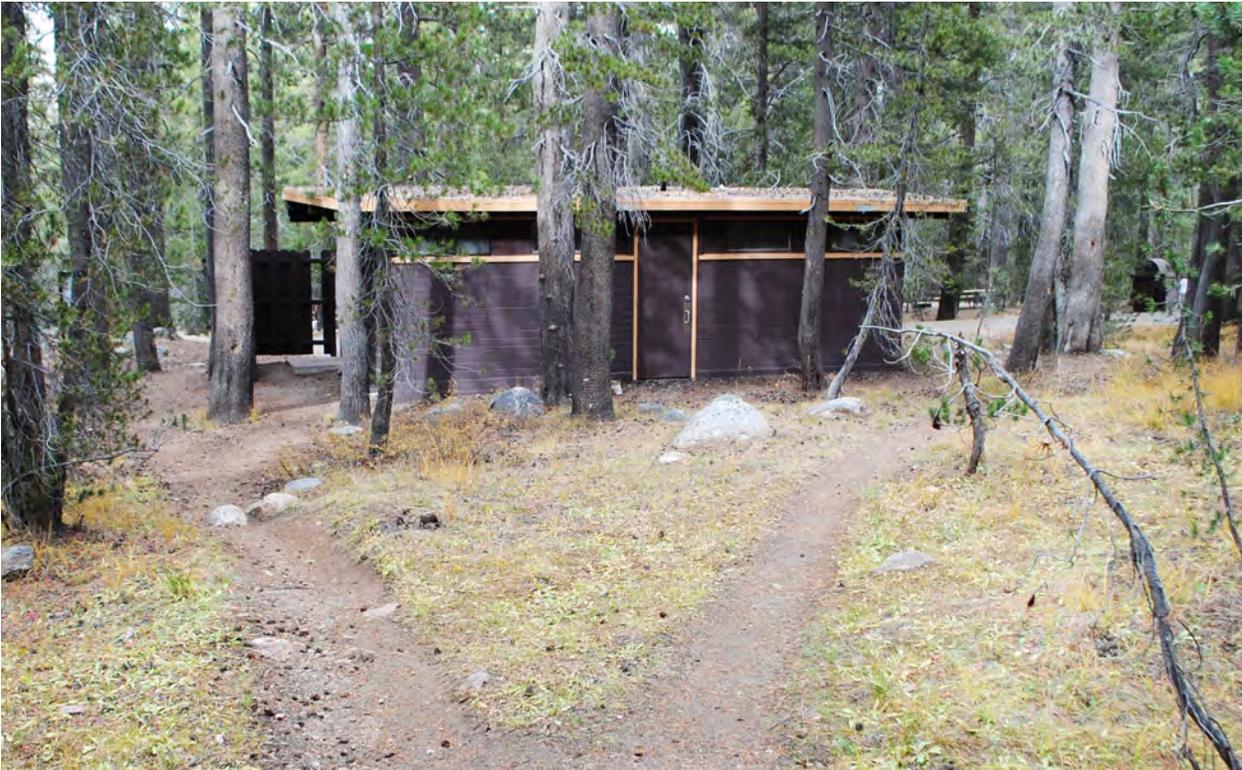
Figure 3-80. Comfort Station (CS3078) (source: Anderson Hallas Architects, 2019).

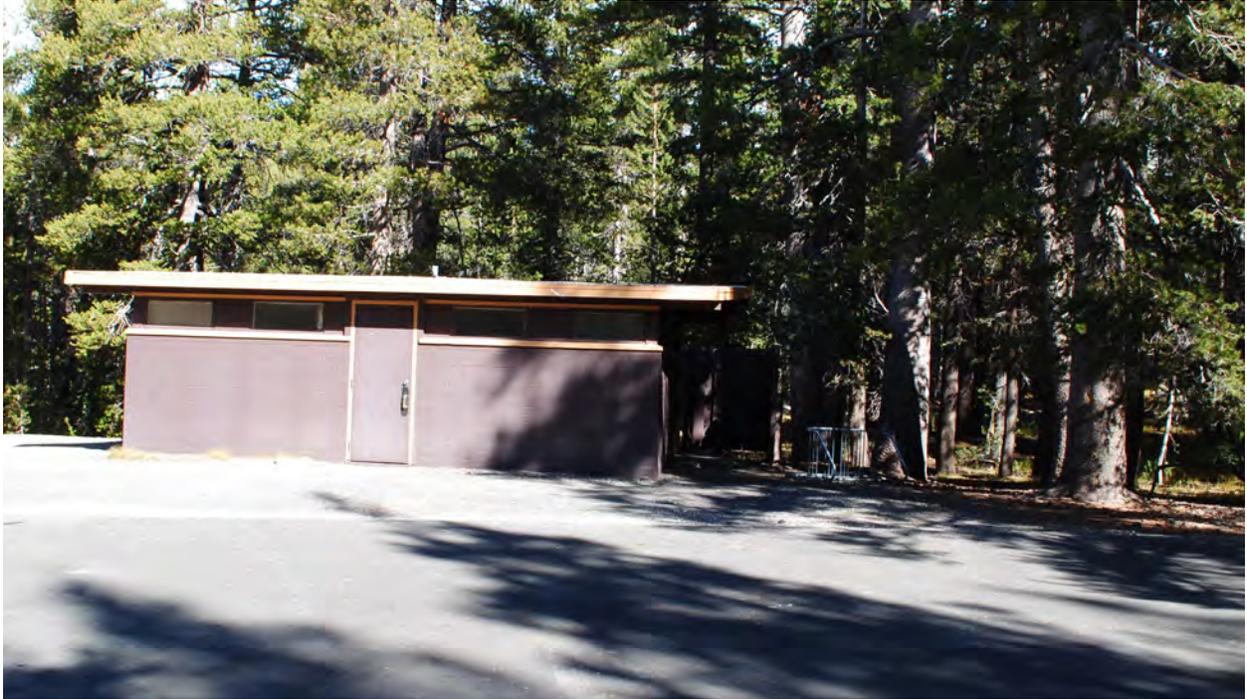
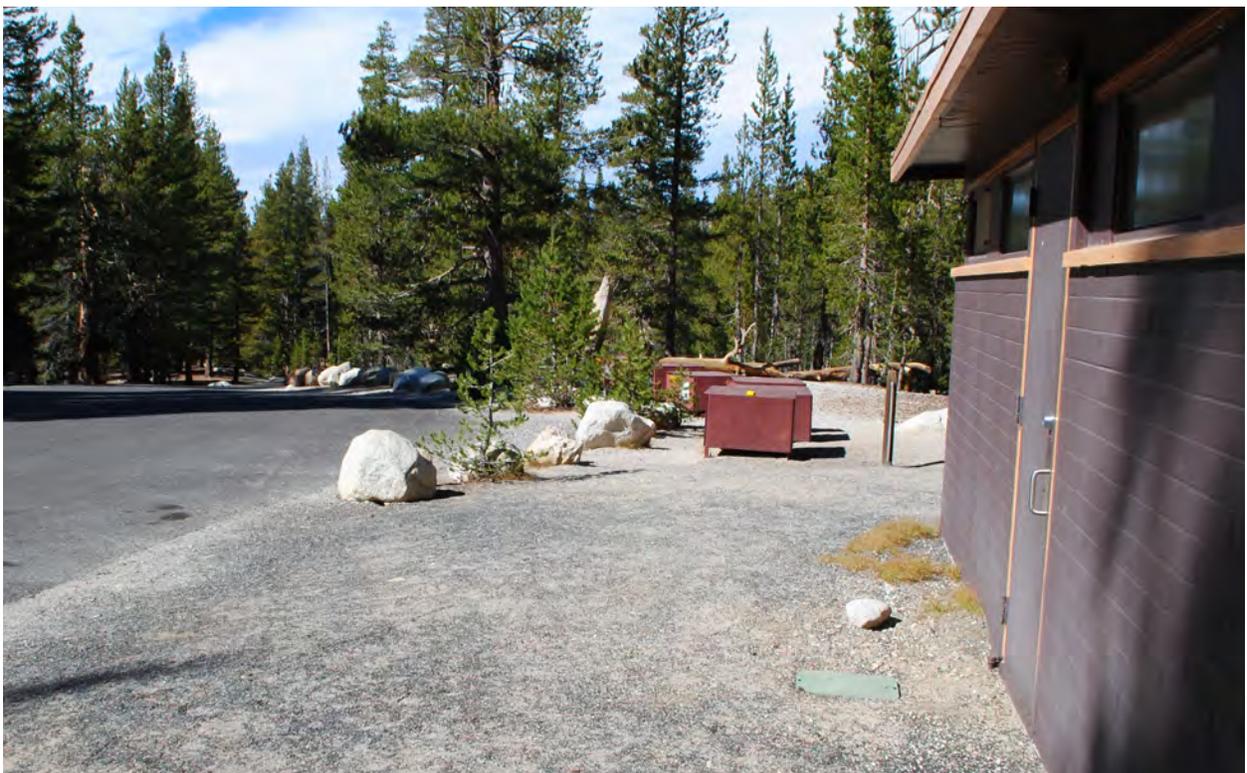
Figure 3-81. Comfort Station (CS3079) (source: Anderson Hallas Architects, 2019).

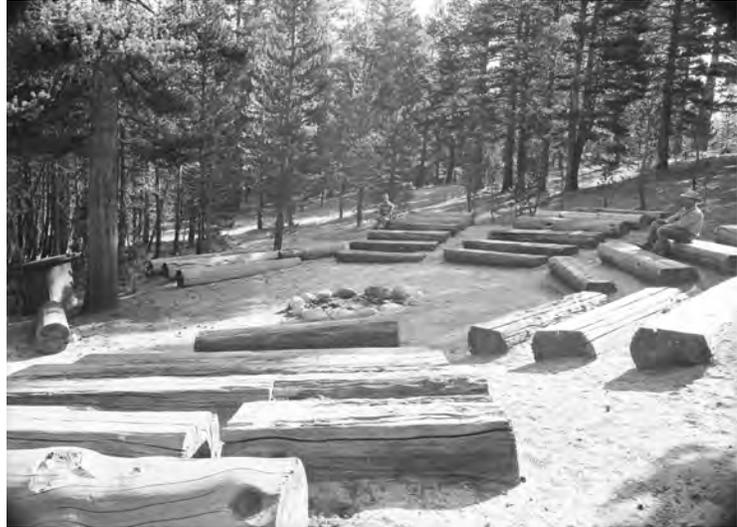
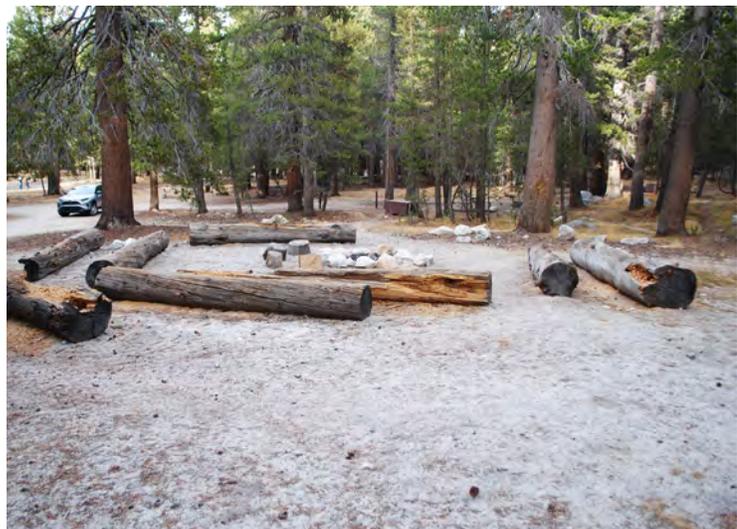
Figure 3-82. Conness Campfire Circle, 1957 and present-day (source: YOSE Archives X_647, Mundus Bishop, 2019).

The originally felled trees appear to have been wholly replaced. The original sloping topography and well-defined rows of seating has been modified, although the fire ring remains at the center of the campfire circle.

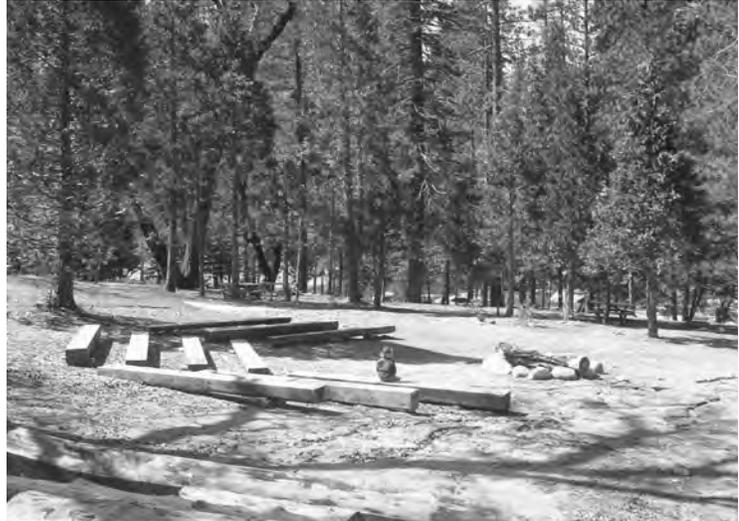
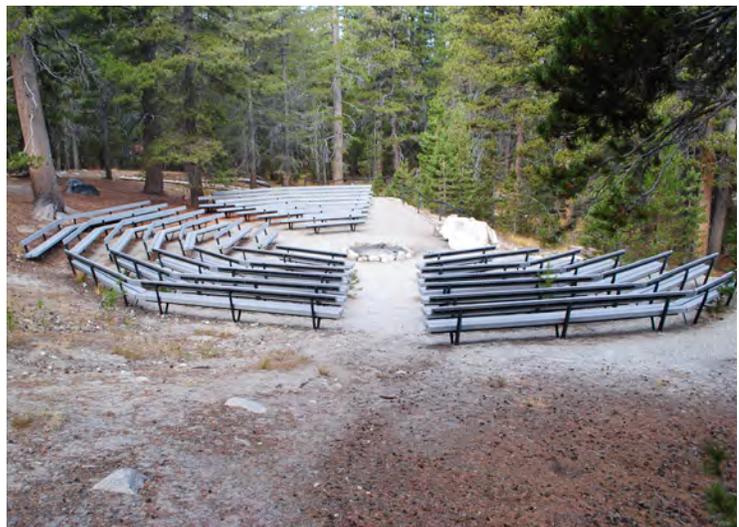
Figure 3-83. Dana Campfire Circle, 1957 and present-day (source: YOSE Archives X_649, Mundus Bishop, 2019).

The original Port Orford cedar benches were replaced in the 1990s with recycled lumber benches. At the time the original galvanized iron frames were noted to have remained. These appear to have been removed and new features added including a low stone wall and painted steel railing on one side of the amphitheater. The number of rows of benches has increased from the original campfire circle. Much of the site is now asphalt paved and the slope of the amphitheater appears flatter than it was historically.

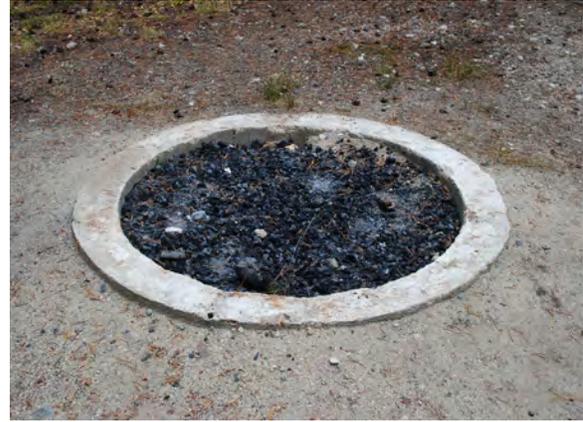
Figure 3-84. Informal Campfire Ring (source: Mundus Bishop, 2019).

An informal campfire ring is located north of Comfort Station (CS3023) in Campground Cluster C. The campfire ring is accessed by several informal social trails from adjacent campsites and Comfort Station (CS3023). The campfire ring includes a one-foot wide concrete band flush with grade. The original date of construction is unknown.

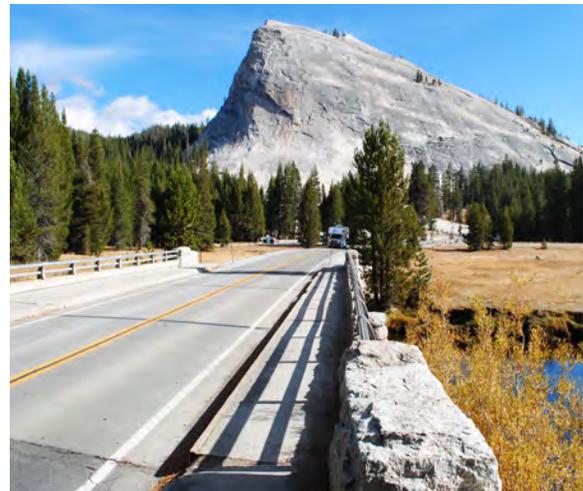
Figure 3-85. Tuolumne River Bridge (source: Mundus Bishop, 2019).

Tuolumne River Bridge was built as an integral component of the construction of Tioga Road (1931 to 1934). The bridge spans the confluence of Lyell and Dana Forks and is east of the campground. It is characterized by large granite rubble blocks for piers and abutments and a concrete deck. Aggregate, measuring 35,000 cubic yards, was excavated from a borrow pit within the adjacent Tuolumne River to provide material to build the bridge.

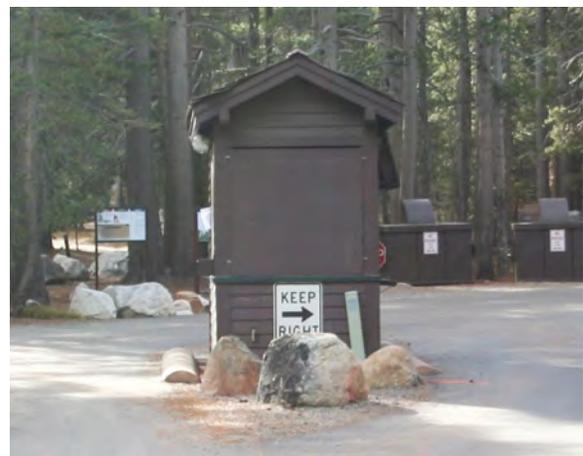
Figure 3-86. Entrance Kiosk (source: Mundus Bishop, 2019).

Entrance Kiosk is a more recent addition to the campground. It is set in the center of the Entrance Road within a small gravel island. The structure has painted wood siding and a gable roof with asphalt shingles. Large operable windows are on both sides of the structure facing the road for transactions with visitors entering and exiting the campground.

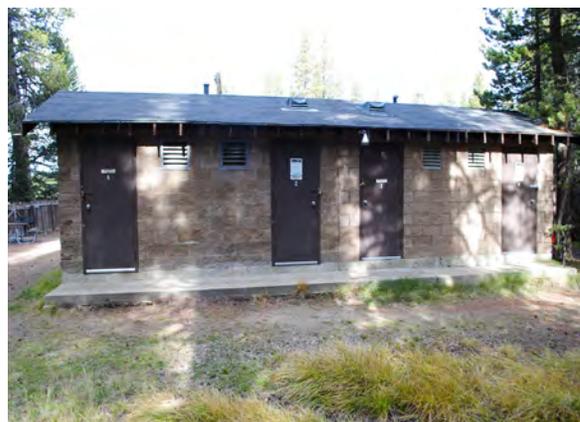
Figure 3-87. Shower House and Restroom (source: Mundus Bishop, 2019).

Shower House and Restroom was built in 1983 to accommodate NPS employees. The building is a twenty-five by ten-foot CMU block structure with a wood shingle gable roof. Shower House and Restroom is located directly south of Tuolumne Meadows Store and used by NPS employees only.

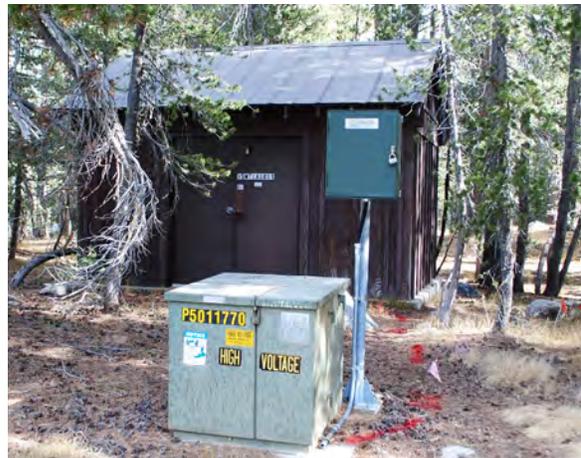
Figure 3-91. Gas Station Utility Shed (source: Mundus Bishop, 2019).

This structure is eleven-foot by fifteen-foot. It has a gable metal roofing and board and batten wood siding painted Wosky Brown. The structure houses telephone and utility equipment.^{3.33}

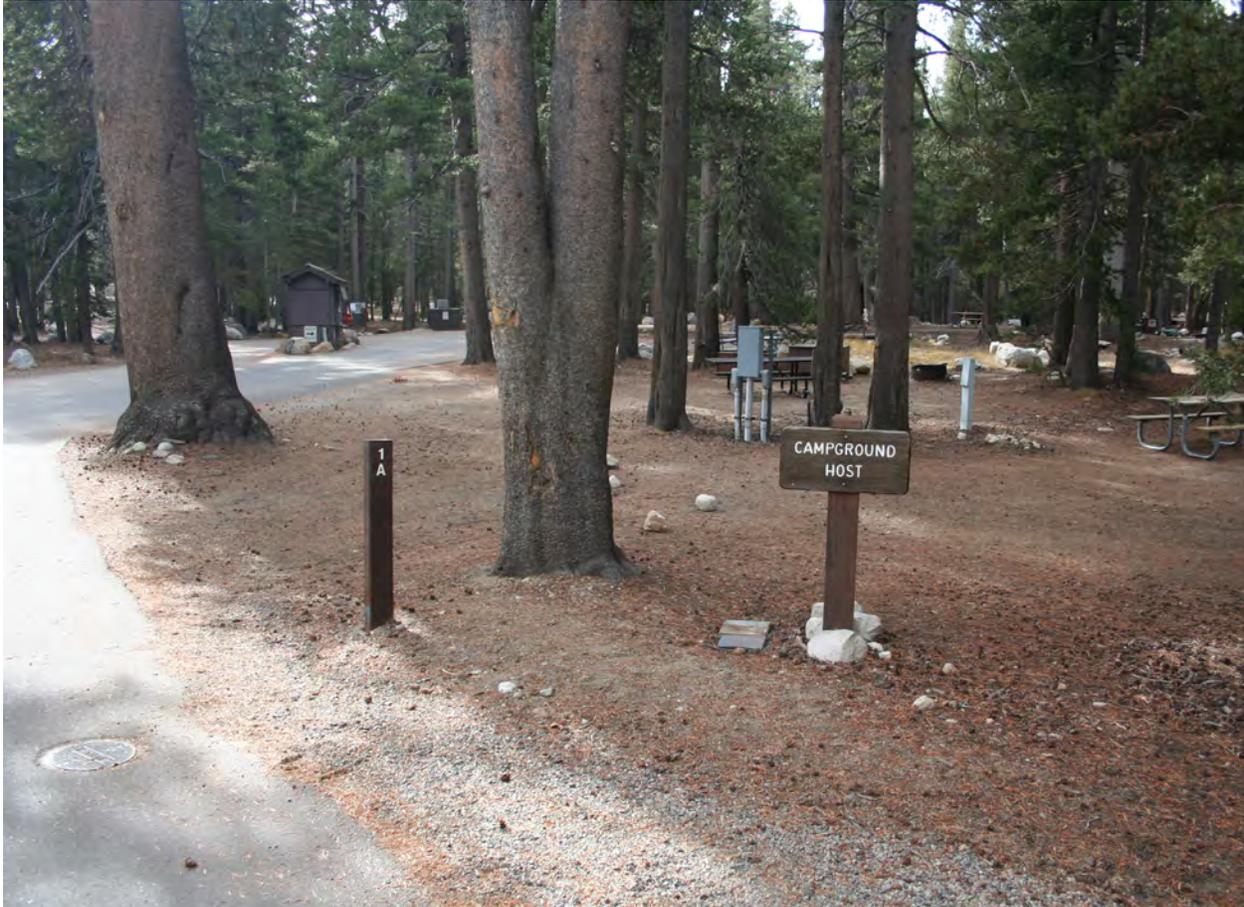
Figure 3-93. Small scale features include signage and campsite amenities (source: Mundus Bishop, 2019).

Campground Cluster A, B, C, D, E, F, and G, Group Camp, and Backpacker Site are modified by modern small scale features. The NPS installed bear boxes at each campsite in 1984. Bear boxes are highly visible throughout the campground, particularly where campsites are densely sited, and alter the setting and views of the campground. Metal and wood tables remain at sites throughout the year. Snow loads distort picnic tables and most are in poor to fair condition.

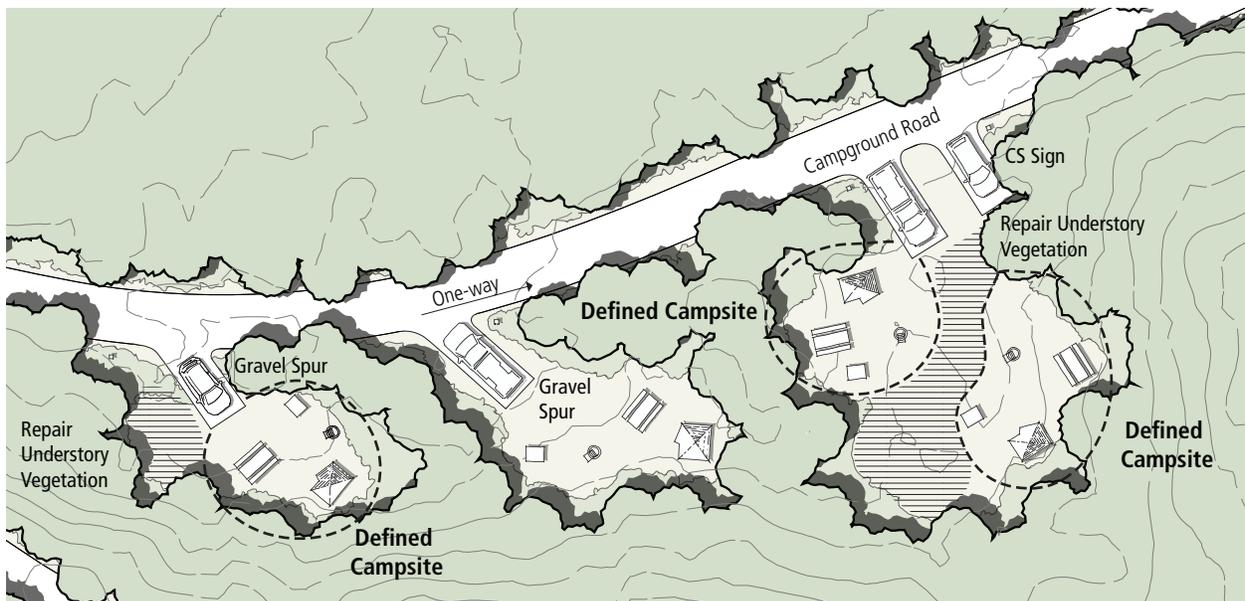
Figure 4-5. Consider repairing campsite arrangements within Campground Cluster's B and C by reestablishing the patterns of parking spurs along campground roads with defined campsites as illustrated in this example (source: Mundus Bishop, 2020).

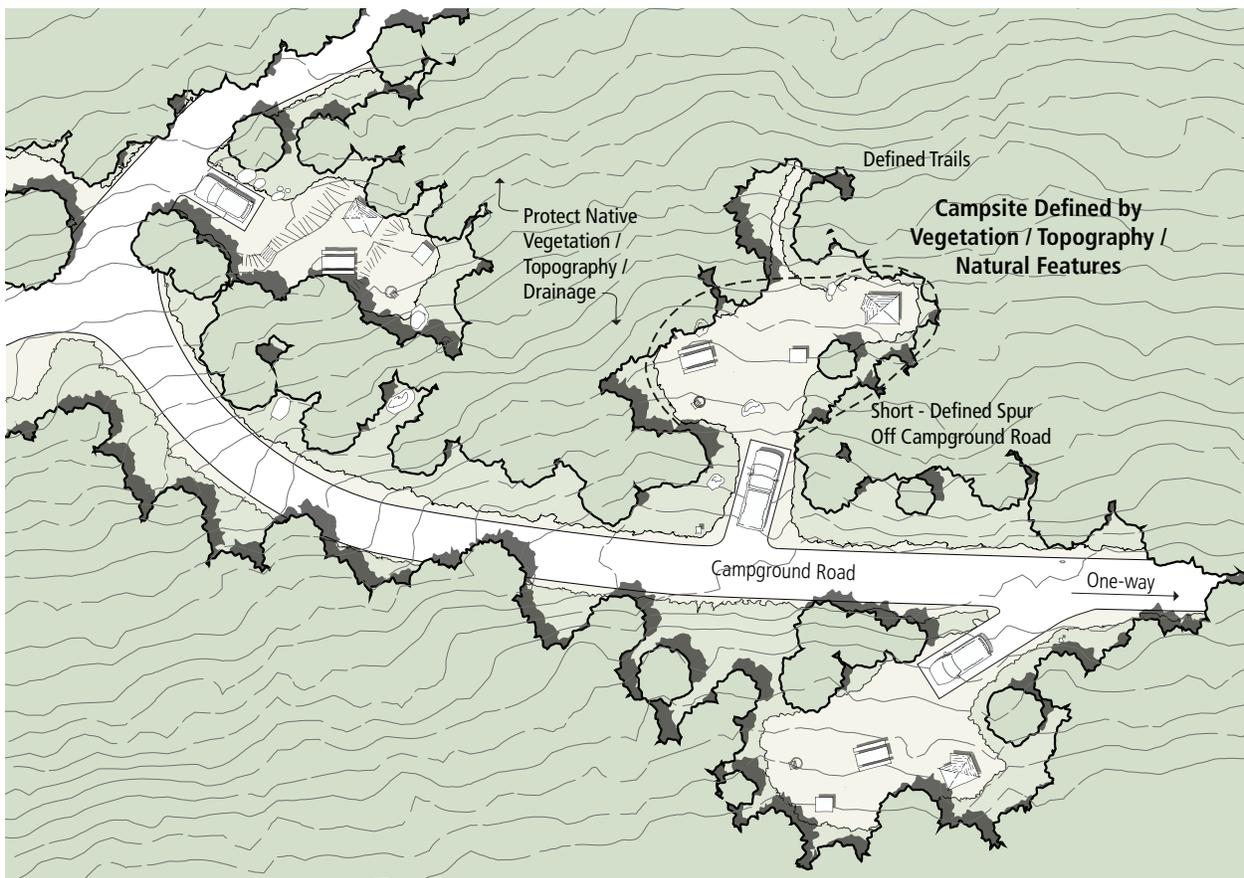
Figure 4-7. Preserve campground roads and repair campground clusters by separating parking from campsites as illustrated in this example (source: Mundus Bishop, 2020).

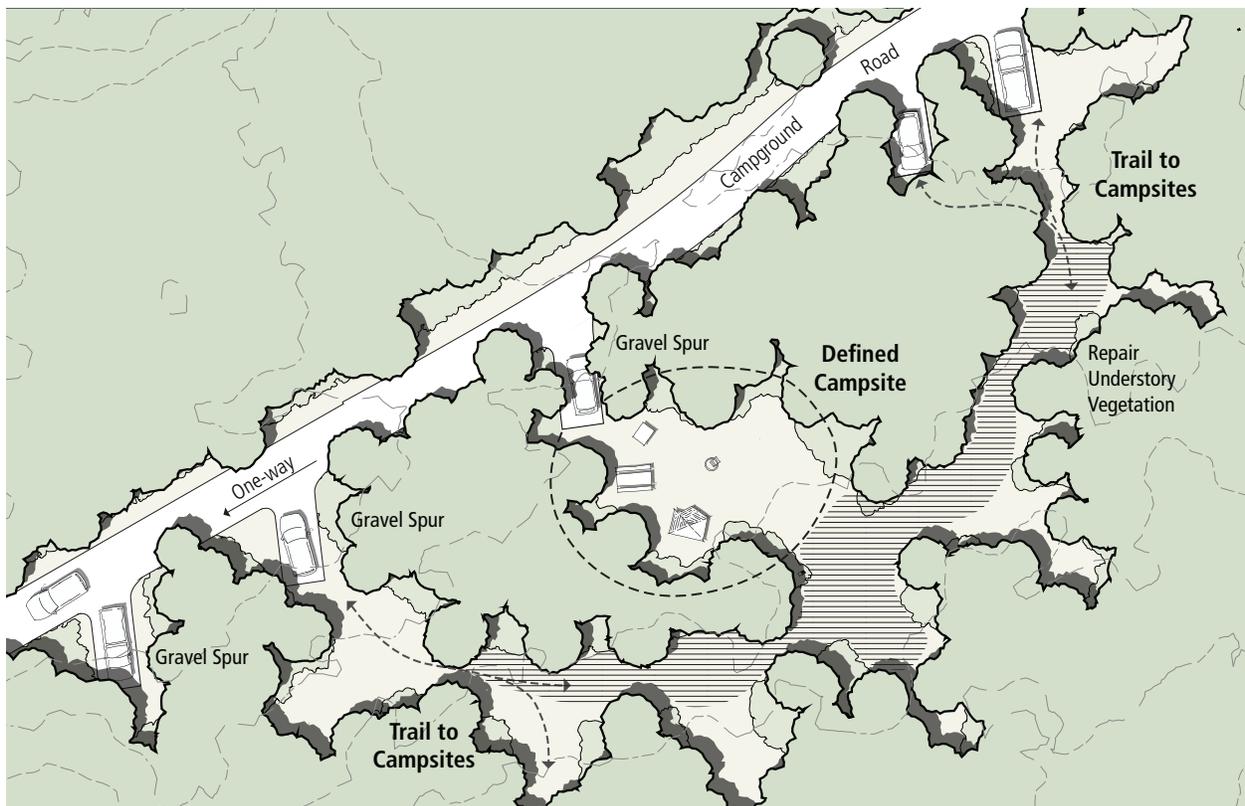
Figure 4-8. Preserve campground roads and repair campground clusters by separating parking from campsites as illustrated in this example (source: Mundus Bishop, 2020).

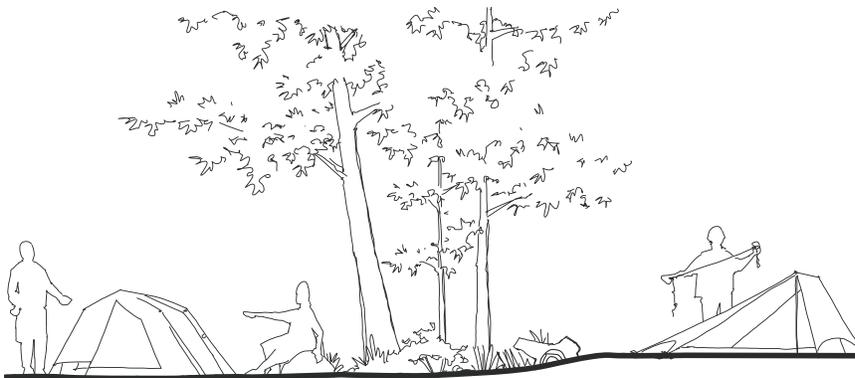
Figure 4-13. Design new campsites and consider repairing existing campsites to reestablish each space as a campsite using understory vegetation and topography to provide a definitive boundary (source: Mundus Bishop, 2020).
