FIGURE B-1

## Caneel Bay Resort Site

VIIS, St. John, USVI

## Site Layout

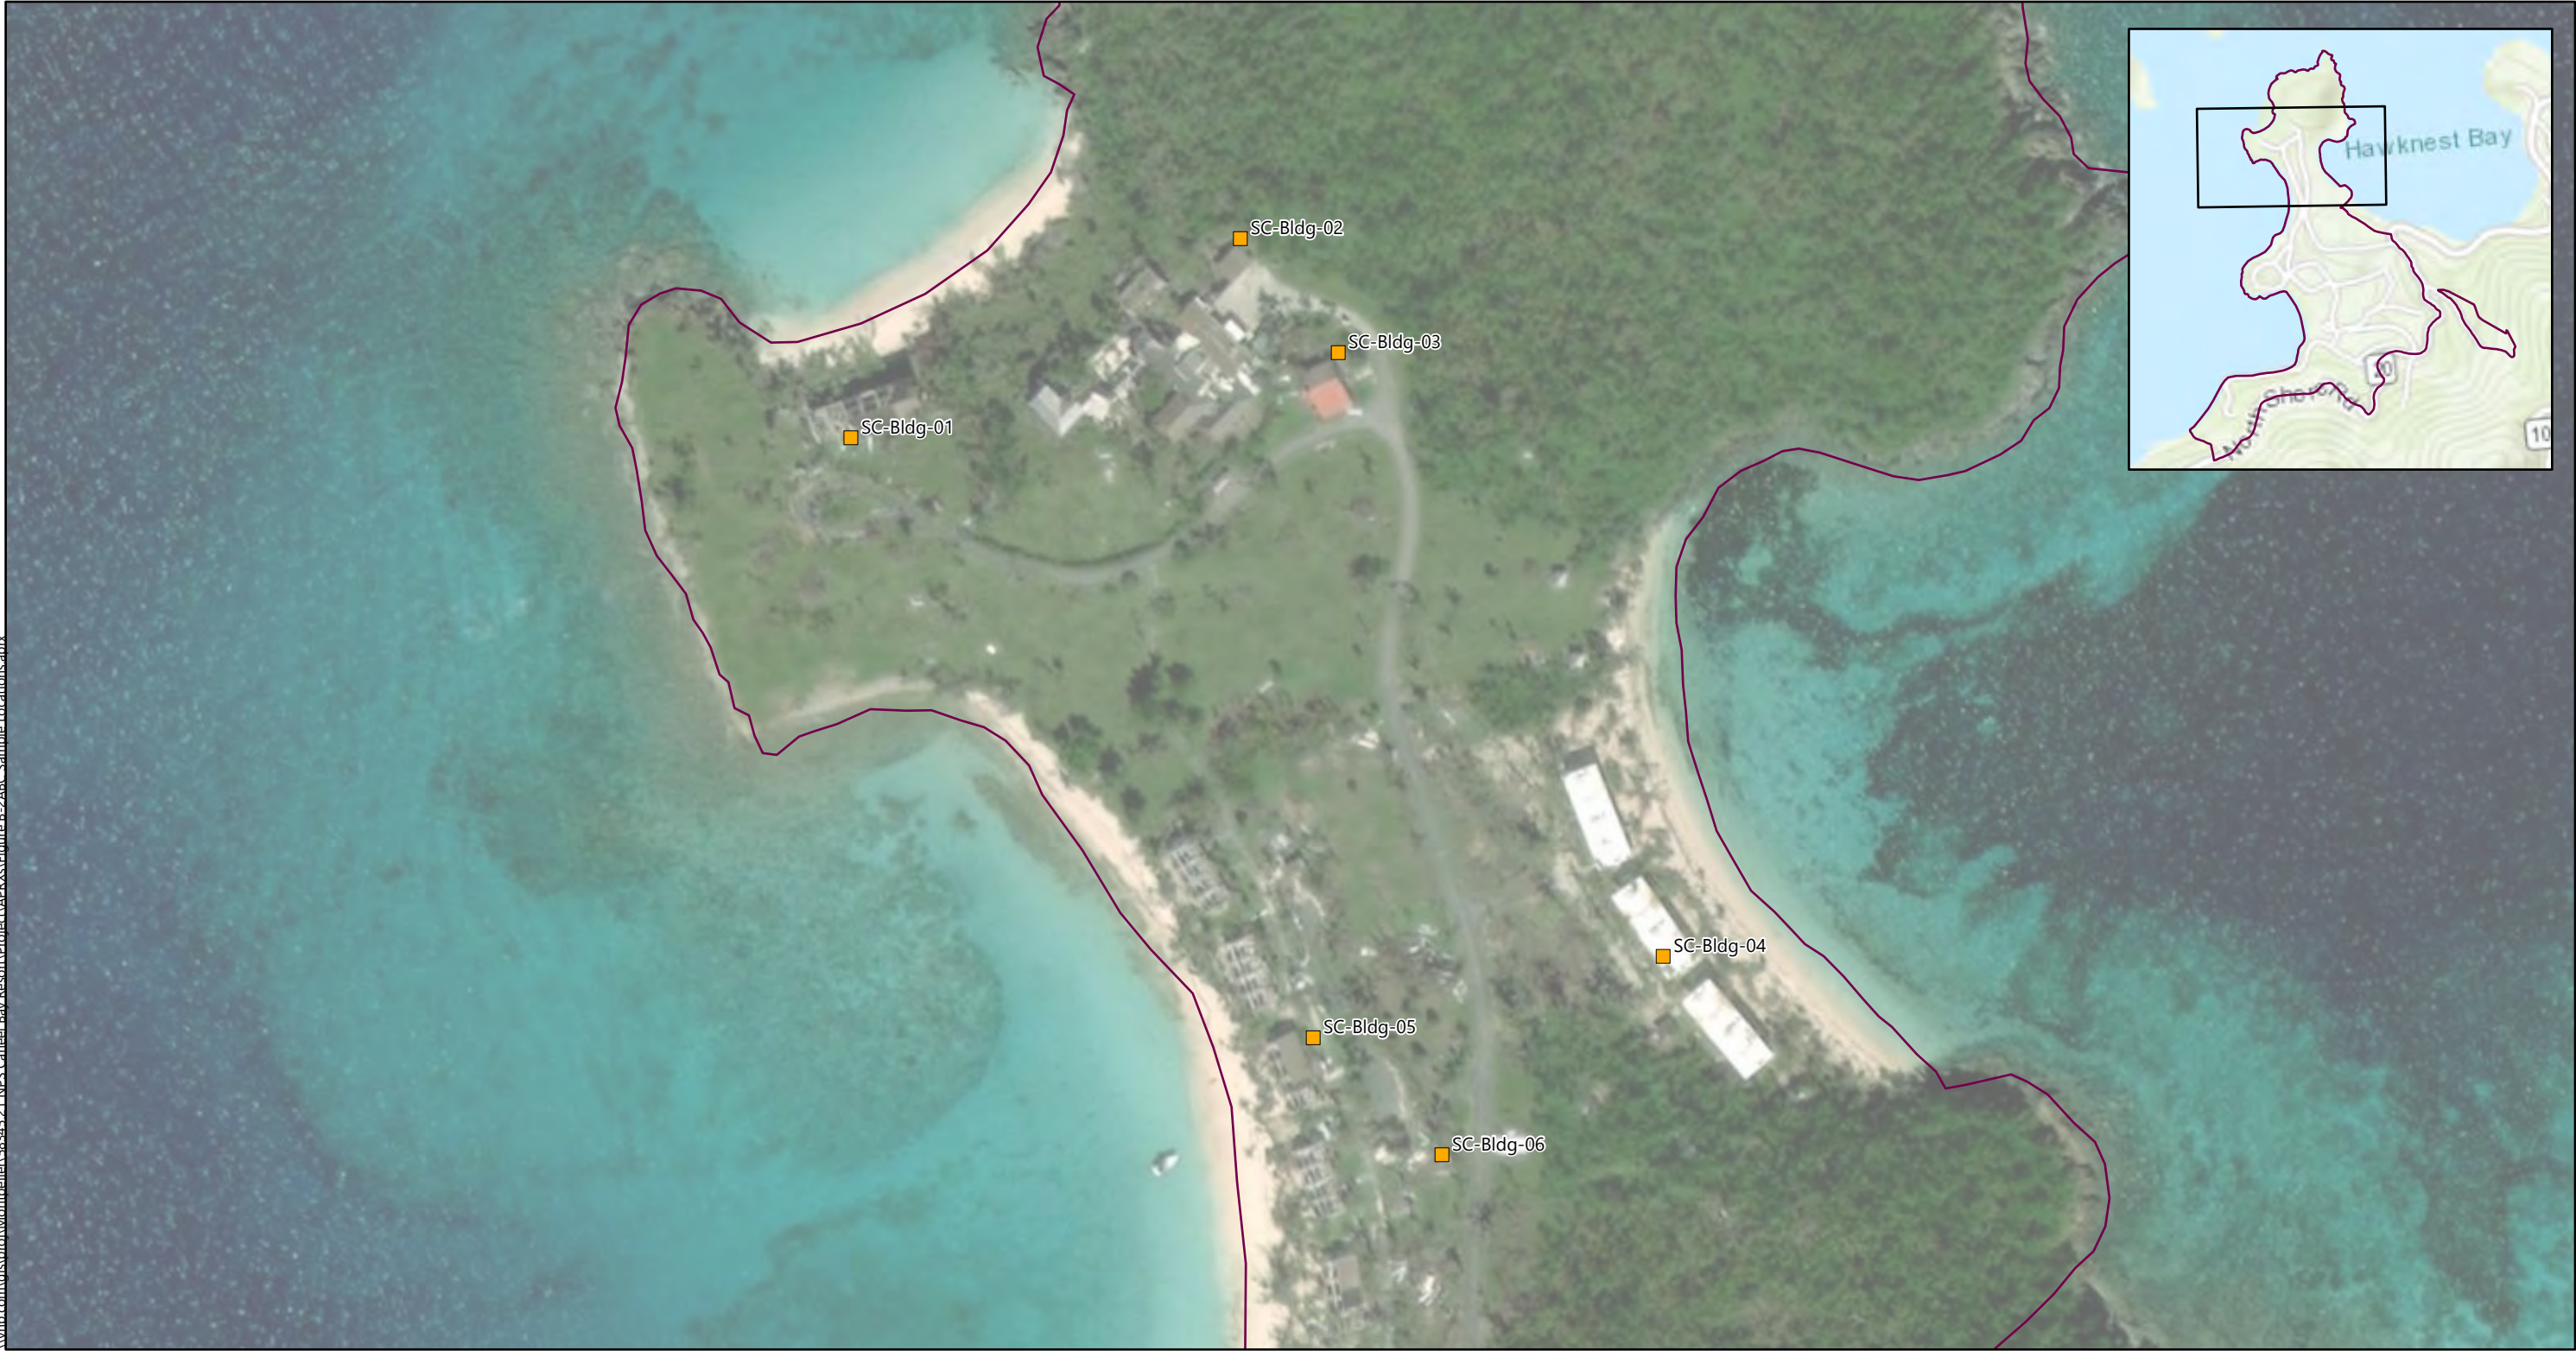
- Soil Sample
- Caneel Bay Resort

Sample Locations - Northern Area

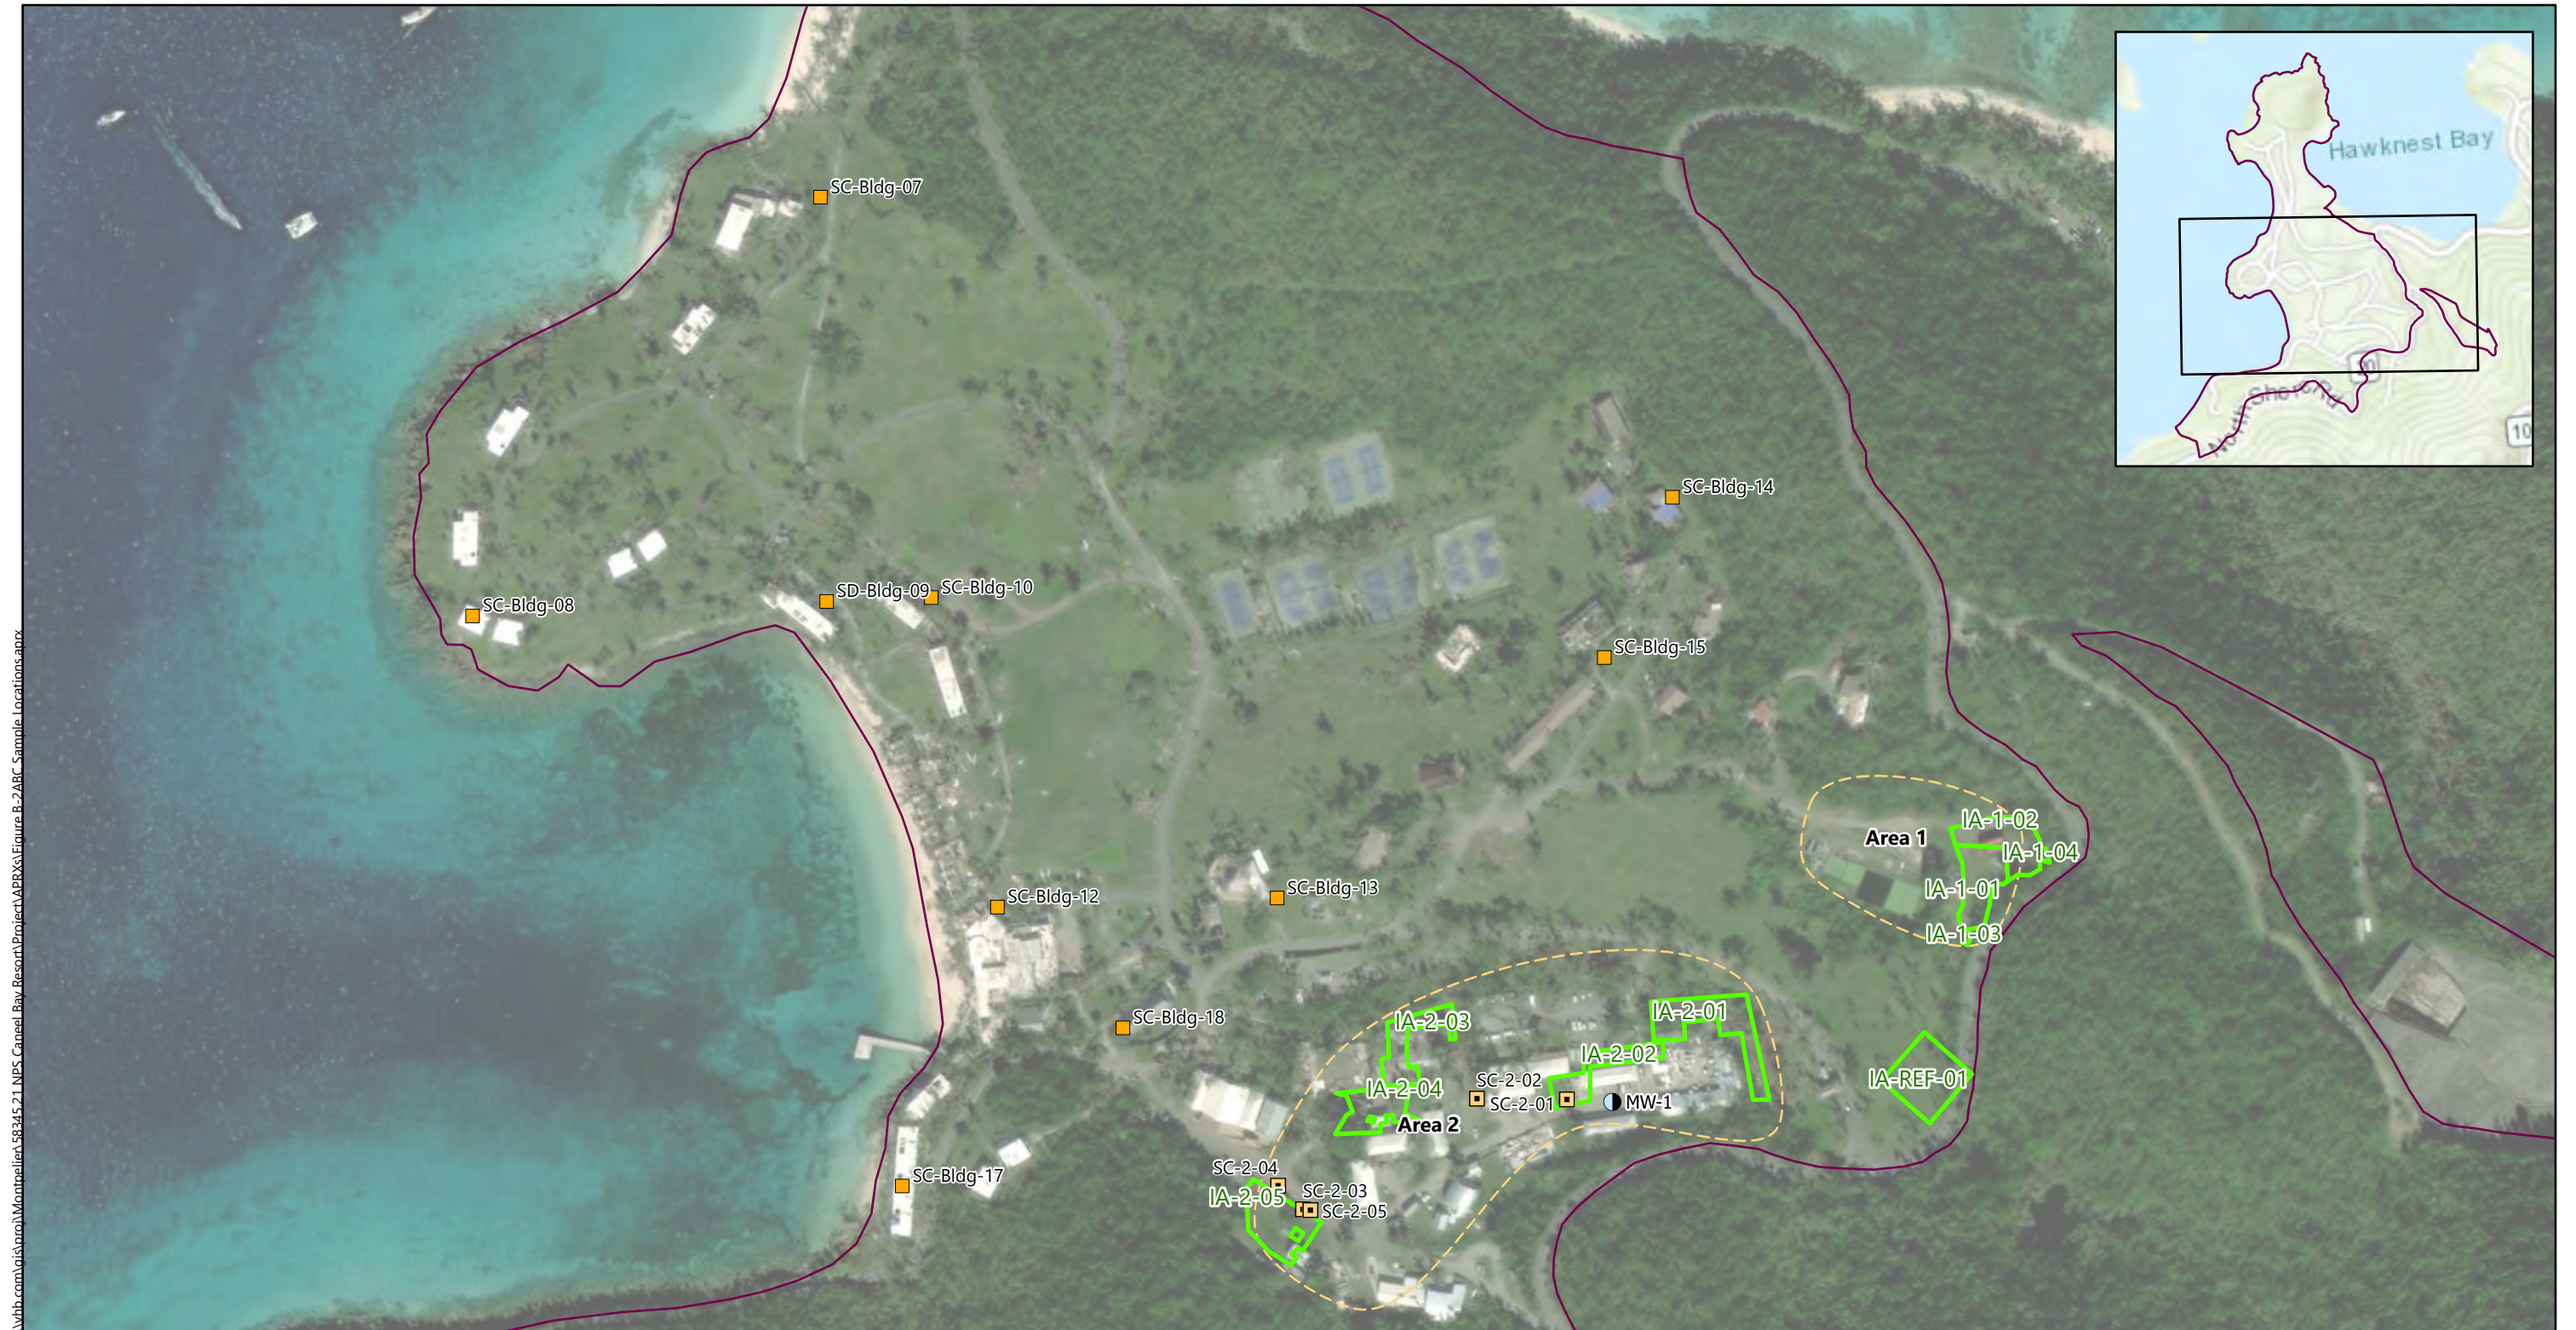
FIGURE B-2B

- Soil Sample
- Soil Boring
- Monitoring Well
- ISM Decision Unit
- Caneel Bay Resort
- Primary Investigation Areas

### Sample Locations - Area 1 and Area 2 Vicinity

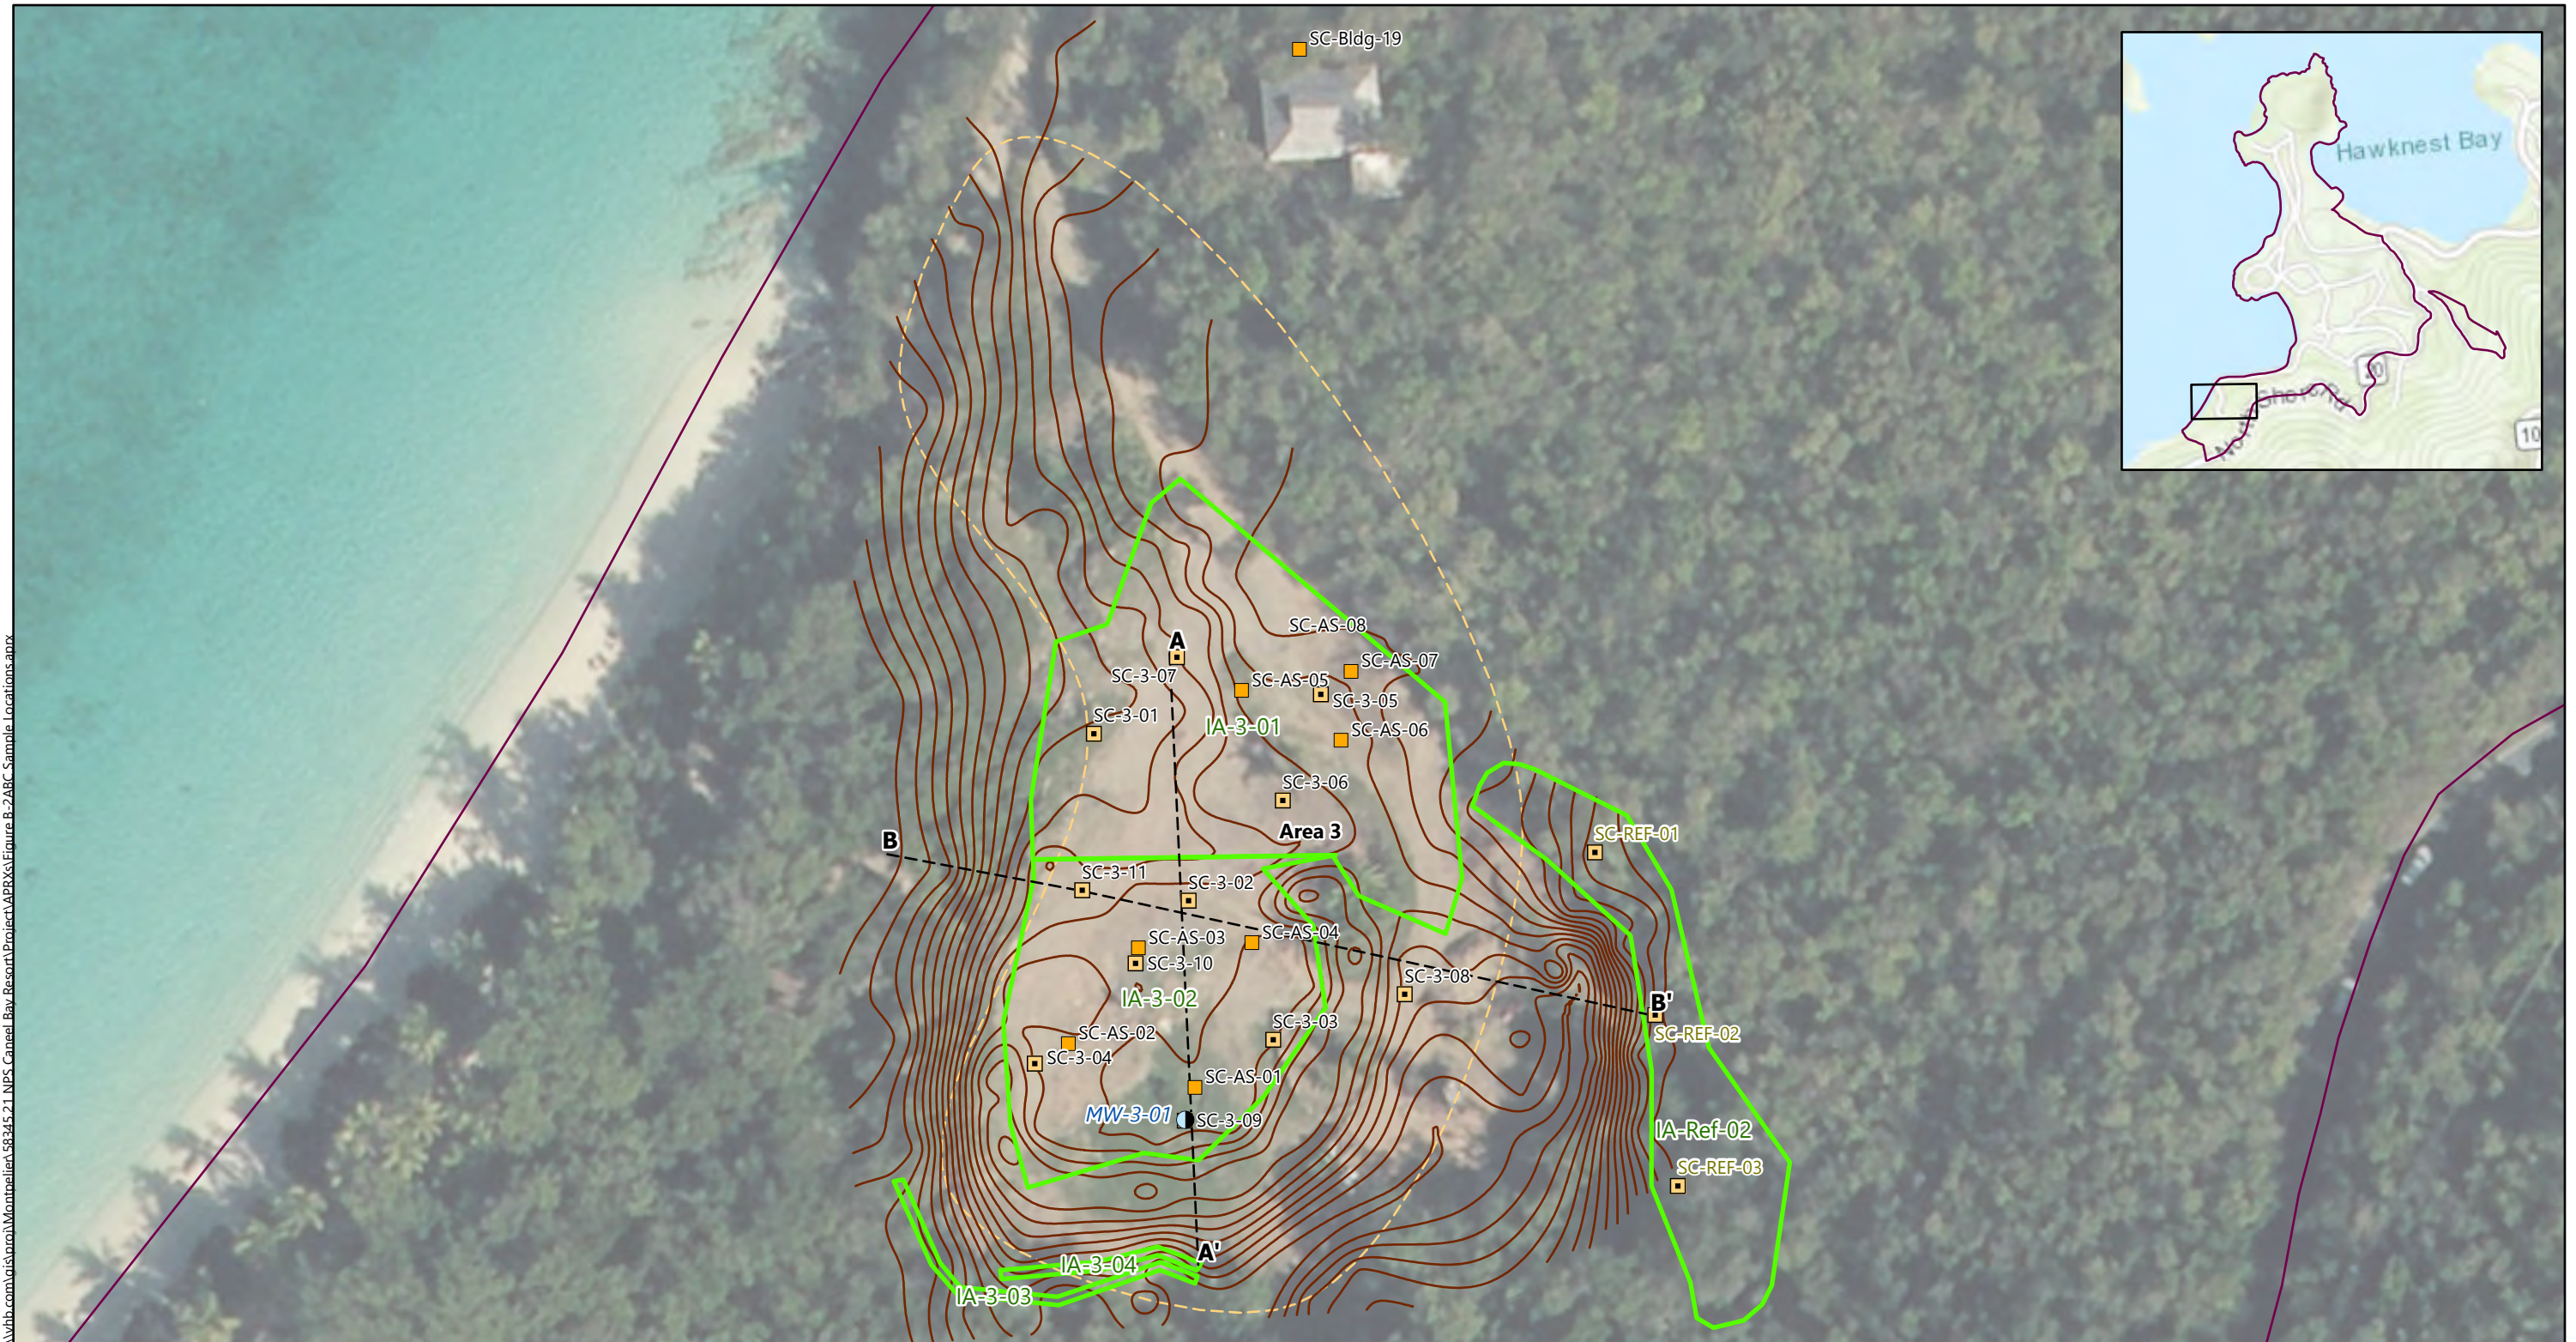
### Sample Locations - Area 3 Vicinity

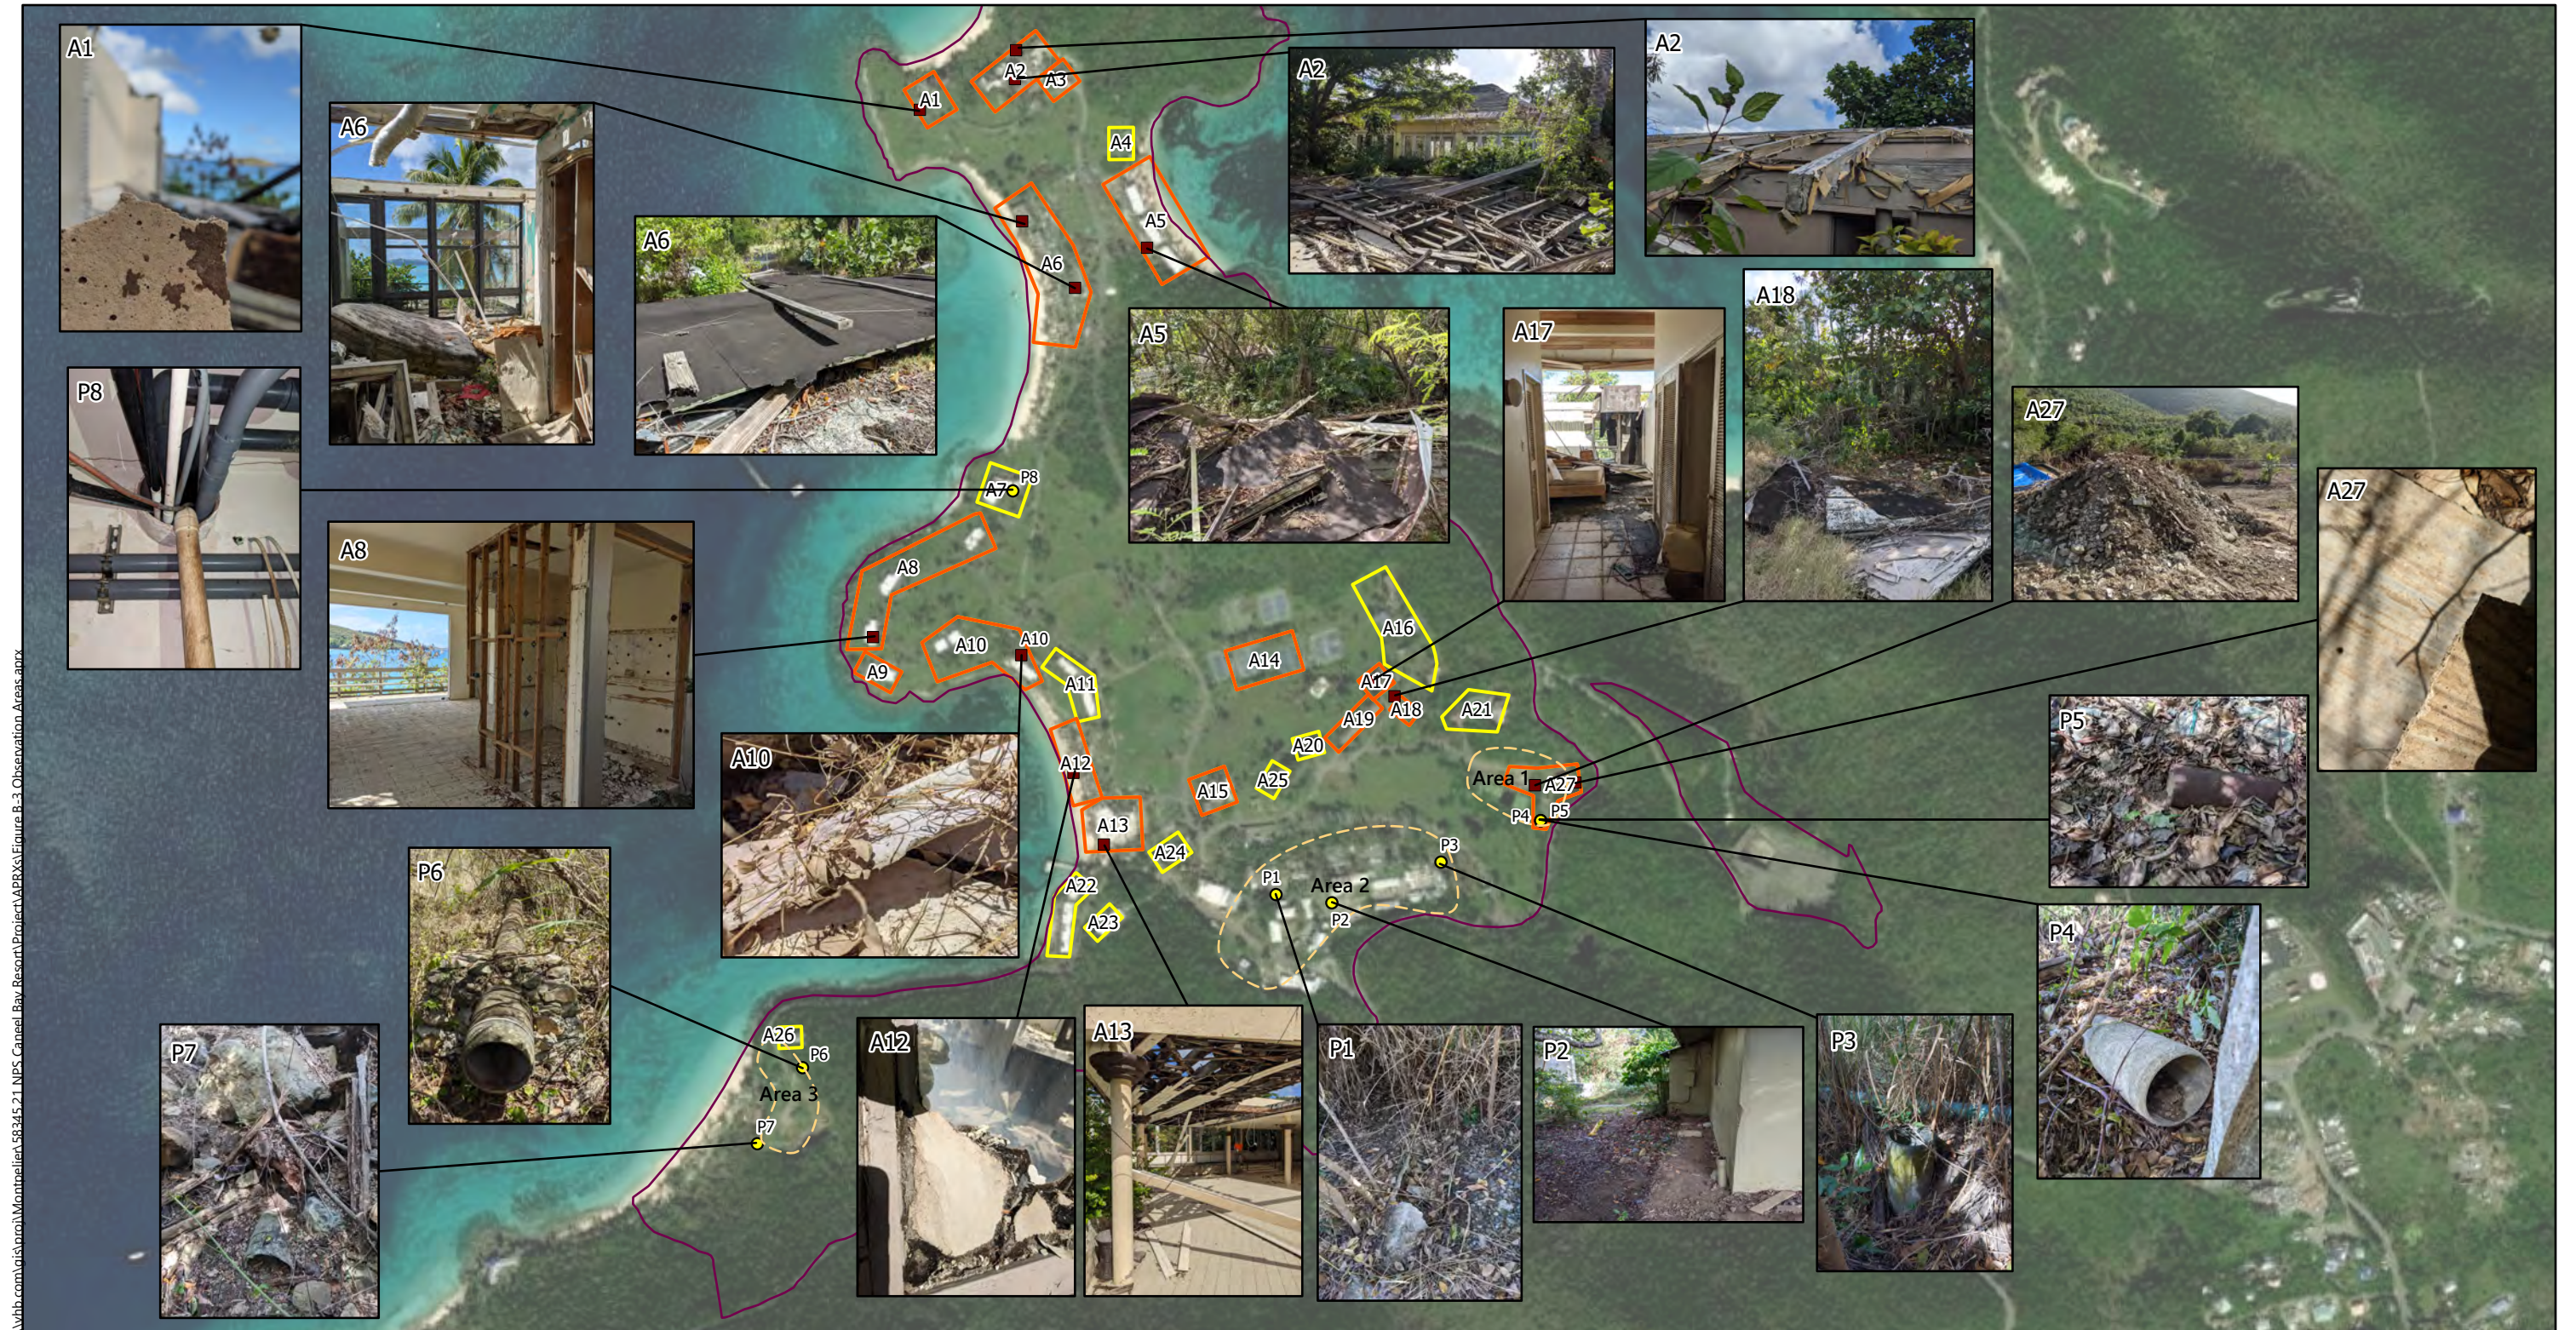
- Observation Location
- Observation Location - Evidence of Potential ACM Exposure to the Environment
- Observation Area
- Observation Area with Potential ACM Exposure to the Environment
- Caneel Bay Resort
- Primary Investigation Areas

See Table B-2 - Potential ACM and Lead-Based Paint Observations for corresponding photo descriptions.

### Potential ACM and Lead-Based Paint Observations

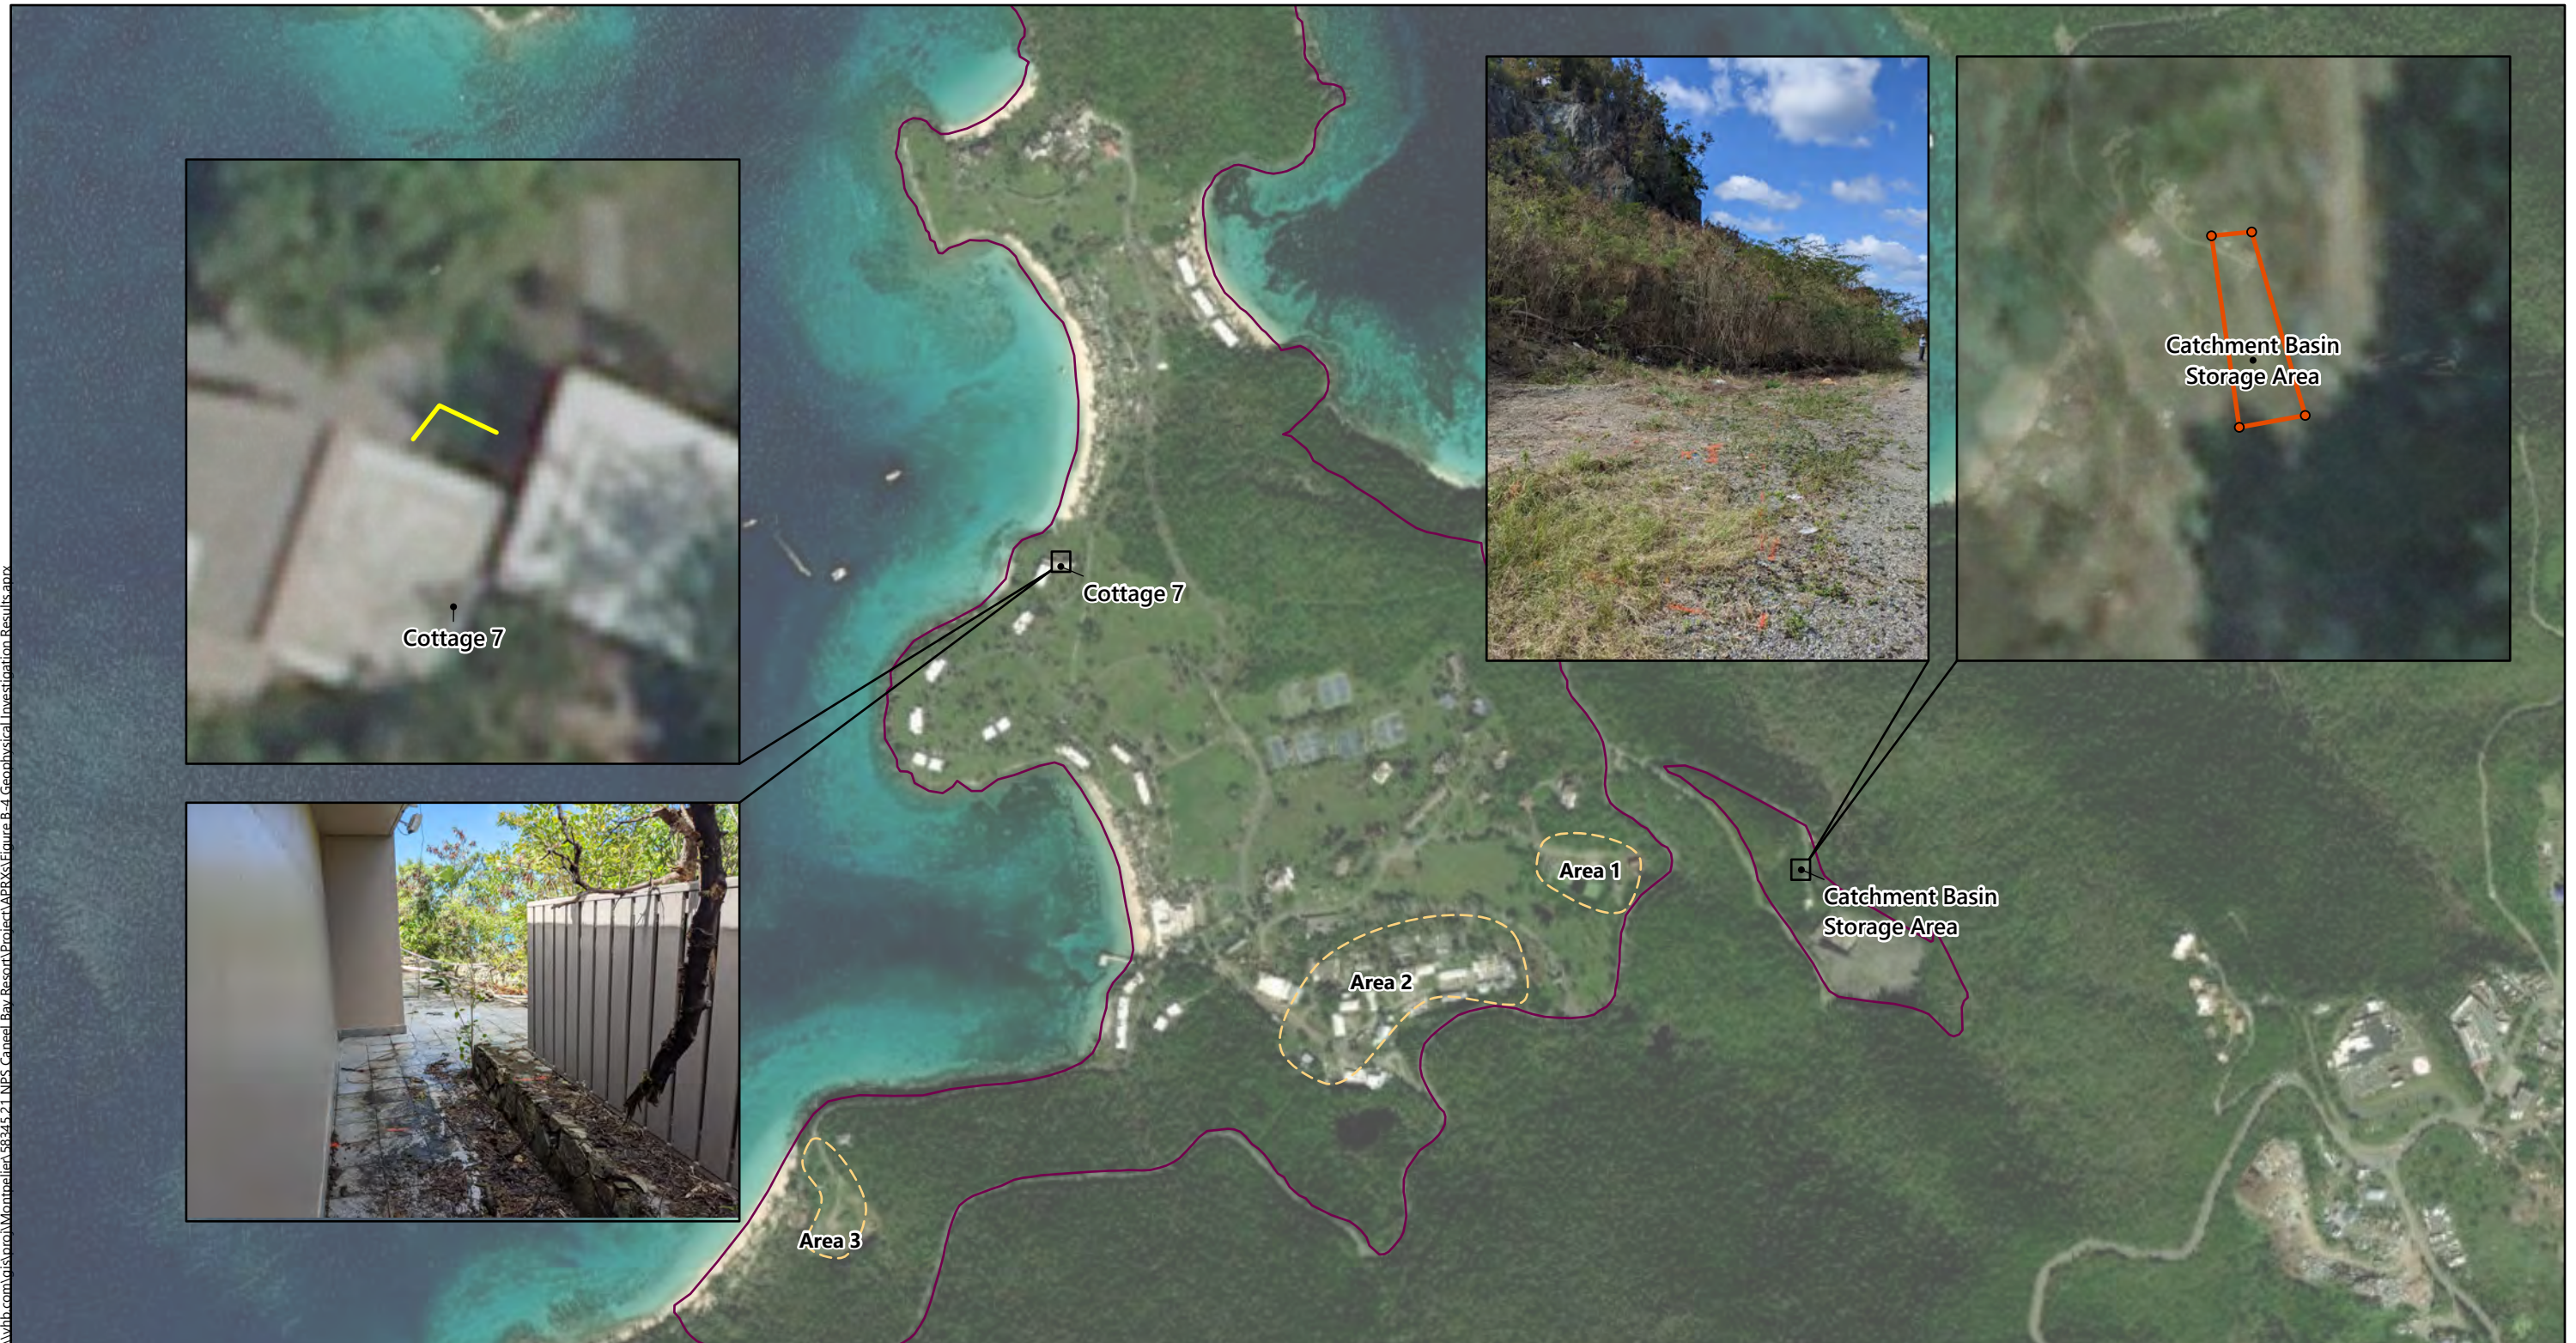
- Primary Investigation Areas
- Caneel Bay Resort
- Suspected Underground Fuel Line
- GPR Anomaly

### Geophysical Investigation Results

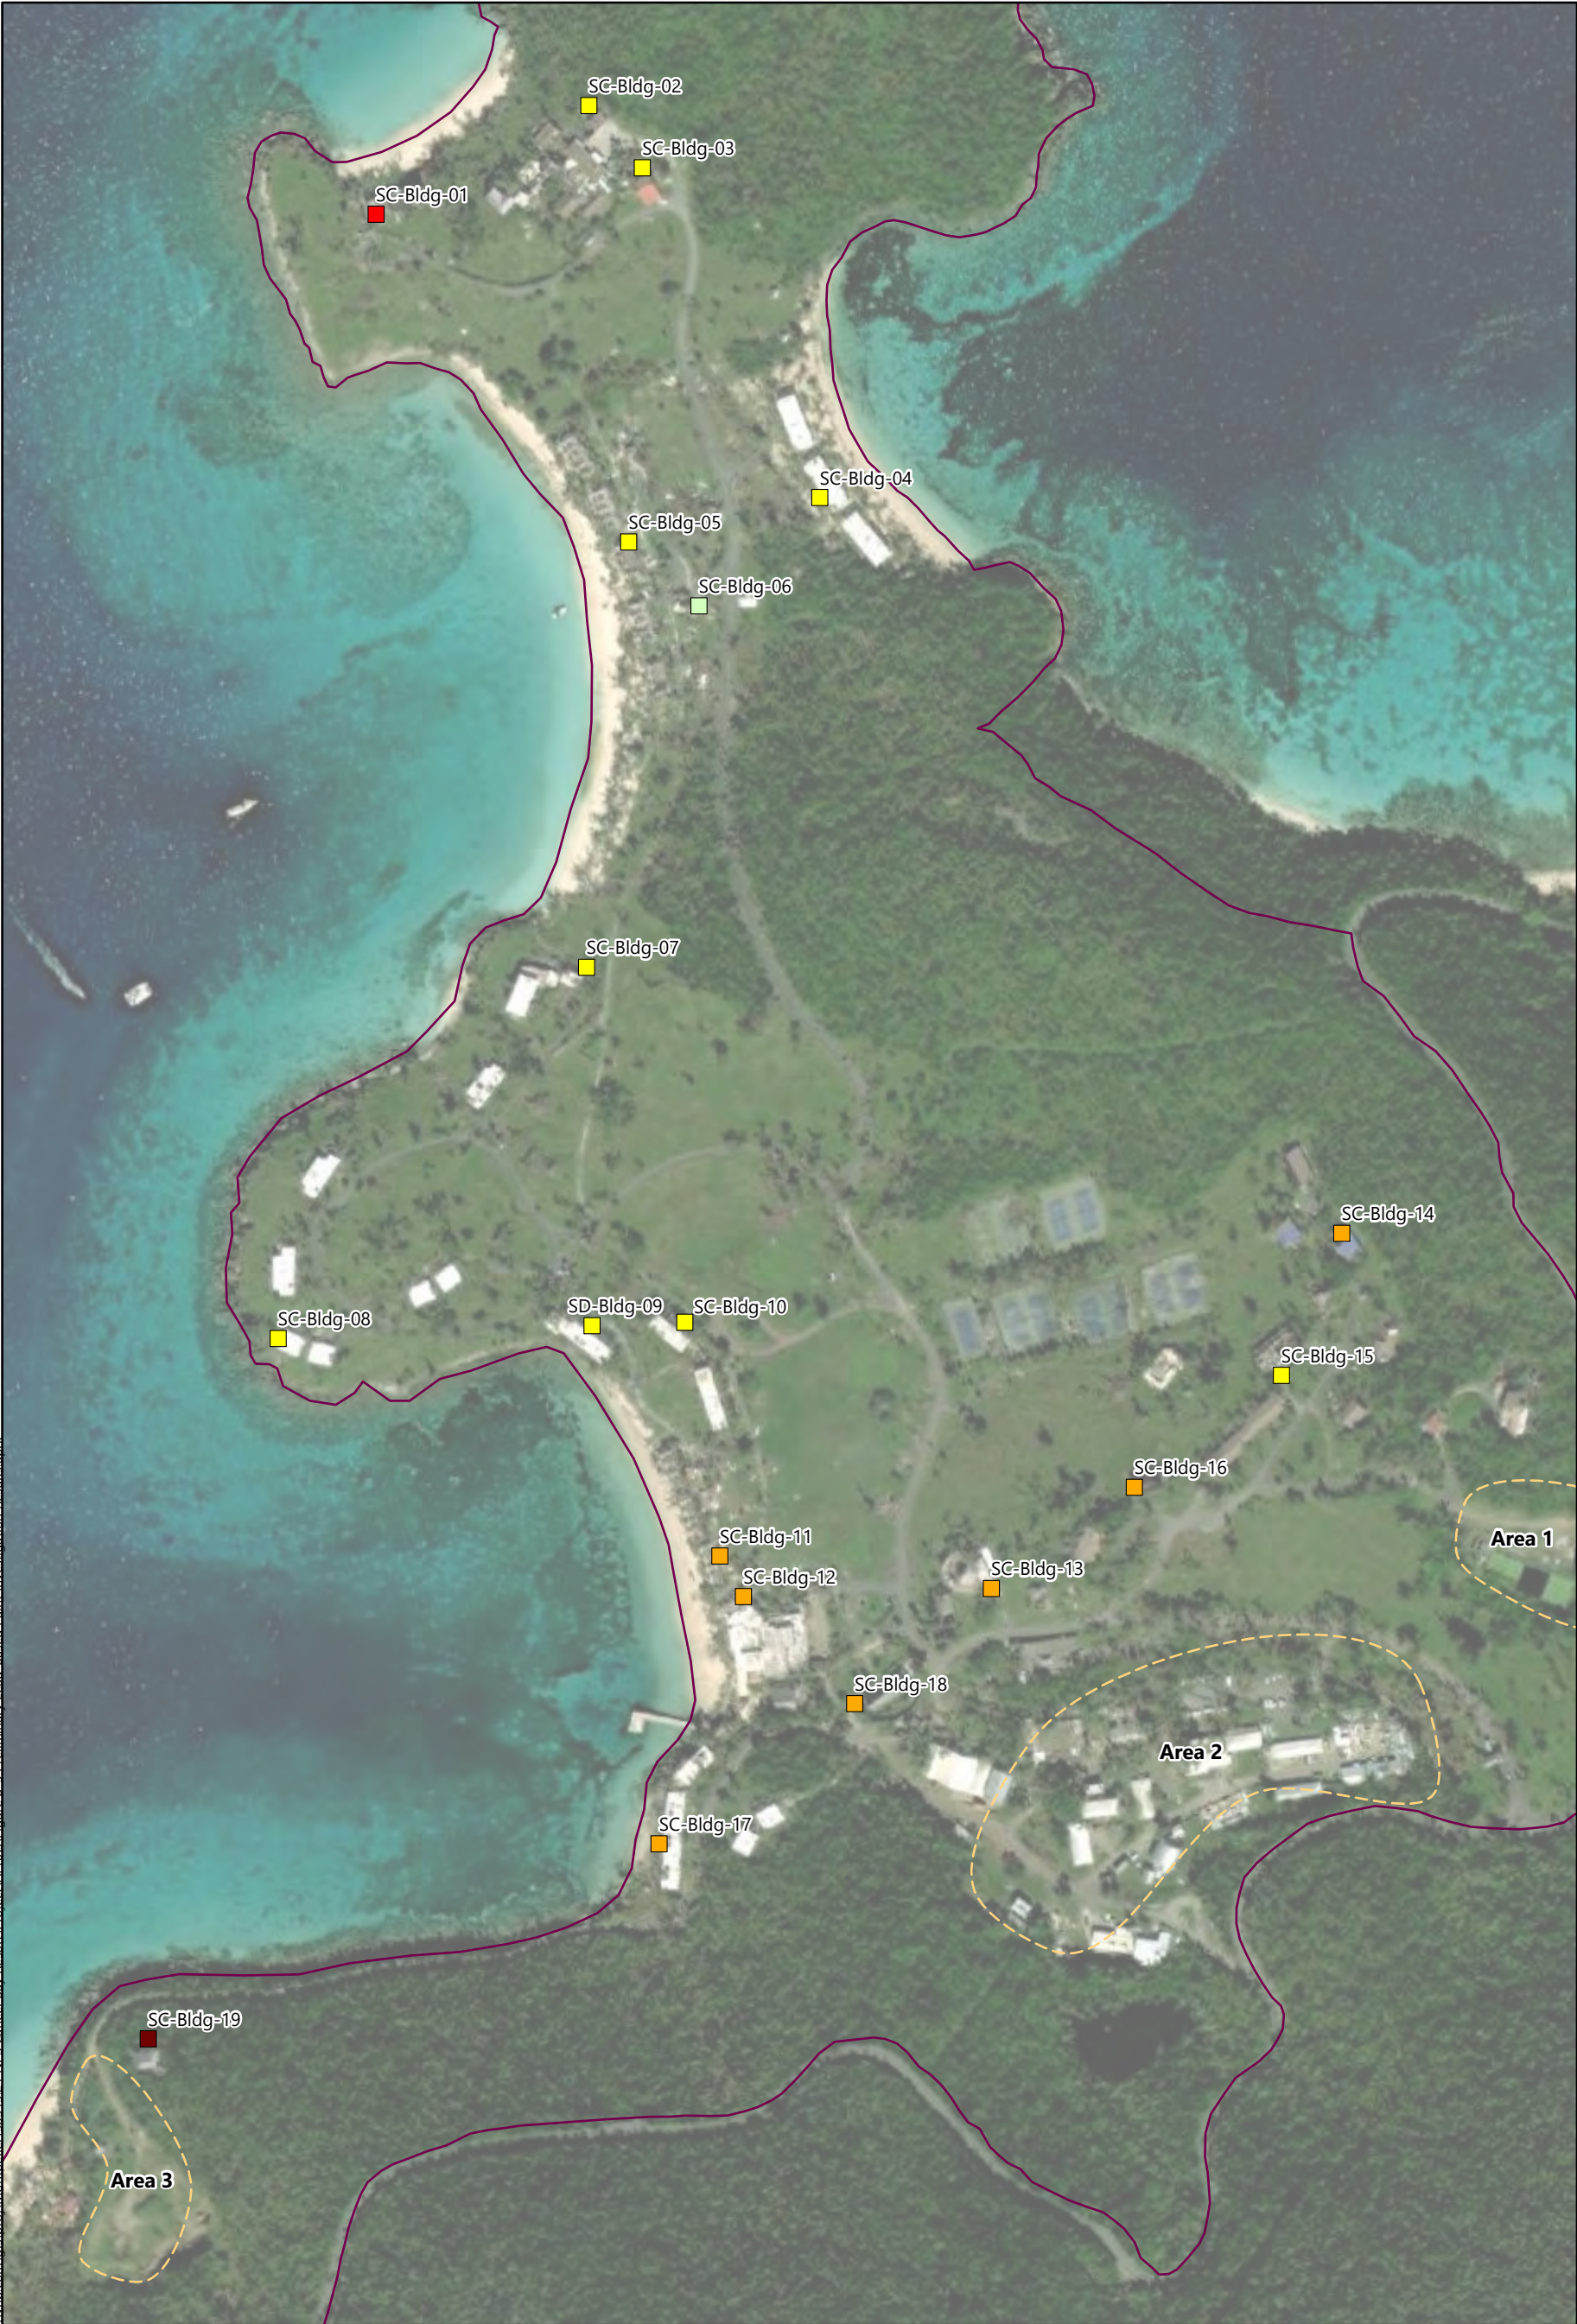
Surface Soil Lead Concentration (mg/kg)

Preliminary Lead-Based Paint Investigation Results
