Caneel Bay Resort Site EE/CA

St. John, USVI

Site Location Map

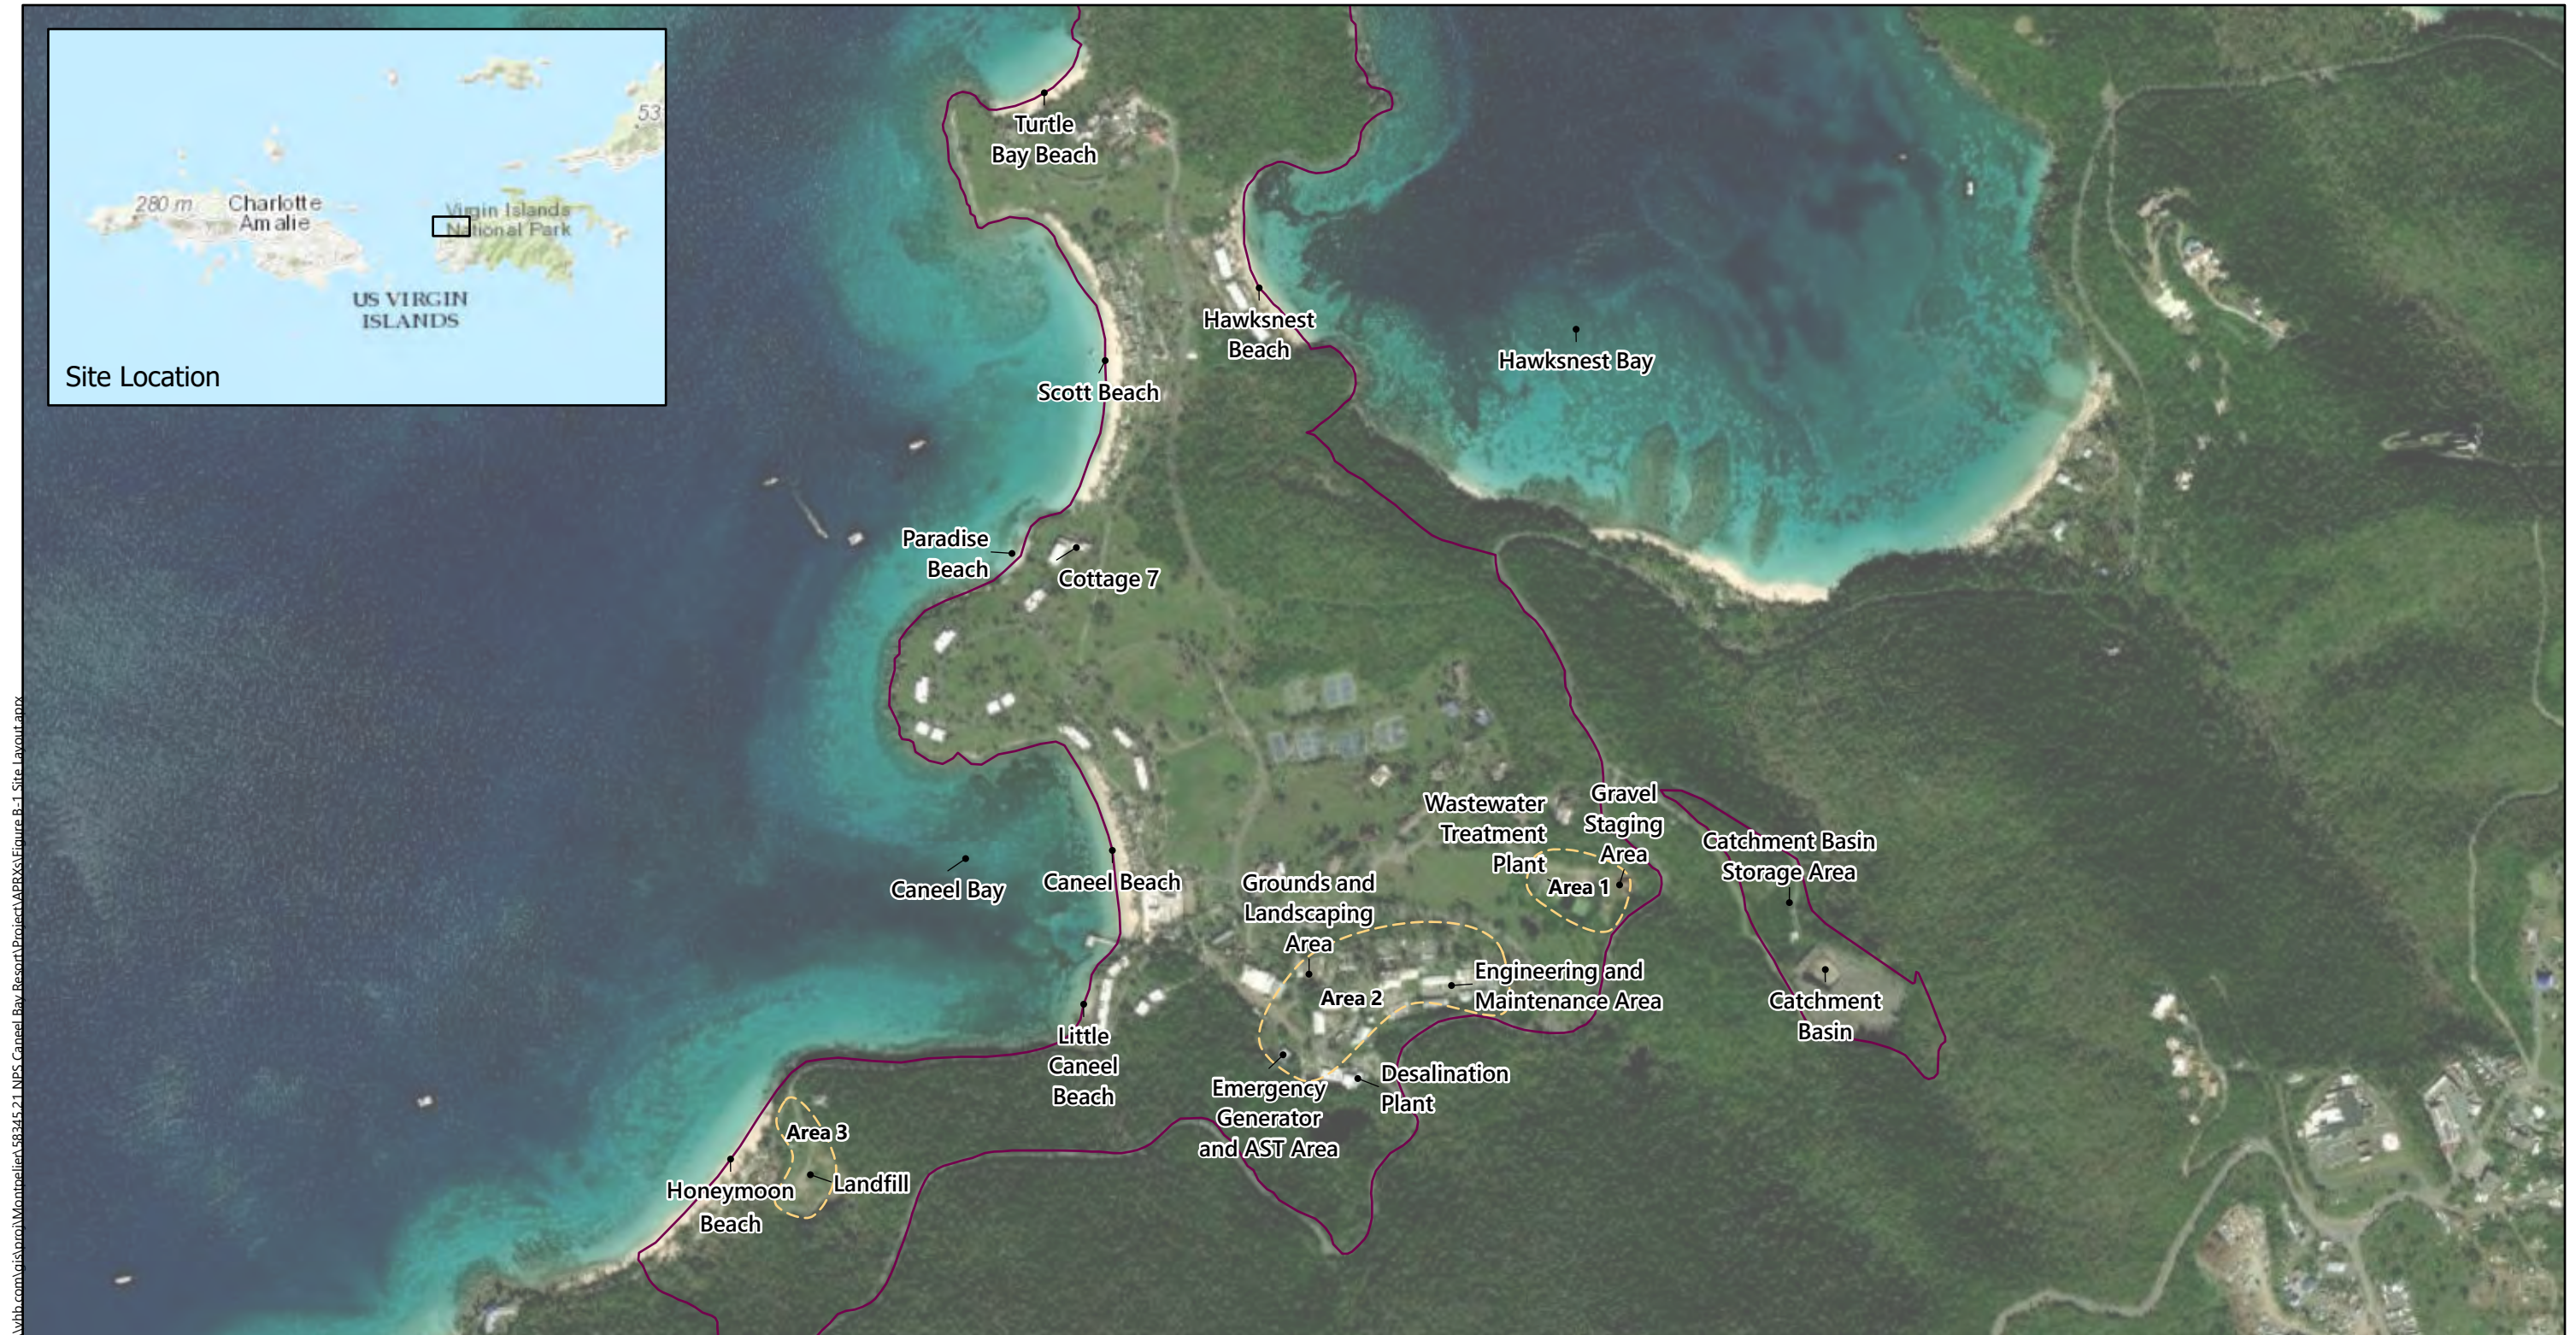
- Primary Investigation Areas
- Caneel Bay Resort

Site Layout

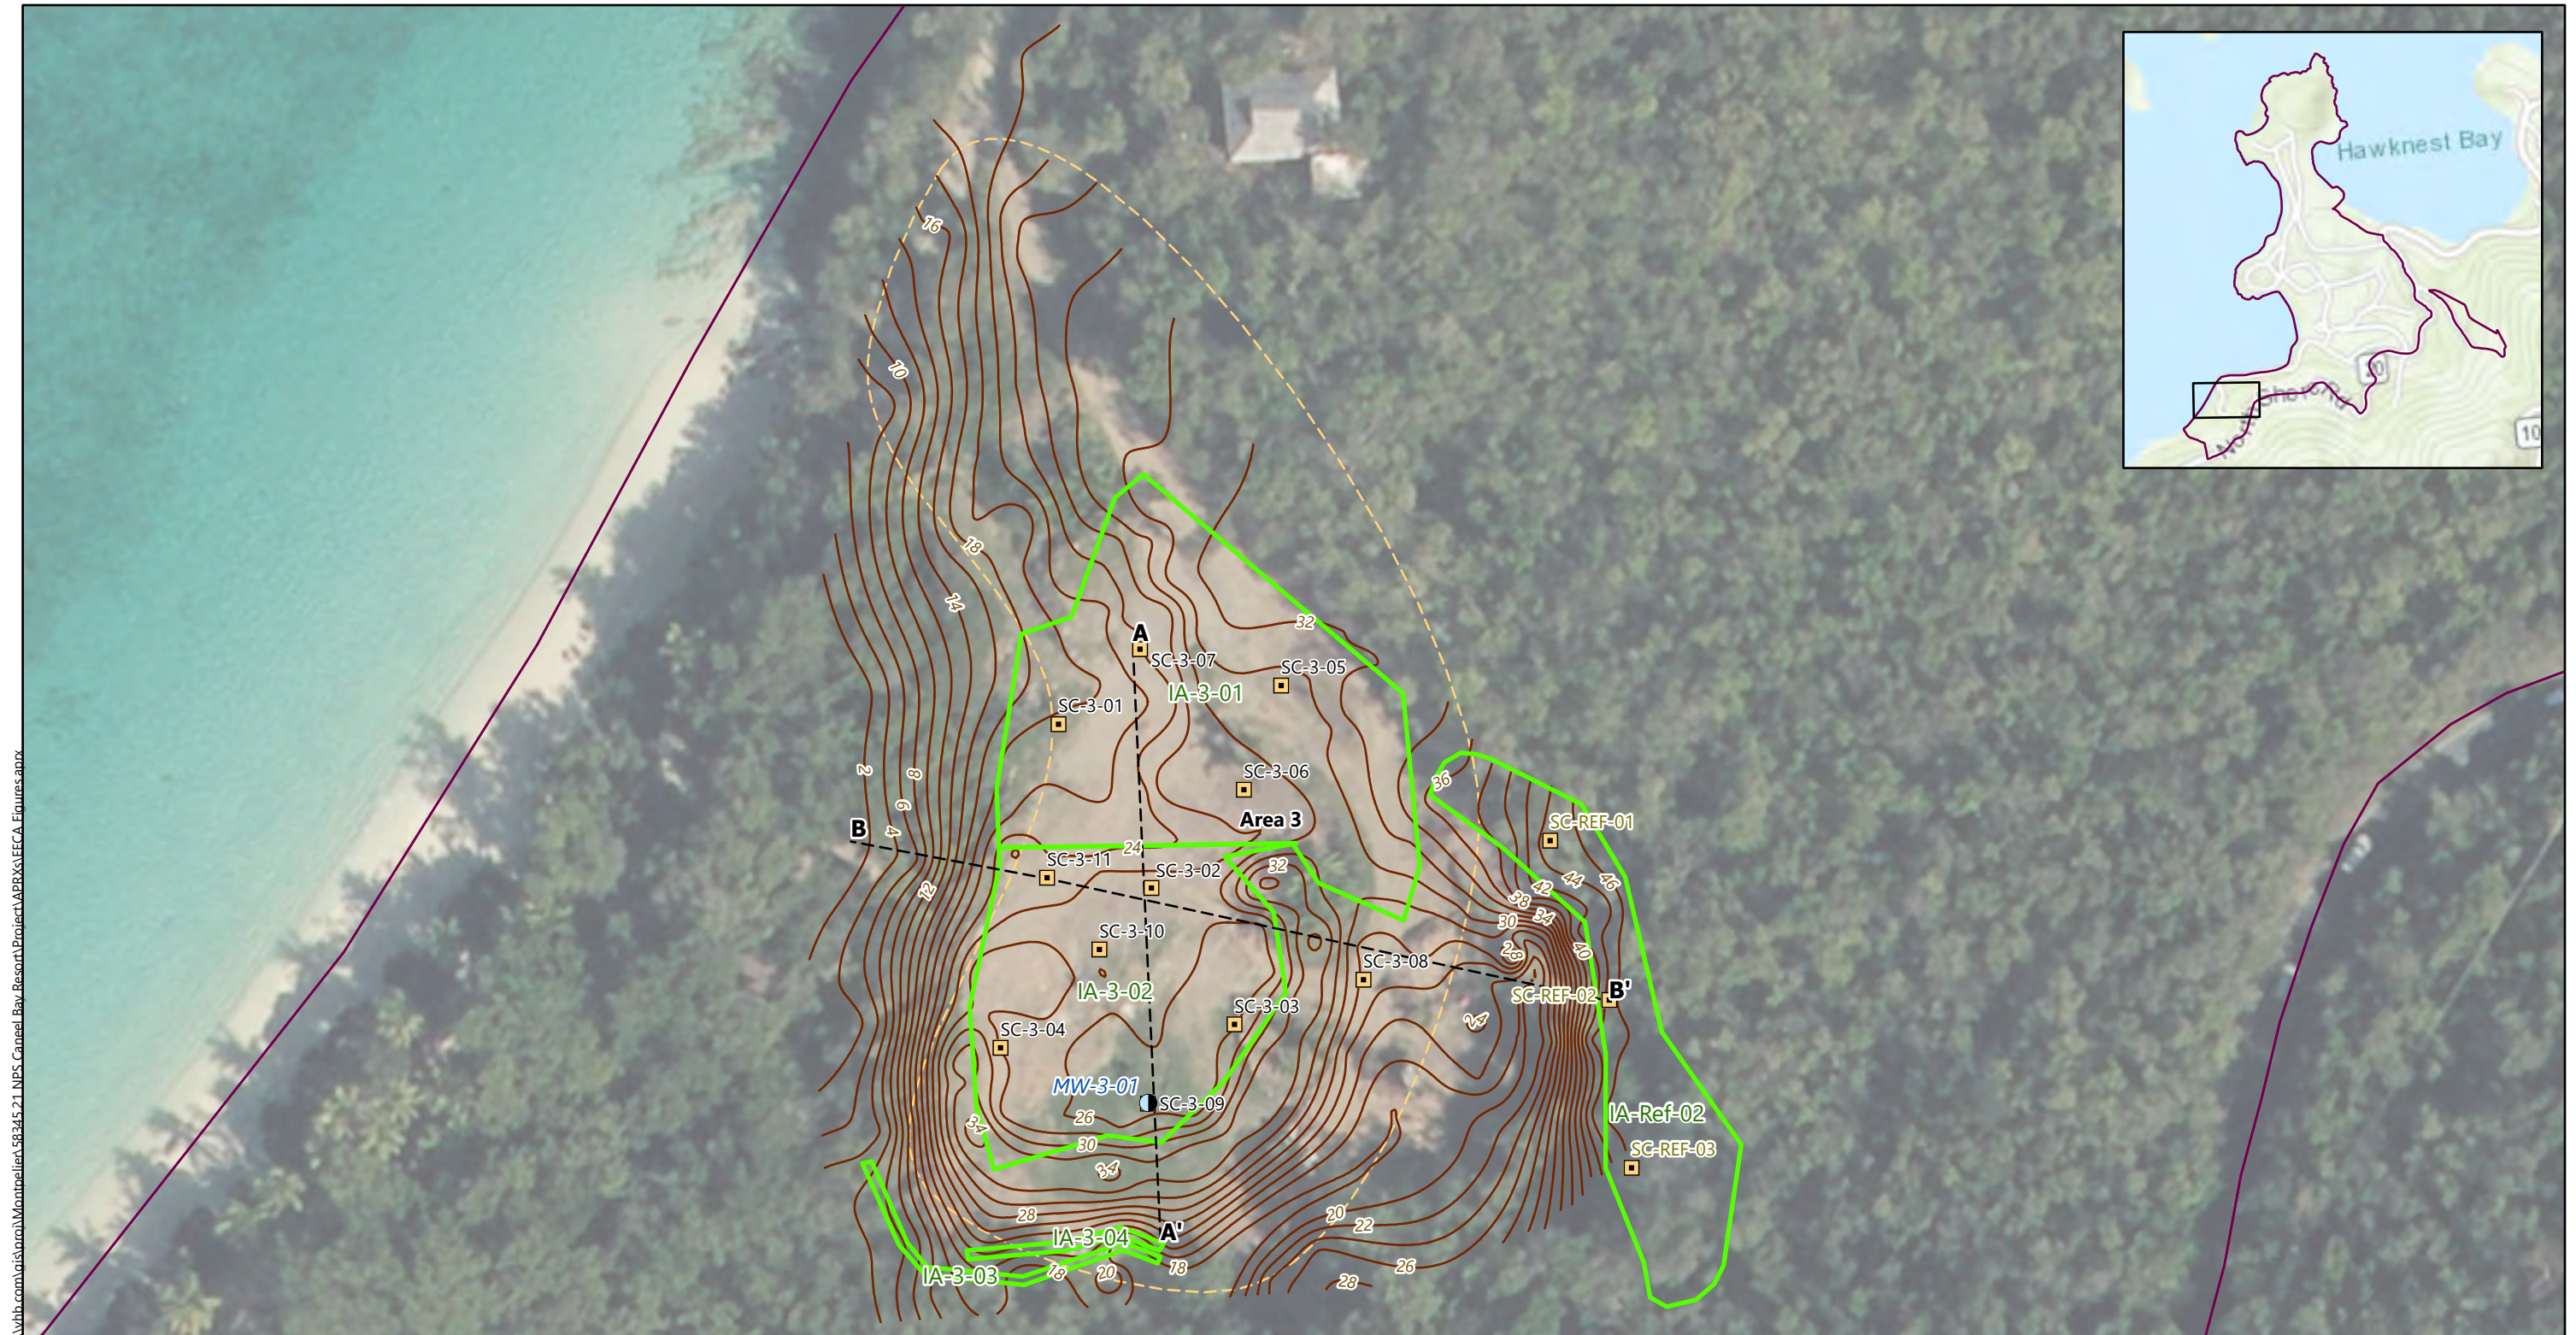
FIGURE 3

- Soil Boring
- Monitoring Well
- ISM Decision Unit
- Caneel Bay Resort
- Primary Investigation Areas
- Contour (2 ft)
- Cross Section Transect

Landfill Topography and Cross-
Section Locations

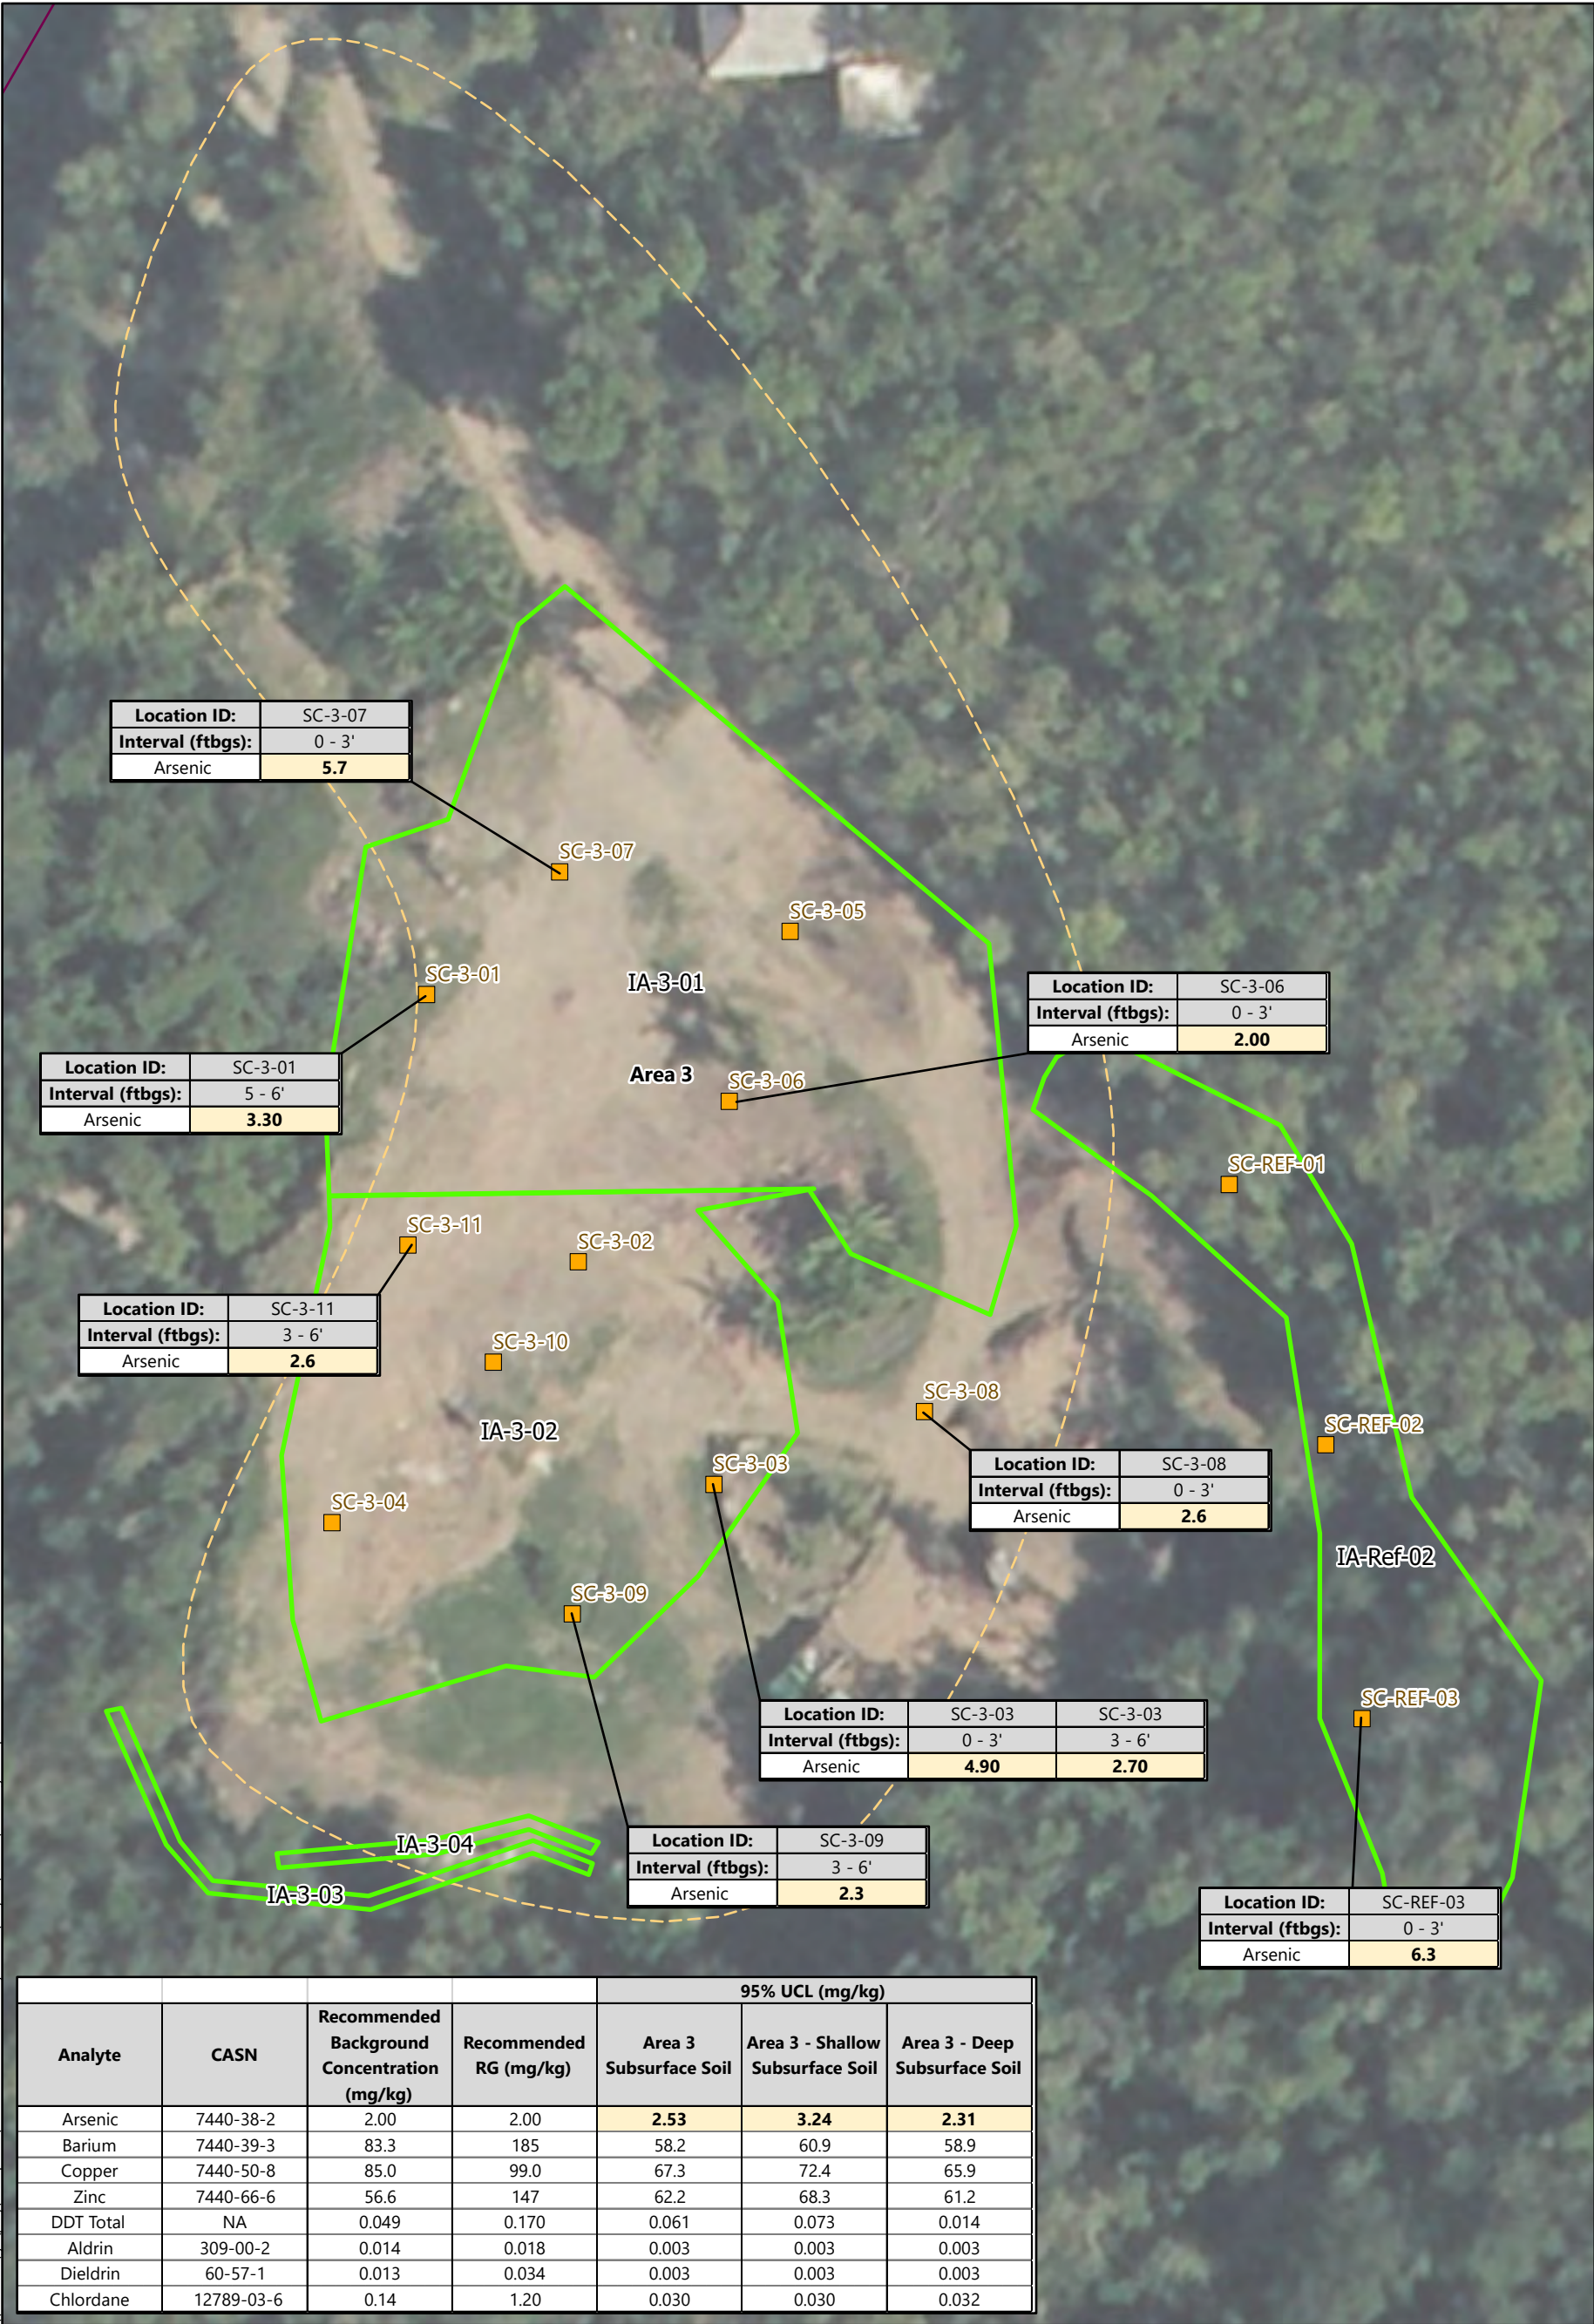
Source Info:
Base map from ESRI/World Imagery (2017)
Notes:
1. Shaded cell and bolded value indicates the calculated 95% UCL exceeds the Recommended RG.
2. "DDT Total" is the sum of DDT and its breakdown products (DDD and DDE).
3. "ftbgs" = feet below ground surface
4. "UCL" = upper confidence level of mean

Removal Goal Exceedances in Subsurface Soil - Area 1
