Appendix **D**

Visual Quality Exhibits

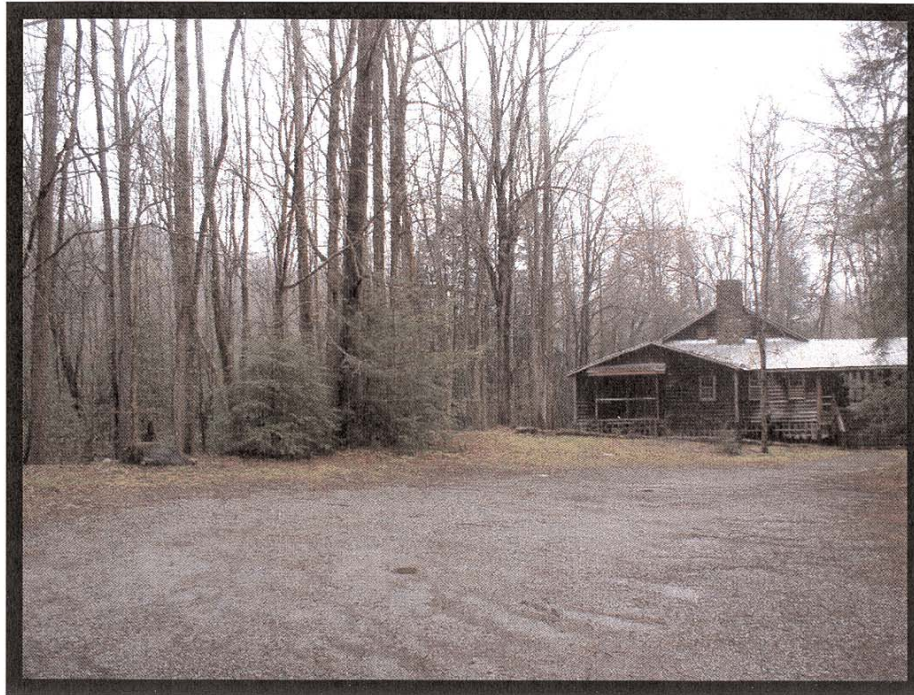
Photo 1: Parking Area at the Appalachian Clubhouse
This photo shows the existing Appalachian Clubhouse and parking area. Most of the alternatives propose restoring the Clubhouse for day use.

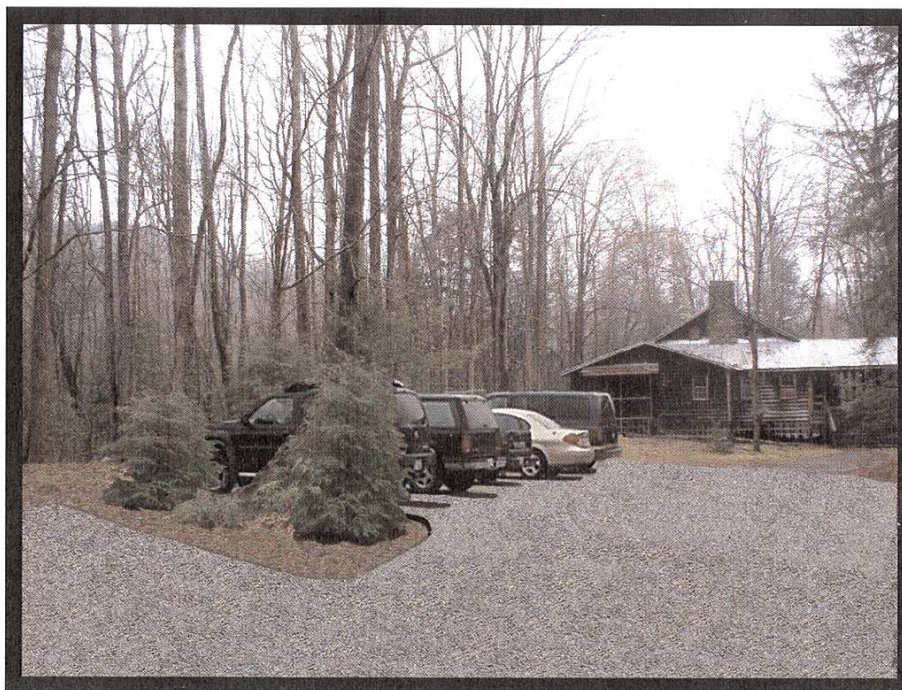
Photo 1A: Proposed Parking Area at the Appalachian Clubhouse
This simulation demonstrates mitigation of adverse visual impacts. The technique minimizes the negative effect of the parking area by screening the views of vehicles. Proposed vegetative screens would enhance the parking area at the Appalachian Clubhouse and assist in reducing the amount of visible parking area. Transplanted evergreen vegetation would provide year round screening. Pervious concrete would allow for accessibility and reduce the potential for impacts to the environment.

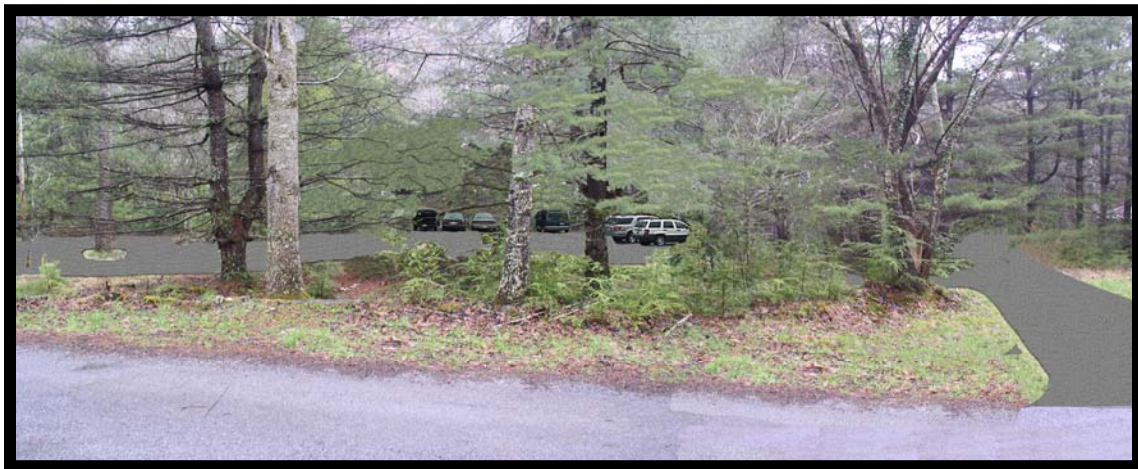
Photo 2A: Proposed Parking Area in Daisy Town

This simulation demonstrates conservation design techniques by proposing parking areas with the existing vegetation preserved. Parking lots will be placed in areas that require minimal impact to surrounding vegetation. Screening between roads and parking areas also reduces views of vehicles and pavement. Small tree seedlings from other locations in the District could be transplanted to provide additional screening.

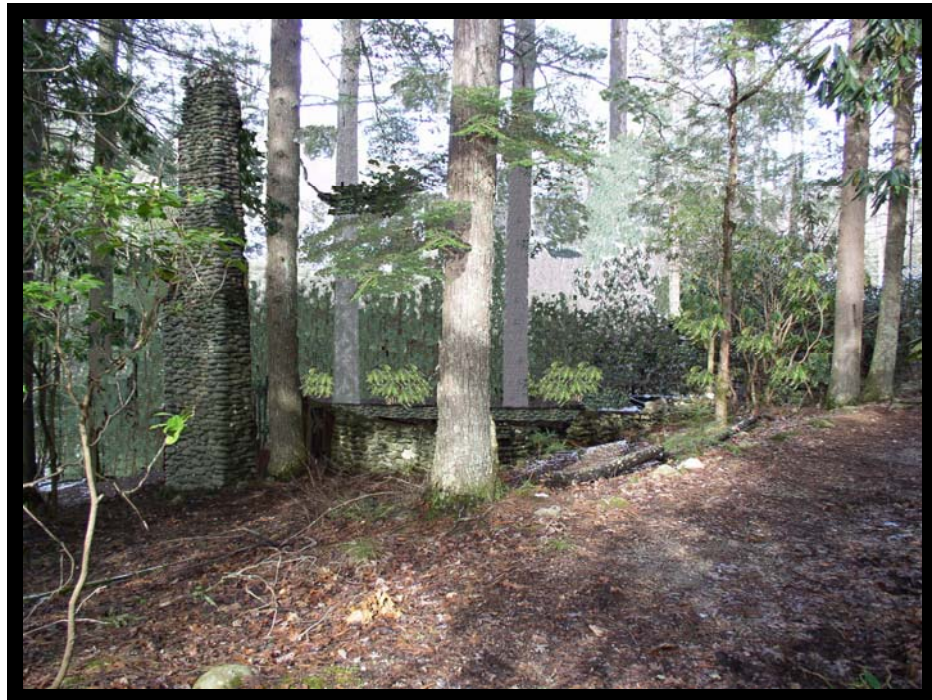
Photo 3A: Former Vernon Moore Cabin

This simulation demonstrates the effect of removal of the Vernon Moore cabin located in the Wonderland Club. This simulation depicts preservation of the rock foundation and chimney.

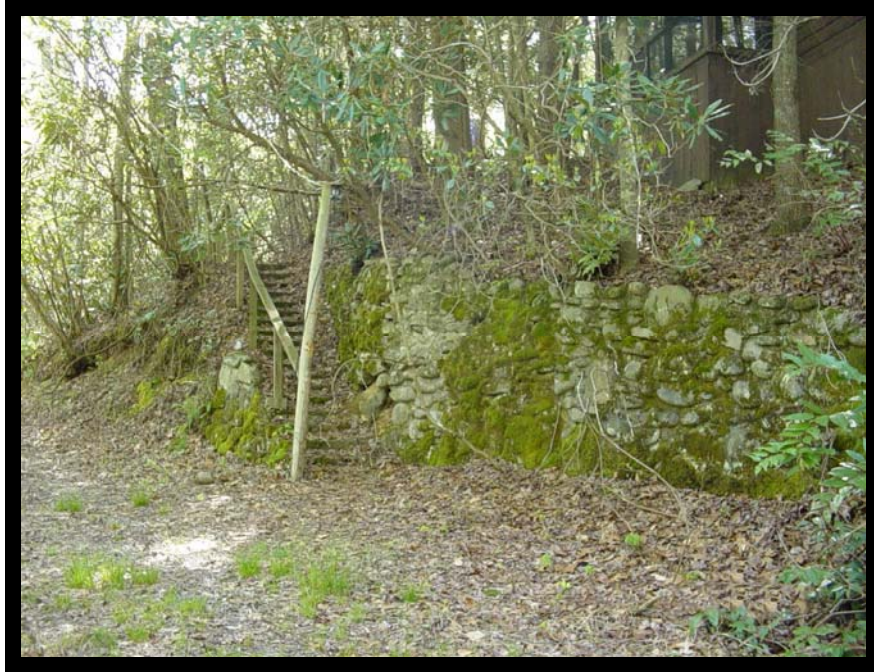
Photo 4: Existing Stone Staircase at Former Beaman Cabin

This figure shows the existing condition of the Beaman (#58-8H) cabin and steps.

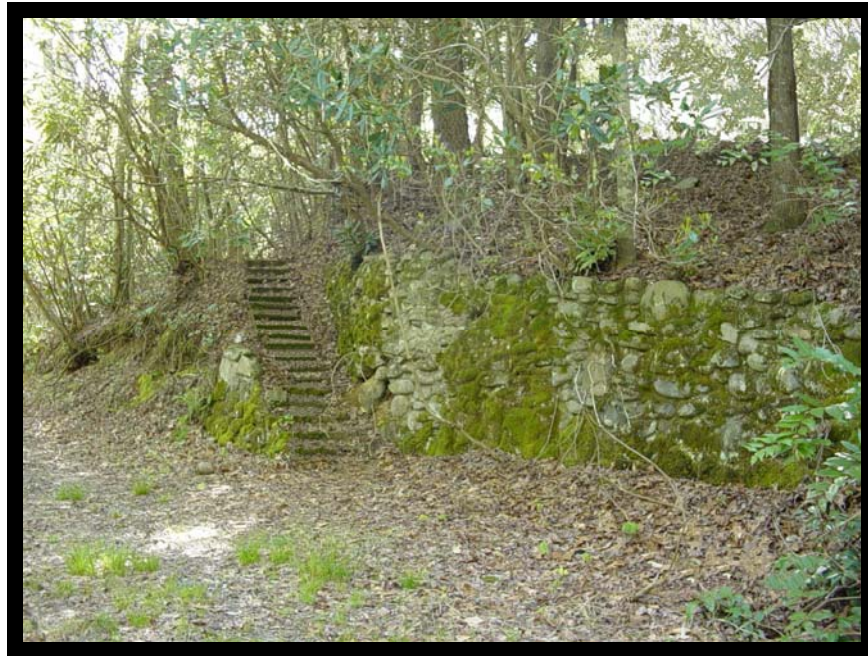
Photo 4A: Stone Staircase at Former Beaman Cabin

This simulation demonstrates the effect of removal of the Beaman (58-8H) cabin in the Wonderland Club. The rock steps and wall are preserved to reflect the historical character of the site.

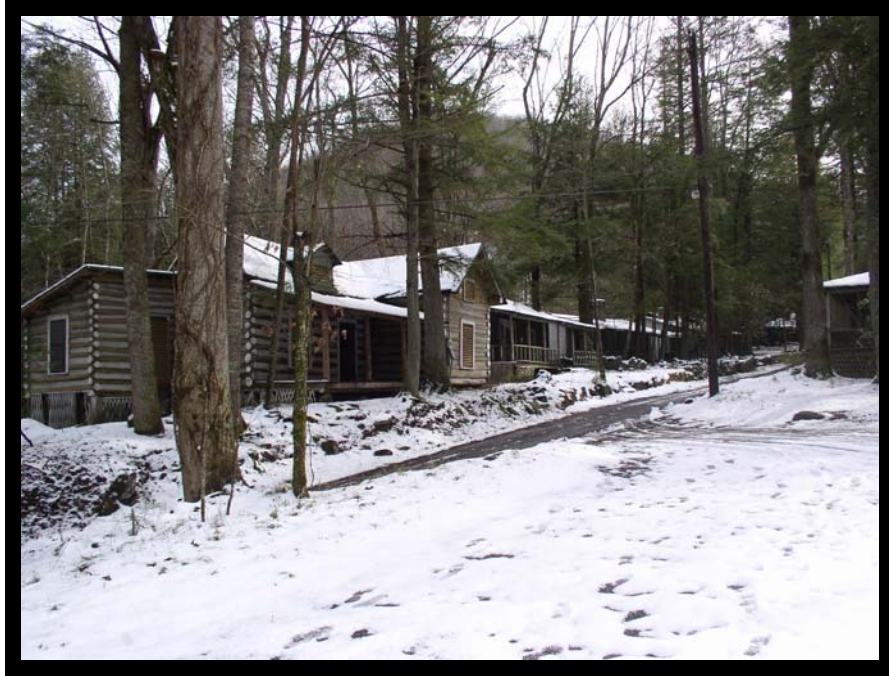
Photo 5: Viewing Platform from Parking Area at Appalachian Clubhouse

This photo depicts the existing Sneed (#1), Higdon (#3), Addicks (#5), and Smith (#2) cabins in Daisy Town.

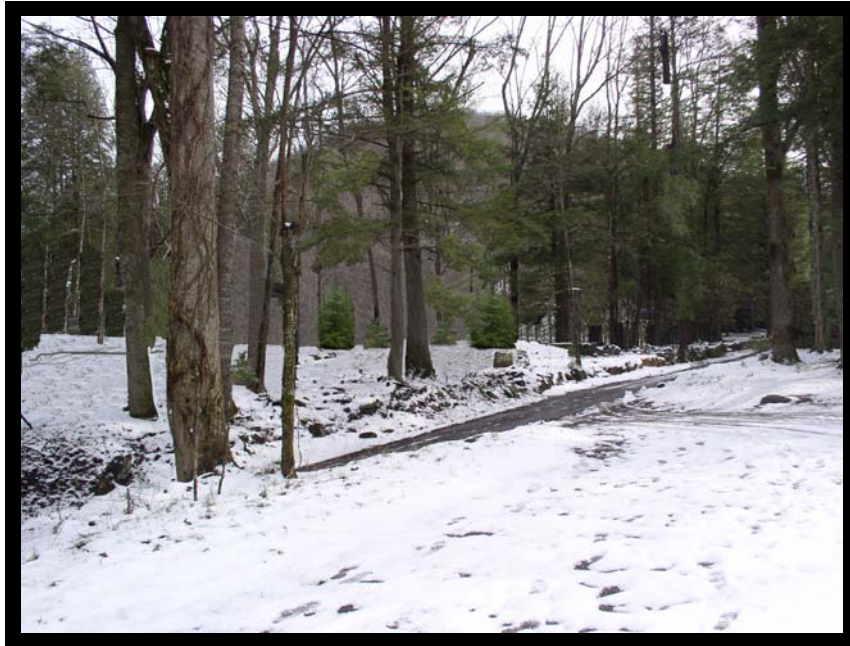
Photo 5A: Viewing Platform from Parking Area at Appalachian Clubhouse

This simulation demonstrates the visual effect of removal of cabins in Photo 5. The existing road would remain for vehicular and pedestrian circulation.

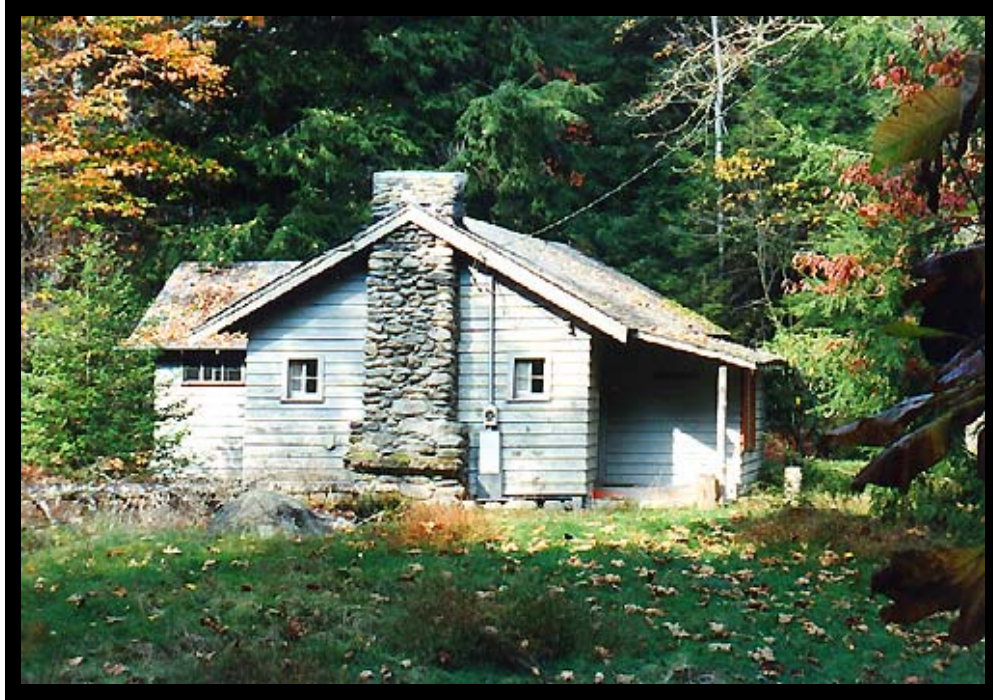
Photo 6: Parrot Cabin

This figure shows the existing Parrot (#44) cabin in Millionaire's Row.

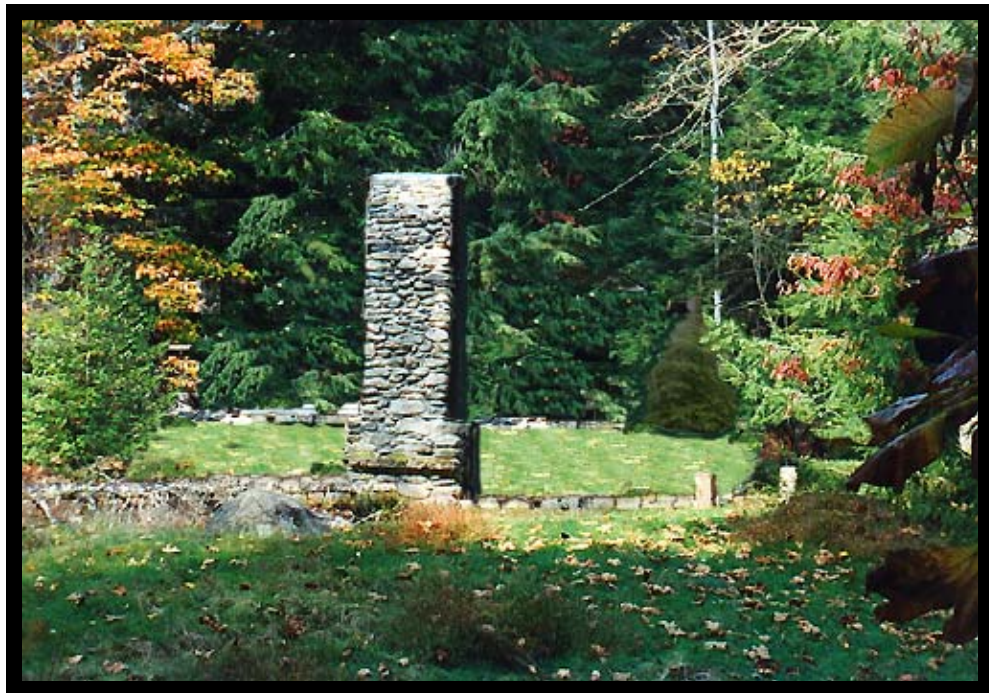
Photo 6A: Former Parrot Cabin

This simulation demonstrates the visual effect of removal of the Parrot (#44) cabin. The rock foundation and chimney could be preserved under some alternatives if they are structurally sound.
