**STATEMENT OF FINDINGS FOR EXECUTIVE ORDER 11990
(PROTECTION OF WETLANDS)**

**CAPE SABLE CANALS DAM RESTORATION PROJECT
EVERGLADES NATIONAL PARK**

June 2009

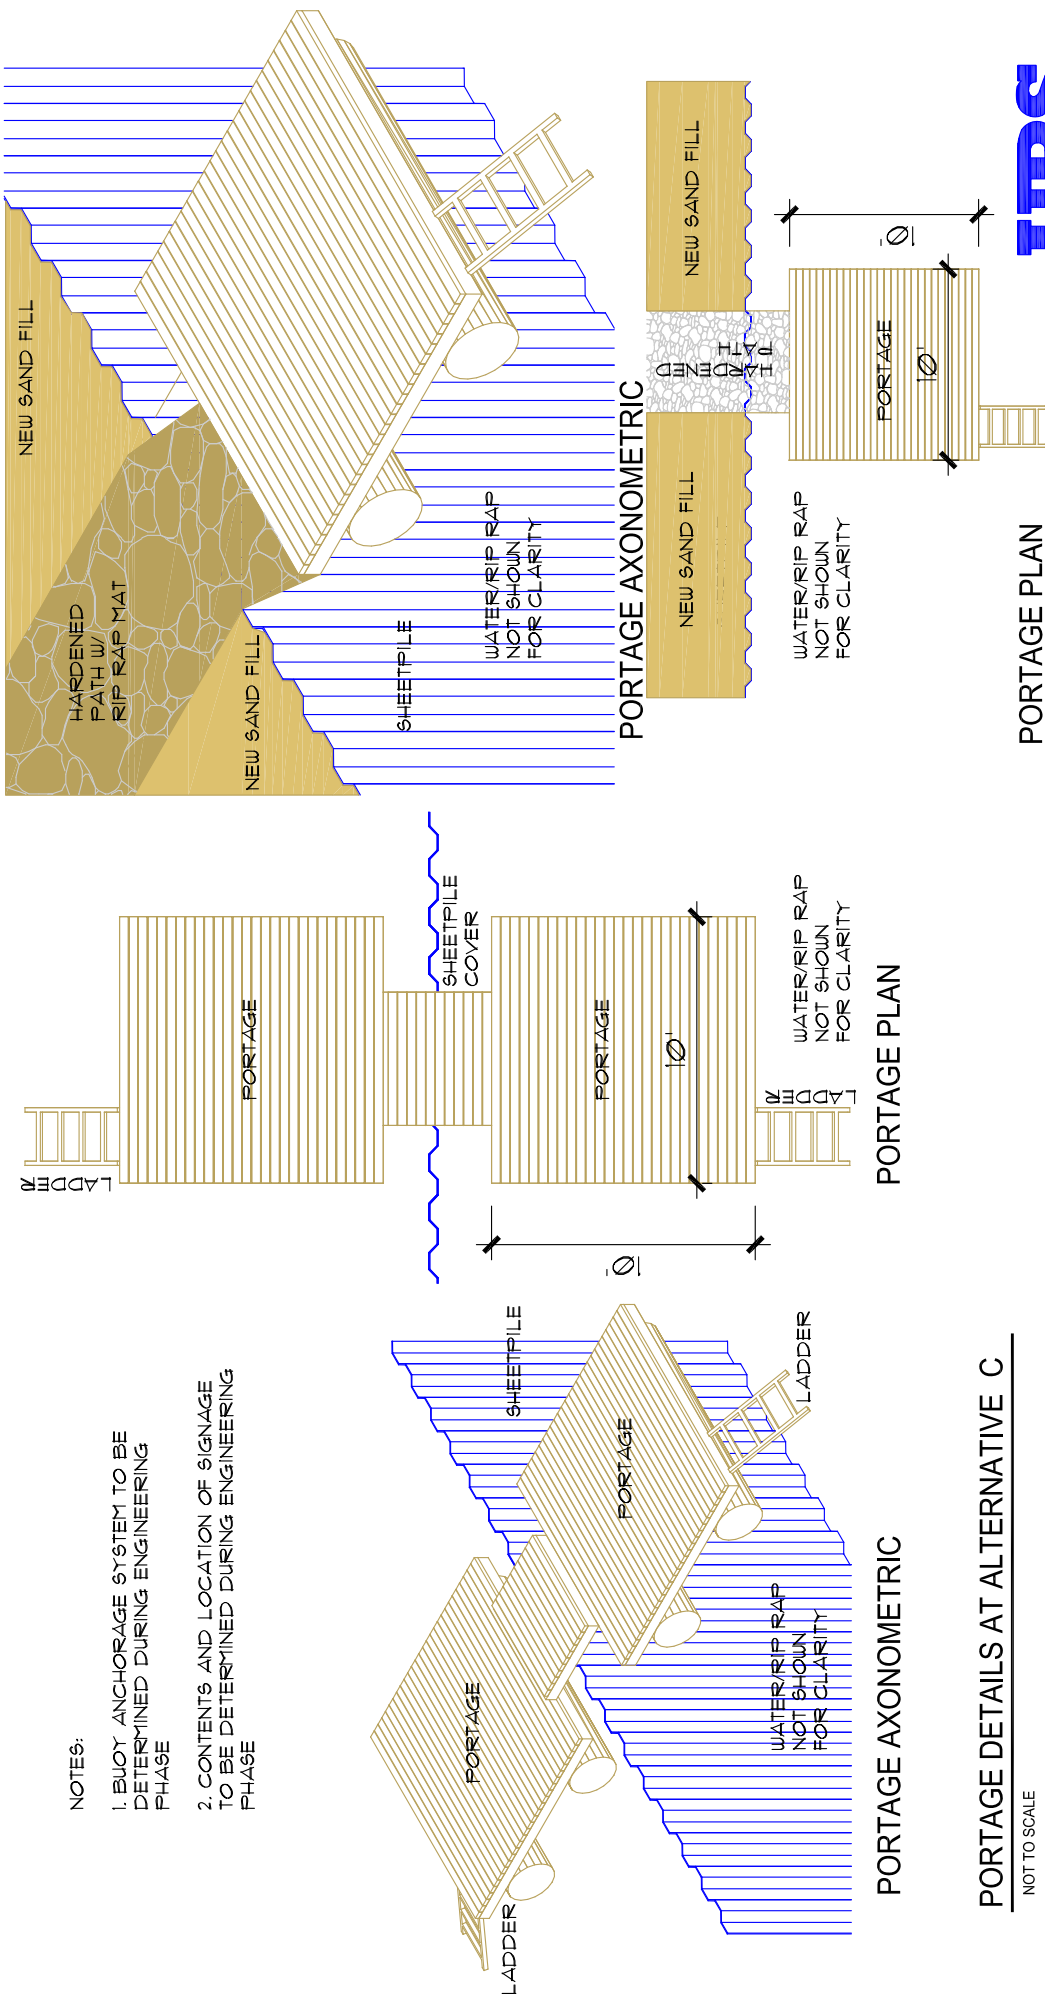
PORTAGE DETAILS AT ALTERNATIVE C

PORTAGE AXONOMETRIC

Installation of the deflector wingwalls and/or riprap would mitigate this type of activity. Also, the repair of the existing dam would include an engineering component to provide safe passage over the restored dam for non-motorized boaters (canoeists/kayakers). To provide safe portage, a floating dock structure (approximately 10-ft by 10-ft) would be constructed in the center of each dam entrance. The dock would be constructed using a wood-plastic composite lumber composed of wood and recycled plastics. The dock structure would be constructed so that a portion of the structure would extend over the water. A ladder would be placed on each dock to allow for access. For Alternatives D/D1 and G/G1, a hardened path would be installed across the proposed plug/dam using articulated block riprap (interlocking mats) to provide safe and sustainable passage across the plug/dam (see Alternative Drawings at the end of this SOF for portage details).

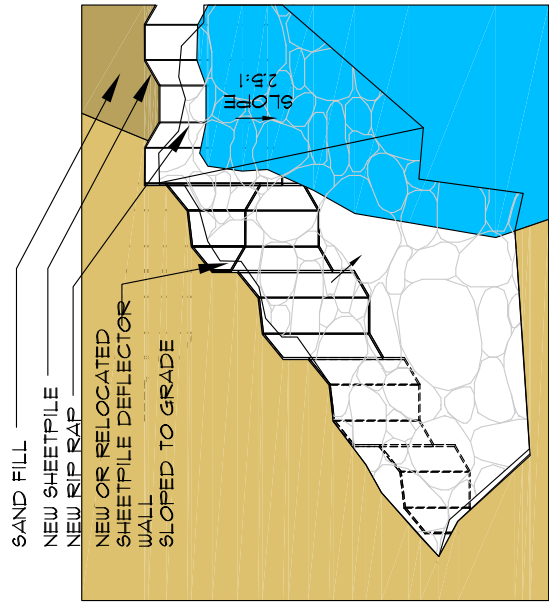
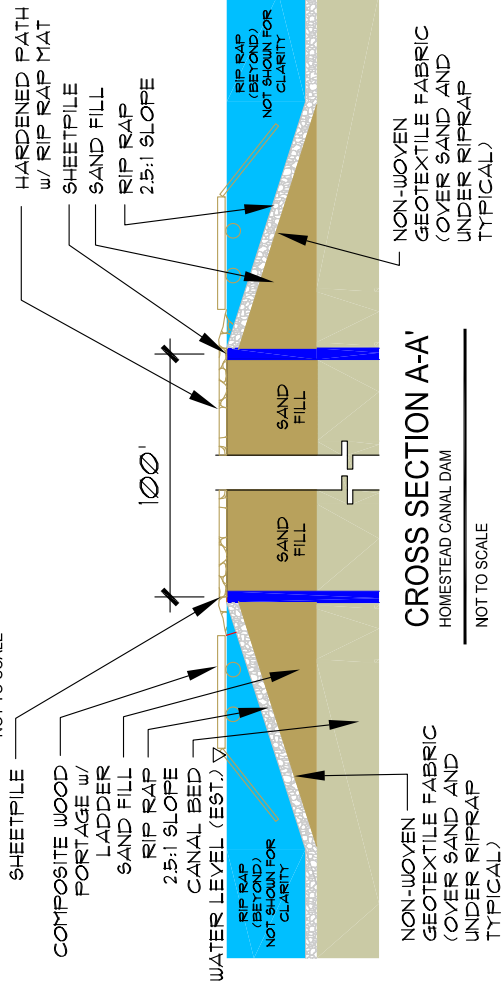
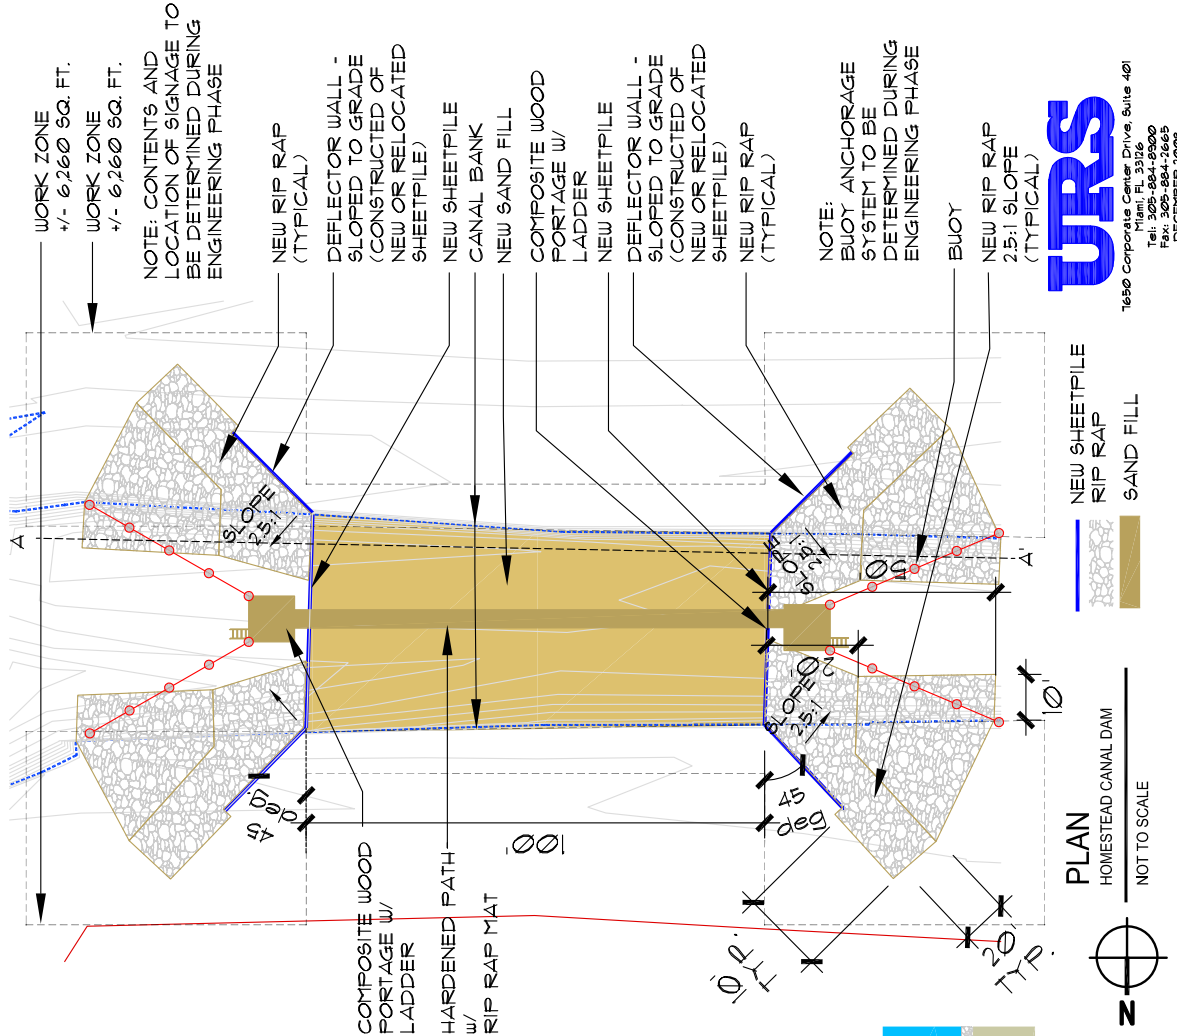
HOMESTEAD CANAL DAM - ALTERNATIVE D DRAWING

RIP RAP / DEFLECTOR WALL DETAIL

AXONOMETRIC

Dredging of an access channel in Lake Ingraham would not be required with these modified alternatives of Alternatives D and G. Geotubes would supplant the proposed sheetpile walls associated with Alternatives D and G. Geotubes are large tubular sand bags that are filled in place by pumping sand or slurry through a pipe from a barge. They are typically used to build structures such as breakwaters, shoreline protection or island

creation. For these modified alternatives, fill material would be transported to the Homestead canal work area through a constructed floating pipeline. The 6 to 8 inch pipeline would be constructed using a shallow draft barge and would run from the work area to a larger barge located at a designated staging area at the western terminus of the Ingraham canal (eastern mouth of Lake Ingraham) for a distance of approximately 1.5 to 2 miles. The constructed floating pipeline would be anchored to the northern edge of the existing channel in Lake Ingraham and the eastern edge of the approach channel to the Homestead canal. The water depths within the Ingraham canal are sufficient and would not require dredging. Fill material would be transported to the staging area at the Ingraham canal and conveyed through the pipe via hydraulic pumping to the work area in order to avoid potential adverse impacts to the lake from dredging activities. In addition, the existing sheetpile dam would be cut off at a suitable level using a torch in place of extracting the sheetpile with heavy equipment as with Alternatives D and G. The sheetpile would be removed for safety. Please reference Figure 4.4 for an aerial-view schematic of the proposed pump/pipeline system.

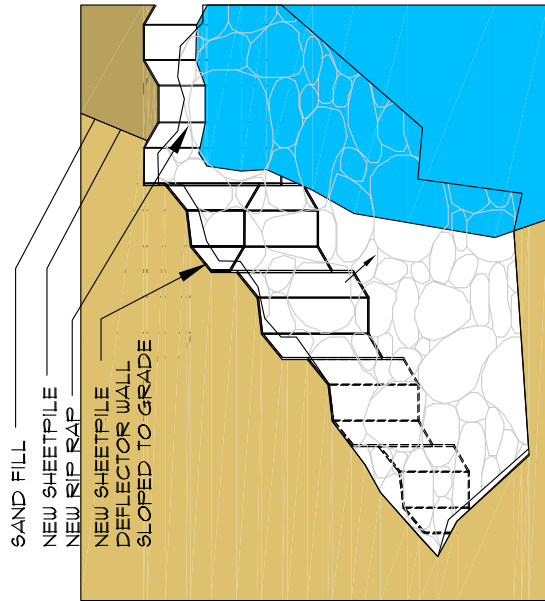
RIP RAP / DEFLECTOR WALL DETAIL

AXONOMETRIC

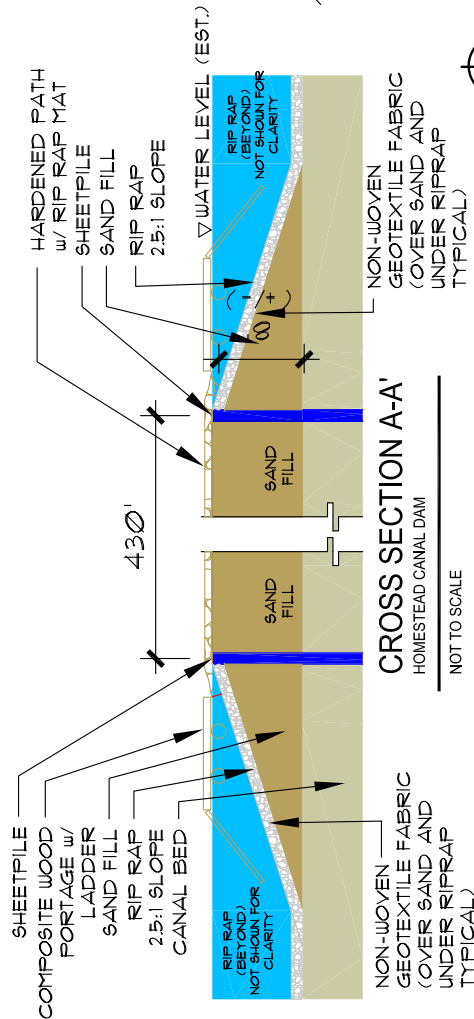
CROSS SECTION A-A'

HOMESTEAD CANAL DAM

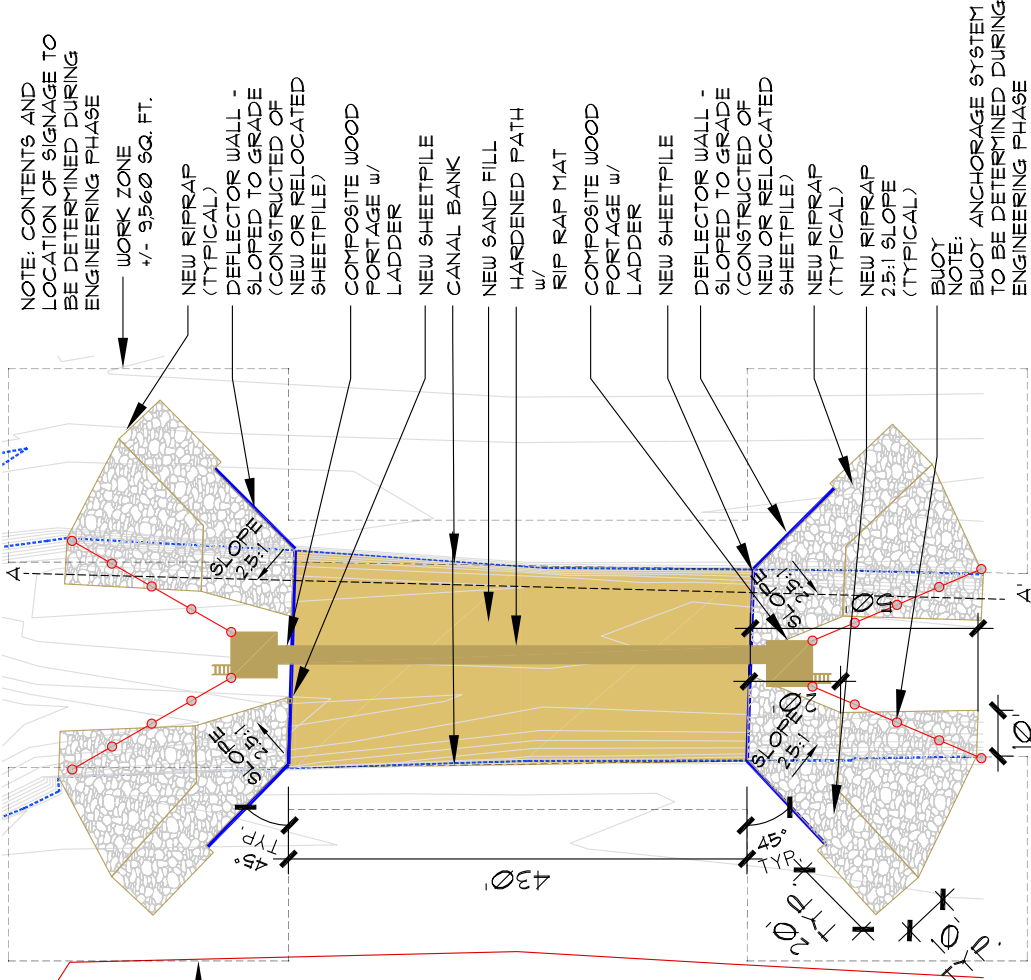
PLAN

HOMESTEAD CANAL DAM

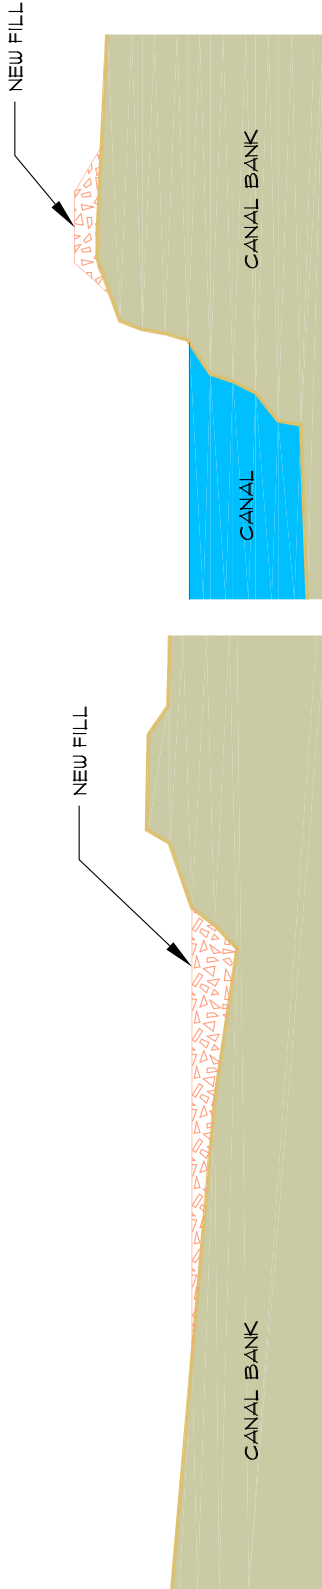
CROSS SECTION A-A'
HOMESTEAD CANAL DAM

HOMESTEAD CANAL DAM - SOUTHERN BANK FILL AREA

To restore the low lying area identified in the DTM survey, additional fill will be added along the southern bank just east of the failed dam structure to raise the elevation along the bank approximately one foot. It is estimated that approximately 500 cubic yards of fill will be required. Since an access channel will be provided, a shallow draft barge will be used to transport the fill material to the site. Once positioned at the site, a long reach excavator will be used to transport the fill from the barge to the low lying area. A small front end loader will then be used to grade the fill placed in the low lying area to match the existing adjacent topographic elevation. Since the resulting elevation would match existing adjacent grades, regrowth of wetland vegetation is expected within two years and the area is expected to return to full functionality within five years. As a precaution, a monitoring program would be initiated by the NPS in order to monitor the re-growth of native vegetation in this area for a period of up to five years. If after two years, sufficient coverage of desirable species is not observed, supplemental plantings may be conducted to facilitate the process.

To restore the low lying area identified in the DTM survey, additional fill will be added along the southern bank just east of the failed dam structure to raise the elevation along the bank approximately one foot. It is estimated that approximately 500 cubic yards of fill will be required. Since an access channel will not be available to allow for a shallow draft barge to enter the work area, a helicopter will be used to transport fill material to the site and place the fill material in the low lying area. Due to the difficulty in transporting heavy equipment to the work site, manual labor will be used to grade the fill to match the existing topographic elevation. Since the resulting elevation would match existing adjacent grades, regrowth of wetland vegetation is expected within two years and the area is expected to return to full functionality within five years. As a precaution, a monitoring program would be initiated by the NPS in order to monitor the re-growth of native vegetation in this area for a period of up to five years.

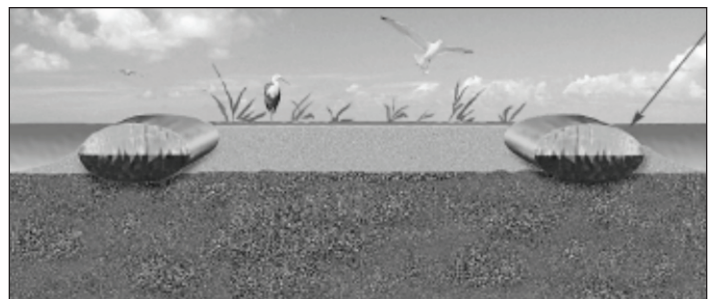
Figure 2. Dam construction using geotubes

- Install additional sheet pile at the existing location
- Install a new earthen dam at the existing location
- Install additional sheet pile and an earthen dam at the existing location
- Install a new dam using sheet piling in a new location
- Install a new dam by placing geotubes (high strength geotextiles) downstream of the existing sheet pile dam and filling the area with sand or other suitable materials (see figure below)
