FINAL Engineering Evaluation/Cost Analysis Report Addendum 1

Caneel Bay Resort

Prepared by VHB

March 2, 2023

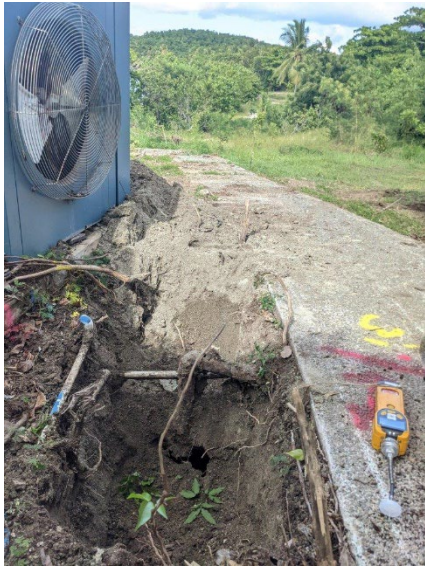
Figure 1, Photo 1 – Top of UST at Cottage 7 exposed; note hole at steel fill piping. Orientation: North. 11/10/21

A small steel UST was discovered buried beneath a concrete pad near Cottage 7 during the EE/CA Addendum Investigation. The top of the UST was rusted away, and the UST was visually confirmed to be empty. Visual, olfactory, and PID evidence of petroleum-contaminated soil was

not observed in soil around the top of tank, the fill piping, or in nearby soil cores. However, multiple PAHs were detected above PALs in two samples collected within several feet of the UST at depths near the bottom of the tank. Reported concentrations of benzo(a)pyrene exceeded PALs in SC-C7-01-5 and SC-C7-02-5. Additionally, reported concentrations of benz(a)anthracene and dibenz(a,h)anthracene exceeded PALs in SC-C7-02-5. PAHs were not detected above laboratory method detection limits at SC-C7-03-6.6, downhill of the UST. Benz(a)anthracene, benzo(a)pyrene, and dibenz(a,h)anthracene in subsurface soil were retained for further evaluation in the risk assessments.

The UST discovered at Cottage 7 reportedly predates the Resort and the type of fuel that was stored in the tank is unknown. Based on its understood use (to fuel a bomb shelter emergency generator) and its small size, potential historical releases from the tank are expected to have been relatively small. Similar to the AST release area, residual contamination appears to be present in soil near the bottom of the UST. Residual petroleum contamination is likely highly weathered with lighter components previously volatilized and/or biodegraded. PAHs in soil are expected to continue to naturally attenuate by microbial biodegradation over time.

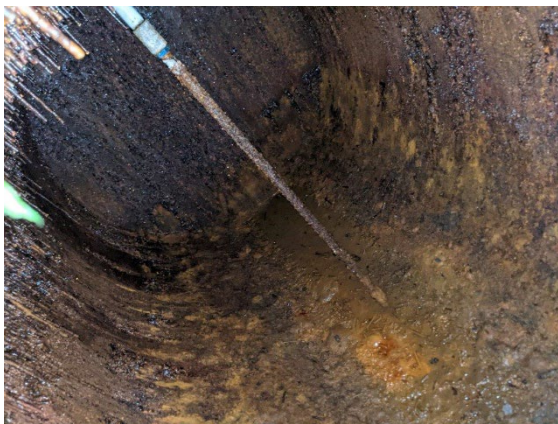
Figure 2, Photo 2 –View of interior of UST at Cottage 7. Orientation: West. 11/10/21

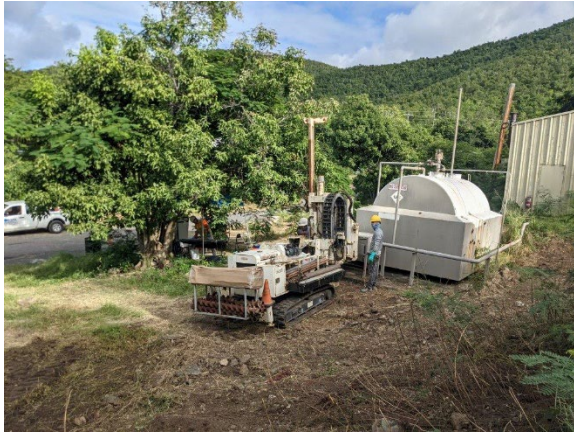
Figure 3, Photo 3 – Soil coring at SC-2-12 adjacent to the gasoline AST in Area 2. Orientation: East. 11/10/21

During the EE/CA Investigation, NPS observed petroleum odors and elevated photoionization detector (PID) readings in soil at borings advanced near the former ASTs and the fuel dispenser.

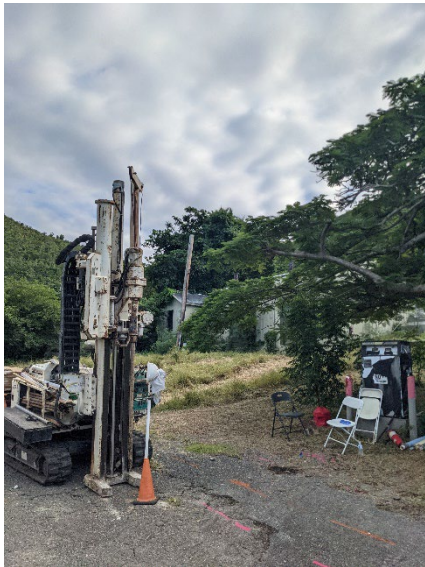
Figure 4, Photo 4 – Temporary piezometer installed at SC-2-06, near fuel dispenser in Area 2. Orientation: East. 11/10/21

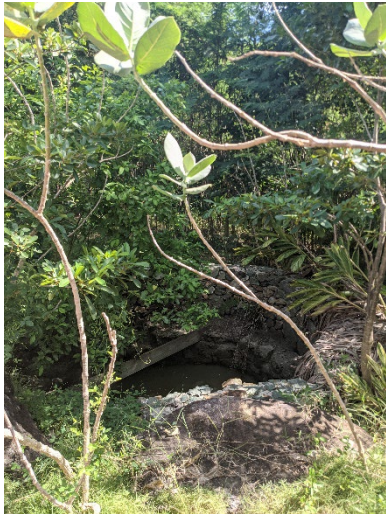
Figure 5, Photo 5 – Dug Well 2. Orientation: South. 11/8/21

Arsenic was detected at concentrations exceeding the PAL at Dug Well 1 and Dug Well 2. As arsenic was not detected above detection limits at nearby monitoring wells, MW-2-21 and MW-2-22, and both dug wells are cased with stone and open to the air, the presence of arsenic in the dug wells may be the result of surface runoff/infiltration and/or atmospheric deposition.

Barium was detected in all groundwater samples from MW-2-21, MW-2-22, Dug Well 1, and Dug Well 2 at concentrations above the PAL. Barium was previously detected at the historical monitoring well MW-01 (now closed) in February 2021; however, due to the poor condition and construction of this well, the sample was suspected to not represent groundwater conditions.

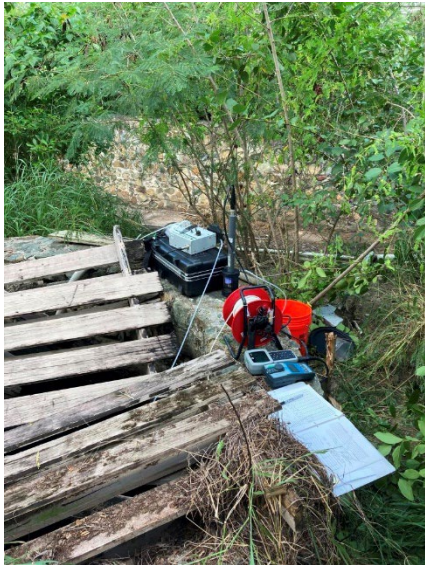
Figure 6, Photo 6 – Dug Well 1. Orientation: West. 11/17/21

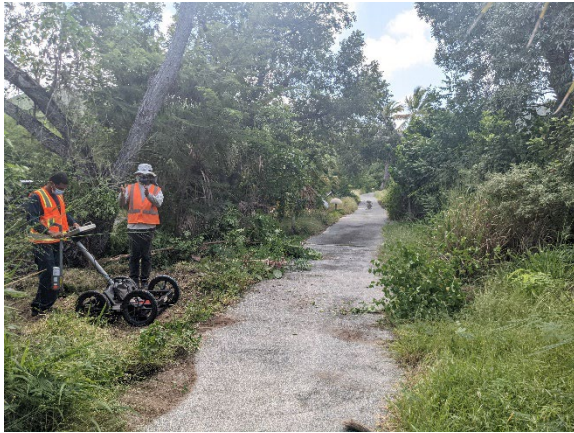
Figure 7, Photo 7 – JJBA tracing buried asbestos piping near Scott Beach. Orientation: South. 11/15/21

The term “debris” is limited by the location and state of the ACM. Several segments of asbestos-cement piping were observed at the Site that are not attached to any building (i.e., loose

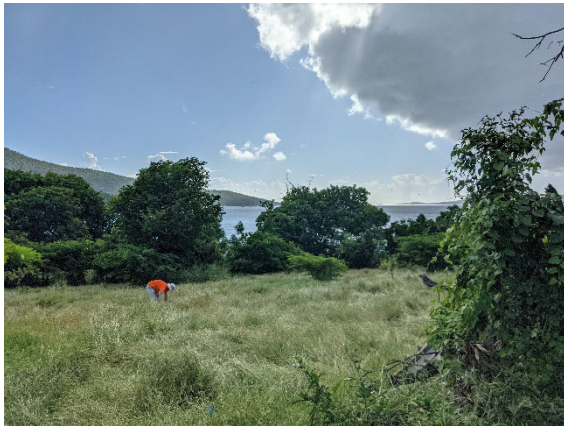
Figure 8, Photo 8 – VHB collecting background surface soil samples in IA-Ref-03. Orientation: West. 11/13/21

during the EE/CA Investigation, using incremental sampling methodology (ISM) with three replicate samples, each comprised of 40 increments, collected from each decision unit. Reported arsenic concentrations in five out of six replicate samples from the two additional background decision units (IA-Ref-03 and IA-Ref-04) exceeded the tentative RG, indicating that the RG was lower than true background conditions at the Resort.
