MALL MAPPING - RECONSTRUCT TURF & SOIL ON THE NATIONAL MALL

National Mall & Memorial Parks, Washington, DC

Contract No. 1443C2000091500 PMIS/PKG. No. NAMA 151515
30 June 2010 - For The Louis Berger Group, Inc. Morristown, NJ

Mall Mapping Project: Landscape Evolution of the National Mall & Union Square

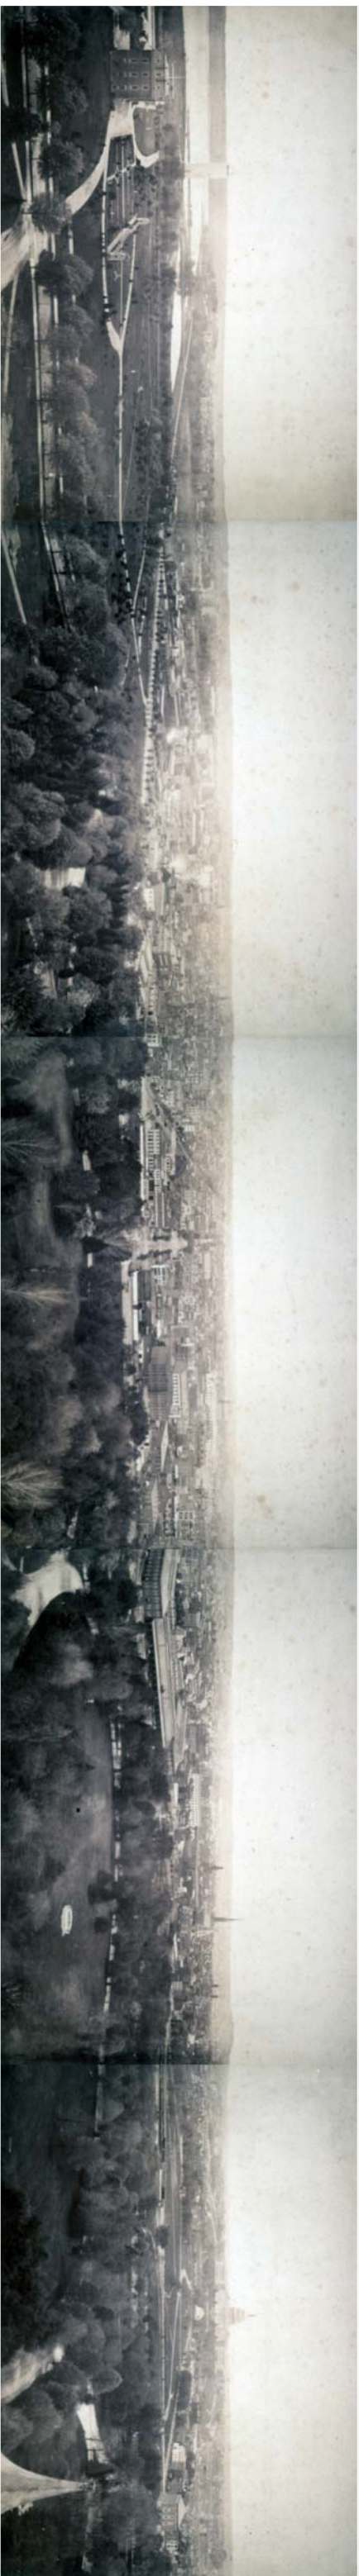
1879 PHOTO OF THE NATIONAL MALL FROM THE WASHINGTON MONUMENT TO THE U.S. CAPITOL
Source: Hacker, “Panoramic View of Washington, D.C.,” c1879. Courtesy Library of Congress. MMP–LC–CapitolfromCastle–1879–USZC4–12138–Panorama

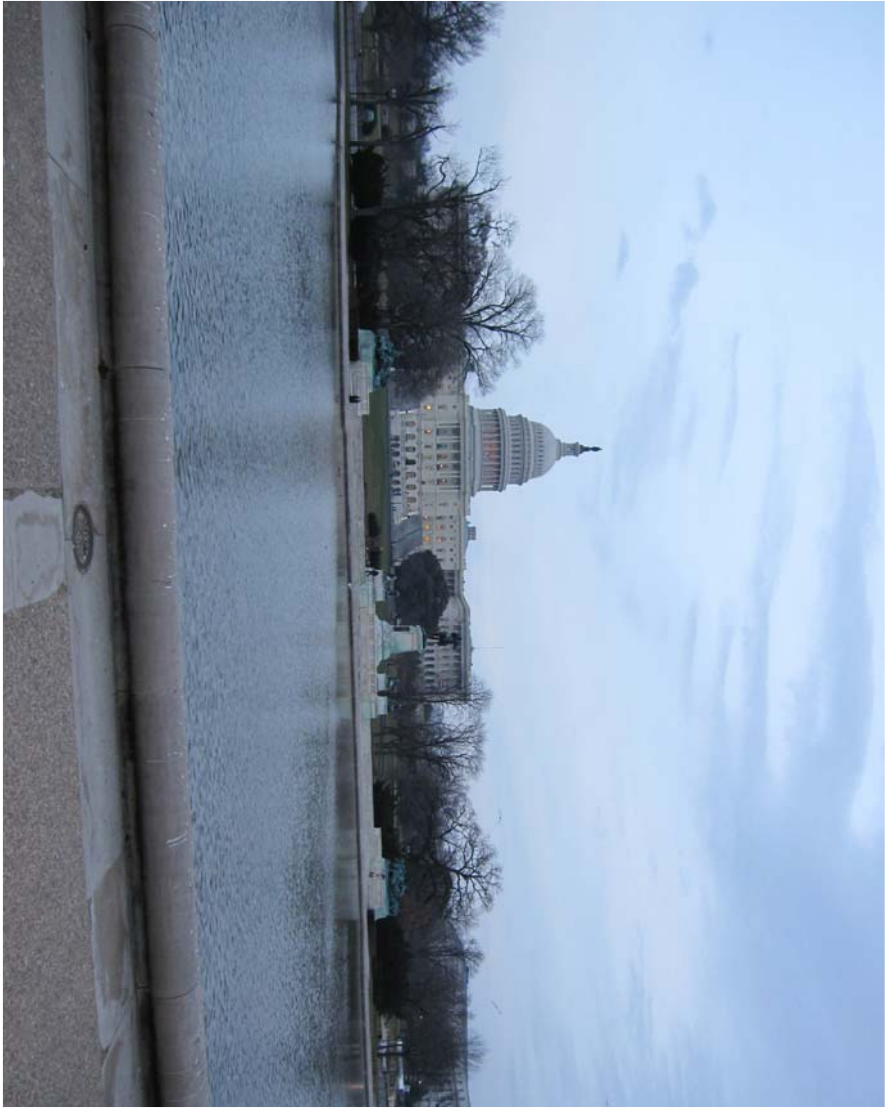
2010 UNION SQUARE PHOTO
Source: Heritage Landscapes. MMP–Mall–Union–Sq–16–HL–11March10
