CAPE LOOKOUT NATIONAL SEASHORE
L. S. S. Boat House

HISTORIC STRUCTURE REPORT

August 2003
Historical Architecture, Cultural Resources Division
Southeast Regional Office
National Park Service

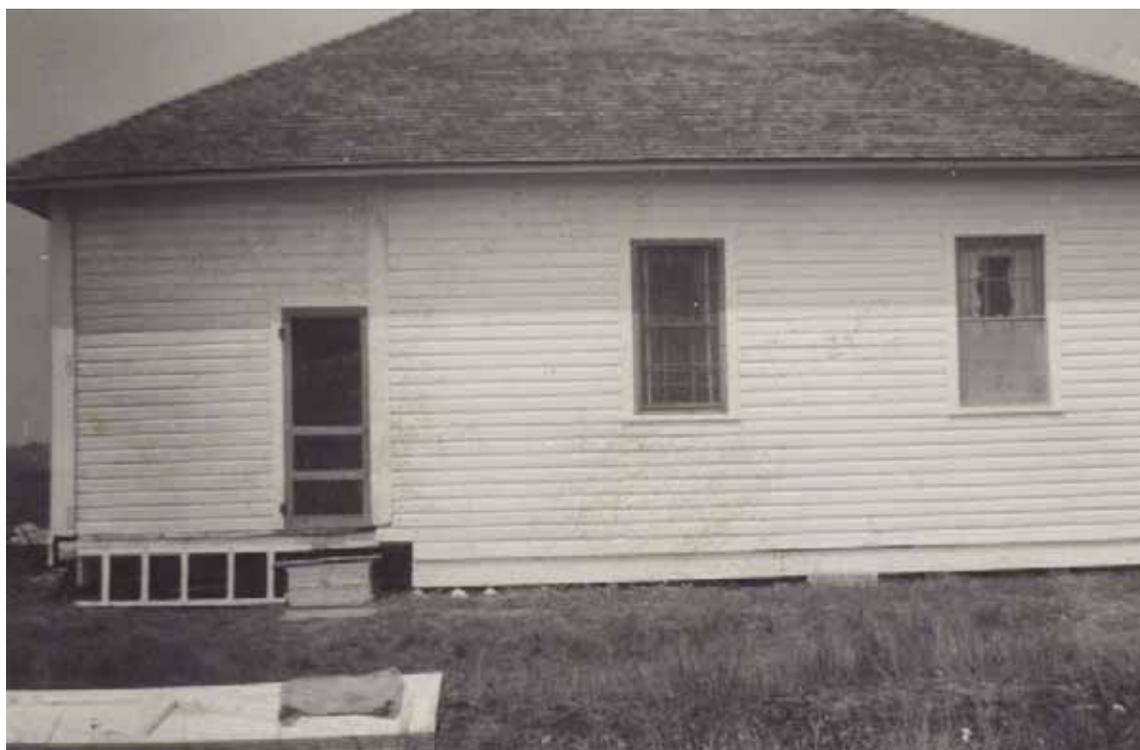
Figure 5 View of Boat House in 1961 after its conversion into a residence. One of the original doors is laying on the ground at lower left. (David Yeomans Coll.)

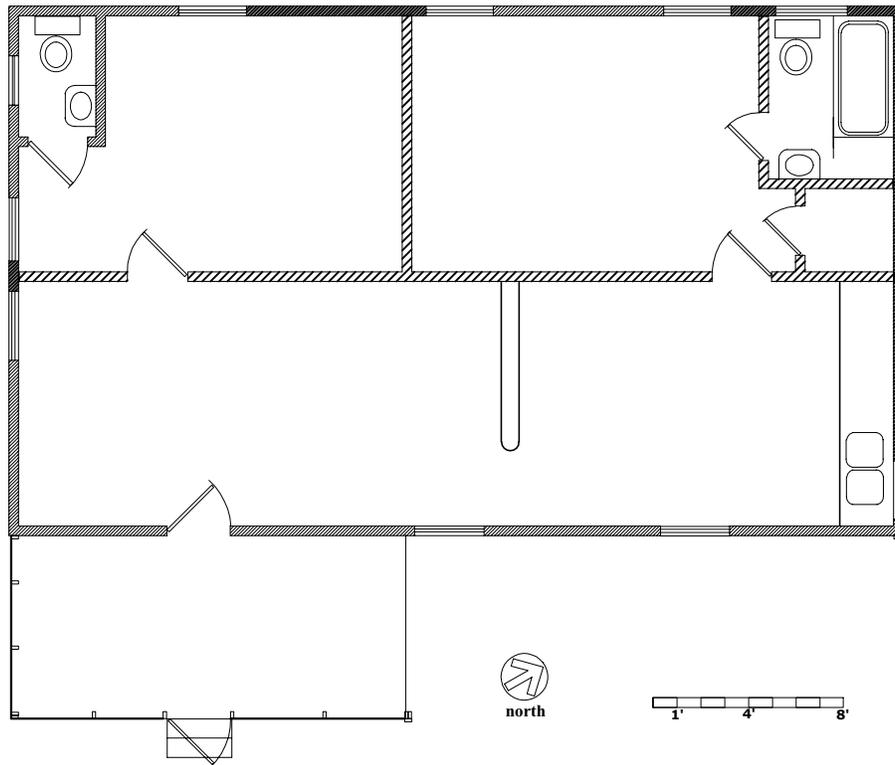
Figure 6 Plan of Boat House showing alterations in the 1960s. (T. Jones, NPS-SERO-CR, 2003)

Alterations to the doors was the first major change. The single door on the southeast side of the building was removed and the opening closed by a wall and a conventional front door.

The exterior of the wall was sided with drop siding that matched the original siding, but it is not clear if the existing front door was installed at that time or if it is a later replacement. At the northeast end of the building, the old double doors were simply fixed in place and the exterior covered with drop siding. The roof was also shingled with wood at the same time.

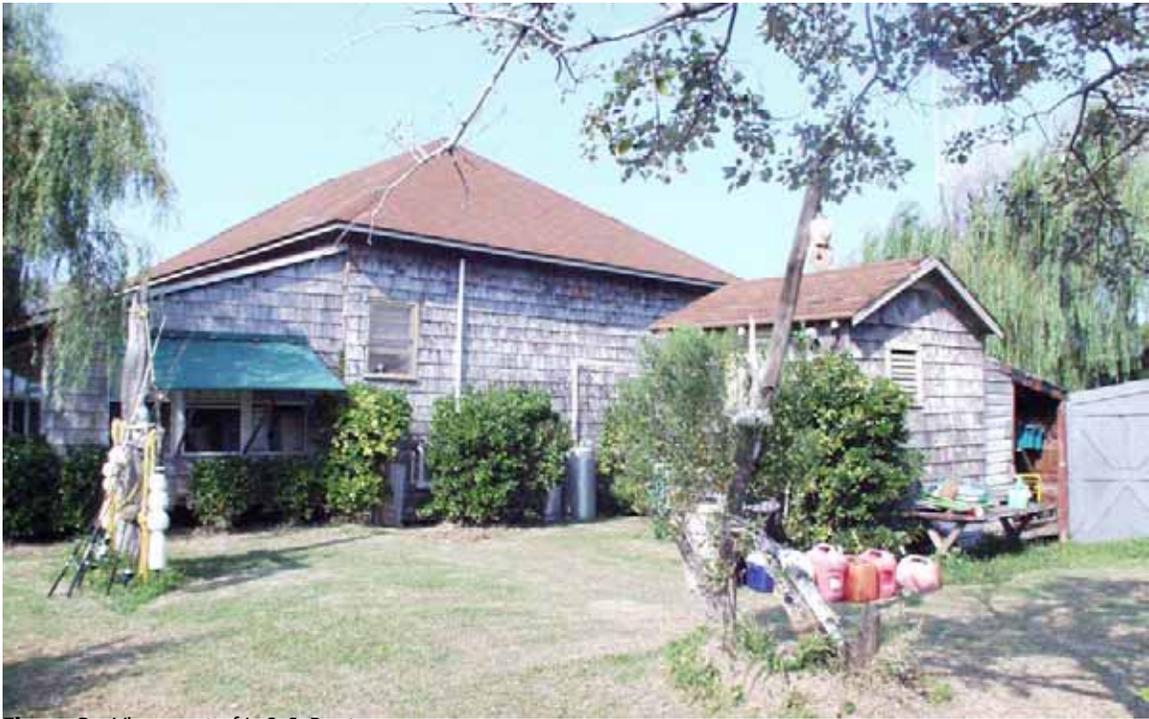
The building’s proximity to the ground, the modern finishes that cover most of the building, and lack of attic access prevent direct examination of most of the structure’s framing. Floor framing can be observed through the wire mesh that encloses the foundation and appears to be 2” by 8” joists on about 20”- 24” centers. Joists run parallel to the building’s long side and are supported at mid- span by a 4” by 8” beam that runs the width of the structure.

Figure 2 View west of L. S. S. Boat House. (NPS-SERO-CR, 2003)

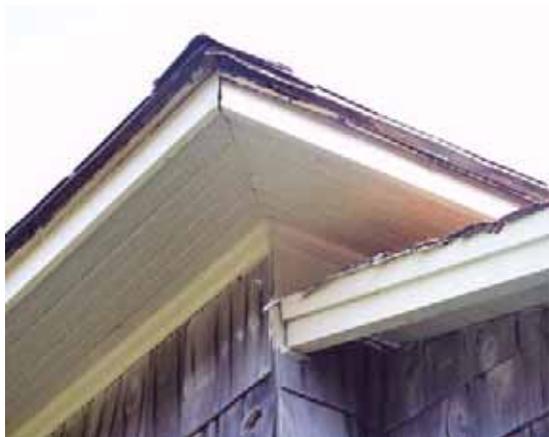
Figure 4 View of south corner and typical eave detail. (NPS-SERO-CR, 2002)

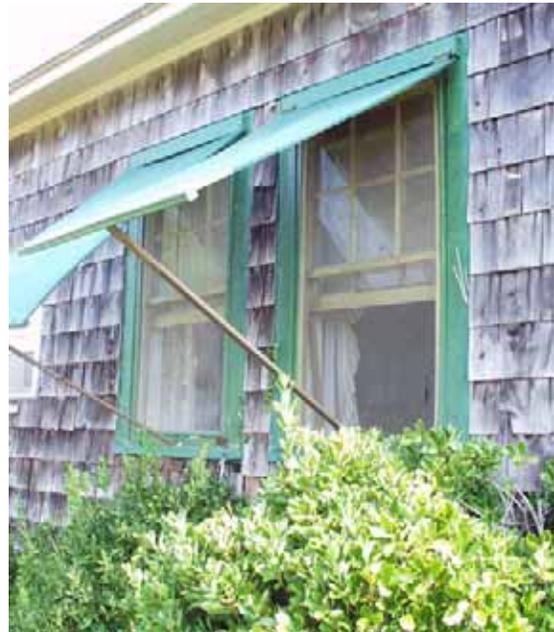
Figure 6 View of historic windows on northwest side of house with modern awning shutters. (NPS-SERO-CR, 2002)

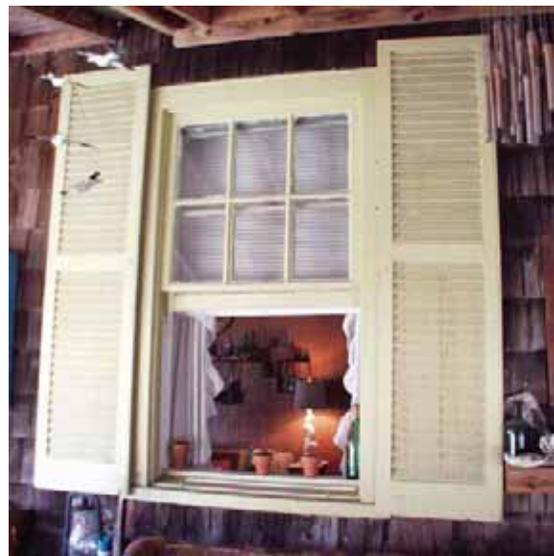
Figure 7 View of historic window on front porch with salvaged shutters added by present owner. (NPS-SERO-CR, 2002)

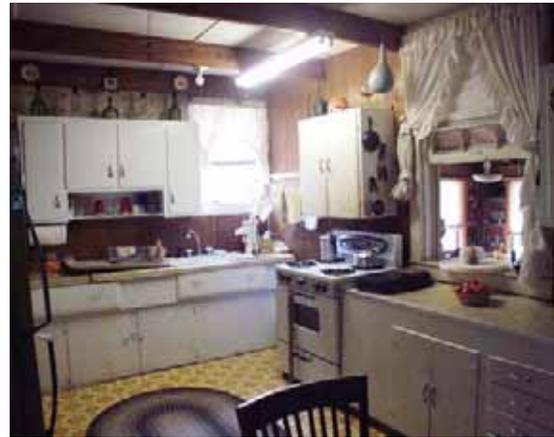
Miscellaneous: A wooden base cabinet approximately 27" wide runs the width of the northeast end of the room. According to the house's present occupant, who moved the building in 1958, this cabinet was part of a somewhat longer workbench that was originally located on the northwest (rear) wall of Room 102. Dimensions of wood used in its construction suggests that the cabinet dates to the building's original construction. The base cabinet door openings may not be original but the two drawers appear to be so. Both have faces 8-1/2" by 33", with broadly chamfered edges. Beneath the cabinet, part of the original boat doors at that end of the building are visible. The door was constructed with double-V-joint, tongue- and-groove, similar to that used on the building's soffit.

Figure 10 View to east in Room 101. Base counter at center left is part of a work bench that was originally in the space now occupied by Room 102. (NPS-SERO-CR, 2002)

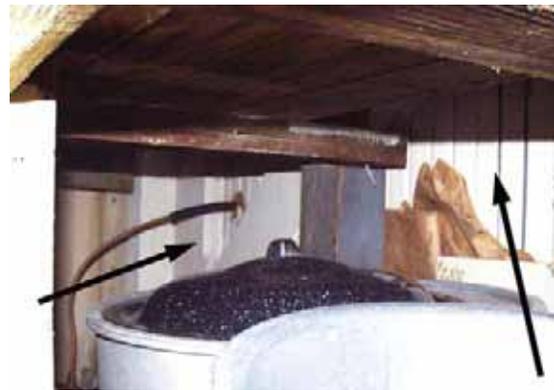
Figure 11 View of part of original boat doors under kitchen counter. Arrows indicate chamfered framing of door, left, and V-joint paneling used to finish doors, right. (NPS-SERO-CR, 2002)

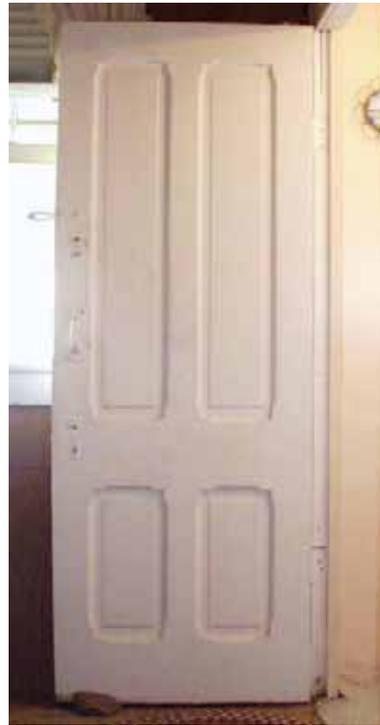
Figure 14 View of door to Room 102, believed salvaged from Life- Saving Station when it was remodeled in 1924. (NPS-SERO-CR, 2002)
