Cape Lookout National Seashore
LEWIS- DAVIS HOUSE

HISTORIC STRUCTURE REPORT

August 2003

2003
Historic Structure Report
Lewis- Davis House
Cape Lookout National Seashore
Cape Lookout Village
LCS#: 091828

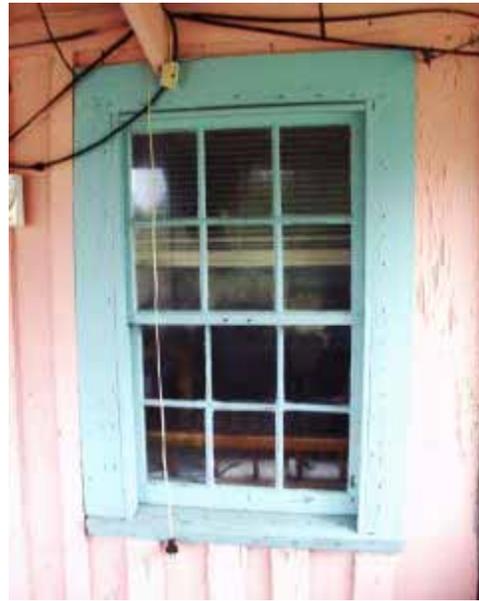
Figure 29 View of window W-2 on southeast (front) side of house, with exterior siding and trim typical of the original building. (NPS-SERO-CR, 2002)

batten siding was left exposed. There are numerous broken shingles, and all of the siding, which is now painted pink, is stained and mildewed.

W- 2: Wooden frame and sash; opening 2'- 4" by 3'- 9"; six- over- six, single- hung sash, in good condition. *W- 3:* Wooden frame and sash; original opening was 2'- 4" by 3'- 9" like *W- 1*; shortened to 3'- 1" and six- over- six sash replaced with modern two- over- two sash. The frame and sash are in poor condition.

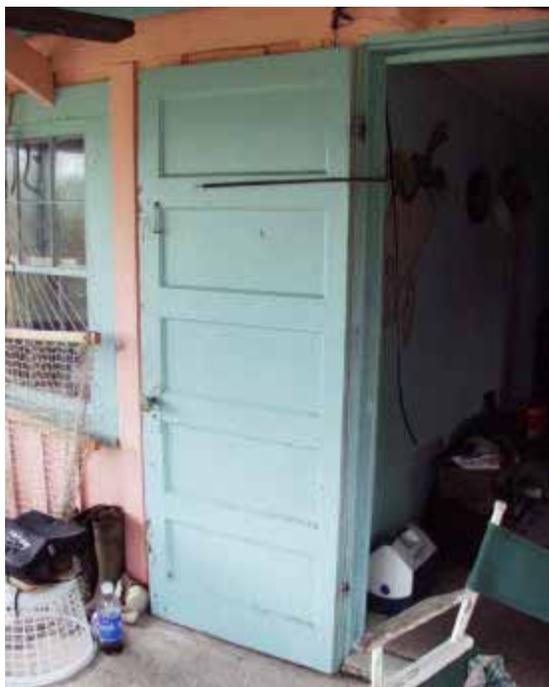
D- 1: Wooden, five- panel door with molded stiles and rails, 2'- 6" by 6'- 5", 1- 3/8" thick, plain metal mortise lock, knob, and escutcheon. Door is historic if not original.

Figure 30 View of front door D-1. (NPS-SERO-CR, 2002)

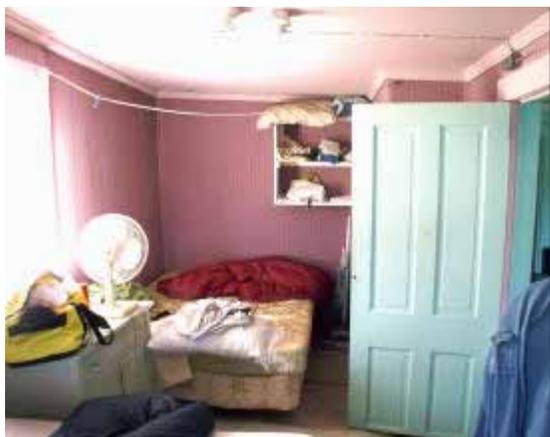
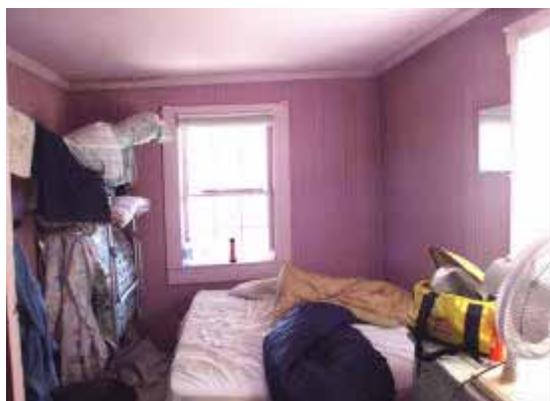
Figure 34 View to west in Room 101. (NPS-SERO-CR, 2002)

Figure 35 View to southeast in Room 101. (NPS-SERO-CR, 2002)

The floor is in dangerous condition and appears to be collapsing due to major deterioration of floor joists and/or piers under this part of the house.

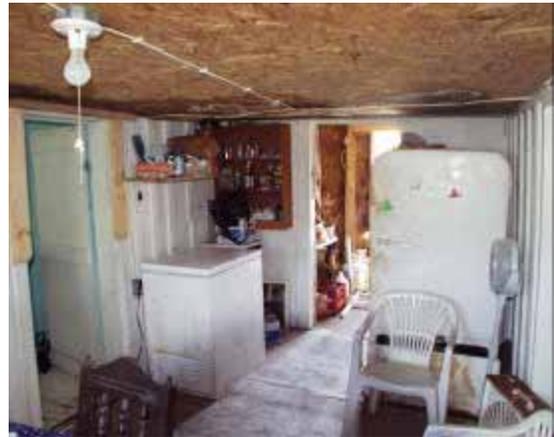
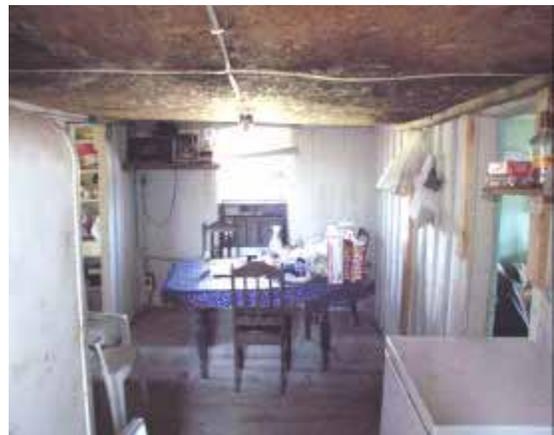
This room measures 8'-2" by about 15'. All of the rooms in the house except Room 101 open to this room. Major damage is ongoing where the roof is leaking along the wall adjoining Room 100.

Figure 36 View to south in Room 102. (NPS-SERO-CR, 2002)

Figure 37 View to northeast in Room 102. (NPS-SERO-CR, 2002)

Ceiling: The ceiling is set at about 7' and covered by sheets of wafer board. Original tongue-and-groove boards, 3-1/2" wide, probably V-joint, remain in place beneath the wafer board, but many are probably damaged or deteriorating due to water penetration. The ceiling has

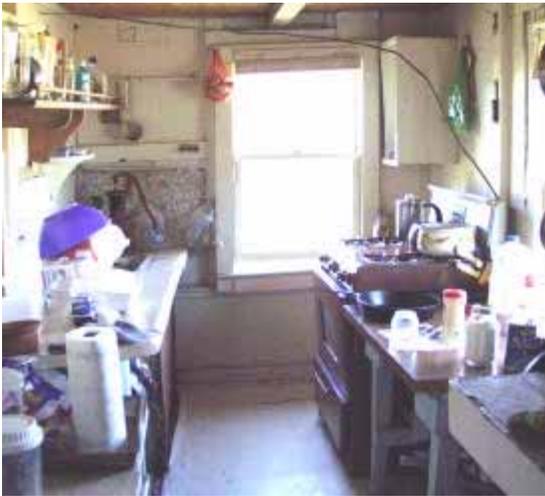
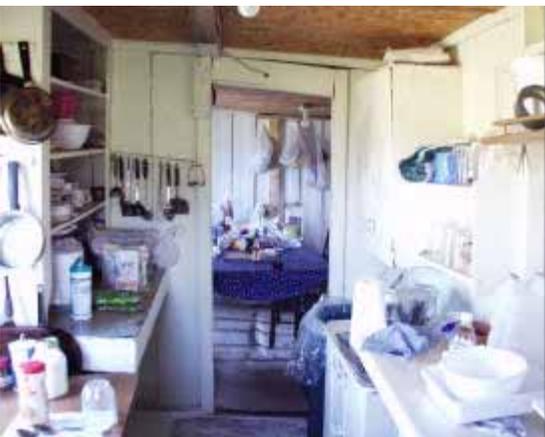
Figure 38 View to northwest in Room 103. (NPS-SERO-CR, 2002)

Figure 39 View to southeast in Room 103. (NPS-SERO-CR, 2002)

been braced along the middle of the east wall because water-damaged joists are collapsing in that area.

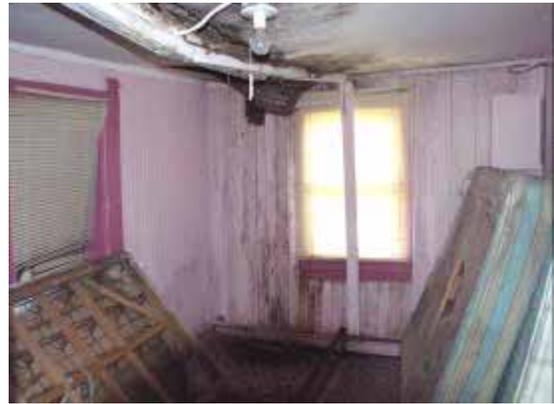
Ceilings: Like the walls, the ceilings appear to be very loosely framed, using widely-spaced 2” by 4” joists or, in some cases, 2” by 6” laid flat. The ceiling above Room 104 has been heavily damaged by water penetration and termites.

Measuring 8'-4" by 11'-6", this room is in extremely poor condition.

Figure 40 View to west in Room 104. (NPS-SERO-CR, 2002)

Ceiling: The ceiling, like the floor, is on the verge of total collapse due to severe termite and water damage. It was originally finished with double-V-joint, tongue- and-groove boards, 3-1/2" wide.

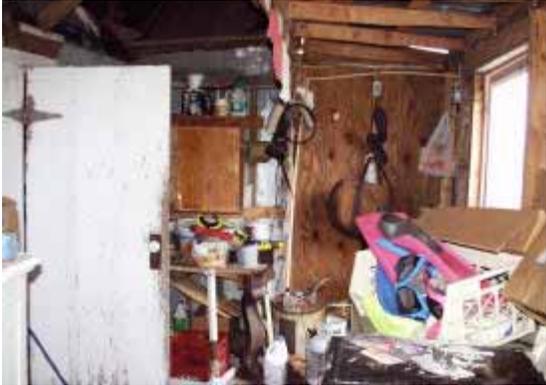
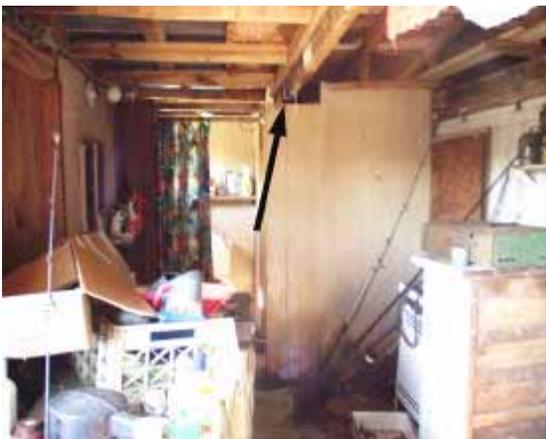
Figure 42 View to southeast in Room 105. (NPS-SERO-CR, 2002)

Figure 43 View northwest in Room 105. Arrow marks header at outside of historic porch. (NPS-SERO-CR, 2002)

Floor: The floor is modern plywood and is suffering from severe water damage near the entrance to the bathroom area.
