# Historic Structure Assessment Report

## **Bishop Barn**

Gettysburg, Pennsylvania

June 2018

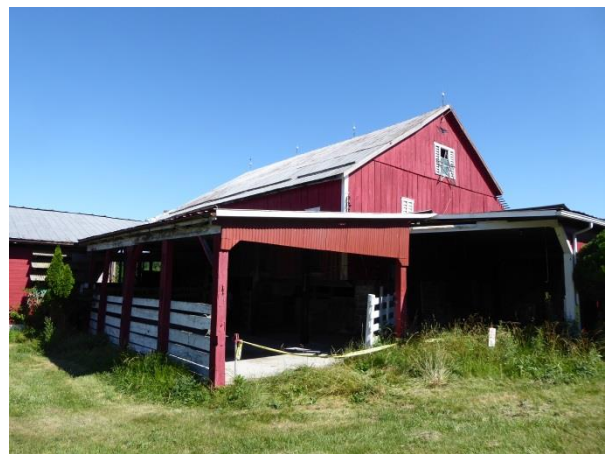
The modern additions obscure the historic bank barn, seen here, left to right: milking parlor, garage, and loading shed. Photo: HPTC, 06/21/17.

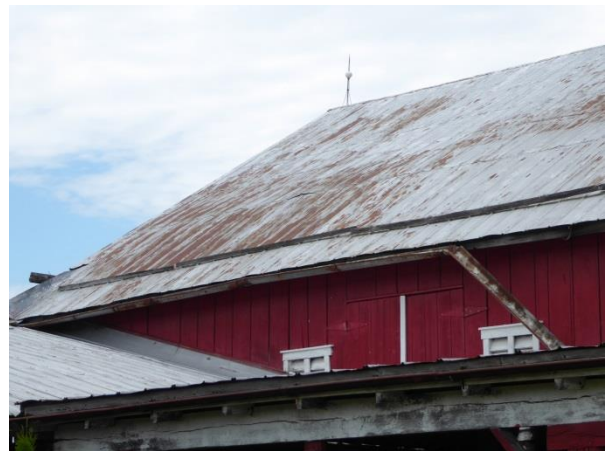
The ribbed metal roofing of the south slope of the bank barn is not character defining, as it likely postdates the period of significance. The snow boards are not CDFs either. Photo: HPTC, 06/22/17.

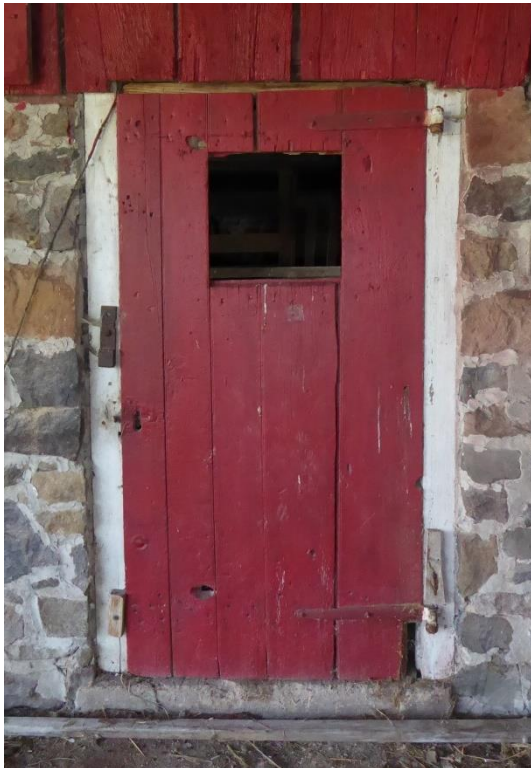
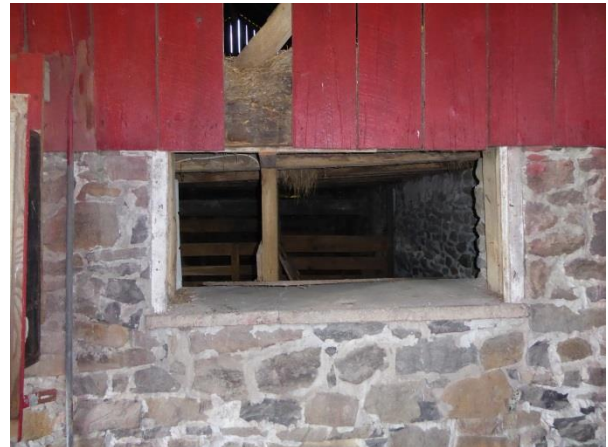
The window opening on the east elevation of the barn stone foundation has been altered and is no longer a CDF. Photo: HPTC, 06/22/17.

*Left:* The door opening on the east elevation of the barn stone foundation is likely original and a CDF. Photo: HPTC, 06/22/17.

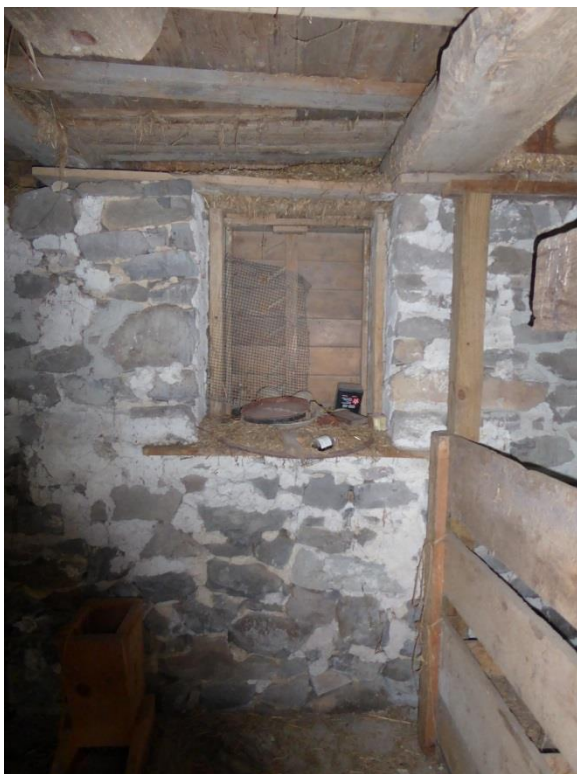
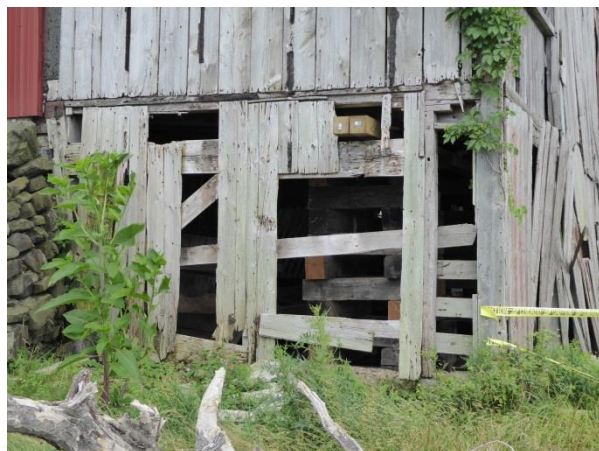
Remnants of original swinging doors on the north elevation of the lower level wagon shed. Photo: HPTC, 06/22/17.

*Left:* The window opening in the north elevation of the stone foundation is original and retains its operable louver. Photo: HPTC, 06/22/17.

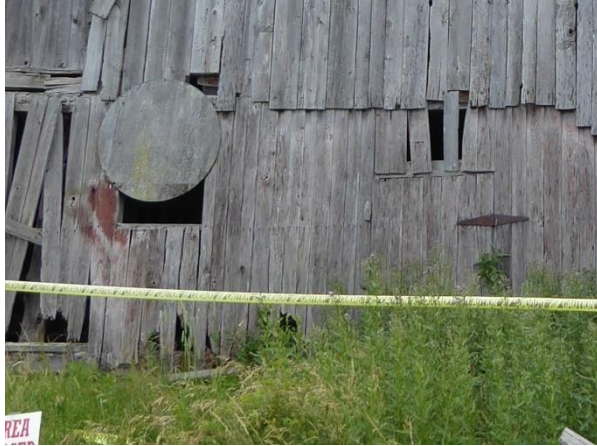
A non-original window and door opening on the west elevation of the lower level wagon shed. Photo: HPTC, 06/22/17.

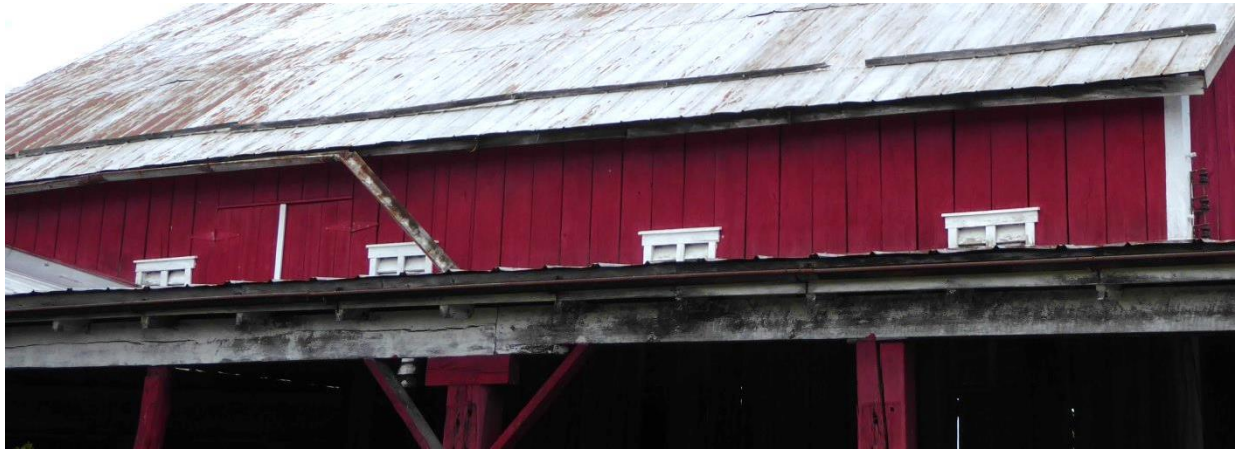
Original threshing are located on the south elevation of the upper floor of the barn. They are covered and made inoperable by the roof of the garage addition. The original louvers have also been covered with roofs of additions. Photo: HPTC, 06/22/17.

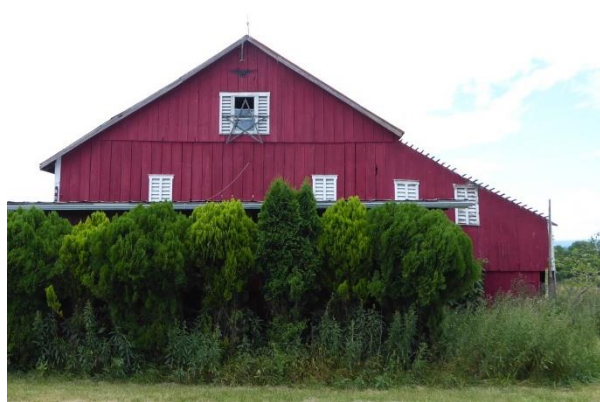
The louvered openings on the upper level of the bank barn are original but obscured by the roof of the addition below. The tripartite opening at the peak is also likely original, but altered with reused window sash. Photo: HPTC, 06/22/17.

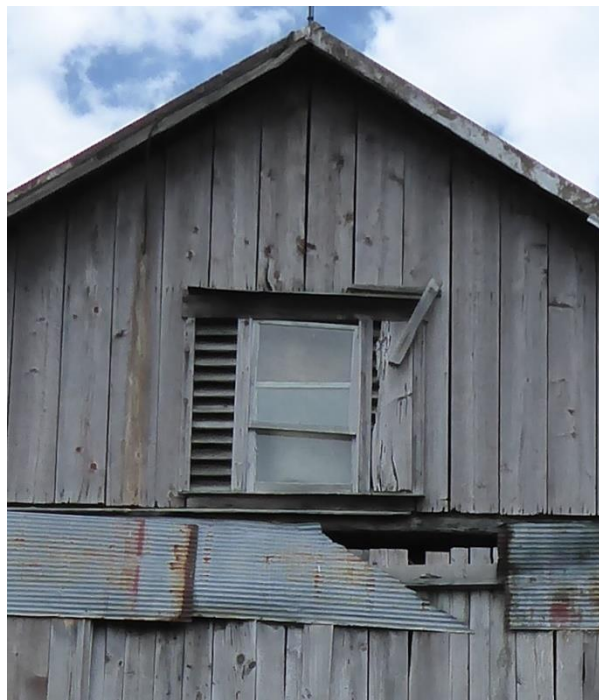
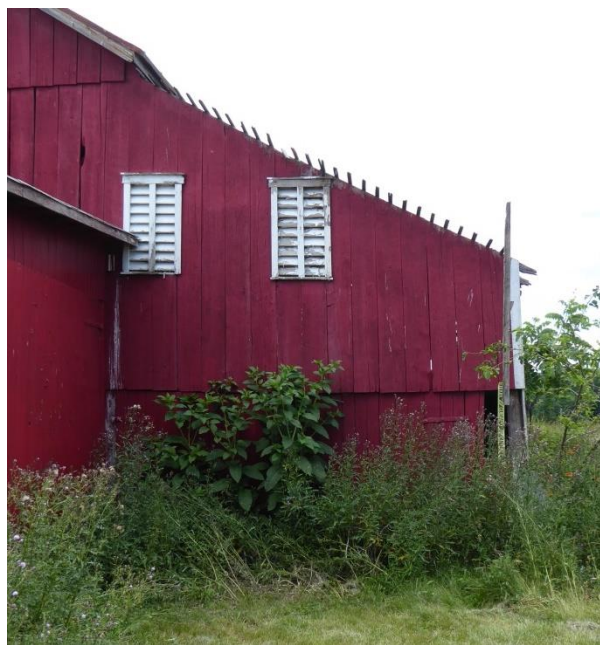
A pair of swining doors (one missing) are located on the west elevation of the outshed granary. Photo: HPTC, 06/22/17.

*Left:* A pair of swinging doors are located at the foundation level of the east elevation of the outshed granary; they are obscured by vegetation. Note the original louvers in the upper floor. Photo: HPTC, 06/22/17.

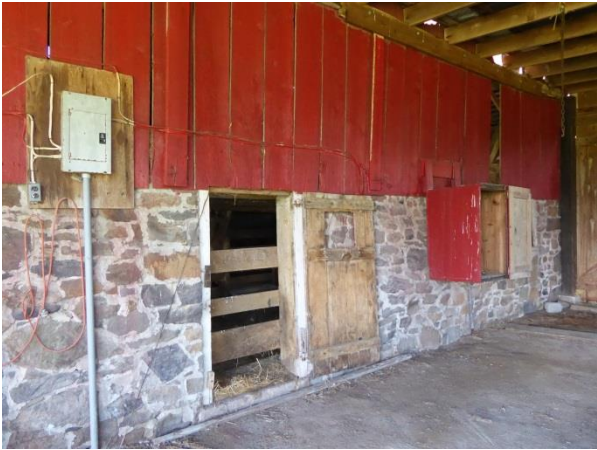
| <p>The stone wall foundations supporting the north, east, and internal west elevations of the barn are original except for a few alterations. The approximately 2'-0"-thick walls are constructed of granite and fieldstone laid in a random rubble and ashlar pattern with primarily historic lime-based mortar (some Portland cement-based mortar extant). Quarry marks can be seen on the ashlar granite.</p> <p>There are two openings on the east elevation; one is a window opening (modern alteration), the other is a door opening (historic). The north and west elevations each have a vent opening (historic).</p> <p>All exterior surfaces of the foundation walls are in fair condition; however the north end of the east elevation has extensive missing mortar and is in poor condition.</p> <p>The interior of the foundation walls are exposed. A portion of the west wall has been repointed with Portland cement. Most of the east wall was replaced with modern cinder blocks and bricks. A portion of the north wall has been parged with concrete. These modern systems and materials appear to be functioning well, but are unsympathetic changes. There are no signs of significant water penetration.</p> | |
| <div style="display: flex; justify-content: space-around;"> <div style="width: 45%;"> <p>The east elevation stone foundation wall of the barn, with historic door opening. Photo: HPTC, 07/21/17.</p> </div> <div style="width: 45%;"> <p>A significant portion of the interior of the east foundation wall was repaired with incompatible and modern cinder block and brick. Photo: HPTC, 06/21/17.</p> </div> </div> | |

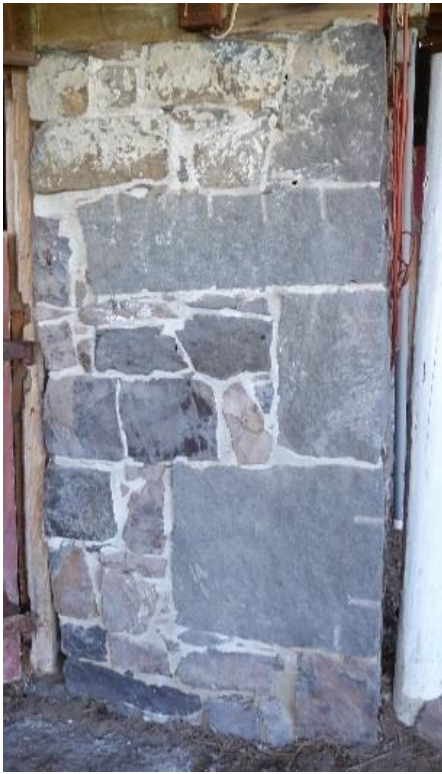
The historic random rubble and ashlar granite and fieldstone foundation walls on the north elevation are covered with modern cement parging. Photo: HPTC, 06/21/17.

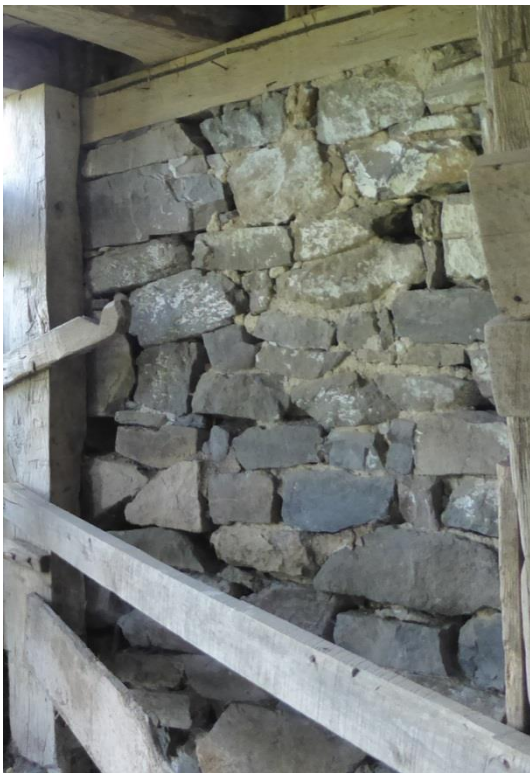
The interior of the west foundation wall has been repointed with Portland cement-based mortar. Photo: HPTC, 06/21/17.

*Left:* The west interior stone foundation wall as seen from the wagon shed. Note the extensive missing mortar in this area. Photo: HPTC, 07/21/17.

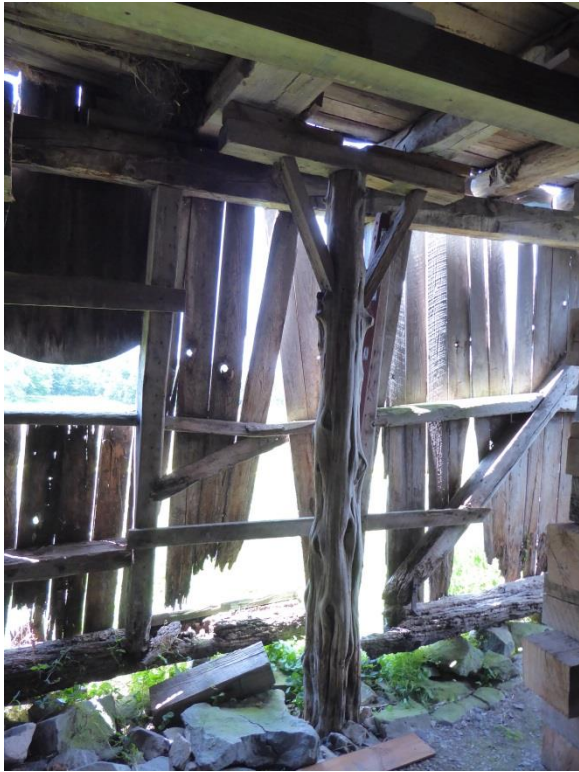
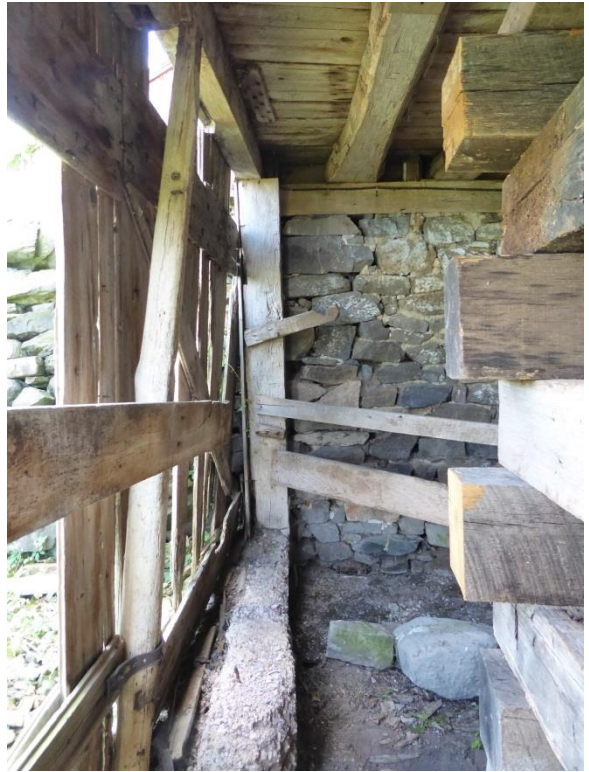
| <b>A101001-2 Barn Timber-Frame Foundations</b> | |
|---|---|
| <p>The barn foundation wall at the west elevation and western third of the north elevation are composed of timber-frame construction. Due to washout of the footings at the base of the posts, much original framing has been lost and supplemental framing has been added.</p> <p>Come-alongs have been added at the base of the structure to deter the wall kicking out at the base. Cribbing has been added at three locations along the west elevation to support the floor structure above.</p> | |
| <p>Framing members on the west elevation of the wagon shed. Photo: HPTC, 06/21/17.</p> | <p>The north elevation timber-frame foundation wall of the wagon shed. Photo: HPTC, 06/21/17.</p> |

| Qualitative Condition Rating | POOR |
| Maintenance Deficiency Rating | CRITICAL |

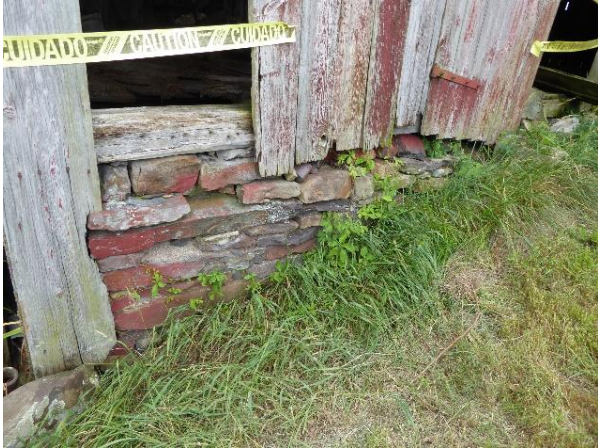
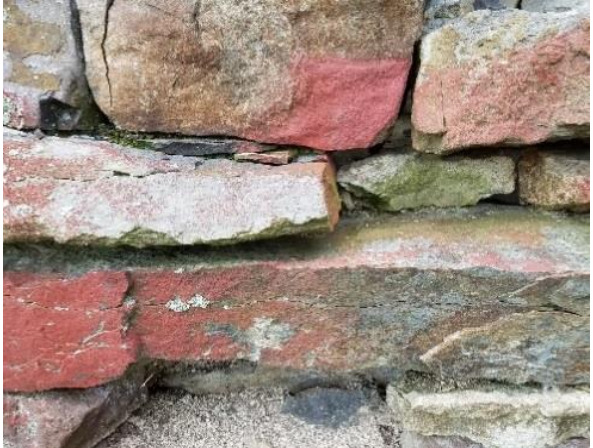
| <p>The historic outshed granary on the north addition is supported by stone foundations walls on the north and west elevations; the entire east elevation is composed of wood doors. The fieldstone is laid in a random rubble pattern with historic lime-based mortar.</p> <p>The stone foundations of the historic outshed granary are in poor condition. The stones are unstable. Major issues are with the mortar: multiple locations exhibit deep voids or the absence of mortar altogether.</p> | |
| <p>Stone foundation wall at the west elevation of the outshed granary. Photo: HPTC, 06/21/17.</p> | <p>Missing mortar in the foundation walls of the outshed granary. Photo: HPTC, 06/21/17.</p> |
| Qualitative Condition Rating | POOR |
| Maintenance Deficiency Rating | CRITICAL |

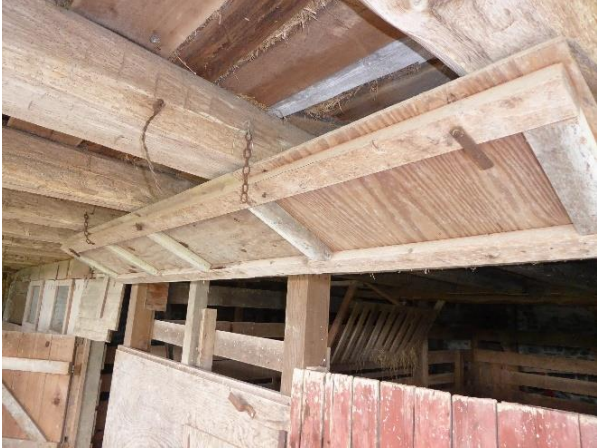
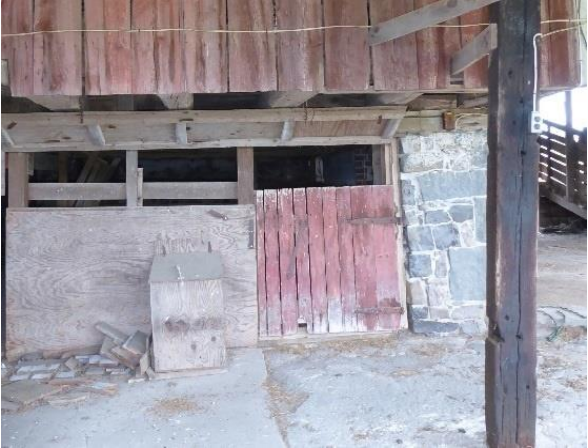
| <b>A2020 Basement Walls</b> | |
|---|--|
| <p>The lower level forebay wall is composed of modern framing materials. The posts vary in size between 2x4s and 6x6s. A majority of the exterior wall is operable via a series of doors and windows.</p> <p>The non-historic wall is in fair condition with minor wood-boring insect damage present.</p> | |

| <p>Lower level modern frame forebay wall with horizontal opening along the length. Photo: HPTC, 06/21/17.</p> | <p>Easternmost portion of the lower level forebay modern frame wall. Photo: HPTC, 06/21/17.</p> |

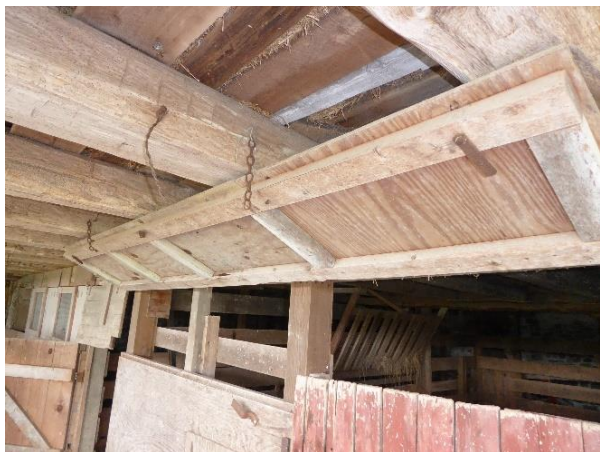
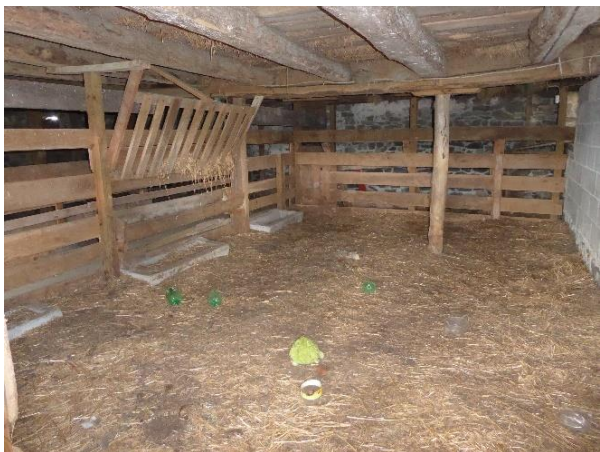
| <div style="display: flex; justify-content: space-around;"> <div style="text-align: center;"> <p>Left to right: P23, P24, and P25. These members are all modern and compose part of the lower-level forebay wall. Photo: HPTC, 06/21/17.</p> </div> <div style="text-align: center;"> <p>P26, left, and P19, right, are modern, supplemental posts. Photo: HPTC, 06/21/17.</p> </div> </div> | |

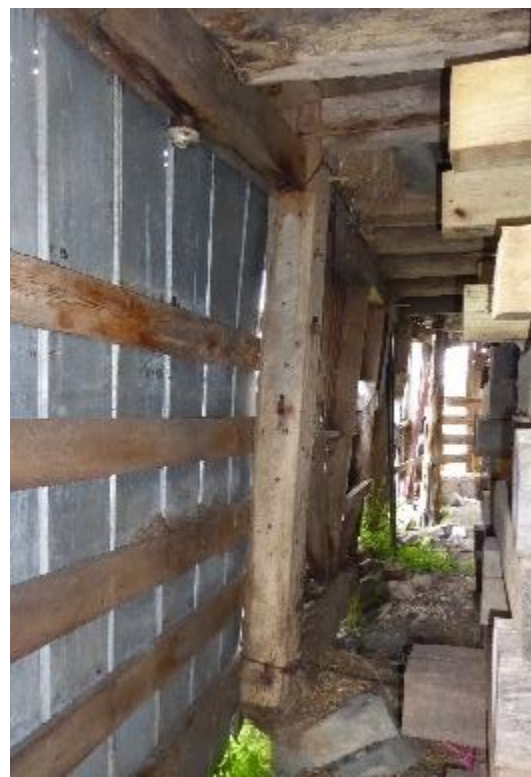
P4 supports the rim beam at the west elevation timber-frame foundation wall of the wagon shed. It is likely historic. Photo: HPTC, 06/21/17.

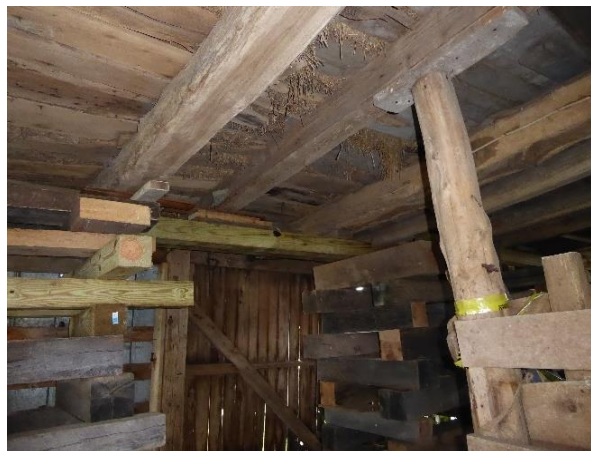
P12 is modern and supplemental to support the floor framing above the wagon shed; the adjacent modern cribbing does the same. Photo: HPTC, 06/21/17.

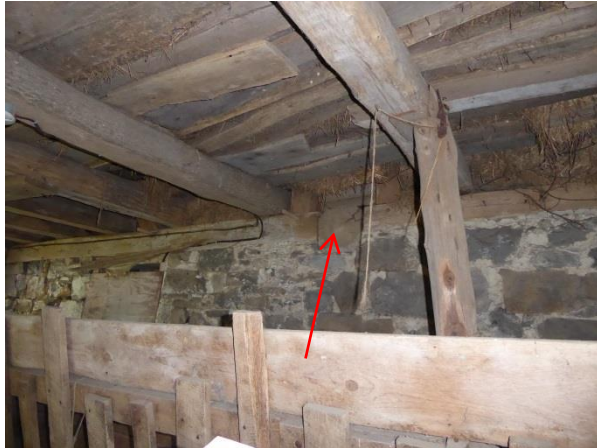
The barn summer beam is supported on its west end by the interior stone foundation wall. Photo: HPTC, 06/21/17.

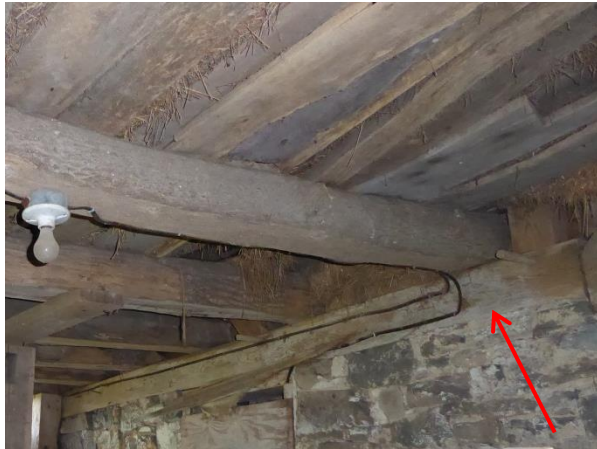
The sill plate atop the western interior stone foundation wall (arrow) supports the perpendicular joists above the wagon shed. Photo: HPTC, 06/21/17.

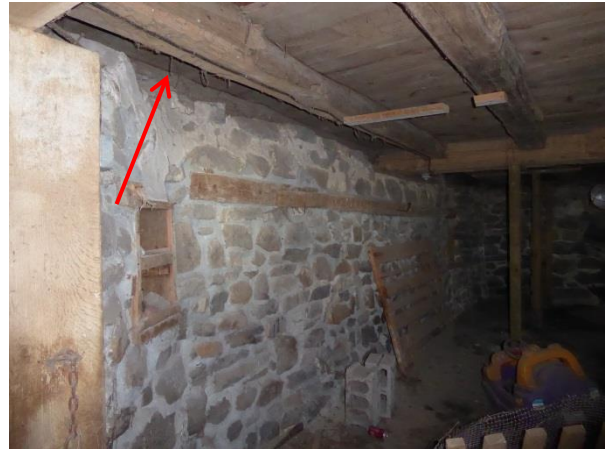
The western interior foundation wall sill plate is exposed along its interior length. Photo: HPTC, 06/21/17.

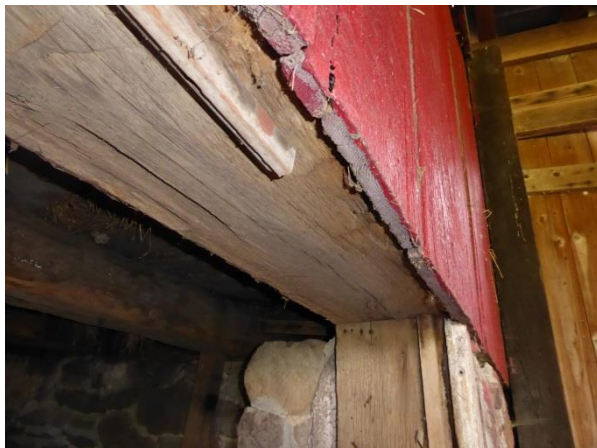
The east elevation sill exposed at the window opening. Photo: HPTC, 06/21/17.

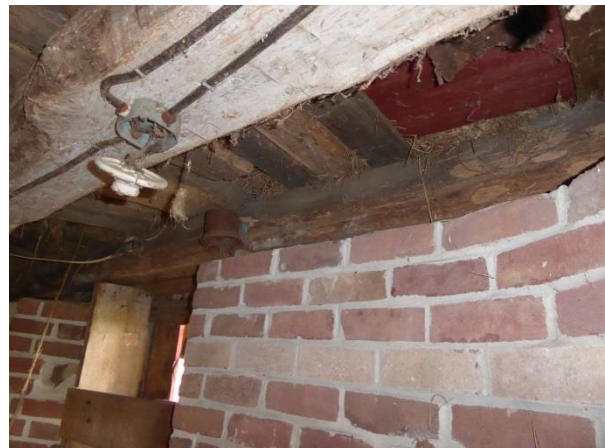
The east elevation sill exposed on the interior of the lower level. Photo: HPTC, 06/21/17.

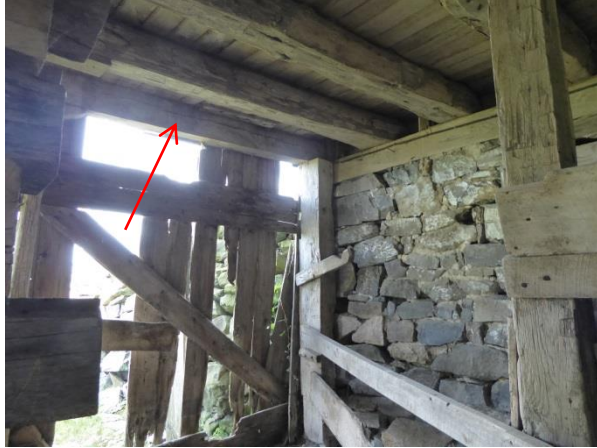
The north elevation sill (arrow) can only be seen within the enclosed lower-level wagon shed. Photo: HPTC, 06/21/17.

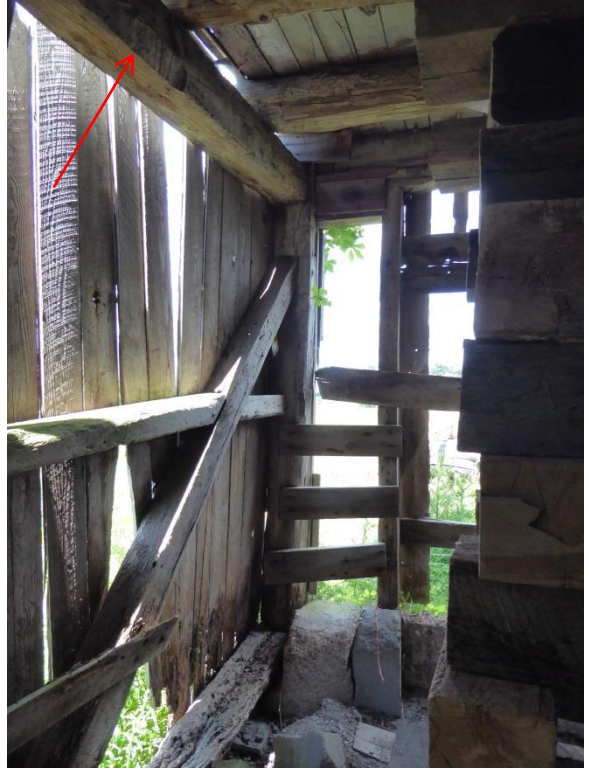
*Right:* The west elevation sill (arrow) can only be seen within the enclosed lower-level wagon shed. Photo: HPTC, 06/21/17.

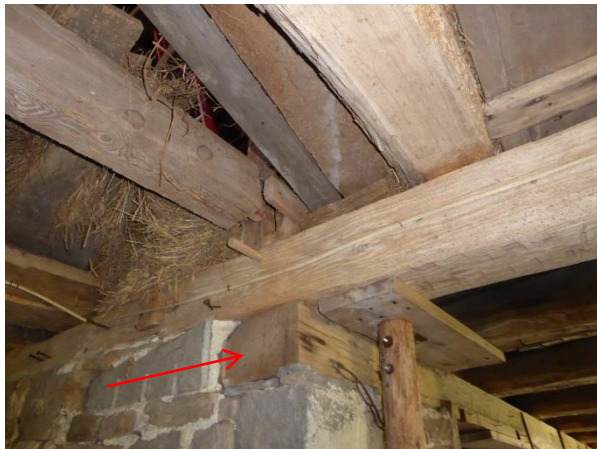
The south forebay wall sill (arrow) supports the perpendicular floor joists and runs under the west stone foundation wall sill. Photo: HPTC, 06/21/17.

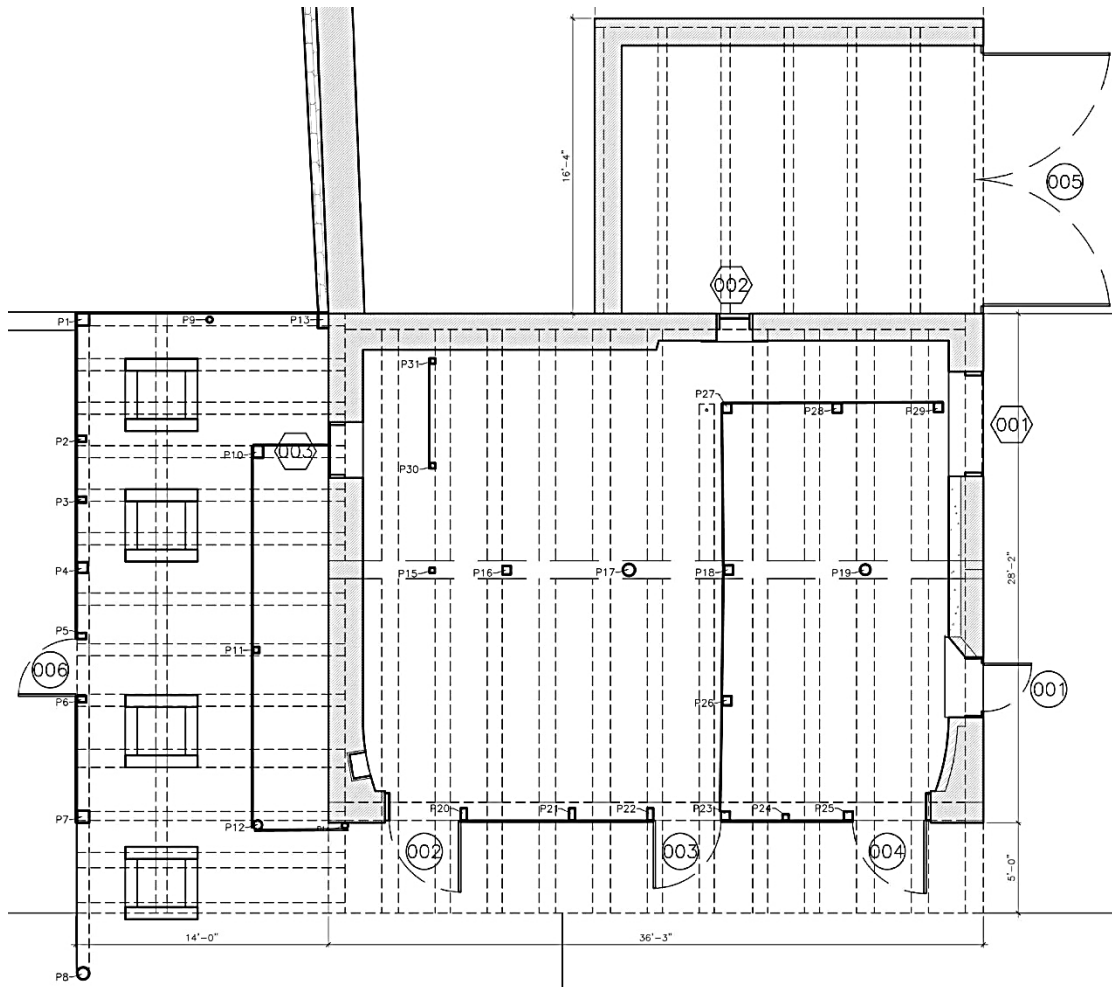
A reflected ceiling plan of the lower level shows the array of joists. North is right. In the western third (top), the joists run E-W. In the eastern two thirds (bottom), the joists run N-S. Note also the N-S floor joists of the outshed granary addition. Drawing: HPTC, 07/11/18.

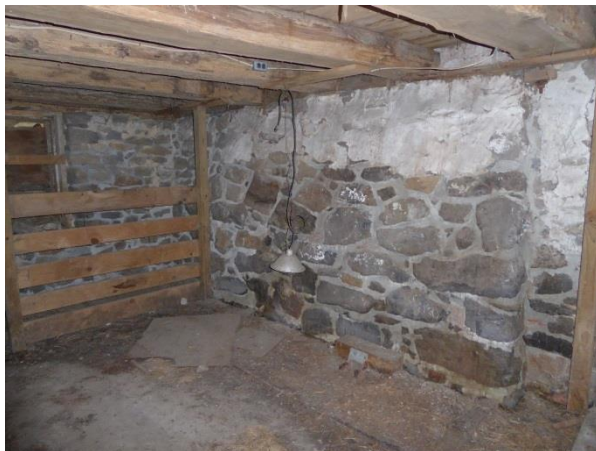
The barn joists are mortised into the north elevation wall. Photo: HPTC, 06/21/17.

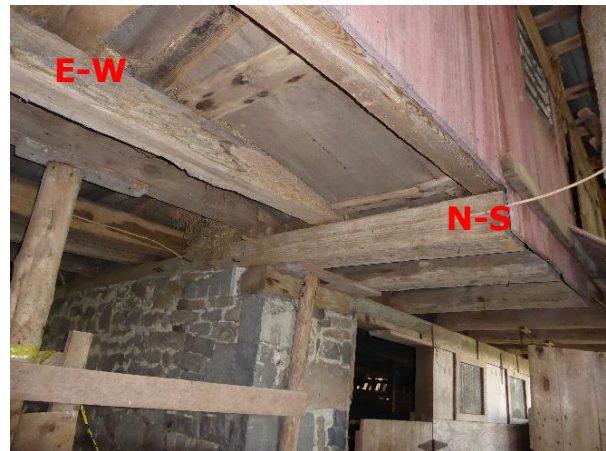
The barn joists run N-S and overhang the south sill to create the forebay. The wagon shed joists run E-W. Photo: HPTC, 06/21/17.

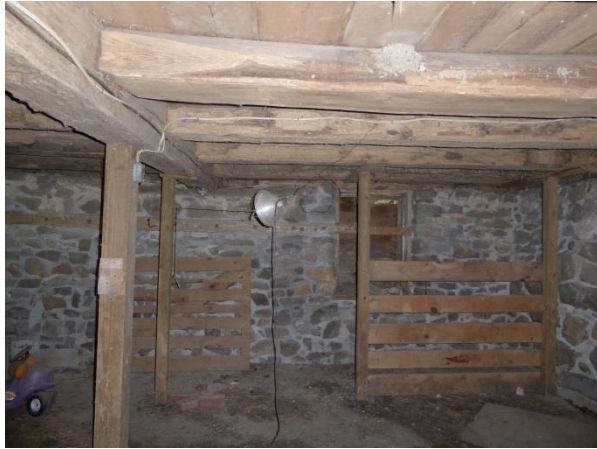
The N-S joists are half lapped over the summer beam at the midpoint. Photo: HPTC, 06/21/17.

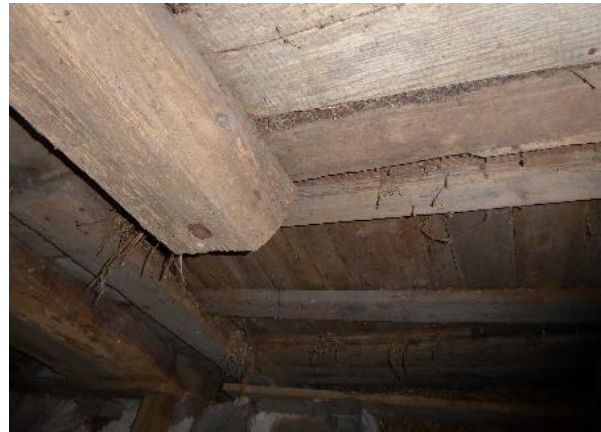
All of the joists contained within the stone foundation walls (eastern two thirds) are oriented north-south. At the north end, they are mortised into the north sill atop the north stone foundation wall. At the south end they cantilever over the framed forebay wall. At the midpoint, the joists are half lapped over the summer beam. One of the joists (J20) has been cut short of the north elevation wall and is bolted into the perpendicular floor board above (a structural concern).

J20 has been cut and bolted to the floor board above. Photo: HPTC, 06/21/17.

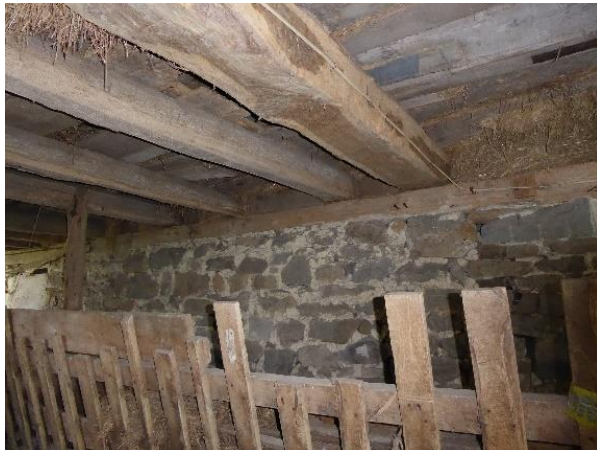
The east ends of the joists above the wagon shed are supported by the sill atop the west interior stone foundation wall. Photo: HPTC, 06/21/17.

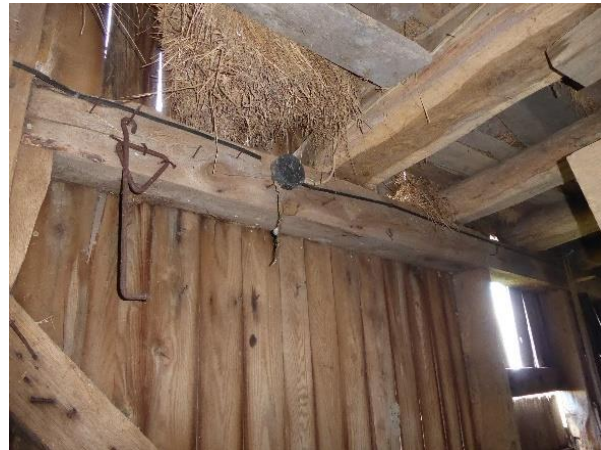
The west ends of the joists above the wagon shed are supported by the horizontal beam in the west frame exterior wall. Photo: HPTC, 06/21/17.

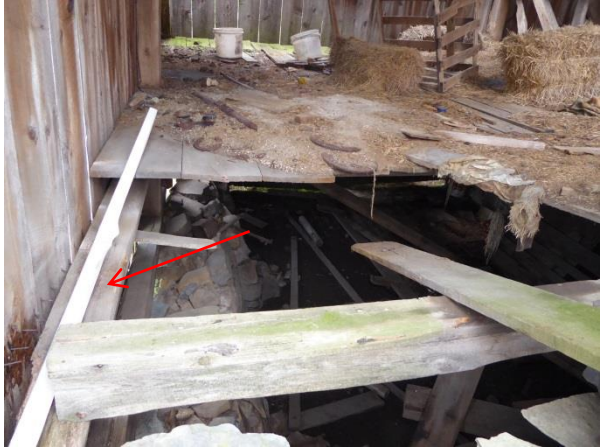
| <b>B101001-5 Outshed Granary Sills</b> | |
|---|---|
| <p>The outshed granary (north elevation) has a single sill plate located along the length of its north elevation. The sill has kicked out off of the foundation wall below and does not appear to be structurally supported in any way at this time.</p> <p><i>Right: The sill (arrow) is no longer supported by the north stone foundation wall. Photo: HPTC, 06/21/17.</i></p> | |

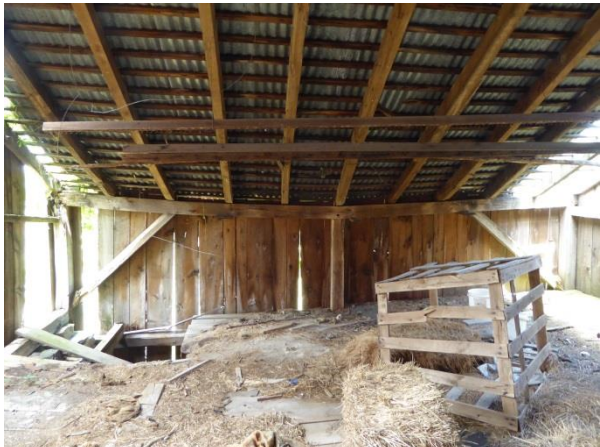
| <b>B101001-6 Outshed Granary Joists</b> | |
|---|---|
| <p>The outshed granary joists run north-south. On the north end, they are supported by the perpendicular north sill and toe-nailed together (see picture above). On the south end, they are likely toe-nailed into the north sill of the barn, however this area is inaccessible due to condition of floor system and straw obscuring the floor.</p> <p>Because the north elevation sill has kicked out off of the foundation wall below, the joists are no longer supported at the north end.</p> | <p>The N-S joists are no longer supported at the north elevation of the outshed granary. Photo: HPTC, 06/21/17.</p> |

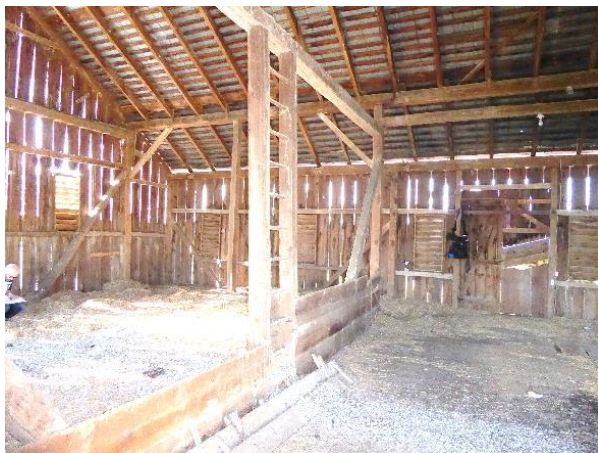
The east bent from the threshing bay. Photo: HPTC, 06/21/17.

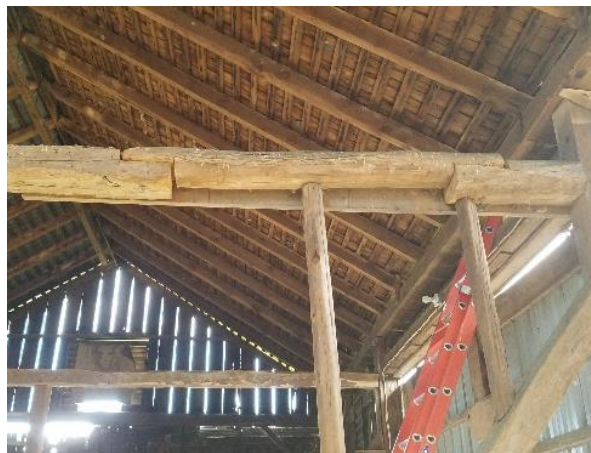
The east bent tie beam has been partially replaced and a tertiary post added, seen here from the east grain mow. Photo: HPTC, 06/21/17.

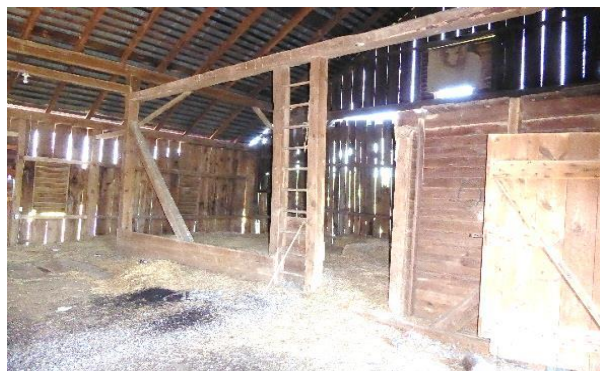
The west bent from the threshing bay. Photo: HPTC, 06/21/17.

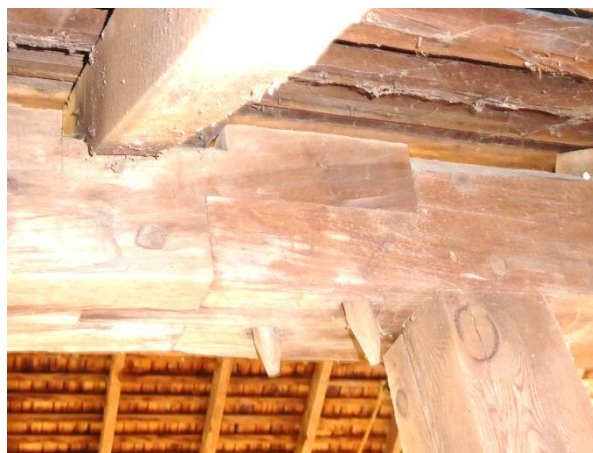
Long pieces of the roof plate are pegged together using a halved bridled scarf joint to run the entire length of the barn from the west exterior wall to the east exterior wall over the two bents. Photo: HPTC, 06/21/17.

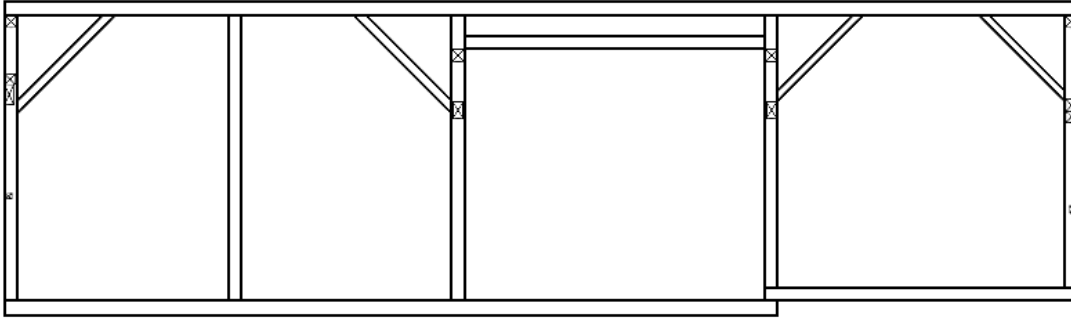
| <b>B102001-2 Barn Interior Forebay Wall</b> |
|---|
| <p>An upper-level interior wall corresponds with the location of the lower-level recessed forebay wall. The upper-level wall is divided into three bays, anchored by two 7x7 corner posts and two 7x7 intermediate posts (referred to the south corner posts for the internal bents above). A 6x6 tertiary post is also located in the center of the east bay (mow) because this bay is wider than the other two. All five posts support the perpendicular roof plate. Diagonal braces (two at 2x4 and two at 5x5) join the corner and intermediate posts to the roof plate above. In the center threshing bay, a 6x7 girt spans the bay between the intermediate posts below, but parallel to the roof plate above. All joinery is achieved through pegged mortise and tenon joints.</p> <p>No issues were visible at the interior forebay wall.</p> |

The three-bay interior forebay wall as seen from the north. Drawing: HPTC, 07/11/18.

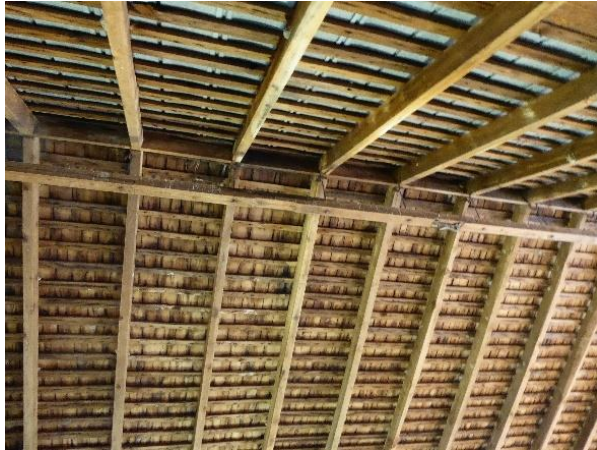
The rafters meet at the continuous ridge plate. A hay track is hung from this plate. Photo: HPTC, 06/21/17.

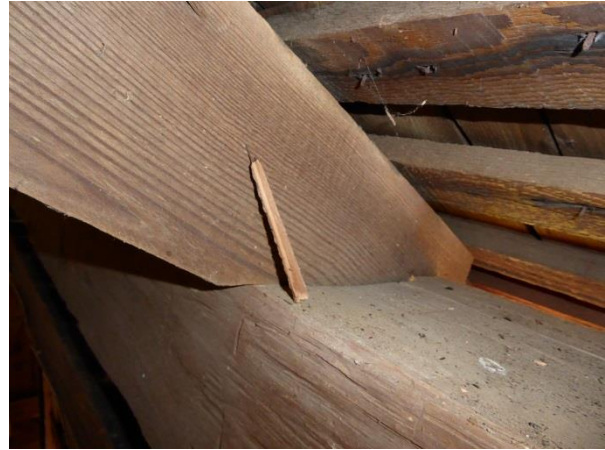
The housed birdsmouth rafter tail on the south slope at the roof plate. This connection is also spiked. Photo: HPTC, 06/21/17.

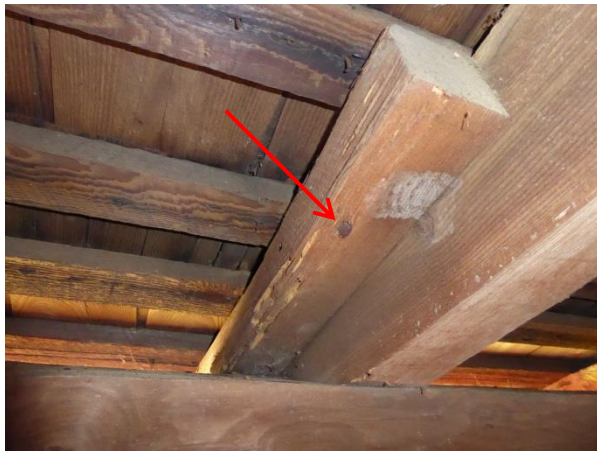
A sprocket added to the end of a rafter on the south slope. Note the spike holding the two together. Photo: HPTC, 06/20/17.

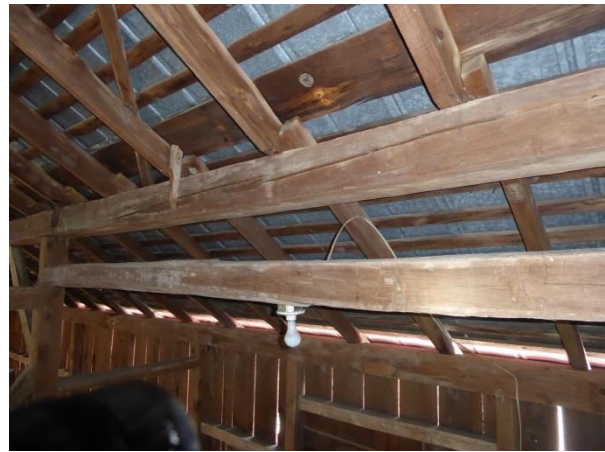
The retained original skip sheathing provides stabilization from racking. Wood shingles wood have also been attached to the sheathing originally. Photo: HPTC, 06/21/17.

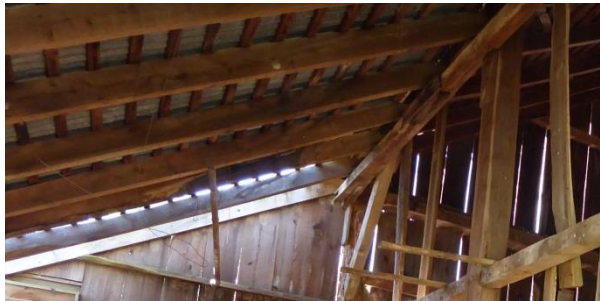
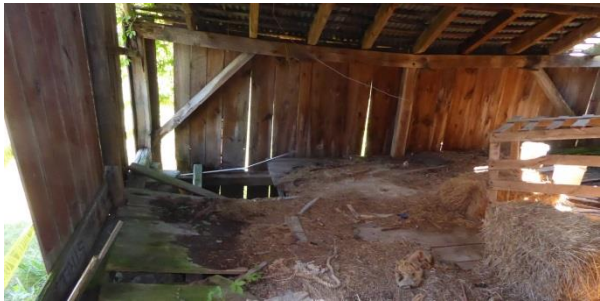
| <b>B102001-4 Outshed Granary Rafters</b> | |
|---|---|
| <p>The steep shed roof of the outshed granary is composed of historic 2x6 rafters at 21" on center. At the peak, the rafters are supported by a beam rudimentarily attached to the framing members of the barn's north elevation wall. At the lower end, the rafters are supported by a roof plate on of the north elevation wall of the granary. It is assumed that each end of the rafter is nailed into the support member.</p> <p>The upper support beam is in good condition. The lower end of several rafters are compromised (rot) due to missing roof coverings. The lower roof plate is also compromised because of missing roof coverings and is visibly sagging in the center due to a lack of structural support in the wall framing and foundation wall below.</p> | |
| <p>Missing roof coverings is causing deterioration of the rafters. Photo: HPTC, 06/21/17.</p> | <p>The lower roof plate supporting the lower end of the rafters is compromised for several reasons. Photo: HPTC, 06/21/17.</p> |

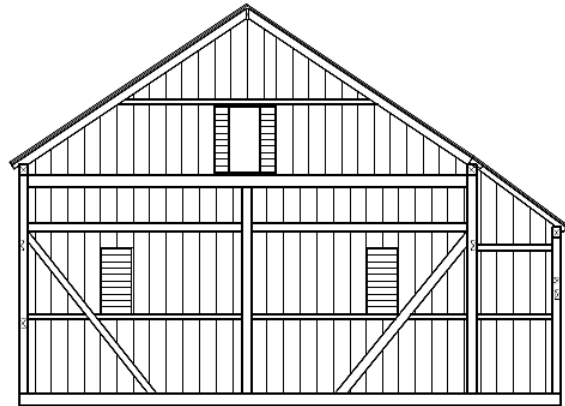
Extensive water and insect damage can be seen at the upper portion of the north end post.

East wall interior elevation. Drawing: HPTC, 07/11/18.

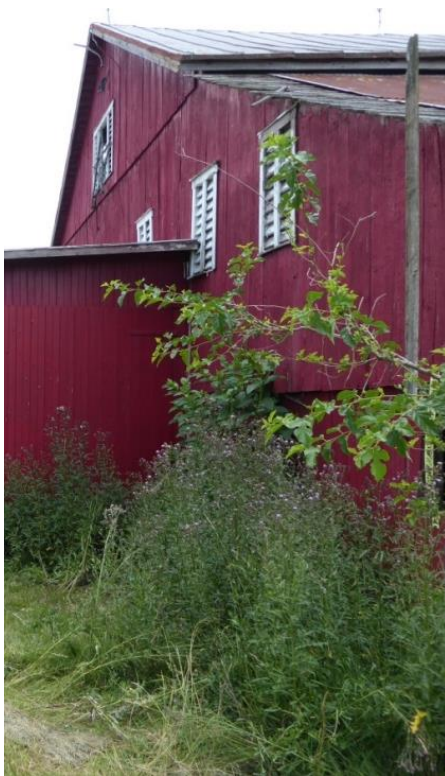
The exterior is clad with painted vertical siding, which is believed to be original (due to only one set of nail holes). The siding has been painted during the last ten years and is in good condition.

The east elevation is clad with painted vertical siding boards. Photo: HPTC, 06/21/17.

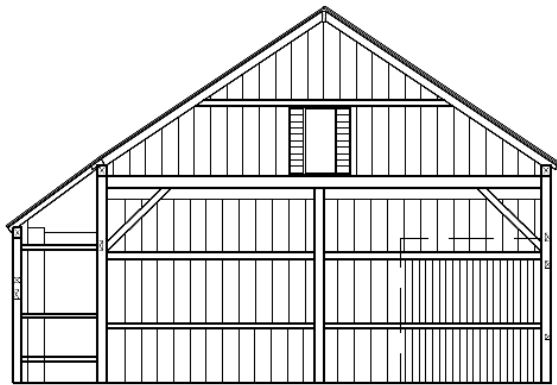
Structurally the west wall is in poor condition, particularly because of the compromised foundation and framing on the lower level. The wall framing is noticeably falling, so much that the tenon on the top of the center post is dislocated from its mortise. Modern cribbing at the lower level is keeping the barn somewhat structurally safe at this time.

West wall interior elevation. Drawing: HPTC, 07/11/18.

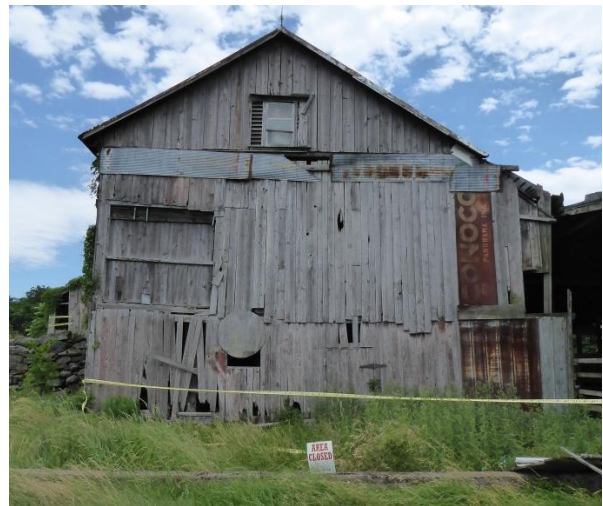
The exterior of the west wall. The siding is not historic and was likely cobbled together when the addition was removed. Photo: HPTC, 06/21/17.

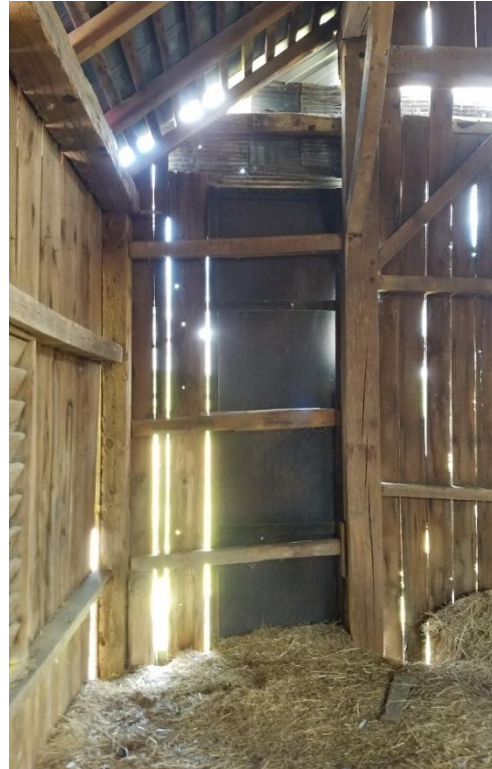
*Right:* Structurally instability along the west exterior wall is causing the forebay cantilever to fall. Photo: HPTC, 06/21/17.

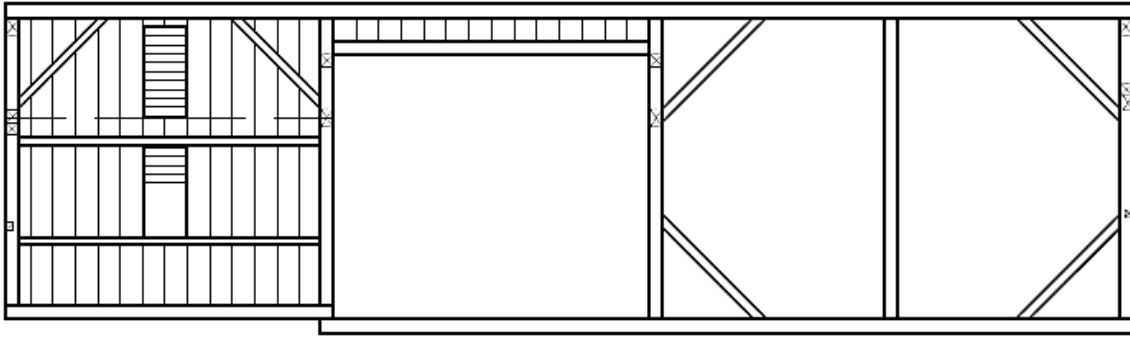
Besides the northeast corner post already mentioned above, and area of insect damage can be seen on the top roof plate of the eastern third of the wall.

North wall interior elevation. Drawing: HPTC, 07/11/18.

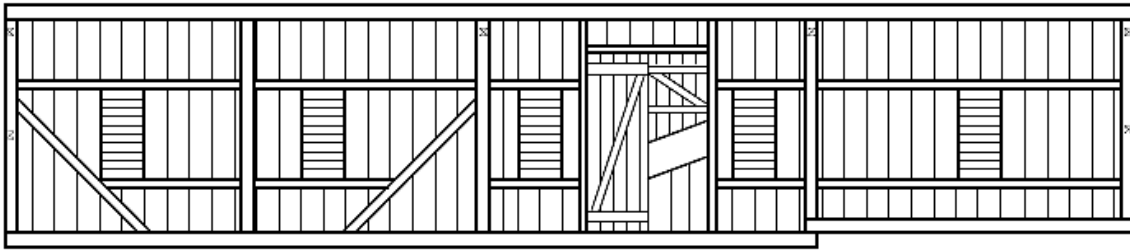
South wall interior elevation. Drawing: HPTC, 07/11/18.

Insect damage can be seen on several of the posts and the east end of the roof plate.

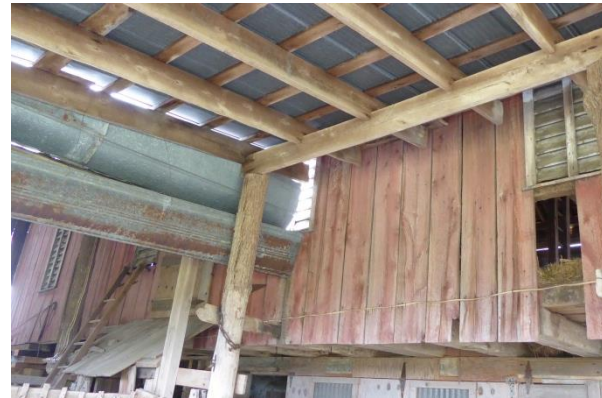
A missing piece of siding on the south elevation, under the later garage addition. Photo: HPTC, 06/21/17.
