# Historic Structure Assessment Report

## **Bishop Barn**

Gettysburg, Pennsylvania

June 2018

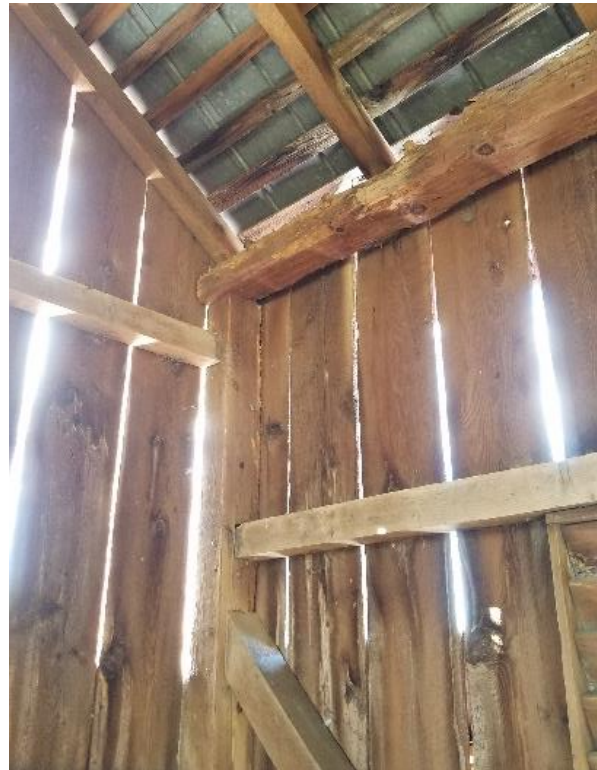
*Right:* Insect damage on the southeast corner and roof plate of the south elevation. Photo: HPTC, 06/21/17.

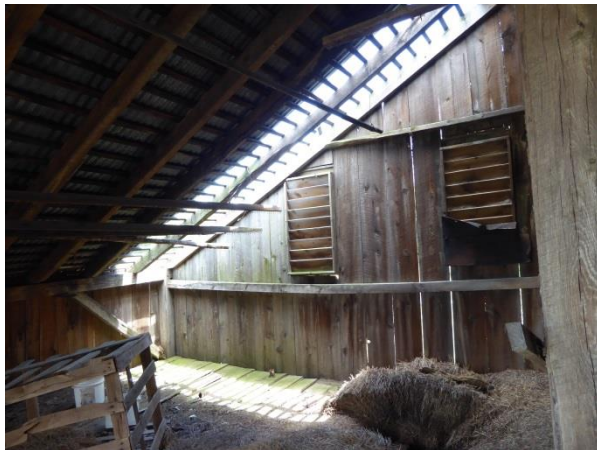
The interior elevation of the outshed granary's east wall. Damage has occurred to the structural members due to the missing roof covering. Photo: HTPC, 06/21/17.

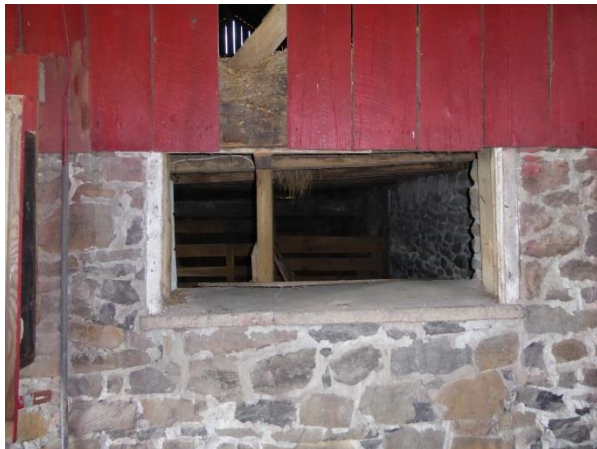
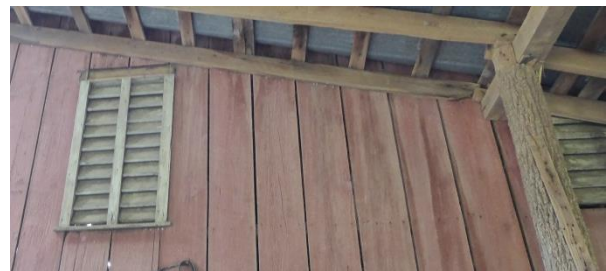
One of the louvered openings on the barn's south elevation is completely covered by an addition. Its paint is fading and it is missing a piece of trim. Photo: HTPC, 06/21/17.

*Left:* A modified opening in the east elevation stone foundation wall was likely originally a louvered opening. Photo: HTPC, 06/21/17.

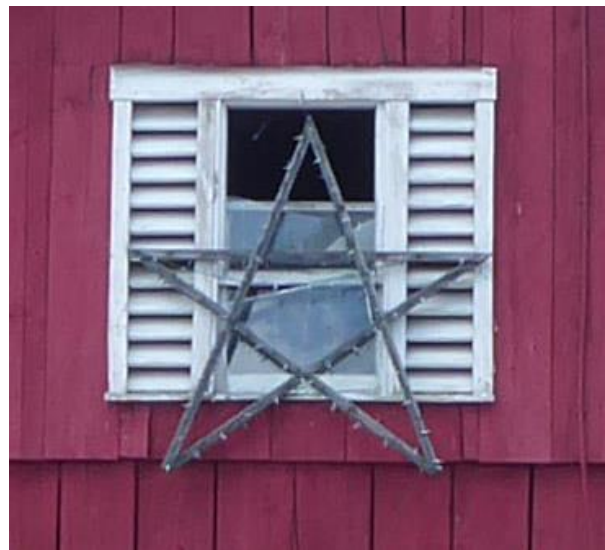
The tripartite louvered opening under the east gable end. The sash in the center are not original. Photo: HPTC, 06/21/17.

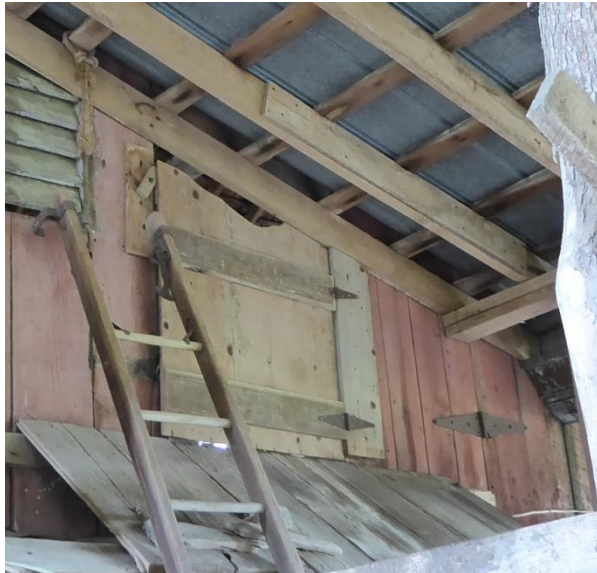
D002 has been altered so that it could be somewhat usable despite the addition roof. Photo: HPTC, 06/21/17.

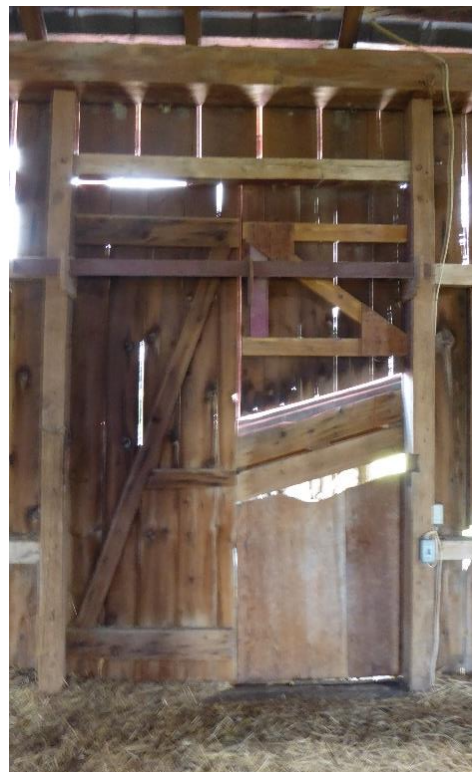
*Right:* The interior of D002 shows the lower portion of the west door has been altered to accommodate the roofline. Photo: HPTC, 06/21/17.

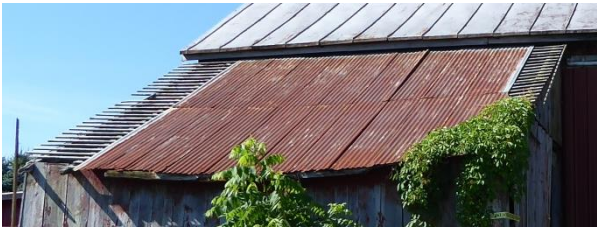
| <b>B301001-2 Outshed Granary Roof Finishes</b> | |
|---|---|
| <p>The shed roof of the outshed granary is covered with corrugated metal panels. The red paint has deteriorated slightly. Panels are missing from the east and west edges of the roof. This allows water to enter the interior of the addition and has already caused deterioration to the interior floor, structural systems, and north foundation wall.</p> | |
| <p>The corrugated metal roof covering of the outshed granary is missing portions on the east and west sides. Photo: HPTC, 06/21/17.</p> <p><i>Right:</i> Deteriorated interior conditions inside the outshed granary due to missing roof coverings. Photo: HPTC, 06/21/17.</p> | |

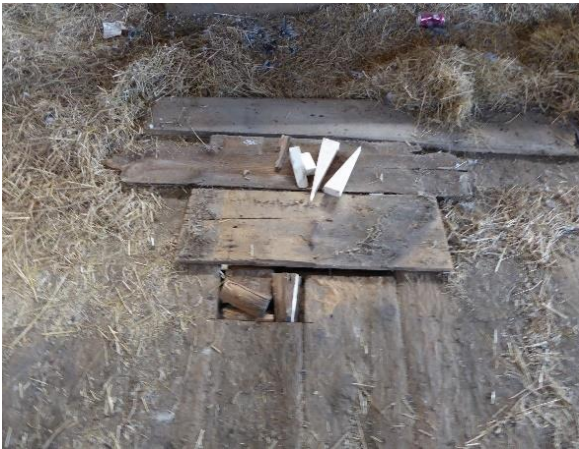
Broken and patched floor in the threshing bay. Photo: HPTC, 06/21/17.

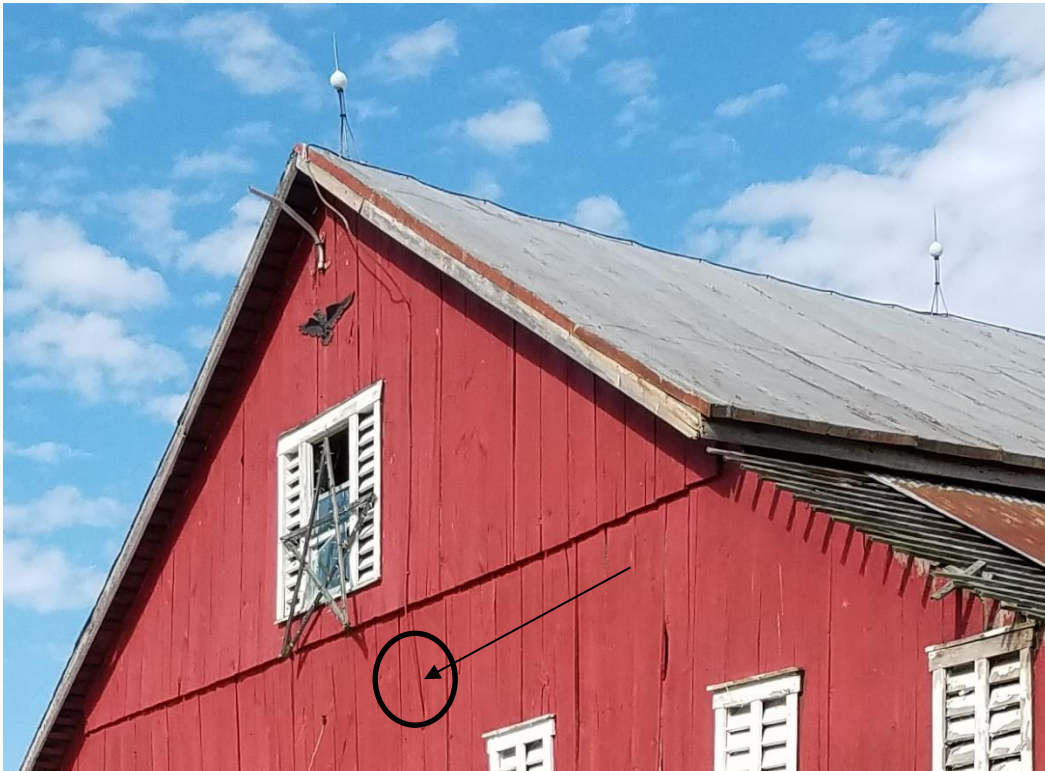
| <p>A lightning protection system located at the barn. Four historic terminals are located at the peak of the gable roof. The download cables have been severed and are not grounded, rendering the system useless.</p> | |
| Severed download cable of the lightning protection terminal on barn roof. Photo: HPTC, 06/21/17. | |

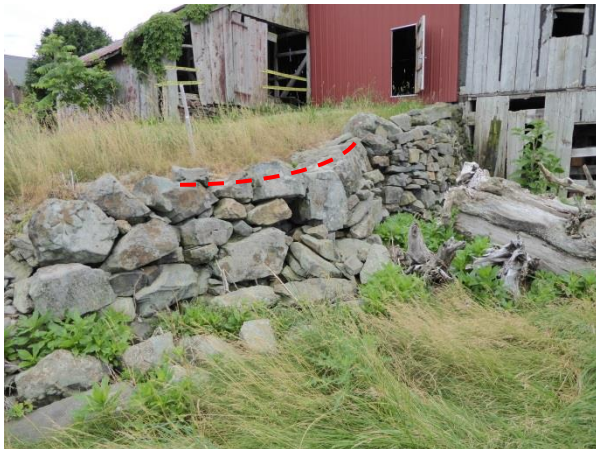
| <p>A stone retaining wall, tapering from grade to approximately 7'-10"-high at the north foundation wall, retains the fill of the bank. Built of large stone rubble, the retaining wall is bulging, likely due to excessive water in this area from no roof drainage system on the barn roof.</p> | | <p>The bank wall is bulging. Photo: HPTC, 06/21/17.</p> |

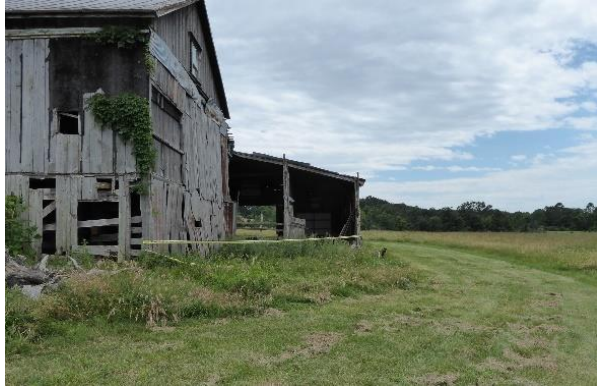
| <p>On the west elevation, there is neutral drainage along the foundation which allows water to pond in an old foundation.</p> <p>On the south elevation, the accretion of many additions allows water to disperse from the historic core. However, drainage remains neutral on the south elevation.</p> <p>On the east elevation, the addition allows water to drain away from the historic core. However, the presence of trees on this elevation retains water on the east elevation.</p> <p>With the absence of a roof drainage system (gutters and downspouts), when the non-historic additions are removed from the south and east elevations, neutral drainage on the west, south, and east elevations could retain water at the base of the barn.</p> | | |

West elevation neutral drainage. Photo: HPTC, 06/21/17.

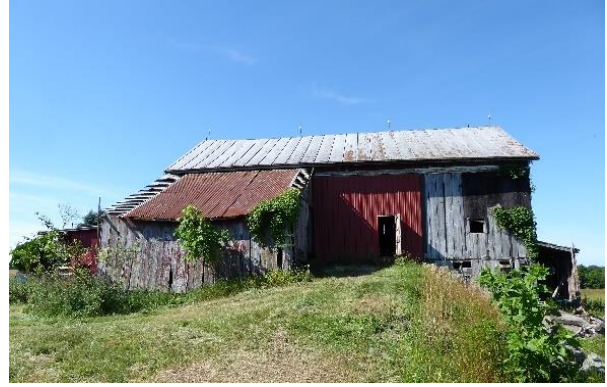
On the north elevation, there is overall positive drainage, due to the bank. Again, with the lack of the roof drainage system, excess water is causing damage to the bank wall.

North elevation positive drainage. Photo: HPTC, 06/21/17.
