## **Bishop House**

Gettysburg, Pennsylvania

# Historic Structure Assessment Report

## **Bishop House 2065 Emmitsburg Road Gettysburg, PA**

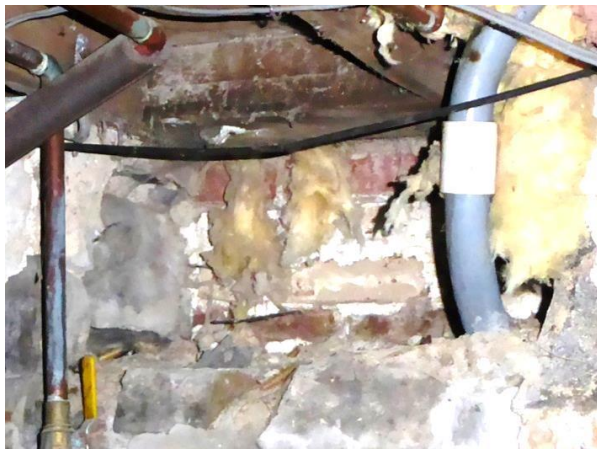
Former basement window opening on the west wall of Room 001 covered over with brick veneer. Photo: HPTC, 06/08/17.

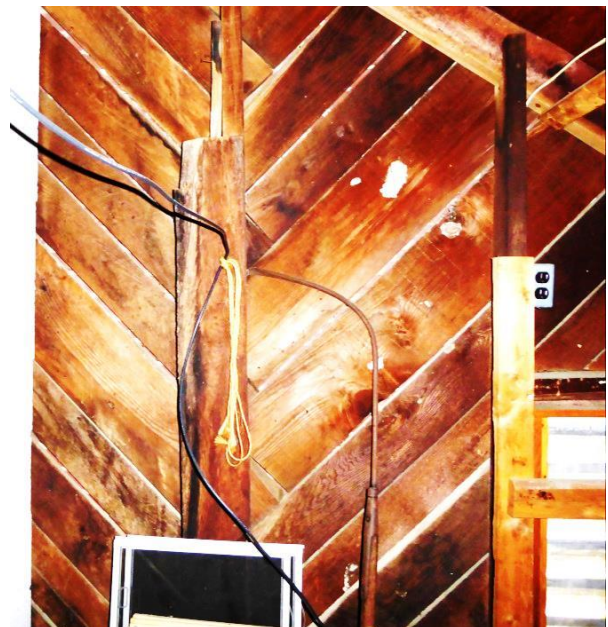
*Right:* Diagonal sheathing visible at the south wall on the attic indicative of balloon framing. Photo: HPTC, 06/08/17.

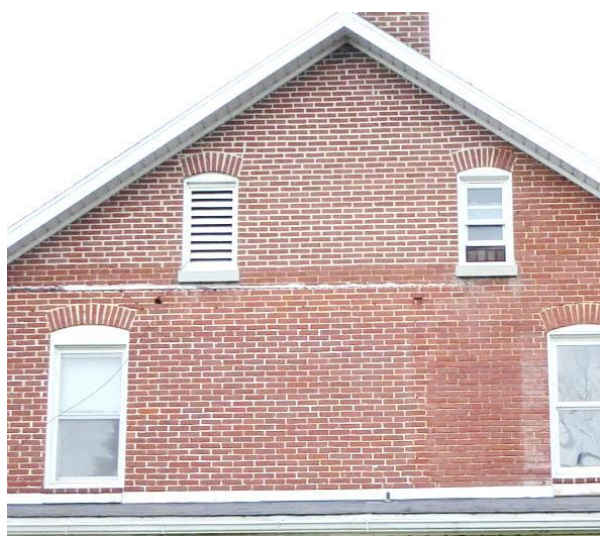
South elevation. The white line below the third-floor windows is likely a former roofline. W202 (at left in this photo) was likely a door. Photo: HPTC, 06/07/17.

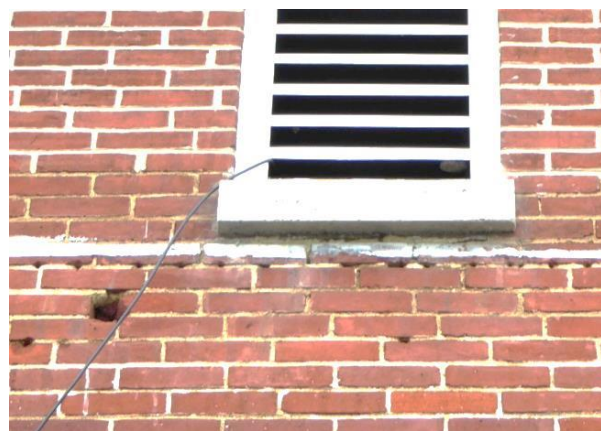
South elevation detail. Note holes below white ghost line, likely where the roof of a non-extant addition was connected, and void at bottom left, possibly to pocket a framing component into masonry. Photo: HPTC, 06/07/17.

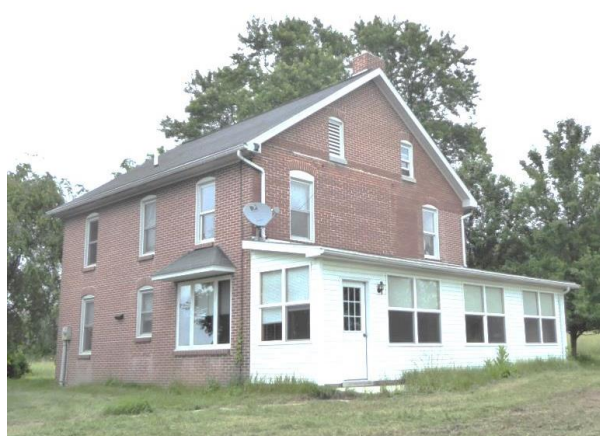
The west and north elevations. Modifications include roof covering, modern chimney, sunroom addition, modified window openings, and roof projection over W105. Photo: HPTC, 06/07/17.

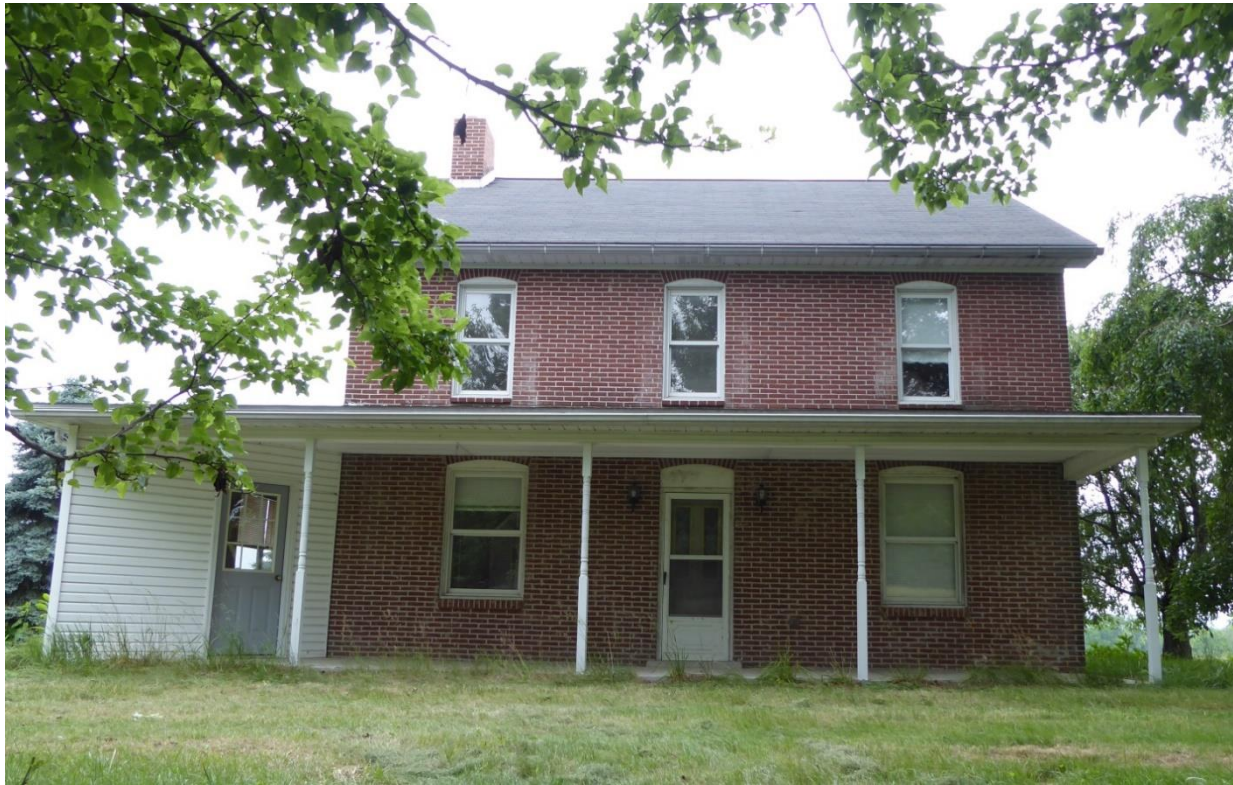
East elevation. Second-floor window openings of the main block are CDFs. First-floor door opening is a CDF, but first-floor window openings are not. Openings in the sunroom (at left) are not CDFs. Sash and doors throughout the house are not CDFs. Note missing transom over main block door opening. Photo: HPTC, 06/07/17.

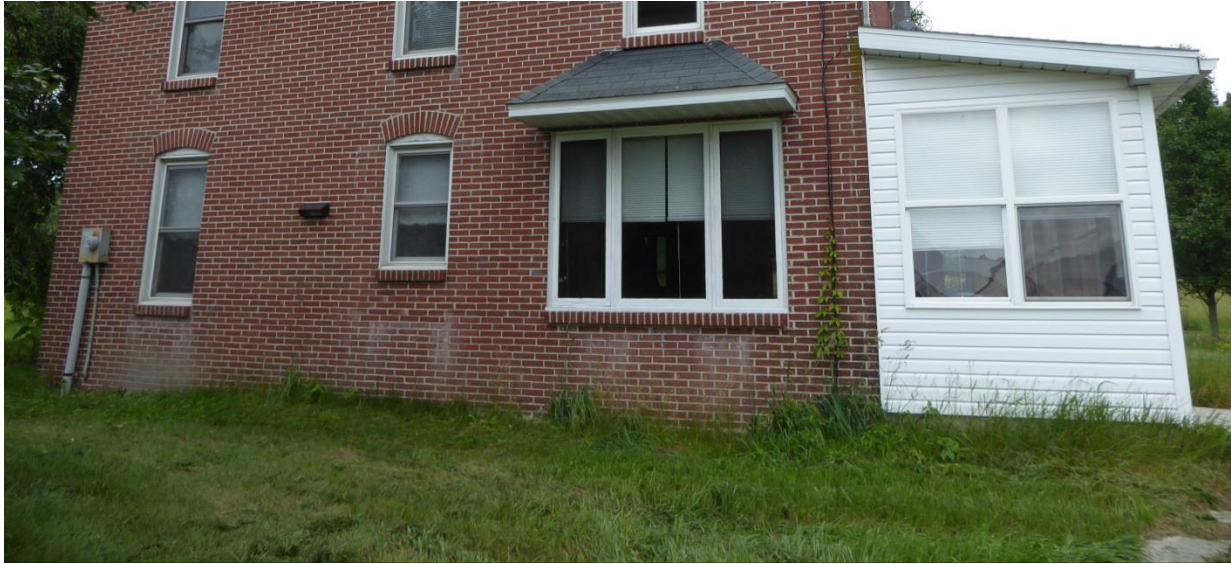
Most of the window openings on the west elevation first floor are not CDFs. From left: W107 is a CDF, modified window openings W106 and W105 are not CDFs, and modern opening W104 is not a CDF. None of the sash are CDFs. Photo: HPTC, 06/07/17.

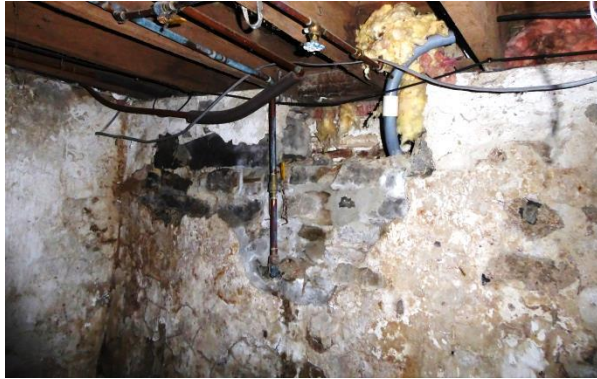
Foundation walls visible in Basement (Room 001) are a CDF. Concrete parging is likely historic. Photo: HPTC, 06/08/17.

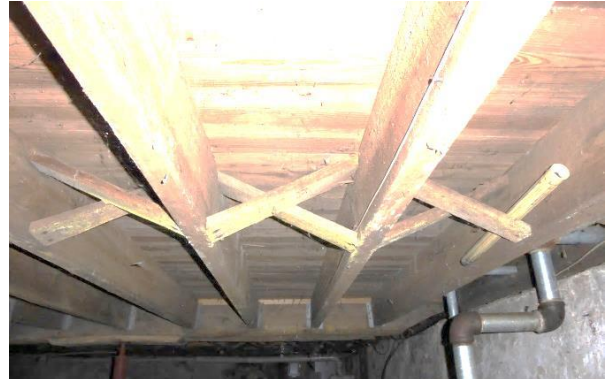
Exposed first-floor structural floor framing in Basement (Room 001) is a CDF. Photo: HPTC, 06/08/17.

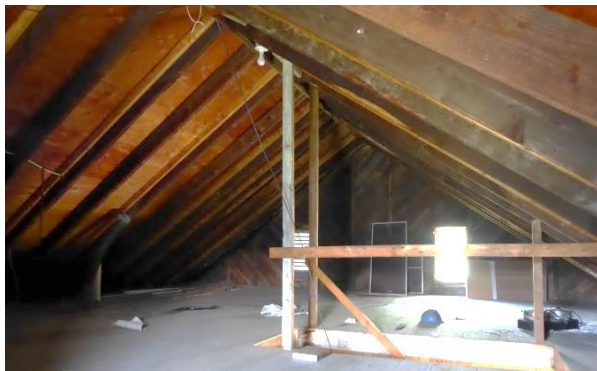
Exposed roof and wall structure in the Attic (Room 301) is character-defining. Photo: HPTC, 6/8/17.

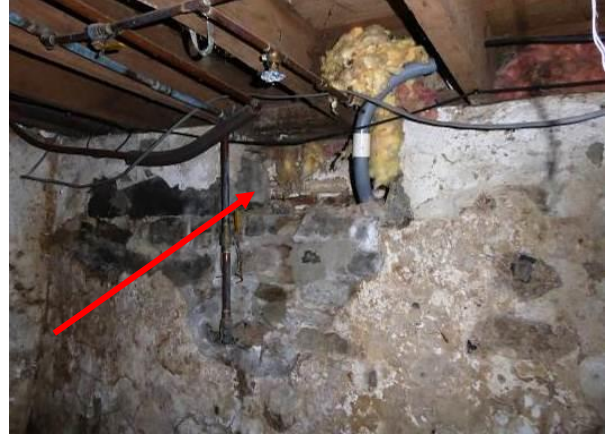
Interior of the main block foundation, southwest corner; note parging failure. Brick veneer visible through former window opening (red arrow). Photo: HPTC, 06/08/17.

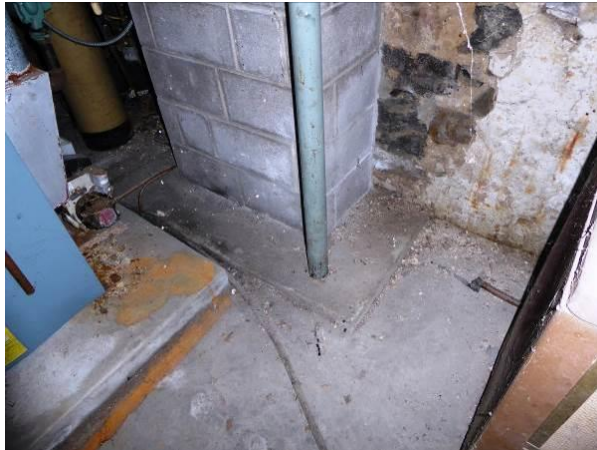
*Left:* Concrete chimney foundation on poured slab floor. Photo: HPTC, 6/8/17.

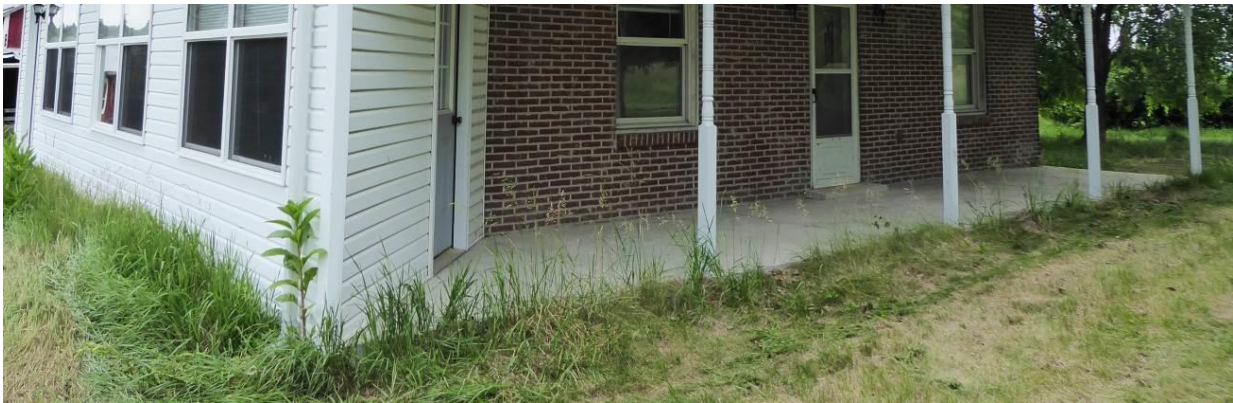
| <p>The sunroom/porch addition foundation is slab on grade. It is modern and in good condition with a few settlement cracks. It is uncovered at the porch and covered with indoor-outdoor carpet within the sunroom.</p> | | | |
| <p>The sunroom/porch addition has a slab on grade foundation. Photo: HPTC, 6/7/17.</p> | | | |

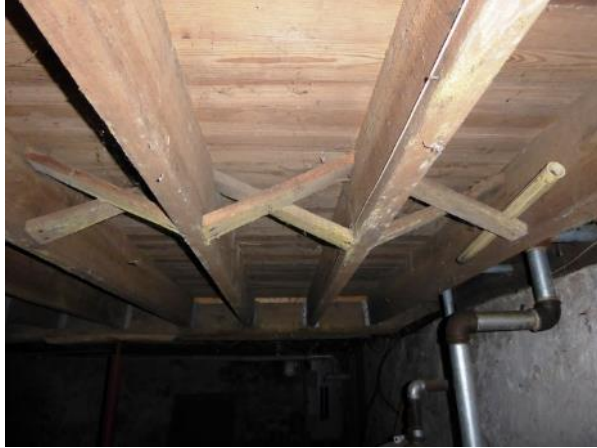
Cross bracing between joists. Photo: HPTC, 06/08/17.

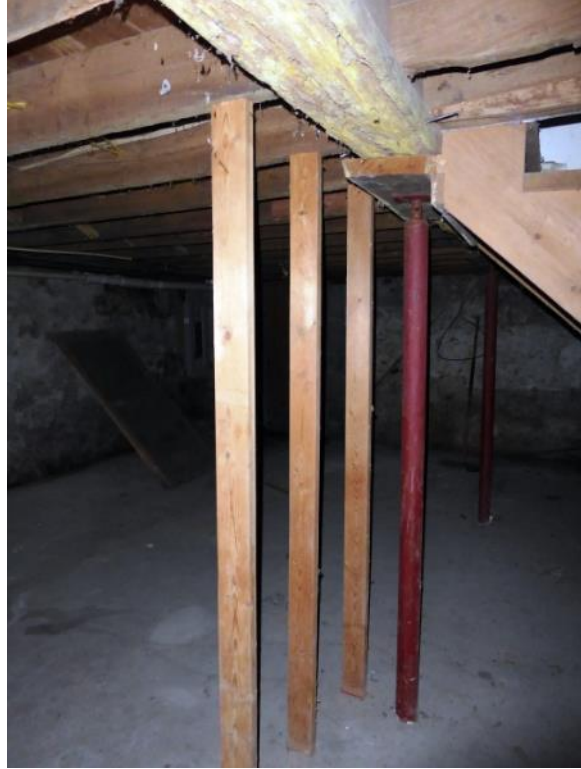
*Right:* 2x4s support joists west of the interior stair. A lally column supports the summer beam. Photo: HPTC, 06/08/17.

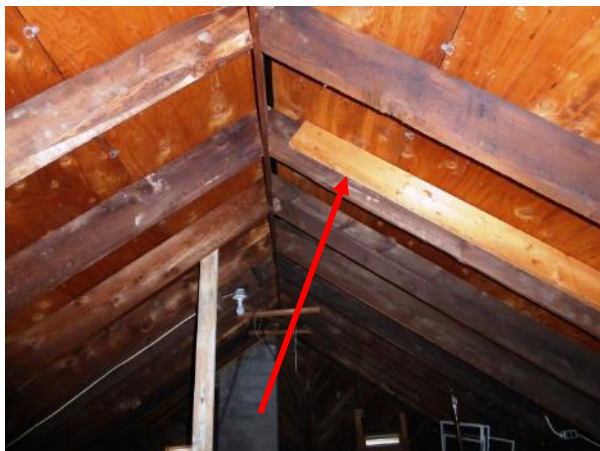
| <p>The main block structural roof frame is composed of 0'-1¾" x 0'-7½" rafters at approximately 24" on center. The rafters meet at a ridge board. Several are sistered with relatively modern 2x4s and 2x6s.</p> <p>Overall, the main block structural roof frame is in fair condition. However, some mold was observed on rafters during HPTC's visit in June 2017. This may dissipate with increased ventilation.</p> | | | |
| Main block rafters meet at a ridgeboard. One rafter is sistered (arrow). Photo: HPTC, 06/08/17. | | Mold on rafters. Photo: HPTC, 06/21/17. | |

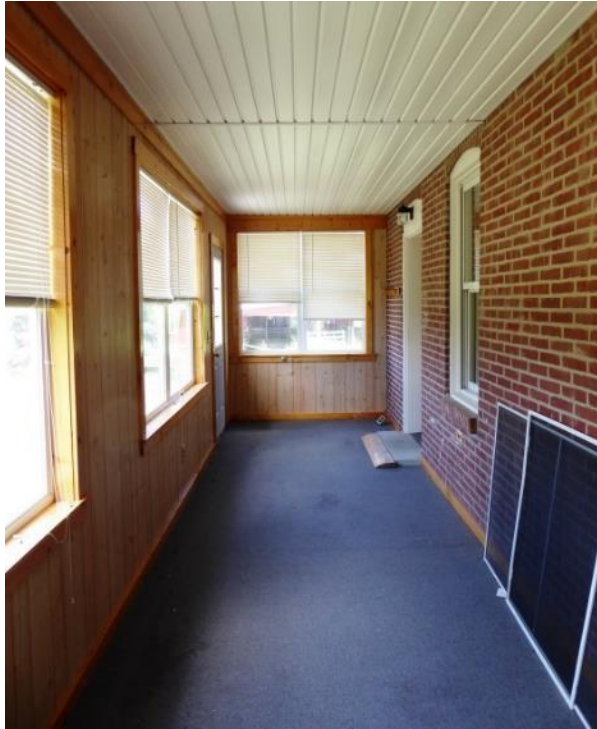
The first-floor south wall of the main block became an interior wall when the addition was constructed. The balloon-framed wall is veneered with brick. Photo: HPTC, 06/08/17.

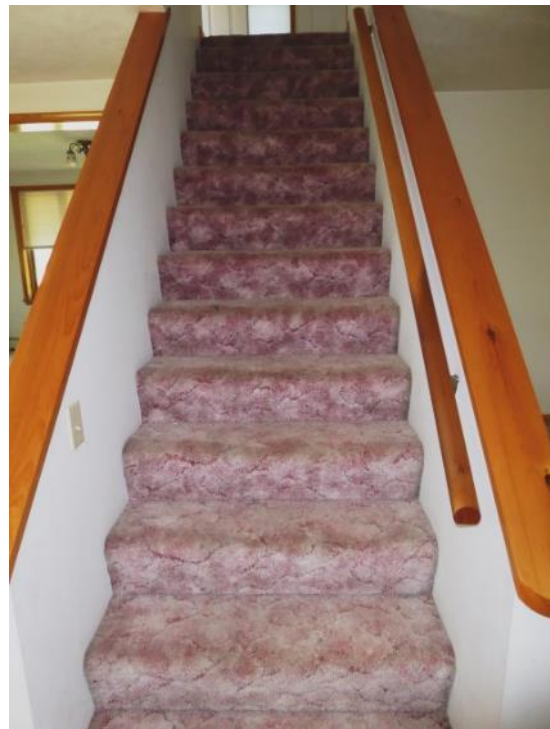
Load-bearing walls support the main stair. Photo: HPTC, 06/08/17.

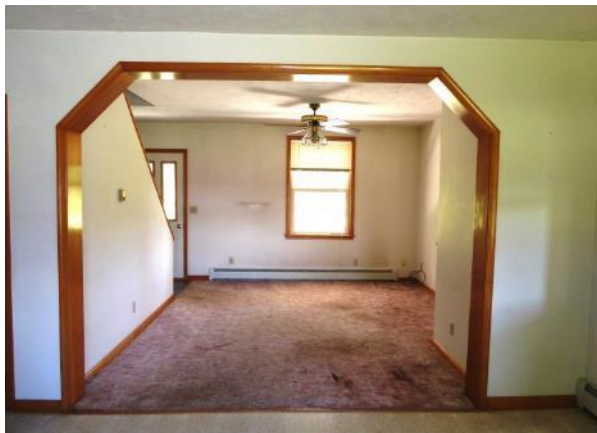
The loadbearing wall between rooms 102 and 105 has been largely removed. Photo: HPTC, 06/08/17.

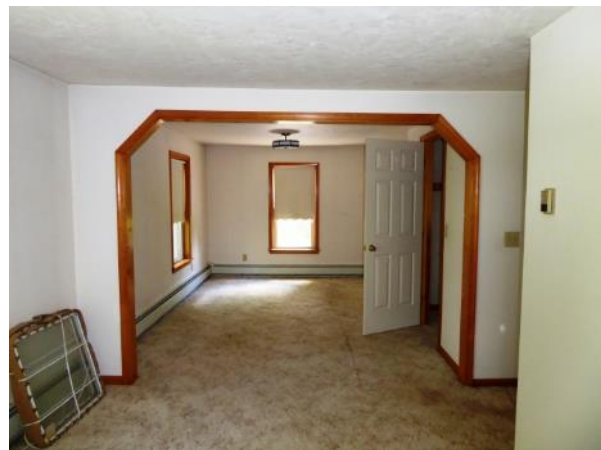
The loadbearing wall which bisects Rooms 201 has also been largely removed. Photo: HPTC, 06/08/17.

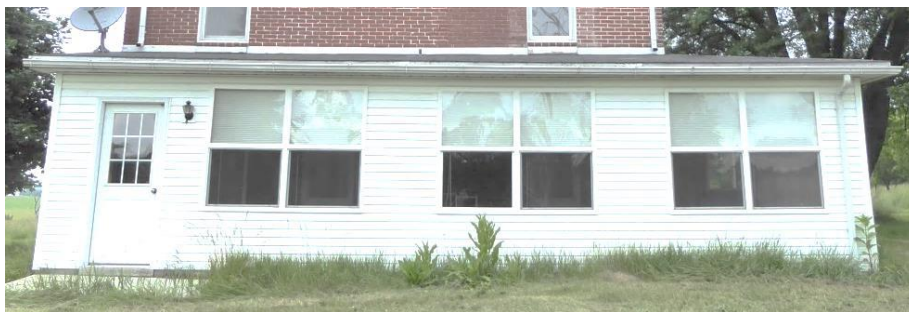
The exterior walls of the addition are likely wood-frame construction. They are clad with modern vinyl siding and are in good condition.

*Left:* The addition is clad with vinyl siding. Photo: HPTC, 06/07/17.

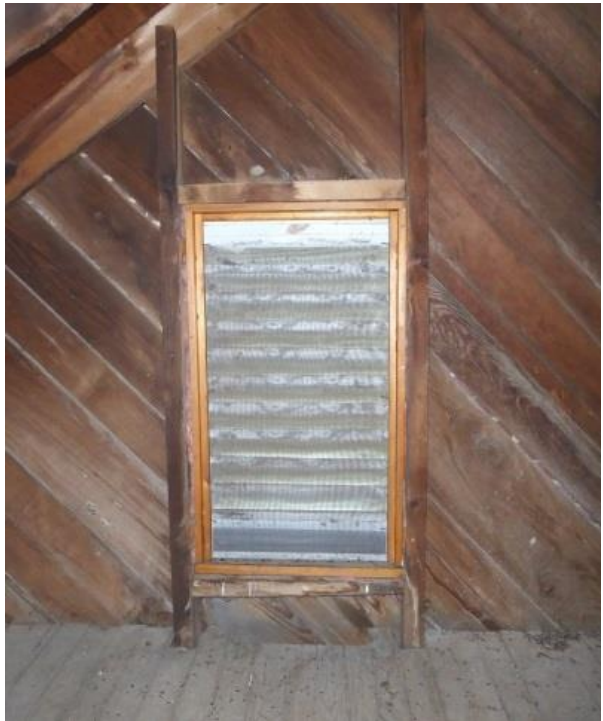
| <p>Wooden louvers are installed in two main block third-floor windows (window openings 302 and 303), one in each gable. These vents are in fair condition and have screens on their interior sides. Wood components of the window openings exhibit paint failure and some rot.</p> | | | | |
| W303 vent, exterior. Note jamb rot and paint failure. Photo: HPTC, 06/07/17. | | W303 vent, interior. Photo: HPTC, 06/08/17. | | |

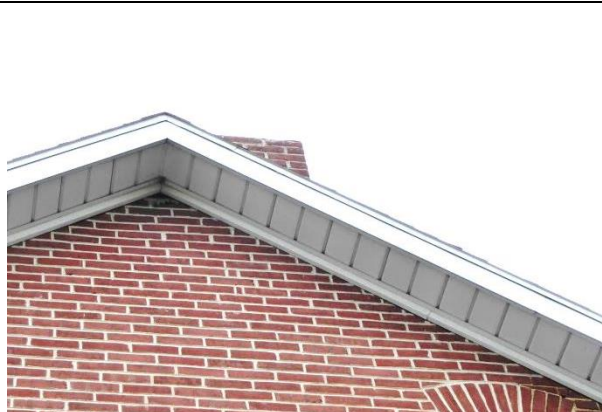
| <p>The main block has modern, synthetic rakes on its gable ends and vinyl soffits. There are soffit vents above the middle bays on the east elevation west elevations. The main block soffits are not historic, but are in good condition.</p> | | | | |
| Main block gable ends have vinyl rakes and vinyl soffits. Photo: HPTC, 06/07/17. | | Modern vinyl soffits on the east and west elevations. Vents are located above center bay. Photo: HPTC, 06/07/17. | | |

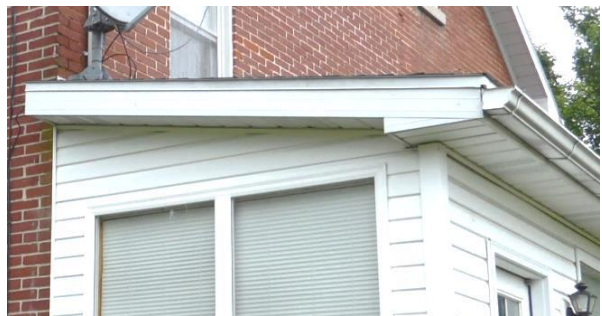
| <b>B201008-2</b> | <b>Sunroom/Porch Exterior Soffits</b> |

| <p>The exterior soffits of the sunroom/east entry porch have modern synthetic rakes and modern vented vinyl soffits with vents, similar to those on the main block. Fascia and soffits are in good condition and are not historic.</p> | | | | |
| Modern vinyl soffits and fascia, southwest corner of sunroom/porch. Photo: HPTC 06/07/17. | | Modern fascia and soffits, northeast corner of east entry porch. Photo: HPTC, 06/07/17. | | |

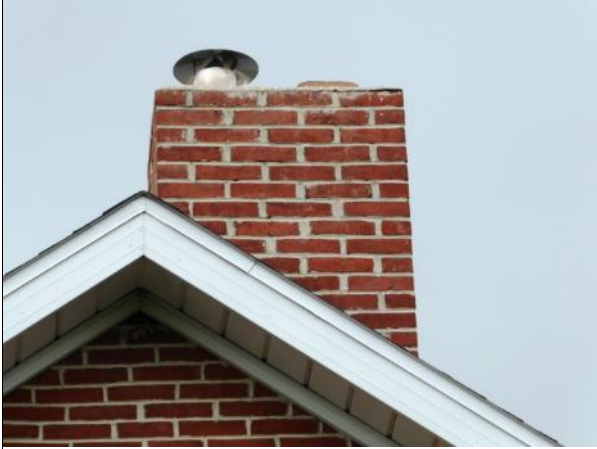
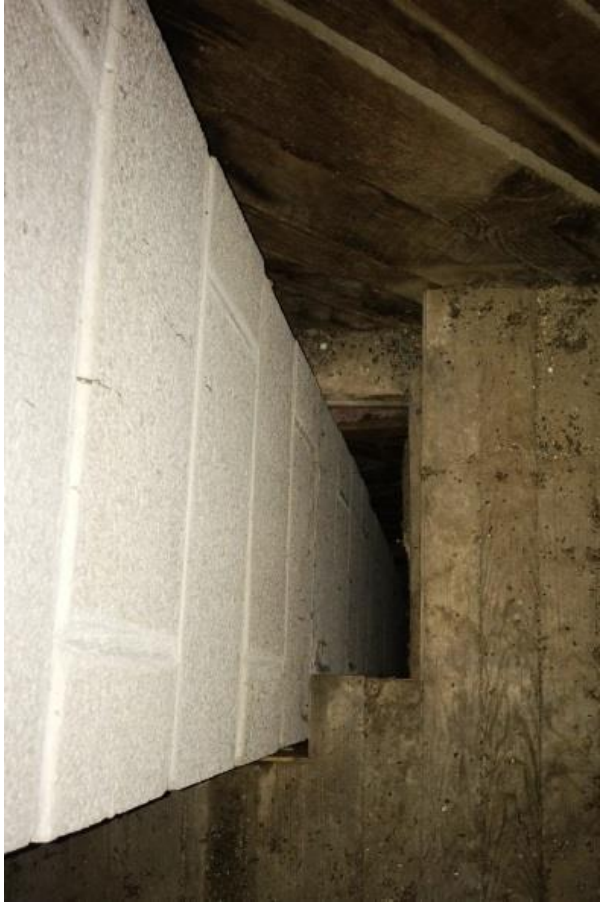
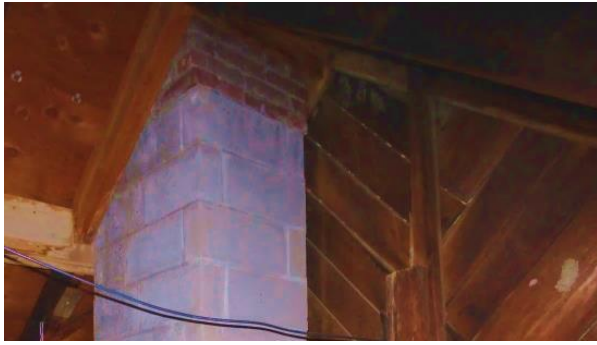
| <b>B201099</b> | <b>Other Exterior Walls - CHIMNEYS</b> |

| <p>The modern chimney is located on the interior of the main block's south wall, just east of the ridge line. It is composed of CMU and clad with brick above the roofline. It has two flues, one with an uncapped terra cotta liner and one with a capped metal liner. The current chimney is slightly offset (east) from the location of the original and occupies part of the historic shaft (seen in the attic floor). The chimney is in fair condition because of the missing cap on the terra cotta flue.</p> | | | | |
| <p>The chimney is offset from the roofline to the east. Photo: HPTC, 06/07/17.</p> | | | | |
| <p>The chimney is built of CMU, but it is clad with brick above the roofline. Photo: HPTC, 06/08/17.</p> | | <p>The extant chimney shaft overlaps the historic one. Photo: HPTC, 06/21/17.</p> | | |

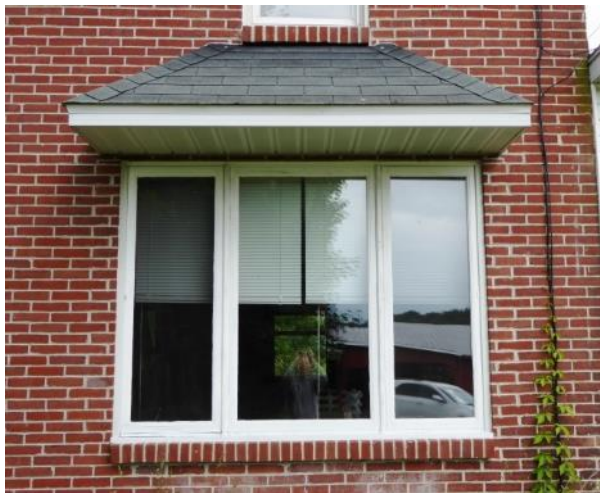
| <p>The majority of main block windows in the house are 1/1 modern double-hung vinyl with insulated glass units (IGUs). Two third-floor openings have vinyl similar to those throughout the house, while two have wood vents and no sash. Wood sash are located in W105 and W109. These openings each have three units—one fixed sash flanked by outswing casements.</p> <p>Main block windows have painted exterior surrounds. Main block first- and second-floor windows have wood interior jambs, sills, and casing and brick exterior sills. Third-floor window openings have poured concrete exterior sills and no interior casing or trim.</p> <p>Openings in the sunroom/porch addition are paired (two units per opening) 1/1 modern double-hung vinyl, with wood interior trim and vinyl exterior trim.</p> <p>Windows are operational and in overall fair condition. Exterior surrounds exhibit moderate paint failure and wood sash, particularly those in W105, exhibit rot on their bottom rails. The IGUs in W206 and W301 exhibit condensation within the IGUs (seal failure). Several IGUs, presumably to replace those in W206 sash, are stored in Room 203. IGUs in W205 and W207 are cracked.</p> | | |
| <div style="display: flex; justify-content: space-around;"> <div style="text-align: center;"> <p>W105 exterior. Rotted bottom rails have been taped over and painted. Photo: HPTC, 06/07/17.</p> </div> <div style="text-align: center;"> <p>W105 interior: a fixed wood sash flanked by wood outswing casements. Photo: HPTC, 06/08/17.</p> </div> </div> | | |

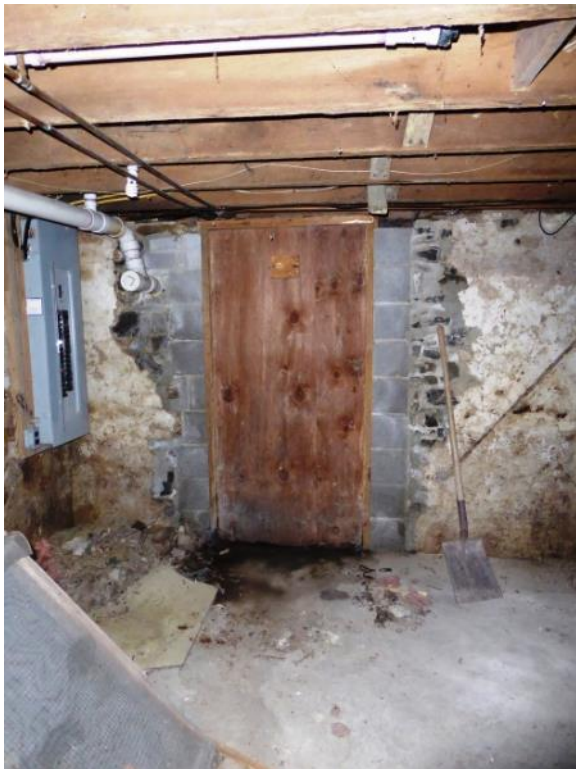
Overall, the doors are in fair condition. The exterior plywood covering of D002 is not sound and should be replaced.

D002 (interior) covered with plywood. Photo: HPTC, 06/08/17.

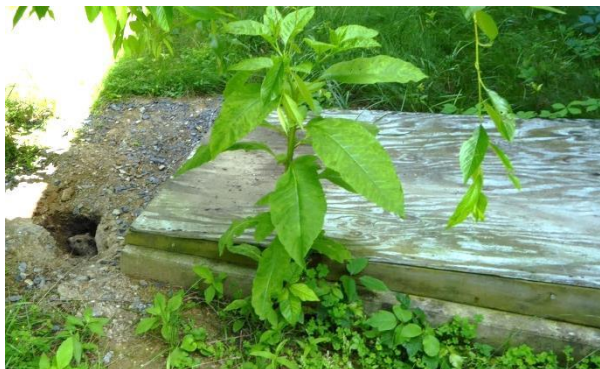
D002, exterior, with resident groundhog. Photo: HPTC, 06/08/17.

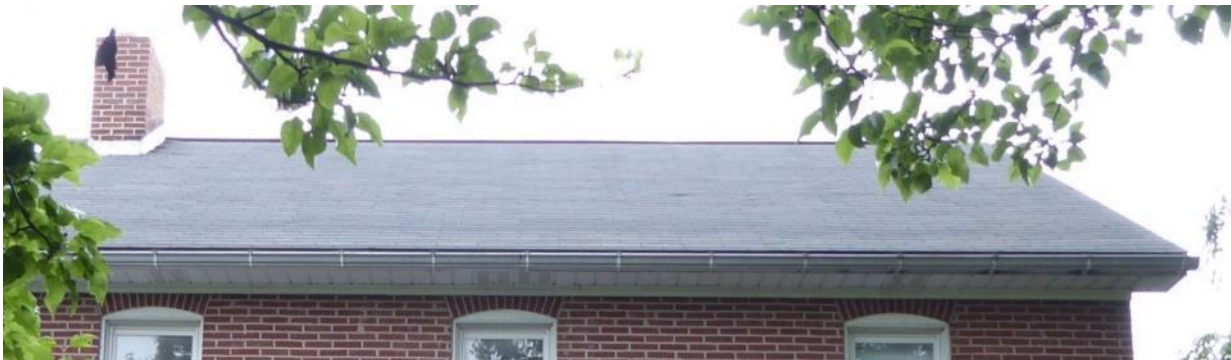
| <p>The steeply sloped main block gable roof (approximately 9:12 pitch) is sheathed with plywood and clad with modern asphalt shingles. The hipped roofs over windows 105 and 109 are also clad with asphalt shingles; sheathing could not be examined.</p> <p>The main block roof shingles and sheathing are in fair condition, with no areas of significant concern. The roofs over windows 105 and 109 are also in fair condition, but biological growth is evident on the roof over window 109. It should be noted that this roof is likely halfway through its useful life with only about a ten-year life expectancy.</p> | | | | |
| <p>The main block roof is clad with asphalt shingles. Photo: HPTC, 06/07/17.</p> | | | | |

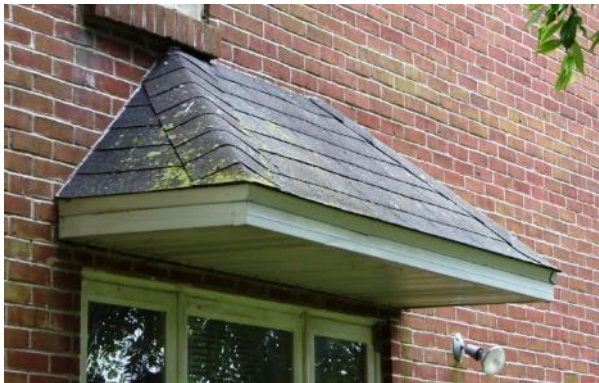
| <p>Left: Biological growth on the asphalt-shingle roof over W109. Photo: HPTC, 06/07/17.</p> | | | | |

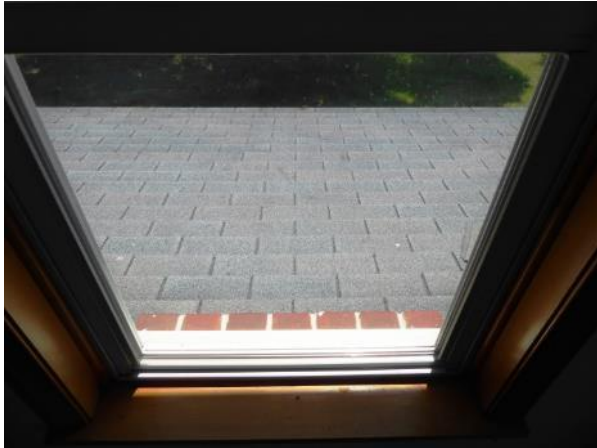
| <p>The low-sloped (considered flat) hipped roof (approximately 3:12 slope) over the sunroom/porch is clad with asphalt shingles. Sheathing could not be accessed. This roof covering is younger than that of the main block and in good condition; however it should be noted that asphalt shingles are not recommended for roofs of this low of slope.</p> | | | | |
| <div><div></div><div><p><i>Left: The porch's asphalt shingle roof covering, from the second of the main block. Photo: HPTC, 06/08/17.</i></p></div></div> | | | | |

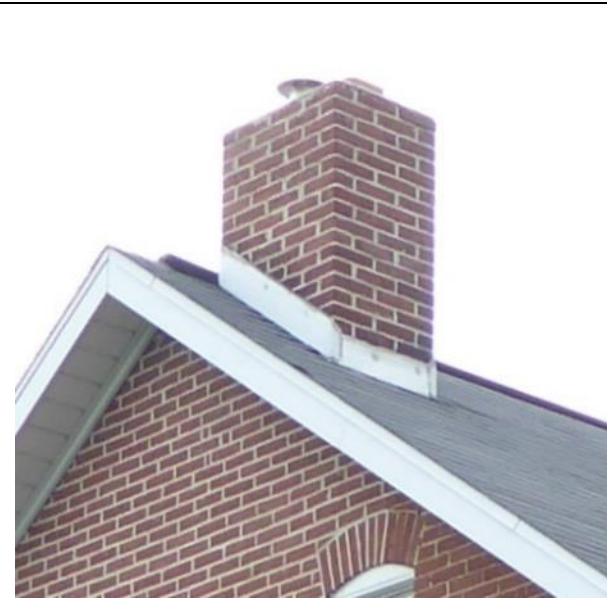
Sidewall flashing and trim, south elevation. Photo: HPTC, 06/21/17.

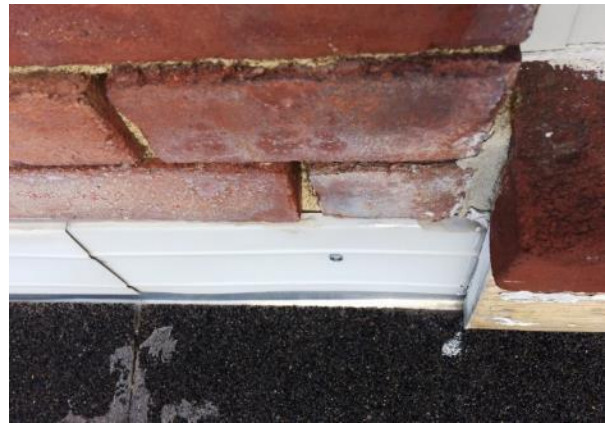
Left: The chimney is not step-flashed. Photo: HPTC, 06/07/17.

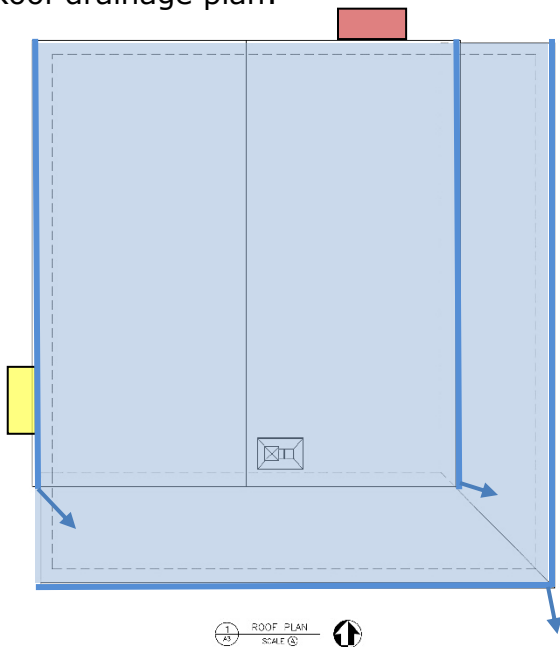
Roof drainage plan:

The gutters are sufficiently sized for the area's rain intensity and the building's roof slopes, and gutter components appear to be in good overall condition. However, the single 2" x 3" downspout to grade is insufficient and erosion on the building's northwest corner indicates that gutters may overflow in this area. See *D2040 Rain Water Drainage* for more information.

**Blue** includes both slopes of the main block roof and the sunroom/porch addition hip roof. Gutters located at the bottom of the main block roof's east and west slopes drain by downspouts to the east and west ends of the sunroom roof. Gutters at the bottom of the sunroom and porch roofs (east and south elevations) collect runoff from the porch roof and, thus, the main block roof. They drain to grade through a single downspout at the southeast corner of the building.

**Red** includes the roof projection over window 109. This roof has no gutters and drains directly from eave to grade.

**Yellow** includes the roof projection over window 105. This roof has no gutters and drains directly from eave to grade.

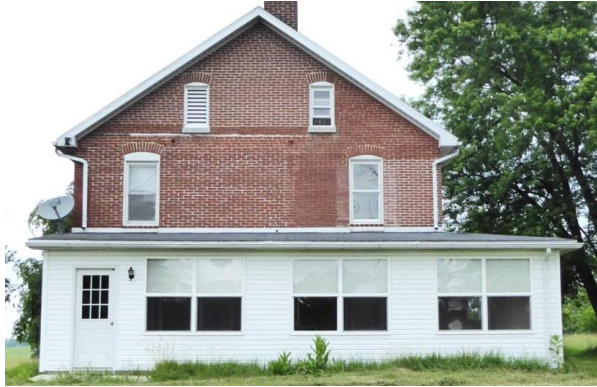
The downspouts from both main block roof slopes drain to the sunroom/porch roof. The sunroom/porch roof runoff drains via a single downspout to grade (at right in this photo). Photo: HPTC, 06/07/17.

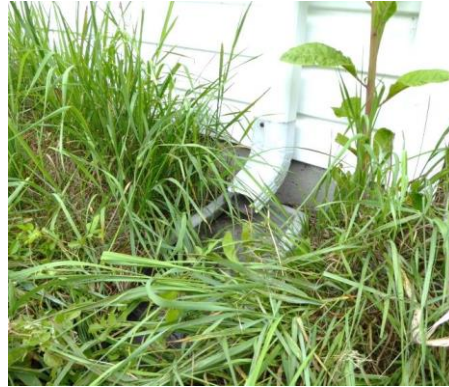
The single downspout to grade drains to a splash pad. Drainage is neutral in this area. Photo: HPTC, 06/07/17.

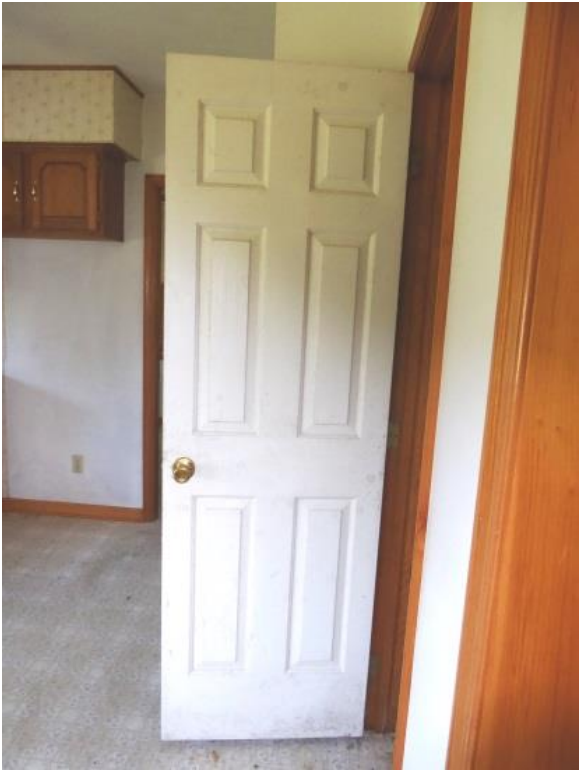
| <p>Interior doors throughout the house are modern, painted hollow-core doors with modern hardware. The exception is Door 105, an enclosed exterior door. This is a modern, decorative 2-lead-light/2-panel varnished wood door. The doors are in good condition though mold has collected on the basement side of D106.</p> | | |
| <div style="display: flex; justify-content: space-around;"> <div style="text-align: center;"> <p>D105, an exterior door enclosed by the sunroom.<br/>Photo: HPTC, 06/08/17.</p> </div> <div style="text-align: center;"> <p>D106, typical of the other doors in the house.<br/>Mold has accumulated on the side adjacent the basement stair. Photo: HPTC, 06/08/17.</p> </div> </div> | | |

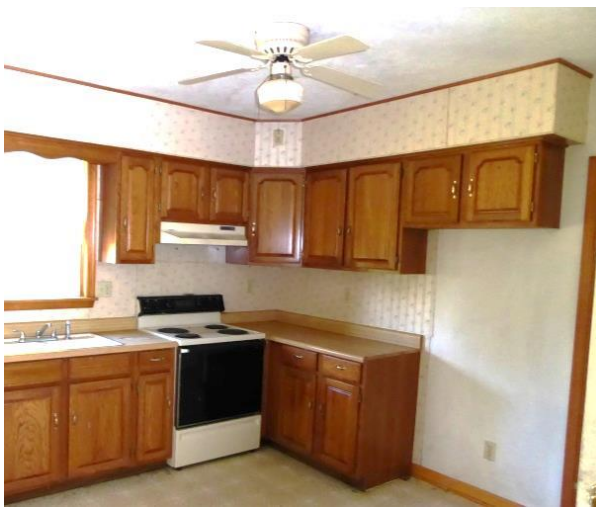
| <div><div><p>Left: Wallpaper, Room 102. Photo: HPTC, 06/08/17.</p></div></div> | | |

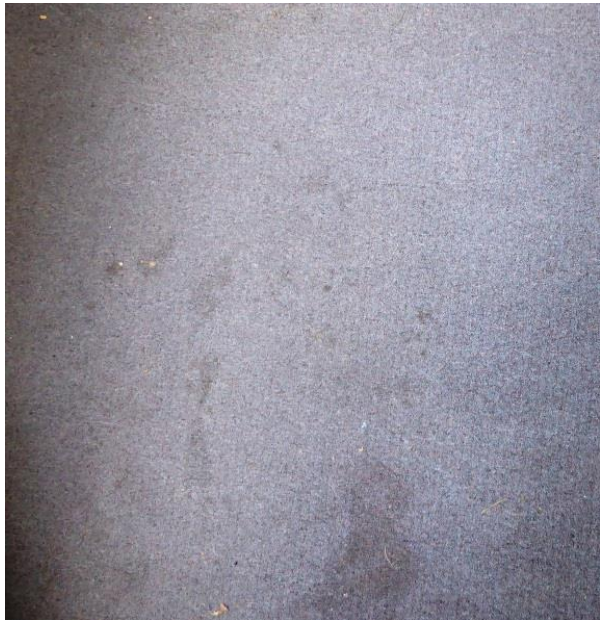
| Low-pile carpet in Room 101 (sunroom). Photo: HPTC, 06/08/17. | | High-pile carpet in Room 201 (bedroom). Photo: HPTC, 06/08/17. |

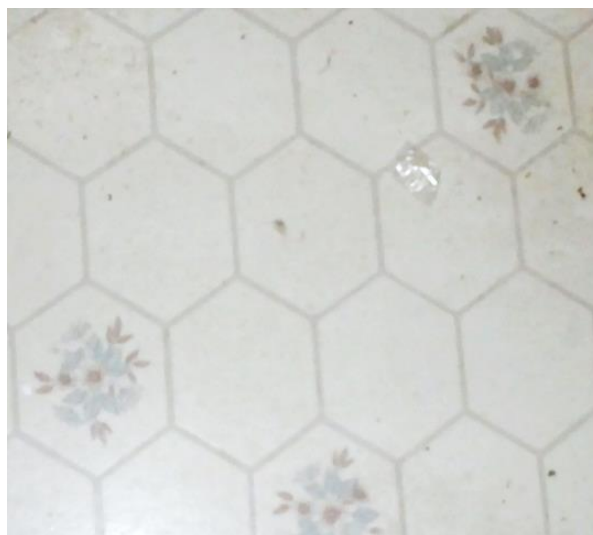
Sheet linoleum between Rooms 104 and 105 mimics natural stone tile. Note area of damage (upper left). Photo: HPTC, 06/08/17.

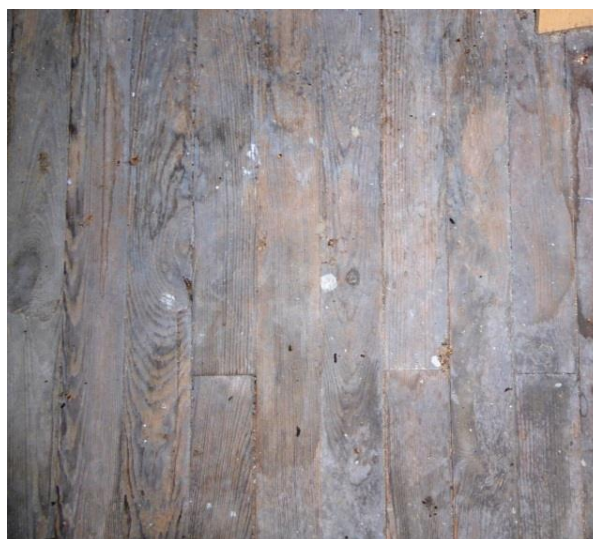
Historic wood flooring, Room 301. Photo: HPTC, 06/08/17.

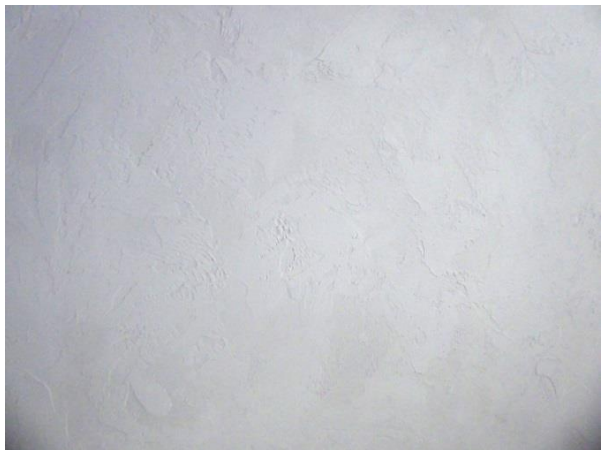
| <p>Typical main block textured ceiling finish, first floor. Photo: HPTC, 06/08/17.</p> | <p>Water staining, northwest corner of Room 102. Photo: HPTC, 06/08/17.</p> |

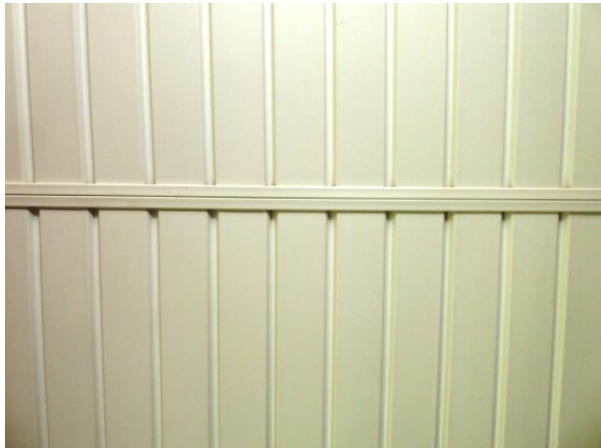
| | <p>Left: Vinyl ceiling finish, Room 101. Photo: HPTC, 06/08/17.</p> |

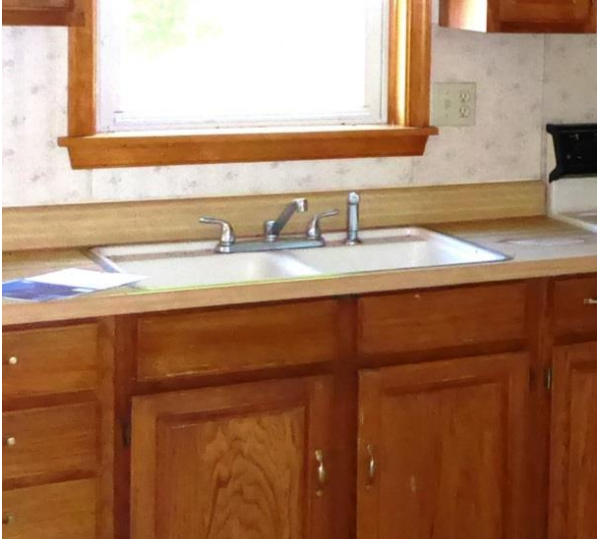
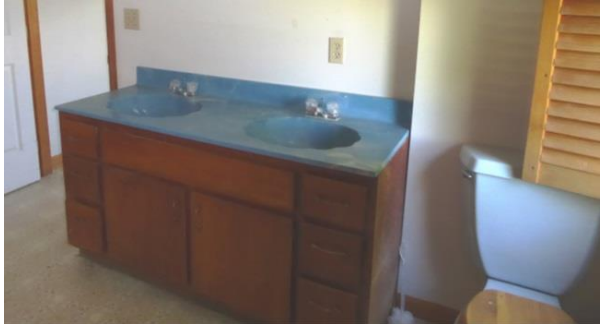
| | | <p>A lavatory with two sinks and a toilet are located in Room 103. Photo: HPTC, 06/08/17.</p> <p>Left: Sink in the kitchen, Room 102. Photo: HPTC, 06/08/17.</p> | |

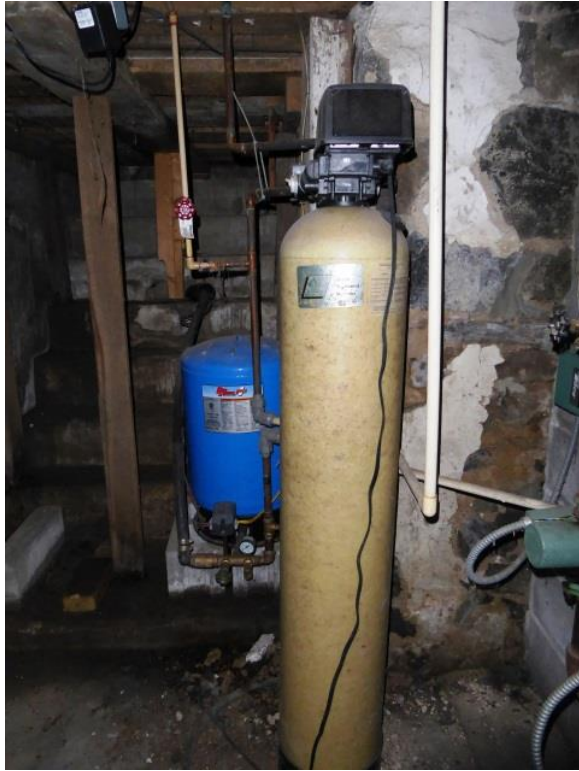
Left: "Pro-Source Plus Steel Pressure Tank" (blue) and "Aqua Treatment Service, Inc. Water Treatment Systems AF163-2D" (tan). Photo: HPTC, 06/08/17.

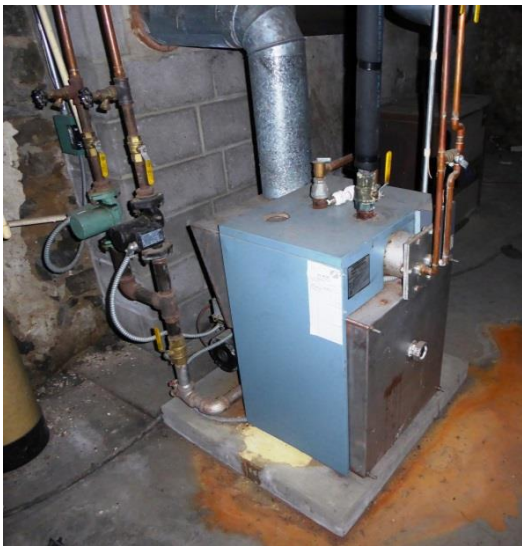
| Oil-burning boiler. Photo: HPTC, 06/08/17. | | Wood-burning stove. Photo: HPTC, 06/08/17. | |

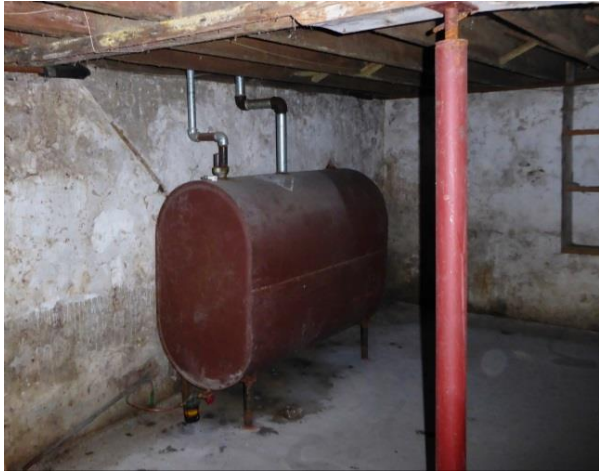
| Oil tank. Photo: HPTC, 06/08/17. | | Oil tank inlet and vent below W109. Photo: HPTC, 06/07/17. | |

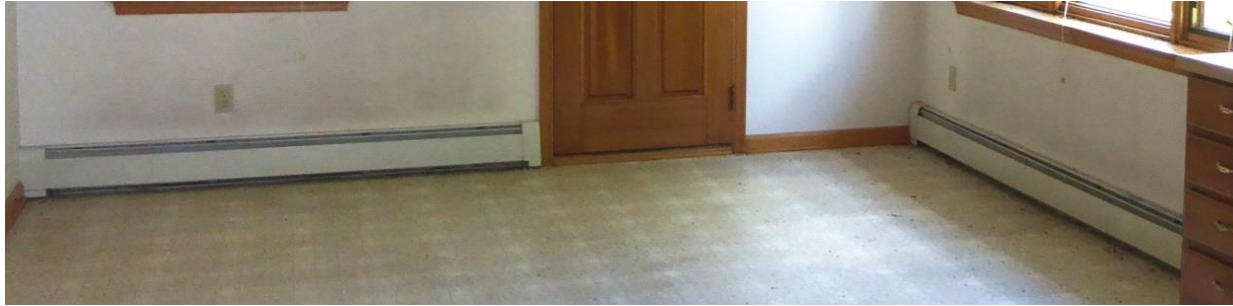
Hot-water baseboard radiators, Room 102. Photo: HPTC, 06/08/17.

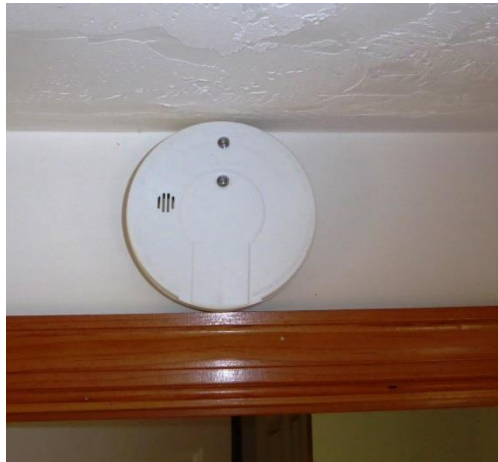
| <p>There are two battery-operated smoke detectors in the house, mounted in the south bedroom (Room 201) above Door 202 and in the main stair. They are not functional.</p> | | | | |
| <div><div></div><div><p>Left: Smoke detector, Room 201, above D202. Photo: HPTC, 06/08/17.</p></div></div> | | | | |

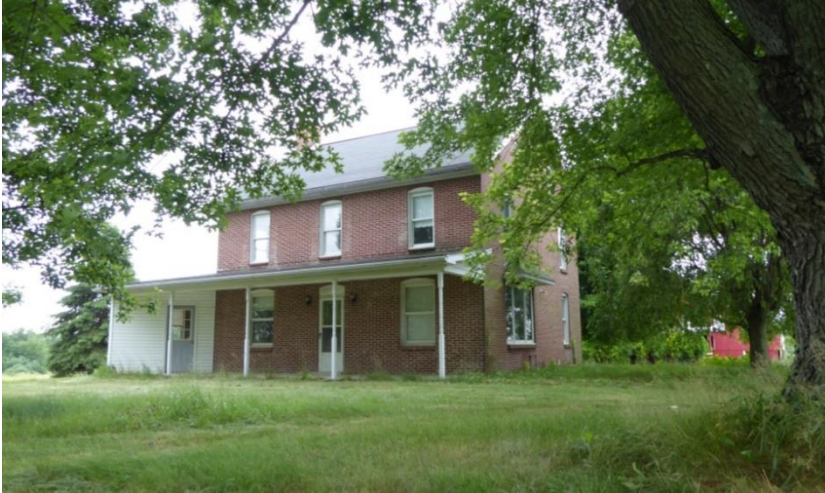
| <b>G BUILDING SITEWORK</b> | |
|---|---|
| <p><i>Left:</i> From the northeast.<br/>Photo: HPTC, 06/08/17.</p> | |

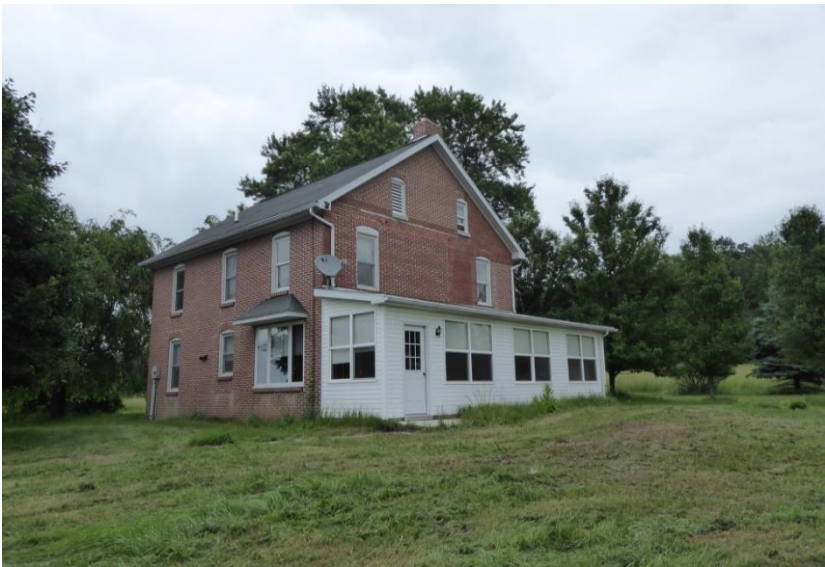
| <b>G BUILDING SITEWORK</b> | |
|---|---|
| <p><i>Left:</i> From the southwest.<br/>Photo: HPTC, 06/08/17.</p> | |

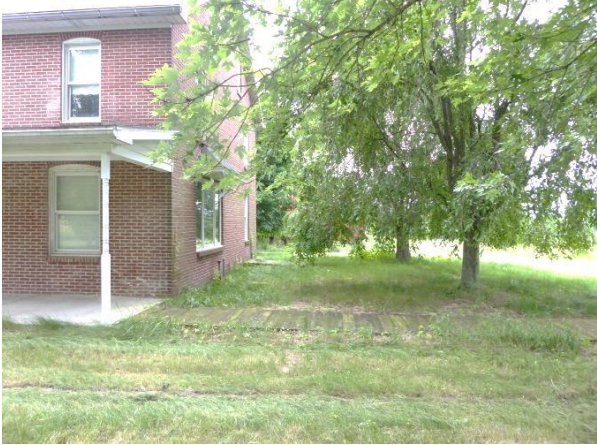
| <p>Site drainage from the house is neutral (neither towards nor away from the house) on all elevations. This can allow water retention around the perimeter of the house. Damp conditions in the basement are proof of this.</p> <p>Vegetation on the sunroom addition's south elevation east corner retains moisture and impedes drainage of the single roof downspout in this area.</p> | | | |
| Neutral drainage, east and north elevations. Photo: HPTC, 06/07/17. | | Neutral drainage along the west elevation. Photo: HPTC, 06/07/17. | |
