## Carter G. Woodson Home

1538 Ninth Street, NW, Washington, DC

**FINAL SUBMISSION  
JANUARY 15, 2008**

# Historic Structure Report

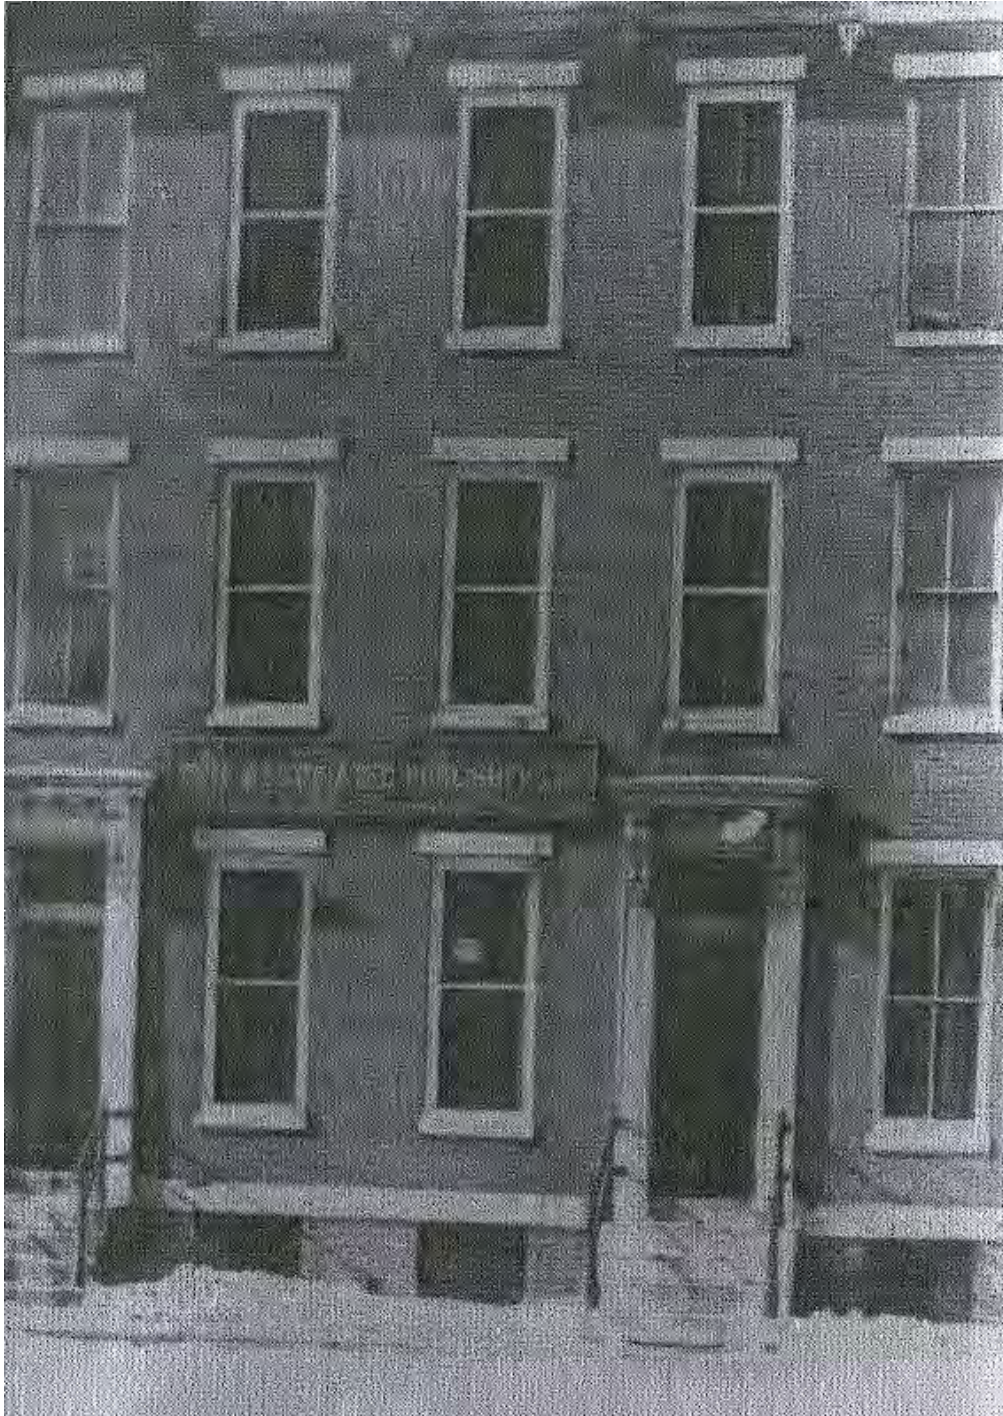
Figure 2-012: Exterior image of the Woodson Home during his occupancy, n.d. (From Jacqueline Goggin, *Carter G. Woodson: A Life in Black History*)

- *Windows:* As can be seen in a photograph of the exterior taken during Dr. Carter G. Woodson's occupancy of the house (See Figure 2-012 – Page 17), wood and wire screens were applied to the exterior of the windows on the East Elevation. The hooks for these screens are still visible on the window frames and date to Period 3.

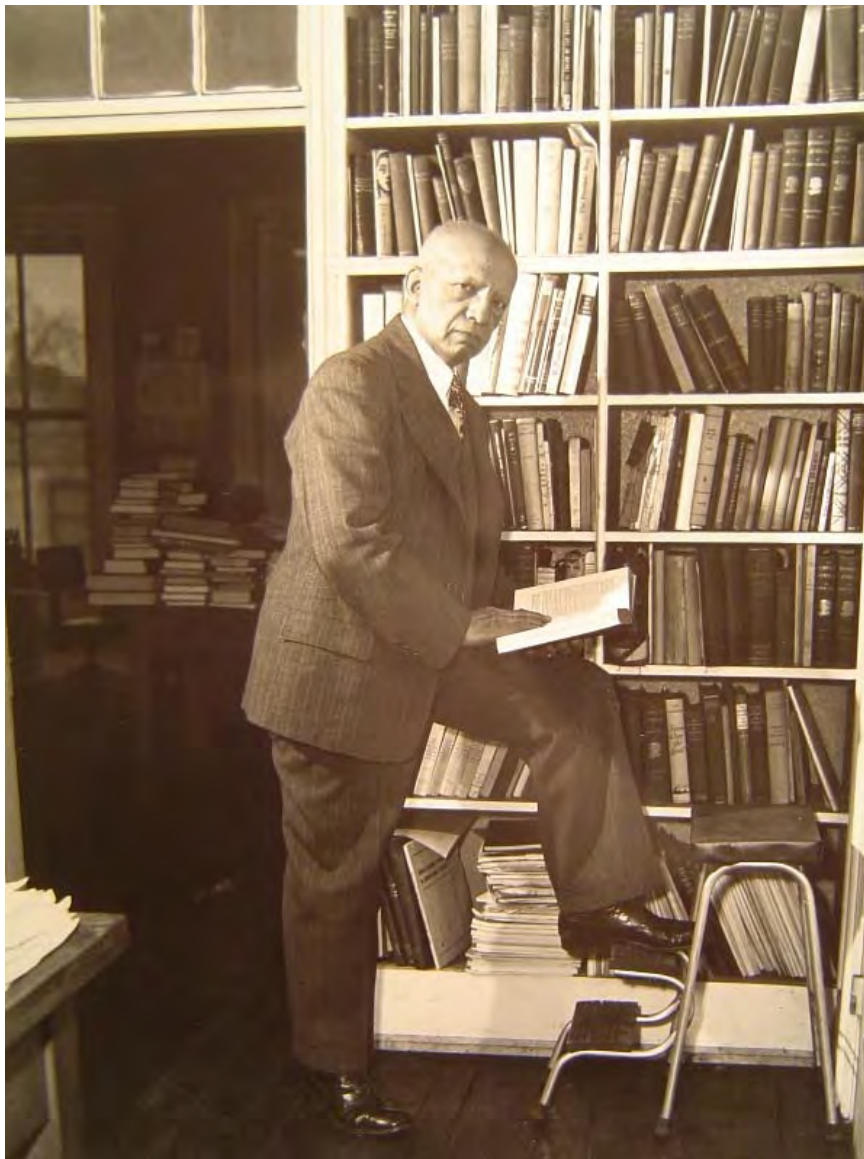
**Figure 2-015:** Dr. Woodson in the house with his collection, February 1948 (Scurlock Collection, Smithsonian Institution – National Museum of American History)

- *Room 205* – Figure 2-015 and Figure 2-016 in the Developmental History Section suggest that Dr. Carter G. Woodson used Room 205 as his library. Evidence of the door and transom in the photo with a room visible beyond confirms that location from which the photograph is taken. The bookshelves represented in the photograph were removed during Period 4.

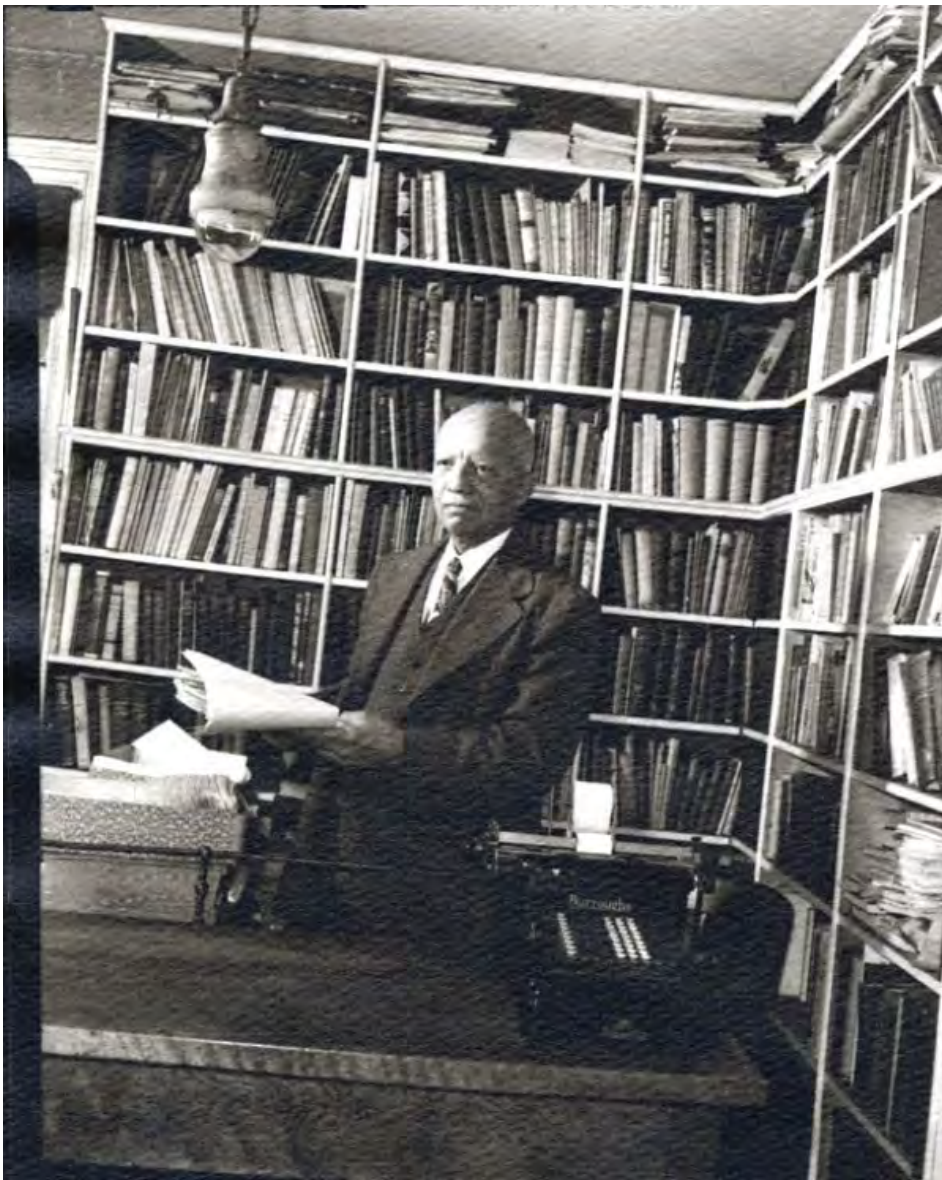
**Figure 2-016:** Dr. Woodson with a manuscript, February 1948 (Scurlock Collection, Smithsonian Institution – National Museum of American History)

- *Lighting* – Figure 2-016 on page 24 of the Developmental History Section clearly shows a pendant incandescent light fixture hanging over Dr. Carter G. Woodson's desk in his second floor library, with Mr. Woodson in the background. All interior lighting was replaced in Period 4 and again in Period 5.

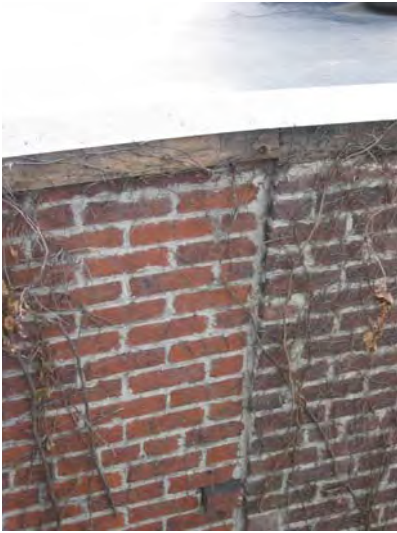
A clear separation joint in the brick construction and change of the type of red brick used (from Brick Type 3 to Brick Type 4) for the existing two story rear extension clearly delineates the Period 1 boundary of that extension (see Fig. 2-020).

**Figure 2-020:** View of joint showing end of Period 1 two-story structure on the left and beginning of Period 2 two-story structure on right. (Photo: BBB, 2006)

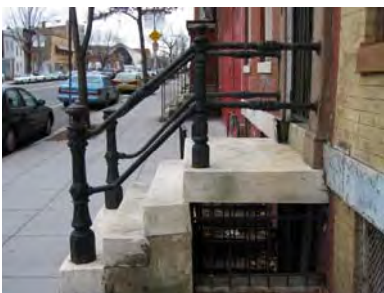
- *Front Stoop*: As was common with townhouse construction of the 1870's, solid marble steps and landing were provided as part of the front entrance stoop design. These marble elements survive today. Similarly, mass produced iron elements were also frequently used. The newel posts and railings date to Period I. Portions of the railing were removed during

**Figure 2-021:** Front Stoop. (Photo: BBB, 2006)

Period 5 and documentation in the NPS 1988 Field Assessment Report indicates that it was stored and reinstalled.

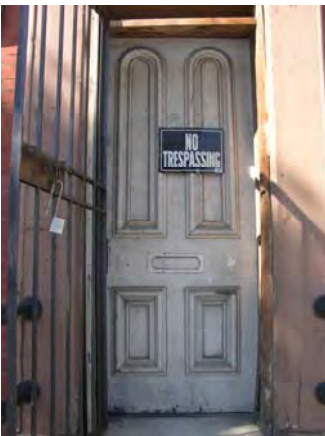
Figure 2-042: Front door at present. (Photo: BBB, 2006)

- **Door Grilles** – Hinged iron security grilles were added after 1983 to the front door and the basement door.
- **Front Door and Door Surround** – The 1983 HABS documentation shows an exterior entry door. This door was of stile and rail construction with two-over-two recessed panels and applied molding. This door was replaced sometime after 1983. The 1988 NPS assessment report does indicate repairs to the door, the molding at the paneled returns and repairs to miscellaneous molding around the door which resulted in replacement of some molding. The replacement molding does not match the Period 1 molding in profile. The molding at the transom does date to Period 1 and is intact.

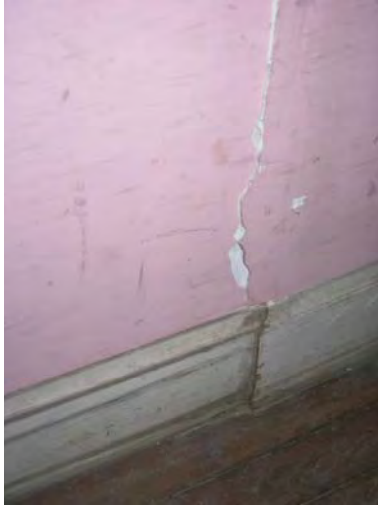
- **Concrete Block at Windows and Door Openings** – In an effort to stabilize the structure and protect it from vandalism, the Association installed concrete masonry units in all windows in Room 105, 109 and 110 in 2002. Concrete masonry units were also installed in the exterior door opening to Room 110 because the wood frame had rotted and the masonry surrounding the opening was failing. Additionally, the Association filled in the window openings on the second floor in Rooms 205 and 210 with concrete block.

Figure 2-043: Joint showing line of infill for opening to room 105. (Photo: BBB, 2006)

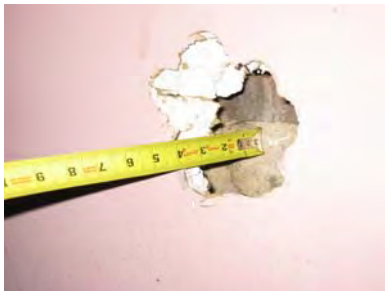
Figure 2-044: Gypsum wall board furred out at room 109 south wall. (Photo: BBB, 2006)

- *Room 109* – The walls in this room have been furred out with wood studs and lined with 5/8" modern sheetrock. These improvements were made at the same time as the installation of the bathroom. At a probe in the south wall it was observed that the wall beyond the gypsum wall board furred out was the exterior brick. However, from a probe in the east wall of Room 110, a plaster wall could be seen behind the furred-out wall.

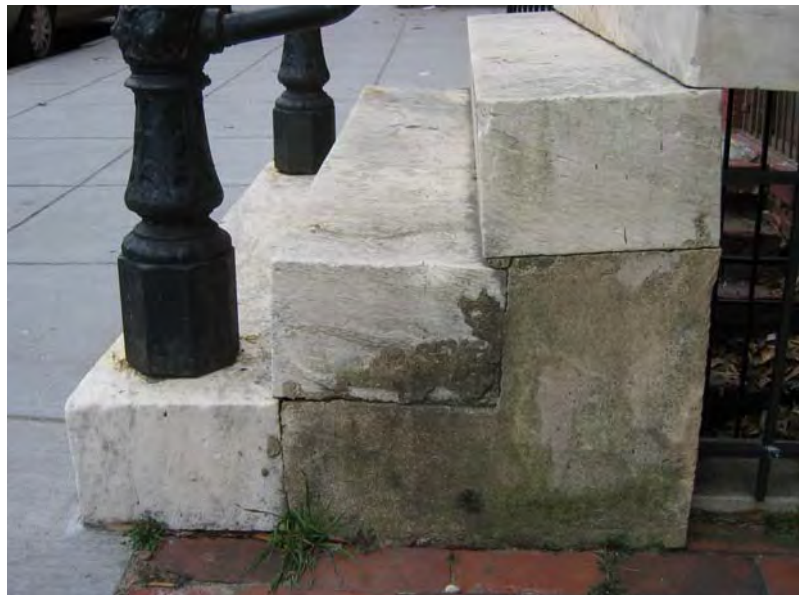
*Bluestone* – The remaining treads leading to the basement are bluestone and have been painted with red paint. These treads are uneven due to displacement.

Figure 3-023: Front stoop. (Photo: BBB, 2007)

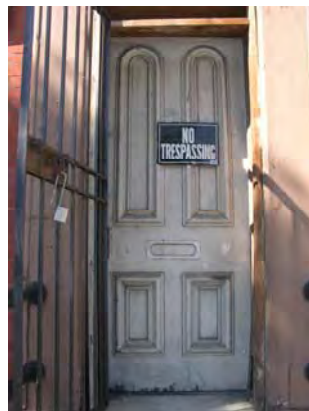
consoles flanking three elaborate modillions. Between the consoles is a transom window, which is currently obscured by signage. The door surround is painted brown and the door itself is painted beige. There are paneled returns at the sides and top of the frame. The molding for the paneling at the top of the frame by the transom dates to Period 1. The molding for the panels on the sides was replaced in the 1980's and has a slightly different profile than the original Period 1 molding.

**Figure 3-027: D101.**  
(Photo: BBB, 2007)

- Replacement of wood window sashes on the East Elevation – Original sashes were replaced in 1970's.
- Restoration of the front entry door (Door D101) – Original door was replaced in 1980's.
- Restoration of front entry door frame – Replacement of molding put in during the 1980's with molding that matches the profile of the historic. Removal of parks sign and replacement of glass at the transom.
- Recreation of Door 103A at the alley – Original door was removed in 2000's.

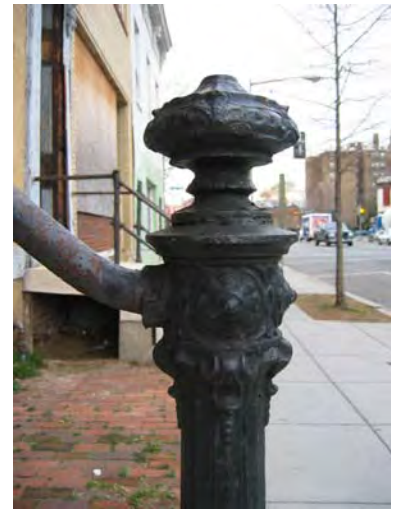
*Cast Iron*-- The front entrance railings, located on the north and south sides of the entrance stair, are composed of primary and secondary cast-iron newel posts each with fluting and decorative florettes. The horizontal and diagonal rails are painted cast iron and are decorated with cast iron beads flanked by tulip-shaped floral ornament at midpoint. The south primary newel post is missing its decorative cap. The railing is painted black.

**Figure 3-031:** Cast iron railing detail. (Photo: BBB, 2007)

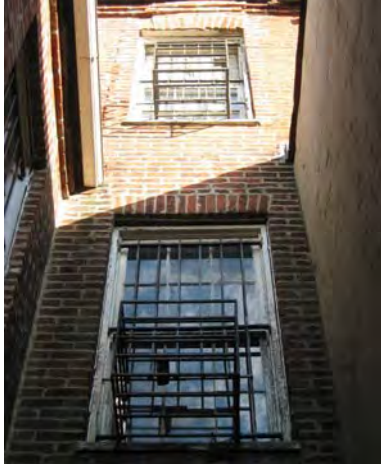
**Figure 3-036:** View of windows W204 and W205. (Photo: BBB, 2007)

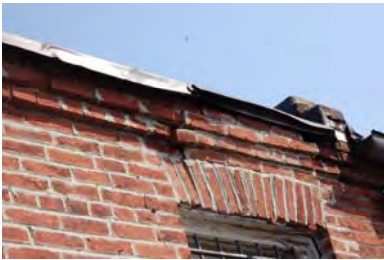
**Figure 3-037:** Corbelled cornice at third story elevation. (Photo: BBB, 2007)

The three story elevation is capped with a corbelled brick cornices composed of three courses. Much of that brick is loose or dislocated.

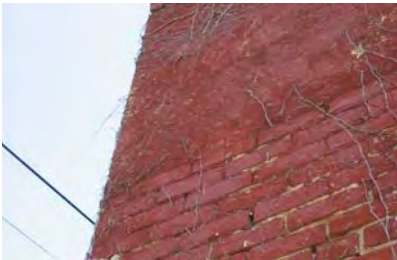
**Figure 3-038:** Cementitious coating and painted brick. (Photo: BBB, 2007)

The brick at the first floor of the two story elevation has been painted red. The brick at the second floor of the two story addition has been parged with a cementitious coating and has been painted red. This coating is cracking in multiple locations above and below window W210.

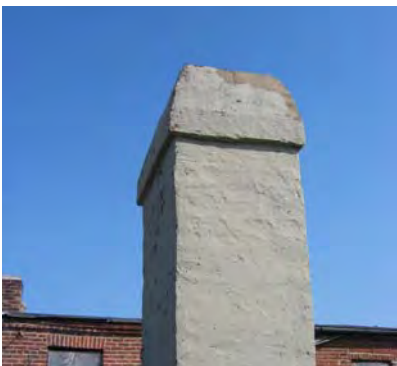
The two story elevation represents the extent of the 1880's addition. Two double-hung windows framed with rounded brick arches are centered over on another on the right side of this elevation. On the top half of this elevation a cementitious coating has been applied to the brick. A brick chimney extends above the roof of the two story addition and has also been covered with a cementitious coating.

**Figure 3-039:** Chimney at two story addition. (Photo: BBB, 2007)

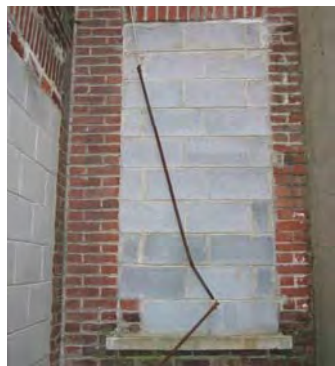
*Concrete Block* – 8"x16" Concrete Masonry Units were been used to infill window opening W103 to prevent entry into the building. A small area at the base of the three story elevation has been patched with concrete masonry units as well. This may have been an infill to a ventilation opening to the basement, similar to the one that appears on the South Elevation.

**Figure 3-040:** CMU infill and concrete sill at W103. (Photo: BBB, 2007)

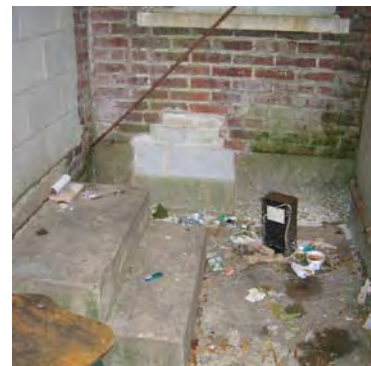
*Concrete Stairs/Sill* – Concrete stairs, composed of two risers and two treads, were installed in the alley to address door opening D103A on the South Elevation. These stairs are one riser short of being of being level with the First Floor Elevation, requiring that one step up into the building.

**Figure 3-041:** Concrete steps and CMU infill below W103. (Photo: BBB, 2007)

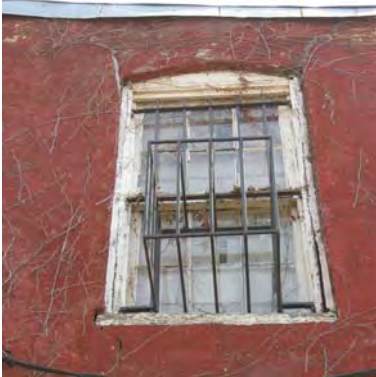
Figure 3-043: W305.  
(Photo: BBB, 2007)

*Brick Masonry* – The common red brick on the west elevation of both the two and three story structures are set in common bond. The brick used on the three story structure (Brick 3) is of a more consistent size and shape than the brick used on the two story structure (Brick 4). Windows at the three story elevation are framed with brick flat arches. Windows at the two story elevation have rounded brick arches. The rounded brick arch at window W107 is missing brick. The brick adjacent to window W305 is experiencing significant cracking and loss of brick.

Five of the six windows on this elevation (W107, W204, W210, W304, and W305) are wood double-hung six-over-six windows with rope pulleys and counterweights. Windows W103, W204, W304 and W305 date to Period 1 while windows W107 and W210 date to Period 2. The window frames are simple wood frames painted white. In all but one case the sills are made of painted wood set into the brick. The one window that does not have a wood sill, window W103, has a concrete sill that has been installed. The window sill at W107 shows significant rot and deterioration of wood window W103 has been in-filled from the exterior with Concrete Masonry Units as was mentioned earlier. Window W305 has been covered with plywood that is bolted through to the interior.

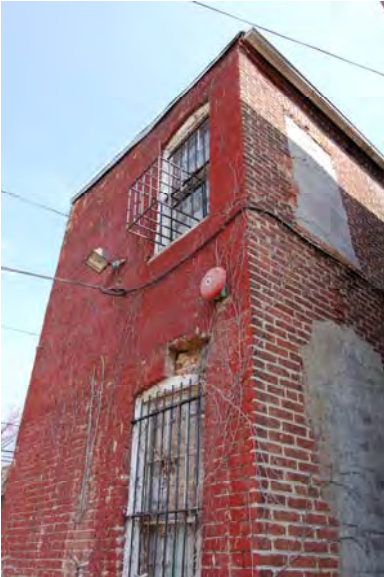
**Figure 3-046:** Surface mounted light fixture and fire alarm bell.  
(Photo: BBB, 2007)

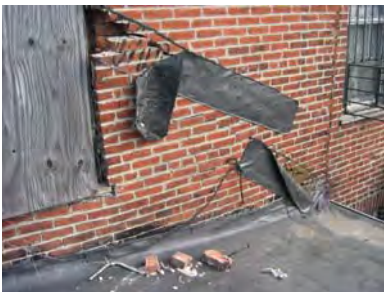
**Figure 3-047:** EPDM membrane patch and flashing detail at second story addition roof. (Photo: BBB, 2007)

*EPDM Roofing Membrane Flashing and Masonry Patching* – The EPDM roofing membrane used at the two story addition roof was not properly installed with flashing. Instead, the membrane roof was turned up and directly adhered to the brick of the three story addition with asphalt. This lack of flashing has resulted in continued leaks at the joint between the two-story and three-story addition. This EPDM membrane was also used to attempt to temporarily patch the failing brick adjacent to window W305. The membrane was applied to the surface of the cracking and dislocating brick with asphalt.

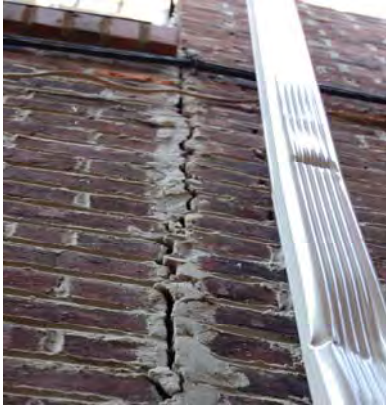
**Figure 3-051:** Joint between 1872-74 addition & 1880 addition. (Photo: BBB, 2007)

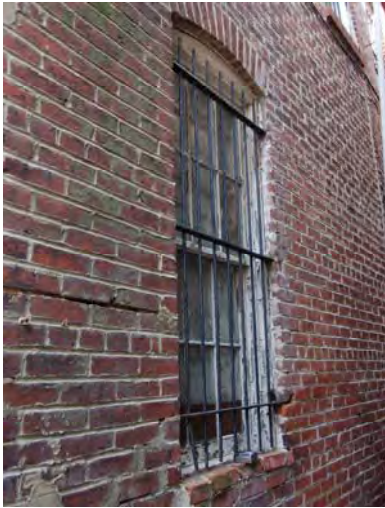
**Figure 3-052:** Window W106 with curved brick arch and replacement sill. (Photo: BBB, 2007)

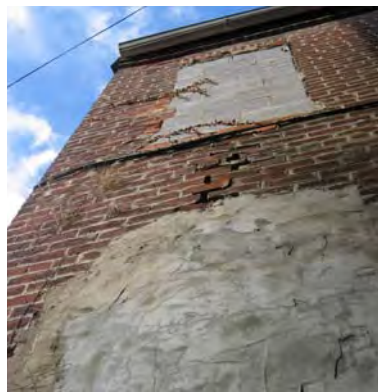
*Brick Masonry* – The common red brick on the south elevation of both the 1872-74 and 1880 portions of the two story structure are set in common bond. The brick used on the 1872-74 extension (Brick 3) is of a more consistent size and shape than the brick used on the 1880 extension (Brick 4). All but one window (W106) have flat brick arches. Window W106 is framed by a curved brick arch. The brick sills provided at windows W106, W207 and W208 are replacement sills and date to Period 5. Windows at the two story elevation have rounded brick arches. The rounded brick arch at window W107 is missing brick. Door D103A is framed by a flat brick arch. The brick above this opening is significantly dislocated. Dislocated brick was also noted above W104 and above and below W105. The brick above and below D110A and W209 is not only dislocated but is also significantly bowing.

*Cementitious Coating* – A cementitious coating was applied to the concrete masonry unit infill at D110A in an attempt to prevent moisture penetration at the joints between the CMU and the brick. This coating was also installed at dislocated brick above the door opening to further stabilize the brick.

**Figure 3-054:** CMU infill and cementitious coating at W209 and D110A – note dislocated brick. (Photo: BBB, 2007)

*Concrete Block* – 8"x16" Concrete Masonry Units were used to infill window openings D103A, D110A and W209. D103A was filled in to prevent entry into the building however W209 and D110A were filled in to stabilize the failing openings.

Door opening D110A also no longer has its door or frame. The brick opening has failed so severely that there are no traces of the wood frame.

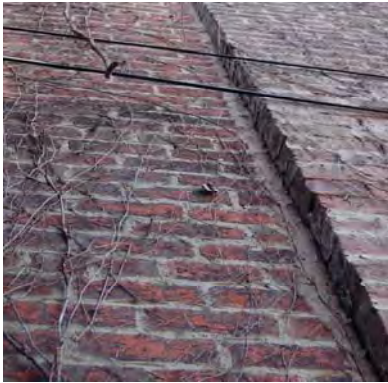
A significant crack has formed between the 1872-74 addition and the 1880's addition. This crack has been filled with mortar. The entire façade has been re-pointed during Period 5. The brick of the 1880 addition is bowing outward by up to 2 ½" inches at its worst point.

**Figure 3-070:** Joint on brick between 1872-74 and 1880 construction. (Photo: BBB, 2007)

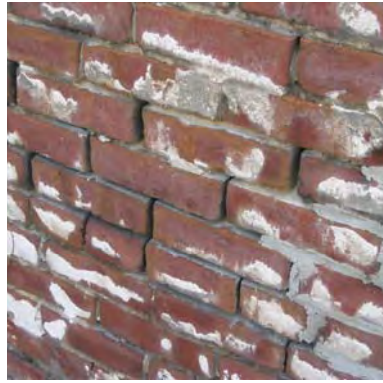
*Cementitious Coating* – A cementitious coating was applied to the lower portion of the 1880's elevation. Most of this coating has worn off and is evident on individual bricks.

**Figure 3-071:** Cementitious coating and open joints. (Photo: BBB, 2007)

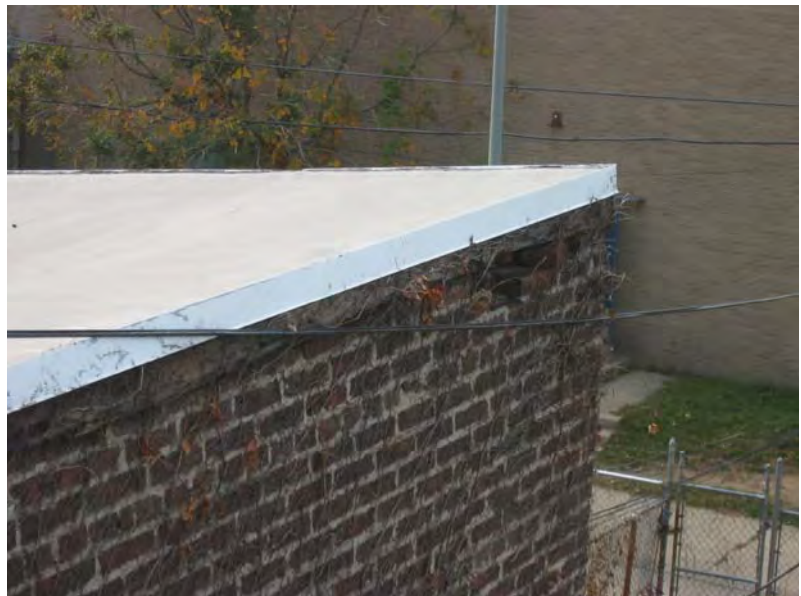
*6" Wood Fascia* – The wood fascia was installed with cut nails dating it to Period 1 or 2. However, it is continuous over the entire elevation, dating it to Period 2. The wood is fully exposed with no paint coverage remaining. Some of the wood has begun to dislocate from the elevation.

**Figure 3-074:** 3 ½" PVC flashing over 6" wood fascia. (Photo: BBB, 2007)

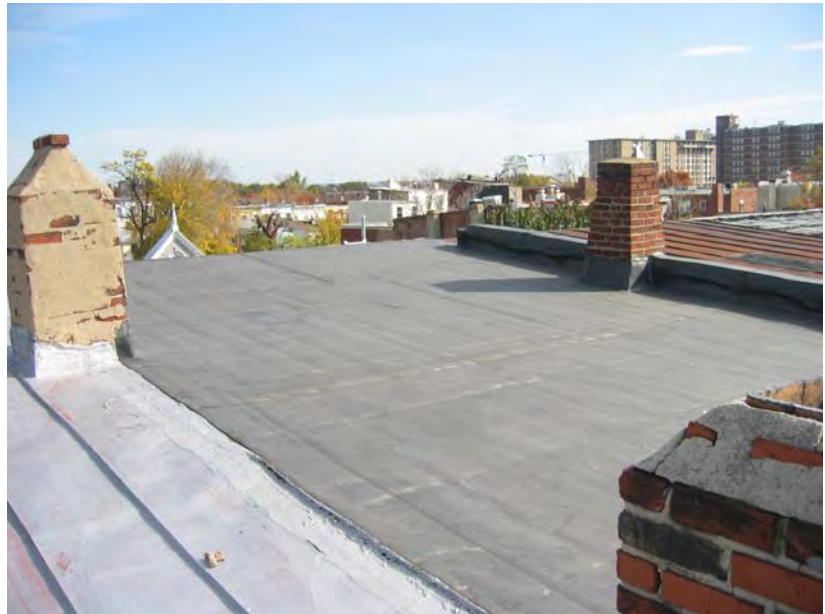
Figure 3-075: Upper Roof. (Photo: BBB, 2007)

The upper roof is an EPDM (ethylene propylene diene terpolymer) single ply rubber membrane roofing that was installed post 2001 (Period 5) in an effort to prevent further water penetration into the existing building. The roof extends the length of the three story portion of the house and pitches from its high point at the east end to the low point at the west end with an approximate slope of 1:9.5. Based on the existence of historic standing seam roofs on the townhouses both to the north and to the south, it can be assumed that the original roofing material for the Carter G. Woodson Home was the same. The roofing to the south terminates at a brick parapet approximately 12" high that tops the party wall between the Woodson Home and the townhouse to the south. This upper roof has no gutter, but evidence of gutter bracket anchoring devices in the masonry indicates that there was once a gutter that would have drained water from the upper roof to the lower roof via a downspout. Currently the water drains to the lower roof by pouring over the western edge of the upper roof. This condition may be the cause of the continuing water damage at the seam between the two-story and three story structure.

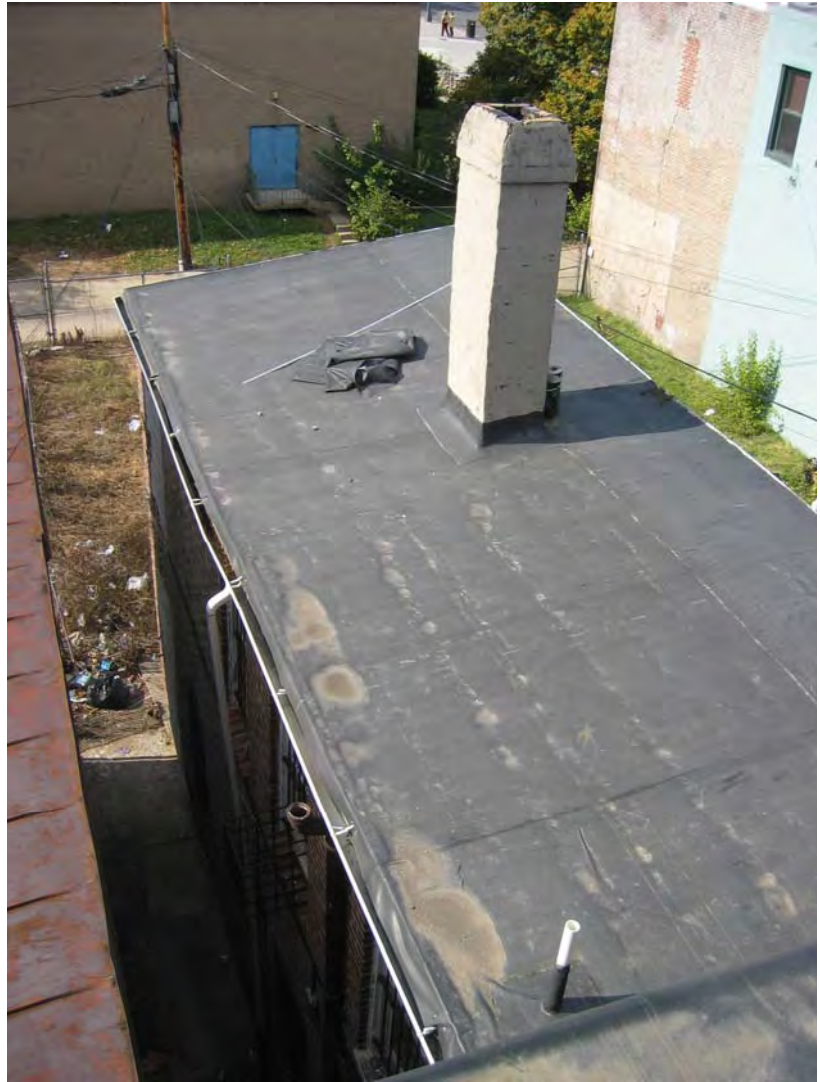
Figure 3-076: Lower Roof. (Photo: BBB, 2007)

Similar to the upper roof, the lower roof is an EPDM membrane roofing that was installed post 2001 (Period 5). This roofing extends the entire length of the two story structure. The roof slopes from its high point to the north to its low point to the south with an approximate slope of 1: 8.5. Water is collected at the south end in an aluminum gutter. Chimney 3 extends from this roof to a height of 8'-3" and serves as the flue for the boiler in the basement. The roof at the east end directly abuts the west elevation of the three story addition. It is this joint that has caused so many problems regarding water infiltration into the building.

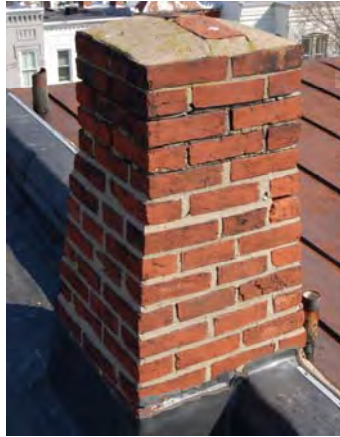
**Figure 3-079:** Chimney 1.  
(Photo: BBB, 2007)

*Chimney 1/Chimney 2* - Chimney 1 is constructed of common red brick (Brick 3), is 25"x24" at its base but after eight brick courses cants upward. This chimney is capped with mortar and a brick. The chimney once served the fireplace in Room 104 and potentially other openings in Rooms 203 and 303 and dates to Period 1. Chimney 2, also constructed of common red brick (Brick 3), is approximately 22" square and is capped with mortar and two pieces of slate. The chimney once served the fireplace in Room 105 and potentially other openings in Rooms 205 and 305 and it also dates to Period 1. It was noted at the first floor fireplaces that two 8" tin pipes are

within the flues that extends to these chimneys. The masonry at these chimneys has significant open mortar joints that will require re-pointing. The south sides of both chimneys engage the parapet of the brick party wall between the townhouses.

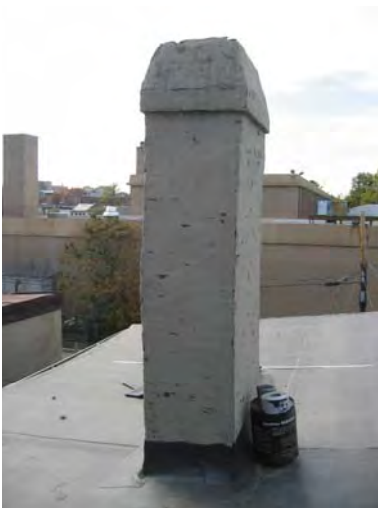
*Chimney 3* – Chimney 3 served a fireplace in Room 110 at one time, but the flue for that fireplace has since been sealed up. Evidence in the basement did indicate that the boiler vent pipe does currently extend into chimney 3. The chimney measures 22" x 31" and is 8'-3" tall. It is constructed with common brick (Brick 4) and coated with a cementitious parging from top to bottom. The chimney tilts slightly to the north. Of the top four brick courses, the bottom two project outward by 2 ½" and the remaining four courses are battered inward.

**Figure 3-081:** Chimney 3.  
(Photo: BBB, 2007)

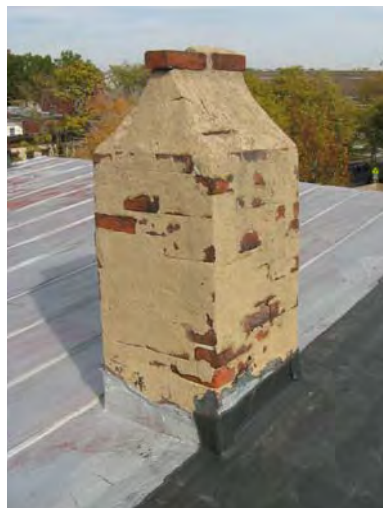
**Figure 3-082:** Chimney 4.  
(Photo: BBB, 2007)

Chimney 4 & 5 – These chimneys belong to the adjacent townhouse but partially project into the roofing of the Carter G. Woodson Home. Chimney 4 measures 23"x24" and its surface is covered with a cementitious parging. The chimney cap consists of sloped mortar topped with a brick. Chimney 5 measures 22"x23" and at its top mortar is applied to corbelled brick. It is the only one of the chimneys at the upper roof that has an open flue and that flue is terra cotta. The joints at this chimney require re-pointing.

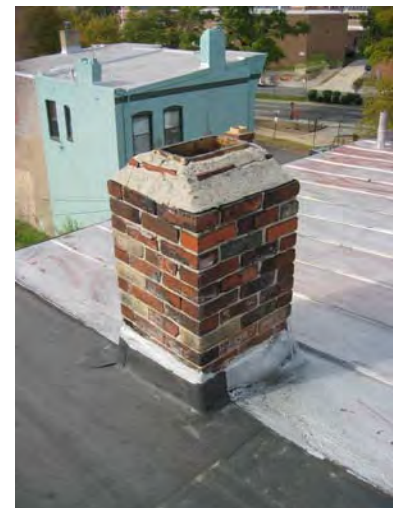
**Figure 3-083:** Chimney 5.  
(Photo: BBB, 2007)

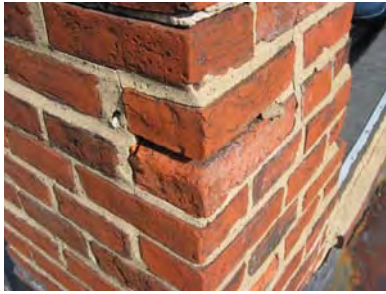
**Figure 3-084:** Open joints at chimney 1. (Photo: BBB, 2007)

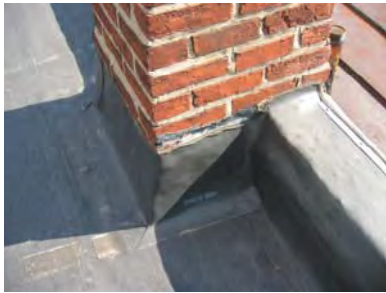
**Figure 3-085:** Roof flashing at party wall; chimney 1 joint. (Photo: BBB, 2007)

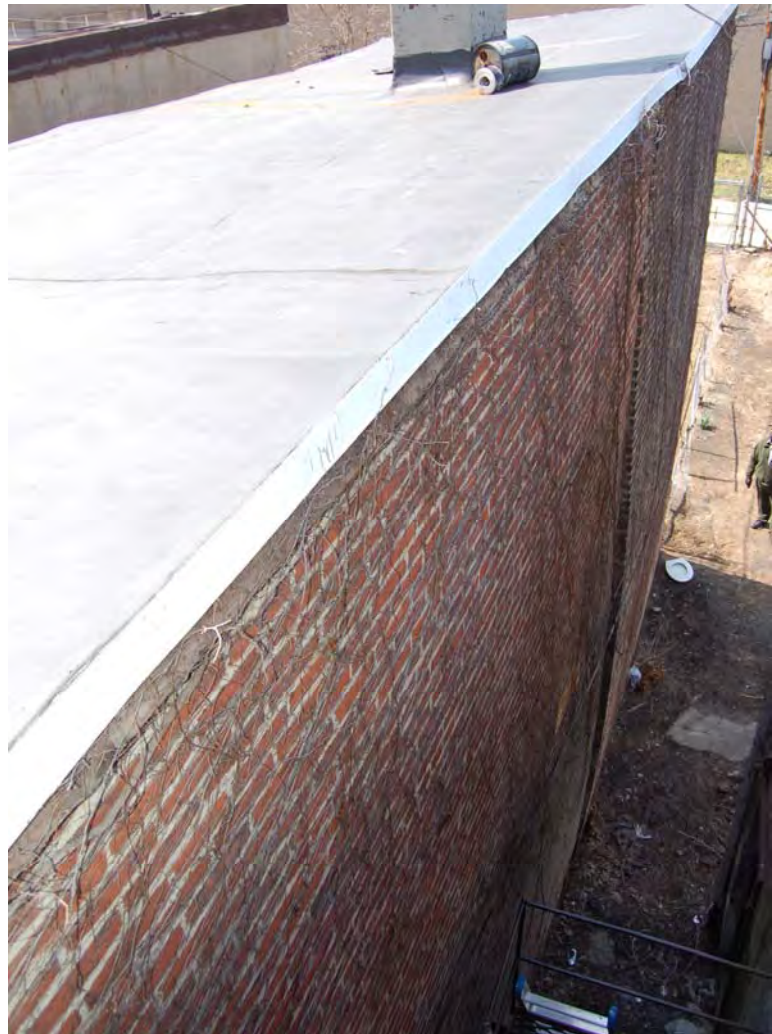
*6" Wood Fascia* – The wood fascia was installed with cut nails dating it to Period 1 or 2. However, it is continuous over the entire elevation, dating it to Period 2. The wood is fully exposed with no paint coverage remaining. Some of the wood has begun to dislocate from the elevation.

**Figure 3-088:** PVC flashing and wood fascia at lower roof. (Photo: BBB, 2007)

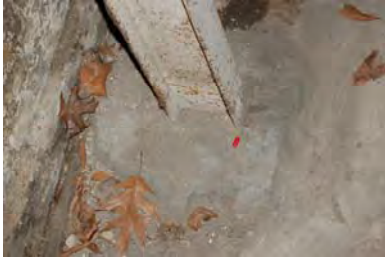
**Figure 3-103:** Concrete roofing at steel column. (Photo: BBB, 2007)

*Miscellaneous:* The (4) steel columns are spaced approximately 7'-4" apart and run east to west. These columns are rusting at their base as a result of continuous water accumulation on the basement floor. This water enters the building through door opening D003 because the door no longer closes. These columns all have labels on them indicating that they were made by the Phoenix Ironworks. The columns support a steel beam. This additional structure was either installed during Dr. Carter G. Woodson's occupancy (Period 3) to support the increased load of office use on the floors above or installed immediately prior to his purchase of the house (Period 2).

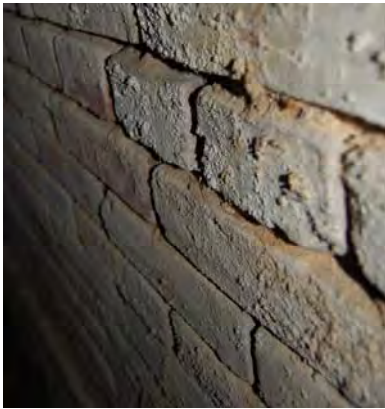
**Figure 3-104:** Open joists at north wall. (Photo: BBB, 2007)

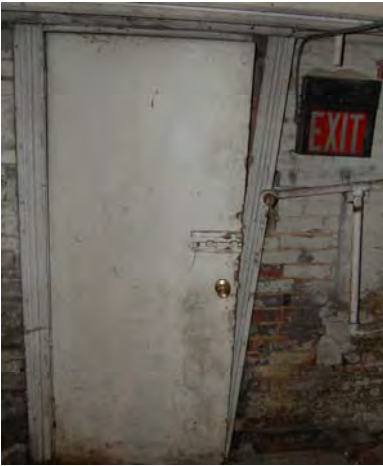
**Figure 3-109:** Door D001. (Photo: BBB, 2007)

*Door D001:* Mitered wood frame painted white. Flush wood door painted white on both sides. Modern brass hardware has been installed on the door. The frame has rotted causing the door to dislocate from the frame allowing water, moisture and small creatures into the basement.

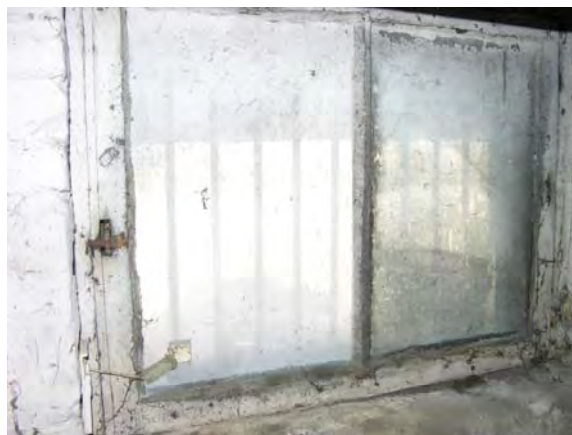
*Windows W001 & W002:* Simple rectangular wood stock painted frames mounted directly to the masonry. The sash is a top hinged casement window with two lites vertically divided, painted white. The metal locking mechanisms are rusted and locked in place.

**Figure 3-112:** Window W001. (Photo: BBB, 2007)

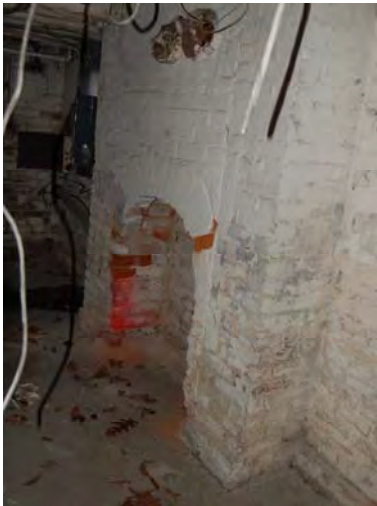
*Fireplace Piers:* A painted brick fireplace with arched brick opening is located on the south wall that corresponds with the fireplace above in Room 104. The flue has been sealed. Based on the line of the piers, the arched opening and fill above was installed after the brick piers. As was mentioned earlier there are two circular openings in the brick above the fireplace that have been filled with insulation material and lined with metal. Similar piers are located further west on the south wall that correspond with the fireplace in Room 105 above.

**Figure 3-114:** East fireplace piers at south wall. (Photo: BBB, 2007)

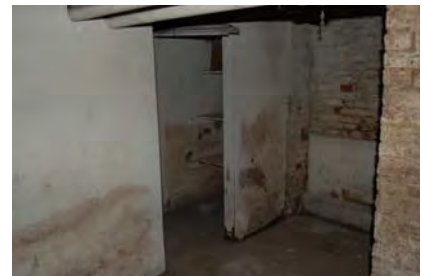
**Figure 3-116:** Shelving partitions and fireplace pier at west of south wall. (Photo: BBB, 2007)

The shelving dates to Period 4 when the ASALH were using the house. Many of their publications were still being stored in boxes on these shelves when the consultant team conducted their survey. Mildew was evident on most surfaces of the gypsum wall board used for the enclosures of these shelves as a result of the floor being consistently wet.

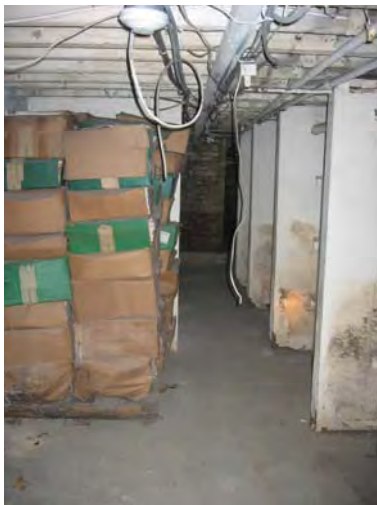
**Figure 3-117:** Looking west at shelving enclosures. (Photo: BBB, 2007)

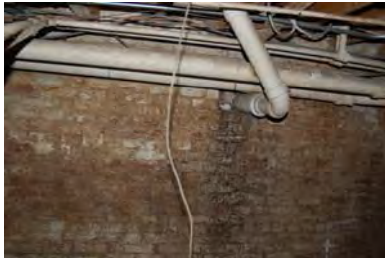
**Figure 3-121:** PVC pipe penetration with radiator pipes and conduit.  
(Photo: BBB, 2007)

Along the south wall an opening (W003) allows for ventilation in the basement. A PVC pipe also penetrates to the east of window W003 and connects to the cast iron piping outside along the south elevation. This PVC pipe is the sanitation pipe for the bathroom installed on the first floor in the 1980's.

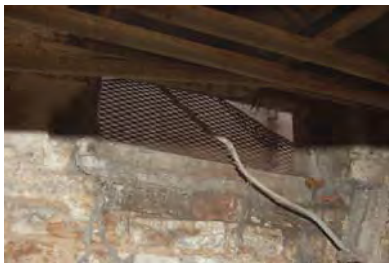
**Figure 3-123:** Opening W003 with wood frame and rusting wire grille.  
(Photo: BBB, 2007)

*Window W003:* Simple rectangular wood stock painted frames mounted directly to the masonry. Rusting wire mesh is attached on the exterior to this frame. The opening dates to Period 1 but the frame and wire mesh date to Period 4.

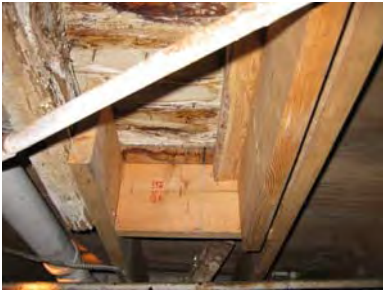
Figure 3-126: Sistering of joists.  
(Photo: BBB, 2007)

*Ceiling:* The ceiling is composed of exposed wood joists. Unlike the joists in Room 001, these joists are new and have not been painted. Some of these joists are sistered to older joists that have experienced significant wood rot or termite damage. The plumbing piping is surfaced mounted to these joists. A mixture of rusting rigid conduit and flexible conduit has been surface mounted to the joists to feed the light fixtures and smoke alarms.

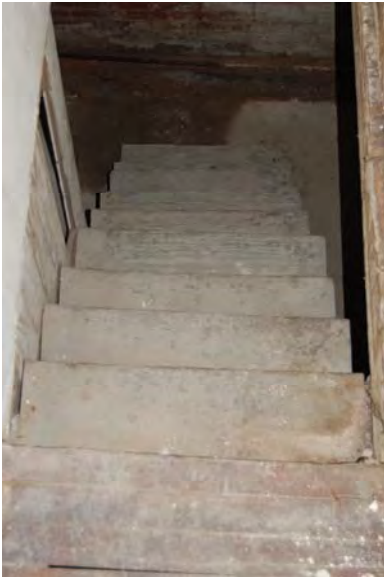
Figure 3-127: View looking down basement stair opening from the first floor. (Photo: BBB, 2007)

*Stair:* The stair is composed of 9 treads attached directly to wood stringers. This stair has no handrails and is very unstable due to its stringers being attached to the first floor framing that has suffered significant water and termite damage. The bottom tread of this stair has lost a piece of wood.

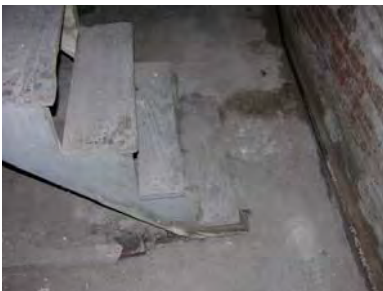
Figure 3-128: Bottom of stair.  
(Photo: BBB, 2007)

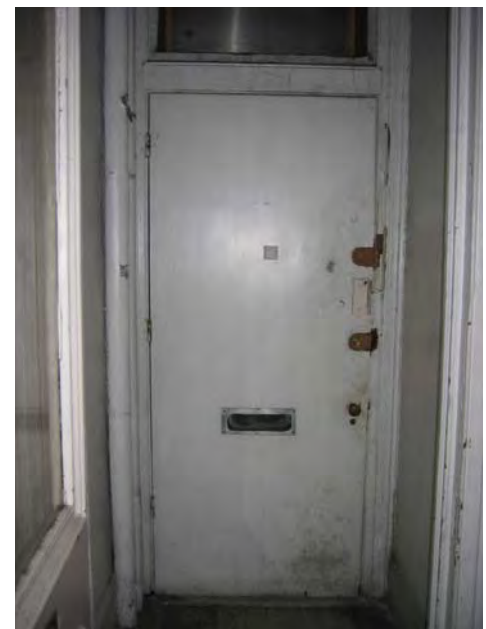
Figure 3-132: Door D101. (Photo: BBB, 2005)

*Door D101:* Door D101 (35"x83") is a flush wood door with applied molding on the front. (type-1) The hardware has been replaced many times as is evidenced by the wood damage to the door frame and the holes that have been filled in on the door. The hardware consists of two deadbolts and a bronze door handle with rectangular escutcheon plate. A mail slot has been installed in the middle of the door between the applied panels. The door frame includes a transom (type-1) (21 ½"x36") above and the glass panel has been replaced with Plexiglas. The frame is trimmed with mitered painted molding type-2 sill is a 4" modern aluminum sill. The exterior paneling is described as part of the East Elevation exterior description.

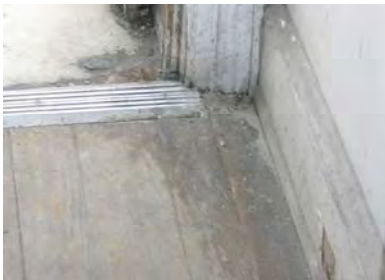
*Flooring:* The flooring is pine wood that varies in size from 2 1/2' to 6" and runs in an east/west direction. The floor finish has been worn off to expose bare wood and the only evidence of the floor finish is at the edges of the floor by the base. This floor finish appears to be a clear finish with no stain.

Figure 3-139: Condition at floor, Room 101. (Photo: BBB, 2006)

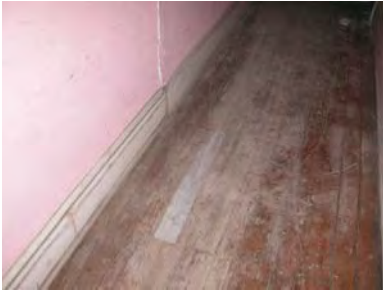
**Figure 3-146:** Room 102 floor damage. (Photo: BBB 2005)

*Flooring:* The flooring is pine wood of varying widths ranging from 2 ½" to 6" that runs in an east/west direction. A sheet metal patch has been nailed to the floor at mid-point of the room to cover over gaps in the floor boards. The finish has been completely worn off of the floor boards except along the baseboards. The floor shows significant wear; the wood is splintering and the grain of the wood is very pronounced.

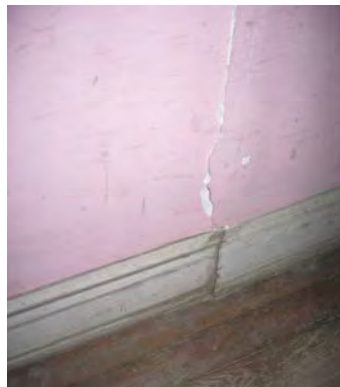
**Figure 3-150:** Line of infill patch at south wall. (Photo: BBB 2005)

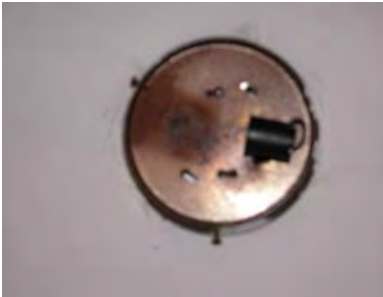
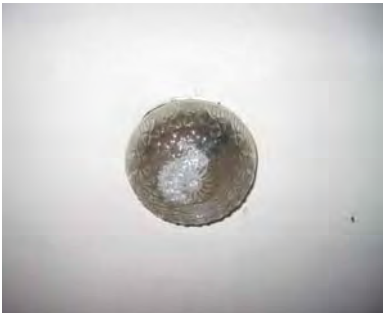
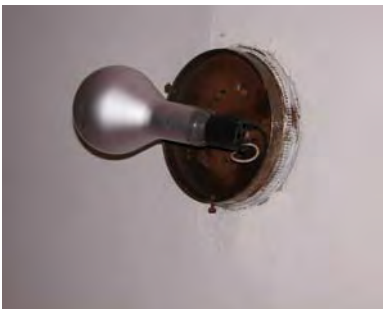
*Fixtures:* Three circular incandescent light fixtures are surfaced mounted to the ceiling. Two of these three fixtures are missing the textured glass globes.

**Figure 3-153:** Incandescent ceiling light fixtures. (Photos: BBB 2006)

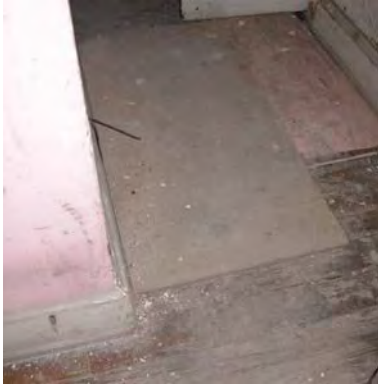
**Figure 3-159:** Room 103 floor.  
(Photo: BBB, 2006)

**Flooring:** The flooring is pine wood of varying widths ranging from 2 ½" to 6" that runs in an east/west direction. Plywood has been installed to cover over areas where the floor and the structure below it have deteriorated. The floor shows significant wear in the path of traffic. The clear floor finish is evident around the base moldings. Significant rot and termite damage of the floor boards has occurred at the base of door D103A.

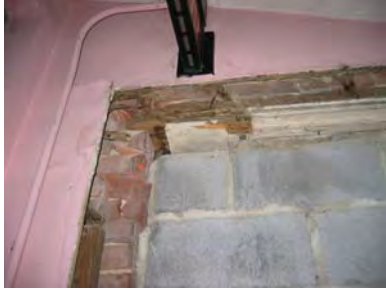
**Figure 3-163:** Door 103A head detail – not shadow of removed mullion. (Photo: BBB, 2006)

*Door D103A:* The door at this location is not extant. The door frame has almost completely been removed and all wood trim has been removed, exposing the brick wall and the edges of the plaster and lath at the door opening. Remnants of the head jamb profile are still nailed to the rotting head framing. These remnants show shadows of where mullions were removed that once created side lights for the door.

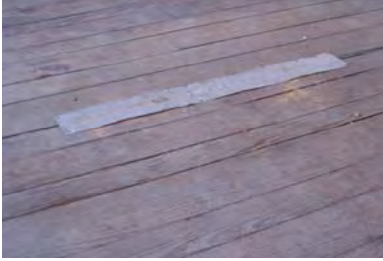
**Figure 3-171:** Room 104 pine wood flooring patch. (Photo: BBB, 2005)

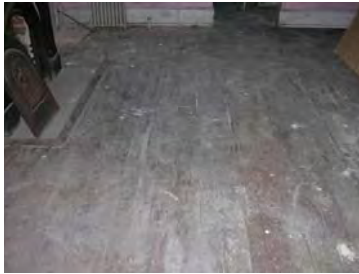
Figure 3-190: Flooring patch in front of fireplace with metal patch. (Photo: BBB, 2006)

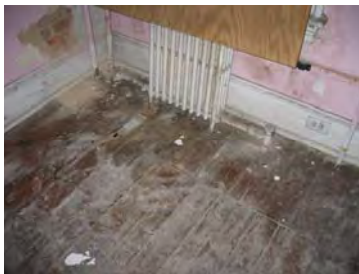
Figure 3-191: Rotting floor below window W103. (Photo: BBB, 2006)

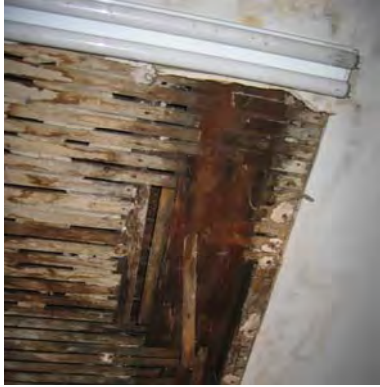
**Ceiling:** The ceiling is gypsum wall board nailed to the existing 1 ½" wood lath and painted white. Portions of the ceiling along the north wall have begun to separate from the lath due to water damage from above. In this area the lath is fully exposed and one can see the interruption of the lath where the north wing wall used to be located that contributed in separating

**Figure 3-192:** Break in lath at ceiling showing where north wing wall once was. (Photo: BBB, 2006)

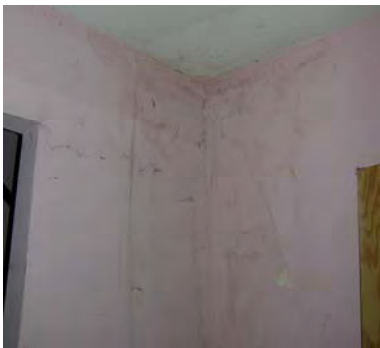
**Figure 3-193:** Water damage at northwest corner. (Photo: BBB, 2006)

Rooms 104 and 105 as separate parlors. Significant water damage and mold formation was evident at the north corner of the west elevation.

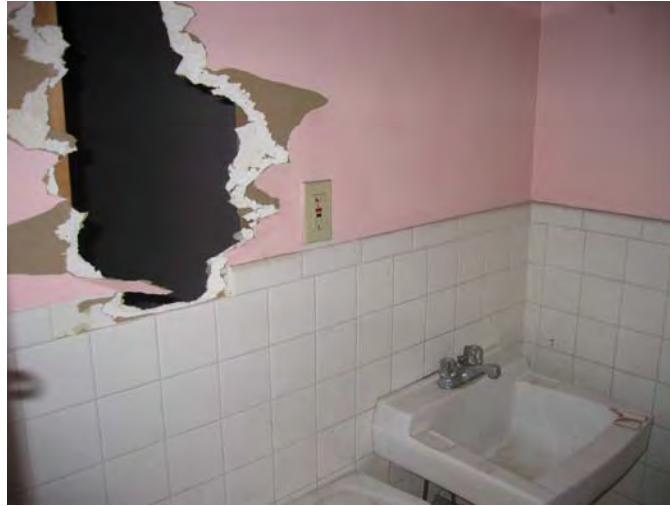
**Figure 3-227:** Hold in GWB at west wall. (Photo: BBB, 2007)

*Walls:* The walls are gypsum wall board painted pink with a 4x4 white ceramic tile wainscot applied up to 3'-6". The wainscot is capped with a 2"x6" ceramic coved trim piece. On the west wall a hole has been made above the tile wainscot that penetrates through the other side of the wall. It was noted that the water pipes within this wall had been cut. The hole was most likely made to cut these pipes so that water was not contained within them during the period that the house was not occupied.

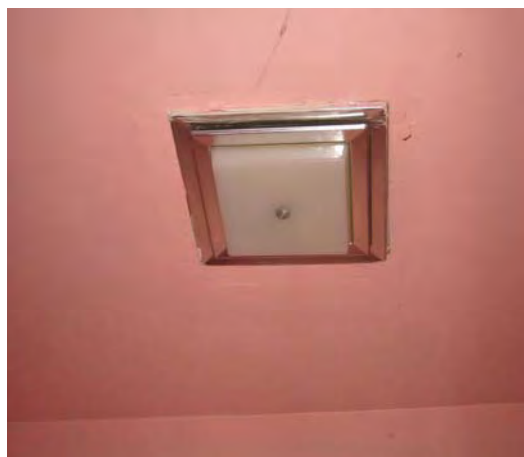
**Figure 3-229:** Light fixture at ceiling. (Photo: BBB, 2007)

*Light Fixture:* 12"x12" steel framed incandescent light fixture with square translucent glass lens. Fixture is semi-recessed into the ceiling.
