## Carter G. Woodson Home

1538 Ninth Street, NW, Washington, DC

**FINAL SUBMISSION  
JANUARY 15, 2008**

# Historic Structure Report

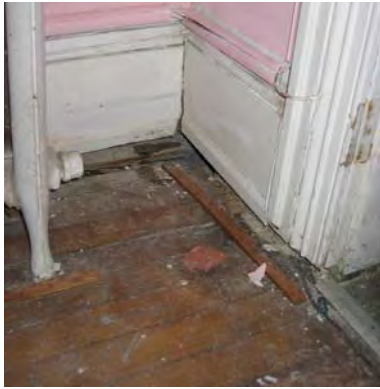
**Flooring.** There are three types of flooring in this room. The flooring directly at the east entry to the room, from Room 103, is 5" pine wood tongue and groove which dates to Period 1. The flooring is 2 1/4" pine tongue and groove strip flooring dates to Period 3. Much of the floor is covered over with 3/4" plywood patching which dates to Period 5 and was installed as a result of the rotting and termite damage to the joists and original flooring. This damage has been caused by the fact that this room, as well as Room 110 have only a crawl space below which has resulted in trapped moisture. The flooring is sagging significantly in the southwest corner, most likely caused by the continued deterioration of the wood floor joists in the crawl space below.

Figure 3-243: Sagging of floor in south west corner. (Photo: BBB, 2007)

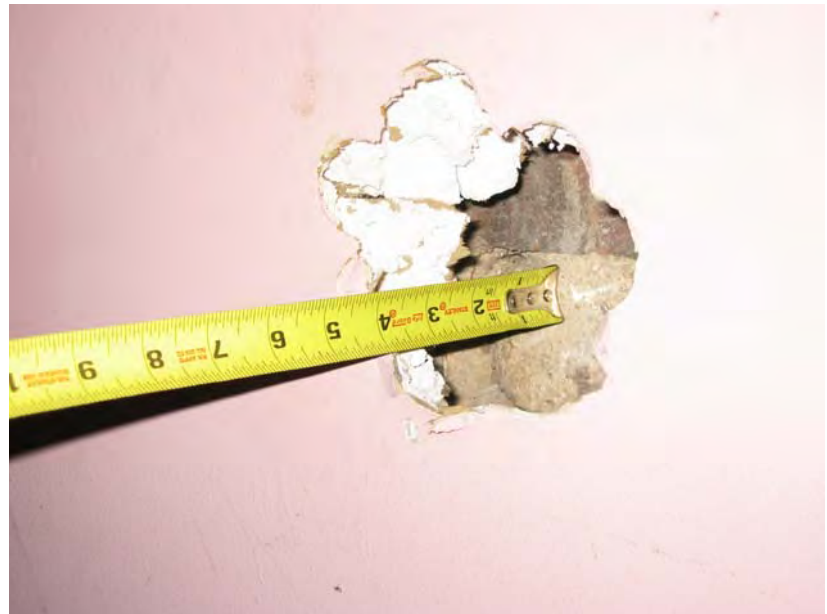
Figure 3-246: Furr-out at south wall. (Photo: BBB, 2007)

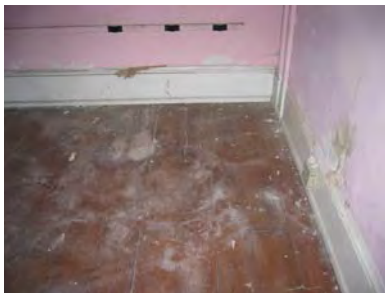
Figure 3-259: Five-inch wood plank flooring. (Photo: BBB, 2007)

**Flooring.** The flooring is 5" pine wood tongue and groove that runs east to west and dates to Period 2. This flooring does not match the varying sized tongue and groove flooring used in the three story portion of the house nor does it match the varying sized tongue and groove flooring that can be seen resting on the second floor joists above Room 110 as a result of portions of the ceiling having fallen. The south portion of the floor in this room is sagging as a result of rotting floor joists in the crawl space below.

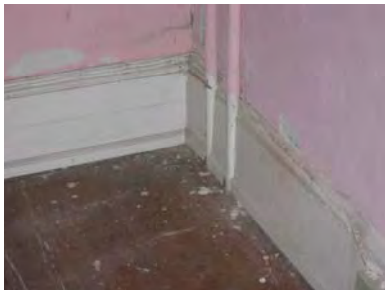
Figure 3-260: Wood base at radiator pipes. (Photo: BBB, 2007)

**Base.** The base is wood painted white and composed of a quarter round and a plain wood base capped by a large ogee trim. (Type-1) Upon first investigation it appears that this molding dates to Period 2 because in areas where the molding is pulling away from the plaster, raw plaster is exposed with no paint. However, at the North wall where radiator pipes lead to the second floor, the base was cut around these pipes indicating that it was installed after the radiators which can be dated to the 1920's.

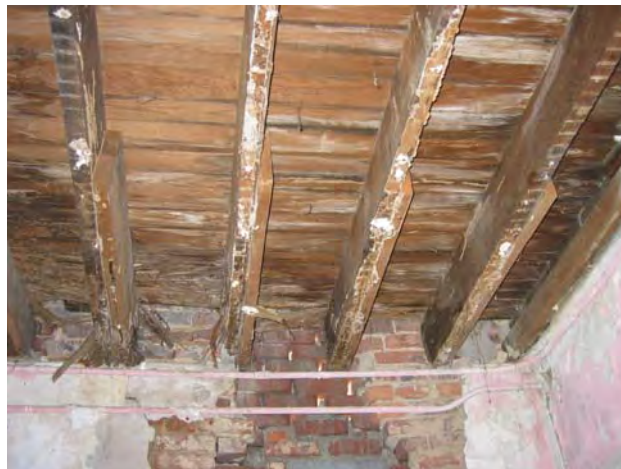
Figure 3-261: Exposed joists with shadowing of lath. (Photo: BBB, 2007)

*Ceiling:* The ceiling is painted gypsum wall board that has been nailed to existing wood joists that support the second floor. A significant portion of the ceiling has been removed along the south elevation and the second floor framing is exposed. The floor joists have experienced significant rot and termite damage. Several joists have new components sistered to them to correct the failing structure. The joists do show a shadow of the wood lath that was once there during Period 1-3.

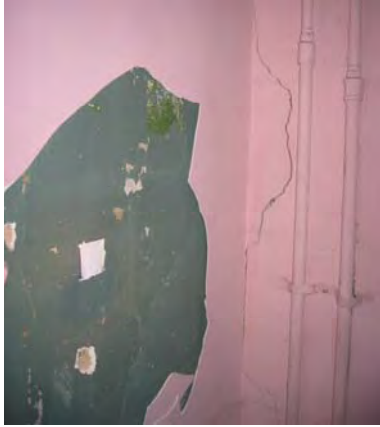
**Figure 3-262:** Plaster damage at west wall. (Photo: BBB, 2007)

The south wall has plaster applied directly to the exterior brick. At least fifty percent of the plaster has fully dislocated from the wall, leaving much of the inside face of the exterior load bearing brick wall exposed. The west wall has plaster applied directly to the exterior brick as well and is painted pink. A thin layer of plaster and paint is delaminating from this wall exposing a dark green color of a previous room finish. This delaminating of material clearly indicates that this room has been skim coated at some point.

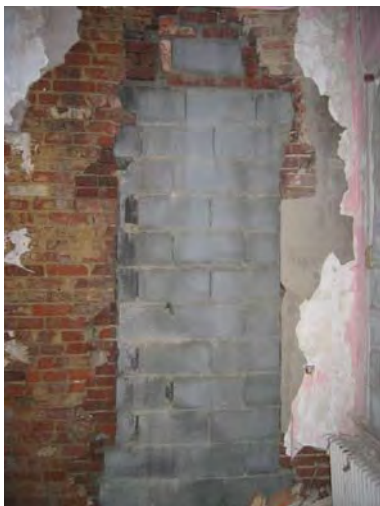
**Figure 3-265:** Door D110A. (Photo: BBB, 2007)

*Door D110A:* This door opening dates to Period 2. However, due to severe deterioration of the wood frame, the opening is close to collapse. There is no longer evidence of the wood frame or wood door. The opening has been filled in with concrete masonry units to stabilize the opening and the exterior wall. It can be noted from the interior that the vertical edge of a brick framed opening does extend from a 7'-0" height to the floor, clearly indicating that this was a door opening, not a window opening.

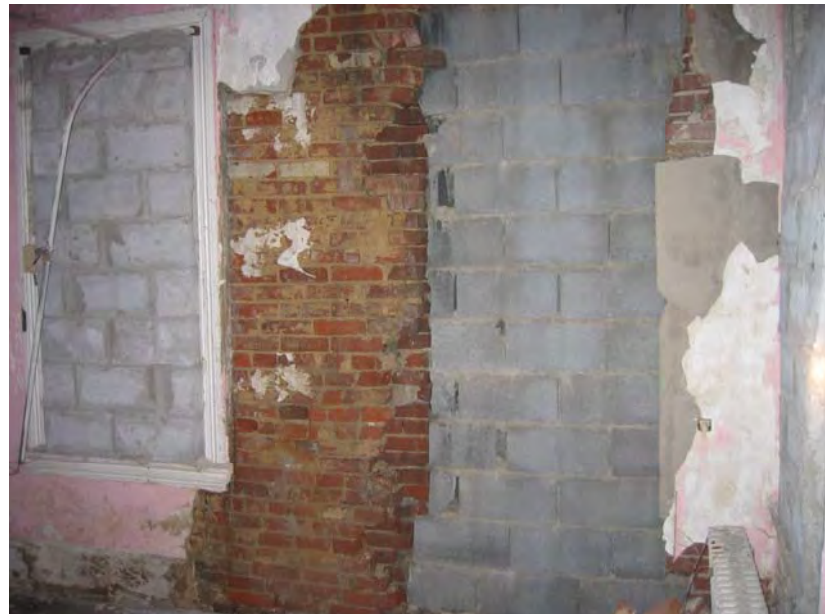
**Figure 3-264:** View of south wall and window W106 and D110A. (Photo: BBB, 2007)

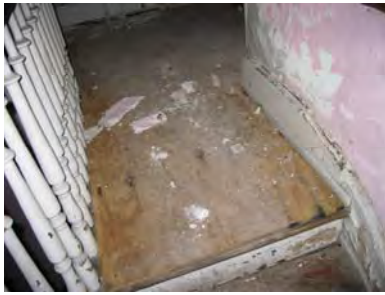
**Figure 3-276:** Plywood patch at top of stairs. (Photo: BBB, 2007)

*Flooring:* The flooring is pine wood tongue and groove of varying widths of 2 ½", 3", 3 ½", 4 ½" and 5 ½". Plywood floor patching has been provided at the top of the stairs where the flooring has significantly deteriorated due to rot and termite damage.

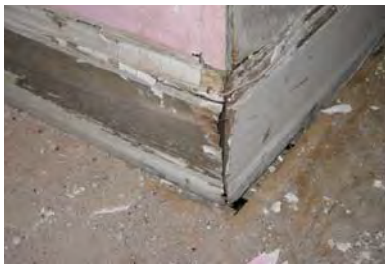
**Figure 3-277:** Deterioration of wood base. (Photo: BBB, 2007)

*Base:* The base is wood painted white and composed of a quarter round and a plain wood base capped by a large ogee trim. (Type-1) Along the east wall the base has suffered significant water damage due to water infiltration from above. At the south wall by Room 207, the base molding has been adjusted due to the shifting of the D207 door frame to allow for the installation of a shower in Room 207 during Period 5.

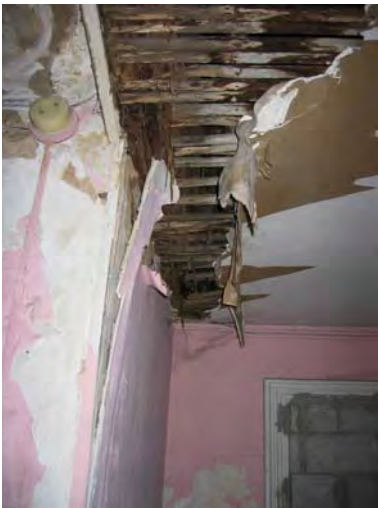
**Figure 3-289:** GWB and wood lath separating from structure. (Photo: BBB, 2007)

*Ceiling:* The ceiling is gypsum wall board nailed to wood lath. Most of the ceiling has fallen at the east end above the stair and the wood lath is exposed and is also detaching from the wood joists. The wood lath is rotting and shows signs of termite damage. This ceiling shows significant water damage due to the continued water penetration at the poor flashing joint of the roof above.

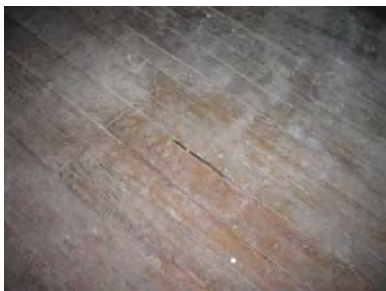
Figure 3-296: Wearing of floor boards.  
(Photo: BBB, 2007)

**Flooring:** The flooring is pine wood tongue and groove of varying widths of 2 1/2", 3", 3 1/2", 4 1/2" and 5 1/2". Plywood floor patching has been provided at the top of the stairs where the flooring has significantly deteriorated due to rot and termite damage. Significant wear of the wood flooring was noted, with most original finishes having been worn off. Evidence of an original finish was noted along the base of the north wall beneath the stair to the third floor.

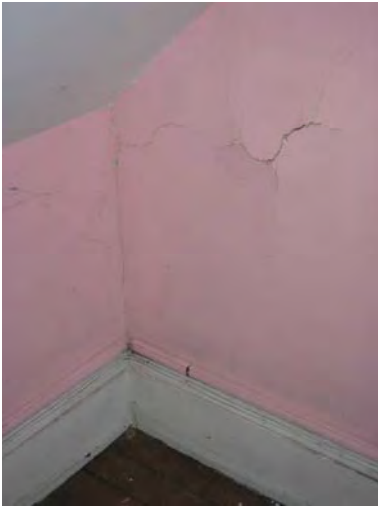
**Figure 3-299:** North wall below stair with cracking plaster.  
(Photo: BBB, 2007)

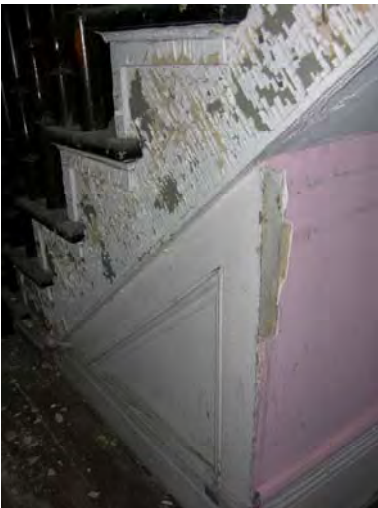
**Figure 3-300:** West wall with evidence of skim coat below stair.  
(Photo: BBB, 2007)

There is a small portion of plaster construction that constitutes the west wall, which is located underneath the stair. This wall is constructed of plaster on wood lath. The plaster at the south edge of this wall has fallen off revealing a wood stop. This condition indicates that at some point the plaster wall was skim coated, most likely immediately prior to or during Dr. Carter G. Woodson's occupancy.

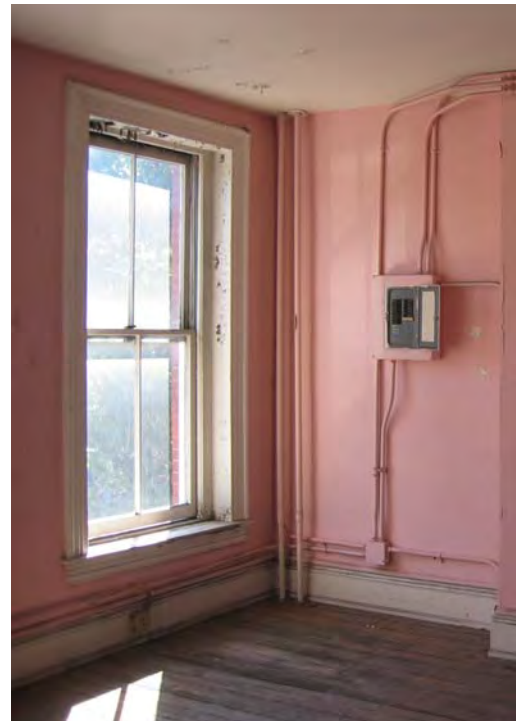
**Figure 3-304:** Surface mounted conduit and box. (Photo: BBB, 2006)

*Walls:* The walls are plaster, painted pink. The plaster on the north wall is applied directly to the brick party wall. The plaster on the east wall is applied directly to the inner face of the exterior brick wall. The plaster on the west wall is applied to 1 ½" wood lath. The south wall plaster is applied to both brick and lath; the chimney chase and closet encroach on the room along this wall. Electrical conduit has been surfaced mounted to the north elevation for increased outlet distribution. An electrical panel and associated conduit have been surface mounted to the south wall by window W203.

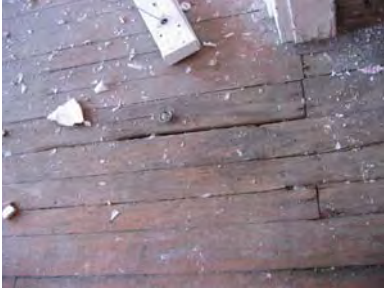
**Figure 3-306:** Floor damage at Door D203. (Photo: BBB, 2006)

*Flooring:* The flooring is pine wood tongue and groove boards of varying widths of 2 ½", 3", 3 ½", 4 ½" and 5 ½" that runs in an east/west direction. Two electrical outlets have been recessed into the floor. Evidence of a clear finish coating can be seen around the perimeter of the room at the baseboard, but the finish coating at flooring in the middle of the room has been completely worn off. The bare floor boards show significant wear and raised graining has become pronounced.

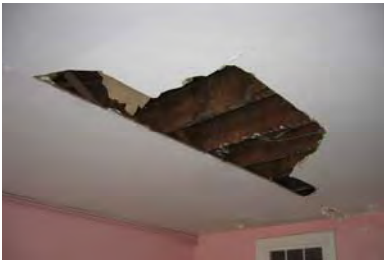
18	Ceiling	Plaster wall board - "Sackett Board" or rock lath - portions of ceiling have fallen	Post 1922	Period 3	JB reviewed sample and identified as rock lath used into the 1920's.		C - Primary
19	Radiator	Type R7 - Painted Cast Iron Radiator made by American Radiator Co. along north wall	Post 1922	Period 3	Based on American Radiator Co. catalogs, the three column radiators date to the early 1920's.		C - Primary

**Figure 3-308:** Loss of plaster wall board ceiling. (Photo: BBB, 2006)

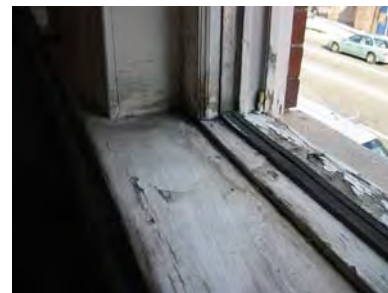
*Windows 201, 202 & 203:* The window frames and stools are mitered wood painted white. (Frame type-1, sill type-1) The windows are two over two windows with aluminum tracks and have been retrofitted into the existing frame with a painted wood frame extension. The existing window hardware is brass. The sashes are painted white. At window W201, the left lite of the bottom sash is cracked. At window W202, the bottom sash has Plexiglas laminated to the outside and the left lite is broken. At window W203 right lite of the top sash is cracked.

**Figure 3-322:** Window W203 sill detail.  
(Photo: BBB, 2006)

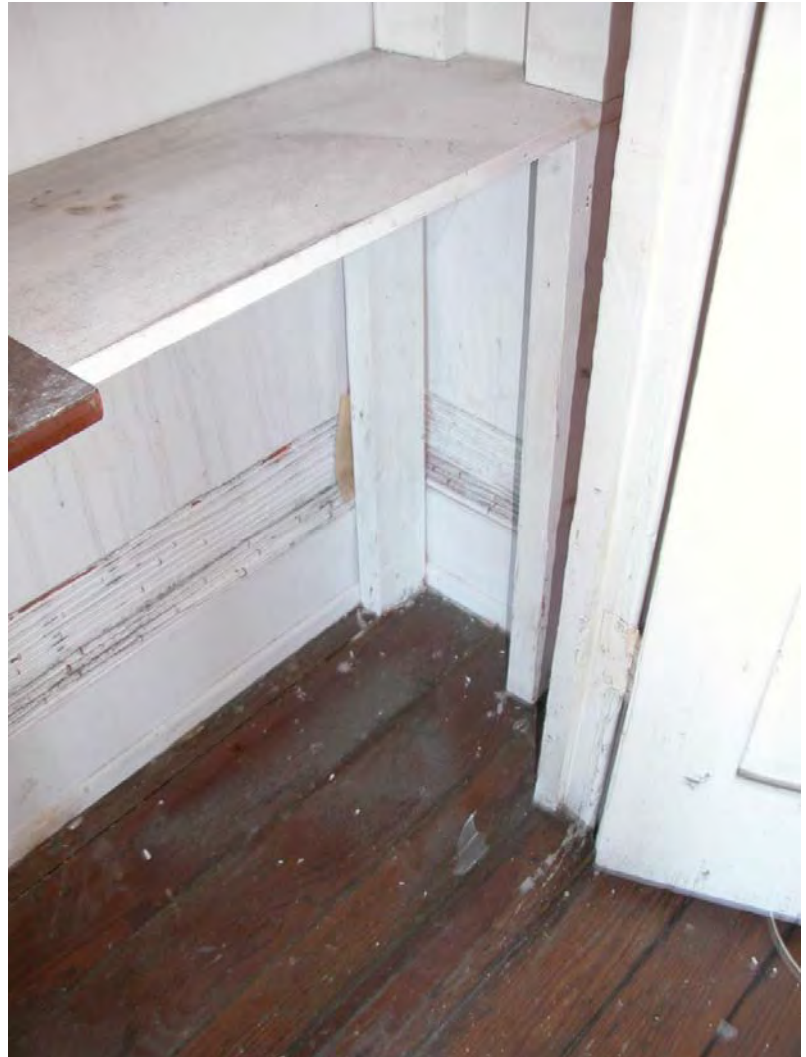
Figure 3-331: Shelving and base condition. (Photo: BBB, 2007)

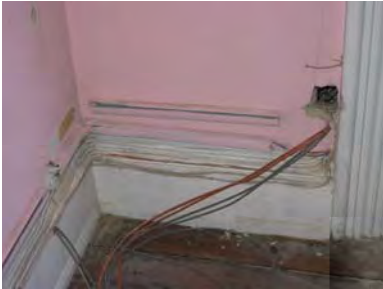
**Figure 3-337:** Wood base at south east corner. (Photo: BBB, 2007)

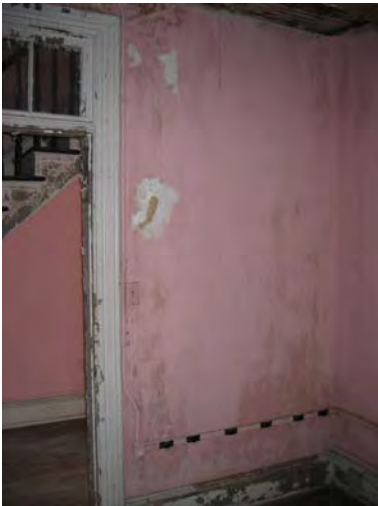
**Figure 3-338:** Water damage at north wall. (Photo: BBB, 2007)

*Walls:* The walls are plaster, painted pink. The plaster on the north wall is applied to wood lath. Due to the continuous leaks from the roof and the transferring of water from the third to the second floor along this wall as a result of these leaks, much of the plaster is in poor condition and has suffered severe water damage.

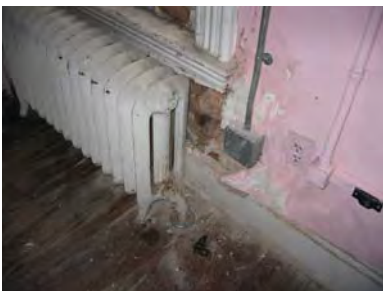
**Figure 3-340:** Plaster damage below window W204. (Photo: BBB, 2007)

The south wall plaster is applied to both brick and lath; the chimney chase and closet encroach on the room along this wall. The west wall has plaster applied to wood lath which is both applied to wood studs and masonry as a result of the wall being partly composed of an exterior wall. This west wall has experienced severe water damage to the plaster below window W204. There are major cracks and loss of plaster behind the radiator.

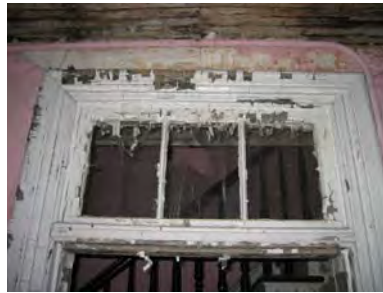
**Figure 3-341:** Transom at door D205.  
(Photo: BBB, 2007)

*Door D205:* The wood door frame has mitered wood molding and a transom (type-3) (15 ¾"x31") with three vertically divided lites and the door casing follows casing molding type-1. One of the lites in the transom panel is broken. The door opening measures 31 ½"x79" however the door is not extant. There is a wood threshold that measures 2 ¾" in width. There are remnants of hardware that exist on the frame that are composed of one hinge and a latch for the box set hardware. This frame has suffered significant deterioration due to water damage, with loss of paint and wood rot.

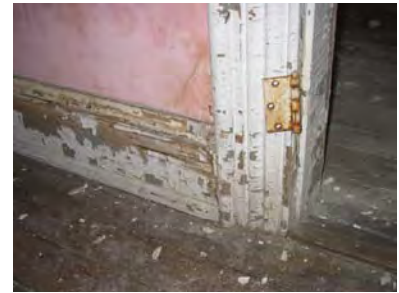
**Figure 3-342:** Frame profile at D205.  
(Photo: BBB, 2007)

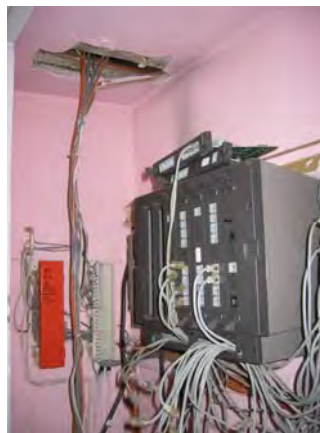
Figure 3-356: Telephone distribution box on south wall. (Photo: BBB, 2007)

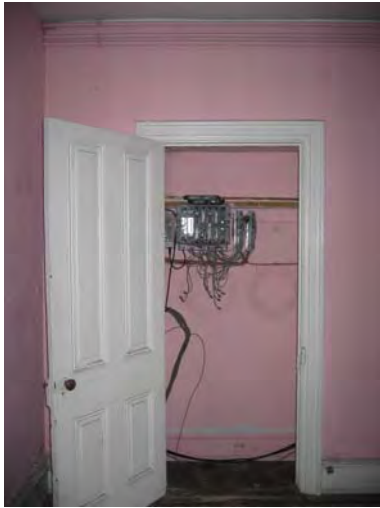
**Figure 3-357:** Note shadow in paint where shelf once was. (Photo: BBB, 2007)

*Miscellaneous:* Wood shelving and shelf supports were installed in the closet. The top wood support members on the east and west walls have been notched to receive a clothing rod. Shadows in the paint show where a shelf was once installed that was later removed. This closet could therefore have been used for a clothing closet; however, during Dr. Carter G. Woodson's occupancy he used this room as his library. The shelving could pre-date Woodson's occupancy but was most likely modified during his use to be a closet that supported his library.

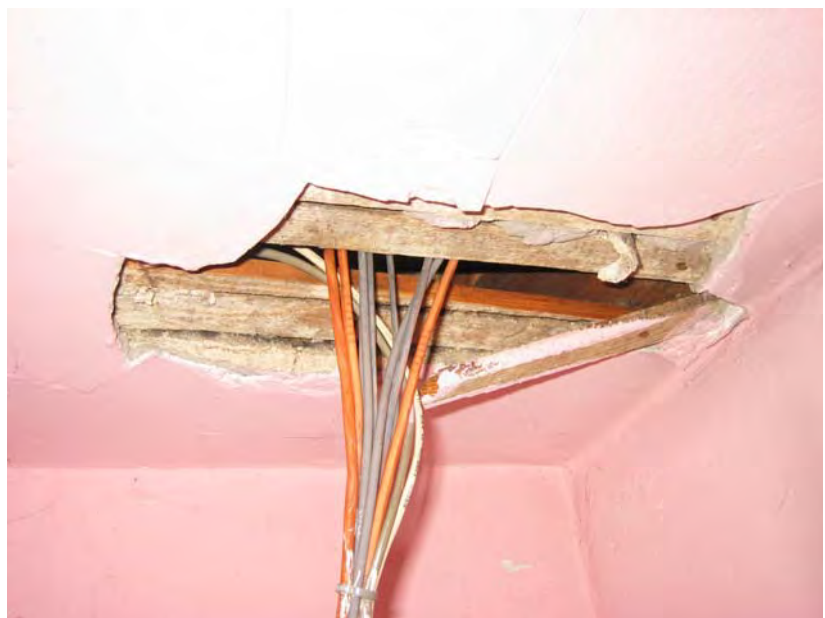
*Ceiling:* This ceiling is made of plaster applied to wood lath and is painted pink. It is set at a different height than the ceiling of the main room. There is a hole in this ceiling where telephone distribution wires have been run from the panel up to the third floor.

**Figure 3-358:** Hole in plaster at ceiling. (Photo: BBB, 2007)

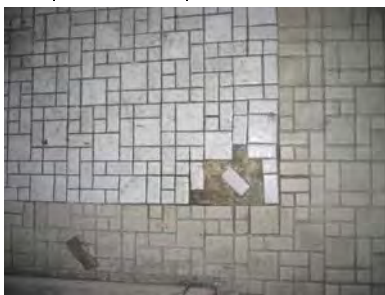
Figure 3-363: Patch at tile flooring.  
(Photo: BBB, 2007)

**Flooring:** The flooring is white porcelain mosaic tile with ¾" and 1 ½" squares and ¾"x1 ½" rectangles used in a non-regular pattern. The tile is set on a mortar bed on top of a plywood underlayment. The tile beneath the sink has been patched with a tile of similar size but a slightly different texture. The tile extends fully beneath the tub indicating that shower was installed at a later date during Period 5.

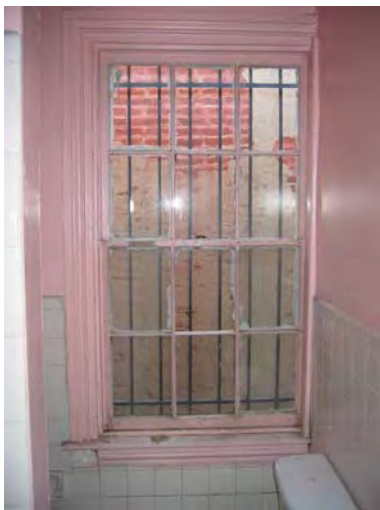
**Figure 3-366:** Window W206. (Photo: BBB, 2007)

*Window W206:* The window frame and stool are mitered wood painted white. The window is a six over six wood double hung window with a rope pulley and counter weight operation. The existing window hardware is brass. The sashes are painted pink however there is significant paint loss on the lower sash and the sill. The window dates to Period 1. (Sill type-4, frame type-4, muntin type-3) The bottom sash has Plexiglas mounted to the inside of the sash and one glass lite is missing in this sash. The west wall of this room intersects the window frame at a peculiar location. The application

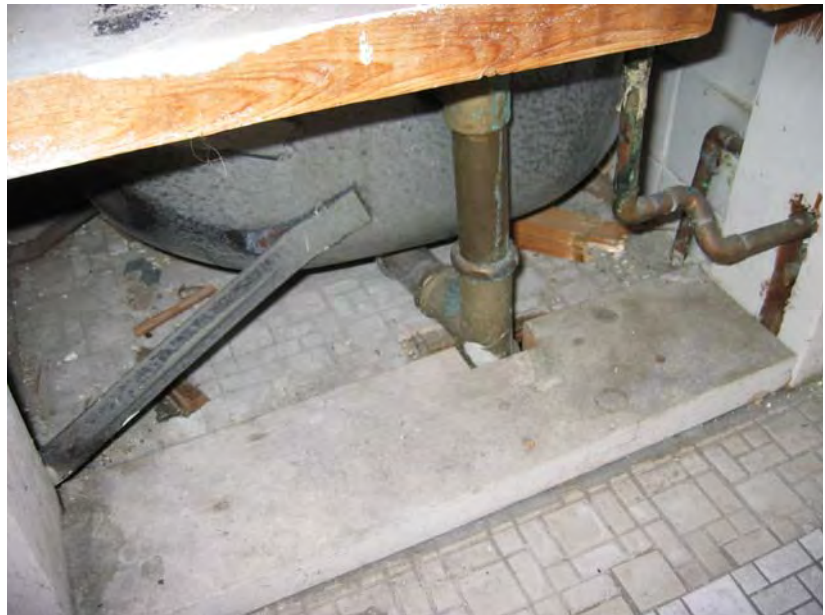
**Figure 3-365:** Tile extending below tub. (Photo: BBB, 2007)

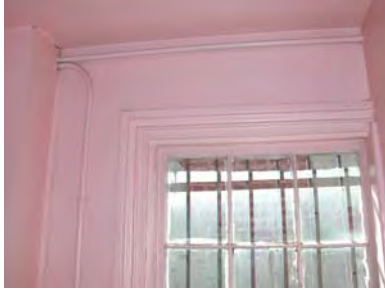
**Figure 3-368:** Wall runs into window frame. (Photo: BBB, 2007)

of gypsum wallboard to the original wall makes this condition even more exaggerated.

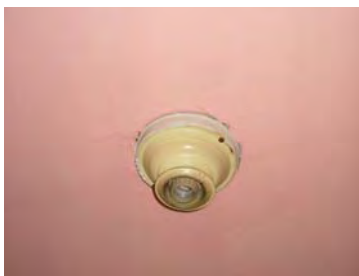
A surface mounted incandescent fixture is located at the center of the ceiling and is missing its glass globe.

**Figure 3-373:** Surface mounted incandescent fixture. (Photo: BBB, 2007)

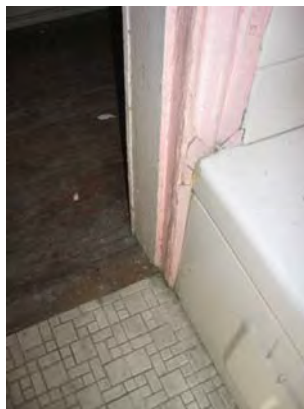
**Figure 3-374:** Tub interferes with door frame. (Photo: BBB, 2007)

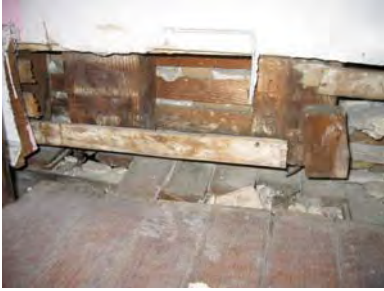
**Figure 3-382:** Exposed studs and lath at east wall. (Photo: BBB, 2007)

*Walls:* The walls are plaster, painted pink. The plaster on the north wall is applied to directly to the exterior masonry wall. The east wall has gypsum wall board nailed to 1 ½" wood lath. This wall construction can be seen along the floor where the baseboard was removed. The studs supporting this wall are 3"x4" timber studs and cut nails can be seen protruding from both the sides and bottoms of these studs. The cut nails place the wall in Period 1 or 2. It appears that the floor joist that these studs were once nailed to has sagged, for none of the bottoms of these studs remain attached to the joists.

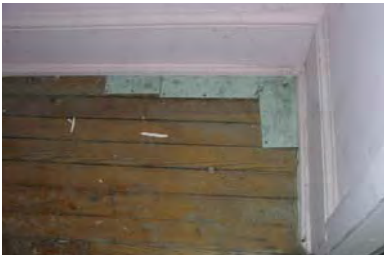
**Figure 3-406:** 2 1/4 Strip flooring and floor patches. (Photo: BBB, 2007)

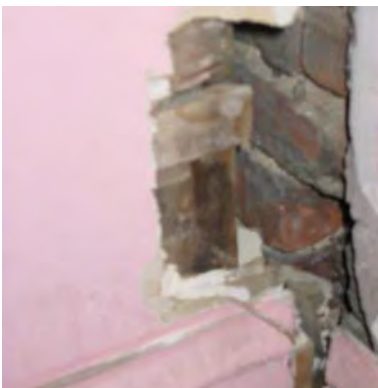
**Figure 3-409:** Opening at east wall corner along south wall exposing timber stud. (Photo: BBB, 2007)

*Walls:* The walls are plaster, painted pink. The north wall is gypsum wall board nailed to wood lath as is the east wall. Where the east wall meets the south wall a gap reveals the 3"x4" wood studs and the wood lath of the east wall, dating it to Period 2. The south wall is plaster applied directly to exterior brick. This plaster has suffered water damage. The west wall is also gypsum wall board nailed to wood lath.

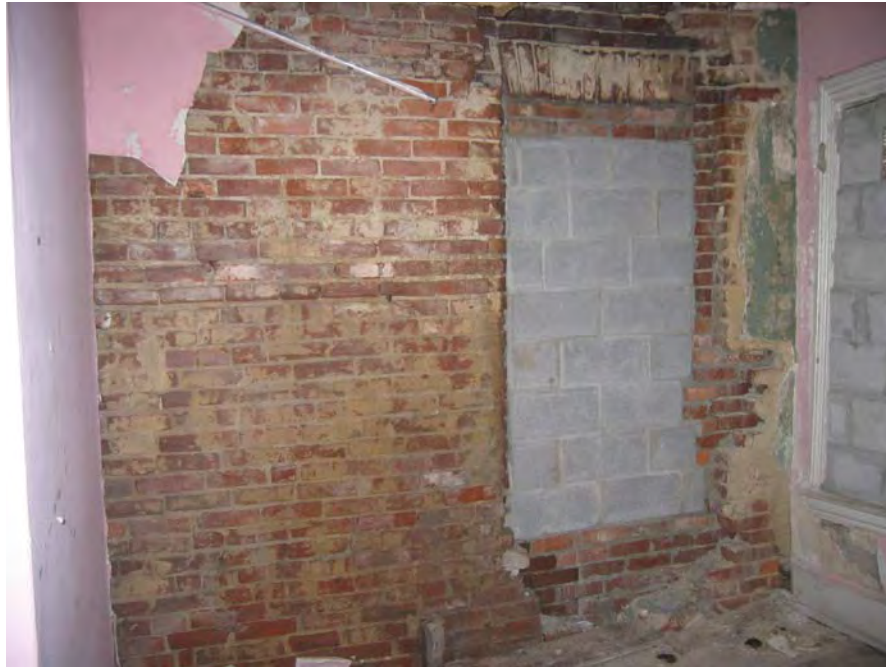
Figure 3-412: South elevation with window opening W209 showing complete loss of plaster.  
(Photo: BBB, 2007)

*Window Opening W209:* This window has been completely removed from the masonry opening and the opening has been filled with concrete masonry units during Period 5. The window was infilled as a result of both the rotting wood window and the failing brick flat arch.

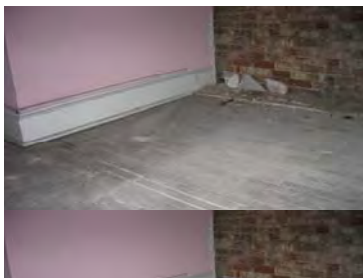
Figure 3-416: Worn pine strip flooring. (Photo: BBB, 2007)

**Flooring:** The flooring is 2 ½" pine wood tongue and groove strip flooring that runs in an east-west direction. This floor was installed on top of a plywood underlayment that rests on the 1880's floor. This layering of flooring can be observed from Room 110 below and indicates that the top flooring was replacement flooring. The floor sags significantly as a result of

the failing floor joists below. These joists are no longer resting on the south masonry wall and as a result the floor sloped significantly to the south.

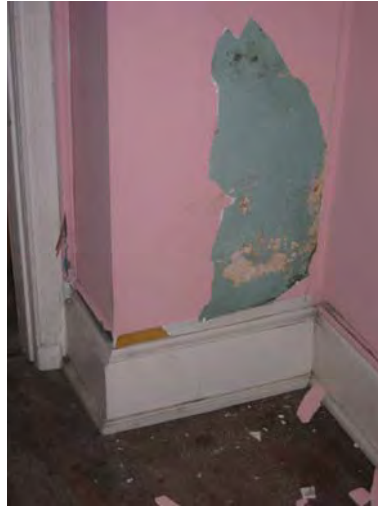
**Figure 3-417:** Wood base and plaster damage at chimney flue. (Photo: BBB, 2007)

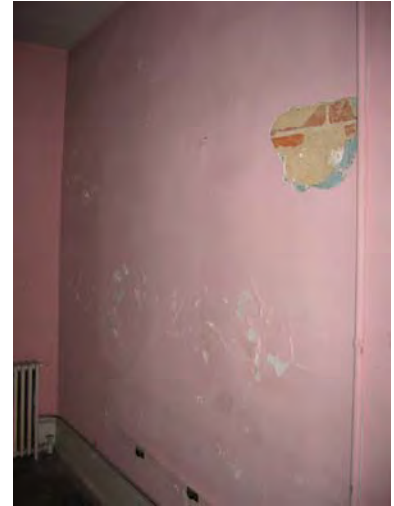
**Figure 3-418:** North elevation showing water damage to plaster. (Photo: BBB, 2007)

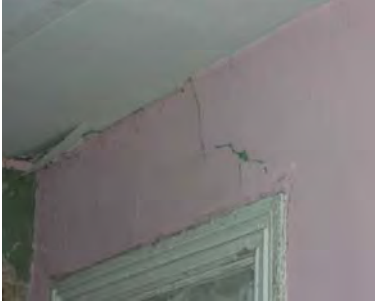
**Figure 3-420:** Plaster damage above W210. (Photo: BBB, 2007)

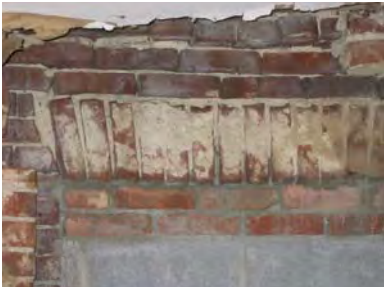
**Figure 3-421:** Failing flat arch at window W209. (Photo: BBB, 2007)

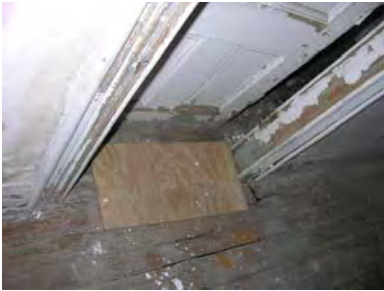
**Figure 3-427:** Plywood patch at floor of door D305. (Photo: BBB, 2007)

***Flooring:*** The flooring is pine wood tongue and groove strip flooring of varying widths of 2 ½", 3", 3 ½", 4 ½" and 5 ½". Plywood floor patching has been provided at door opening D305 where the flooring has significantly deteriorated due to rot and termite damage. The flooring along the west wall and at portions of the south wall is sagging significantly as a result of the deteriorating second floor wood floor joists below. A small floor patch has been provided directly below window W303.

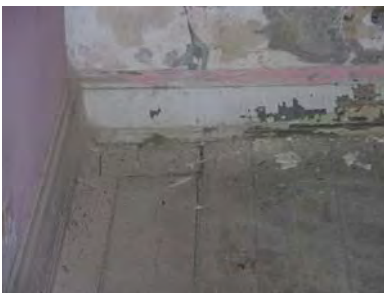
**Figure 3-428:** Floor and base damage at south west corner. (Photo: BBB, 2007)

***Base:*** The base is wood painted white and composed of a quarter round and a plain wood base capped by a large ogee trim. (Base type-1) Along the east and south wall the base has suffered significant water damage due to water infiltration.

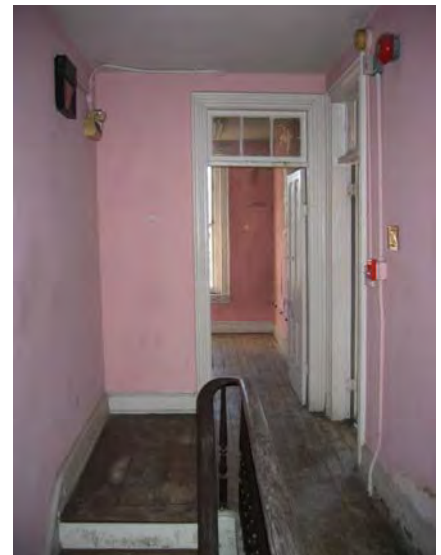
The east wall is plaster applied to wood lath and has been painted pink. The south wall is plaster applied to wood lath. Above and surrounding door D305 the plaster has experienced severe water damage. As a result of the hole in the ceiling above this door and the staining visible on the roof joists, this location was previously a point of significant water penetration due to a failing roof. The roof has since been patched preventing further deterioration of plaster in this location. A smoke alarm, pull station, fire alarm strobe, fire alarm bell and surface mounted conduit are located on this wall to the right of door D303A.

**Figure 3-430:** Plaster damage at south wall. (Photo: BBB, 2007)

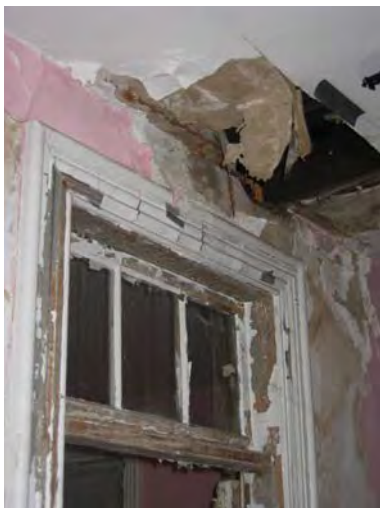
**Figure 3-440:** Transom damage at door D305. (Photo: BBB, 2007)

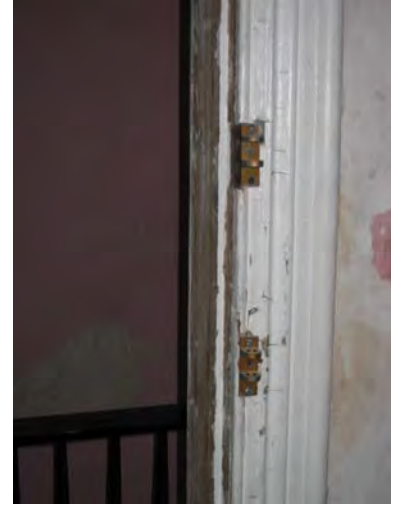
*Door D305:* The door opening ( $31 \frac{1}{2}'' \times 78 \frac{3}{4}''$ ) has a wood frame painted white with mitered casing molding and a transom with three vertically divided lites. (Casing molding type-6, transom type-3) There is a  $3 \frac{1}{2}''$  wood threshold that is mostly covered over by the plywood patch panel. The door is detached from the frame as a result of the hinges disengaging from the wood because of water deterioration and is of a stile and rail construction with two over two recessed panels. (Molding type-8) This door has significant paint loss as does the frame due to the constant leaking of water directly above the door. Hardware set 11 was used and a deadbolt had been installed on the Room 305 side of the door. An additional latch is located on the frame indicating that there has another deadbolt on this door previously. Similar to door D303A, the door jamb has been damaged due to frequent relocation of latching devices.

**Figure 3-444:** Door D305 frame damage. (Photo: BBB, 2007)

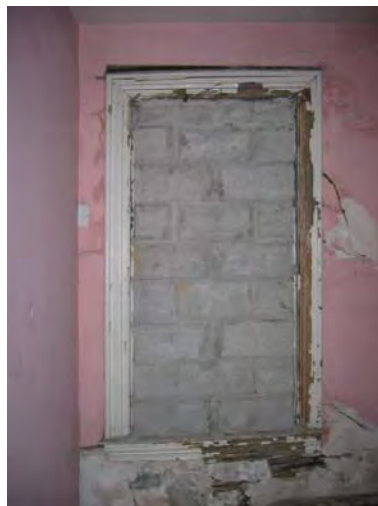
**Figure 3-445:** Frame damage at W303.  
(Photo: BBB, 2007)

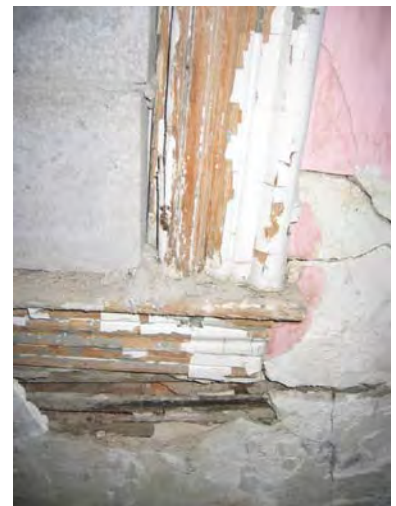
**Figure 3-446:** Sill condition at W303.  
(Photo: BBB, 2007)

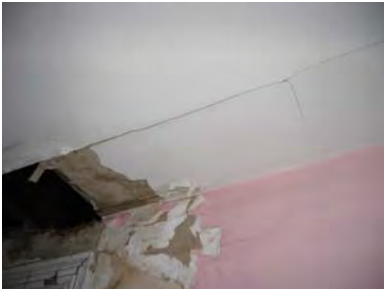
**Figure 3-449:** Cracks at rock lath ceiling panels. (Photo: BBB, 2007)

*Ceiling:* The ceiling is rock lath nailed to the wood joists. Rock lath, as noted in the Conservator's Report in Appendix A, is an early version of gypsum wall board that came in panels of 16"x4'-0". The seams of the panels have generated hairline cracks in the ceiling finishes that clearly delineate the size and location of each panel. This ceiling shows significant water damage directly above door D305 due to water penetration at a roof leak that has since been patched. A wire mesh and plaster patch was attempted at the top of this door at some point after the installation of the rock lath.

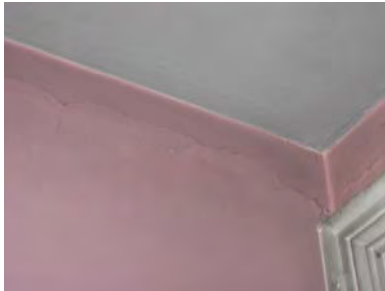
**Figure 3-458:** Hairline cracks on walls close to ceiling. (Photo: BBB, 2007)

south wall as well as loss of paint due to water damage. A major crack in the plaster was noted to the right of door D302 that extends the length of the wall. A hairline crack appears approximately 5" below the ceiling on all four walls. Electrical conduit is surface mounted to the north and south walls to provide additional outlets.

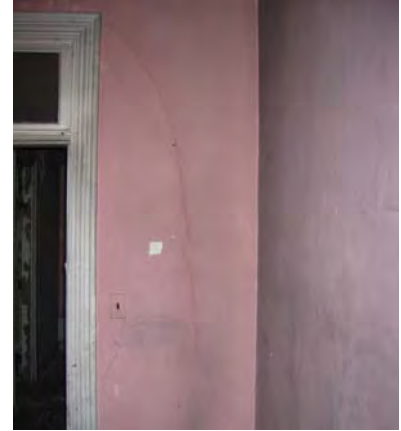
**Figure 3-460:** Major crack in plaster by door D302. (Photo: BBB, 2007)

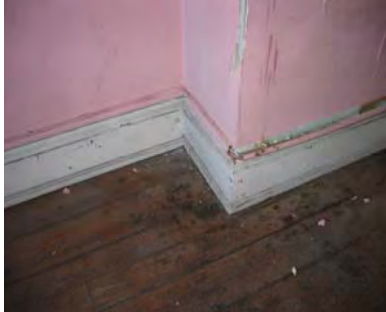
**Figure 3-467:** Wood base at south wall with surface mounted conduit. (Photo: BBB, 2007)

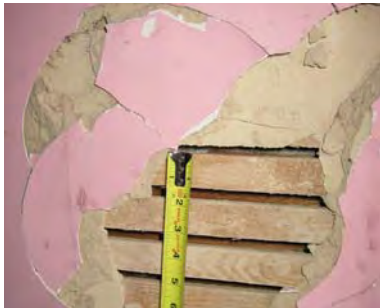
**Figure 3-468:** Loss of plaster at north wall exposing wood lath. (Photo: BBB, 2007)

*Walls:* The walls are plaster, painted pink. The north wall has plaster applied to wood lath. This wall has suffered severe water damage as a result of a previous leak in the roof. Major cracks are evident in the plaster and there is loss of plaster in the middle of the wall, exposing wood lath.

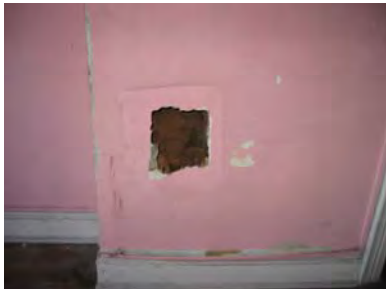
**Figure 3-470:** Probe at south wall chimney chase. (Photo: BBB, 2007)

A probe hole was made at the chase location of this wall, revealing the construction of the flue. A curved metal tube was found in the chase. This metal tubing was also found in the first floor fireplaces and in the basement. Per the historic catalog documentation found on the fireplaces and grilles on the first floor, this tubing was an early form of ductwork that was attached to the furnace in the basement and attached on each floor to a decorative grille with louvers. The uncovering of the elbow at this location implies that the tube turned to the wall to meet a grille at this location. This tubing dates to Period 1 when the fireplace grilles were installed.

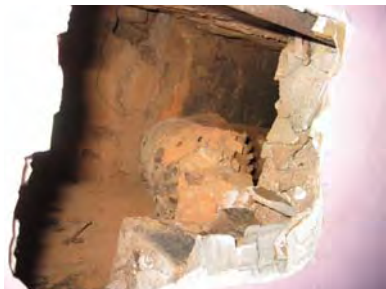
**Figure 3-471:** Metal tube elbow at chimney. (Photo: BBB, 2007)

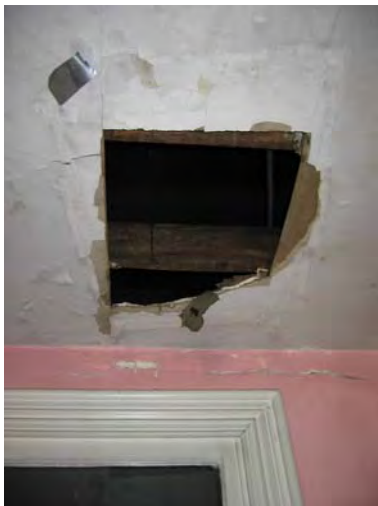
**Figure 3-482:** hole in ceiling by door D303B. (Photo: BBB, 2007)

*Ceiling:* The ceiling is rock lath nailed to wood lath. The seams of the panels have generated hairline cracks in the ceiling finishes that clearly delineate the size and location of each panel. Partial loss of ceiling was noted by door D303B as a result of previous water penetration from leaks in the roof.

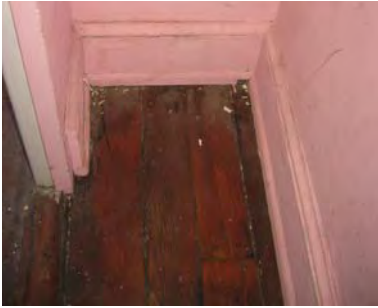
**Figure 3-486:** Flooring with evidence of a floor finish. (Photo: BBB, 2007)

***Flooring:*** The flooring is pine wood tongue and groove strip flooring of varying widths of 2 ½", 3", 3 ½", 4 ½", 5 ½" and 6". The floor finish is relatively intact and indicates what the finish would have been for the adjacent Room 304.

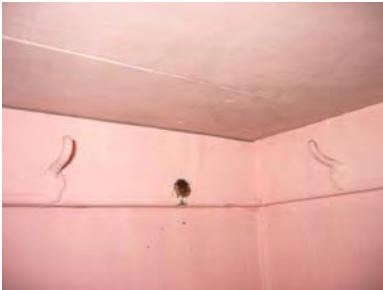
**Figure 3-487:** Underside of shelf with missing hook exposing stained finish. (Photo: BBB, 2007)

***Miscellaneous:*** A wood shelf has been installed and is painted pink and hooks are mounted to the shelf support. Hooks have been installed along the horizontal shelf support members. Where one of the hooks was removed, a stained finish can be seen on the shelf support board.

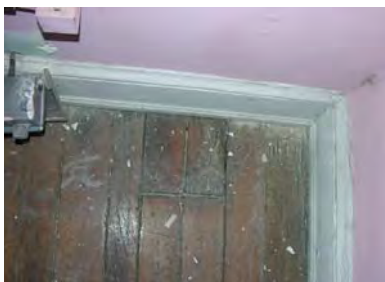
**Figure 3-495:** Flooring condition at northwest corner. (Photo: BBB, 2007)

**Flooring:** The flooring is pine wood tongue and groove strip flooring of varying widths of 2 1/2", 3", 3 1/2", 4 1/2", 5 1/2" and 6". The floor shows moderate wear in the middle of the room and the floor finish can be seen at the base around the perimeter. This floor shows less wear than most rooms in the house.

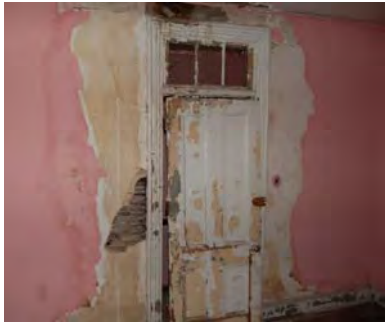
**Figure 3-496:** Plaster damage at north wall by door D305. (Photo: BBB, 2007)

*Walls:* The north wall has plaster applied to wood lath and is painted pink. This wall has suffered significant water damage, especially around door opening D305. There are major cracks in the plaster and some plaster loss as a result of a long term leak above this door.

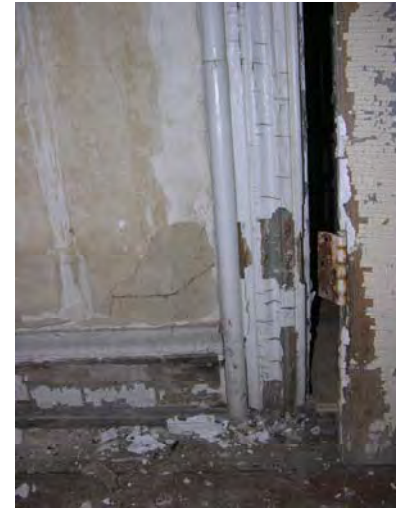
**Base:** The base is wood painted white and composed of a quarter round and a plain wood base capped by a large ogee trim. (type-1) Along the west and north walls the base has suffered significant water damage due to water infiltration.

**Figure 3-498:** Water damage at wood base on north wall. (Photo: BBB, 2007)

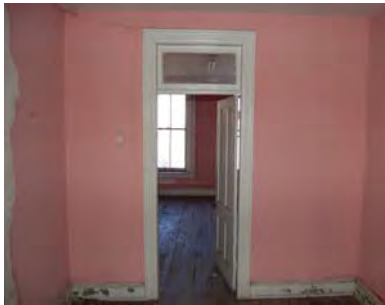
**Figure 3-499:** East wall. (Photo: BBB, 2007)

The east wall is plaster applied to wood lath and has been painted pink. Many hairline cracks were identified on this wall.

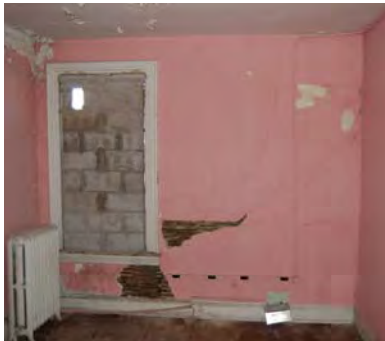
**Figure 3-500:** Plaster loss at west wall. (Photo: BBB, 2007)

The west wall has plaster applied to lath that is attached to the exterior masonry wall. Major cracks were noted throughout this wall as a result of the significant shift of the wall due to the failing support structure below. In addition to the cracks, there is significant water damage to the plaster directly below window W304, with major cracks and separation of the plaster from the lath as well as plaster loss.

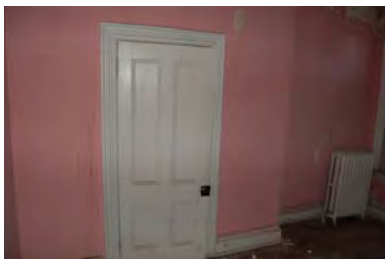
The south wall is composed partly of the masonry party wall where plaster is applied directly to the brick. The protrusion from this wall is composed of a chase for the chimney flues and a closet. The chase is constructed of brick and plaster is applied directly to the brick. The closet is framed with wood studs and plaster is applied to wood lath. The western edge of this protrusion has a wood edge strip that has loss of paint and plaster. The partial exposure of this edge strip shows that the wall was at some point skim coated. Some loss of paint and limited areas of severe water damage were noted on this elevation.

**Figure 3-501:** South wall with plaster water damage. (Photo: BBB, 2007)

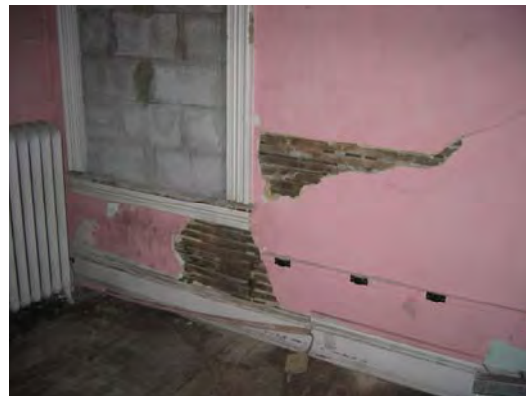
**Figure 3-502:** Loss of plaster and major cracks at west wall by window W304. (Photo: BBB, 2007)

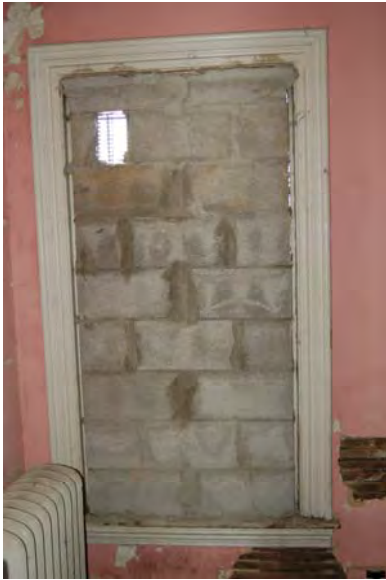
**Figure 3-503:** CMU infill at window W304. (Photo: BBB, 2007)

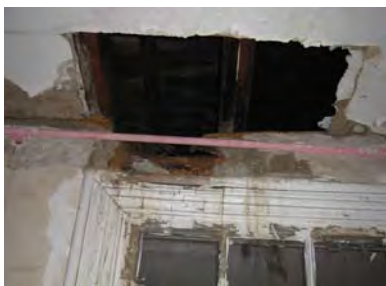
**Figure 3-505:** Hole at ceiling by door D305. (Photo: BBB, 2007)

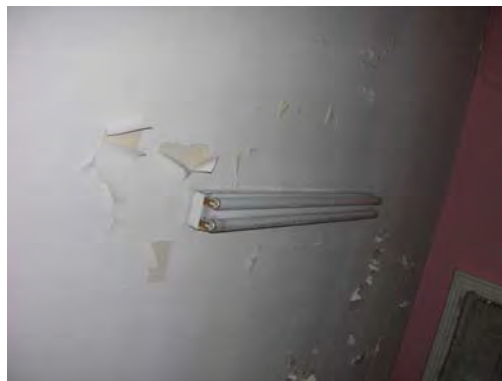
**Figure 3-506:** Ceiling showing light fixture and paint loss. (Photo: BBB, 2007)

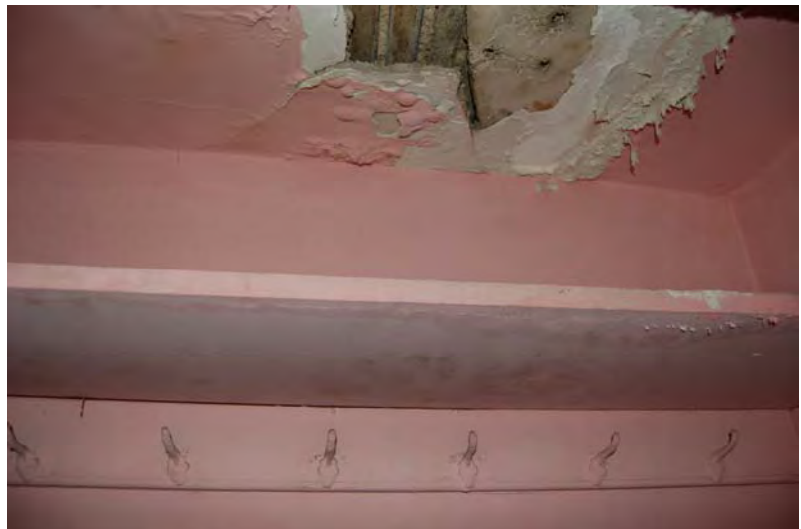
*Miscellaneous:* A wood shelf has been installed and is painted pink and hooks are mounted to the shelf support. Hooks have been installed along the horizontal shelf support members. Where one of the hooks was removed, a stained finish can be seen on the shelf support board.

**Figure 3-514:** Wood shelf and hooks under mounted on shelf support.  
(Photo: BBB, 2007)

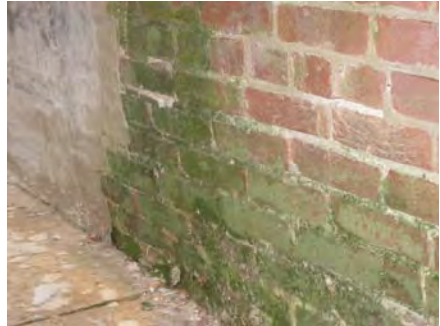
EXTERIOR BRICK	SYMBOL	CONDITION	LOCATION	EXAMPLE IMAGE
	BIO GR	Biological Growth	South Elevation, Brick Below East Elevation Entry Stair

DESCRIPTION		POTENTIAL CAUSES	
	Unwanted growth or infestation of fungi, algae, microbes or plants that may result in organic staining and bio-deterioration of the pore structure of the masonry. (Photo: South elevation at grade.)		Biological growth is associated with excess moisture in protected areas and is related to fluctuations in temperatures. It often occurs where there is not adequate drainage of rain water. It also provides the perfect environment for insect and animal infestations, and may indicate elevated moisture levels within the substrate.

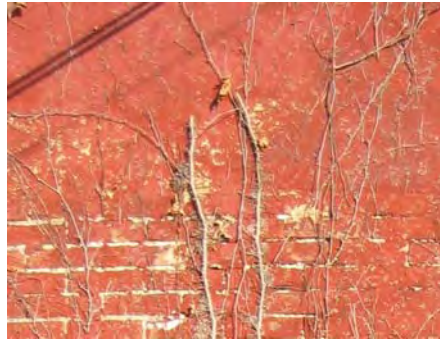
EXTERIOR BRICK	SYMBOL	CONDITION	LOCATION	EXAMPLE IMAGE
	CC	Cementitious Coating	West Elevation

DESCRIPTION		POTENTIAL CAUSES	
	A cementitious coating has been applied to the top half of the West Elevation at the two story addition. Significant cracks in the brick load bearing wall have translated through the coating, causing it to be unstable and separate from the brick. (Photo: West Elevation at second floor line).		Structural failure of the southwest corner of the West Elevation is caused by failing structure in openings on the South Elevation, resulting in cracks in the cementitious coating. Continuous vegetative growth has also contributed to increased moisture levels in the substrate and subsequent failing of mortar joints and coating.

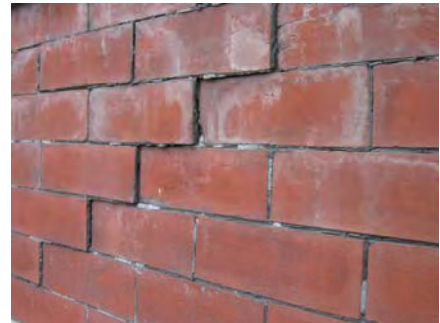
EXTERIOR BRICK	SYMBOL	CONDITION	LOCATION	EXAMPLE IMAGE
	CJ	Crack Through Masonry Joint	Discrete locations on North, East, South and West Elevations

DESCRIPTION		POTENTIAL CAUSES	
	A crack that follows the mortar joints of the brick and doesn't translate through the brick. In some cases these cracks result in brick displacement. (Photo: East Elevation – note that photo also shows displacement of brick outward)		Joints open due to weathering or differential stresses from movement within the building envelope. The mortar can be further damaged with salts and moisture migration.

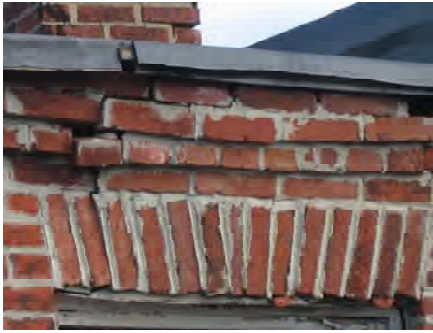
EXTERIOR BRICK	SYMBOL	CONDITION	LOCATION	EXAMPLE IMAGE
	DIS-B	Dislocated Brick	North, West and South Elevations

DESCRIPTION		POTENTIAL CAUSES	
	Brick units that have shifted out of plumb or are not level. (Photo: West Elevation - Three Story Structure above Window W304).		Dislocation of the brick units may be caused by differential movement within the masonry wall or deterioration of adjacent mortar caused by excessive penetration of moisture within the wall.

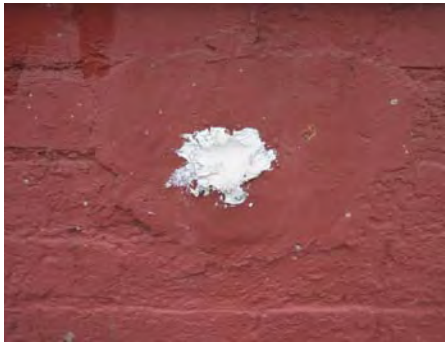
EXTERIOR BRICK	SYMBOL	CONDITION	LOCATION	EXAMPLE IMAGE
	IC	Incompatible Patch	West and South Elevations

DESCRIPTION		POTENTIAL CAUSES	
	Previous repair of the masonry which is physically incompatible with the historic fabric (Photo: Patch at East Elevation below water course.)		Previous penetrations through the brick which have been abandoned have required patching. The patching materials are not sympathetic to the historic fabric and may fail as a result of improper testing of the repair system or a misunderstanding of the long term effects of the repair from weathering.

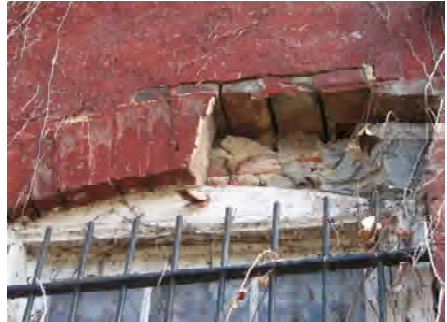
EXTERIOR BRICK	SYMBOL	CONDITION	LOCATION	EXAMPLE IMAGE
	MI-B	Missing Brick	North, West and South Elevations

DESCRIPTION		POTENTIAL CAUSES	
	Brick units that have dislodged completely from the masonry wall or that have been removed. (Photo: West Elevation - Two Story Structure - above Window W108).		Caused by deterioration of mortar, allowing brick to shift in combination with differential movement resulting in brick fully dislodging from masonry arch or wall. Deterioration of mortar and resulting loss of brick has also been accelerated on the West and North Elevations due to excessive plant growth on the elevations, trapping moisture in joints.
