## Carter G. Woodson Home

1538 Ninth Street, NW, Washington, DC

**FINAL SUBMISSION  
JANUARY 15, 2008**

# Historic Structure Report

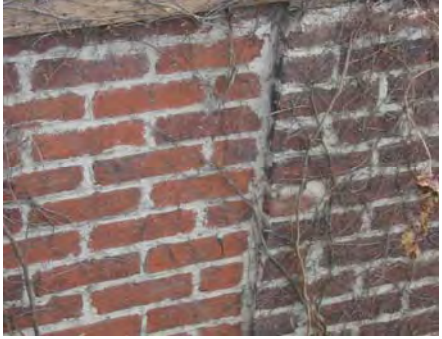
EXTERIOR BRICK	SYMBOL	CONDITION	LOCATION	EXAMPLE IMAGE
	Outward Bulging	OB	North, West and South Elevation

DESCRIPTION		POTENTIAL CAUSES	
	Brick is showing evidence of bulging outward, in some cases as much two inches. (Photo: North elevation at joint between 1874 and 1880 two story additions).		Weak mortar joints in conjunction with deterioration of the interior wood structure that gives lateral stability to the load bearing walls. Also, failing footings or a lack of footings could contribute to the bulging.

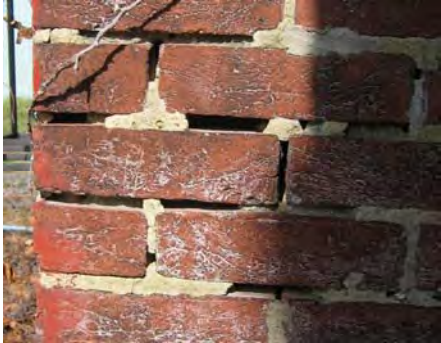
EXTERIOR BRICK	SYMBOL	CONDITION	LOCATION	EXAMPLE IMAGE
	OJ-B	Open Joints	All Exterior Elevations

DESCRIPTION		POTENTIAL CAUSES	
	Complete or partial loss of pointing mortar. This condition allows moisture to migrate into the masonry substrate and may also result in potential structural instability. Open joints are most prevalent on the South Elevation but are also located across areas of all facades (Photo: South Elevation - West Corner).		Joints open due to weathering or differential stress from movement within the building envelope. The mortar on the South, West and North elevations are particularly weak and susceptible to deterioration.

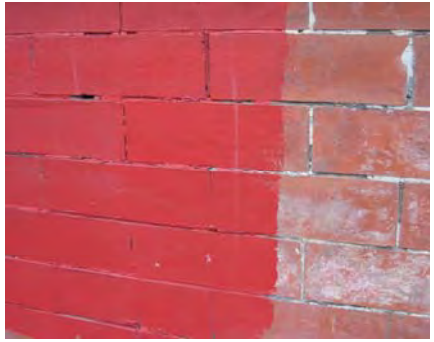
EXTERIOR BRICK	SYMBOL	CONDITION	LOCATION	EXAMPLE IMAGE
	P/G	Paint/Graffiti on Brick	East Elevation

DESCRIPTION		POTENTIAL CAUSES	
	Red paint has been applied directly to the brick below and partially above the marble water course. (Photo: East Elevation above marble water course).		Paint has frequently been applied to the East Elevation to cover over graffiti as a substitute for cleaning the spray paint directly off the brick.

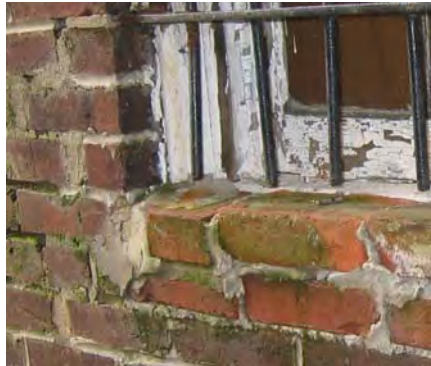
EXTERIOR BRICK	SYMBOL	CONDITION	LOCATION	EXAMPLE IMAGE
	RS	Replacement Sill	South Elevation and West Elevation - Three Story Portion

DESCRIPTION		POTENTIAL CAUSES	
	Non-matching brick has been installed as a replacement for a previous wood sill. (Photo: South Elevation - Window W106).		Rot and deterioration of the wood sills due to lack of regular painting and maintenance led to select sills being replaced. At the time of replacement, brick was used instead of wood.

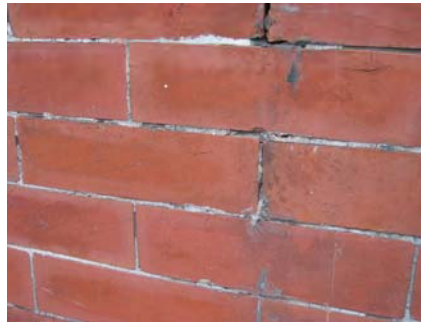
EXTERIOR BRICK	SYMBOL	CONDITION	LOCATION	EXAMPLE IMAGE
	SMJ	Sealant at Mortar Joints	East Elevation

DESCRIPTION		POTENTIAL CAUSES	
	Application of sealant over the existing mortar or into open mortar joints. Aged sealant is now failing (Photo: East Elevation directly above water course).		Sealant was applied as an effort to repair the failing thin mortar joints on the East Elevation. This repair is inappropriate due to the potential for the sealant to trap moisture within the mortar joints, which will accelerate deterioration of both the mortar and the brick.

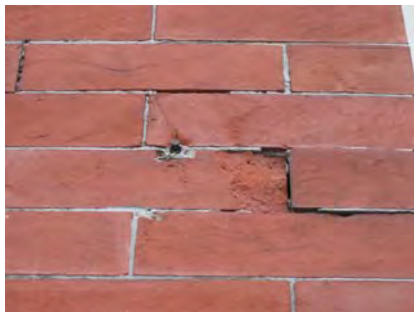
EXTERIOR BRICK	SYMBOL	CONDITION	LOCATION	EXAMPLE IMAGE
	SP-B	Brick Spall	East Elevation

DESCRIPTION		POTENTIAL CAUSES	
	Detachment of brick fragment from brick unit. (Photo: East Elevation above window W102).		Spalls may be caused by pressure within wall, expansion of embedded ferrous elements or from repair materials that are overly hard in comparison to the surrounding substrate.

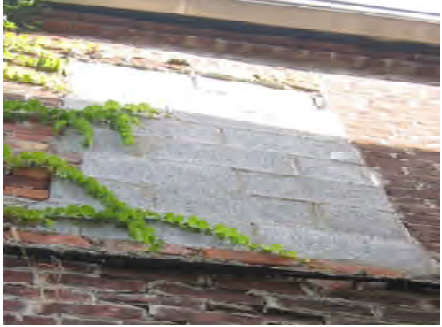
EXTERIOR CONCRETE MASONRY UNIT	SYMBOL	CONDITION	LOCATION	EXAMPLE IMAGE
	CMU-I	CMU Infill	West, South Elevation

DESCRIPTION		POTENTIAL CAUSES	
	Existing window opening has been filled with concrete masonry units either to stabilize opening or prevent entry through opening. (Photo: South Elevation - Infill at Window W107).		Instability of brick masonry and mortar due to consistent moisture penetration as well as rotting of opening framing resulted in failed opening support.

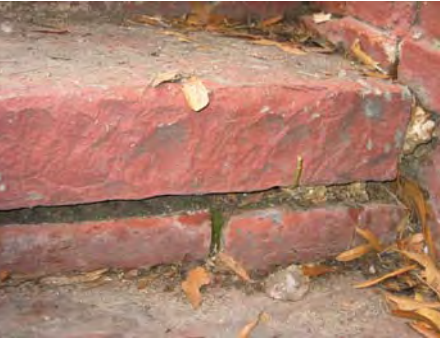
EXTERIOR STONE	SYMBOL	CONDITION	LOCATION	EXAMPLE IMAGE
	DIS-S	Dislocation of Stone	Bluestone at East Elevation Stairs to Basement

DESCRIPTION		POTENTIAL CAUSES	
	Stone units that are out of plumb or not level. (Photo: West Elevation - Stairs to Basement Entry).		Dislocation of individual stone units may be caused by differential movement, impact, deterioration of adjacent mortar or vegetative growth in mortar joints.

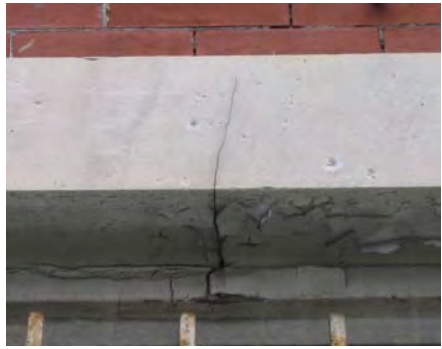
EXTERIOR STONE	SYMBOL	CONDITION	LOCATION	EXAMPLE IMAGE
	HC	Hairline Crack in Single Unit	East Elevation

DESCRIPTION		POTENTIAL CAUSES	
	Fracture or fissure in single stone unit at mid-span. (Photo: East Elevation - Stone Lintel Above Window W203).		Cracks through a single unit are due to excess flexural stresses within the wall system from differing expansion and contraction rates between mortar and the brick or from localized load increase due to expanding metal. It may also be caused by excessive loading of the center of the lintel span.

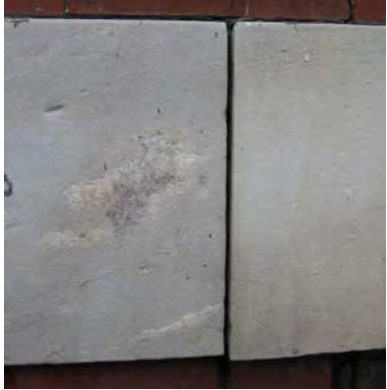
EXTERIOR STONE	SYMBOL	CONDITION	LOCATION	EXAMPLE IMAGE
	OP-S	Open Joint	East Elevation

DESCRIPTION		POTENTIAL CAUSES	
	Complete or partial loss of pointing mortar. This condition allows moisture to migrate into the masonry substrate and may also result in potential structural instability. (Photo: East Elevation - Stone at Stone Water Course).		Joints open due to weathering or differential stress from movement within the building envelope or due to weak mortar that is susceptible to deterioration. Loss of mortar is consistent at most stone locations on the East Elevation.

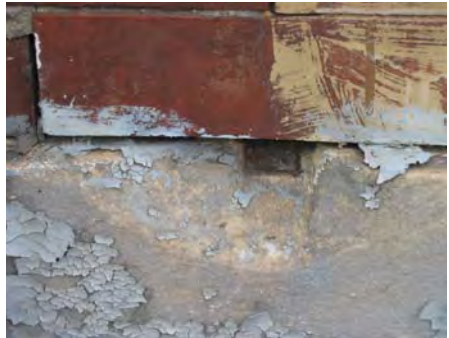
EXTERIOR STONE	SYMBOL	CONDITION	LOCATION	EXAMPLE IMAGE
	SP-S	Stone Spall	East Elevation

DESCRIPTION		POTENTIAL CAUSES	
	Detachment of stone fragment from base stone unit. (Photo: East Elevation at Stone Water Course to the right of the Entry Door).		Spalls may be caused by pressure within the stone, from impact damage, from the expansion of embedded ferrous elements or from repair materials that are overly hard in comparison to the surrounding substrate.

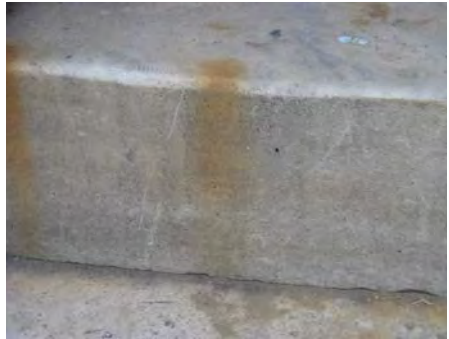
EXTERIOR STONE	SYMBOL	CONDITION	LOCATION	EXAMPLE IMAGE
	ST-M	Staining-Metallic	East Elevation

DESCRIPTION		POTENTIAL CAUSES	
	When water runs off a corroding metallic element, the transfer of ions can cause metallic deposits to build up on masonry elements. This type of staining most often occurs with iron or steel (orange rust color). (Photo: Staining of marble at front door entry sill).		Lack of regular maintenance and painting for the front door steel gate and front stoop iron railings has caused significant rust and loss of metal. On going exposure to water is causing splashing of metallic deposits on the stone, resulting in the staining.

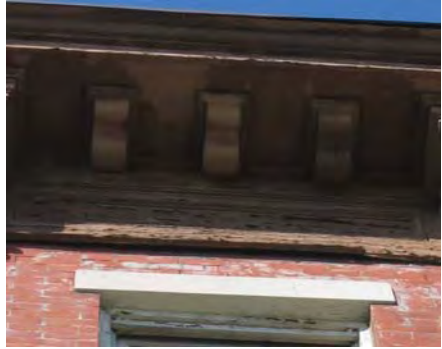
EXTERIOR WOOD	SYMBOL	CONDITION	LOCATION	EXAMPLE IMAGE
	DIS-W	Dislocated Wood Member	East Elevation

DESCRIPTION		POTENTIAL CAUSES	
	Wood members that are out of plumb or have separated from the substrate. (Photo: East Elevation Painted Wood Cornice).		Lack of regular maintenance and painting of the wood members has resulted in significant paint loss, allowing for wood to absorb moisture. The absorption of moisture caused the wood members to deform, pulling away from the substrate.

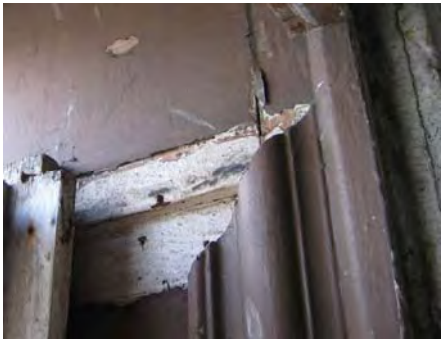
EXTERIOR WOOD	SYMBOL	CONDITION	LOCATION	EXAMPLE IMAGE
	ME	Missing Element	Exterior Windows on North, West and South Elevations, Front Door

DESCRIPTION		POTENTIAL CAUSES	
	Missing component of wood members at window and door frames and trim. (Photo: East Elevation - Front Entry Door Paneled Return).		Severe wood rot will eventually lead to disintegration of material and result in the loss of the element. Missing element may also be caused by rusting or inadequate anchoring or vandalism.

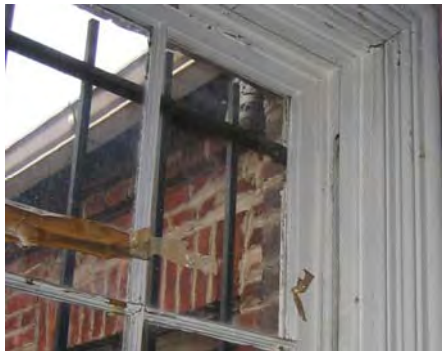
EXTERIOR WOOD	SYMBOL	CONDITION	LOCATION	EXAMPLE IMAGE
	MP	Missing Putty	All Exterior Windows

DESCRIPTION		POTENTIAL CAUSES	
	Glazing putty loss at perimeters of glass lites. (Photo: South Elevation - Interior of Window W204).		Continuous weathering leads to breakdown and drying out of the putty material, leaving these areas vulnerable to moisture penetration.

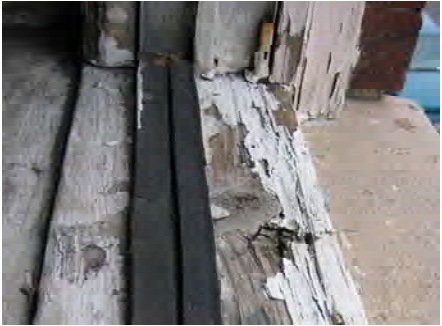
EXTERIOR WOOD	SYMBOL	CONDITION	LOCATION	EXAMPLE IMAGE
	PL	Paint Loss	Wood Window Frames and Door Frames at All Exterior Elevations

DESCRIPTION		POTENTIAL CAUSES	
	Failure of paint coating, which acts as a protective sacrificial layer against weathering. The loss of paint exposes the wood substrate to moisture penetration, deterioration and eventually will lead to wood rot. (Photo: East Elevation - Sill at Window W201).		Most paint coatings fail due to age and weathering. In some cases, when the substrate is not prepared correctly or is too wet, the coating cannot maintain a bond and will fail. Paint loss is most severe at areas of high weathering, such as window sills, base of frames, projecting elements and horizontal members.

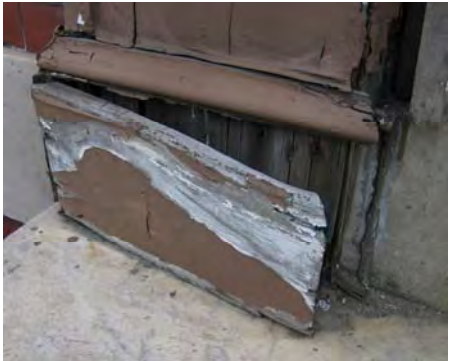
EXTERIOR WOOD	SYMBOL	CONDITION	LOCATION	EXAMPLE IMAGE
	WR	Wood Rot	Windows at West and South Elevations

DESCRIPTION		POTENTIAL CAUSES	
	Decay of wood substrate, eventually leading to failure and loss of material. This process is accelerated by moisture, fluctuations in temperature and poor maintenance. (Photo: East Elevation - Base of Wood Surround at Entry Door).		Failure of protective paint coating and prolonged exposure to direct weathering.

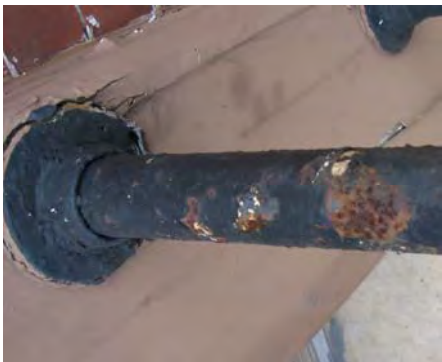
EXTERIOR METAL	SYMBOL	CONDITION	LOCATION	EXAMPLE IMAGE
	CORR	Corrosion	Window Grilles on East, West and South Elevations, Cast Iron Entry Railing

DESCRIPTION		POTENTIAL CAUSES	
	Oxidation of the metal substrate, in severe cases, leads to through metal corrosion and loss of material. Corrosion may affect the color, texture or form of the metal object and cause staining to surrounding areas. (Photo: East Elevation - Cast Iron Railing).		Paint loss and prolonged exposure to moisture.

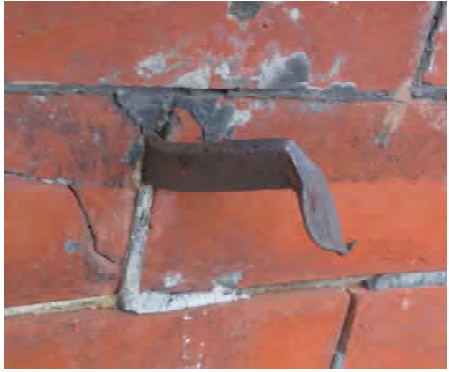
EXTERIOR METAL	SYMBOL	CONDITION	LOCATION	EXAMPLE IMAGE
	FMA	Ferrous Metal Anchors	East Elevation

DESCRIPTION		POTENTIAL CAUSES	
	Ferrous metal strips set into mortar joints to surface mount materials to the brick masonry. (Photo: East Elevation above Window W102).		Anchors were set into masonry to anchor signage and if not treated will continue to rust and expand, jeopardizing adjacent masonry stability.

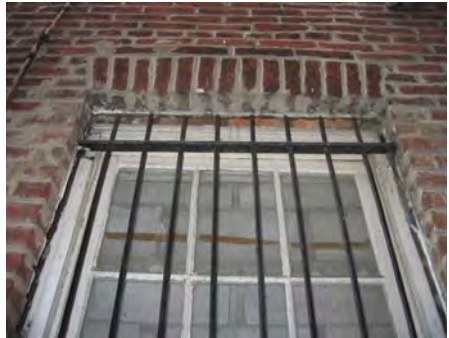
EXTERIOR METAL	SYMBOL	CONDITION	LOCATION	EXAMPLE IMAGE
	GR	Metal Grille	East Elevation Basement and First Floor Windows, All West and South Elevation Windows

DESCRIPTION		POTENTIAL CAUSES	
	Metal security grille bolted to anchors set in mortar joints at brick masonry. (Photo: South Elevation - Window W105).		Security grilles were installed to prevent vandalism and forced entry to the building. Ferrous metal anchors set in masonry joints have rusted and caused damage to adjacent masonry.

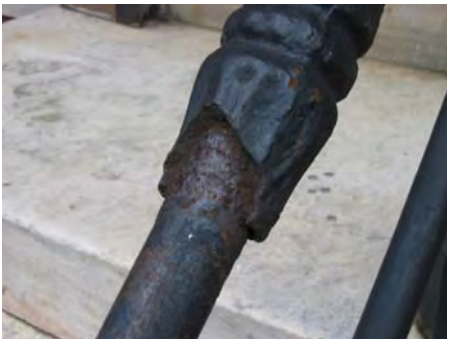
EXTERIOR METAL	SYMBOL	CONDITION	LOCATION	EXAMPLE IMAGE
	MTL-LS	Metal Loss of Section	East Elevation - Cast Iron Entry Railing

DESCRIPTION		POTENTIAL CAUSES	
	Oxidation of the metal substrate, in severe cases, leads to through metal corrosion and loss of material. (Photo: East Elevation - Cast Iron Railing).		Paint loss and prolonged exposure to moisture.

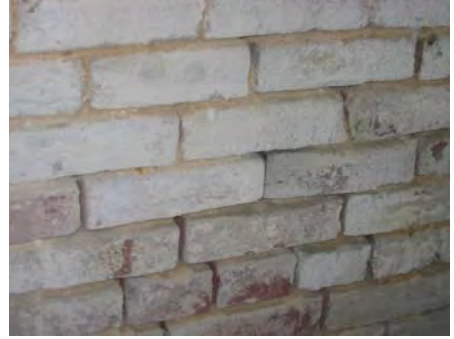
INTERIOR BRICK	SYMBOL	CONDITION	LOCATION	EXAMPLE IMAGE
	OJ-I	Interior Open Joints	Basement North Elevation

DESCRIPTION		POTENTIAL CAUSES	
	Complete or partial loss of pointing mortar. This provides access for moisture migration into the masonry substrate and may also result in potential structural instability. (Photo: North Elevation at Basement).		Joints open due to differential stresses from movement within building envelope and can be further damaged with salts and moisture migration as a result of flooding of the basement.

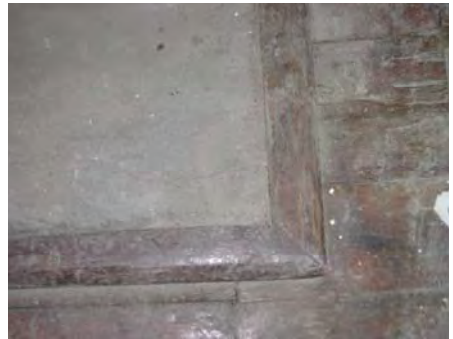
INTERIOR STONE	SYMBOL	CONDITION	LOCATION	EXAMPLE IMAGE
	SS	Stone Soiling	Fireplace Hearths – Rooms 104, 105

DESCRIPTION		POTENTIAL CAUSES	
	This problem type refers to any foreign matter (inorganic or organic) which accumulates on a building surface over time, commonly referred to as dirt, grime, or other residue. (Photo: Stone hearth at fireplace in Room 105).		Building has been abandoned for a significant amount of time, and deterioration of interior ceiling and wall finishes has resulted in accumulation of debris on the floors.

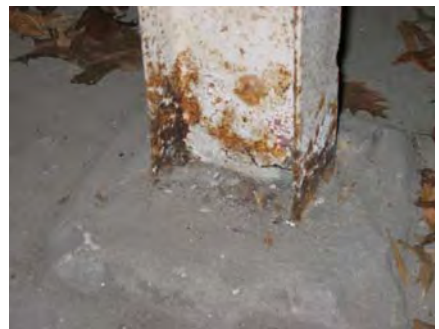
INTERIOR METAL	SYMBOL	CONDITION	LOCATION	EXAMPLE IMAGE
	SR	Surface Rust at Steel	Steel Columns and Beams at Basement

DESCRIPTION		POTENTIAL CAUSES	
	Corrosion of metal due to consistent exposure to moisture. Corrosion may affect the color, texture, or form of the metal object and may cause staining to surrounding materials (Photo: Steel column in Basement).		Corrosion is caused by continuous moisture exposure in conjunction with lack of maintenance of paint coating on steel. Frequent infiltration of rain water into the basement due to the lack of a water tight exterior envelope is also accelerating the corrosion.

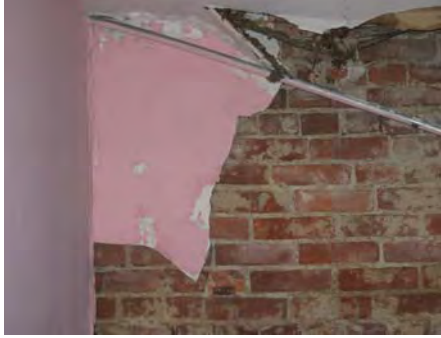
INTERIOR PLASTER	SYMBOL	CONDITION	LOCATION	EXAMPLE IMAGE
	PL-L	<b>Complete Loss of Plaster from Lath or Masonry</b>	Interior Elevations of Rooms 103, 110, 205, 210, 305

DESCRIPTION		POTENTIAL CAUSES	
	Complete breakdown of bonding of scratch coat keys with wood lath or bonding of scratch coat with brick masonry resulting in loss of plaster. (Photo: Loss of plaster at South Elevation of Room 210).		Consistent water infiltration as a result of failing roof and open mortar joints along the exterior masonry walls results in plaster holding moisture causing a weakened bond between the plaster and the substrate, eventually resulting in failure.

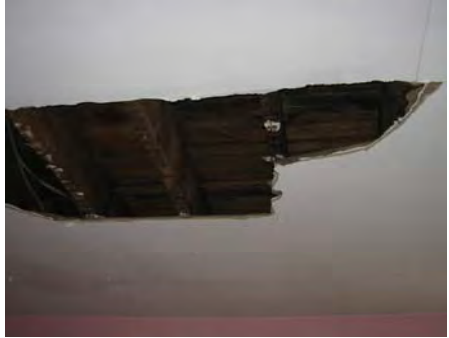
INTERIOR PLASTER	SYMBOL	CONDITION	LOCATION	EXAMPLE IMAGE
	PL-LWBD	<b>Complete Loss of Plaster Wall Board</b>	Ceilings of Rooms 102, 103, 105, 110, 201, 203, 205, 210, 305

DESCRIPTION		POTENTIAL CAUSES	
	Separation and loss of plaster board from either wood lath or wood structure resulting in complete failure of board. (Photo: Ceiling of Room 203).		Consistent water infiltration as a result of failing roof resulting in plaster board absorbing moisture. Deflection of structure causes nails attaching wall board to lath or wood structure to fail.

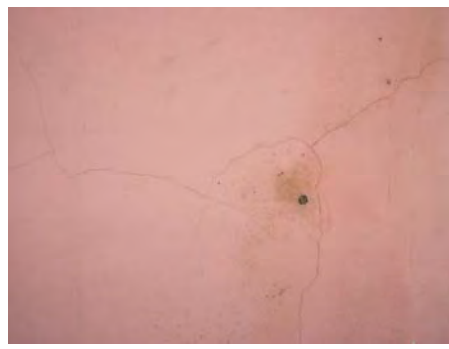
INTERIOR PLASTER	SYMBOL	CONDITION	LOCATION	EXAMPLE IMAGE
	PL-HC	<b>Hairline Crack in Plaster Wall</b>	Interior Elevations of Rooms 102, 104, 105, 201, 202, 203, 205, 302, 303

DESCRIPTION		POTENTIAL CAUSES	
	Crack through the surface of the plaster that does not extend into substrate (Photo: Crack at East wall of Room 302).		Hairline cracks in plaster throughout the building are a result of continued settlement of structure, significant fluctuation in temperature and moisture levels.

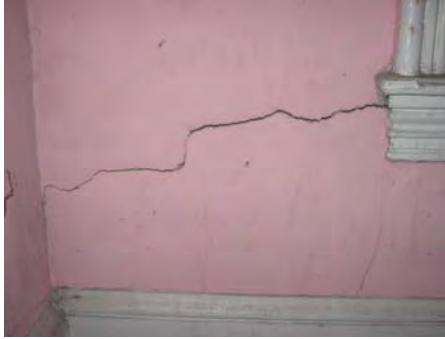
INTERIOR PLASTER	SYMBOL	CONDITION	LOCATION	EXAMPLE IMAGE
	PL-MC	Major Crack in Plaster Wall	Interior Elevations of Rooms 102, 103, 104, 105, 110, 201, 202, 203, 205, 208, 210, 301, 303, 305

DESCRIPTION		POTENTIAL CAUSES	
	Crack through surface material that may extend into substrate. (Photo: Crack at East wall of Room 101).		Cracks may open in plaster due to differential stresses from movement of the building envelope or substrate settlement. If element becomes unstable, it could lead to loss of material.

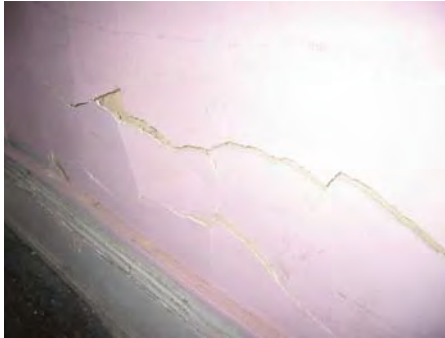
INTERIOR PLASTER	SYMBOL	CONDITION	LOCATION	EXAMPLE IMAGE
	PL-S	Separation of Plaster from Wood Lath or Masonry	Interior Elevations of Rooms 102, 105, 201, 301, 305

DESCRIPTION		POTENTIAL CAUSES	
	Partial breakdown of bonding of scratch coat keys with wood lath or bonding of scratch coat with brick masonry resulting in partial separation of plaster from substrate. (Photo: Loss of plaster at South Elevation of Room 210).		Consistent water infiltration as a result of failing roof and open mortar joints along the exterior masonry walls results in plaster holding moisture causing a weakened bond between the plaster and the substrate, eventually resulting in separation.

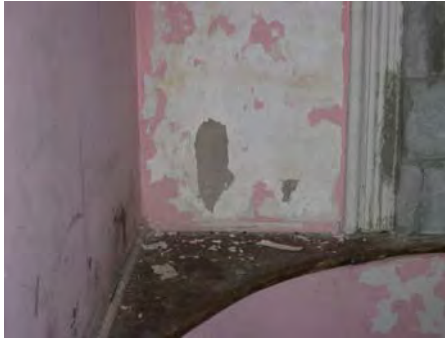
INTERIOR PLASTER	SYMBOL	CONDITION	LOCATION	EXAMPLE IMAGE
	WDM	Severe Water Damage	Interior Elevations of Rooms 103, 201, 202, 205, 301, 305

DESCRIPTION		POTENTIAL CAUSES	
	The irreversible loss of scales, flakes, or layers from a surface. This may occur on interior plaster due to moisture penetration, deterioration from salts, or inherent properties in the material. (Photo: South Elevation Detail - Room 201).		Severe water damage at walls is a sign of a serious water infiltration problem. Once the water infiltration begins, the plaster will retain the moisture and the problem will continue to spread.

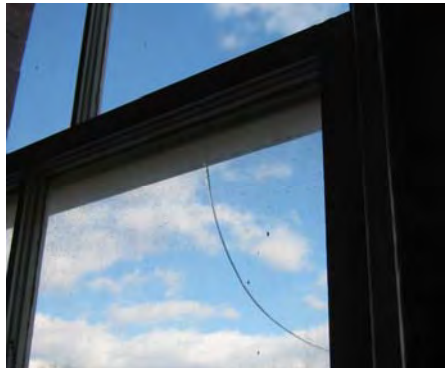
INTERIOR WINDOWS	SYMBOL	CONDITION	LOCATION	EXAMPLE IMAGE
	W-CRK	Cracked or Broken Window Glass	Windows W102, W106, W201, W202, W206,

DESCRIPTION		POTENTIAL CAUSES	
	Cracked glass window unit. (Photo: East Elevation - Interior of Window W202).		Cracked glass may be a result of impact or differential movement within the frame due to fluctuations in relative humidity/temperature from the exterior to the interior.

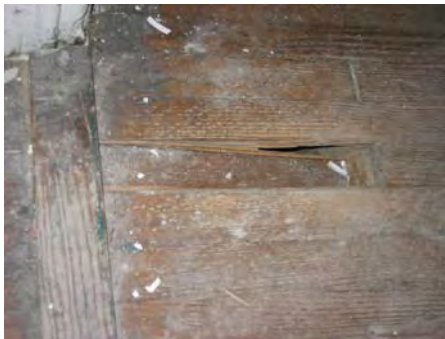
INTERIOR WOOD FLOORS	SYMBOL	CONDITION	LOCATION	EXAMPLE IMAGE
	WD-FF	Failed Floor Board	Flooring at Rooms 208, 301

DESCRIPTION		POTENTIAL CAUSES	
	Pine strip flooring has failed, resulting in unstable floor boards. (Photo: Failed floor board at Room 208 entry).		Continuous exposure to moisture has resulted in wood rot and failing of select wood members.

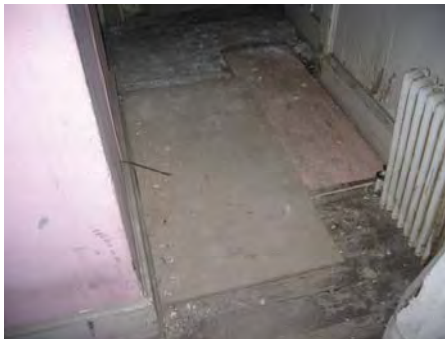
INTERIOR WOOD FLOORS	SYMBOL	CONDITION	LOCATION	EXAMPLE IMAGE
	WD-PC	Plywood Patch	Flooring at Rooms 103, 109, 201, 305

DESCRIPTION		POTENTIAL CAUSES	
	Plywood panel sheathing has been installed at locations where the existing wood floor is failing. (Photo: Plywood panels at Room 103).		In order to maintain safe access to the entire house plywood panels were installed in select areas where the flooring and/or supporting structure below had failed due to wood rot or termite damage.

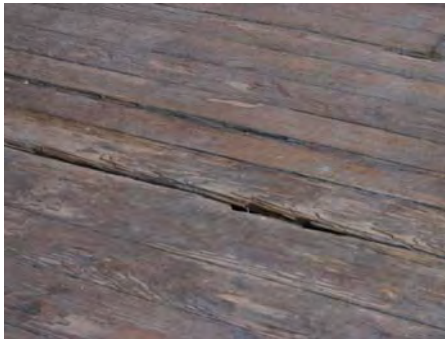
INTERIOR WOOD FLOORS	SYMBOL	CONDITION	LOCATION	EXAMPLE IMAGE
	WD-SW	Significant Wear	All Interior Wood Floors

DESCRIPTION		POTENTIAL CAUSES	
	Significant wear of the wood surface resulting in exposed and pronounced grain. (Photo: Wear at floor of Room 303).		The pine plank flooring is a very soft flooring material that is susceptible to significant wear if not properly maintained. The finish coat of the wood flooring has been completely worn away resulting in significant wearing of the floor boards, resulting in splintering and gaps.

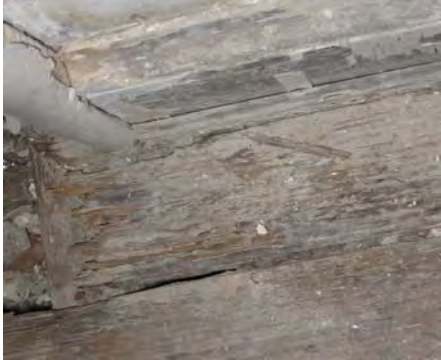
INTERIOR WOOD FLOORS	SYMBOL	CONDITION	LOCATION	EXAMPLE IMAGE
	WD-TD	Termite Damage	Wood Flooring in Rooms 103, 201, 301, 305

DESCRIPTION		POTENTIAL CAUSES	
	Deterioration and loss of section of wood as a result of termite infestation. (Photo: Termite damage at wood floor - Room 305).		Continuous water infiltration in combination with cool temperature and little air circulation provides an ideal environment for termites to thrive. The most significant termite damage has occurred in direct correspondence with areas below two primary roof leaks.

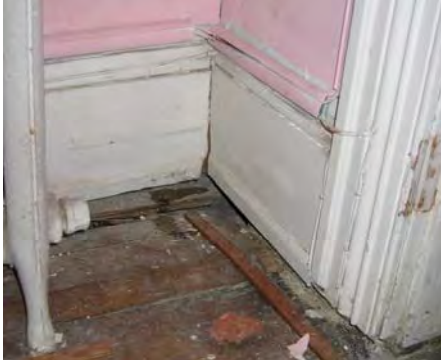
INTERIOR WOOD FLOORS	SYMBOL	CONDITION	LOCATION	EXAMPLE IMAGE
	WD-SFL	Sagging Floor	Flooring at Rooms 103, 109, 110, 201, 208, 210, 301

DESCRIPTION		POTENTIAL CAUSES	
	Floor structure is failing resulting in flooring sagging in discrete locations. (Photo: Sagging of wood floor at Southwest corner of Room 109).		The wood joists have separated from the masonry because of moisture damage, termite damage or deflection, resulting in unsupported section of floor.

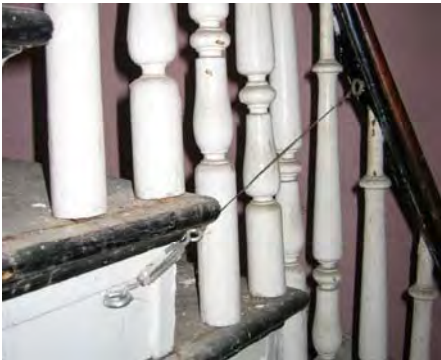
INTERIOR WOOD STAIR	SYMBOL	CONDITION	LOCATION	EXAMPLE IMAGE
	STR-IR	Unstable Railing	Main Stair - First to Second Floor

DESCRIPTION		POTENTIAL CAUSES	
	The failing support structure of the Main Stair has caused the main railing to be unstable and it has lost capacity for significant lateral load. Metal cables and screws have been installed to maintain tension, and thus stability, in the railing. (Photo: Temporary support devices installed at first floor railing).		The first floor framing below this stair lost significant section due to termite damage, resulting in the stair sagging and the railing, becoming unstable. Although the stair support has been sistered with new structure, the railing still remains unstable.

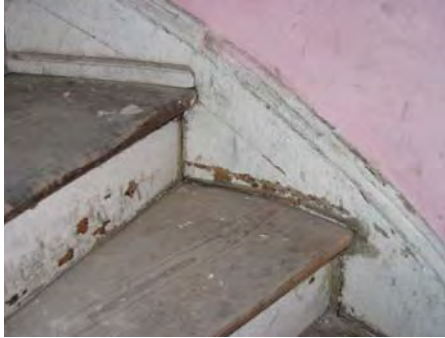
INTERIOR WOOD STAIR	SYMBOL	CONDITION	LOCATION	EXAMPLE IMAGE
	STR-ST	Sagging Tread	Main Stair - First to Second Floor

DESCRIPTION		POTENTIAL CAUSES	
	<p>The failing support structure of the Main Stair has caused the stringer to sag, resulting in the shifting of most stair treads leading from the first to the second floor. (Photo: Sagging Stair treads at first floor)</p>		<p>Similar to the stair railing, the stair treads have shifted in conjunction with the stair stringer as a result of the termite damage to the stair support structure.</p>

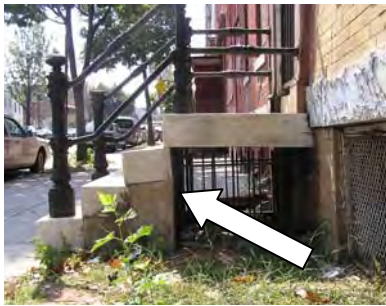
**Figure 4-019:** Stone rotation at front stoop, facing south. (RSA, 2006)

The front stoop has some visible structural problems (Figure 4-019). The landing constructed of a single stone slab. At the stone bearing along the main building wall, localized masonry deterioration is apparent. In addition, the stone slab appears to be sloping inward toward the building wall. This is likely the result of the front steps rotating outward toward the sidewalk due to settlement. It is possible that there is not a footing at the front of the steps and settlement of soil behind the basement stair wall is causing the observed movement.

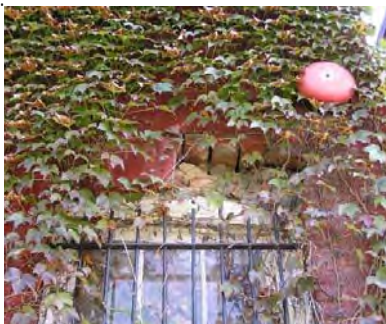
**Figure 4-022:** Loose and missing bricks at top of window W107. (RSA, 2006)

Severe brick deterioration is evident at window openings W107 and W210. Figure 4-022 & 023 show the top and bottom of window W107. At the top of this window, bricks are missing from the arch, and at the bottom, brick units and mortar joints are cracked and the wall bulges outward.

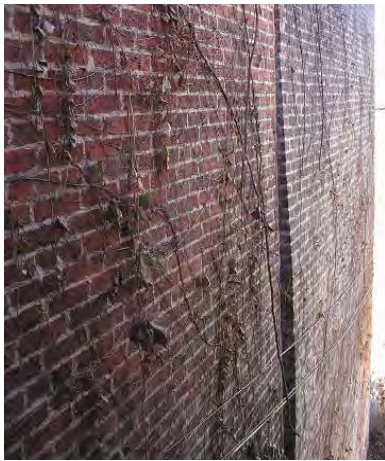
**Figure 4-024:** Bulging of north elevation. (RSA, 2006)

**North Elevation:** Figure 4-024 shows bulging along the north elevation. The brick has bulged outward approximately the width of one wythe of brick (about 4 inches). This is likely the result of foundation movements in combination with insufficient connection of the exterior wall to the floor diaphragms within.

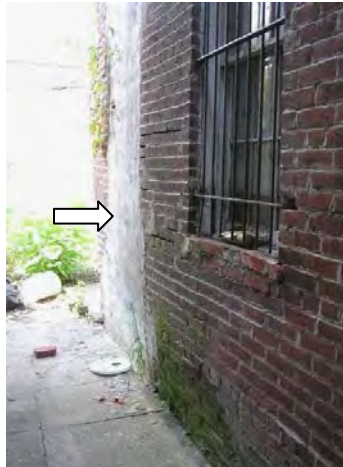
**Figure 4-025:** South elevation, outward building of brick. (RSA, 2006)

The south elevation shows signs of further structural problems. The wall below the door opening D110A at this elevation is bulging outward above the foundation. Many open mortar joints and cracking are evident here as well. The rotation appears to take place near the bottom of the south elevation in its transition from the foundation wall (if present) at grade and the first floor of the Period 2 addition which bears on the south wall at approximately 2 feet above grade - see Figure 4-025.

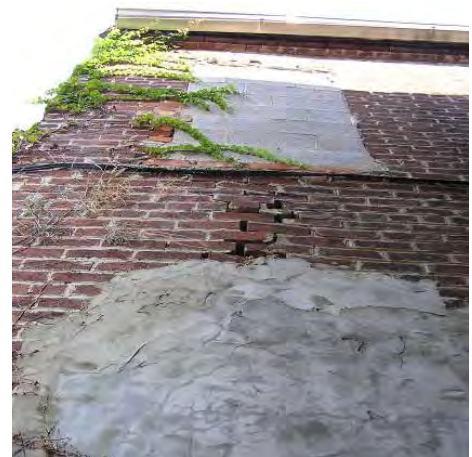
**Figure 4-026:** Cracking below second floor window W209. (RSA, 2006)

More severe cracking and shifting brick is shown in Figure 4-026 below window W209. Concrete masonry units (CMU) have been used as infill in W209 and D110A to prevent further structural deterioration. Not visible in this Figure 4-026 is the serious shifting of brick above the second floor window (W209).

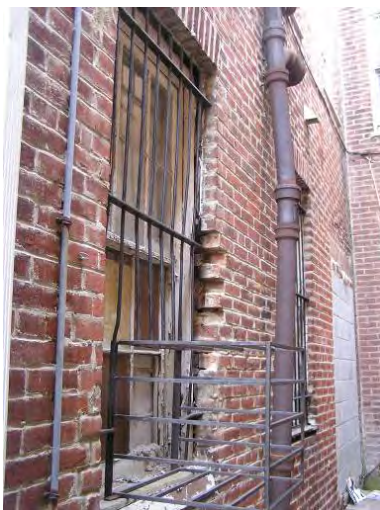
**Figure 4-027:** Spalling brick at first floor south wall window. (RSA, 2006)

Figure 4-027 depicts spalling and missing brick at the painted iron security grilles of the first floor window – W208. The observed conditions are largely the result of excess and sustained moisture intrusion within the masonry. Subsequent freeze-thaw cycling and the development of rust with embedded iron elements results in displacement and disassembly of the masonry. Foundation movements and the loss of bracing from the interior wood floor diaphragms appear to also be associated with the excessive movement in the masonry. Such movement is also manifested in the separated mortar joint running along the joint between the Period 1 and Period 2 two-story construction - Figure 4-028.

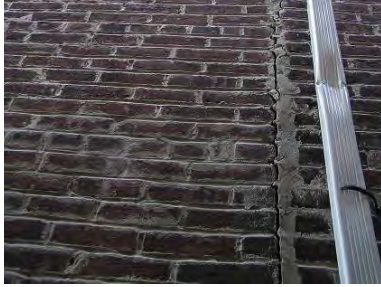
**Figure 4-028:** Separation of mortar at joint, between Period I and Period II construction. (RSA, 2006)

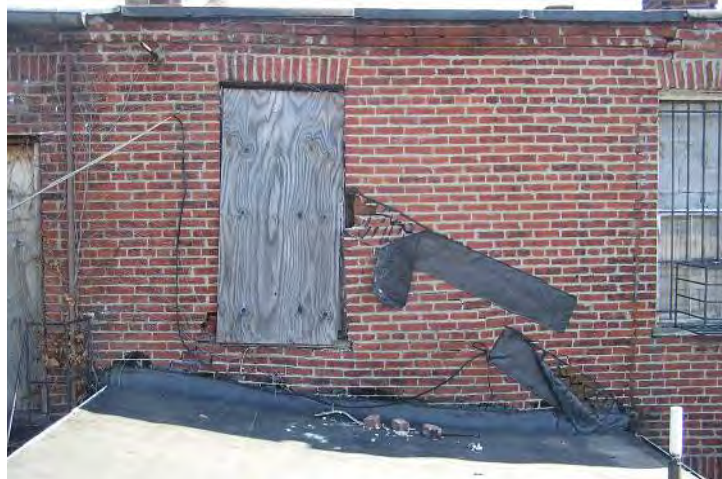
**Figure 4-030:** Roof and west elevation at third floor. (RSA, 2006)

The joint where the lower roof meets the west elevation of the three-story structure significant deterioration was noted, largely due to water intrusion where the roof abuts the base of the exterior masonry wall (Figure 4-030). The poor condition of the exterior west wall at the third floor is visible from this vantage point. The wall is deflecting downward and has extensive cracking. EPDM roofing has been used to patch some cracks, however the repairs have failed and the damaged areas are open to the elements and allow direct water infiltration (Figure 4-029). The wall is sinking due to a failing support beam below that spans sidewall to sidewall at the stair inside (see SSK-3).

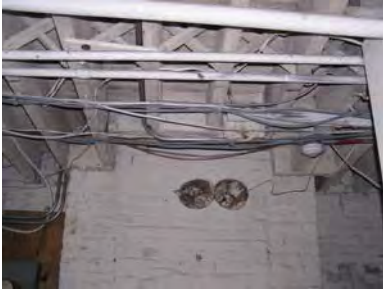
**Figure 4-043:** South chimney with insufficient trimmer support. (RSA, 2006)

The fireplace in the basement is suffering from joint deterioration and deteriorating brick in the arch (Figure 4-042). The fireplace is headed off with a 2"x9 ¾" timber beam; however, the trimmers are insufficiently supported along the face of the chimney (Figure 4-043). It appears that the wood beam along the face of the chimney has been cut so that it no longer spans across the chimney width.

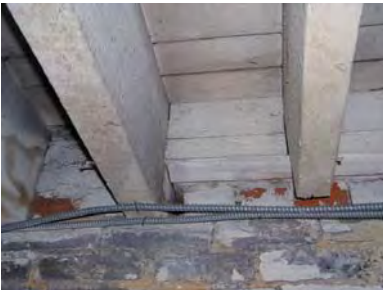
Joists within the width of the chimneys frame into a 2½"x9½" header along the north wall by mortise and tenon connections (Figure 4-044). The header opposite the west chimney is missing its bottom 4 inches and is cracked horizontally through the full span right at the tenons. The deterioration may be the result of a previous overstress condition; however, the similar header opposite the east chimney appears sound.

**Figure 4-044:** Header corresponding to party wall chimneys – splitting at north wall header. (RSA, 2006)

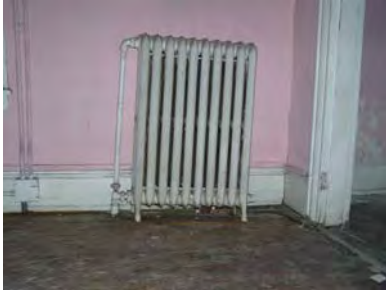
The first floor presents significant areas of sagging and displacement, particularly at the Period 2 two-story addition to the west. As depicted in Figure 4-045, the flooring in Room 110 suffers severe deterioration of both floor framing and perimeter masonry bearing walls. The framing in this location is over the crawlspace and has rotted and displaced along the south bearing conditions. The load bearing masonry, particularly along the window lines, has shifted and begun to disassemble. In Room 109, where the basement below transitions from crawl space to basement, there is further sagging of the floor (Figure 4-046). This is due to the rotted bearing ends of the floor joists observed from the basement area below.

**Figure 4-046:** Room 109 - Floor sagging at first floor. (RSA, 2006)

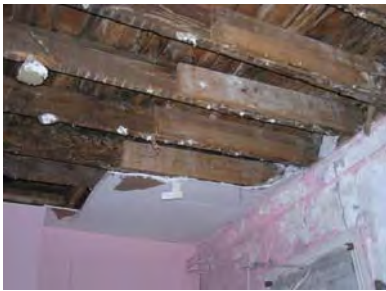
**Figure 4-047:** Sistered floor joists visible from first floor. (RSA, 2006)

Figure 4-047 illustrates the sistered second floor joists as visible from Room 110 on the first floor. The joists are  $1\frac{3}{4}$ " x  $7\frac{1}{2}$ " @ 16" o.c. These repairs do not currently appear sufficient to provide adequate strengthening of this floor, with insufficient lap lengths and connections between original joist and added sister, and the joists were observed to have poor bearing on the south wall. The joists have shifted from their bearings and represent a disengagement of the floor diaphragm from the masonry bearing wall. This lack of diaphragm bracing plays a significant part in the amount of masonry movement and cracking observed in this area.

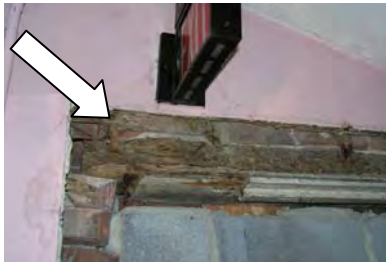
**Figure 4-048:** Deterioration at lintel of door D103A. (RSA, 2006)

The wood lintel above the door D103A along the south alley has severely deteriorated, likely due to the combined effects of sustained moisture infiltration and termite damage (Figure 4-048).

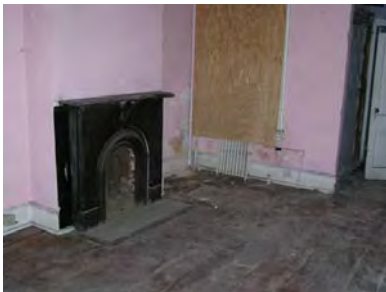
**Figure 4-050:** Room 105 - Fireplace in room east of stairwell. (RSA, 2006)

The fireplace in Room 105, east of the stairwell, appears to be missing a lintel (Figure 4-050). This can be observed from within the fireplace area, looking upward into the chimney. The brick masonry is arching at this time and the observed condition does not represent a significant instability.

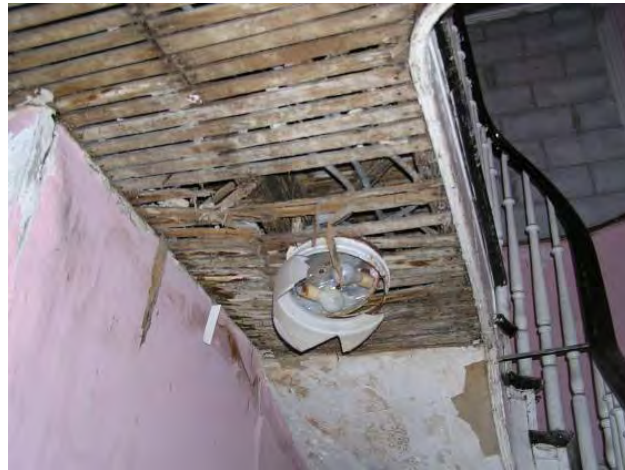
The stairwell, depicted in Figure 4-049, is deflecting downward toward the basement because of significant first floor framing deterioration observed in the basement below. The entire structural system including the upper story walls connected to the stair appears to be deflecting downward as well, corresponding to significant water penetration into the house from the roof joint at the three story elevation directly above the stair.

**Figure 4-049:** Room 103 - Fallen plaster at stairwell. (RSA, 2006)

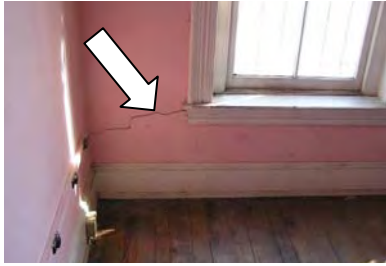
Room 104 exhibits extensive cracking in the wall plaster and around the windows. One typical diagonal crack is depicted in Figure 4-051 at window W102, corresponding to shifting in the masonry observed from the exterior. Though much of the plaster deterioration is architectural in nature (see

Figure 4-051: Room 104 - Crack at bottom lintel of window. (RSA, 2006)

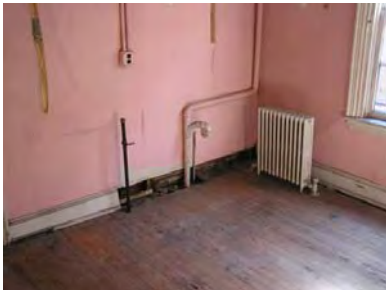
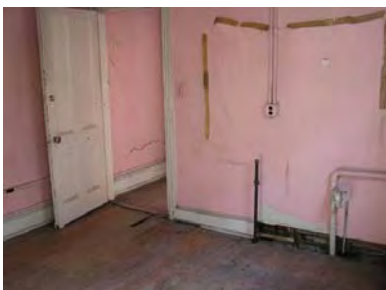
Figure 4-054: Room 208 - Floor sagging below east wall. (RSA, 2006)

Figure 4-055: Room 208 - Floor sagging below east wall. (RSA, 2006)

In Room 208, significant deflection of the floor framing along the east wall is visible (Figure 4-054 & 4-055). Closer inspection of the framing below the base of the stud wall shows evidence of previous repairs and modification. It appears that the beam below the east wall was at one time spliced near its south end; however the splicing detail appears to have been inadequate and failed, resulting in the downward deflection along this wall.

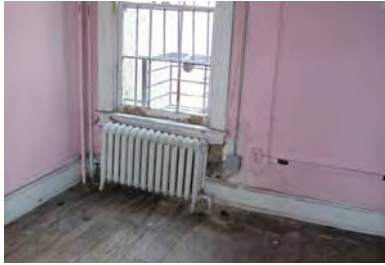
**Figure 4-056: Photo 44.** Room 205 - Cracking at window along west wall, original construction. (RSA, 2006)

**Figure 4-058:** Room 205 - Cracks in wall. (RSA, 2006)

In Figure 4-056, 4-058, 4-059 & 4-060, significant cracking is evident below the sill at window W204 of Room 205. This is likely the result of a lintel or arch failure above the first floor window below. The window opening and radiator likely have contributed to increased moisture levels. As a result, it is likely that localized floor framing deterioration may also be found in this area. Typical third floor framing in this area consists of 2" x 9 3/4" wood joists @ 16" on center.

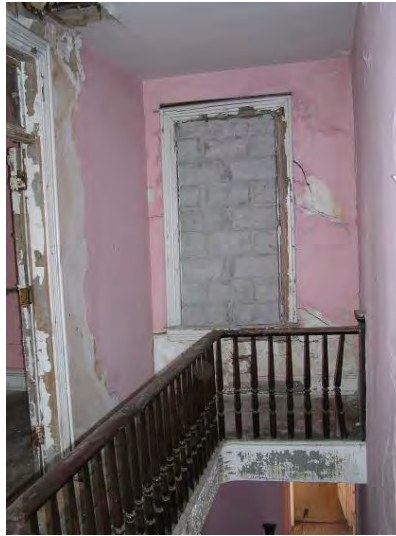
**Figure 4-060:** Room 301 - Top of staircase, third floor. (RSA, 2006)

Figure 4-060 shows a CMU in-filled window (W303) at the top of the staircase on the third floor. Diagonal crack patterns in the wall at this window indicate that the wall is deflecting downward with the wall supporting the stairwell. Diagonal cracks in the west wall of Room 305 suggest this same type of settlement (Figure 4-061). Substantial cracking of the plaster is indicative of large movements in the exterior masonry, which is corroborated by observations from the exterior. The movement corresponds to the severe deterioration of the built-up wood transfer beam at the third floor framing level, which was observed from the floor level below.

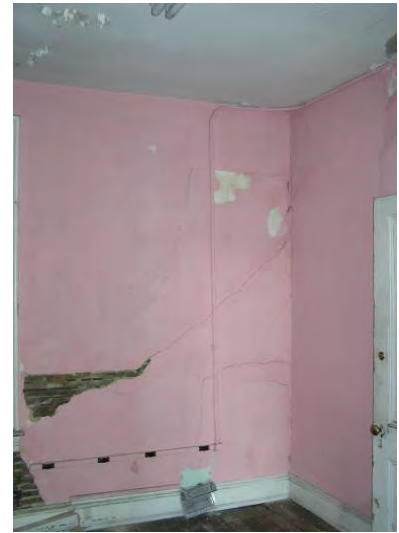
**Figure 4-061:** Room 305 - Diagonal cracks, west wall. (RSA, 2006)

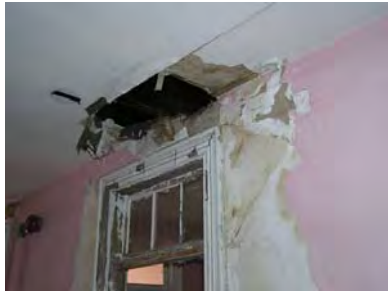
**Figure 4-062.** Room 305 - Ceiling damage. (RSA, 2006)

Ceiling failure is evident on the third floor at the partition wall south of the staircase. This plaster failure is primarily due to water damage, but some localized fire damage was also observed (Figure 4-062). The finish damage appears to correspond to previous framing damage, which has since been repaired.

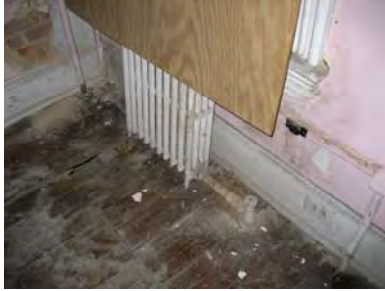
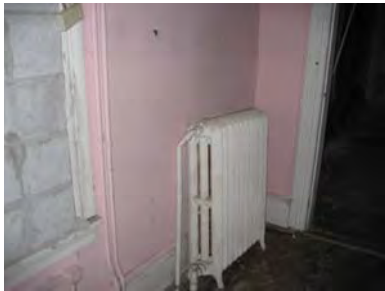
**Figure 4-072:** View of typical radiator and surface mounted conduit. (Photo: GHT, 2006)

**Figure 4-073:** Typical radiator. (Photo: GHT, 2006)

**Figure 4-074:** Radiator Pipes. (Photo: GHT, 2007)

The building has no air conditioning system and the existing heating system is based on a gas fired boiler that feeds hot water to radiators throughout the building. The entire system is currently inoperable. The typical radiators are covered with multiple layers of paint on the exterior, and the inside of the radiators and associated piping is corroded and oxidized. Figures 4-072 and 4-073 demonstrate the condition of the typical radiators. A further description of all radiator types can be found in the Section 3: Physical Description – Interior. These radiators all date to Period 3 and are all manufactured by the American Radiator Company. After cleaning, they could potentially be reused. The piping for this heating system was installed late in Period 2 or in early Period 3 and was thus run exposed along the walls and ceilings. This piping, if replaced, could be used with the reconditioned existing radiator units as part of a new heating system.

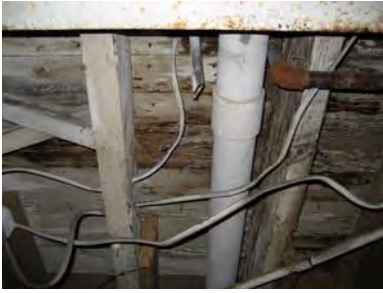
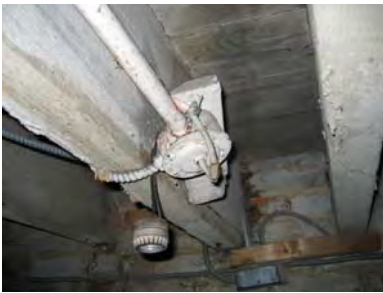
**Figure 4-079:** Wiring in the basement.  
(Photo: GHT, 2006)

**Figure 4-080:** Wiring in the basement.  
(Photo: GHT, 2006)

the basement is not consistently secured to the ceiling joists and will need to be further supported if they remain.

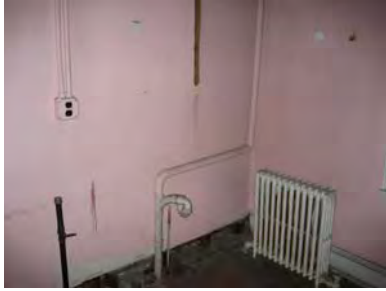
**Figure 4-087:** Radiator, radiator piping, sink and gas piping (Photo: GHT, 2006)

The building has two bathrooms and a kitchen area. Room 108 has a porcelain toilet and a sink both manufactured by Gerber. Room 207 has a porcelain toilet and sink. The sink was made by Gerber, similar to the first floor bathroom sink, but the toilet was made in Venezuela. This bathroom also has an enameled metal tub/shower. In Room 208, PVC piping extends out from the wall indicating where a sink was removed. Similarly, gas piping has been cut that indicated where a stove was once located (Figure 4-087)

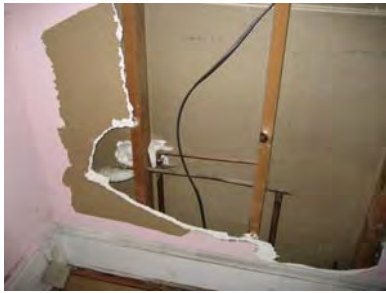
**Figure 4-088:** Remaining piping that has been cut. (Photo: GHT, 2006)

Much of the hot and cold copper pipe has been removed; remaining copper pipe was left in place only because it was difficult to get to. The integrity of the pipe pieces that remains is questionable. See figures 4-088, 4-089, 4-089, 4-090 & 4-091 for a representation of the remaining piping. Because of the age of the remaining copper pipe used for hot and cold water in the house, piping was joined together with high content lead in the sweat fittings. If the existing water pipes were to remain the lead content of the water could potentially be unacceptable. It is recommended that the water be tested for lead. All lead fittings must be replaced.

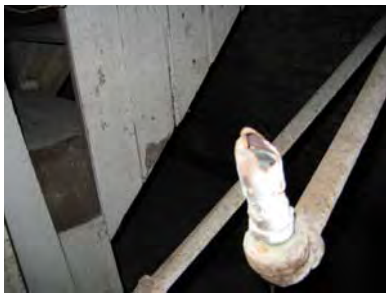
**Figure 4-089:** Remaining piping that has been cut. (Photo: GHT, 2006)
