EVALUATION OF THE WASHINGTON MONUMENT

OEHRLIN & ASSOCIATES ARCHITECTS

**EVALUATION OF
THE WASHINGTON MONUMENT
WASHINGTON, DC**

December 1993

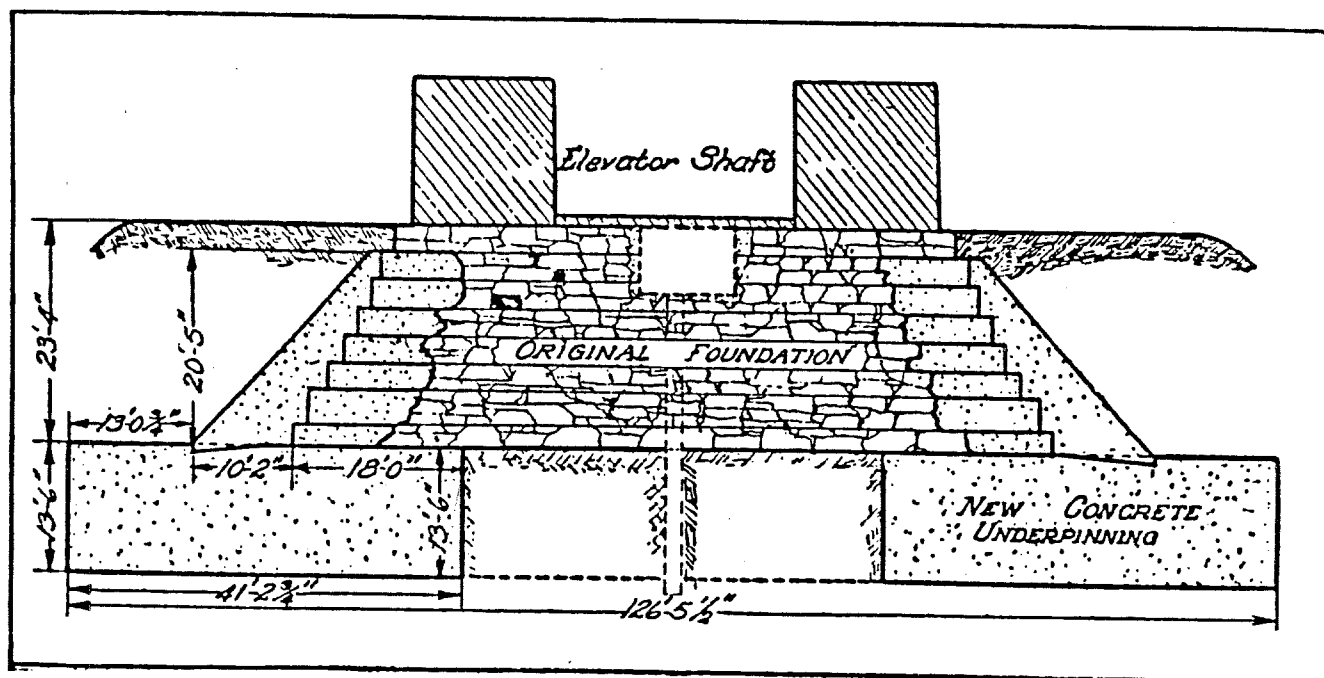
Figure 1.

Section of the completed foundation as constructed, showing concrete buttresses and underpinning which were completed in 1880. Scale 1" = 20'. Society of American Military Engineers, *The Washington Monument*, (Washington, D.C.: Society of American Military Engineers), 1929, p. 17.

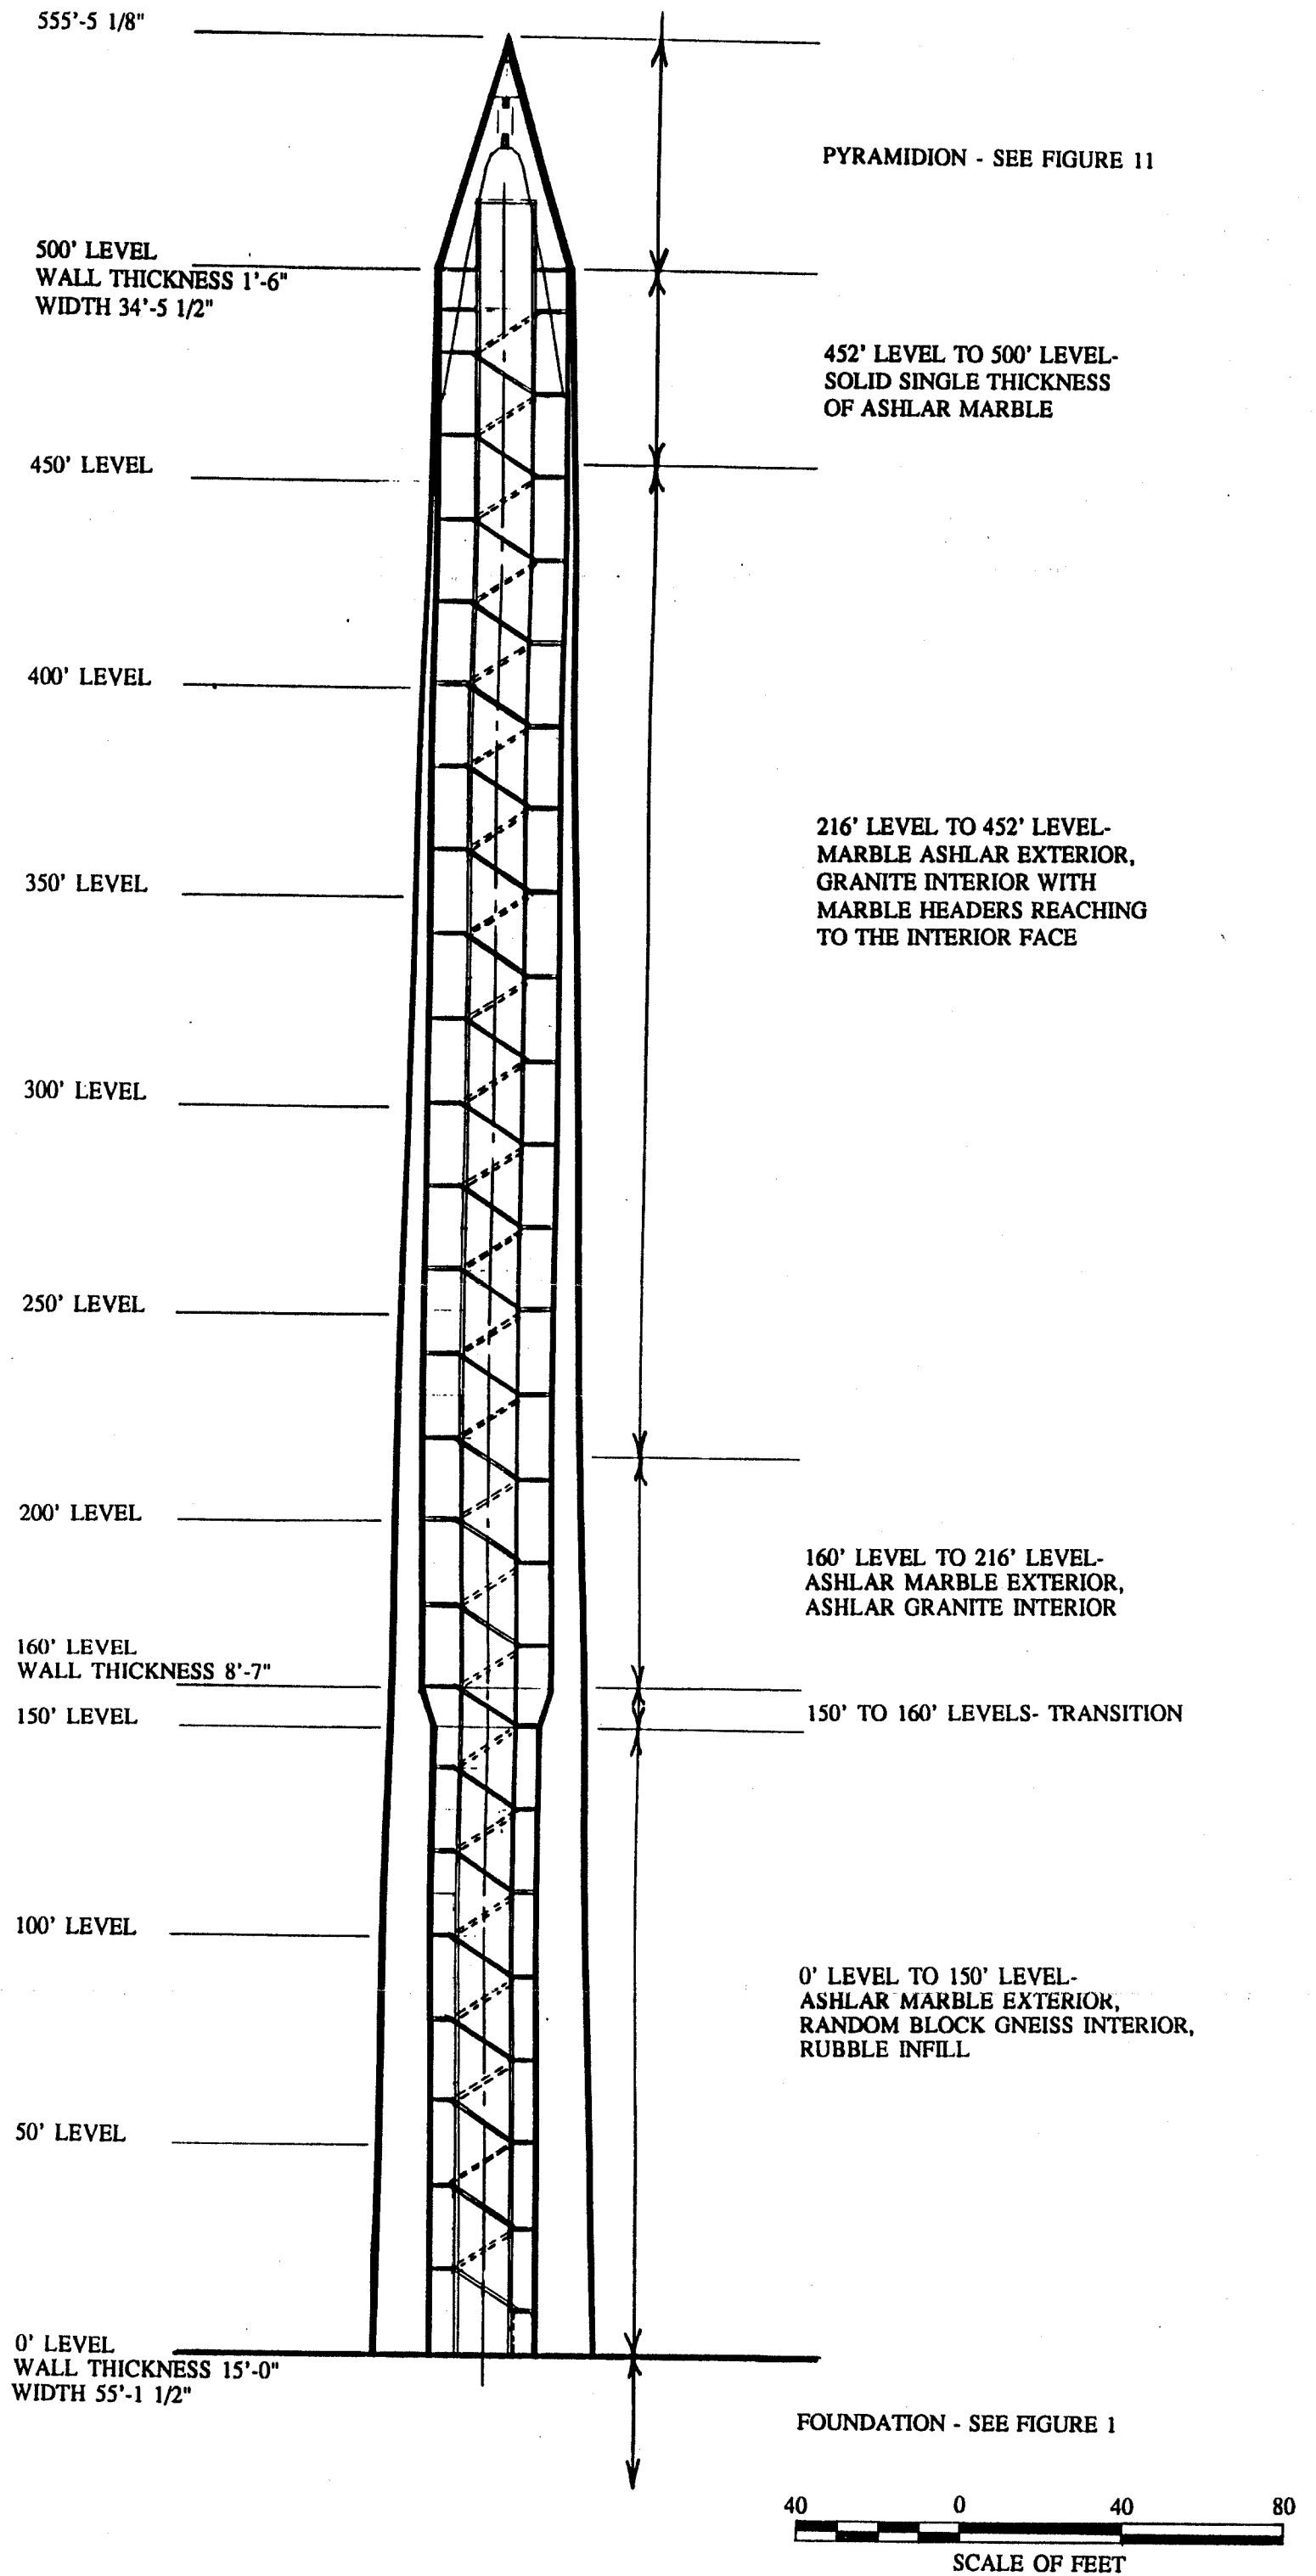
Figure 2. Section of the Washington Monument shaft and pyramidion, indicating the different types of construction. Drawing by Ohrlein & Associates Architects.

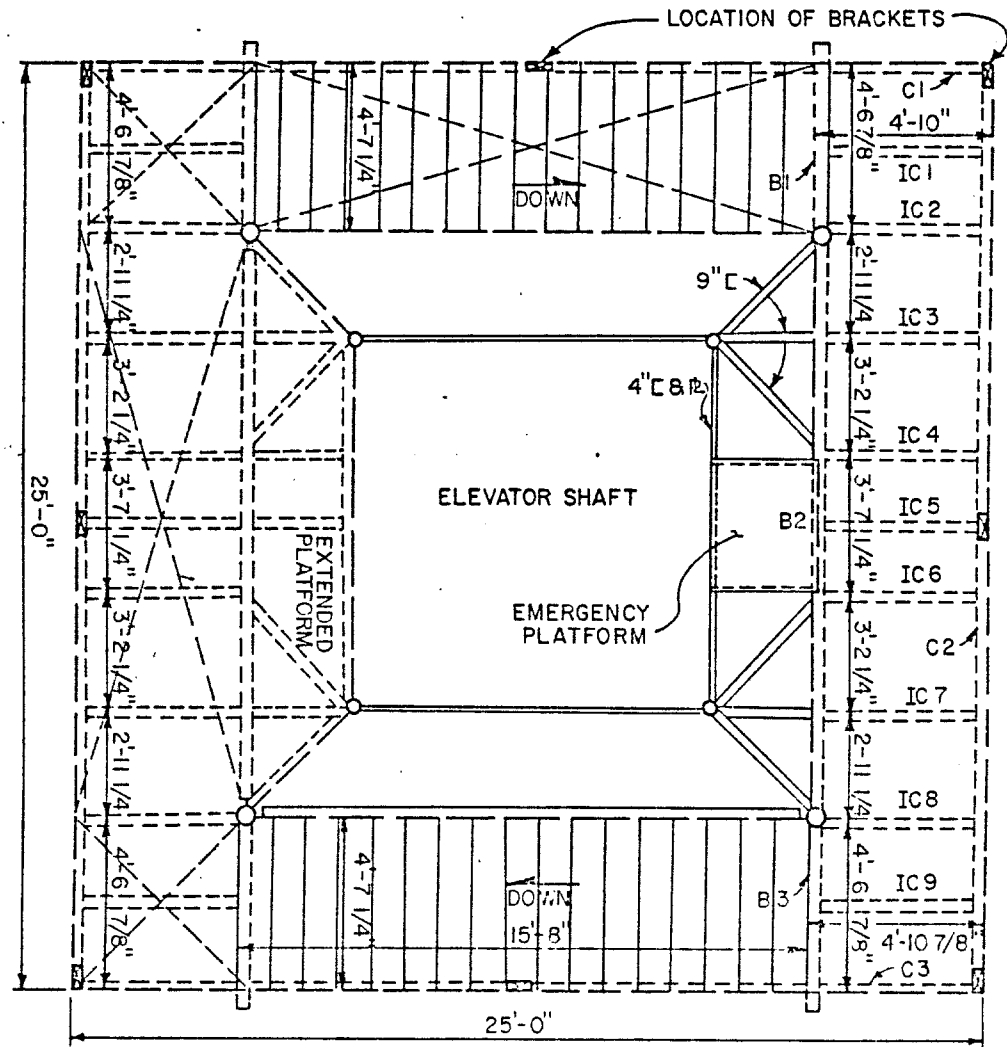
Figure 13.

Typical stair and landing framing plan, 30' level through 150' level. The existing framing is a combination of the original iron and replacement steel. Scale $\frac{3}{16}" = 1'-0"$. Robinson Engineering, Interior Structural and Mechanical Analysis, 1973.

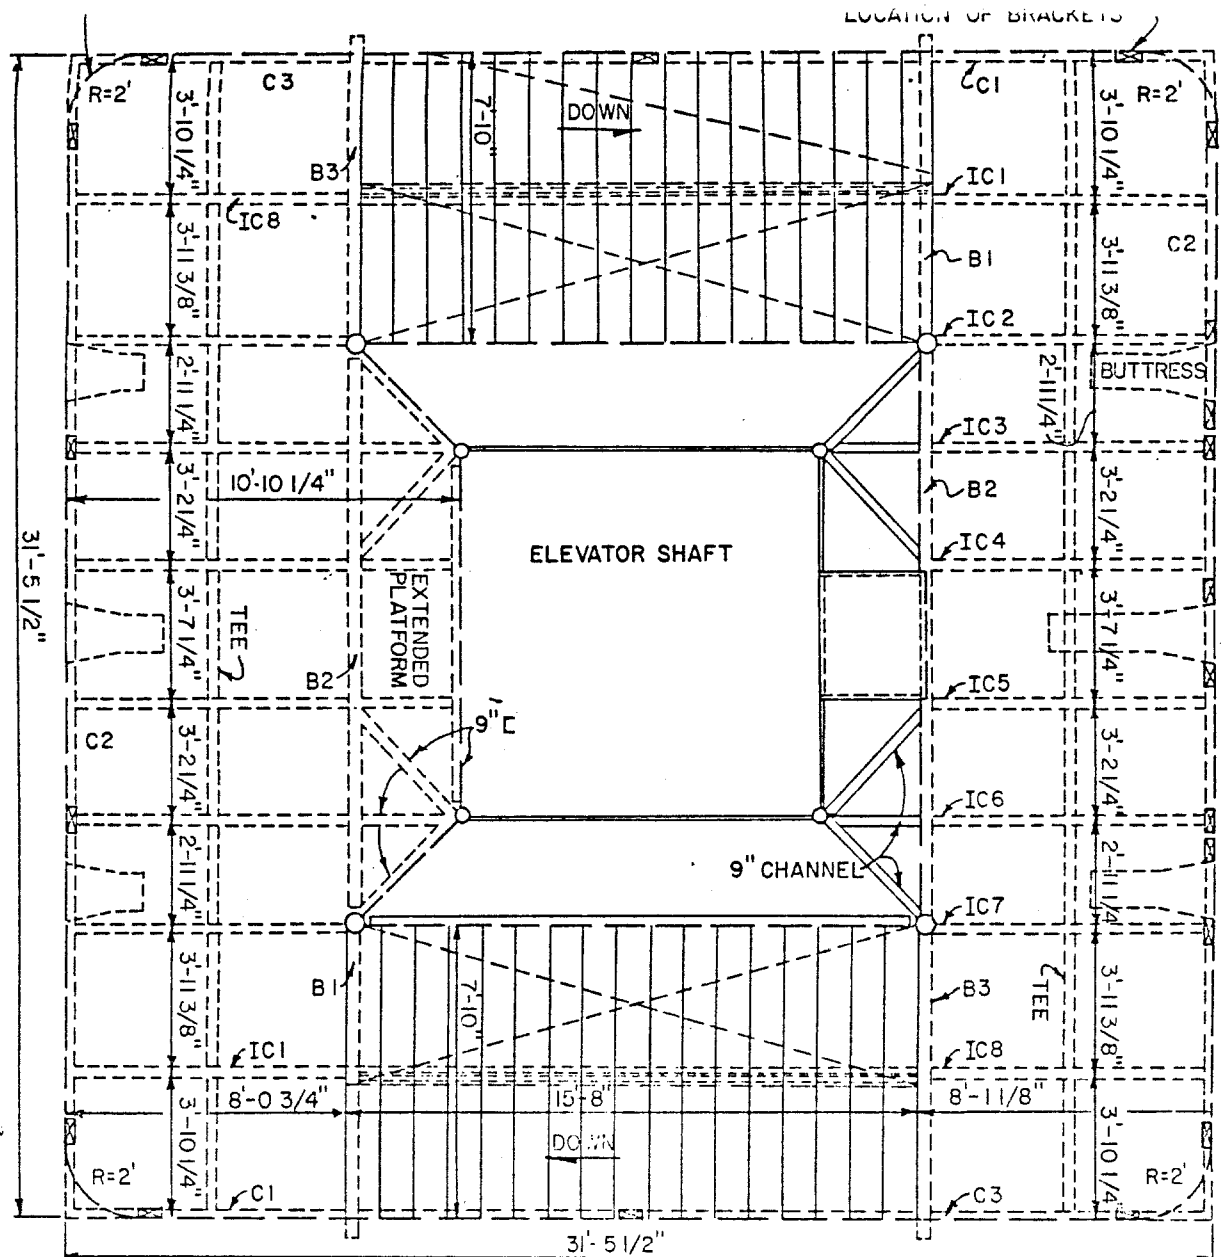
Figure 14.

Typical stair and landing framing plan, 160' level to 490' level. The existing framing is a combination of the original iron and replacement steel. Scale $\frac{3}{16}" = 1'-0"$. Robinson Engineering, Interior Structural and Mechanical Analysis, 1973.

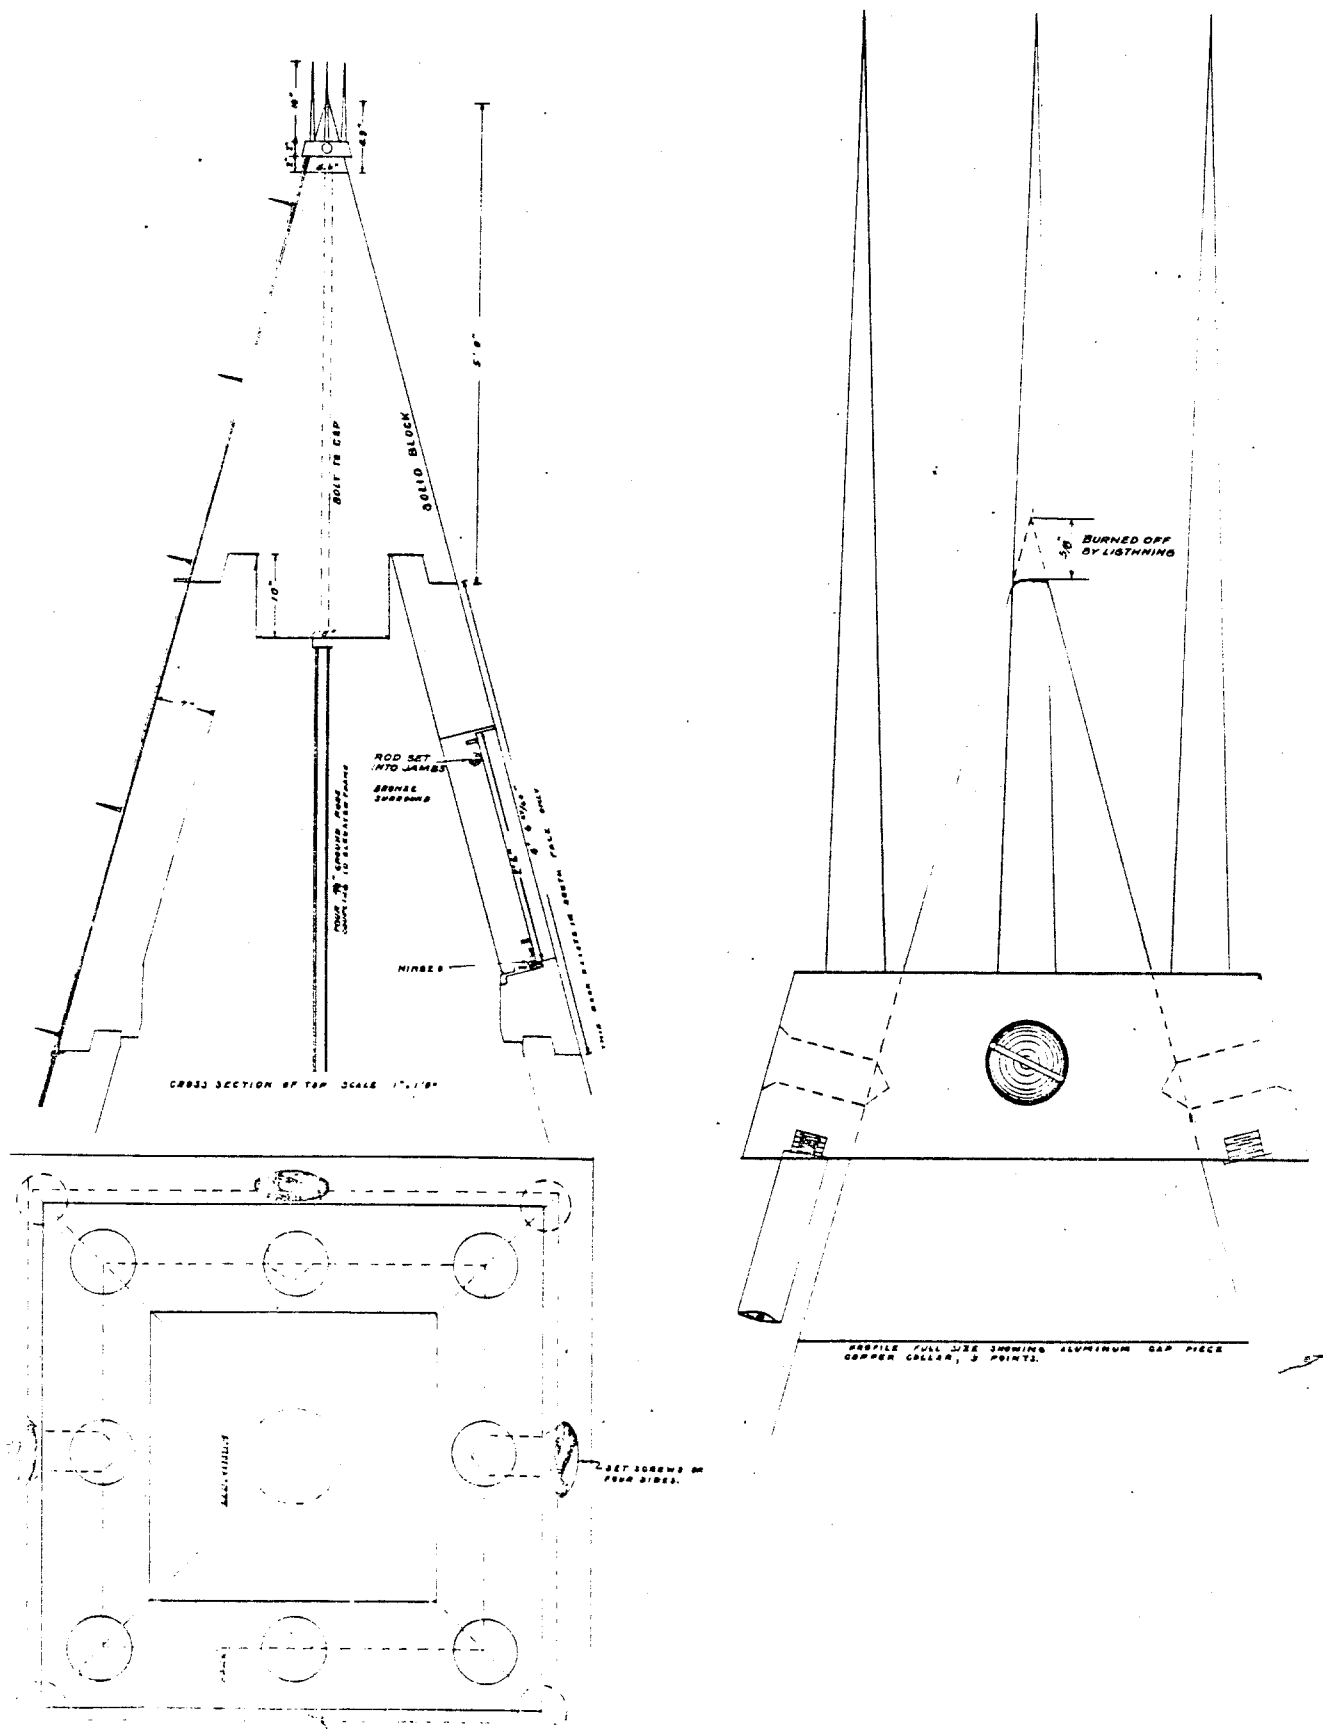
The original lightning protection system was installed soon after the Monument was topped out. The system was replaced in 1935 with a series of rods mounted to the apex and attached to cables which ran down the hips of the pyramidion (see Figure 16). A metal rod runs from the aluminum apex through the capstone and grounds the system with cable to the iron columns of the elevator shaft.

Figure 16. Lightning protection system. This system was installed in 1934 and is still in use today. NCP Files.
