Benito Pablo Juarez Monument and Plaza Investigative Condition Assessment and Report

National Mall and Memorial Parks (NAMA)
Washington, DC

**REPORT & REPAIR PLAN
FINAL SUBMISSION**
March 22, 2010

Prepared by:
Oehrlein & Associates Architects
Washington, DC

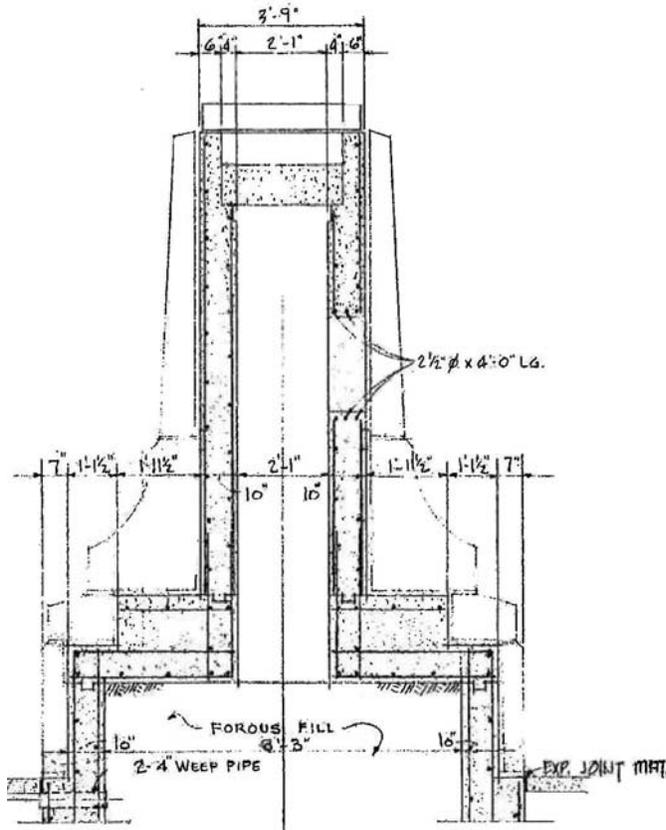
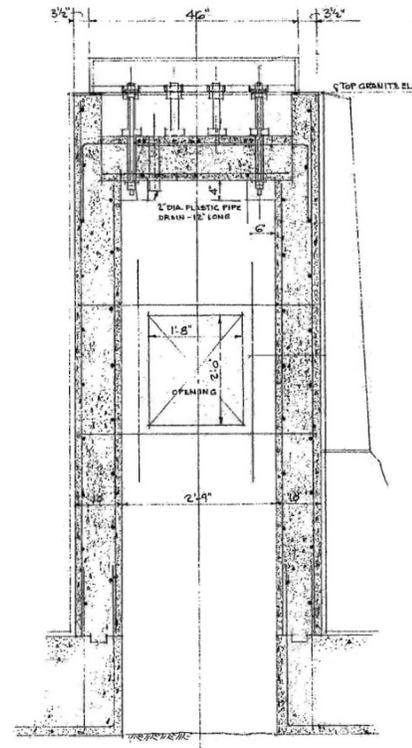
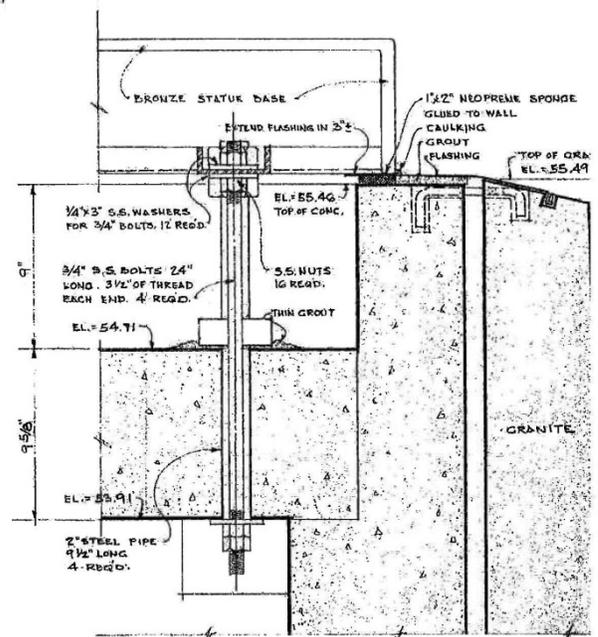
The structure of the pedestal as illustrated in the original as-built drawings by Palmer, Campbell and Reese Consulting Engineers. Section B-B (above) is cut through the pedestal. Section L-L (above right) shows the anchor bolts attaching the bronze statue to the concrete structure. Section N (right) details the statue anchor bolt connection and the metal cramps attaching the granite cladding to the concrete structure.

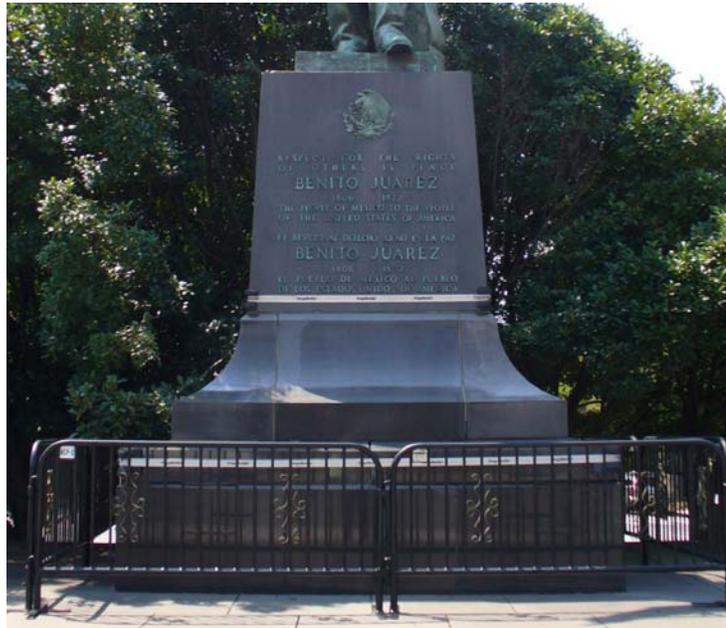
The granite pedestal base for the Juarez Monument.

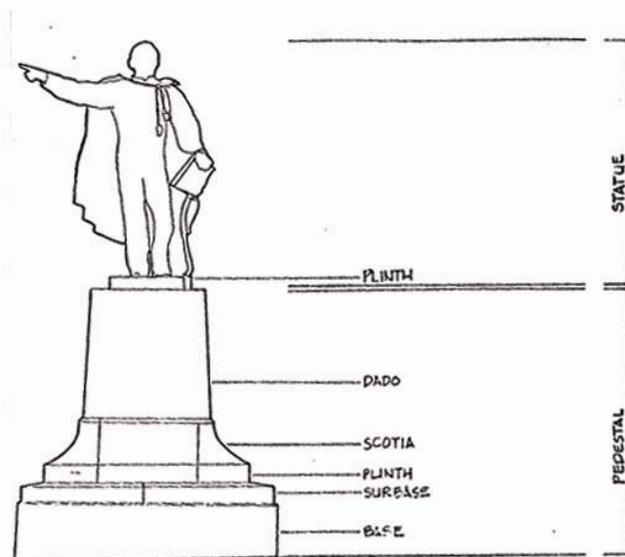
Diagram of the monument's bronze statue and granite pedestal illustrating the individual stone courses referenced in the report. (Diagram Source: "Investigation of Sixteen Selected Statues and Monuments," NPS, April 1985.)

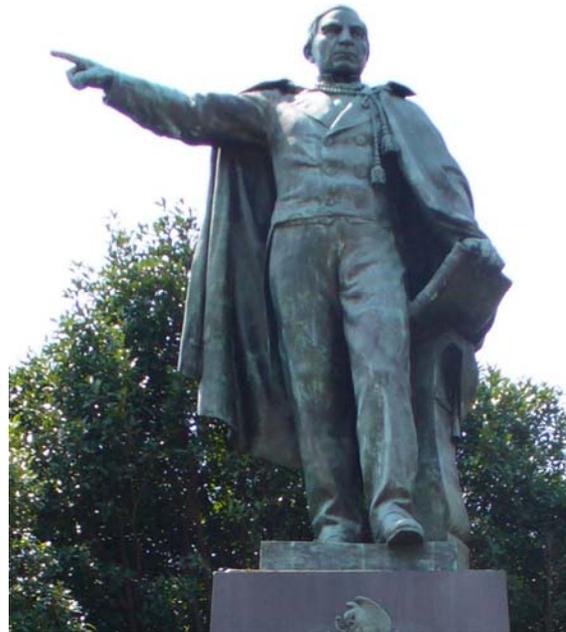
The bronze is generally in good condition with minor deterioration and damage that should be addressed. The bronze likely originally had a dark statuary bronze finish as is typical of monumental statutes of this type. There has been recent refinishing of the statue, probably within the last ten years. The wax used to refinish the statue had dark brown and green pigment additive. Much of the recent wax, however, has deteriorated or worn away completely resulting in streaks and large patches of green oxidation commonly associated with weathered bronze. In archival documents regarding the monument, there is mention of the statue being painted green at one point. The close range survey conducted for this assessment, however, located no remnants of paint on the bronze.

View of the Juarez Monument's bronze statue from the northeast.
