Physical Description

CHARACTER DEFINING FEATURES

Figure 3-017: Street elevation. (Photo: BBB, 2007)

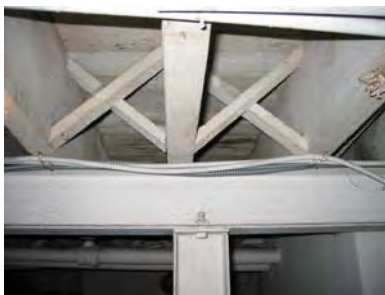
Steel I-beams in the basement were added at some point in the late-19th/early-20th century, to provide added structural support either when the house was renovated for multiple tenants or for Dr. Carter G. Woodson's occupancy. The steel beams and posts are stamped with the label Phoenix. Phoenix Ironworks, in Phoenixville, PA, was in business from 1855-1949 as the Phoenix Iron Co. From 1949-1955 it was Phoenix Iron & Steel, and after 1955 was called the Phoenix Steel Corp. The Phoenix Iron Co. made railroad rails, the griffin gun (Civil War), and the Phoenix Column (a cast iron column), I-beams and other structural members. The company flourished in the mid-late 19th century, and constructed a great deal of worker housing in the town of Phoenixville. In 1886 the company began to manufacture steel as well as iron, so the steel dates to this date at the earliest. Robert Silman

Figure 3-013: Phoenix steel beams at basement. (Photo: BBB, 2006)

& Associates, has determined the beams are an early form of steel. Whether or not they were installed in conjunction with or prior to Woodson's occupancy, the evidence above supports the assumption that they were in place during Woodson's occupancy and are character defining features of changes to the house during the period of significance.

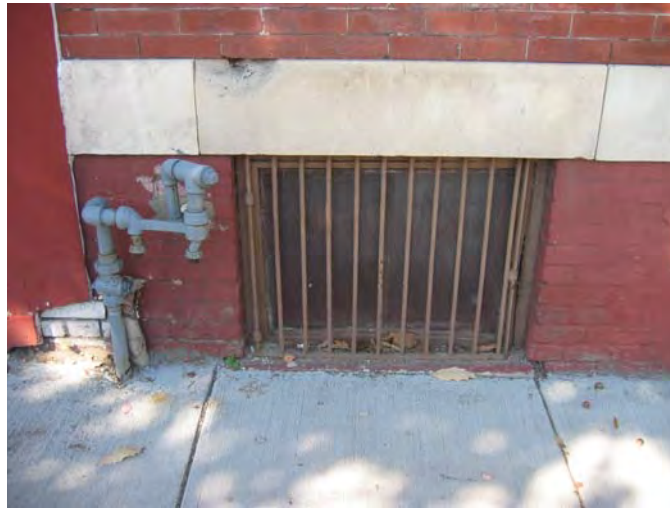
The two basement windows (W001, W002) are single sash casements each with two lites divided by a single vertical muntin. These windows date to Period 1. These two windows also have a painted fixed iron security grille bolted to iron anchors recess into the masonry joints.

Figure 3-025: Basement window. (Photo: BBB, 2007)

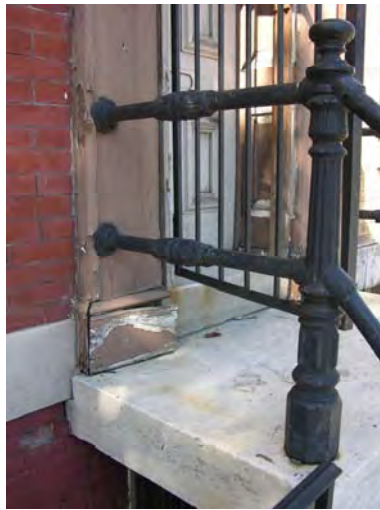
Cast Iron-- The front entrance railings, located on the north and south sides of the entrance stair, are composed of primary and secondary cast-iron newel posts each with fluting and decorative florettes. The horizontal and diagonal rails are painted cast iron and are decorated with cast iron beads flanked by tulip-shaped floral ornament at midpoint. The south primary newel post is missing its decorative cap. The railing is painted black.

Figure 3-030: Cast iron guard railing detail. (Photo: BBB, 2007)

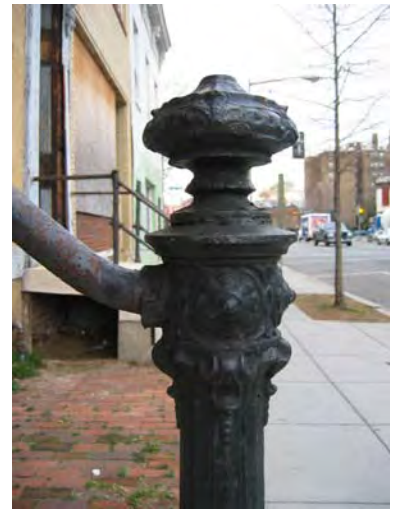
Figure 3-031: Cast iron railing detail. (Photo: BBB, 2007)

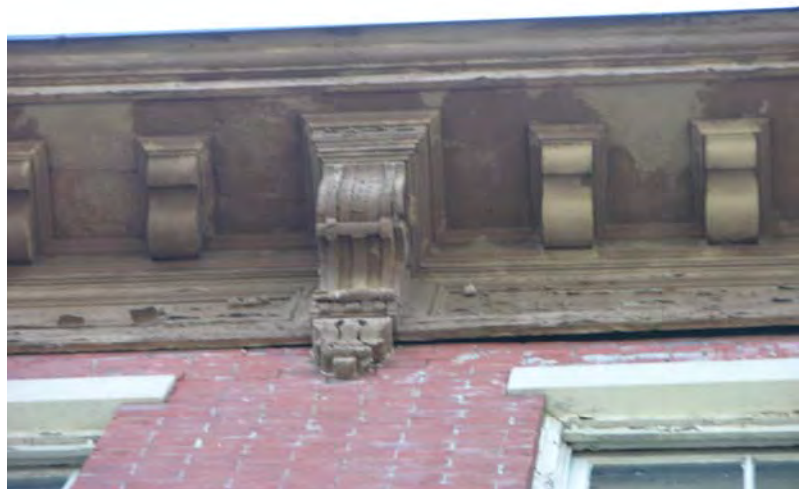
The façade is capped by a painted wood bracketed and modillioned cornice characteristic of its style and period. The cornice has four single brackets and modillions that match those of the entrance hood. The southern and northern brackets straddle the property line. Three modillions are located in the intervals between brackets. The cornice is painted brown.

Figure 3-032: Cornice. (Photo: BBB, 2007)

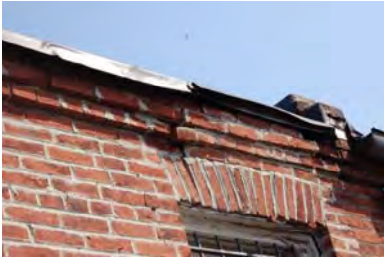
Figure 3-037: Corbelled cornice at third story elevation. (Photo: BBB, 2007)

The three story elevation is capped with a corbelled brick cornices composed of three courses. Much of that brick is loose or dislocated.

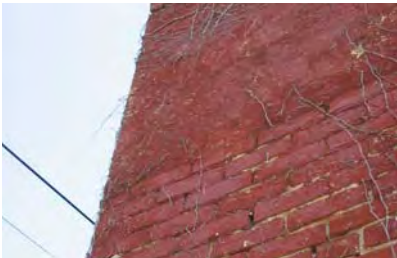
Figure 3-038: Cementitious coating and painted brick. (Photo: BBB, 2007)

The brick at the first floor of the two story elevation has been painted red. The brick at the second floor of the two story addition has been parged with a cementitious coating and has been painted red. This coating is cracking in multiple locations above and below window W210.

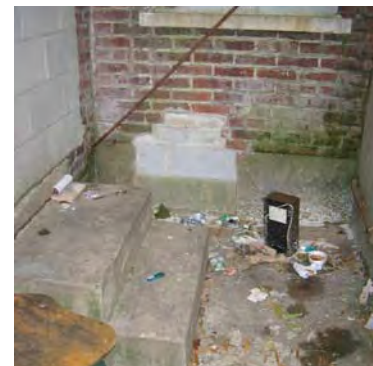
Figure 3-041: Concrete steps and CMU infill below W103. (Photo: BBB, 2007)

Concrete Block – 8"x16" Concrete Masonry Units were used to infill window openings D103A, D110A and W209. D103A was filled in to prevent entry into the building however W209 and D110A were filled in to stabilize the failing openings.

Door opening D103A, measuring 4'-6" x 6'-11", has been filled in with concrete masonry units during Period 5 however the door dates to Period 1. This was done not only for security reasons but also because the wood door frame and the floor structure behind the door was experiencing significant deterioration due to water damage, rot and termite damage. The door no longer exists and all that remains of the door frame on the inside are remnants of the head jamb which show shadows of where mullions were removed that once created side lights for the door.

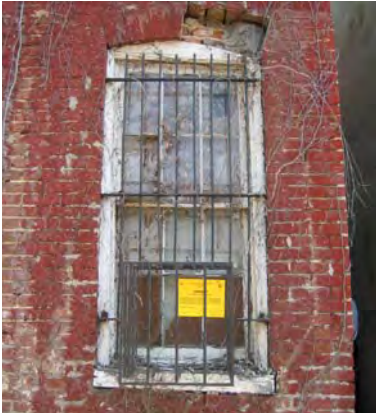
Figure 3-042: W107.
(Photo: BBB, 2007)

Five of the six windows on this elevation (W107, W204, W210, W304, and W305) are wood double-hung six-over-six windows with rope pulleys and counterweights. Windows W103, W204, W304 and W305 date to Period 1 while windows W107 and W210 date to Period 2. The window frames are simple wood frames painted white. In all but one case the sills are made of painted wood set into the brick. The one window that does not have a wood sill, window W103, has a concrete sill that has been installed. The window sill at W107 shows significant rot and deterioration of wood window W103 has been in-filled from the exterior with Concrete Masonry Units as was mentioned earlier. Window W305 has been covered with plywood that is bolted through to the interior.

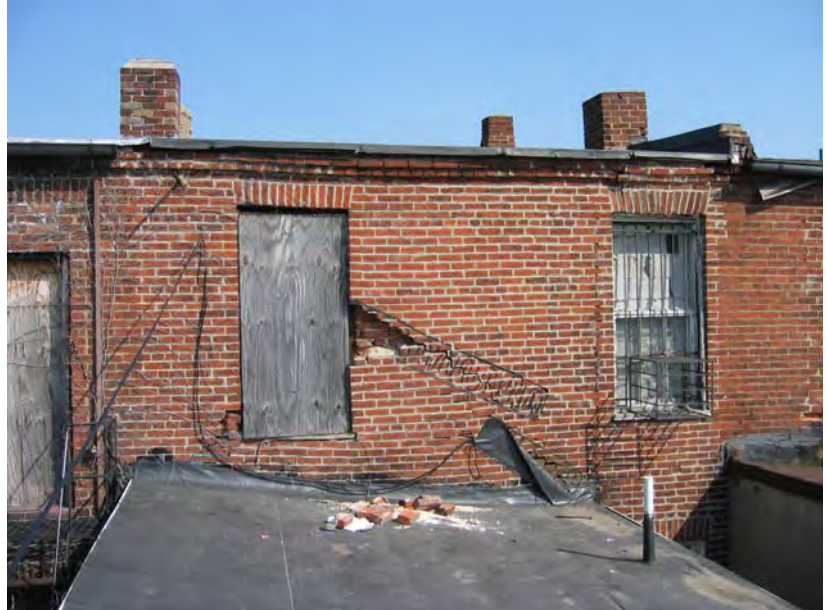
Figure 3-044: View of top of third story elevation with W304, W305 and chimneys in the distance. (Photo: BBB, 2007)

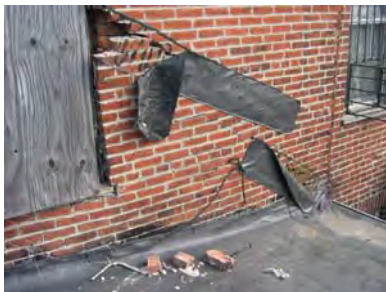
Figure 3-047: EPDM membrane patch and flashing detail at second story addition roof. (Photo: BBB, 2007)

EPDM Roofing Membrane Flashing and Masonry Patching – The EPDM roofing membrane used at the two story addition roof was not properly installed with flashing. Instead, the membrane roof was turned up and directly adhered to the brick of the three story addition with asphalt. This lack of flashing has resulted in continued leaks at the joint between the two-story and three-story addition. This EPDM membrane was also used to attempt to temporarily patch the failing brick adjacent to window W305. The membrane was applied to the surface of the cracking and dislocating brick with asphalt.

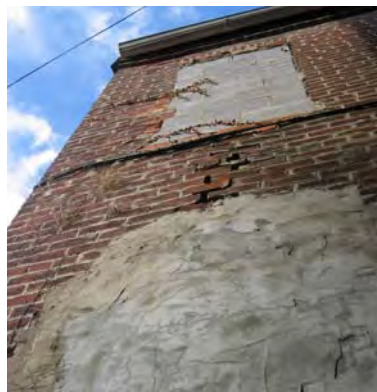
Brick Masonry – The common red brick on the south elevation of both the 1872-74 and 1880 portions of the two story structure are set in common bond. The brick used on the 1872-74 extension (Brick 3) is of a more consistent size and shape than the brick used on the 1880 extension (Brick 4). All but one window (W106) have flat brick arches. Window W106 is framed by a curved brick arch. The brick sills provided at windows W106, W207 and W208 are replacement sills and date to Period 5. Windows at the two story elevation have rounded brick arches. The rounded brick arch at window W107 is missing brick. Door D103A is framed by a flat brick arch. The brick above this opening is significantly dislocated. Dislocated brick was also noted above W104 and above and below W105. The brick above and below D110A and W209 is not only dislocated but is also significantly bowing.

Cementitious Coating – A cementitious coating was applied to the concrete masonry unit infill at D110A in an attempt to prevent moisture penetration at the joints between the CMU and the brick. This coating was also installed at dislocated brick above the door opening to further stabilize the brick.

Figure 3-054: CMU infill and cementitious coating at W209 and D110A – note dislocated brick. (Photo: BBB, 2007)

Door opening D110A also no longer has its door or frame. The brick opening has failed so severely that there are no traces of the wood frame.

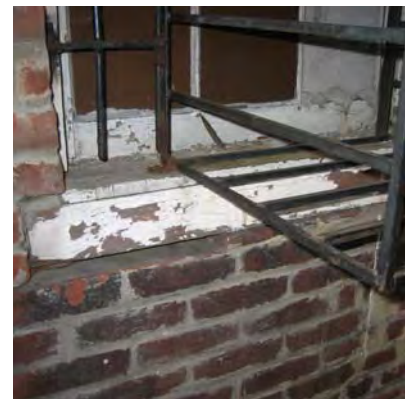
Figure 3-055: Wood sill at window W105. (Photo: BBB, 2007)

All six existing windows on this elevation (W104, W105, W106, W205, W206, W207, W208) are wood double-hung six-over-six windows with rope pulleys and counterweights. Windows W104, W105, W205, W206 and W207 date to Period 1 while windows W106 and W208 date to Period 2. The window frames are simple wood frames painted white. The wood sills for all windows were originally wood, but brick replacement sills have been installed at windows W106, W207 and W208 during Period 5. The existing wood sills show significant wood deterioration and the wood frames and trim are consistently separating from the masonry.

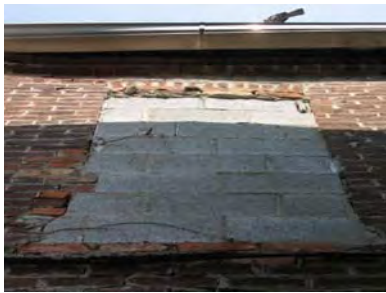
Figure 3-058: View of window W209 opening. (Photo: BBB, 2007)

W209, although the opening dates to Period 2, is missing its wood window. The opening, as was mentioned earlier, has been filled in with concrete masonry to stabilize the opening.

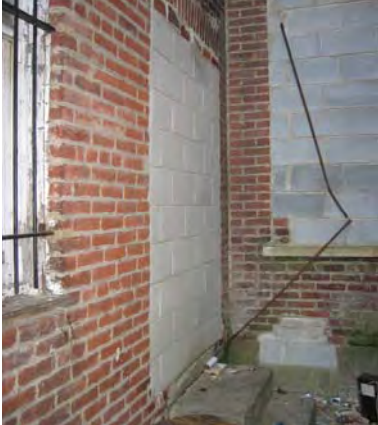
Figure 3-060: Door D103A with CMU infill. (Photo: BBB, 2007)

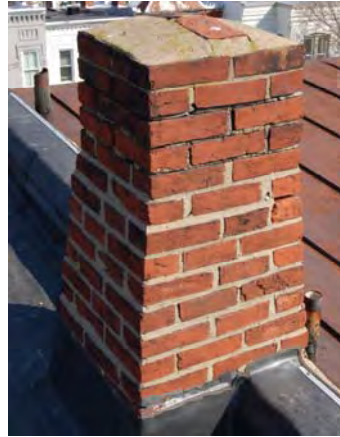
Chimney 1/Chimney 2 - Chimney 1 is constructed of common red brick (Brick 3), is 25"x24" at its base but after eight brick courses cants upward. This chimney is capped with mortar and a brick. The chimney once served the fireplace in Room 104 and potentially other openings in Rooms 203 and 303 and dates to Period 1. Chimney 2, also constructed of common red brick (Brick 3), is approximately 22" square and is capped with mortar and two pieces of slate. The chimney once served the fireplace in Room 105 and potentially other openings in Rooms 205 and 305 and it also dates to Period 1. It was noted at the first floor fireplaces that two 8" tin pipes are

Figure 3-079: Chimney 1.
(Photo: BBB, 2007)

within the flues that extends to these chimneys. The masonry at these chimneys has significant open mortar joints that will require re-pointing. The south sides of both chimneys engage the parapet of the brick party wall between the townhouses.

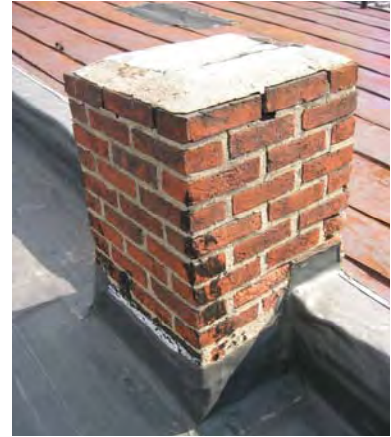
Figure 3-080: Chimney 2.
(Photo: BBB, 2007)

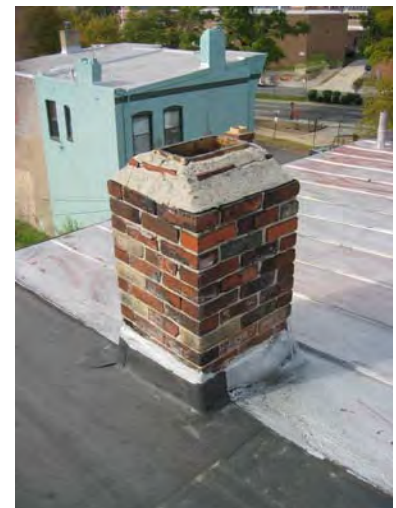
Figure 3-082: Chimney 4.
(Photo: BBB, 2007)

Figure 3-083: Chimney 5.
(Photo: BBB, 2007)

Chimney 4 & 5 – These chimneys belong to the adjacent townhouse but partially project into the roofing of the Carter G. Woodson Home. Chimney 4 measures 23"x24" and its surface is covered with a cementitious parging. The chimney cap consists of sloped mortar topped with a brick. Chimney 5 measures 22"x23" and at its top mortar is applied to corbelled brick. It is the only one of the chimneys at the upper roof that has an open flue and that flue is terra cotta. The joints at this chimney require re-pointing.

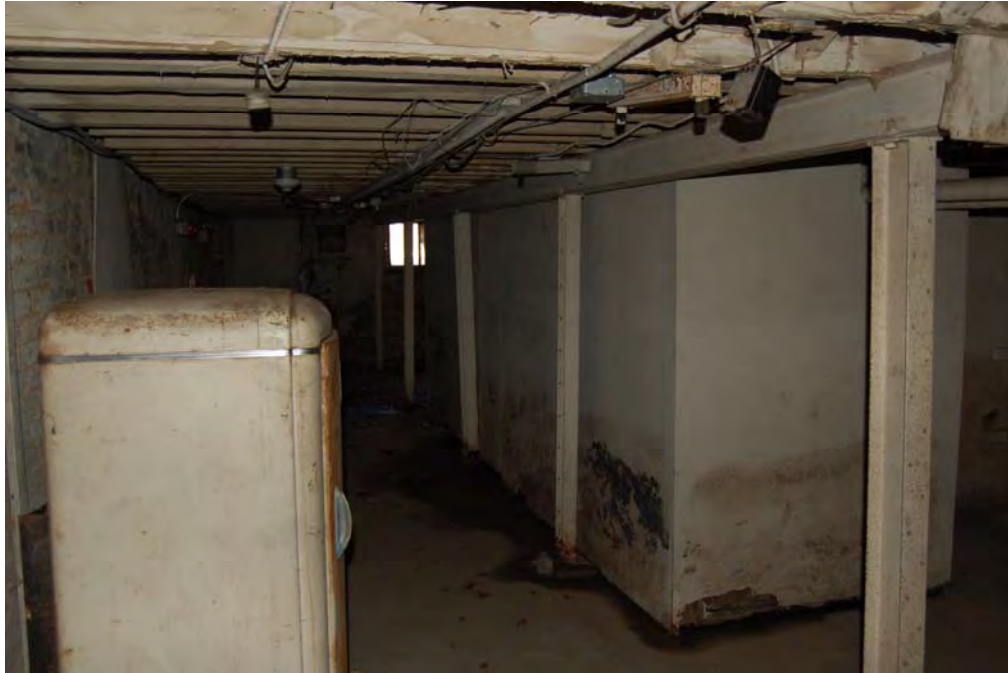
Figure 3-100: View looking east with Phoenix steel columns on right. (Photo: BBB, 2007)

Miscellaneous: The (4) steel columns are spaced approximately 7'-4" apart and run east to west. These columns are rusting at their base as a result of continuous water accumulation on the basement floor. This water enters the building through door opening D003 because the door no longer closes. These columns all have labels on them indicating that they were made by the Phoenix Ironworks. The columns support a steel beam. This additional structure was either installed during Dr. Carter G. Woodson's occupancy (Period 3) to support the increased load of office use on the floors above or installed immediately prior to his purchase of the house (Period 2).

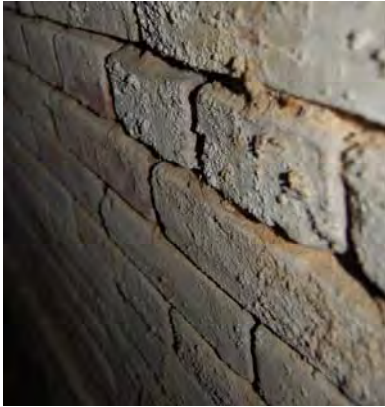
Figure 3-104: Open joists at north wall. (Photo: BBB, 2007)

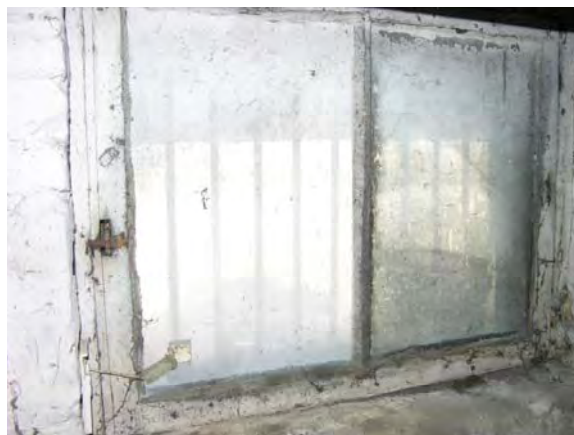
Windows W001 & W002: Simple rectangular wood stock painted frames mounted directly to the masonry. The sash is a top hinged casement window with two lites vertically divided, painted white. The metal locking mechanisms are rusted and locked in place.

Figure 3-112: Window W001. (Photo: BBB, 2007)

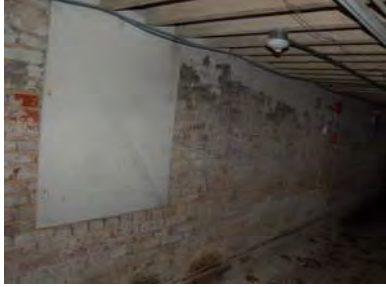
Walls: The walls are painted brick. All walls have deteriorating mortar and significant areas with open mortar joints. On the north wall a fire alarm strobe, fire alarm bell and fire alarm pull station were surface mounted. A battery operated emergency lighting pack has also been surface mounted along this wall. Surface mounted conduit on the east wall supplies power to an exit sign. A 4" and a 1.5" disconnected pipe penetrate the east wall. The 4" pipe was most likely a fuel line that fed a fuel tank. Early drawings do indicate a reference to a fuel tank in the east area of Room 001.

Figure 3-113: North wall looking east. (Photo: BBB, 2007)

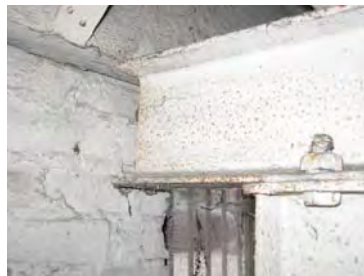
Figure 3-115: Phoenix steel beam. (Photo: BBB, 2007)

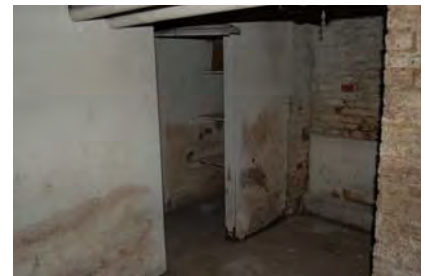
Figure 3-116: Shelving partitions and fireplace pier at west of south wall. (Photo: BBB, 2007)

The shelving dates to Period 4 when the ASALH were using the house. Many of their publications were still being stored in boxes on these shelves when the consultant team conducted their survey. Mildew was evident on most surfaces of the gypsum wall board used for the enclosures of these shelves as a result of the floor being consistently wet.

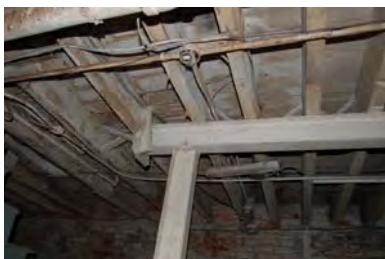
Figure 3-125: Framing east of the stair.
(Photo: BBB, 2007)

Ceiling: The ceiling is composed of exposed wood joists. Unlike the joists in Room 001, these joists are new and have not been painted. Some of these joists are sistered to older joists that have experienced significant wood rot or termite damage. The plumbing piping is surfaced mounted to these joists. A mixture of rusting rigid conduit and flexible conduit has been surface mounted to the joists to feed the light fixtures and smoke alarms.

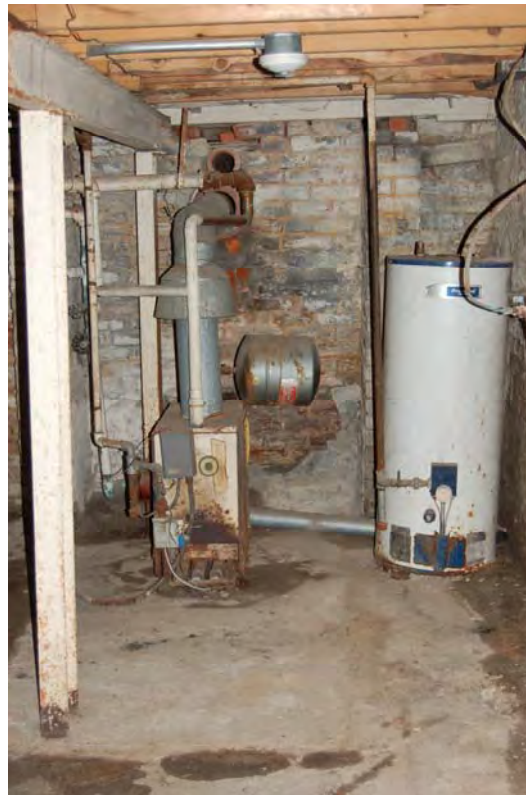
Figure 3-124: West wall with boiler and water heater.
(Photo: BBB, 2007)

On the west wall, two piers are located in the north corner that indicate where the fireplace was once located in Room 109 on the first floor during Period 1. When the extension was added during Period 2, the fireplace above was reoriented. A gap at the top of this wall allows one to see into the crawl space below the Period 2 extension. Radiator piping extends through this gap to feed the radiators in that area of the building. A hole in this wall with a pipe extension directly behind the boiler allows for the boiler exhaust to connect to the chimney that extends to above the two-story addition. An additional hole with pipe extension is directly above the boiler exhaust connection. Based on the appearance of the exhaust connection, this boiler has been retrofitted to a connection meant for an earlier boiler.

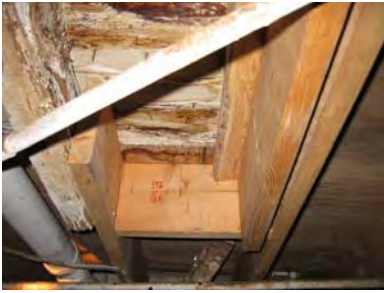
Figure 3-126: Sistering of joists.
(Photo: BBB, 2007)

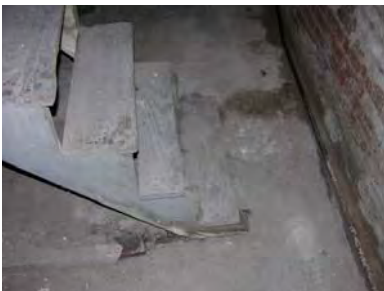
Figure 3-128: Bottom of stair.
(Photo: BBB, 2007)

Stair: The stair is composed of 9 treads attached directly to wood stringers. This stair has no handrails and is very unstable due to its stringers being attached to the first floor framing that has suffered significant water and termite damage. The bottom tread of this stair has lost a piece of wood.

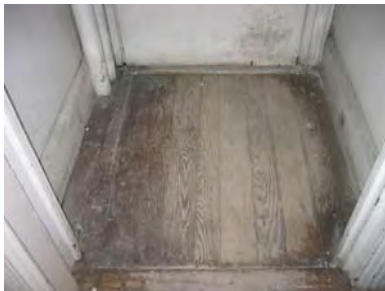
**Figure 3-134: Room 101 floor.**
(Photo: BBB, 2005)**Description of Features and Materials: Room 101**

Flooring: The flooring is pine wood that varies in size from 2 1/2' to 6" and runs in an east/west direction. The floor finish has been worn off to expose bare wood and the only evidence of the floor finish is at the edges of the floor by the base. This floor finish appears to be a clear finish with no stain.

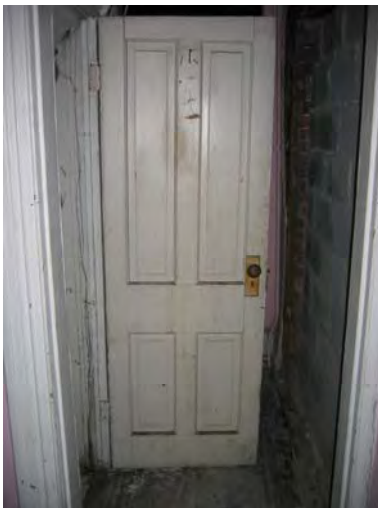
Figure 3-161: Door D103.
(Photo: BBB, 2006)

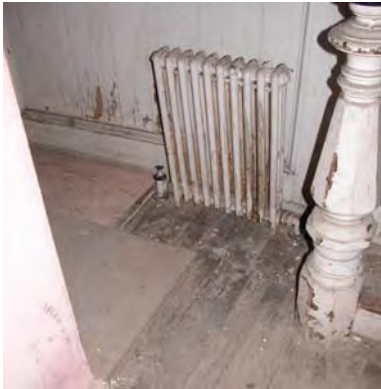
Figure 3-164: View looking west with cast iron radiator in front of painted bead board at stair. (Photo: BBB, 2006)

Miscellaneous: A painted cast iron radiator (Radiator Type R3) is located at base of stair on the west elevation.

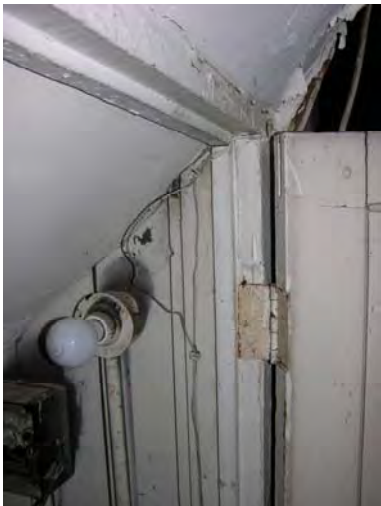
Figure 3-165: Door 103 jamb detail. (Photo: BBB, 2006)

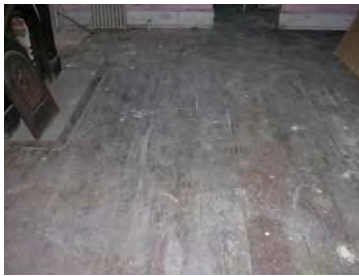
Figure 3-190: Flooring patch in front of fireplace with metal patch. (Photo: BBB, 2006)

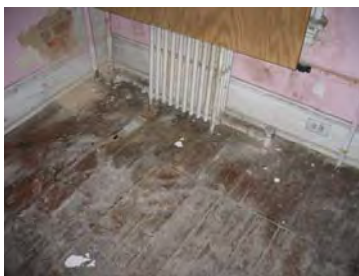
Figure 3-191: Rotting floor below window W103. (Photo: BBB, 2006)

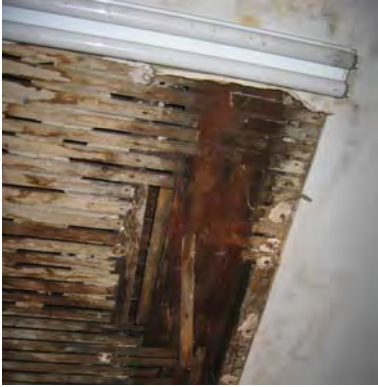
Ceiling: The ceiling is gypsum wall board nailed to the existing 1 ½" wood lath and painted white. Portions of the ceiling along the north wall have begun to separate from the lath due to water damage from above. In this area the lath is fully exposed and one can see the interruption of the lath where the north wing wall used to be located that contributed in separating

Figure 3-192: Break in lath at ceiling showing where north wing wall once was. (Photo: BBB, 2006)

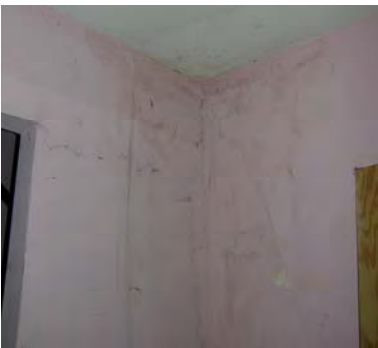
Figure 3-193: Water damage at northwest corner. (Photo: BBB, 2006)

Rooms 104 and 105 as separate parlors. Significant water damage and mold formation was evident at the north corner of the west elevation.

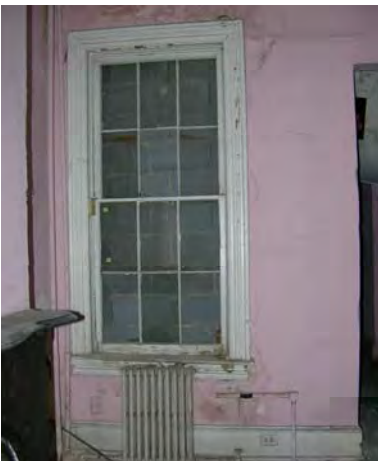
Figure 3-195: Window W103. (Photo: BBB, 2006)

Window W103: The window frame and stool is mitered wood painted white. The window sashes are six-over-six divided lites that are operated with rope pulleys and pocketed counterweights. The window hardware consists only of a window lock which is brass and dates to the time of the window sashes. This window was secured with a plywood panel nailed to the interior frame during Period 5, followed by the installation of concrete masonry block on the outside of the frame. Three panes of glass are missing from the sashes. The molding is separating from the plaster around the top and north edges of the frame. Frame molding type-1, sill type-1 and muntin type-3.

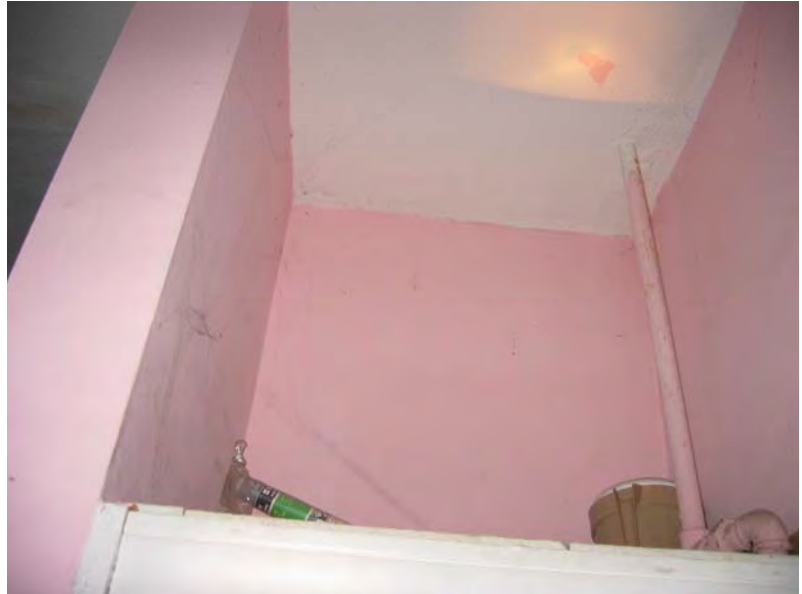
Figure 3-220: Space above closet with painted water pipe. (Photo: BBB, 2007)

Water Pipe: A 3" water pipe rises through the closet, bends slight to the west above the closet and penetrates the GWB ceiling. This pipe provides heater water from the basement to the radiator in the bathroom above.

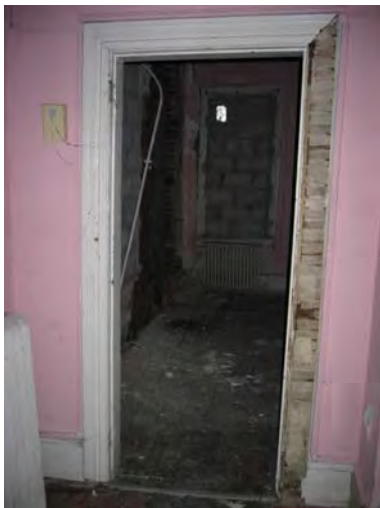
Figure 3-245: Door D110. (Photo: BBB, 2007)

Door D110: This door opening (31"x80") is framed with mitered painted wood molding that matches wood molding profiles type 4 & 5. The north vertical casing is missing, exposing the wood lath and plaster construction of this wall. No door is extant, but existing hinges remaining on the frame indicate that there was once a door in this location. The door has a 1 1/2" aluminum sill.

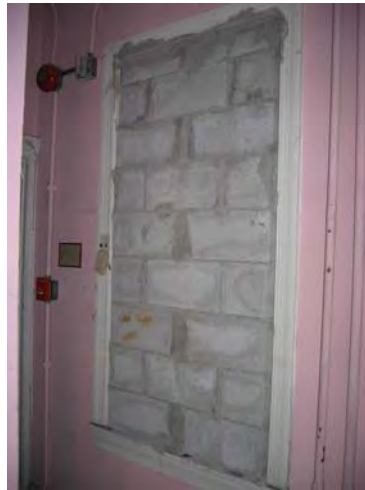
Windows W104 & W105: The window frames and stools are mitered wood painted white. This window trim was installed during Period 5 when this wall was furred out and the casing follows frame molding type 2. The window sashes are wood double sashes with six-over-six divided lites painted white. The existing window hardware is brass. The windows are covered over with concrete block infill installed in Period 5.

Figure 3-249: Window W104.
(Photo: BBB, 2007)

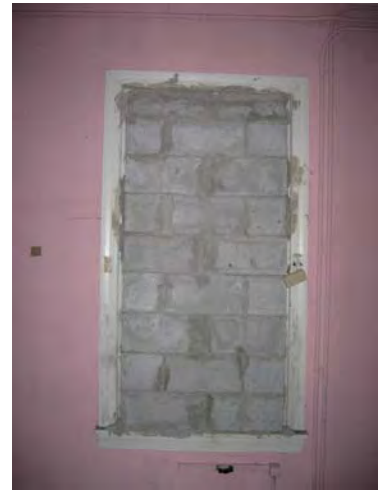
Figure 3-250: Window W105.
(Photo: BBB, 2007)

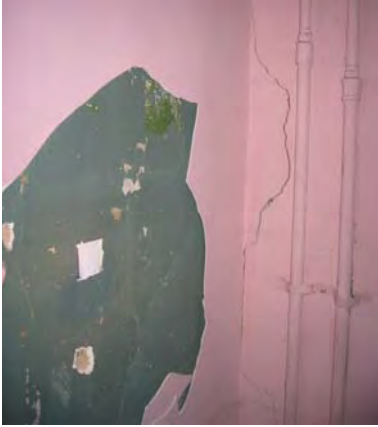
Figure 3-262: Plaster damage at west wall. (Photo: BBB, 2007)

The south wall has plaster applied directly to the exterior brick. At least fifty percent of the plaster has fully dislocated from the wall, leaving much of the inside face of the exterior load bearing brick wall exposed. The west wall has plaster applied directly to the exterior brick as well and is painted pink. A thin layer of plaster and paint is delaminating from this wall exposing a dark green color of a previous room finish. This delaminating of material clearly indicates that this room has been skim coated at some point.

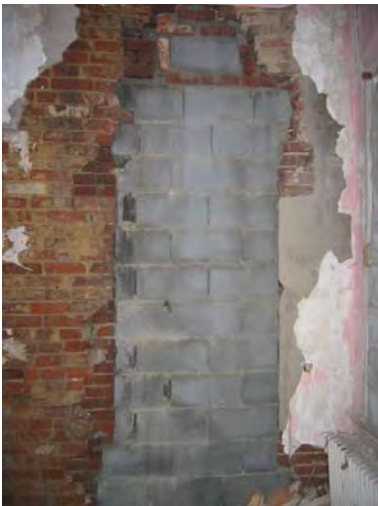
Figure 3-265: Door D110A. (Photo: BBB, 2007)

Door D110A: This door opening dates to Period 2. However, due to severe deterioration of the wood frame, the opening is close to collapse. There is no longer evidence of the wood frame or wood door. The opening has been filled in with concrete masonry units to stabilize the opening and the exterior wall. It can be noted from the interior that the vertical edge of a brick framed opening does extend from a 7'-0" height to the floor, clearly indicating that this was a door opening, not a window opening.

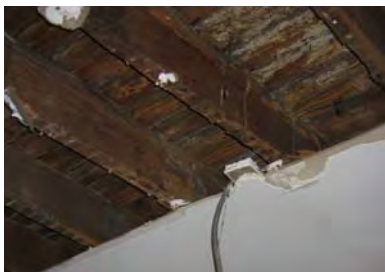
Figure 3-271: Second floor joists with exposed underside of original tongue and groove flooring. (Photo: BBB, 2007)

remaining half of the joist it appears that plywood sub-flooring have been installed as the preparation for the installation of the new floor in the room above. Fire damage along with water staining can be seen at the underside of this second floor wood flooring.

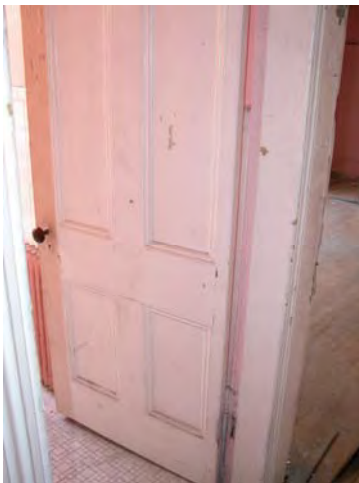
Figure 3-279: Door D207. (Photo: BBB, 2007)

Door D207: The door frame has painted mitered casing trim (type-7) and as was mentioned earlier, the left side of the frame has been trimmed and shifted to the left to accommodate the tub in the bathroom beyond during Period 5. The right side of this frame has no casing because the frame directly abuts the frame of door D208 which is perpendicular to it. The door is paneled with two recessed lower panels over two recessed upper panels and has been trimmed on the right side to fit into the trimmed frame molding type-5. The hardware is composed of a rim lock 4"x3 1/2" in size with a dark marble knob on the interior and exterior.

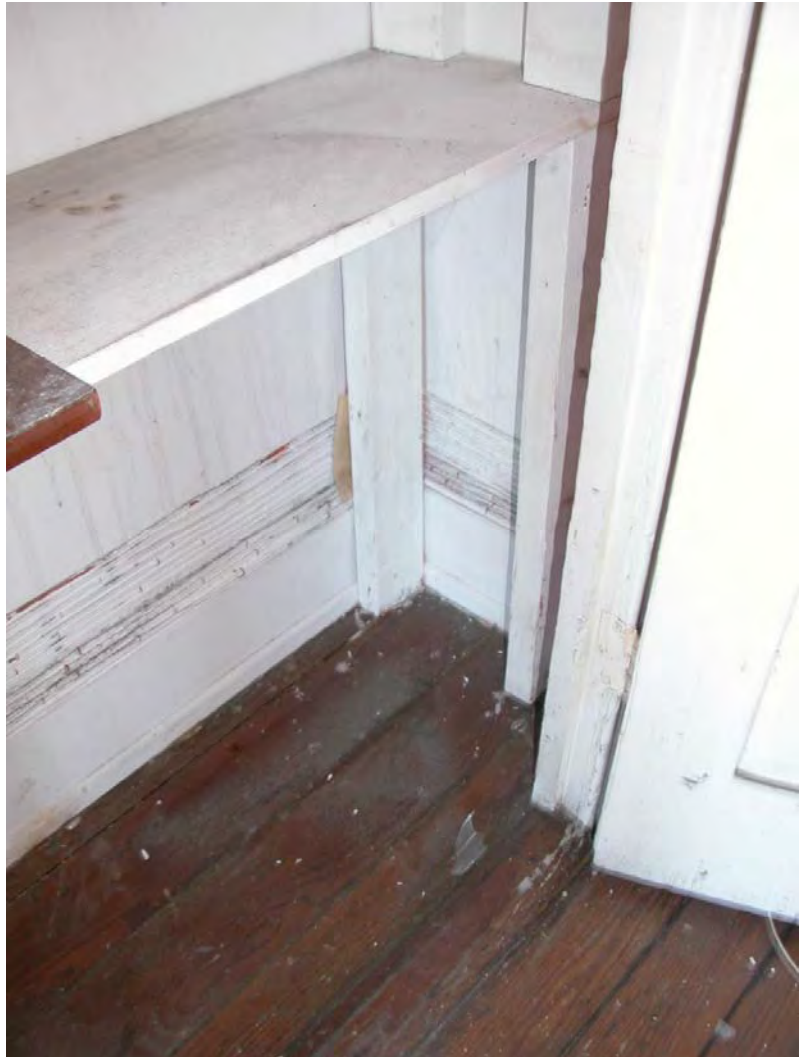
Figure 3-331: Shelving and base condition. (Photo: BBB, 2007)

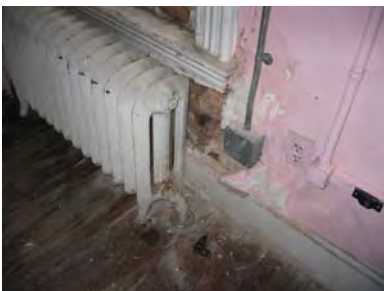
Figure 3-340: Plaster damage below window W204. (Photo: BBB, 2007)

The south wall plaster is applied to both brick and lath; the chimney chase and closet encroach on the room along this wall. The west wall has plaster applied to wood lath which is both applied to wood studs and masonry as a result of the wall being partly composed of an exterior wall. This west wall has experienced severe water damage to the plaster below window W204. There are major cracks and loss of plaster behind the radiator.

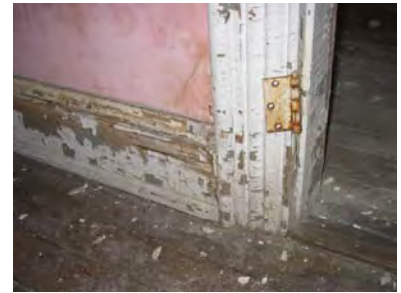
Figure 3-342: Frame profile at D205.
(Photo: BBB, 2007)

Door D205: The wood door frame has mitered wood molding and a transom (type-3) (15 ¾"x31") with three vertically divided lites and the door casing follows casing molding type-1. One of the lites in the transom panel is broken. The door opening measures 31 ½"x79" however the door is not extant. There is a wood threshold that measures 2 ¾" in width. There are remnants of hardware that exist on the frame that are composed of one hinge and a latch for the box set hardware. This frame has suffered significant deterioration due to water damage, with loss of paint and wood rot.

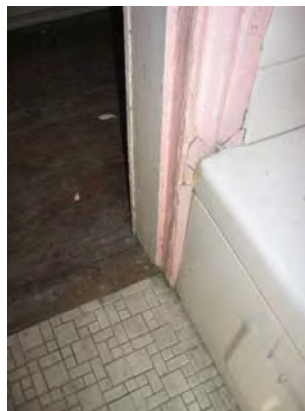
Figure 3-374: Tub interferes with door frame. (Photo: BBB, 2007)

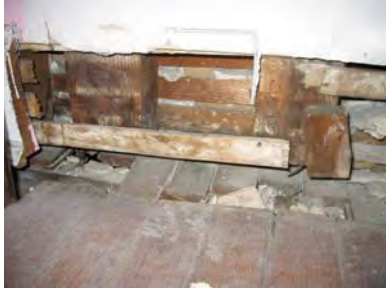
Figure 3-382: Exposed studs and lath at east wall. (Photo: BBB, 2007)

Walls: The walls are plaster, painted pink. The plaster on the north wall is applied to directly to the exterior masonry wall. The east wall has gypsum wall board nailed to 1 ½" wood lath. This wall construction can be seen along the floor where the baseboard was removed. The studs supporting this wall are 3"x4" timber studs and cut nails can be seen protruding from both the sides and bottoms of these studs. The cut nails place the wall in Period 1 or 2. It appears that the floor joist that these studs were once nailed to has sagged, for none of the bottoms of these studs remain attached to the joists.

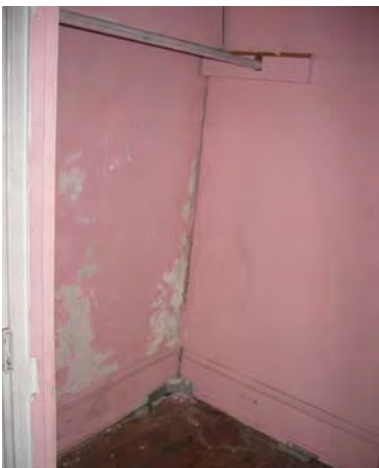
Figure 3-408: Partial south and west walls. (Photo: BBB, 2007)

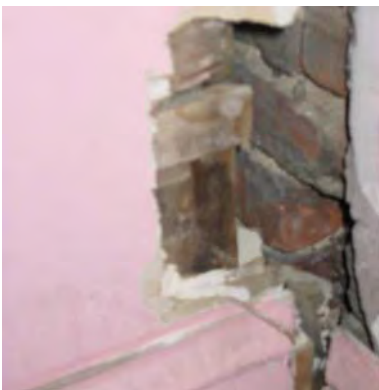
Figure 3-409: Opening at east wall corner along south wall exposing timber stud. (Photo: BBB, 2007)

Walls: The walls are plaster, painted pink. The north wall is gypsum wall board nailed to wood lath as is the east wall. Where the east wall meets the south wall a gap reveals the 3"x4" wood studs and the wood lath of the east wall, dating it to Period 2. The south wall is plaster applied directly to exterior brick. This plaster has suffered water damage. The west wall is also gypsum wall board nailed to wood lath.

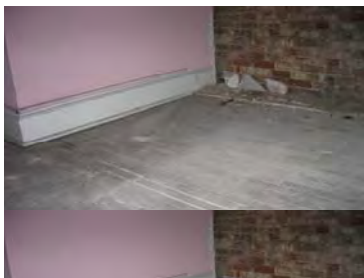
Figure 3-416: Worn pine strip flooring. (Photo: BBB, 2007)

Flooring: The flooring is 2 ½" pine wood tongue and groove strip flooring that runs in an east-west direction. This floor was installed on top of a plywood underlayment that rests on the 1880's floor. This layering of flooring can be observed from Room 110 below and indicates that the top flooring was replacement flooring. The floor sags significantly as a result of

the failing floor joists below. These joists are no longer resting on the south masonry wall and as a result the floor sloped significantly to the south.

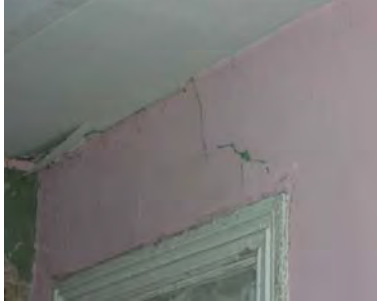
Figure 3-420: Plaster damage above W210. (Photo: BBB, 2007)

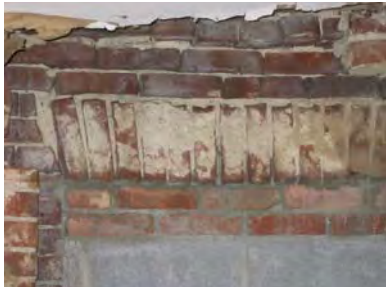
Figure 3-421: Failing flat arch at window W209. (Photo: BBB, 2007)

Window Opening W209: This window has been completely removed from the masonry opening and the opening has been filled with concrete masonry units during Period 5. The window was infilled as a result of both the rotting wood window and the failing brick flat arch.

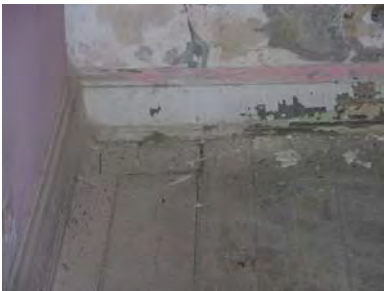
Figure 3-428: Floor and base damage at south west corner. (Photo: BBB, 2007)

Base: The base is wood painted white and composed of a quarter round and a plain wood base capped by a large ogee trim. (Base type-1) Along the east and south wall the base has suffered significant water damage due to water infiltration.

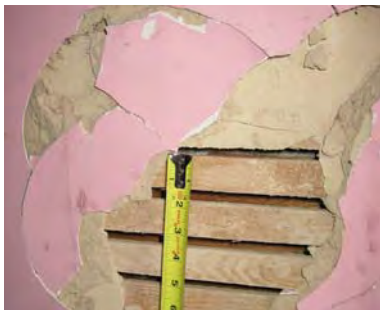
Figure 3-468: Loss of plaster at north wall exposing wood lath. (Photo: BBB, 2007)

Walls: The walls are plaster, painted pink. The north wall has plaster applied to wood lath. This wall has suffered severe water damage as a result of a previous leak in the roof. Major cracks are evident in the plaster and there is loss of plaster in the middle of the wall, exposing wood lath.

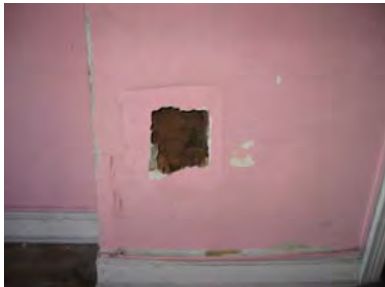
Figure 3-470: Probe at south wall chimney chase. (Photo: BBB, 2007)

A probe hole was made at the chase location of this wall, revealing the construction of the flue. A curved metal tube was found in the chase. This metal tubing was also found in the first floor fireplaces and in the basement. Per the historic catalog documentation found on the fireplaces and grilles on the first floor, this tubing was an early form of ductwork that was attached to the furnace in the basement and attached on each floor to a decorative grille with louvers. The uncovering of the elbow at this location implies that the tube turned to the wall to meet a grille at this location. This tubing dates to Period 1 when the fireplace grilles were installed.

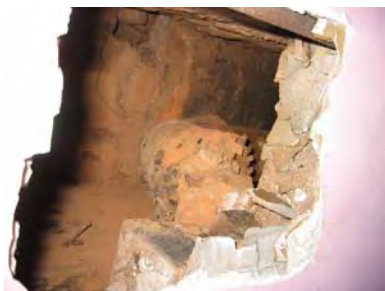
Figure 3-471: Metal tube elbow at chimney. (Photo: BBB, 2007)

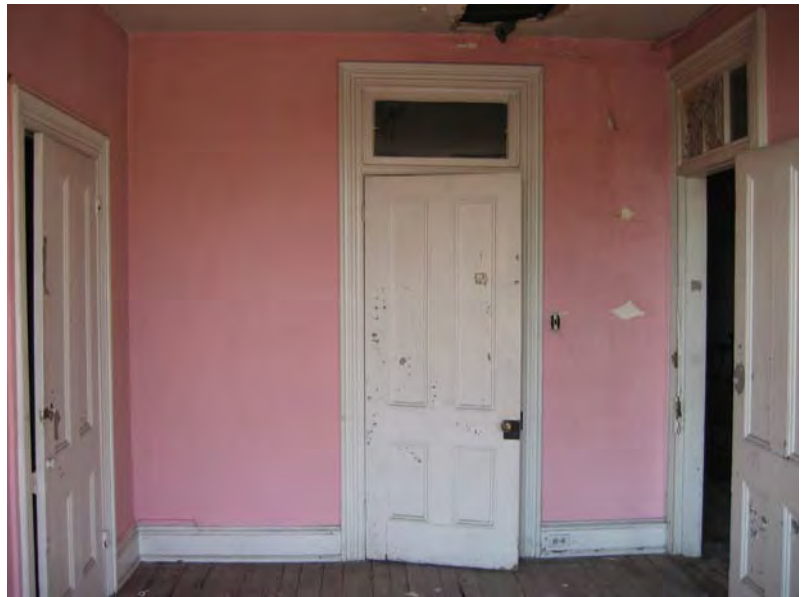
The west wall has plaster applied to wood lath. Paint loss is evident to the right of door D303B. 5" Electrical conduit is surface mounted to the north east and south walls to provide additional outlets.

Figure 3-473: West wall with door D303B. (Photo: BBB, 2007)

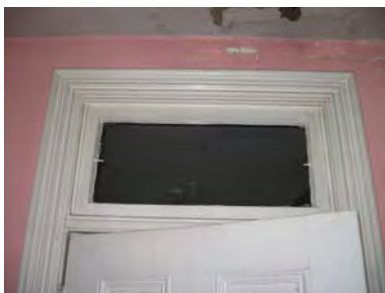
Door 303B: The wood door frame has an opening that measures 31 ½"x79 ¼" and has mitered wood molding and a transom (15 ¾"x32") with one large lite. (Casing type-6, transom profile type-3) This transom is different from all of the other transom in the house which have 3 vertically divided lights. The painted wood stile and rail door is paneled with two recessed lower panels over two recessed upper panels. (Molding type-8) The door has hardware set 13. This box latch hardware set was has typically been used only on closet doors within the house, so this hardware may have been relocated. Shadows on the door frame indicate that the bottom hinge was moved.

Figure 3-475: Transom at door D303B. (Photo: BBB, 2007)

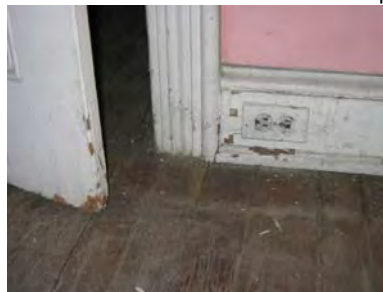
Figure 3-476: Frame detail at door D303B. (Photo: BBB, 2007)

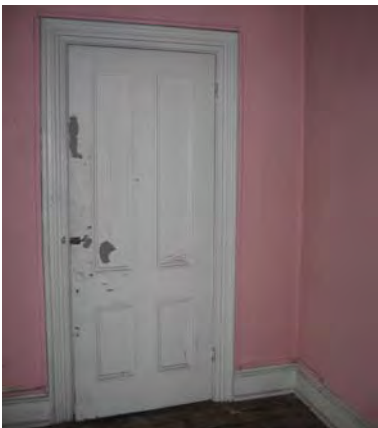
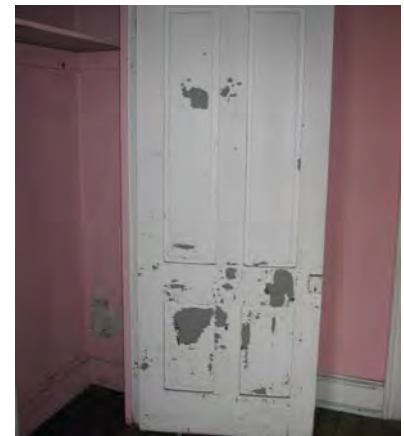
Figure 3-488: Door D304, view from room 303. (Photo: BBB, 2007)

Figure 3-490: Door D304, room 304 side. (Photo: BBB, 2007)

Door 304: The wood door frame has an opening that measures 31 ¾"x79"¾" and has mitered wood casing only on the side facing Room 303. (Type-6) The painted wood stile and rail door is paneled with two recessed lower panels over two recessed upper panels. (Type-6) The door has a hardware set similar to Hardware Set 10 but with a knob only on the room side made of wood. A small slide lock has been installed on the Room 303 side of the door frame. There is a 3 ¾" wood threshold located at this door. Loss of paint was noted on a significant portion of the door.

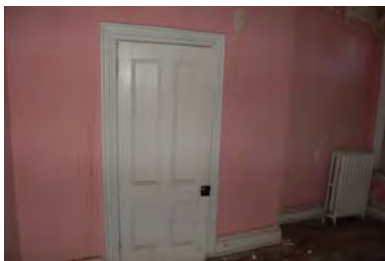
The south wall is composed partly of the masonry party wall where plaster is applied directly to the brick. The protrusion from this wall is composed of a chase for the chimney flues and a closet. The chase is constructed of brick and plaster is applied directly to the brick. The closet is framed with wood studs and plaster is applied to wood lath. The western edge of this protrusion has a wood edge strip that has loss of paint and plaster. The partial exposure of this edge strip shows that the wall was at some point skim coated. Some loss of paint and limited areas of severe water damage were noted on this elevation.

Figure 3-501: South wall with plaster water damage. (Photo: BBB, 2007)

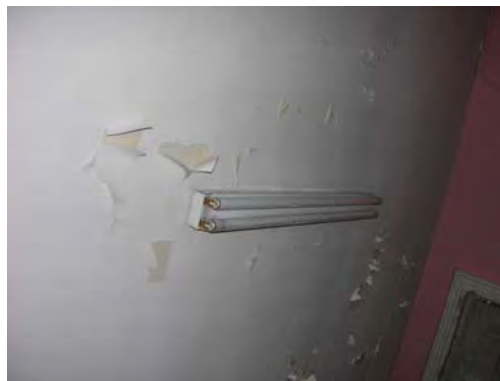
Ceiling: The ceiling is rock lath nailed to the wood joists. The seams of the panels have generated hairline cracks in the ceiling finishes that clearly delineate the size and location of each panel. This ceiling shows significant water damage directly above door D305 due to water penetration at a roof leak that has since been patched. A wire mesh and plaster patch was attempted at the top of this door at some point after the installation of the rock lath. It was noted that the roof joists above this hole show fire damage so at some point there was a fire that impacted the roof structural system from below and could therefore have required replacement of the ceiling.

Figure 3-506: Ceiling showing light fixture and paint loss. (Photo: BBB, 2007)

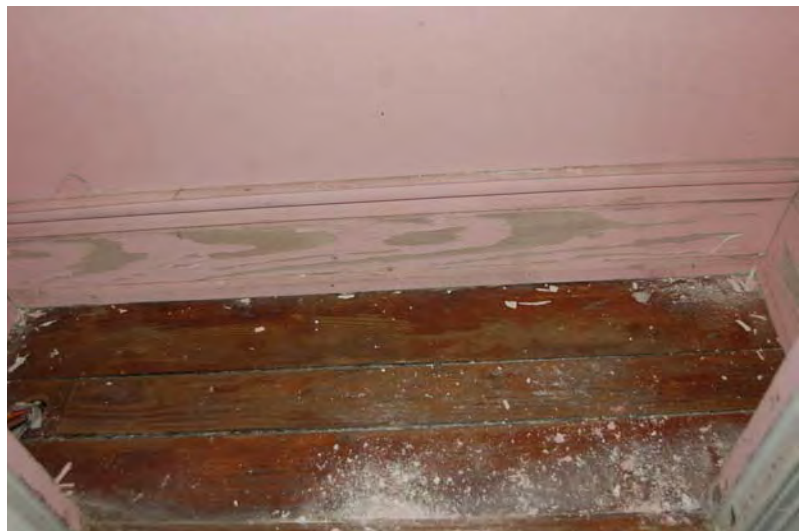
Flooring: The flooring is pine wood tongue and groove strip flooring of varying widths of 2 1/2", 3", 3 1/2", 4 1/2", 5 1/2" and 6". The floor finish is relatively intact and indicates what the finish would have been for the adjacent Room 305.

Figure 3-511: Closet flooring and base. (Photo: BBB, 2007)

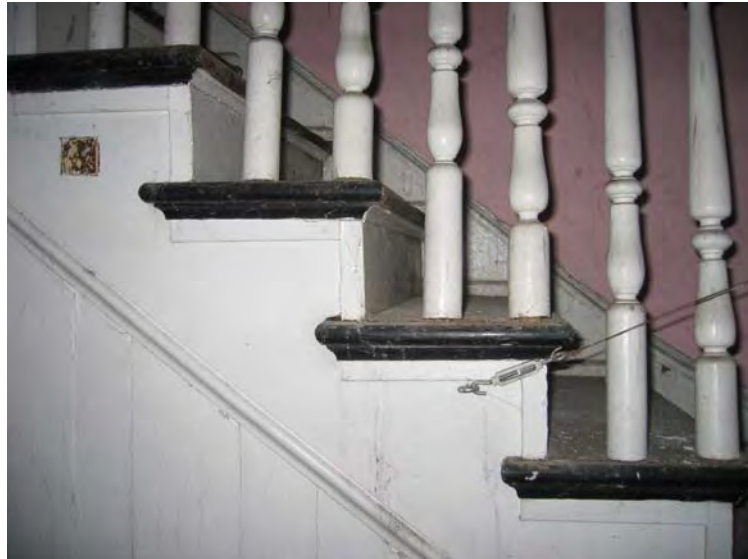
Figure 3-521: Stringer at first floor stair. (Photo: BBB, 2007)

The stair from the first to the second floor is structurally unstable. Due to moisture damage that has deteriorated the supporting structure, the stair has sagged, causing separation of the stair members from the wall and from each other.

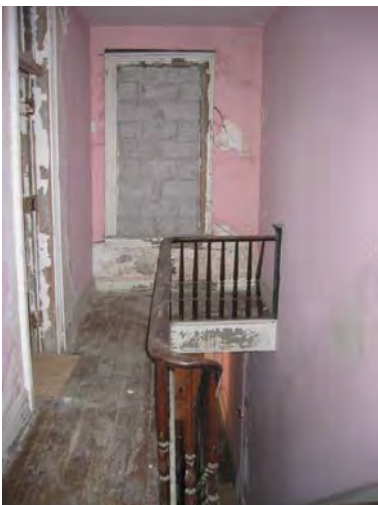
Railing: The carved wood hand rail is stained dark brown. It begins at the first floor with a closed circle with a raised center, and follows the curvature of the stair between the first and second floors. At the first floor it is supported by a turned and carved wood newel post, with circular and hexagonal elements, painted white. The newel post was originally stained during Period 1 but painted over during Period 3. From the first floor to the second the railing is supported by delicate turned wood balusters, painted white, divided in four sections by beads and delicate indentations, the uppermost of which becomes very narrow where it intersects the hand rail. The balusters were originally stained during Period 1 but were painted over during Period 3. From the second to third floors the railing is supported by similar but slightly simpler balusters, which are stained dark brown to match the hand rail and consist of three sections, lacking the upper beaded element and not quite as narrow at their tops. Both runs of the stair feature two balusters per step. The second floor newel is stained rather than painted white, and is less elaborate than its primary floor counterpart, without hexagonal sections. Several balusters are either broken or missing at the second and third floor.

Figure 3-528: Railing at third floor. (Photo: BBB, 2007)
