Golden Gate National Recreation Area

TITLE I REPORT

Stinson Beach Parking Lot Storm Damage Repairs

August 2015

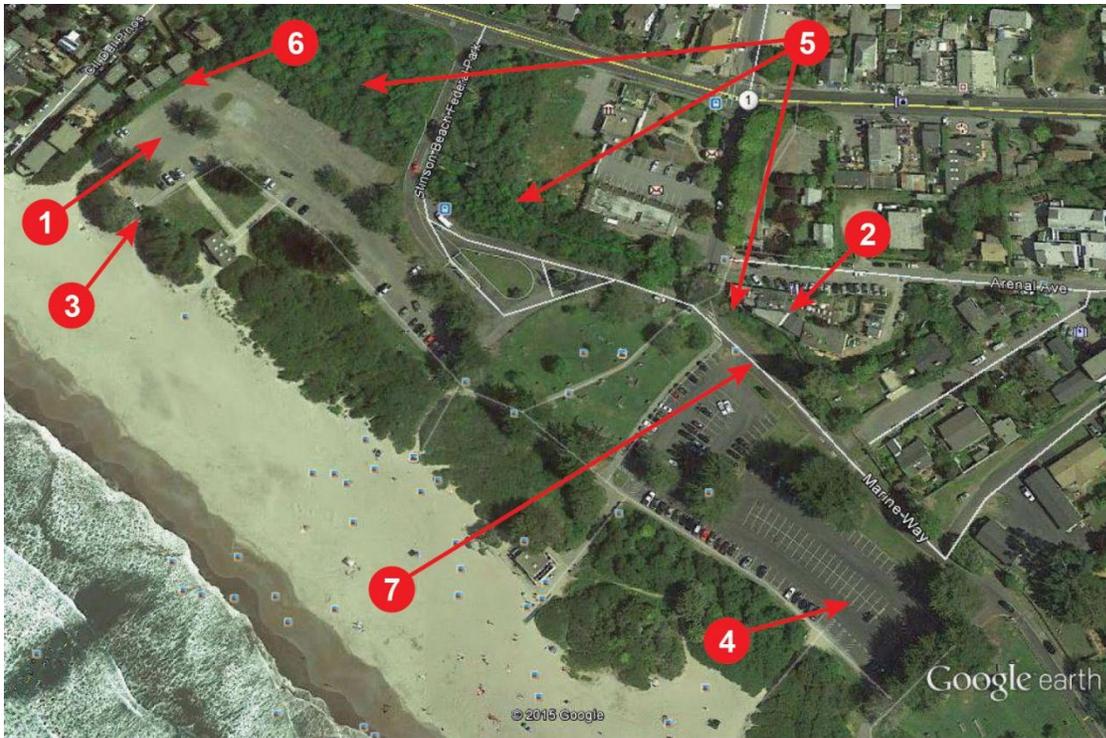
Site Aerial Photo, Figure 1

It is a very popular summer destination and is easily accessible from a major highway. This area of the Park can experience a peak usage of 10,000 visitors on warm holidays. The Stinson Beach public areas are divided into three main areas, South, Central and North, each served by public comfort stations, picnic areas, beach access and parking lots as shown on the Site Aerial Photo, Figure 1.
