# Merced River Riparian Corridor Restoration in Yosemite Valley

Restoration Concept  
Designs

March 2016

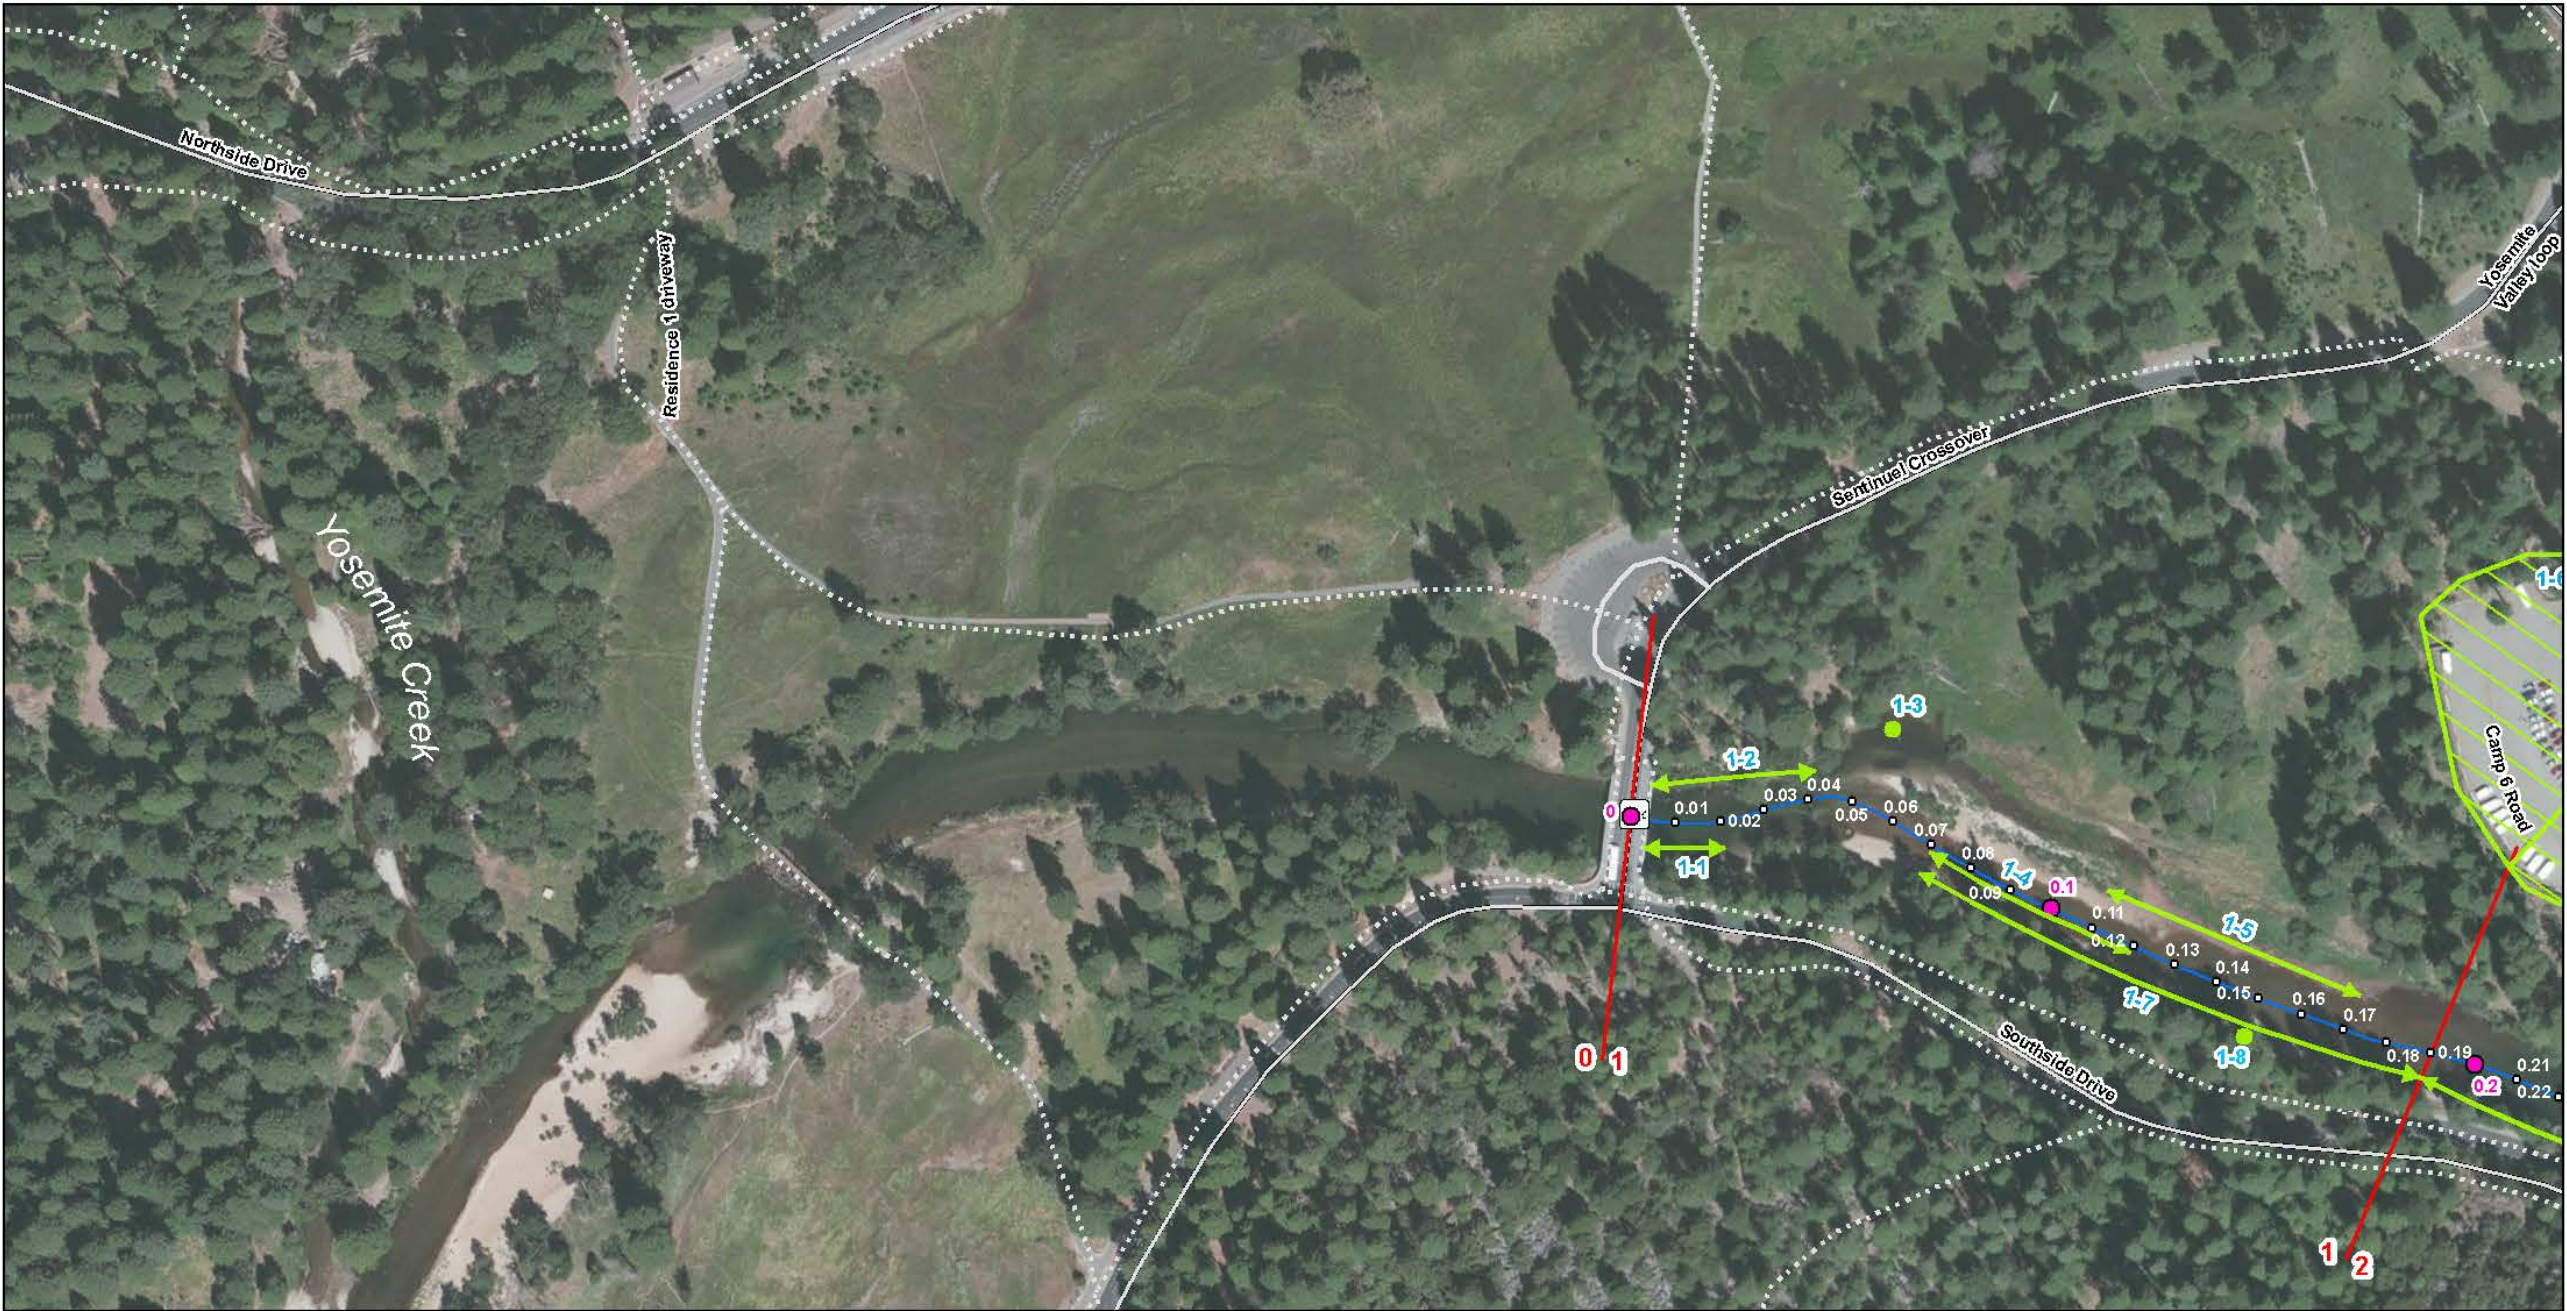
<b>Restoration Treatment Features</b> <ul style="list-style-type: none"><li>Primary Rd</li><li>Secondary/Local Rd</li><li>Trail</li><li>Reach Breaks</li></ul>	<b>Reach and Treatment ID</b>			
	<b>Map 1 of 7</b>

1-7	0.07-0.19 (LB)	<ul style="list-style-type: none"><li>Eroding Banks (toe)</li><li>Eroding Banks (face)</li><li>Lateral Confinement</li><li>Simplified Vegetation Structure</li><li>Minimal Vegetation Recruitment</li></ul>	<b>Stabilize streambank and enhance riparian corridor.</b>	<ul style="list-style-type: none"><li>Reconstructed Bank (Typical Graphic C-1)</li></ul>	<ul style="list-style-type: none"><li>Topographic and Visual Survey</li><li>Bank Stability Modeling</li><li>Ballasting Calculations</li></ul>	<ul style="list-style-type: none"><li>Details</li><li>Specifications</li><li>Materials List/Quantities</li><li>Cost Estimate</li></ul>	<ul style="list-style-type: none"><li>Staking</li><li>Construction Training</li><li>Inspection</li></ul>
1-8	0.15 (LB)	<ul style="list-style-type: none"><li>Eroding Banks (toe)</li><li>Eroding Banks (face)</li><li>Lateral Confinement</li><li>Denuded and/or Compacted Soils</li><li>Simplified Vegetation Structure</li><li>Minimal Vegetation Recruitment</li></ul>	<b>Stabilize streambank and enhance riparian corridor.</b> Exclude / redirect recreation access.	<ul style="list-style-type: none"><li>Riparian Buffer Enhancement</li></ul>	<ul style="list-style-type: none"><li>Visual Survey</li></ul>	-	<ul style="list-style-type: none"><li>Staking</li></ul>

To alleviate erosion caused by recreation use, hardened river access to direct activity (Treatment 1-1) and riparian buffer enhancement with fencing would limit recreation access within the riparian corridor (Treatment 1-8). Streambank reconstruction (Treatment 1-7) would stabilize the streambank and enhance the riparian corridor. Construction of a mid-bar-forming engineered log feature (ELF) (Treatment 1-4) and lowering of the right streambank to reconnect the floodplain (Treatment 1-5) together would reduce velocities along the eroding left streambank, promote sediment deposition to narrow the channel, and enhance the riparian corridor. Additional modeling analyses will be required prior to implementation of these two potential treatment concepts to determine the value and design of the floodplain reconnection and engineered features.

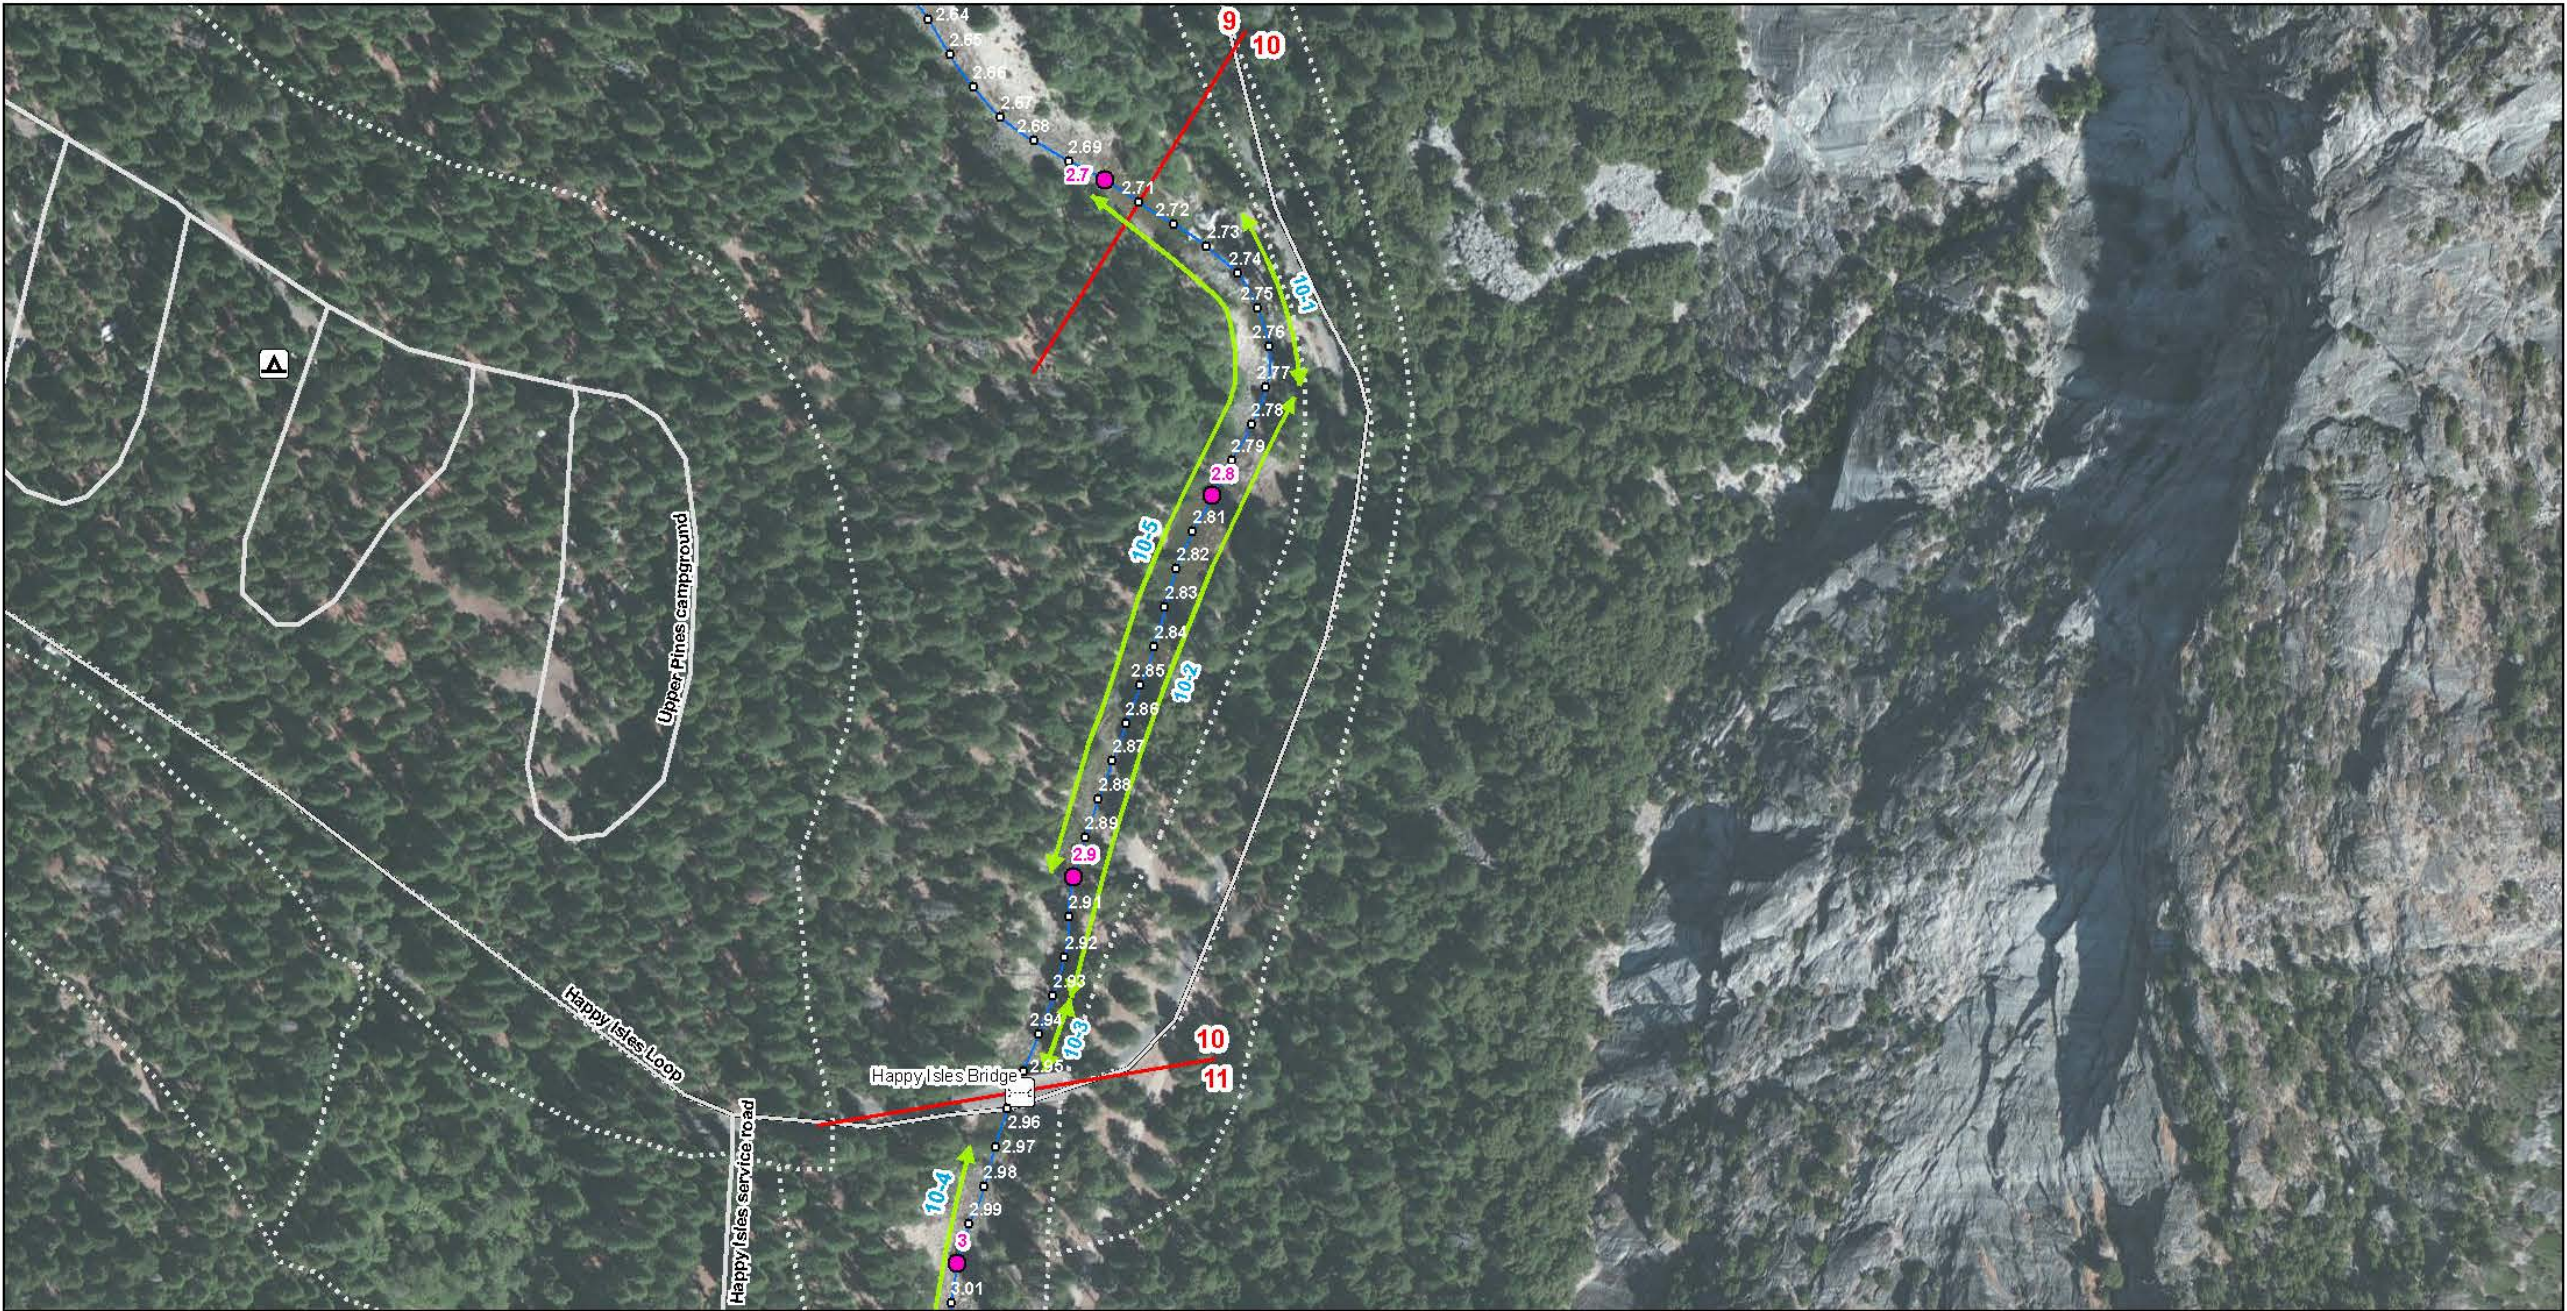
Reach and Treatment ID # (Map ID)	Location (River Miles) (LB or RB)	Existing Condition and Recommendations			Implementation Needs		
		Problems and Issues	Treatment Objective	Treatment Type	Analyses	Design	Field Oversight
Reach 10	RM 2.71-2.95						
10-1	2.73-2.77 (RB)	<ul style="list-style-type: none"><li>Artificial Bank Protection</li><li>Denuded and/or Compacted Soils</li><li>Simplified Vegetation Structure</li><li>Minimal Vegetation Recruitment</li></ul>	<b>Stabilize streambanks and enhance riparian corridor.</b> Remove existing riprap and plant native vegetation.	<ul style="list-style-type: none"><li>Selective Riprap Removal (Typical Graphic C-2)</li></ul>	<ul style="list-style-type: none"><li>Visual Survey</li></ul>	<ul style="list-style-type: none"><li>Specifications</li></ul>	<ul style="list-style-type: none"><li>Construction Training</li></ul>
10-2	2.77-2.93 (RB)	<ul style="list-style-type: none"><li>Artificial Bank Protection</li><li>Eroding Banks (face)</li><li>Simplified Vegetation Structure</li><li>Minimal Vegetation Recruitment</li><li>Disconnected Floodplain / Entrenched Channel</li></ul>	<b>Stabilize streambanks and enhance riparian corridor.</b> Remove existing riprap and plant native vegetation.	<ul style="list-style-type: none"><li>Selective Riprap Removal (Typical Graphic C-2)</li><li>Floodplain Grading and Soil Modification</li></ul> Coordinate with Treatment 10-3 to determine boundary between riprap removal and retention	<ul style="list-style-type: none"><li>Visual Survey</li></ul>	<ul style="list-style-type: none"><li>Specifications</li></ul>	<ul style="list-style-type: none"><li>Staking</li><li>Construction Training</li></ul>

To address bank instability along the right bank, potential treatments involve removal of existing riprap and revegetation (Treatments 10-1 and 10-2). Localized down-cutting and bank erosion immediately downstream of Happy Isle Bridge are potentially caused by the disconnection of high flow channels upstream of the bridge such that now all the high flow is being directed through the bridge. Historically, a portion of the high flows were directed into the high flow channels through a culvert located on the left floodplain. At some point in time, these high flow channels were blocked by large cobbles and boulders. The potential restoration concept at Happy Isle Bridge involves reactivating these high flow channels to allow high flows to be directed through the culverts, and return into the main channel downstream of the bridge (Treatments 10-4 and 10-5). This will reduce channel velocities at the bridge, and it is anticipated it will reduce channel down-cutting and erosion of the right streambank immediately downstream from the bridge. Additional river modeling and engineering design would be required to inform the design prior to implementation.

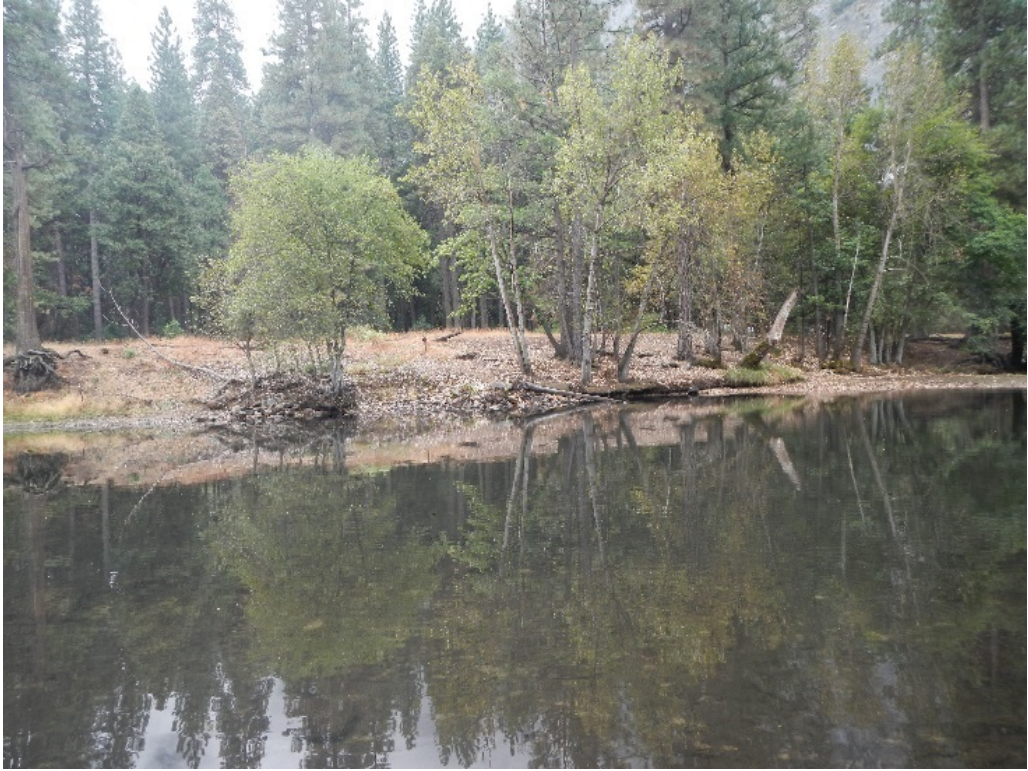
Location (River Miles)	<i>Photos and Caption</i> <i>Describing Problems, Opportunities, or Constraints</i>
1.05-1.16 (LB)

<p data-bbox="532 989 1349 1018">Analog for LWD at upstream end (left bank downstream of Stoneman Bridge)</p>
1.19-1.22 (LB)

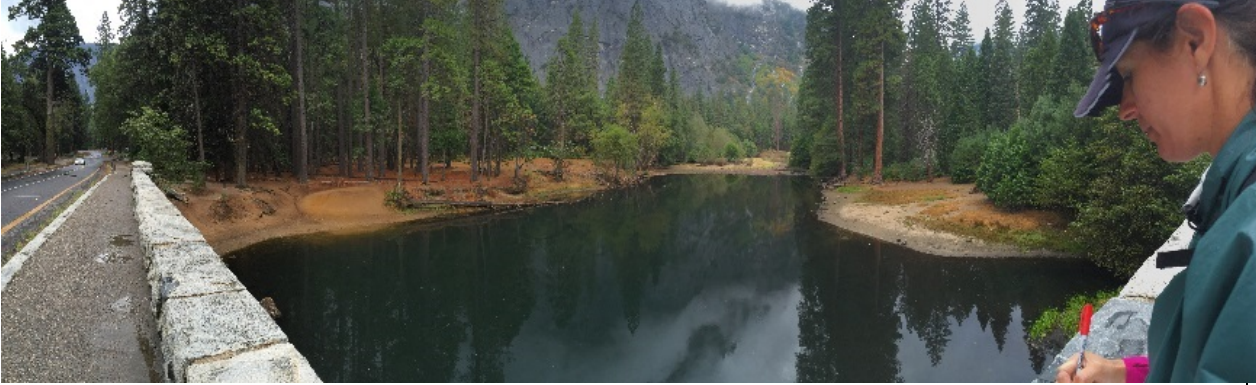
<p data-bbox="743 611 1138 636">DS panorama from Stoneman Bridge</p>
<p data-bbox="90 657 293 720"><b>RM 1.22 – 1.51</b> 1.24-1.51 (RB)</p>	<p data-bbox="329 657 1008 682"><b>Reach 5 – Stoneman Bridge to Ahwahnee Bridge</b></p>
