ANSEL ADAMS GALLERY COMPLEX REHABILITATION

ENVIRONMENTAL ASSESSMENT
APRIL 2014

Yosemite National Park
National Park Service

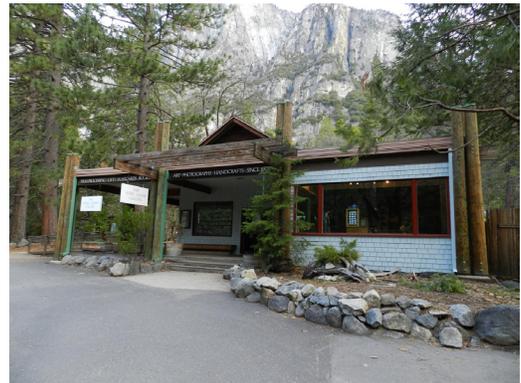
Building 900A

Gallery (Building 900A)

- An existing ramp with handrails was built to make the Gallery main entrance accessible, but this access does not adequately meet park policy.
- The south entrance threshold from the Gallery porch exceeds variance restrictions.
- The lower retail level is approximately 16 inches higher than the upper retail level.
- The Gallery's west entrance door swings opposite of the direction of exit travel.
- There is no accessible employee restroom. (The closest accessible restroom is in the public restrooms located to the west, between the Visitor Center and Museum.)

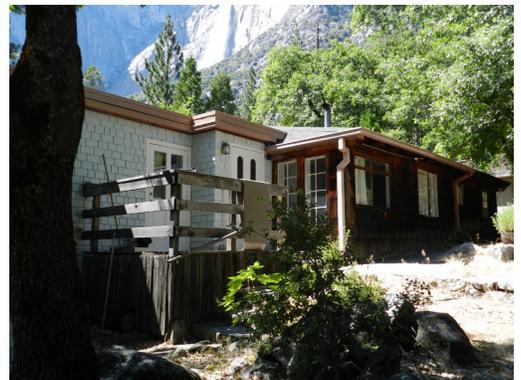
Building 900B

Family Residence (Building 900B)

- East entry terrain is steep and rocky.
- East entry porch elevated 3 feet above grade.
- Vestibule area of entry does not provide adequate clearance for door swing.
- Door width and swing inadequate throughout.
- No accessible bath fixtures and grab bars.

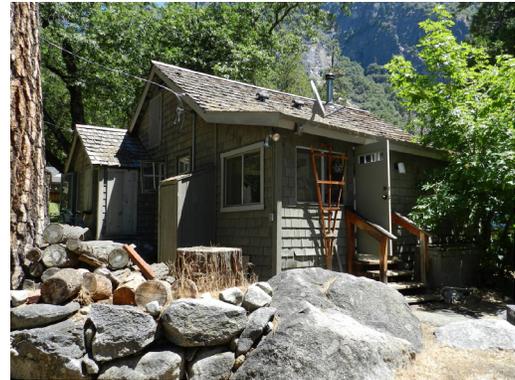
Building 902

Duplex (Building 902)

- South and west entry terrain is steep and rocky.
- South entry is considerably above grade.
- Vestibule areas of entry areas do not provide adequate clearance for door swing.
- Door width and swing inadequate throughout.
- No accessible bath fixtures and grab bars.

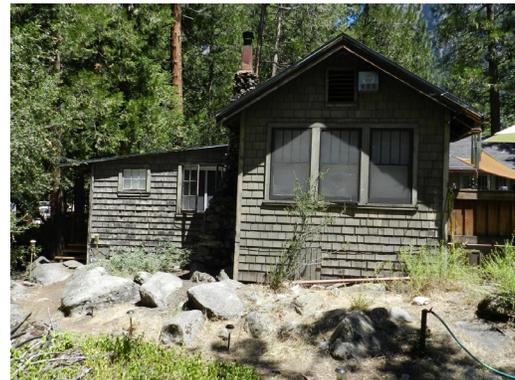
Building 904

Upper Residence (Building 904)

- East and west entry terrain is steep and rocky considerably elevated above grade.
- Vestibule areas of entry areas do not provide adequate clearance for door swing.
- Door width and swing inadequate throughout.
- No accessible bath fixtures and grab bars.

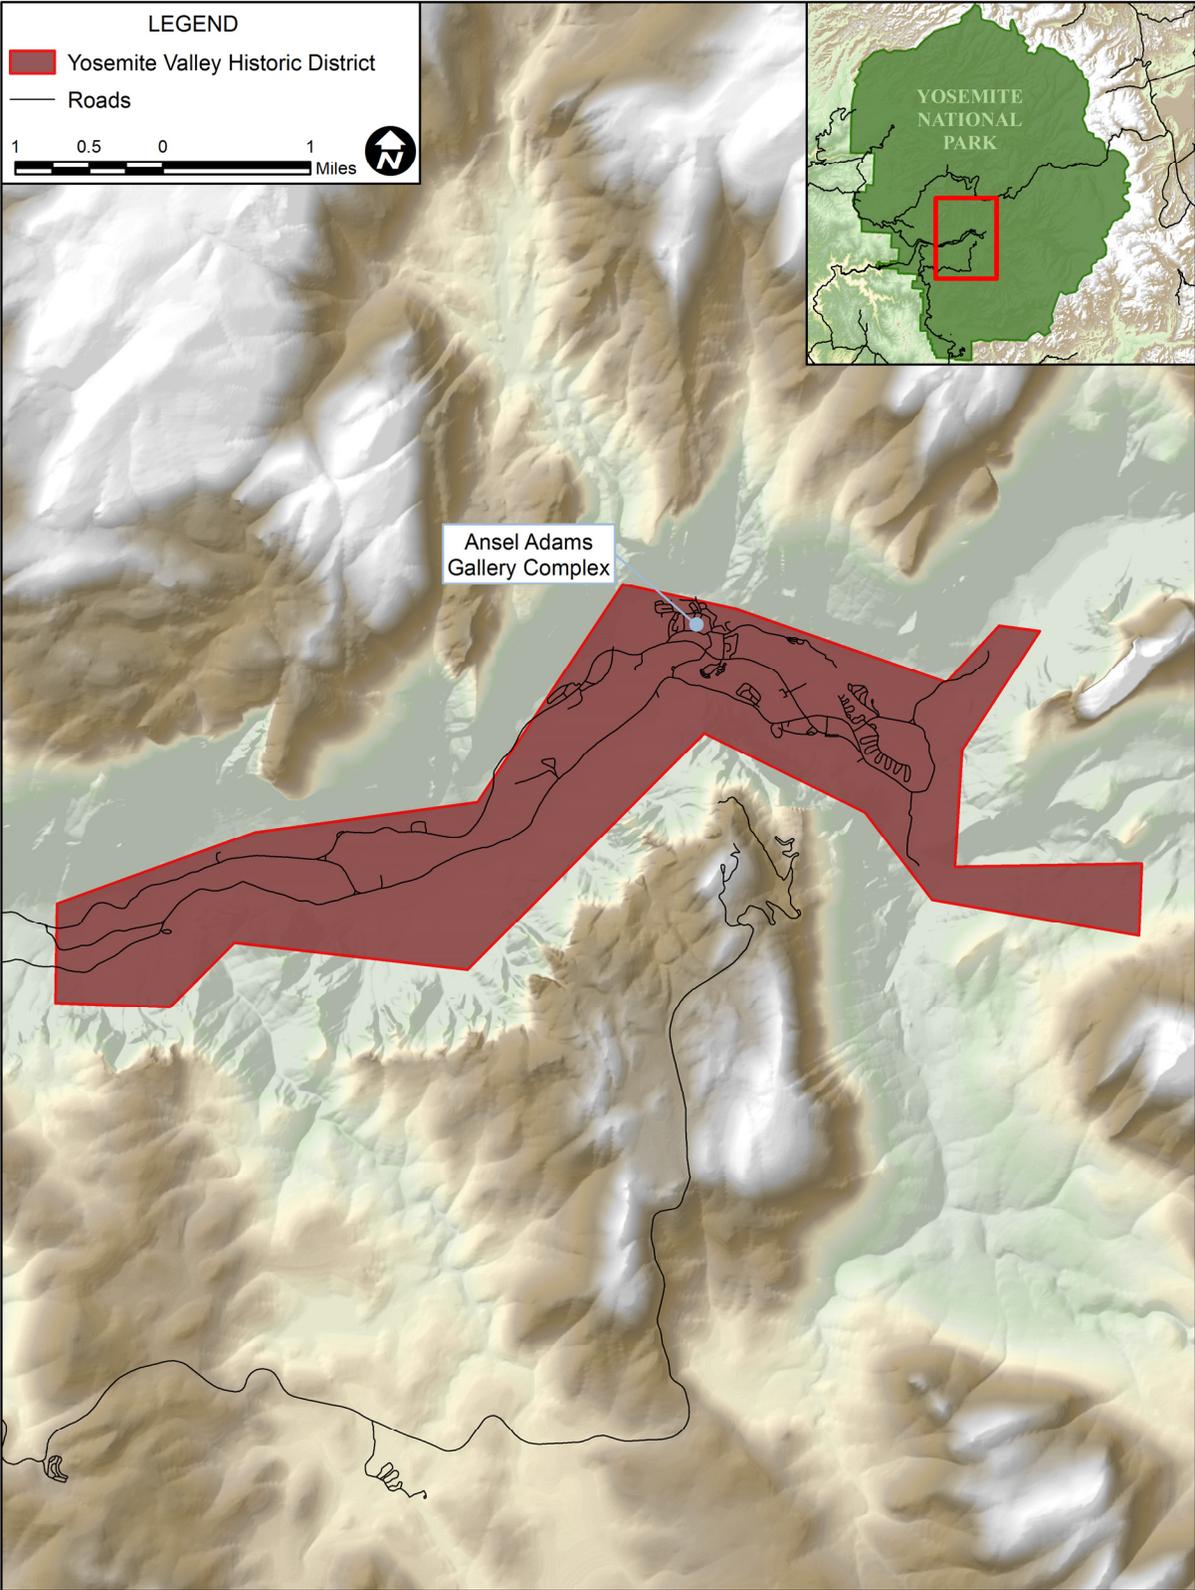
FIGURE 3-1. AREA OF POTENTIAL EFFECTS FOR THE ANSEL ADAMS GALLERY COMPLEX REHABILITATION PROJECT

Area of Potential Effects for this Project. As defined under NHPA section 106, the area of potential effects for this project is the Yosemite Valley Historic District, which encompasses properties included in the Yosemite Village Historic District and the Yosemite Valley Archeological District (Figure 3-1).

Affected Environment. The APE for the Ansel Adams Gallery complex project sits atop a large archeological site complex referred to as CA-MRP-56/H (refer to Figure 3-1). This site complex is located within the Yosemite Valley Archeological District.

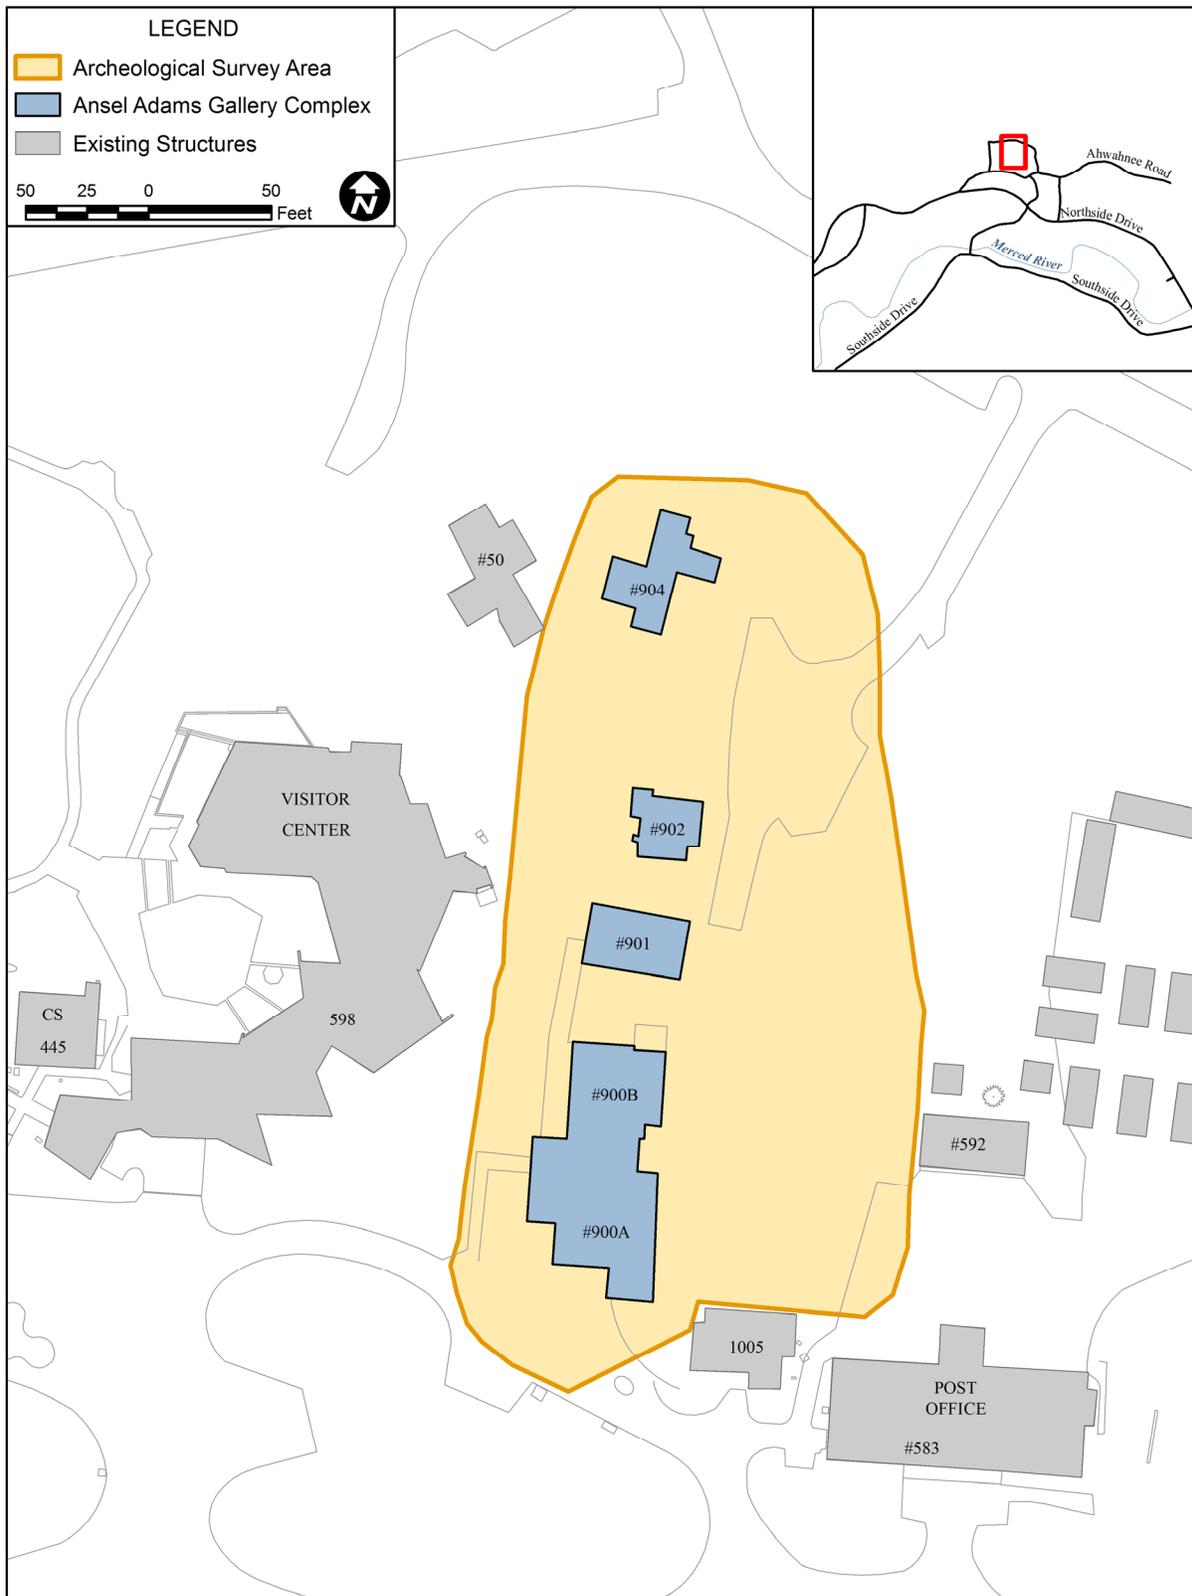
FIGURE 3-2. ARCHEOLOGICAL SURVEY AREA OF ANSEL ADAMS GALLERY SITE

Archeological testing and evaluation of the portion of CA-MRP-56/H within the area of the planned rehabilitation improvements to the Ansel Adams Gallery complex was conducted to determine the potential for impacts to CA-MRP-56/H by the proposed project undertaking. Figure 3-2 shows the boundaries of the archeological investigation, which included ethnohistorical research, systematic surface pedestrian survey, and test excavations focused on areas of subsurface disturbance for the rehabilitation project (e.g., foundation footings, utility lines, path construction or reconstruction). The field investigation identified four undocumented surface archeological features, 1,022 prehistoric-era artifacts, and 1,072 historic-era artifacts (Schneider *et al.* 2012). These investigations revealed several locations within the rehabilitation project area that retain integrity and possess archeological data potential capable of yielding important scientific information. Tribal consultations conducted for both the archeological project and the larger proposed rehabilitation project confirmed that the archeological resources are considered to possess cultural and religious significance.
