NATIONAL PARK SERVICE EVERGLADES NATIONAL PARK

Cape Sable Dams Restoration – Phase II Topographic and Bathymetric Survey Report

August 2015

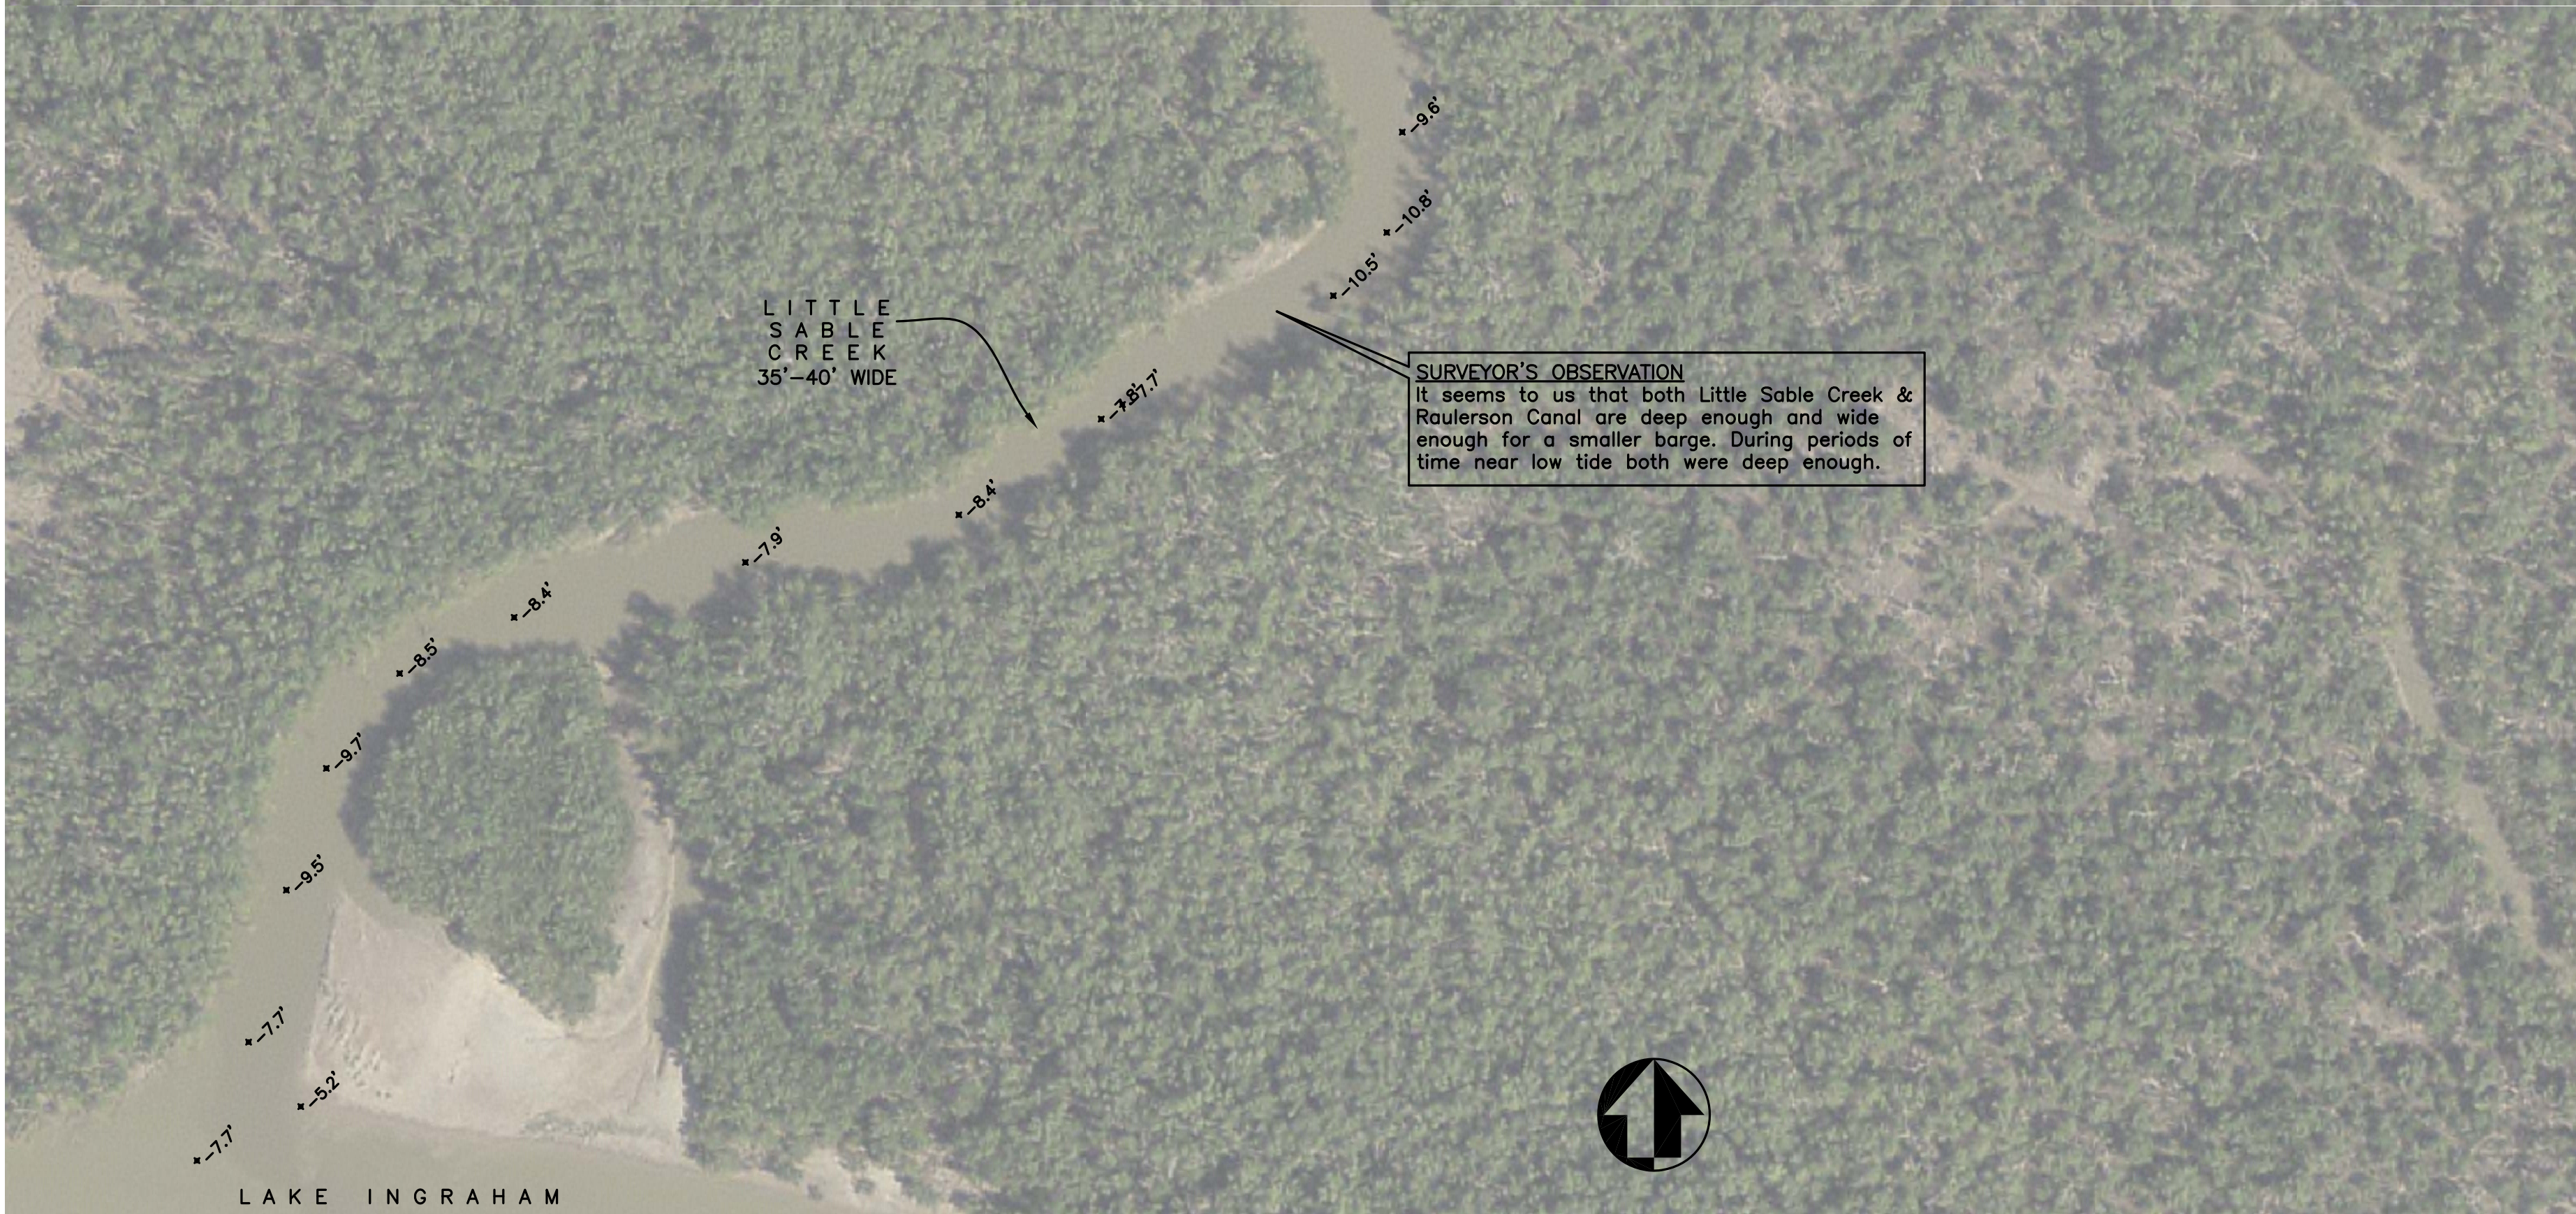
○ = High points in vicinity of proposed dam location

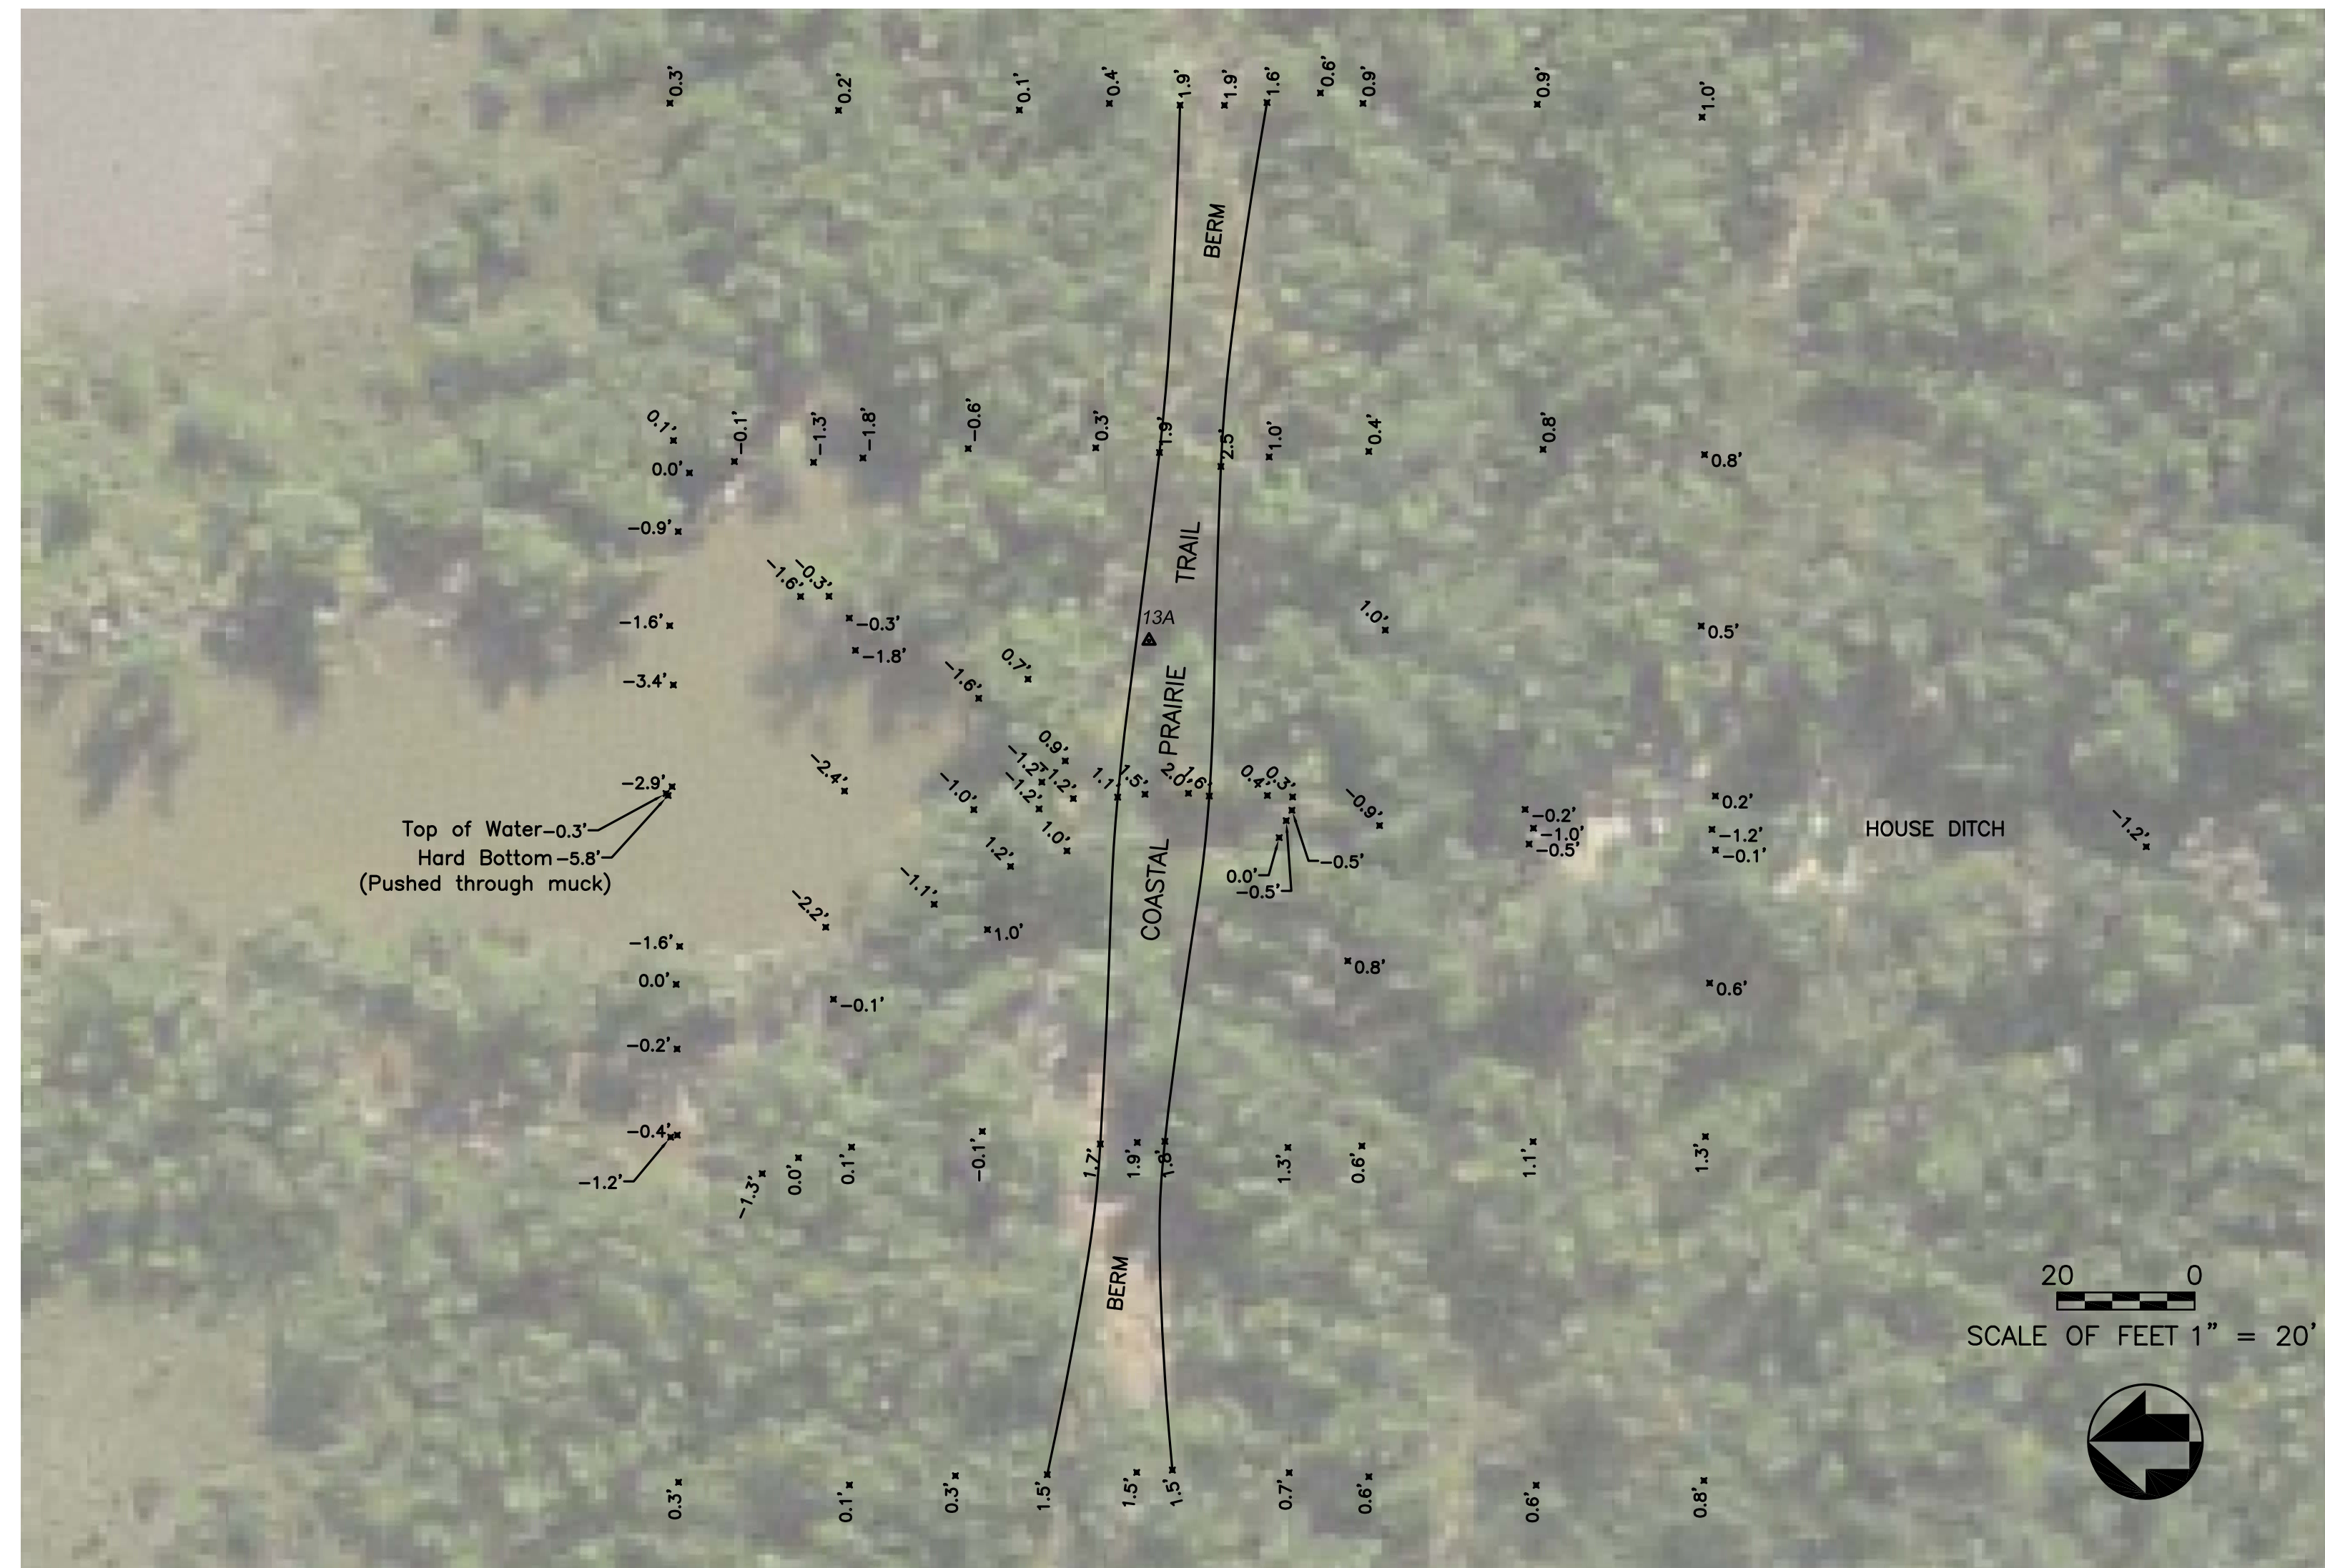
SLAGLE DITCH DAM

DETAIL DITCH DAM AREA

Based on the topographic survey data collected along the House and Slagle Ditches, it appears that the existing earthen dams are located at the approximate topographic high point in the area associated with what is assumed to be the Marl Ridge (see Sheets 4 and 5, respectively, of Appendix A). Therefore, these areas (see Figures 2a and 2b for House Ditch and Figures 3a and 3b for Slagle Ditch) would be an appropriate selection for future dam locations, contingent upon a full NEPA analysis of the dam alternatives.
